DeKalb County School District/Admin/Support

Administrative and Instructional Complex (AIC) Facility (EAHS and DECA)

School Assessment Report

May 19, 2016

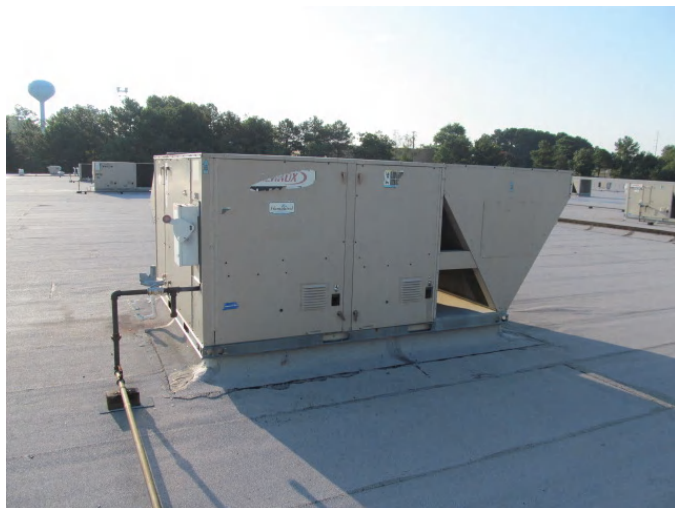
System: D3050 - Terminal & Package Units

Location: Roof

Distress: Damaged

Notes: All of the original ERTUs, comprising approximately 25% of the total rooftop units, are rusted; failing; reported as damaged, leaking and working intermittently; and should be replaced.

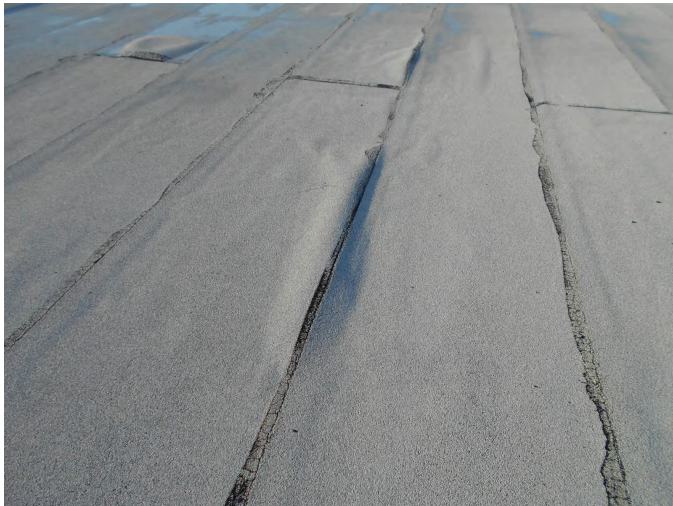
System: B3010 - Roof Coverings - BUR

Location: Roof

Distress: Damaged

Notes: The roof covering is delaminating, has numerous leaks, and should be replaced.

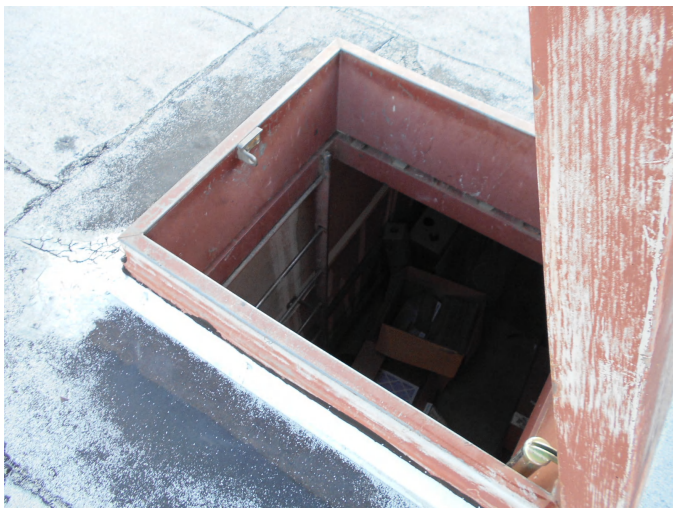
System: B3020 - Roof Openings

Location: Roof

Distress: Beyond Service Life

Notes: The roof hatch is not safe for maintenance personnel. The ladder rungs do not extend high enough for a person to safely exit and enter the hatch. Recommend installation of an approved roof hatch/ladder system for all hatches, and replace all roof openings in conjunction with roof covering replacement.

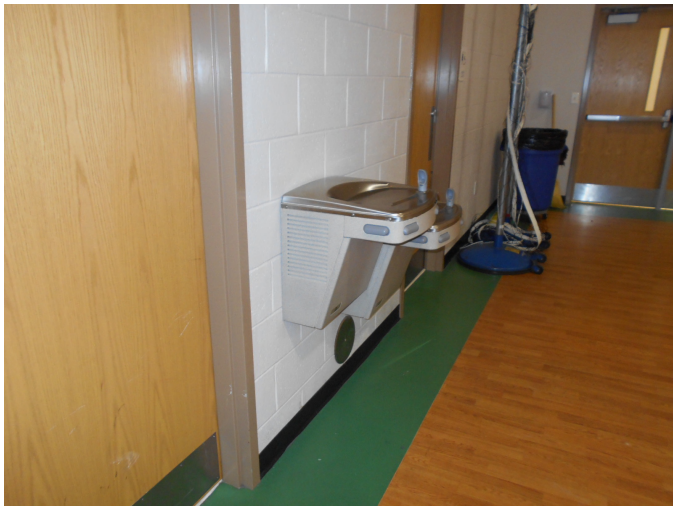
System: D2010 - Plumbing Fixtures

Location: Throughout Building

Distress: Needs Remediation

Correction: Remove/replace drinking fountain w/recessed ADA compliant drinking fountain

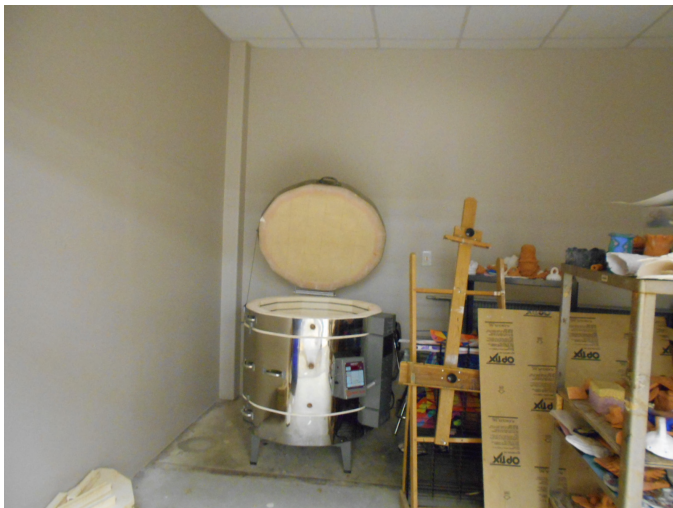
System: D3040 - Distribution Systems & Exhaust Systems

Location: Room B120 Art

Distress: Missing

Notes: The kiln does not have an exhaust hood. Recommend installation of a heat exhaust hood/system.

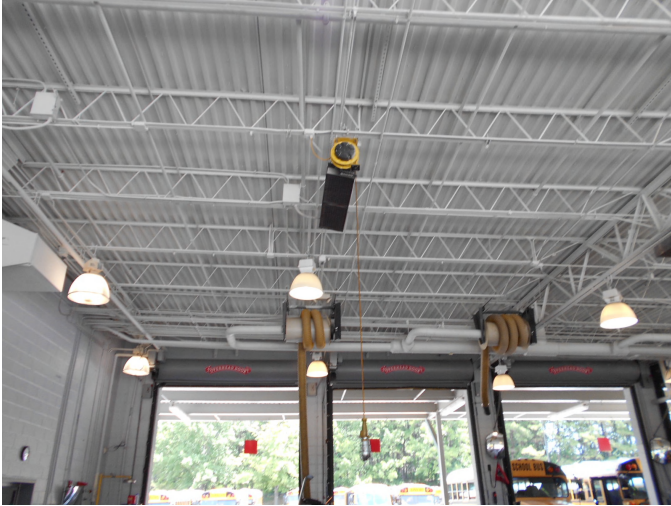
System: B3020 - Roof Openings

Location: Roof

Distress: Missing

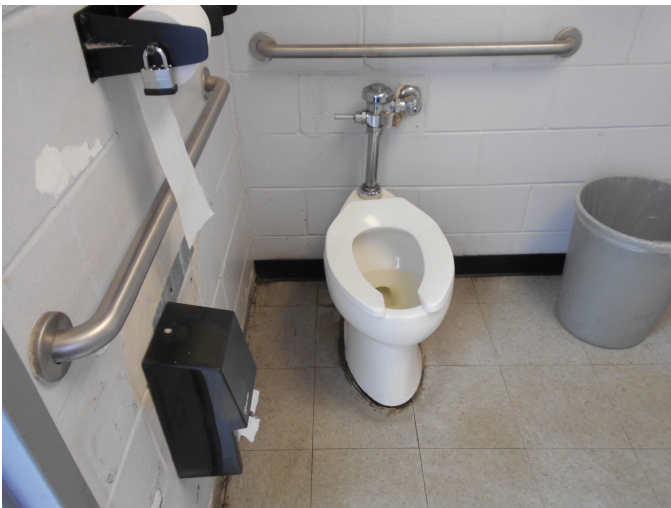
System: C3010 - Wall Finishes - Paint

Location: Throughout Building

Distress: Beyond Service Life

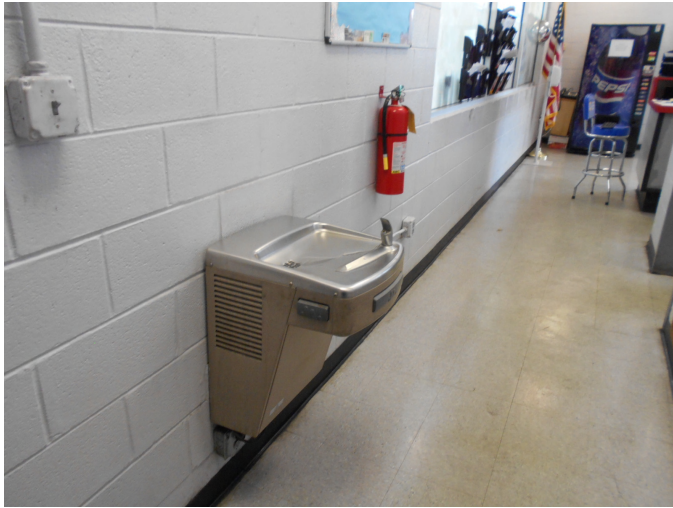
System: D2010 - Plumbing Fixtures

Location: Hallway

Distress: Needs Remediation

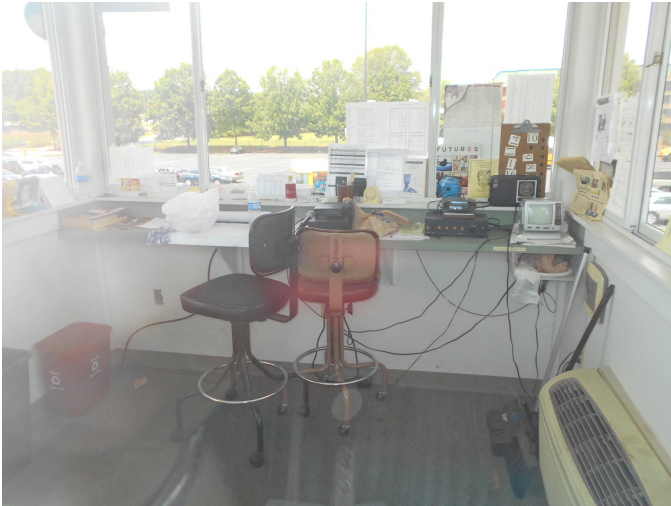
System: C3020 - Floor Finishes

Location: Tower Office

Distress: Beyond Service Life

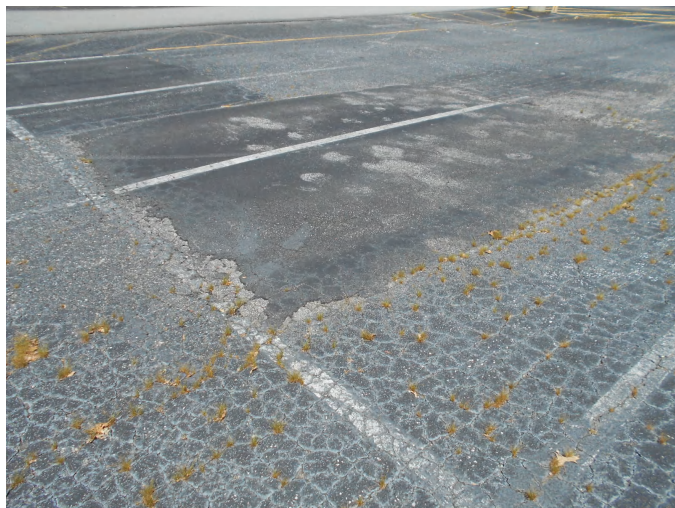
System: G2020 - Parking Lots

Location: Site

Distress: Damaged
