DeKalb County School District/Elementary Schools

Allgood Elementary

School Assessment Report

May 19, 2016

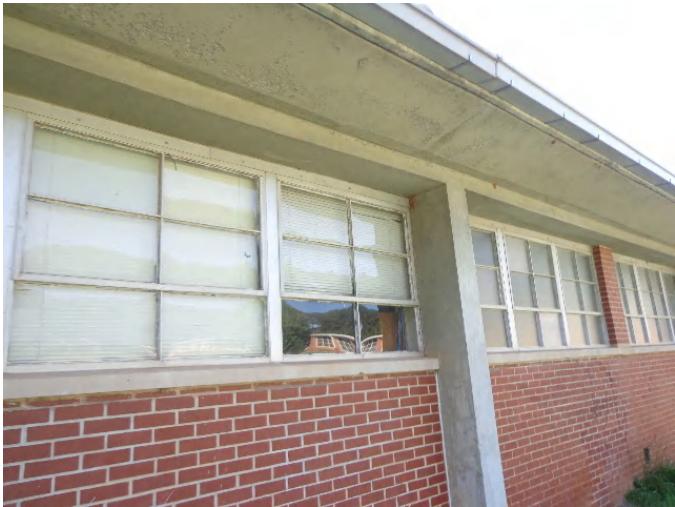
System: B2020 - Exterior Windows

Location: Throughout Building

Distress: Beyond Service Life

Notes: The metal frame, fixed, single pane windows are aged, rusted, not energy efficient, and should be replaced.

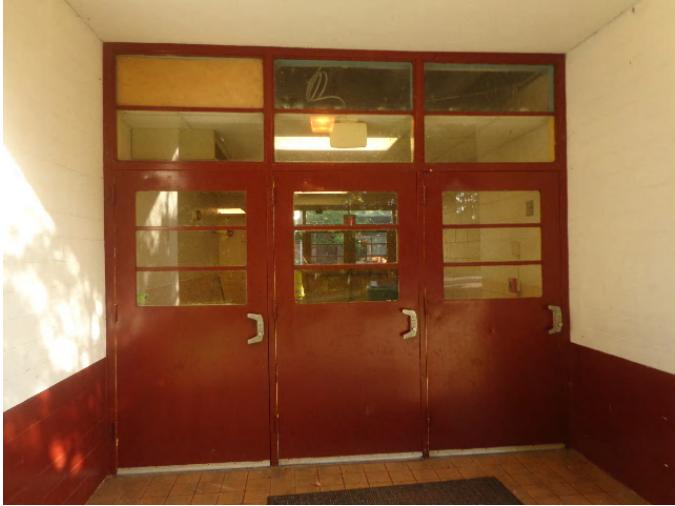
System: B2030 - Exterior Doors

Location: Throughout Building

Distress: Beyond Service Life

Notes: The exterior doors are aged and rusted, do not lock/seal properly, and should be replaced.

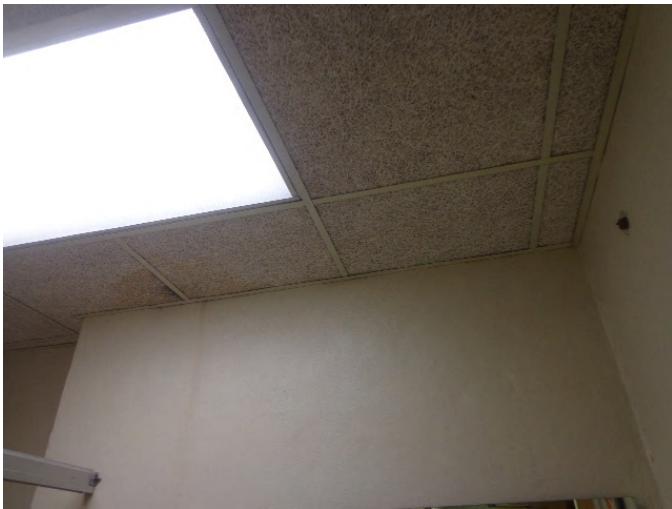
System: C3010 - Wall Finishes - Paint

Location: Throughout Building

Distress: Beyond Service Life

Notes: The painted wall finishes are beyond their expected service life, damaged, scuffed and stained, and should be replaced.

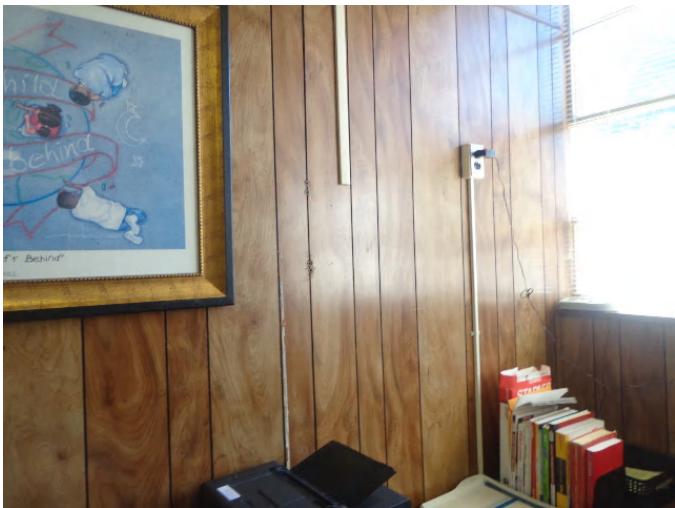
System: C3010 - Wall Finishes - Wall Paneling

Location: Offices

Distress: Beyond Service Life

Notes: The wall panels are aged and should be replaced.

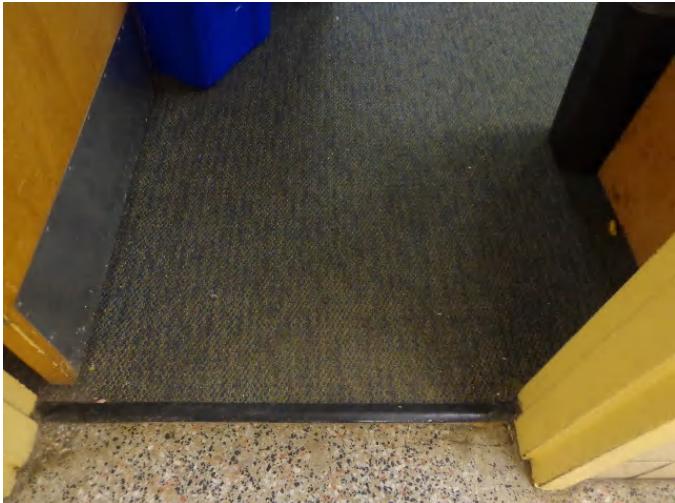
System: C3020 - Floor Finishes - Carpet

Location: Throughout Building

Distress: Beyond Service Life

Notes: The carpet is beyond its expected service life, stained, and should be replaced.

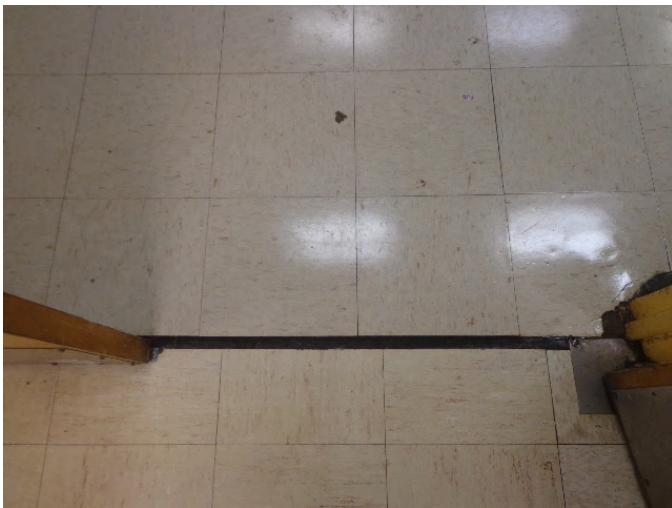
System: C3020 - Floor Finishes - VCT

Location: Throughout Building

Distress: Beyond Service Life

Notes: The VCT flooring is aged, cracked and worn, and should be replaced.

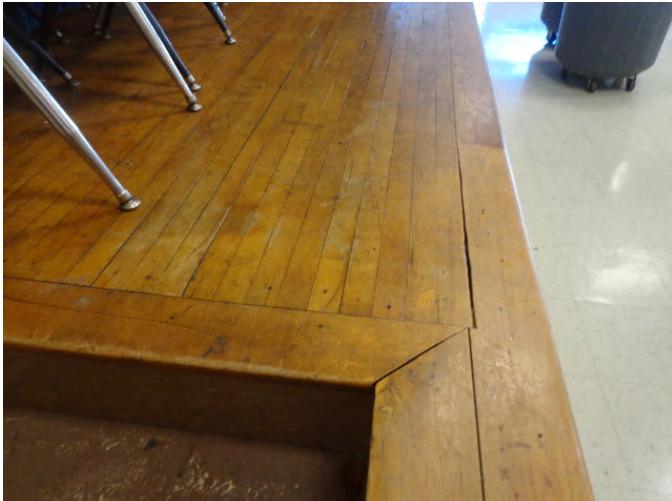
System: C3020 - Floor Finishes - Wood

Location: Stage

Distress: Beyond Service Life

Notes: The original wood flooring is in poor condition and should be replaced.

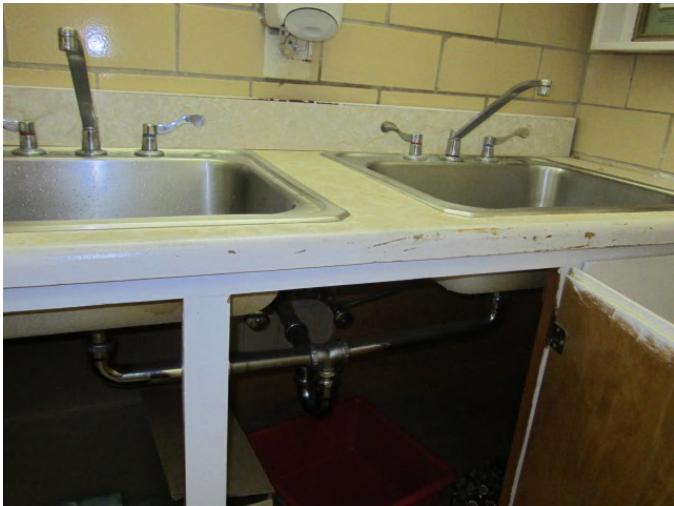
System: D2020 - Domestic Water Distribution

Location: Throughout Building

Distress: Beyond Service Life

Notes: The domestic water distribution system is beyond its expected service life, aged, and should be scheduled for replacement. Domestic water heaters/converters not equipped with adequate expansion compensation. Water is reported to be unclear after a long weekend or holiday. SPLOST project 300-422 to replace water storage tanks with gas fired water heater.

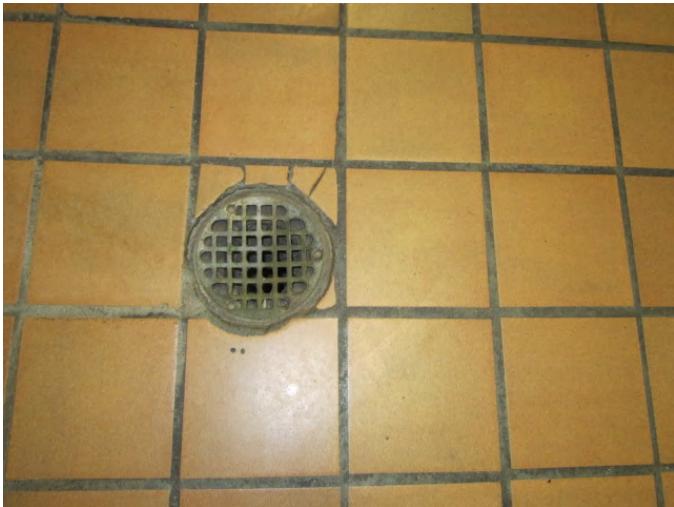
System: D2030 - Sanitary Waste

Location: Throughout Building

Distress: Beyond Service Life

Notes: The sanitary waste system is beyond its expected service life and should be scheduled for replacement. School staff reports odors in the building. SPLOST project 300-422 to replace sanitary waste lines.

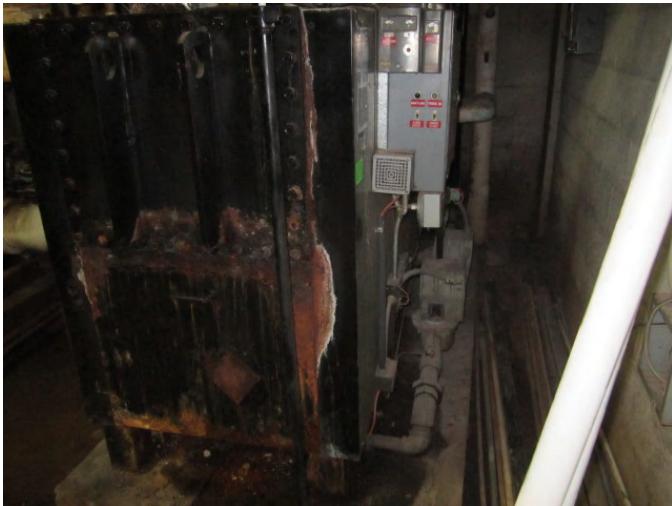
System: D2090 - Other Plumbing Systems - Natural Gas

Location: Throughout Building

Distress: Beyond Service Life

Notes: The natural gas system is beyond its expected service life and should be scheduled for replacement.

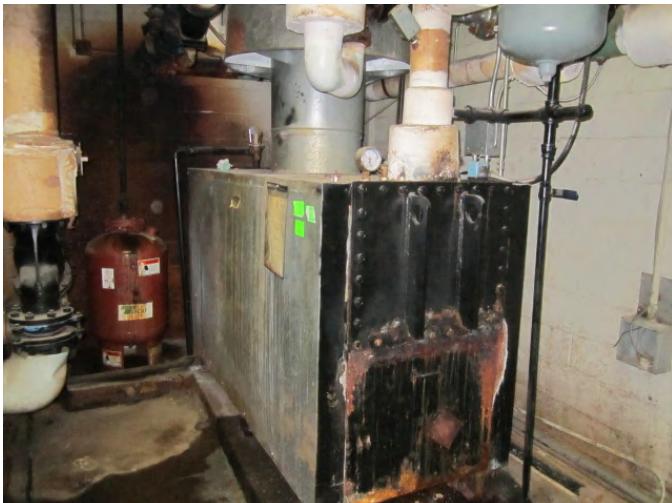
System: D3020 - Heat Generating Systems

Location: Mechanical Room

Distress: Beyond Service Life

Notes: The heat generating system is beyond its expected service life, inadequate, and should be scheduled for replacement. Gas mains serving the burners are not equipped with required vents and redundant valves.

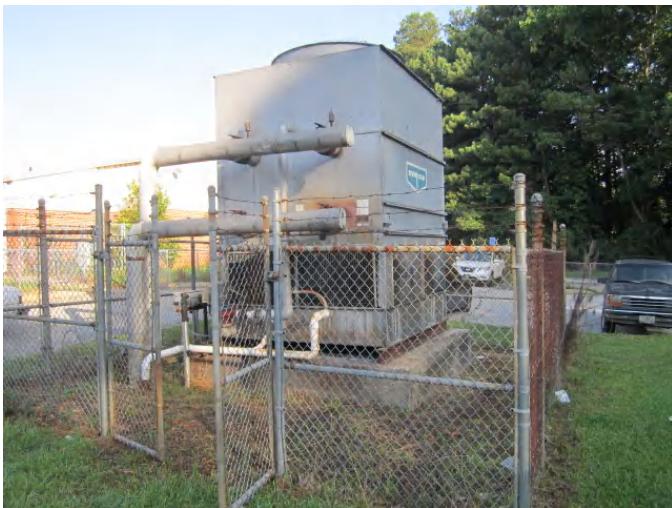
System: D3030 - Cooling Generating Systems

Location: Exterior of Building

Distress: Beyond Service Life

Notes: The cooling generating system is beyond its expected service life, inadequate, and should be scheduled for replacement. SPLOST project 300-422 to replace cooling tower and heat exchanger.

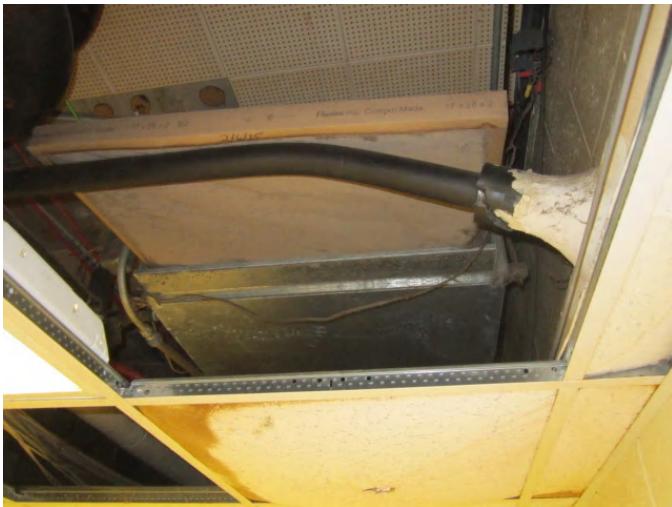
System: D3040 - Distribution & Exhaust Systems

Location: Throughout Building

Distress: Beyond Service Life

Notes: The distribution and exhaust systems are beyond their expected service life, inadequate, and should be scheduled for replacement. School staff reports indoor air-quality problems.

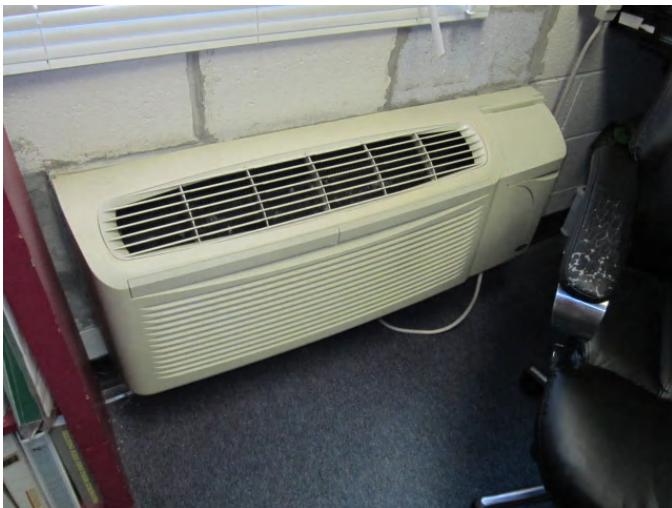
System: D3050 - Terminal & Package Units

Location: Throughout Building

Distress: Beyond Service Life

Notes: The terminal and package units are beyond their expected service life and should be scheduled for replacement.

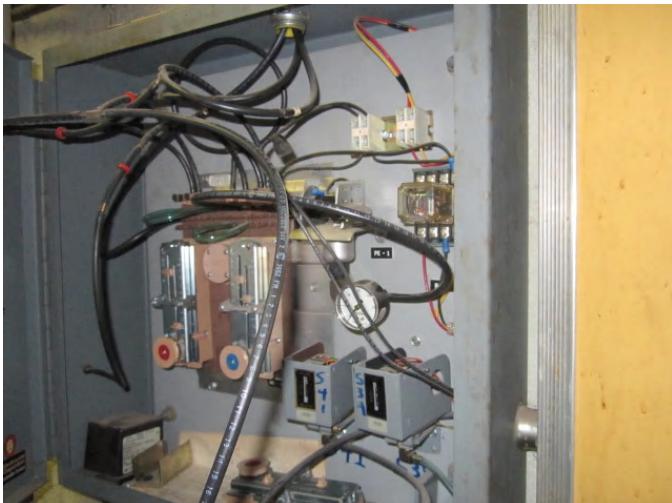
System: D3060 - Controls & Instrumentation

Location: Throughout Building

Distress: Beyond Service Life

Notes: The controls and instrumentation system is beyond its expected service life, aged, obsolete, and should be scheduled for replacement.

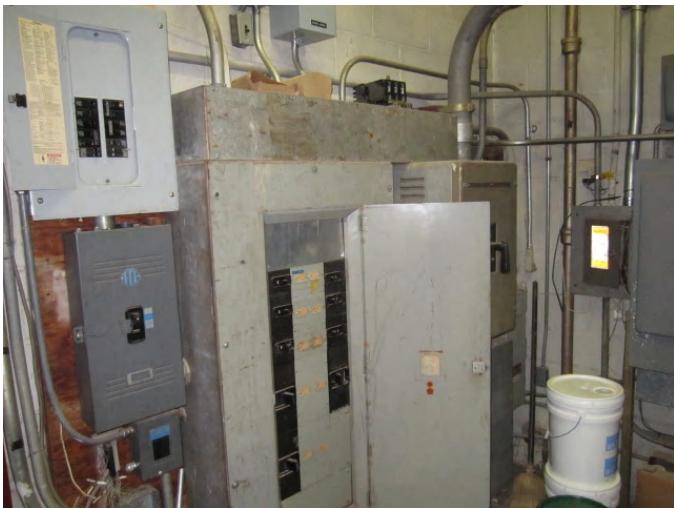
System: D5010 - Electrical Service/Distribution

Location: Main Switch Room/Throughout Building

Distress: Beyond Service Life

Notes: The electrical service/distribution system is beyond its expected service life, aged, and should be scheduled for replacement.

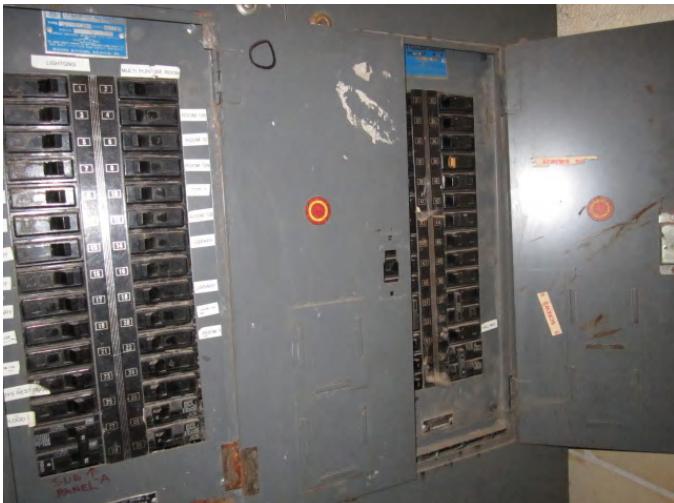
System: D5020 - Branch Wiring

Location: Throughout Building

Distress: Beyond Service Life

Notes: The branch wiring system is beyond its expected service life, aged, and should be scheduled for replacement. GFI electrical outlets are missing in wet areas.

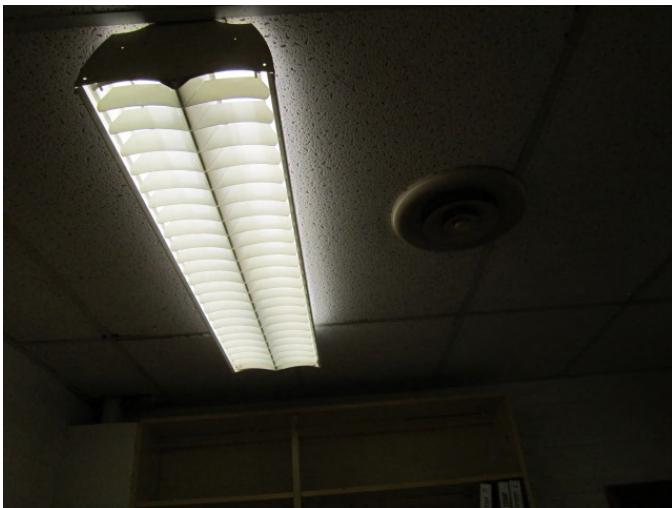
System: D5020 - Lighting

Location: Throughout Building

Distress: Beyond Service Life

Notes: The lighting system is beyond its expected service life, aged, and should be scheduled for replacement. SPLOST project 300-422 to replace lighting throughout the building.

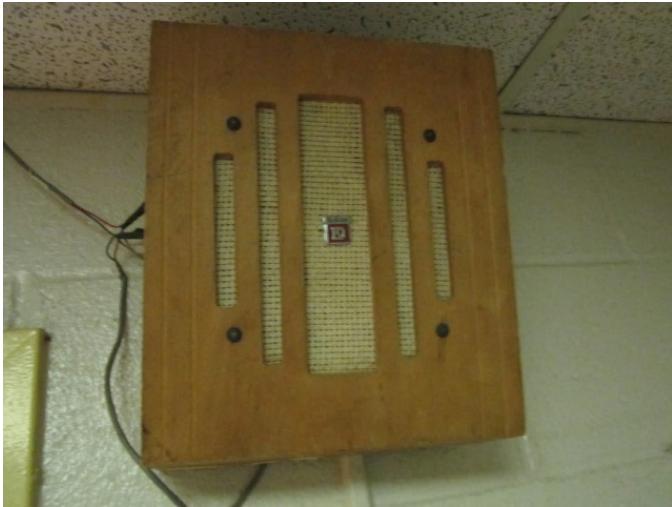
System: D5030 - Communications and Security - Clock & PA Systems

Location: Throughout Building

Distress: Beyond Service Life

Notes: Clock and PA systems are beyond their expected service life, inadequate, and should be scheduled for replacement.

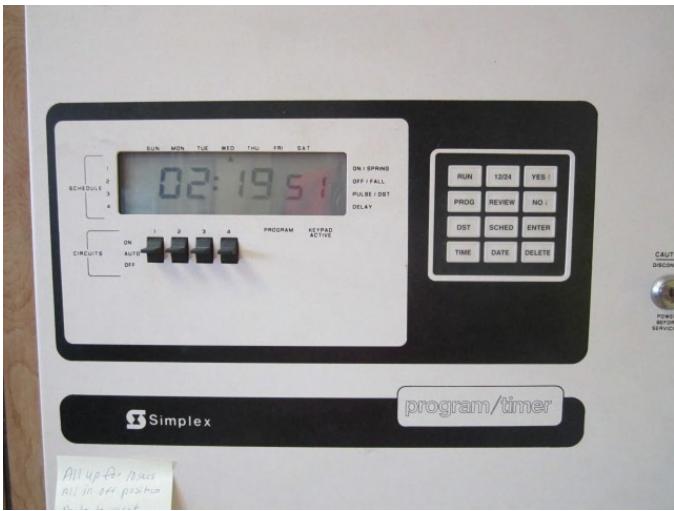
System: D5030 - Communications and Security - Fire Alarm

Location: Throughout Building

Distress: Beyond Service Life

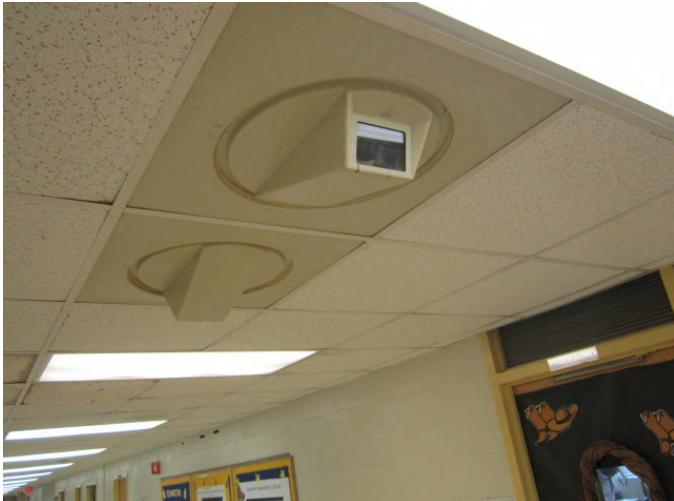
System: D5030 - Communications and Security - Security & CCTV

Location: Throughout Building

Distress: Beyond Service Life

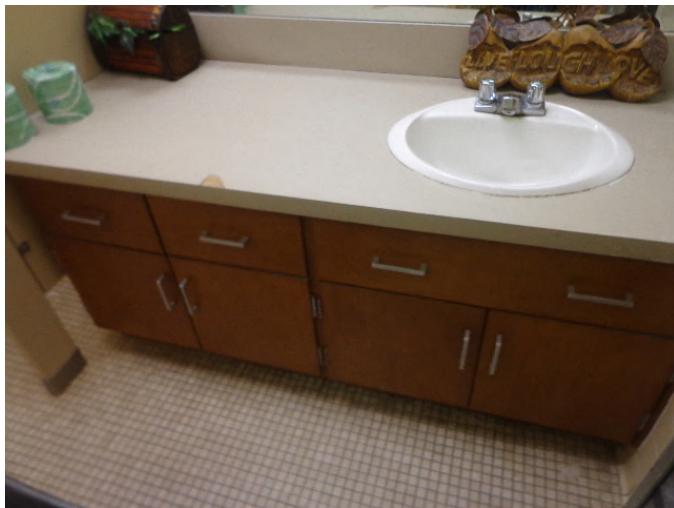
System: E2010 - Fixed Furnishings

Location: Throughout Building

Distress: Beyond Service Life

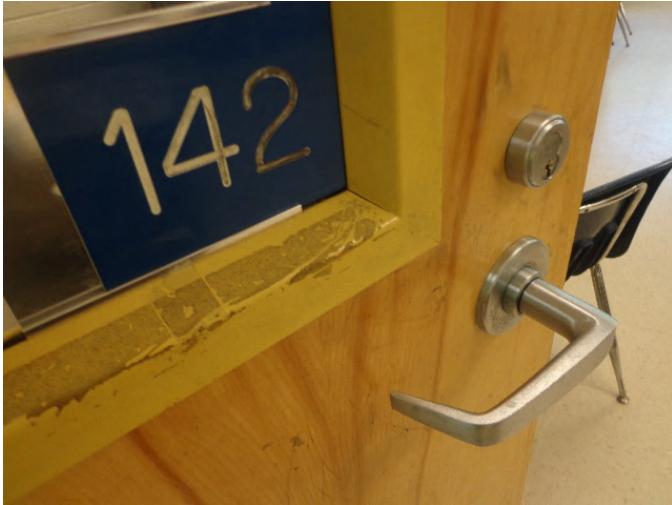
System: C1030 - Fittings

Location: Throughout Building

Distress: Inadequate

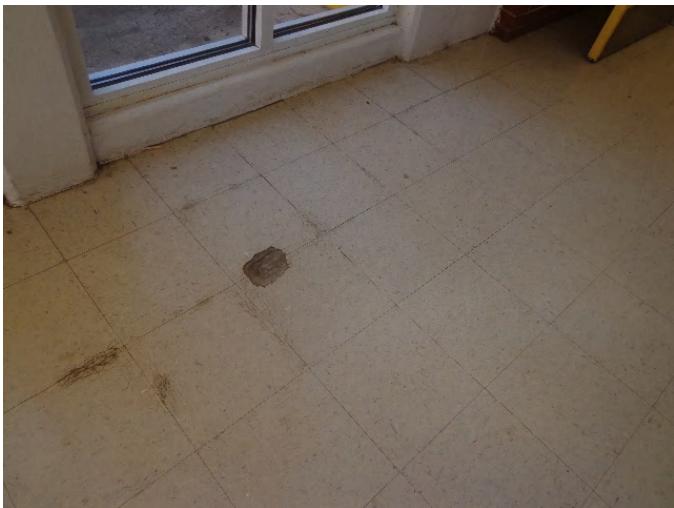
System: C3020 - Floor Finishes - VCT

Location: Throughout Building

Distress: Beyond Service Life

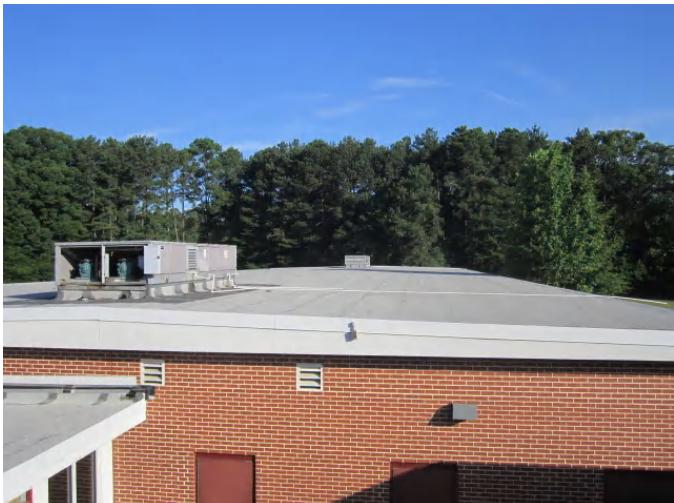
System: D3050 - Terminal & Package Units

Location: Throughout Building

Distress: Beyond Service Life

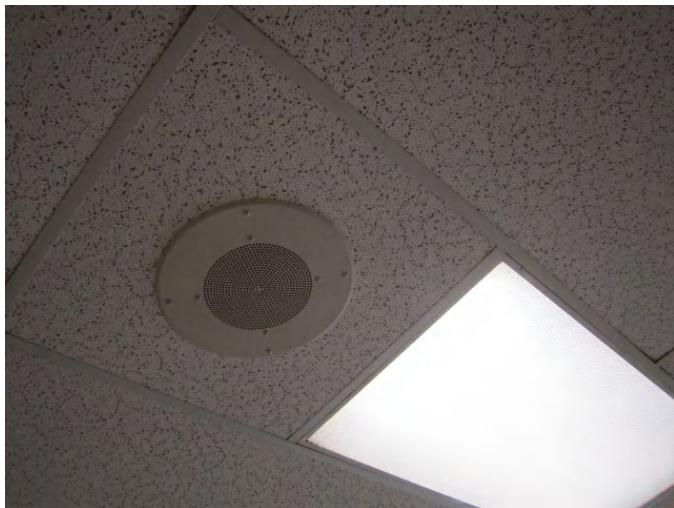
System: D5030 - Communications and Security - Clock & PA Systems

Location: Throughout Building

Distress: Beyond Service Life

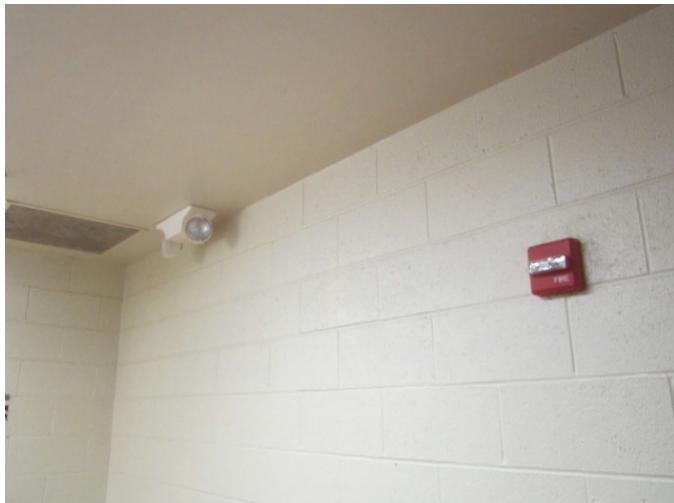
System: D5030 - Communications and Security - Fire Alarm

Location: Throughout Building

Distress: Beyond Service Life

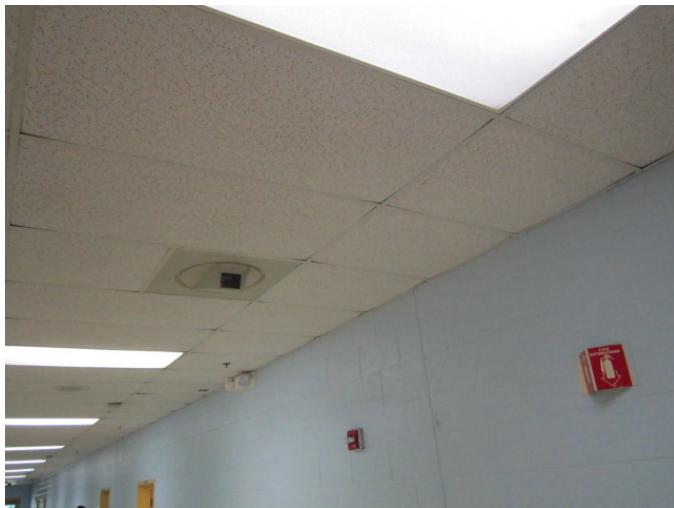
System: D5030 - Communications and Security - Security & CCTV

Location: Throughout Building

Distress: Beyond Service Life

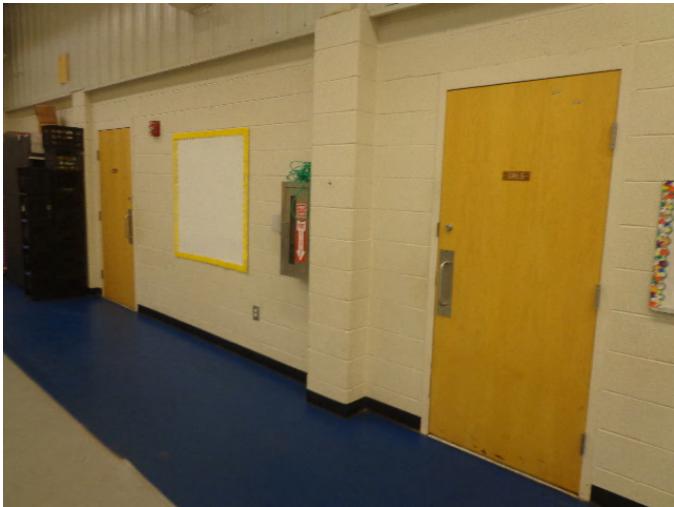
System: C1030 - Fittings

Location: Throughout Building

Distress: Missing

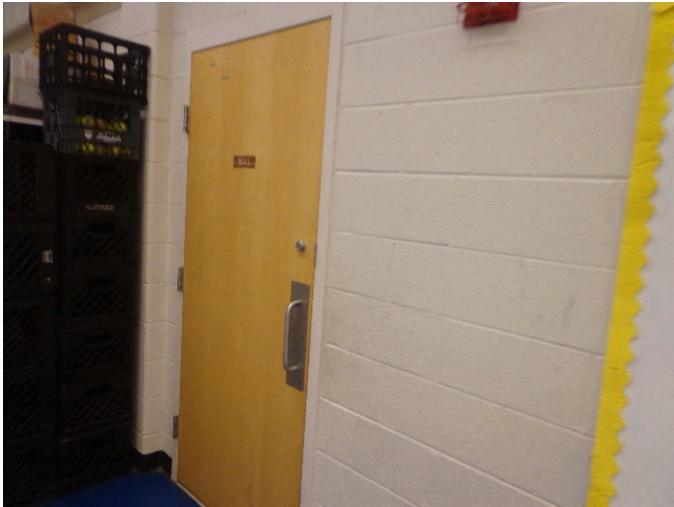
System: C3010 - Wall Finishes - Paint

Location: Throughout Building

Distress: Beyond Service Life

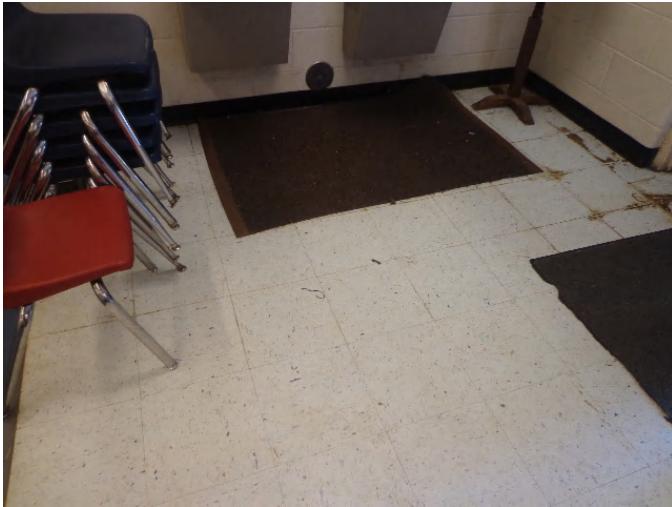
System: C3020 - Floor Finishes - VCT

Location: Entrance Area and Offices

Distress: Beyond Service Life

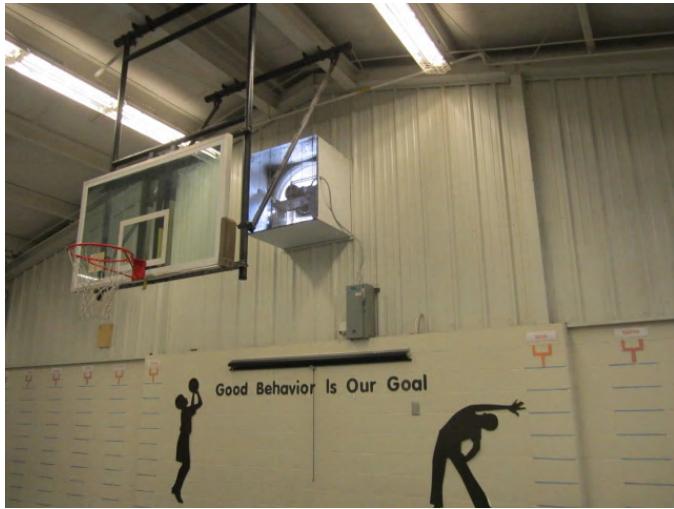
System: D3050 - Terminal & Package Units

Location: Throughout Building

Distress: Inadequate

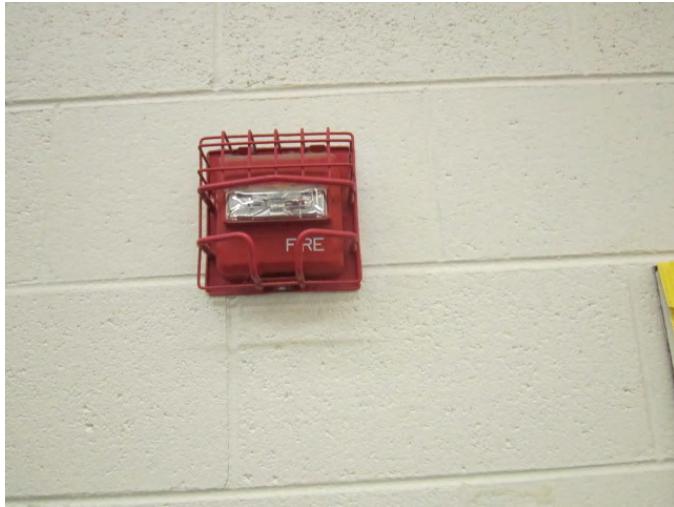
System: D5030 - Communications and Security - Fire Alarm

Location: Throughout Building

Distress: Beyond Service Life

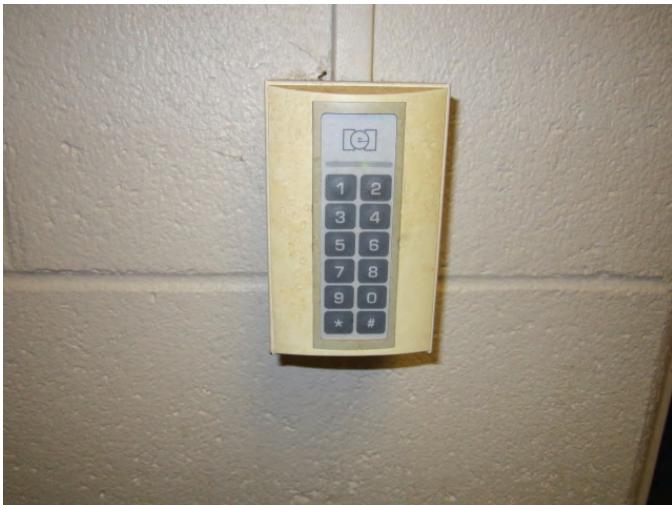
System: D5030 - Communications and Security - Security & CCTV

Location: Throughout Building

Distress: Beyond Service Life

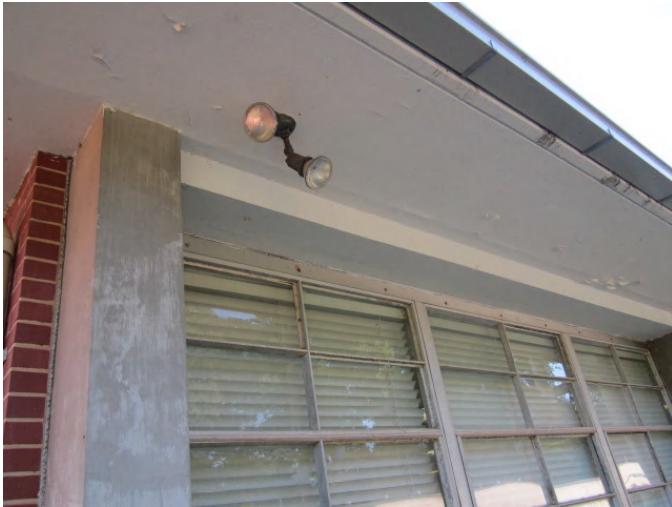
System: G4020 - Site Lighting

Location: Site

Distress: Beyond Service Life

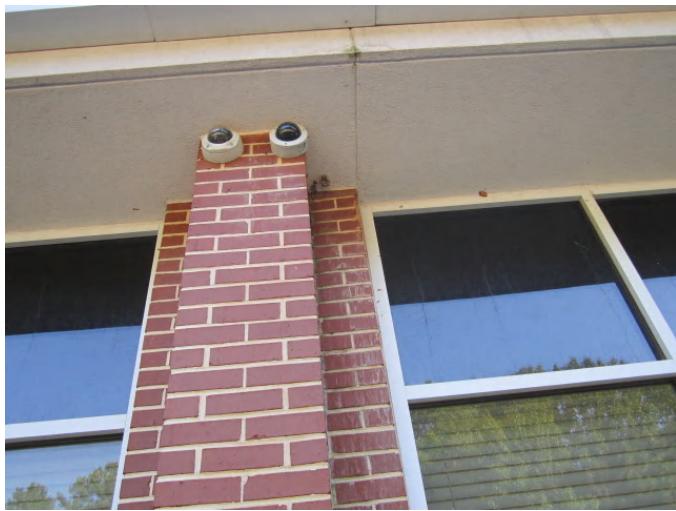
System: G4030 - Site Communications & Security

Location: Site

Distress: Beyond Service Life

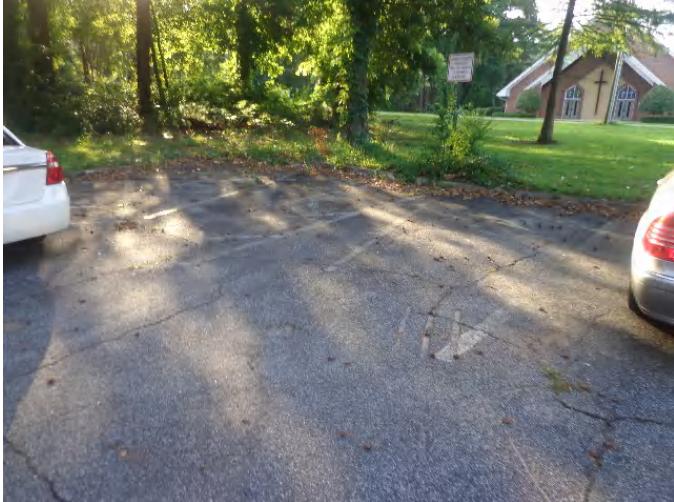
System: G2020 - Parking Lots

Location: Site

Distress: Beyond Service Life

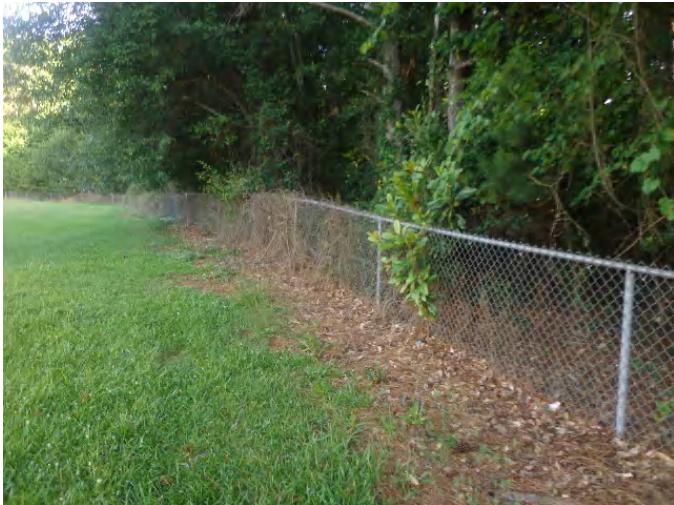
System: G2040 - Fencing & Guardrails

Location: Site

Distress: Beyond Service Life

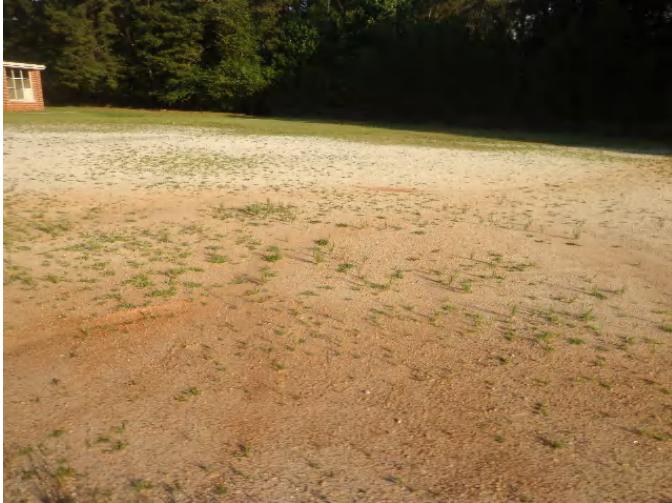
System: G2040 - Playing Field

Location: Site

Distress: Beyond Service Life

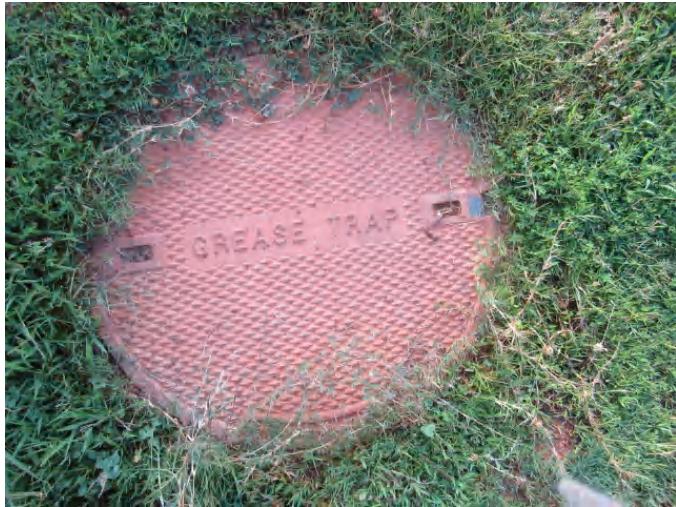
System: G3020 - Sanitary Sewer

Location: Site

Distress: Beyond Service Life

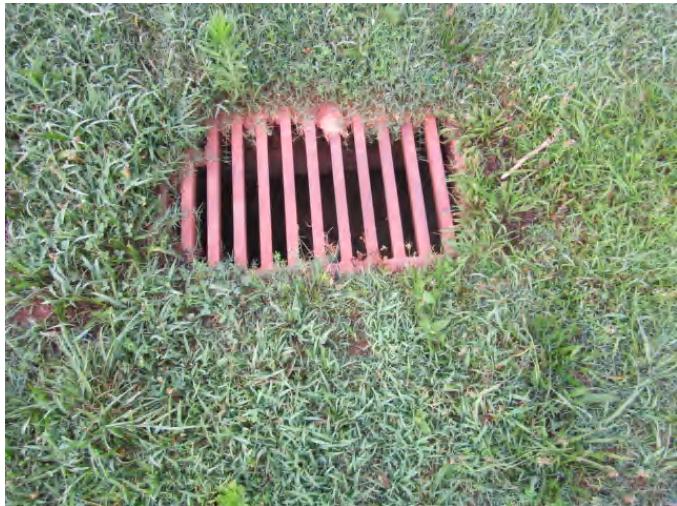
System: G3030 - Storm Sewer

Location: Site

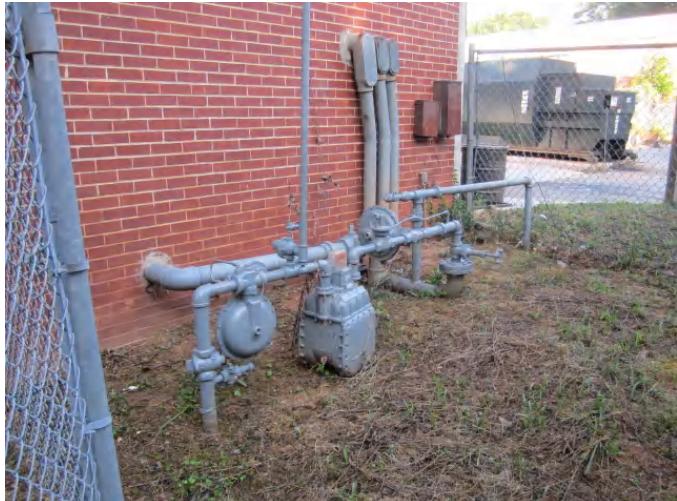
System: G3060 - Fuel Distribution

Location: Site

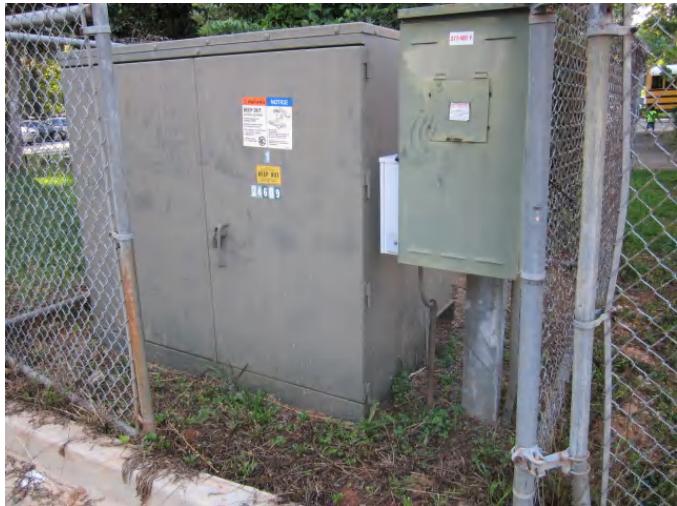
System: G4010 - Electrical Distribution

Location: Site
