DeKalb County School District/Stadiums

Avondale Stadium

School Assessment Report

May 20, 2016

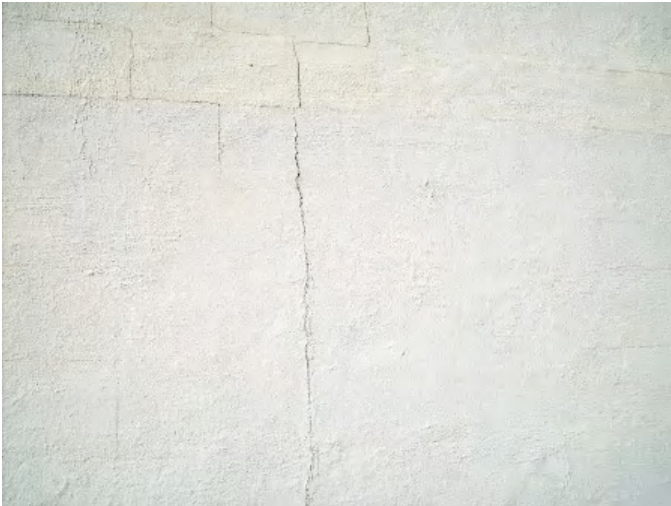
System: B2010 - Exterior Walls

Location: Exterior Walls

Distress: Damaged

Notes: The exterior walls have observable cracks that should be studied by a professional engineer. Pricing does not include remediation measures.

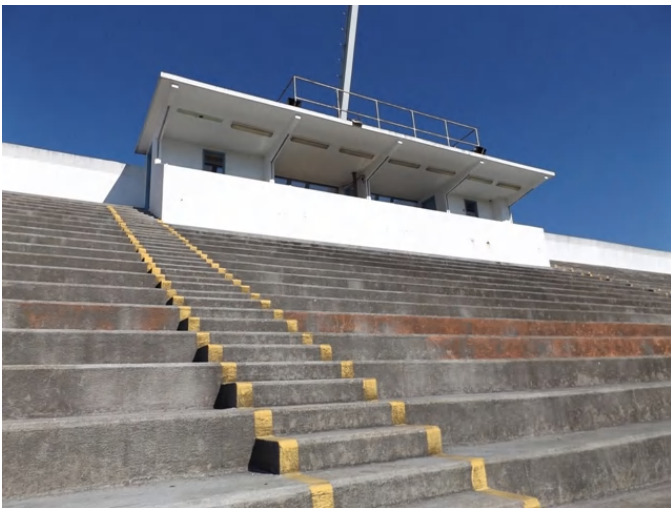
System: C2010 - Stair Construction

Location: Throughout Stadium

Distress: Inadequate

Notes: The stadium steps, access ramps, and stairs do not have adequate railing, are damaged, and do not provide ADA accessibility to all areas.

Correction: Replace stadium stairs (\$1.86/sf)

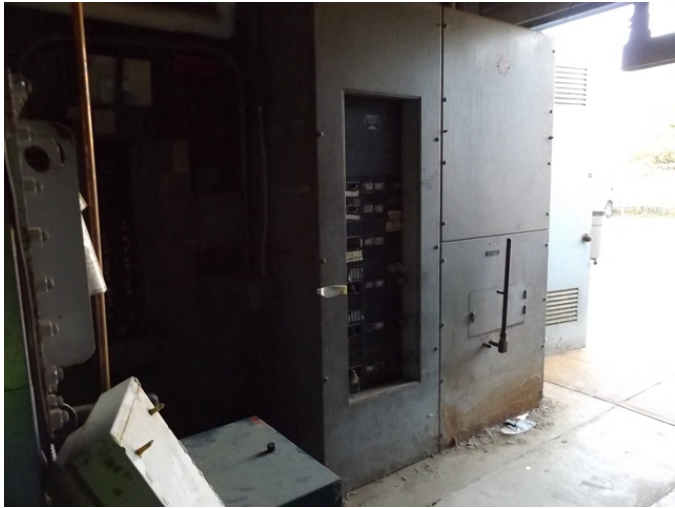
System: D5010 - Electrical Service/Distribution

Location: Throughout Stadium

Distress: Beyond Service Life

Notes: The original electrical service/distribution system does not have proper working space, is rusted, beyond its expected service life, and should be replaced and relocated to meet current code.

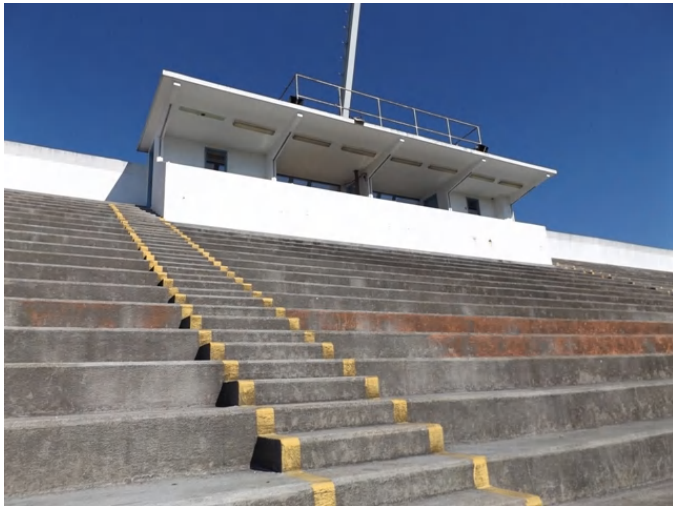
System: B2010 - Exterior Walls

Location: Exterior Surfaces

Distress: Needs Remediation

Notes: The exterior surfaces are stained and should be power washed.

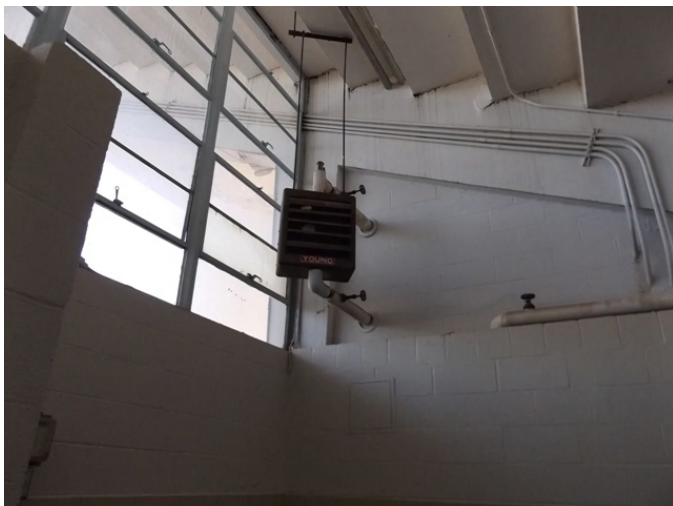
System: B2020 - Exterior Windows

Location: Exterior Walls

Distress: Beyond Service Life

Notes: The exterior windows are beyond their expected service life and should be scheduled for replacement.

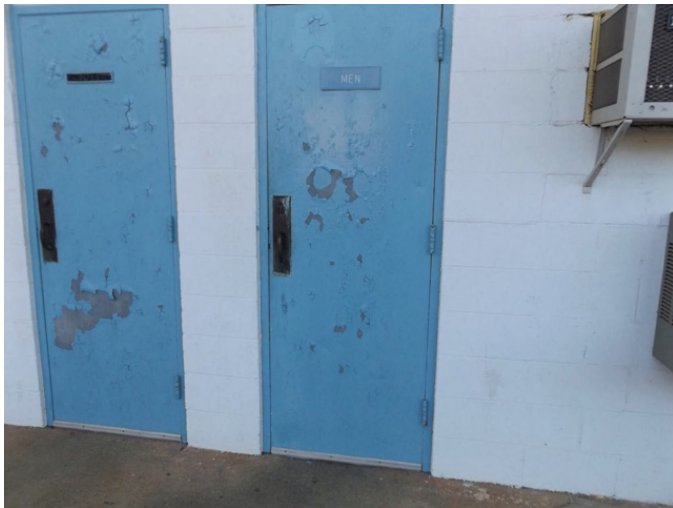
System: B2030 - Exterior Doors

Location: Exterior Walls

Distress: Beyond Service Life

Notes: The exterior doors are beyond their expected service life, not ADA compliant, and should be scheduled for replacement.

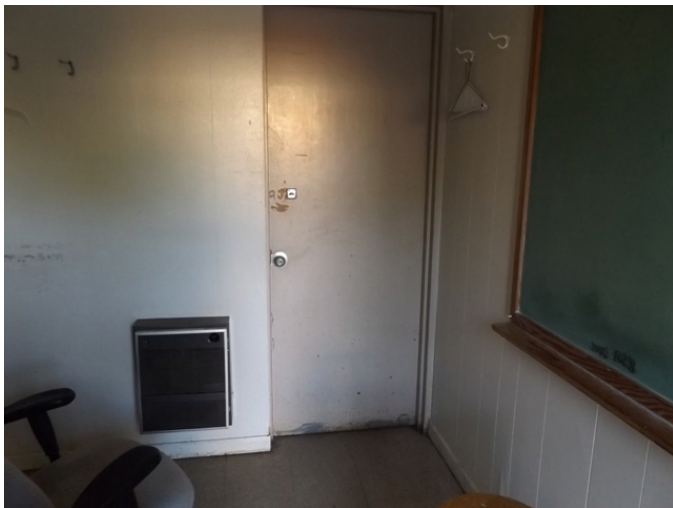
System: C1020 - Interior Doors

Location: Throughout Stadium

Distress: Beyond Service Life

Notes: The interior doors are beyond their expected service life, not ADA compliant, and should be scheduled for replacement.

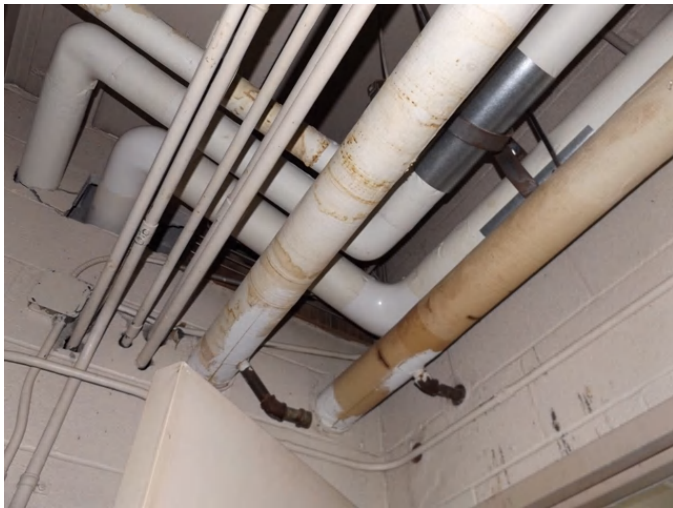
System: C3010 - Wall Finishes - Paint

Location: Throughout Stadium

Distress: Beyond Service Life

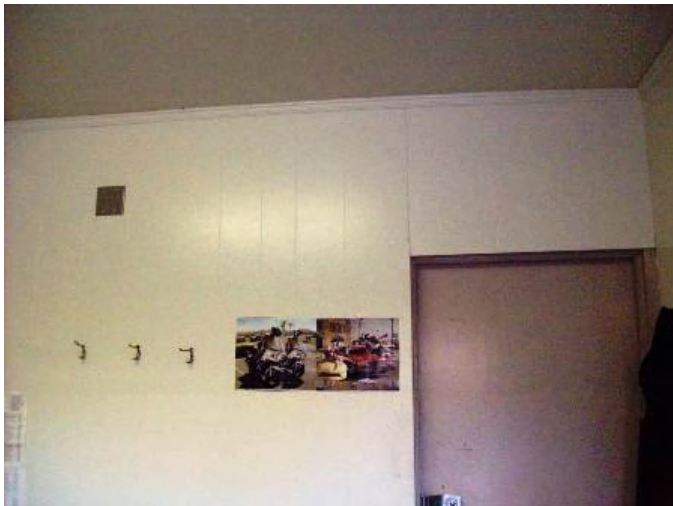
System: C3010 - Wall Finishes - Wood Paneling

Location: Offices

Distress: Beyond Service Life

Notes: The wood paneling is aged and should be replaced.

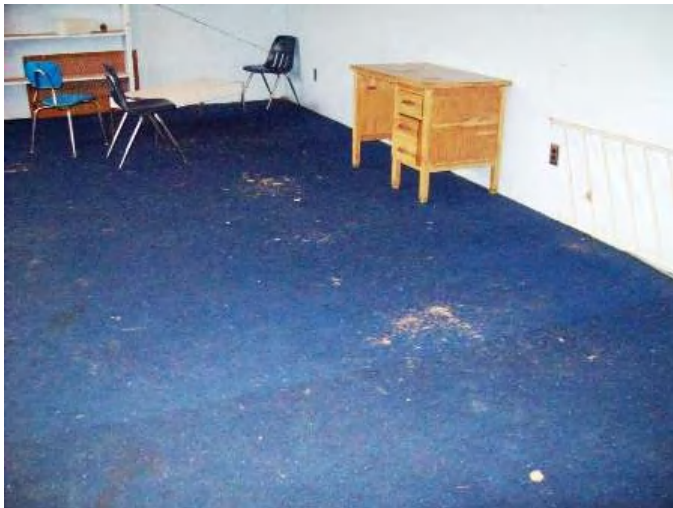
System: C3020 - Floor Finishes - Carpet

Location: Offices

Distress: Beyond Service Life

Notes: The carpet is aged, worn, stained and frayed, and should be replaced.

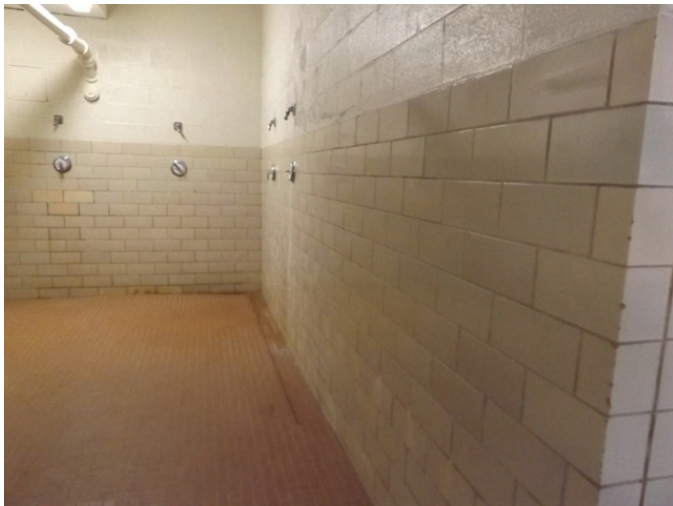
System: C3020 - Floor Finishes - Ceramic Tiles

Location: Throughout Stadium

Distress: Beyond Service Life

Notes: The ceramic tile flooring is beyond its expected service life and should be scheduled for replacement.

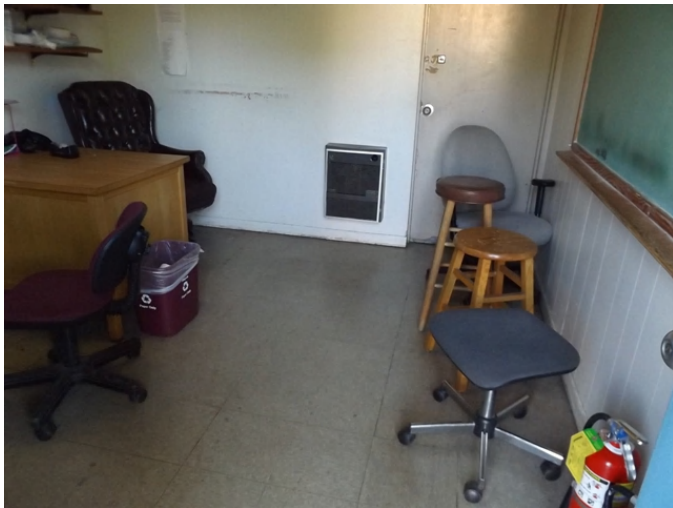
System: C3020 - Floor Finishes - VCT

Location: Offices

Distress: Beyond Service Life

Notes: The VCT flooring is beyond its expected service life and should be scheduled for replacement.

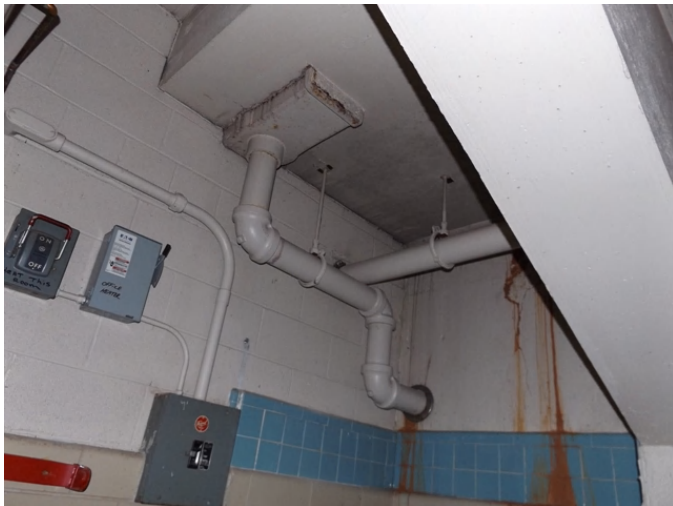
System: C3030 - Ceiling Finishes

Location: Throughout Stadium

Distress: Beyond Service Life

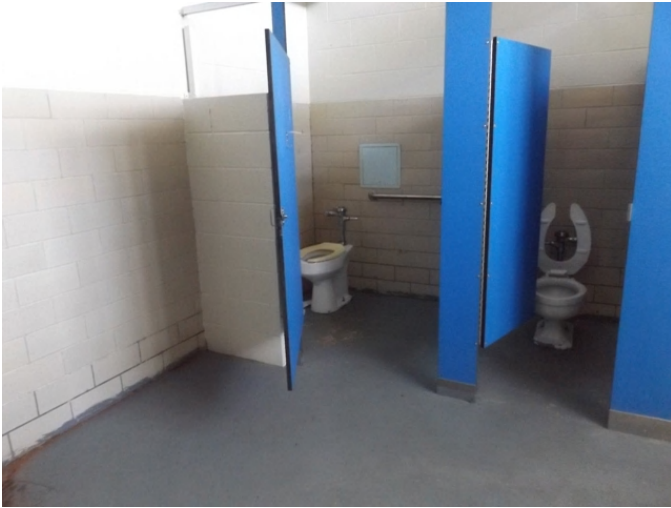
System: D2010 - Plumbing Fixtures

Location: Throughout Stadium

Distress: Beyond Service Life

Notes: The plumbing fixtures are beyond their expected service life, not ADA compliant, do not function adequately, and should be scheduled for replacement.

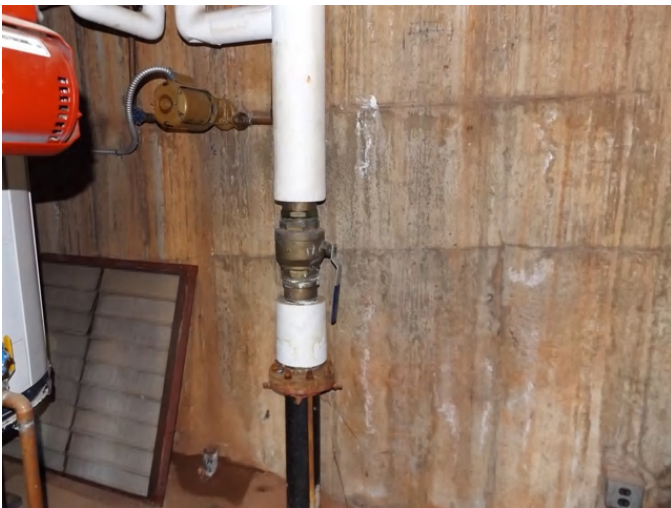
System: D2020 - Domestic Water Distribution

Location: Throughout Stadium

Distress: Beyond Service Life

Notes: The original domestic water system is beyond its expected service life, does not meet current code, and should be scheduled for replacement. The pipes gaskets, valve packaging may contain suspected material and should be professionally handled.

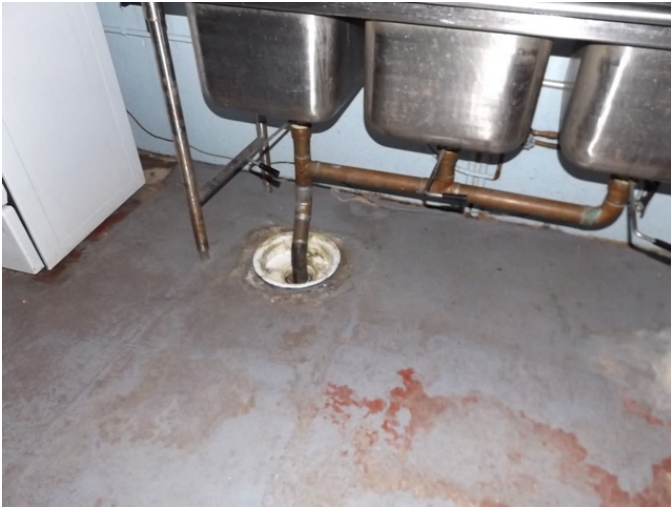
System: D2030 - Sanitary Waste

Location: Throughout Stadium

Distress: Beyond Service Life

Notes: The original sanitary sewer system is beyond its expected service life and should be scheduled for replacement.

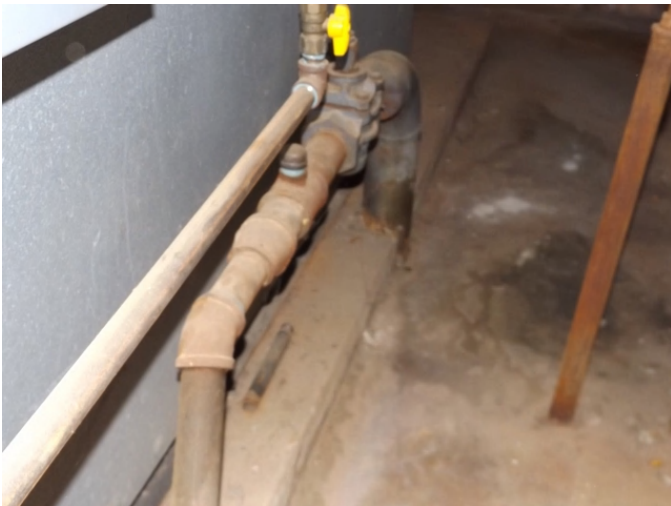
System: D2090 - Other Plumbing Systems - Nat Gas

Location: Throughout Stadium

Distress: Beyond Service Life

Notes: The original natural gas piping is beyond its expected service life, not code compliant, and should be scheduled for replacement.

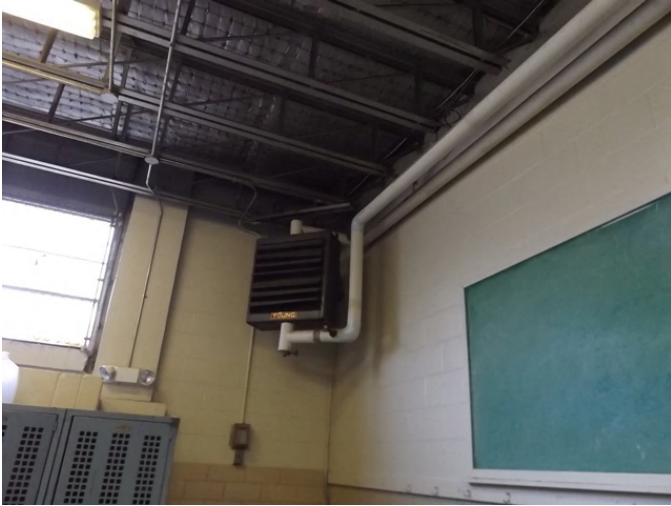
System: D3040 - Distribution Systems

Location: Throughout Building

Distress: Beyond Service Life

Notes: The distribution systems are aged and should be scheduled for replacement.

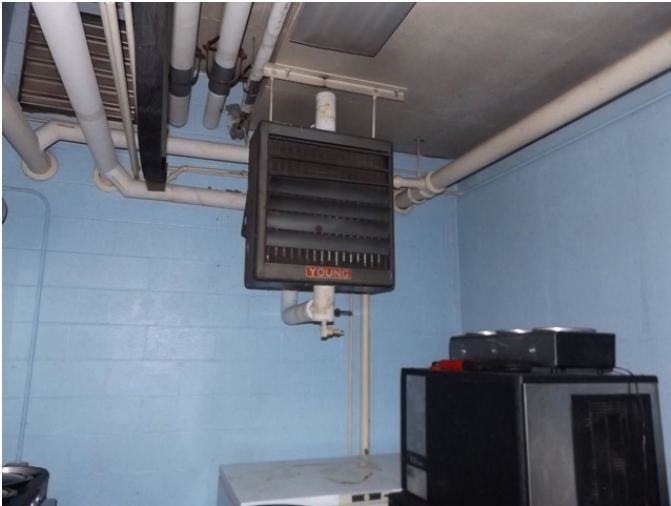
System: D3050 - Terminal & Package Units

Location: Throughout Building

Distress: Beyond Service Life

Notes: The terminal and package units are beyond their expected service life and should be scheduled for replacement.

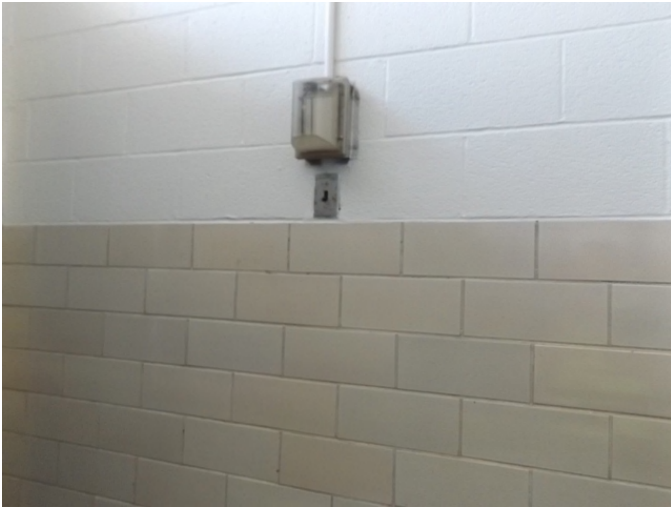
System: D3060 - Controls & Instrumentation

Location: Throughout Building

Distress: Beyond Service Life

Notes: Controls and instrumentation are original, beyond their expected service life, and should be scheduled for replacement.

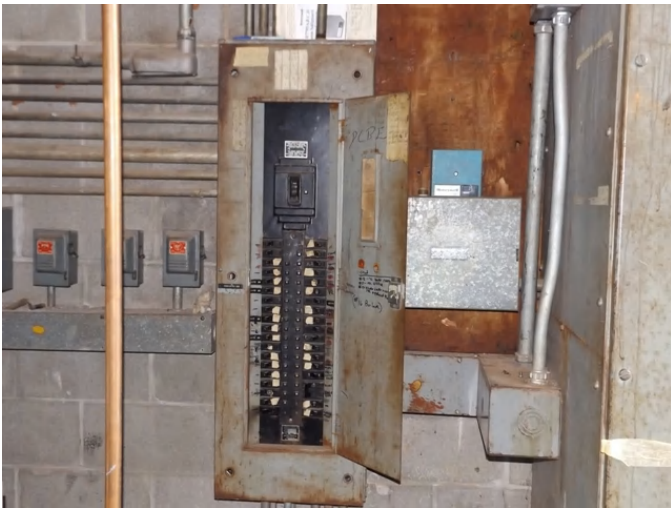
System: D5020 - Lighting and Branch Wiring

Location: Throughout Stadium

Distress: Beyond Service Life

Notes: The original lighting and branch wiring system is beyond its expected service life, inadequate, not code compliant, and should be scheduled for replacement. SPLOST IV project 203-422 to replace stadium lighting is expected to be complete by August 2017.

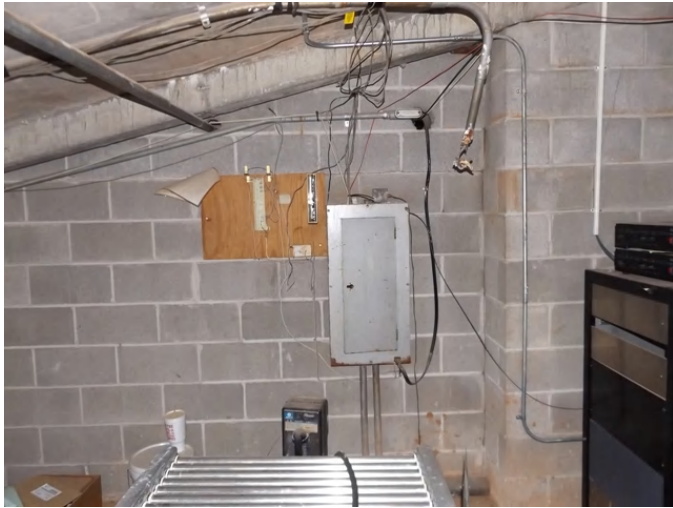
System: D5030 - Communications and Security

Location: Throughout Stadium

Distress: Beyond Service Life

Notes: Telephone and data, PA and clock system, and security and CCTV systems are beyond service life and should be replaced. Audible and visible fire alarm is missing and should be added.

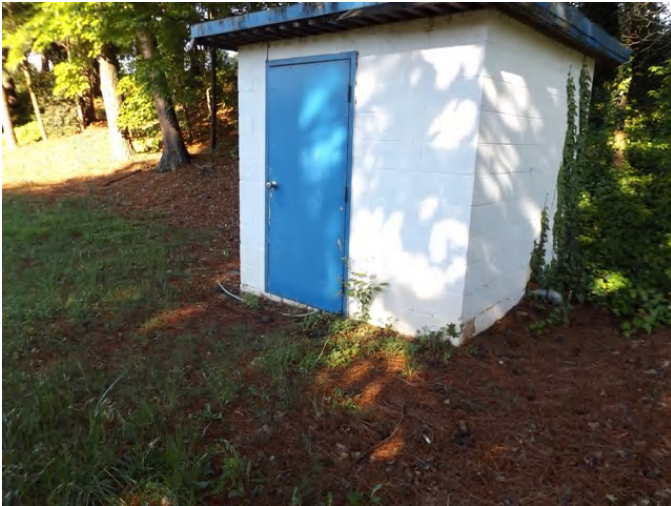
System: B2030 - Exterior Doors

Location: Exterior Wall
Distress: Beyond Service Life
Category: Deferred Maintenance
Priority: 3 Priority
Correction: Renew System
Qty: 60.00
Unit of Measure: S.F.
Estimate: \$341.00
Assessor Name: Joanne Romanelli
Date Created: 04/11/2015

Notes: The exterior door is beyond its expected service life and should be scheduled for replacement.

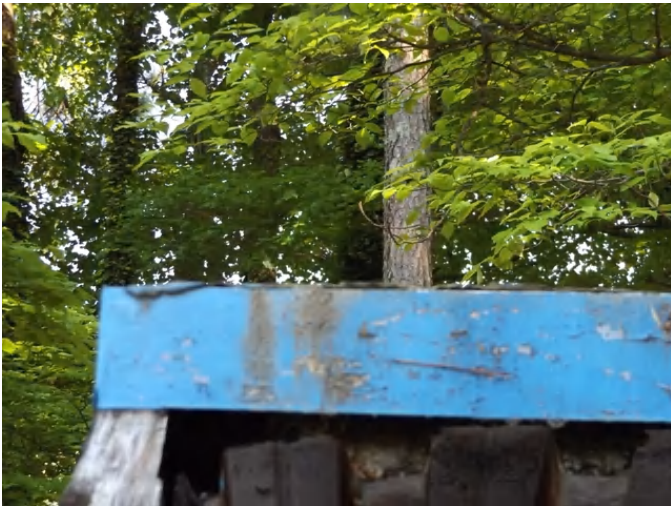
System: B3010 - Roof Coverings

Location: Roof
Distress: Beyond Service Life
Category: Deferred Maintenance
Priority: 3 Priority
Correction: Renew System
Qty: 60.00
Unit of Measure: S.F.
Estimate: \$1,108.00
Assessor Name: Joanne Romanelli
Date Created: 04/11/2015

Notes: The roof covering is beyond its expected service life and should be scheduled for replacement.

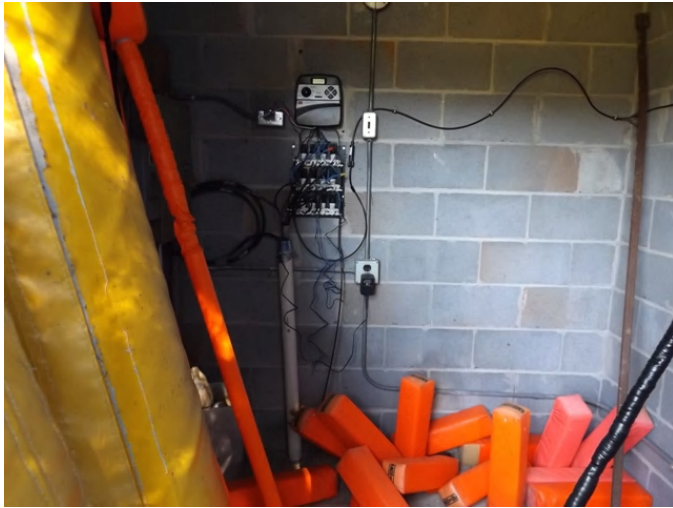
System: D5020 - Lighting and Branch Wiring

Location: Throughout Building

Distress: Beyond Service Life

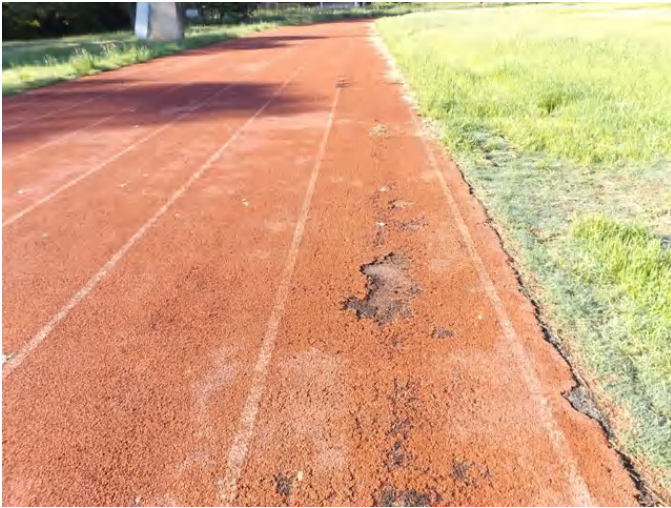
System: G2040 - Track

Location: Site

Distress: Damaged

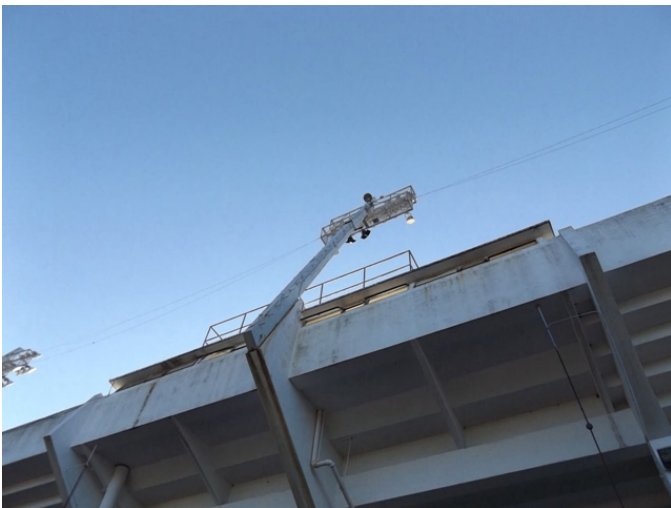
System: G4020 - Site Lighting

Location: Site

Distress: Inadequate

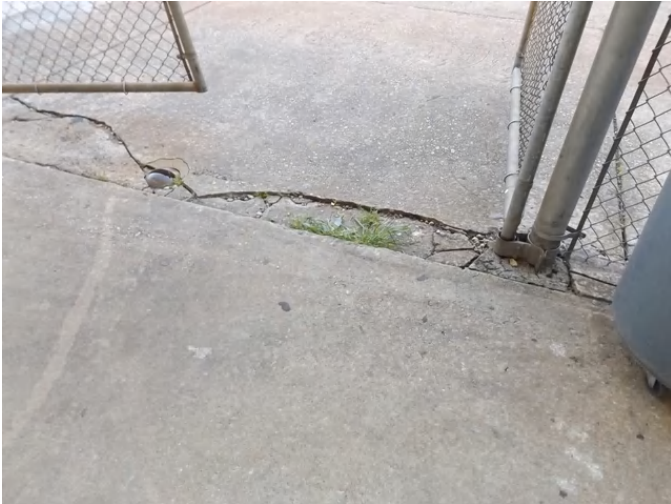
System: G2030 - Pedestrian Paving

Location: Site

Distress: Beyond Service Life

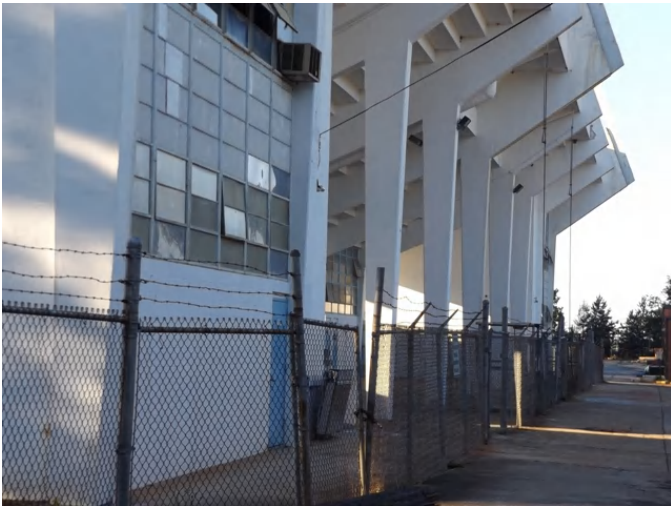
System: G2040 - Fencing & Guardrails

Location: Site

Distress: Beyond Service Life

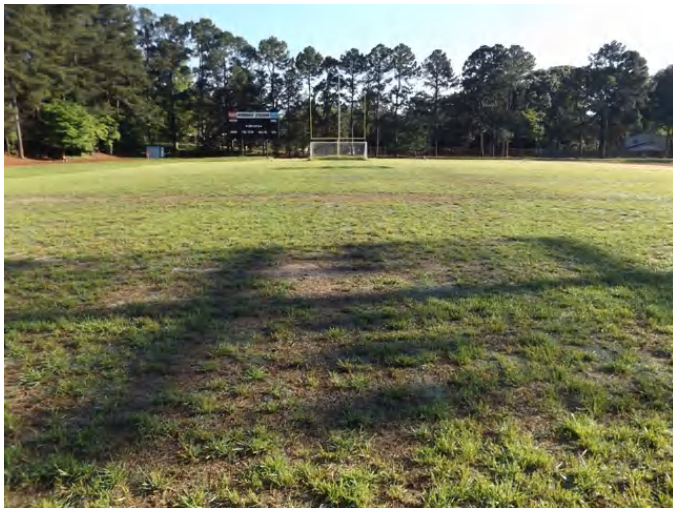
System: G2040 - Football Field

Location: Site

Distress: Damaged

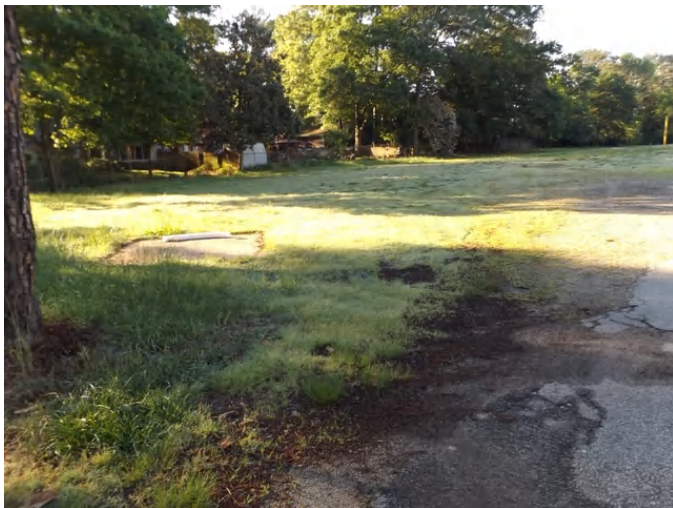
System: G2050 - Landscaping

Location: Site

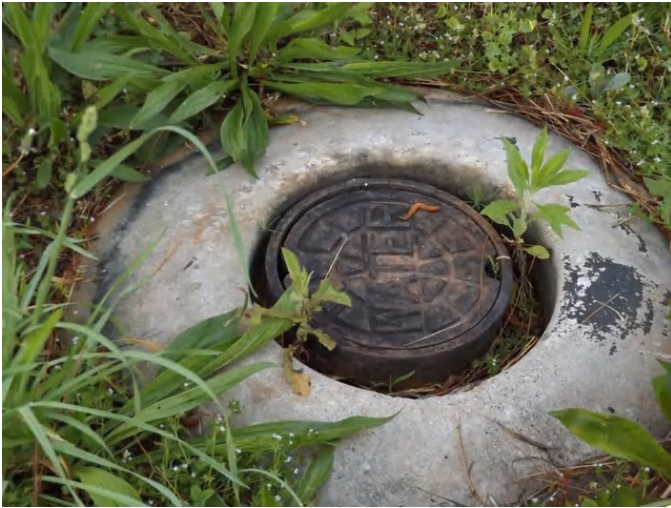
System: G3010 - Water Supply

Location: Site

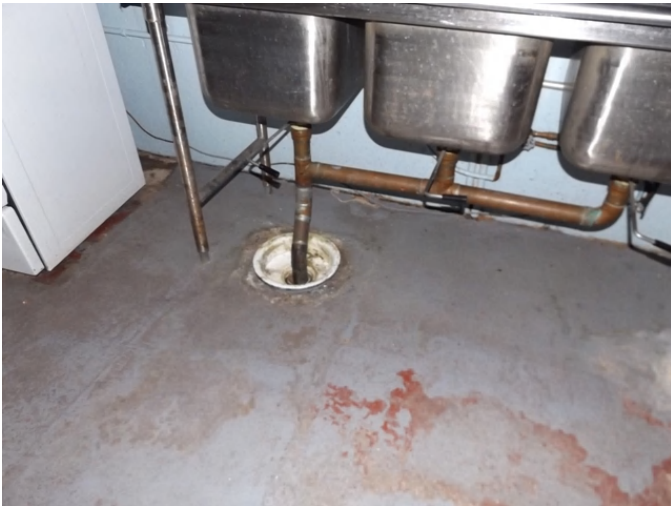
System: G3020 - Sanitary Sewer

Location: Site

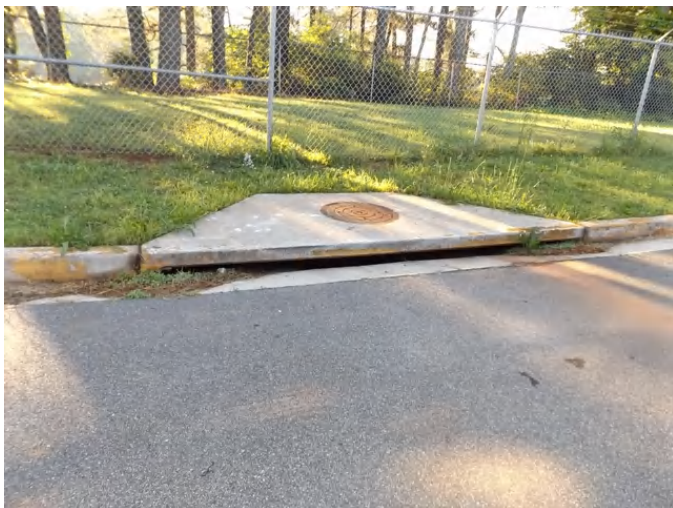
System: G3030 - Storm Sewer

Location: Site
Distress: Beyond Service Life
Category: Deferred Maintenance
Priority: 3 Priority
Correction: Renew System
Qty: 21,012.00
Unit of Measure: S.F.
Estimate: \$82,051.86
Assessor Name: Eduardo Lopez
Date Created: 04/30/2015

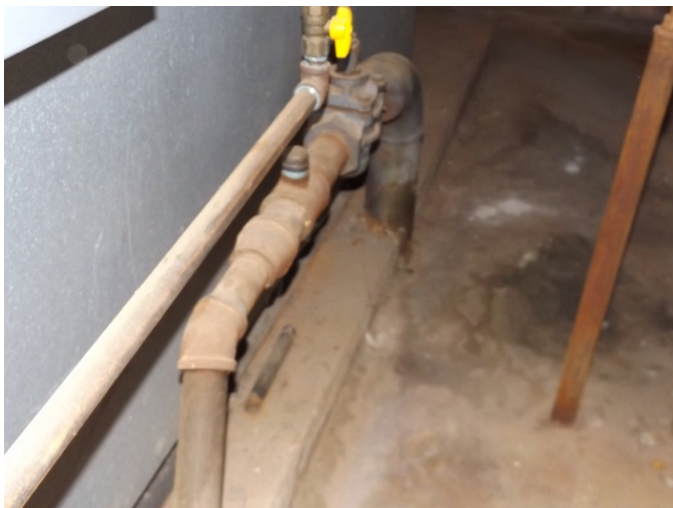
System: G3060 - Fuel Distribution

Location: Site
Distress: Beyond Service Life
Category: Deferred Maintenance
Priority: 3 Priority
Correction: Renew System
Qty: 21,012.00
Unit of Measure: S.F.
Estimate: \$18,028.30
Assessor Name: Eduardo Lopez
Date Created: 04/30/2015

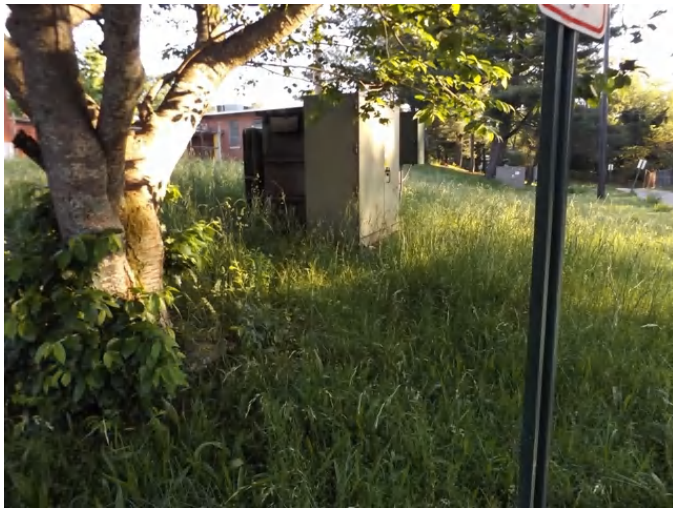
System: G4010 - Electrical Distribution

Location: Site
Distress: Beyond Service Life
Category: Deferred Maintenance
Priority: 3 Priority
Correction: Renew System
Qty: 21,012.00
Unit of Measure: S.F.
Estimate: \$42,990.55
Assessor Name: Eduardo Lopez
Date Created: 04/30/2015

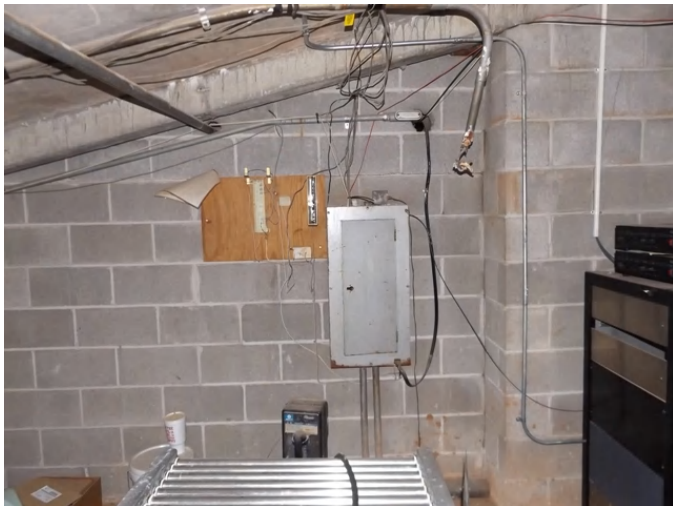
System: G4030 - Site Communications & Security

Location: Site
Distress: Beyond Service Life
Category: Deferred Maintenance
Priority: 3 Priority
Correction: Renew System
Qty: 21,012.00
Unit of Measure: S.F.
Estimate: \$15,485.84
Assessor Name: Eduardo Lopez
Date Created: 04/30/2015
