DeKalb County School District/Elementary Schools

Bob Mathis Elementary

School Assessment Report

May 19, 2016

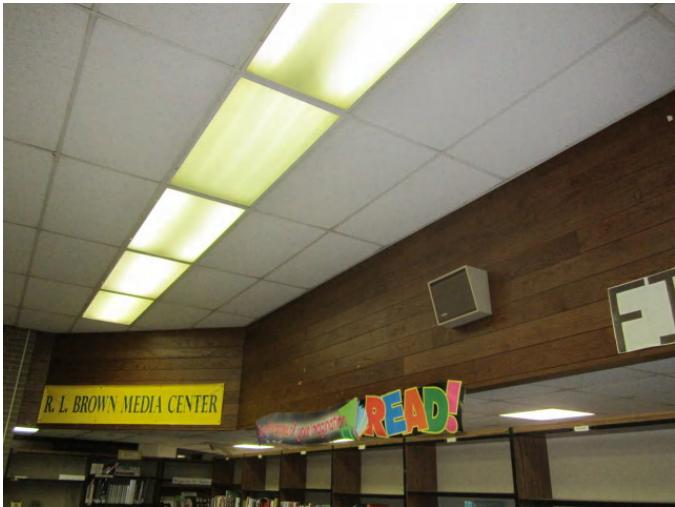
System: D5020 - Lighting

Location: Throughout Building

Distress: Beyond Service Life

Notes: The lighting system is beyond its expected service life, inadequate, and should be scheduled for replacement. Light switches are not located near doors. Many illuminated exit signs are non-functional.

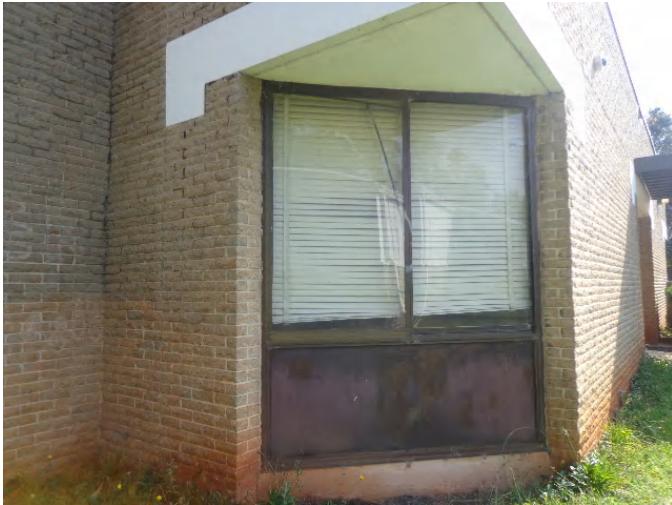
System: B2020 - Exterior Windows

Location: Throughout Building

Distress: Beyond Service Life

Notes: The aluminum frame, operable, single pane windows are aged, damaged, not energy efficient, and should be replaced.

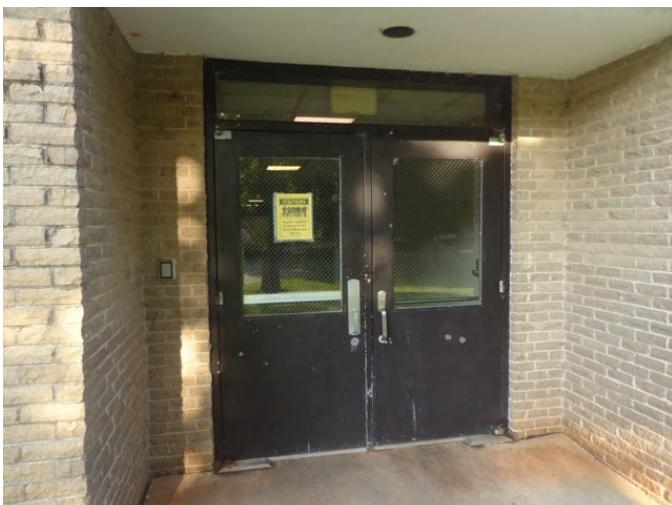
System: B2030 - Exterior Doors

Location: Throughout Building

Distress: Beyond Service Life

Notes: The original exterior doors are aged, rusted, and not ADA compliant, do not lock/seal properly, and should be replaced.

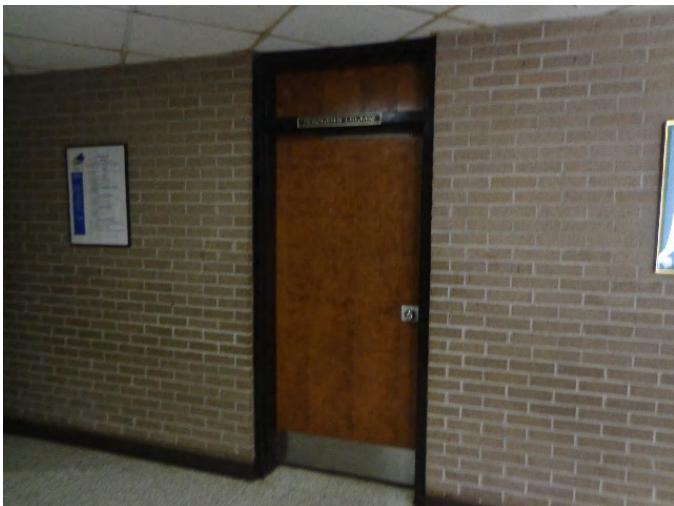
System: C1020 - Interior Doors

Location: Throughout Building

Distress: Beyond Service Life

Notes: The interior doors are aged, failing, not ADA or building code compliant, and should be replaced. Exit doors in electrical room do not have fire exit hardware.

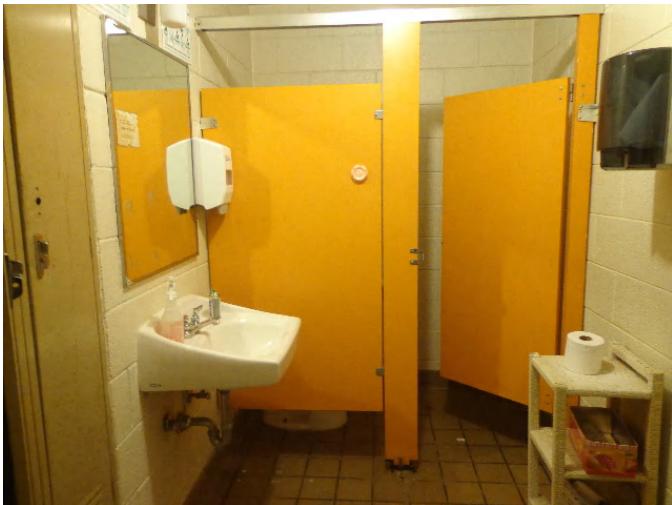
System: C1030 - Fittings

Location: Throughout Building

Distress: Beyond Service Life

Notes: Fittings, such as toilet partitions, handrails and signage, are beyond their expected service life, signage is not ADA compliant, and the entire system should be replaced.

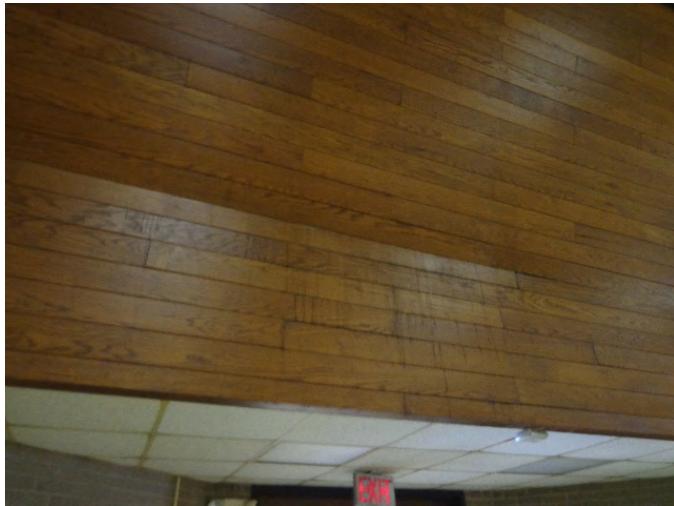
System: C3010 - Wall Finishes - Wall Coverings

Location: Throughout Building

Distress: Beyond Service Life

Notes: Wall coverings are beyond their expected service life and should be replaced.

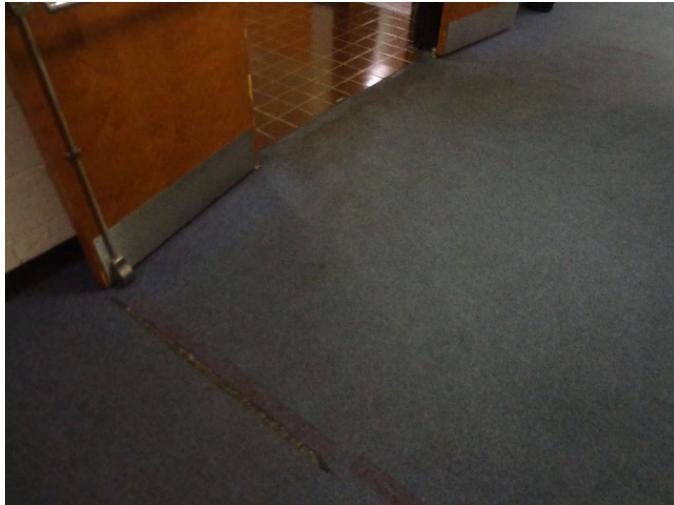
System: C3020 - Floor Finishes - Carpet

Location: Throughout Building

Distress: Beyond Service Life

Notes: The carpet is aged, stained, frayed and torn, and should be replaced.

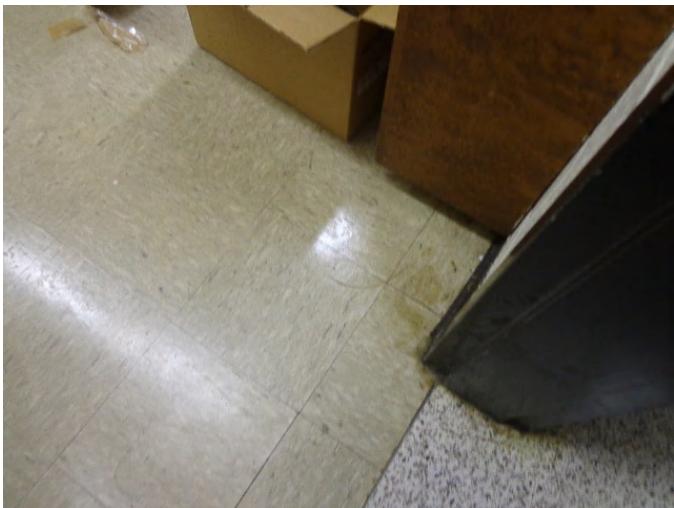
System: C3020 - Floor Finishes - VCT

Location: Throughout Building

Distress: Beyond Service Life

Notes: The VCT flooring is aged, cracked, worn and patched, and should be replaced.

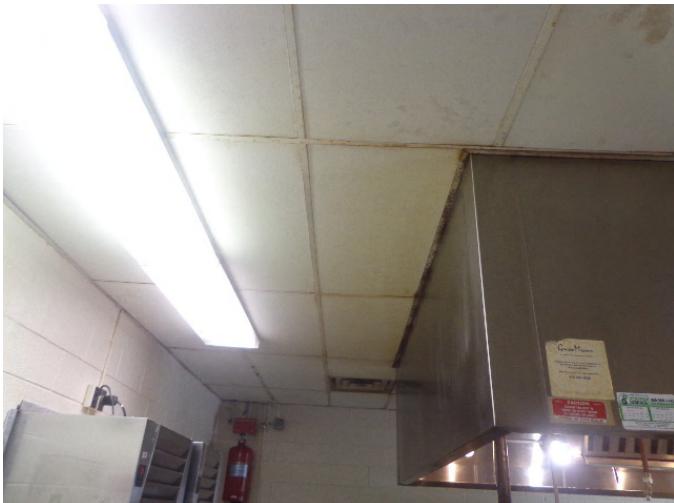
System: C3030 - Ceiling Finishes

Location: Throughout Building

Distress: Beyond Service Life

Notes: The acoustical ceiling system is aging, most tiles are sagging or damaged, and the entire system should be replaced in conjunction with the lighting system.

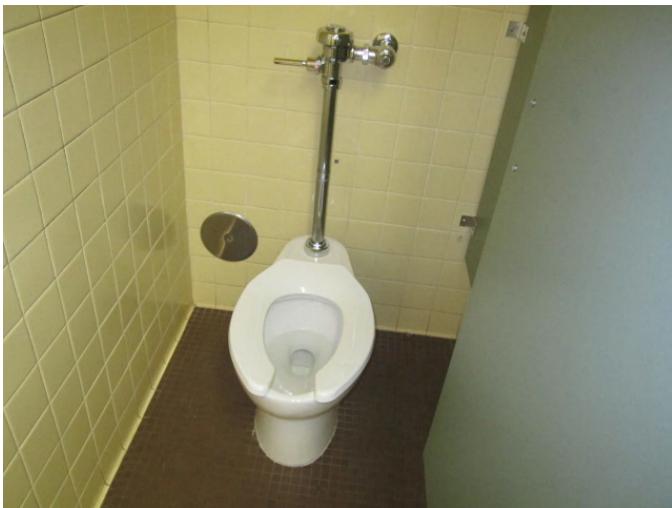
System: D2010 - Plumbing Fixtures

Location: Throughout Building

Distress: Beyond Service Life

Notes: The plumbing fixtures are beyond their expected service life, inadequate, and should be scheduled for replacement.

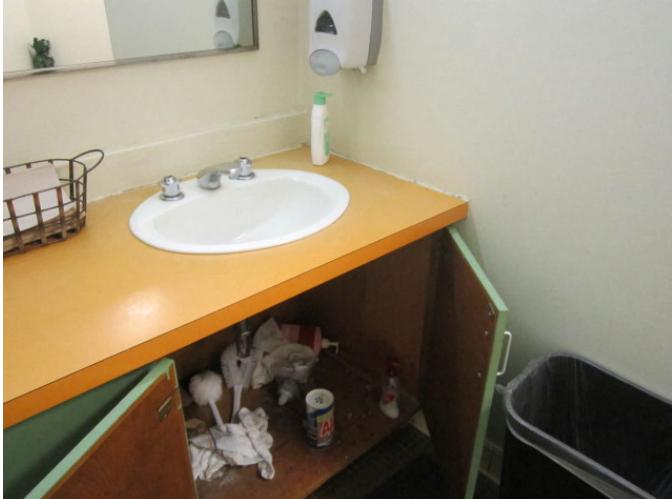
System: D2020 - Domestic Water Distribution

Location: Throughout Building

Distress: Beyond Service Life

Notes: The domestic water distribution system is beyond its expected service life, not building code compliant, and should be scheduled for replacement. Domestic water heaters or converters equipped with adequate expansion compensation.

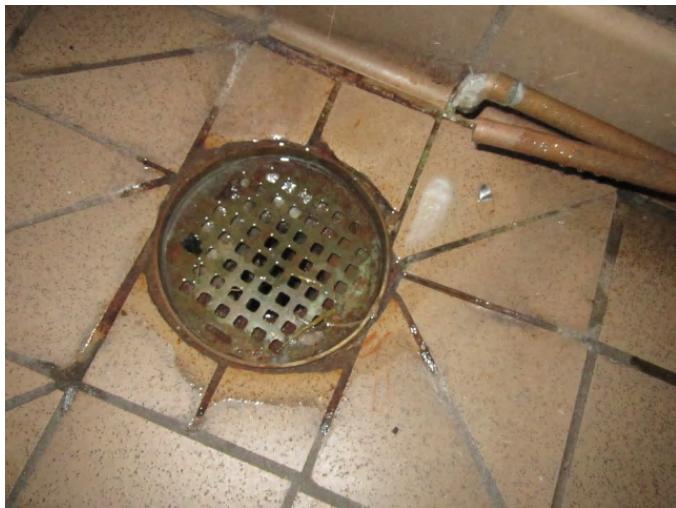
System: D2030 - Sanitary Waste

Location: Throughout Building

Distress: Beyond Service Life

Notes: The sanitary waste system is beyond its expected service life and should be scheduled for replacement.

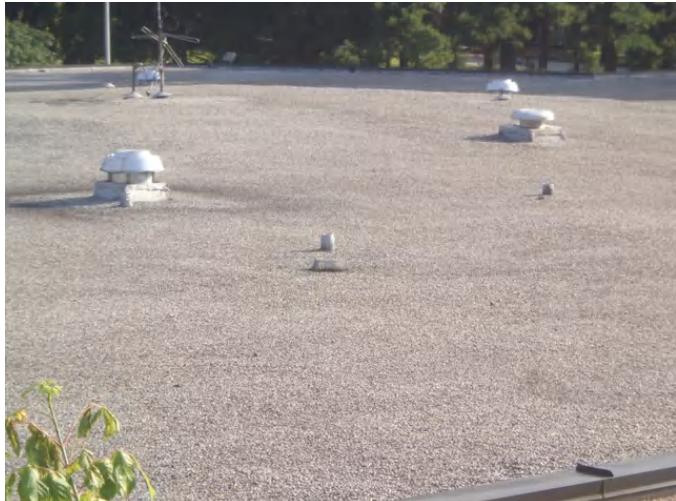
System: D2040 - Rain Water Drainage

Location: Throughout Building

Distress: Beyond Service Life

Notes: The rainwater drainage system is beyond its expected service life and should be scheduled for replacement.

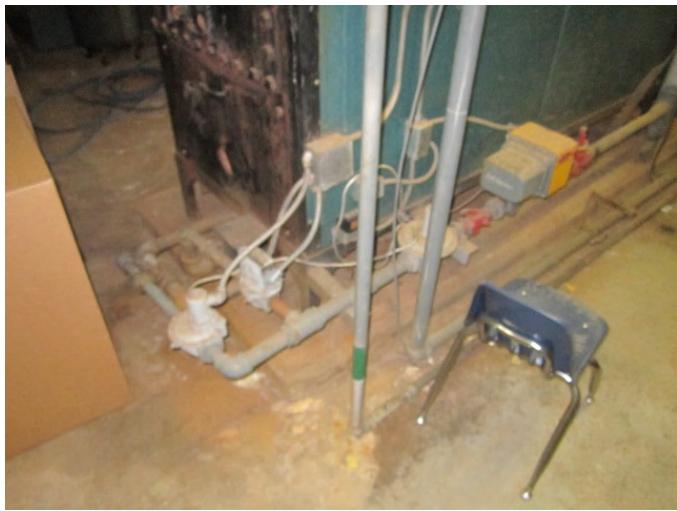
System: D2090 - Other Plumbing Systems - Natural Gas

Location: Throughout Building

Distress: Beyond Service Life

Notes: The natural gas system is beyond its expected service life and should be scheduled for replacement. SPLOST project 100-422 to replace grease trap and backflow preventer.

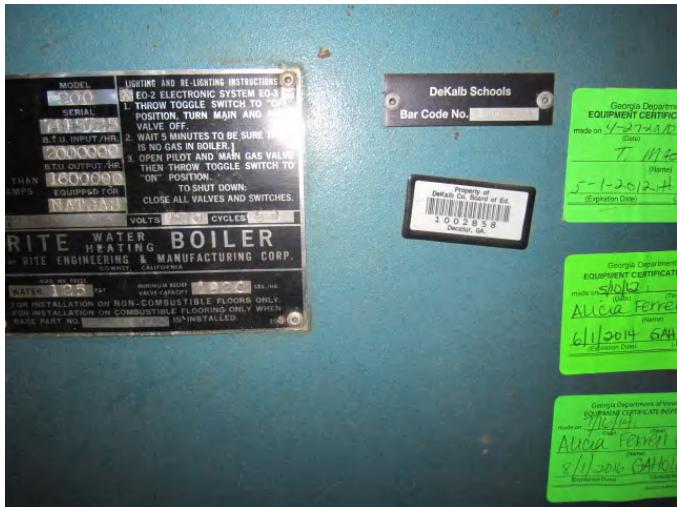
System: D3020 - Heat Generating Systems

Location: Mechanical Room

Distress: Beyond Service Life

Notes: The heat generating system is beyond its expected service life, inadequate, and should be scheduled for replacement. White mastic on fiberglass pipe insulation was identified as ACM by others.

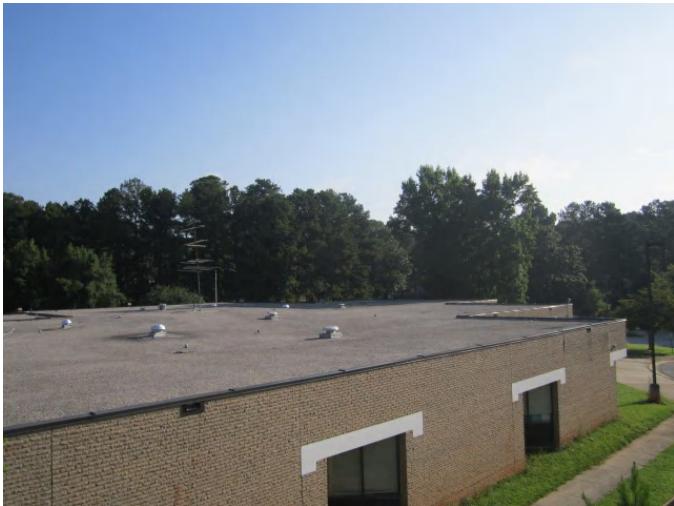
System: D3040 - Distribution & Exhaust Systems

Location: Throughout Building

Distress: Beyond Service Life

Notes: The distribution and exhaust systems are beyond their expected service life, inadequate, and should be scheduled for replacement. White mastic on fiberglass pipe insulation was identified as ACM by others.

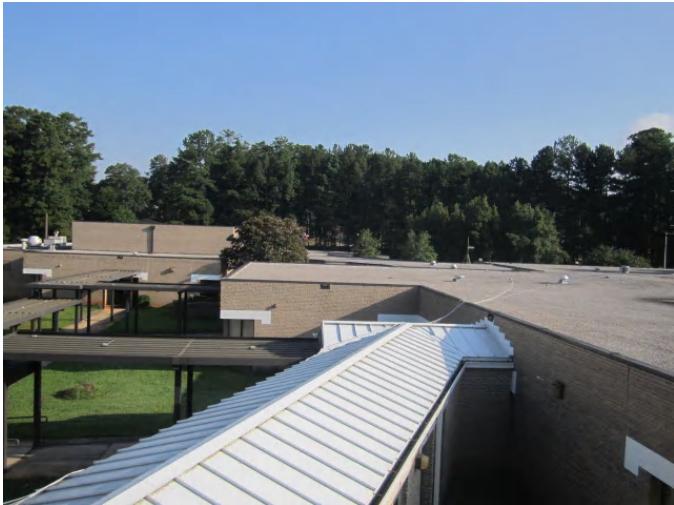
System: D3050 - Terminal & Package Units

Location: Throughout Building

Distress: Beyond Service Life

Notes: Terminal and package units are beyond their expected service life, inadequate, and should be scheduled for replacement. White mastic on fiberglass pipe insulation was identified as ACM by others. SPLOST project 100-422 to replace the roof top units.

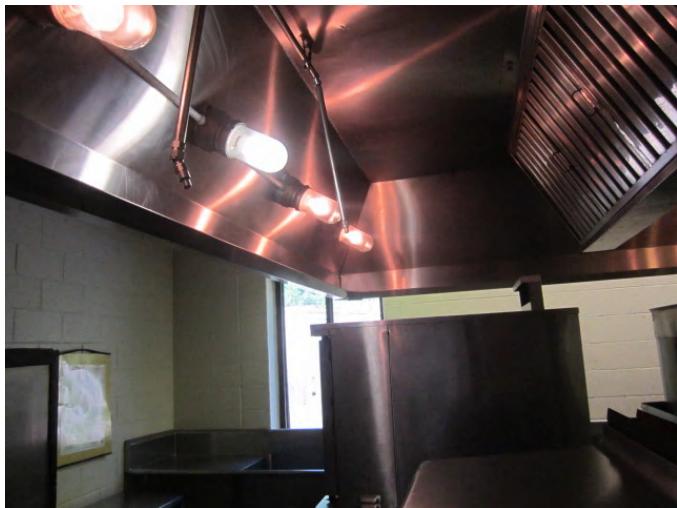
System: D3090 - Other HVAC Systems/Equip - Kitchen Hood

Location: Kitchen

Distress: Beyond Service Life

Notes: The kitchen hood system is beyond its expected service life, aged, and should be scheduled for replacement.

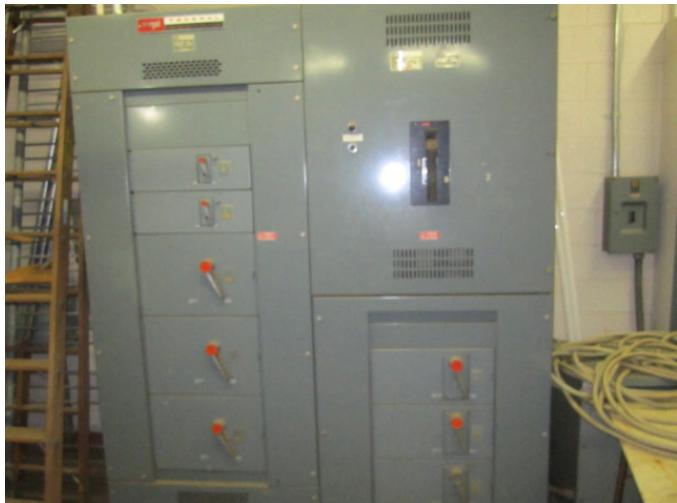
System: D5010 - Electrical Service/Distribution

Location: Main Switch Room/Throughout Building

Distress: Beyond Service Life

Notes: The electrical service/distribution system is beyond its expected service life, aged, and should be scheduled for replacement.

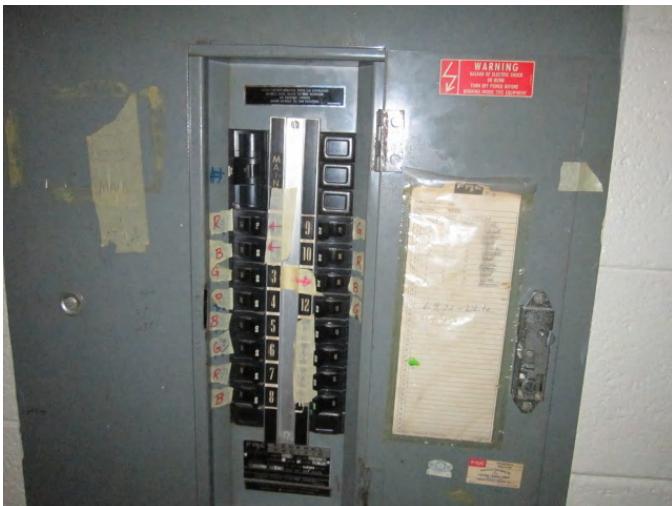
System: D5020 - Branch Wiring

Location: Throughout Building

Distress: Beyond Service Life

Notes: The branch wiring system is beyond its expected service life, inadequate, and should be scheduled for replacement. GFI electrical outlets are missing in wet areas.

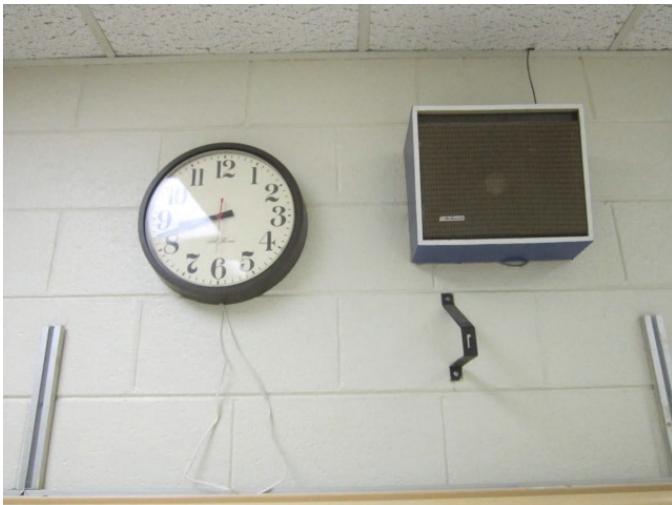
System: D5030 - Communications and Security - Clock & PA Systems

Location: Throughout Building

Distress: Beyond Service Life

Notes: Clock and PA systems are beyond their expected service life, aged, and should be scheduled for replacement.

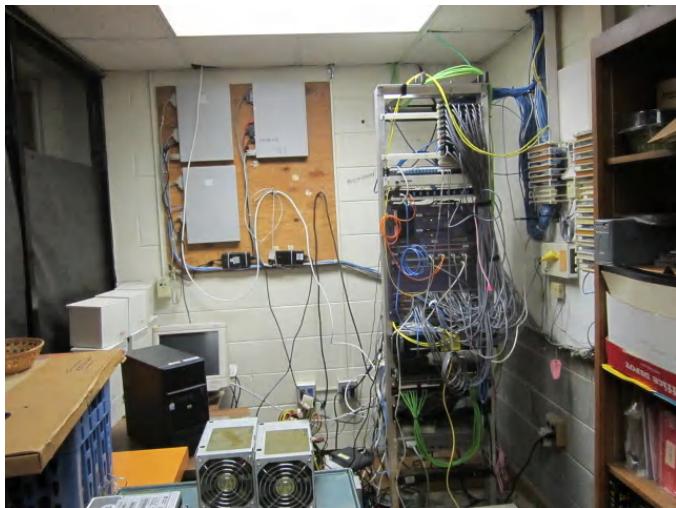
System: D5030 - Communications and Security - Data Communication

Location: Throughout Building

Distress: Beyond Service Life

Notes: The data communications system is beyond its expected life and should be schedule for replacement.

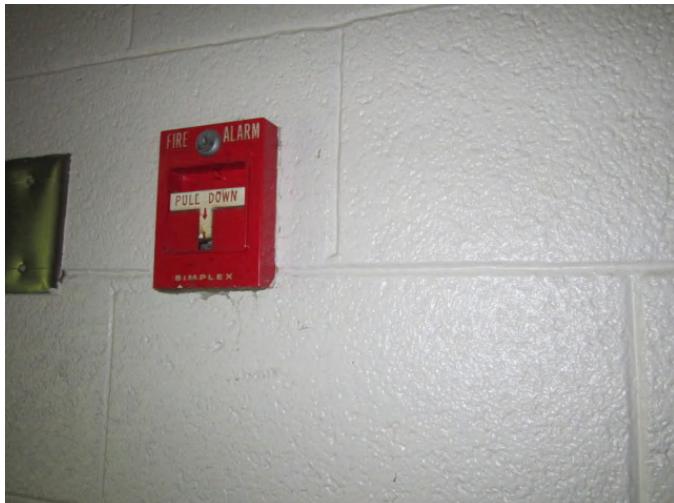
System: D5030 - Communications and Security - Fire Alarm

Location: Throughout Building

Distress: Beyond Service Life

Notes: The fire alarm system is beyond its expected service life, not building code compliant, and should be scheduled for replacement. Fire pull stations are six feet from the floor. Visible alarms (strobes) are not installed in multiple occupancy, common use areas

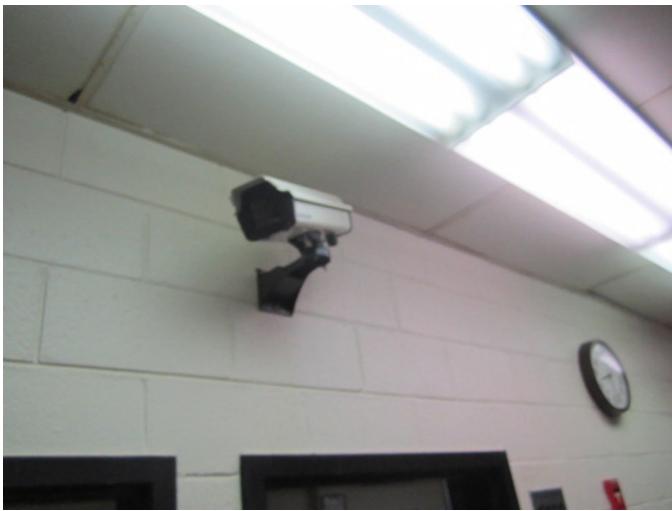
System: D5030 - Communications and Security - Security & CCTV

Location: Throughout Building

Distress: Beyond Service Life

Notes: The security and CCTV systems are beyond their expected service life, inadequate, and should be scheduled for replacement.

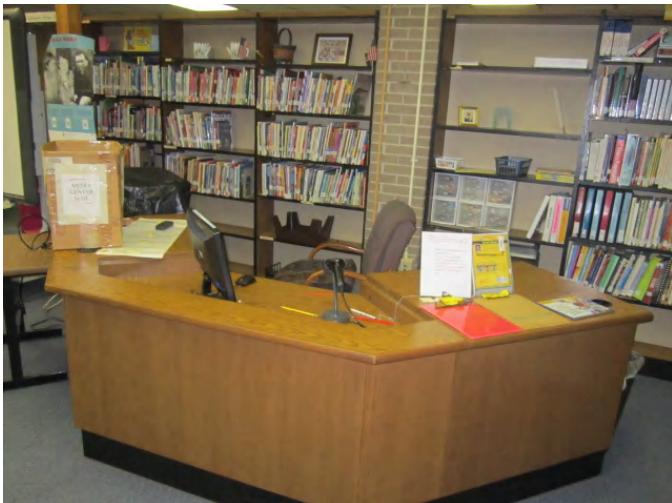
System: D5030 - Communications and Security - Telephone Systems

Location: Throughout Building

Distress: Beyond Service Life

Notes: The telephone system is beyond its expected service life, inadequate, and should be scheduled for replacement.

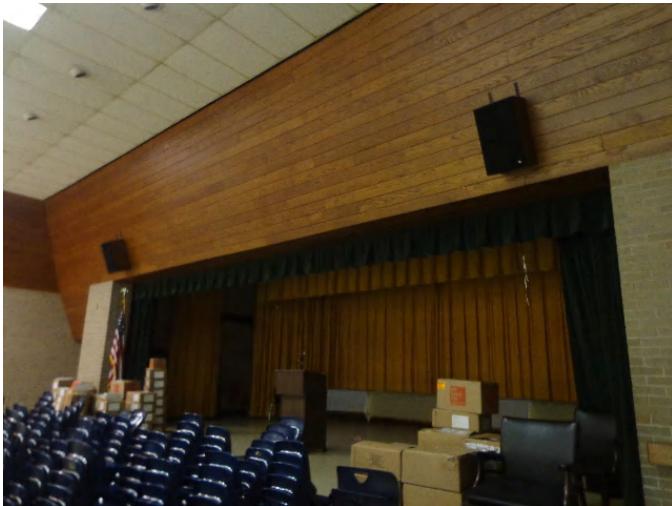
System: E1020 - Institutional Equipment

Location: Throughout Building

Distress: Beyond Service Life

Notes: Institutional equipment, such as theater and stage equipment and library equipment, is beyond its expected service life and should be scheduled for replacement.

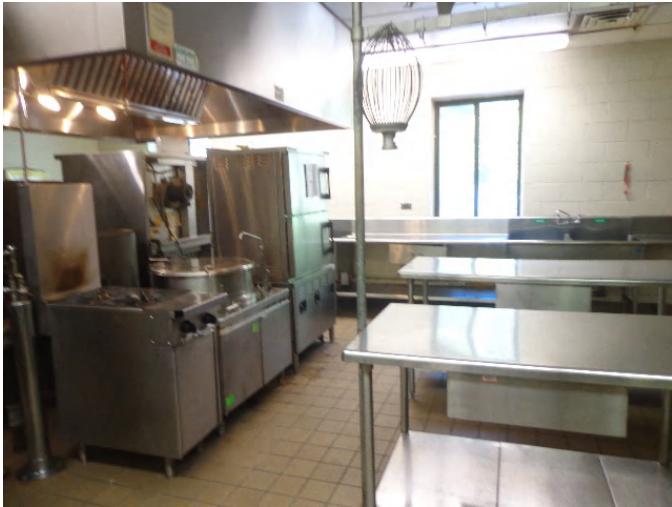
System: E1090 - Other Equipment - Kitchen Equipment

Location: Kitchen

Distress: Beyond Service Life

Notes: Kitchen equipment is beyond its expected service life and should be scheduled for replacement.

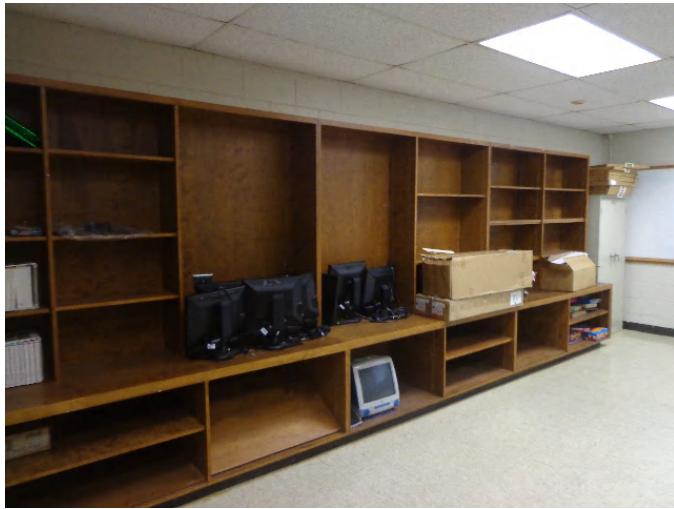
System: E2010 - Fixed Furnishings

Location: Throughout Building

Distress: Beyond Service Life

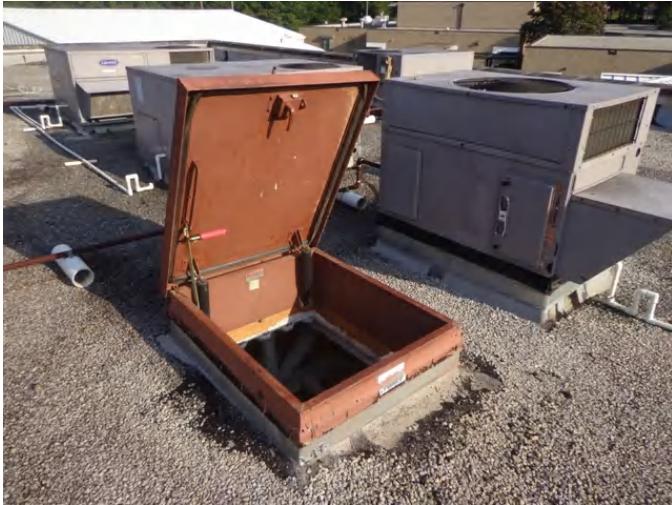
System: B3020 - Roof Openings

Location: Roof

Distress: Inadequate

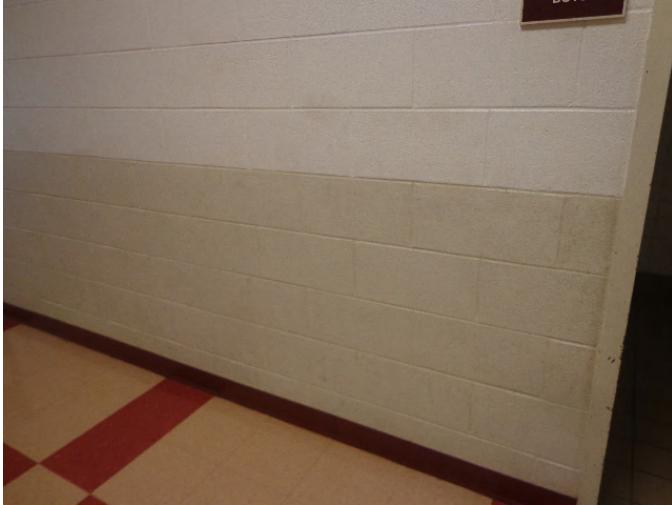
System: C3010 - Wall Finishes - Paint

Location: Throughout Building

Distress: Beyond Service Life

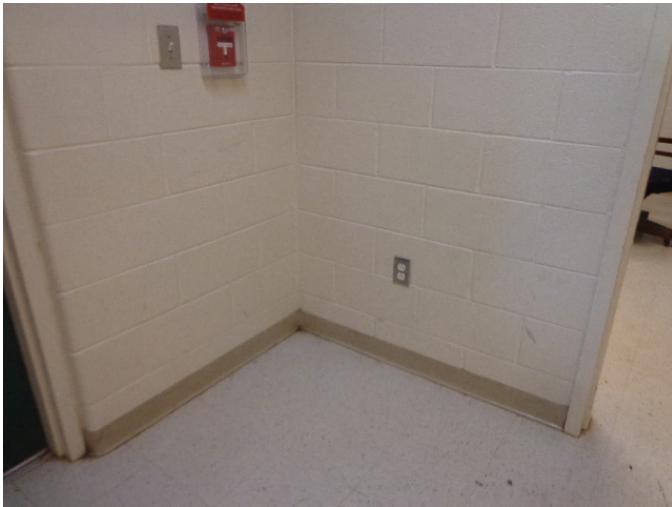
System: C3010 - Wall Finishes - Paint

Location: Throughout Building

Distress: Beyond Service Life

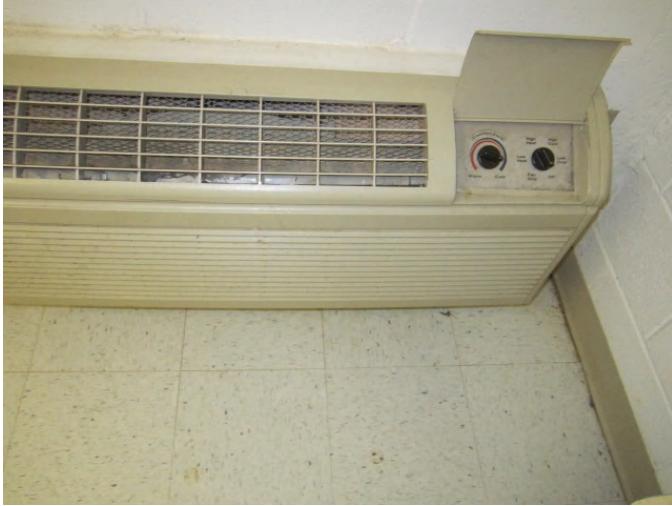
System: D3050 - Terminal & Package Units

Location: Gym

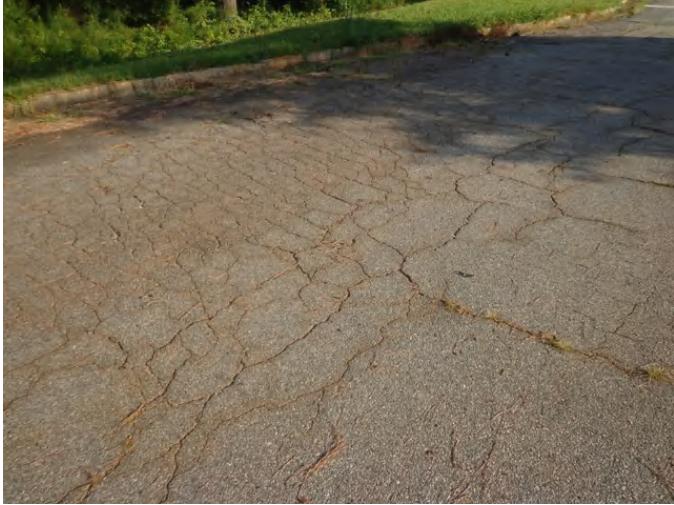
System: G2010 - Roadways

Location: Site

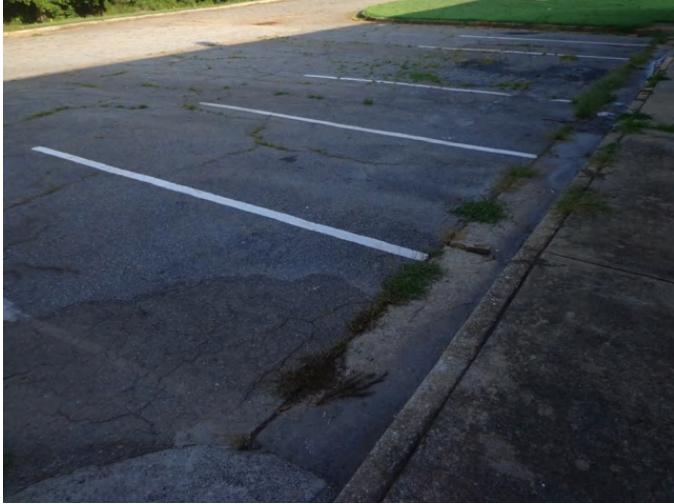
System: G2020 - Parking Lots

Location: Site

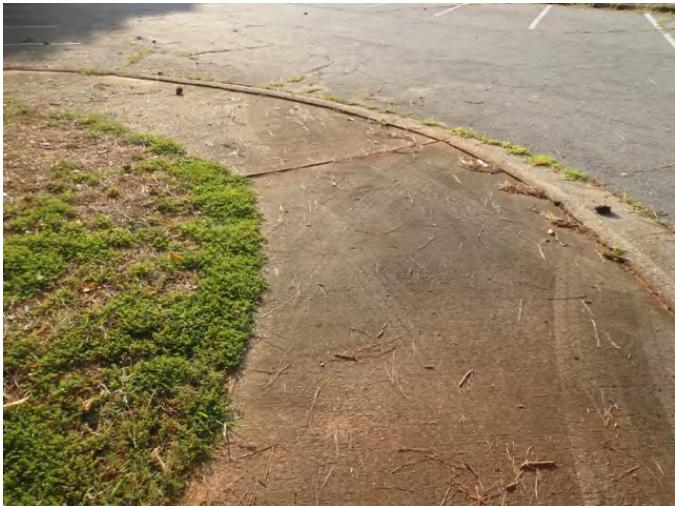
System: G2030 - Pedestrian Paving

Location: Site

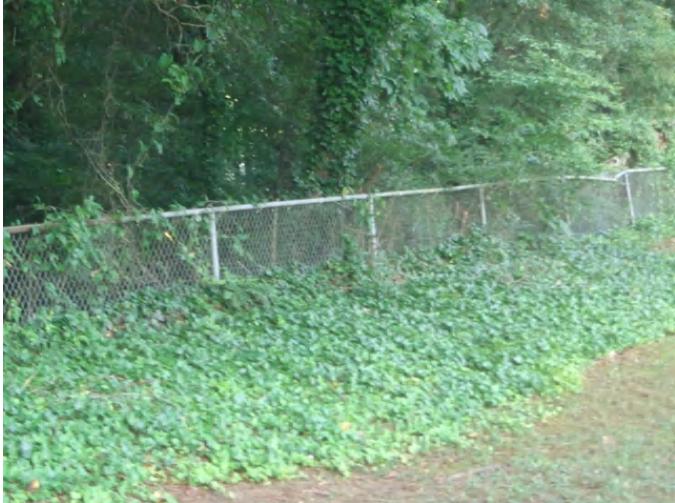
System: G2040 - Fencing & Guardrails

Location: Site

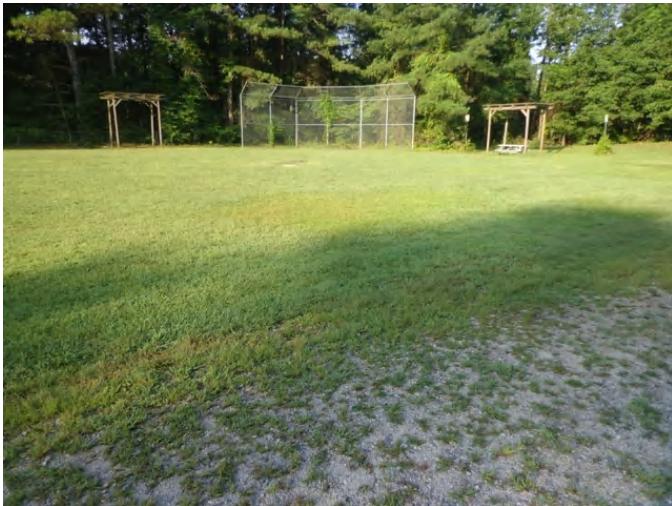
System: G2040 - Playing Field

Location: Site

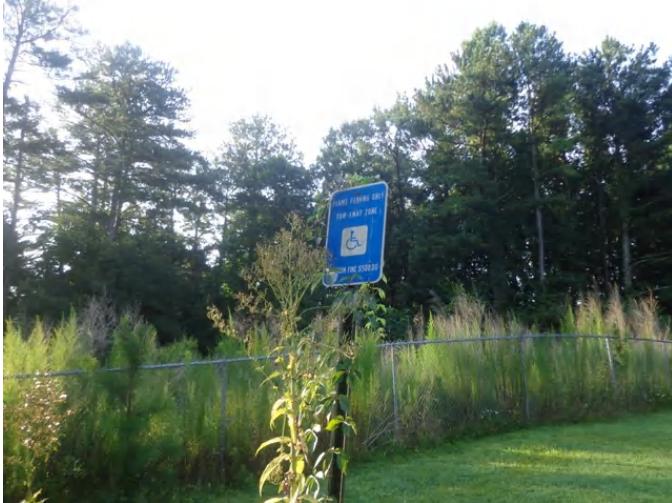
System: G2050 - Landscaping

Location: Site

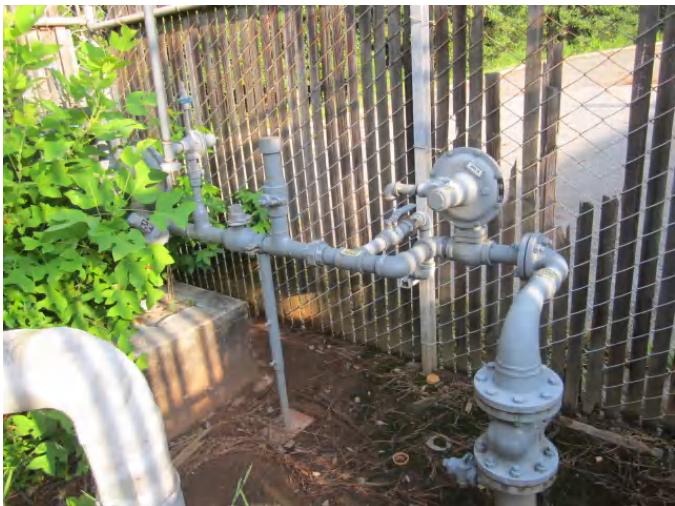
System: G3060 - Fuel Distribution

Location: Site

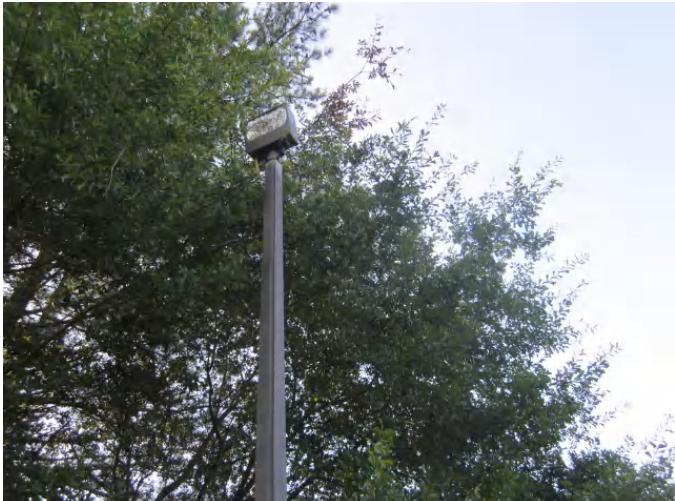
System: G4020 - Site Lighting

Location: Site

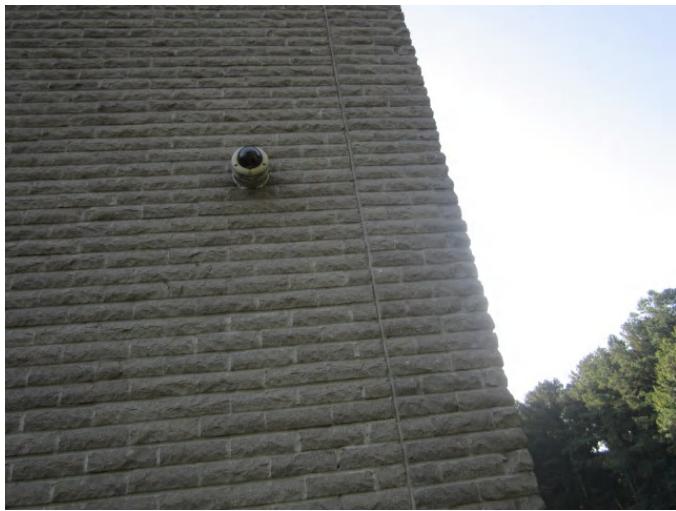
System: G4030 - Site Communications & Security

Location: Site
