DeKalb County School District/Elementary Schools

Briar Vista Elementary

School Assessment Report

May 19, 2016

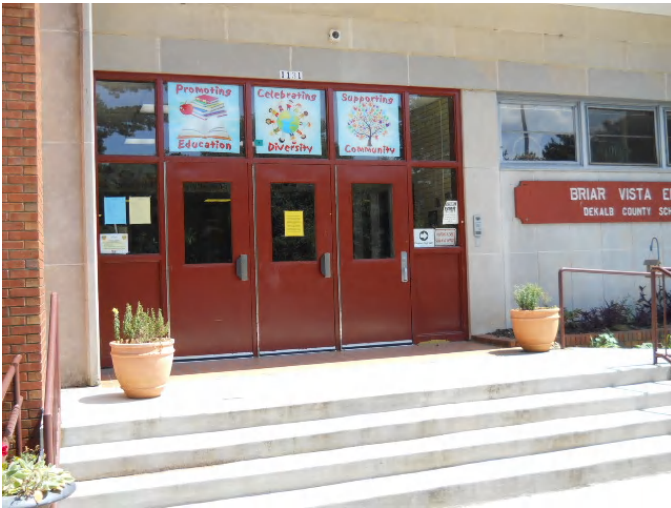
System: B2030 - Exterior Doors

Location: Throughout Building

Distress: Beyond Service Life

Notes: The exterior door system is beyond its expected service life, not ADA compliant, and should be replaced. SPLOST IV project 101-422 to replace exterior and interior doors.

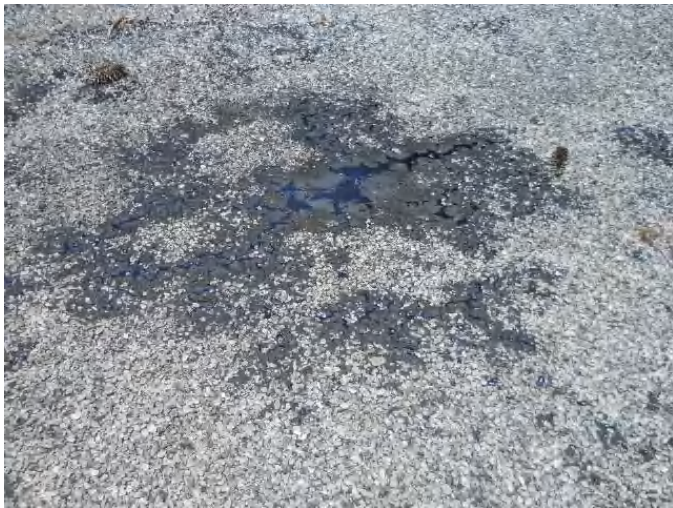
System: B3010 - Roof Coverings - BUR

Location: Roof

Distress: Beyond Service Life

Notes: The roof covering is leaking, beyond its expected service life, and should be replaced.

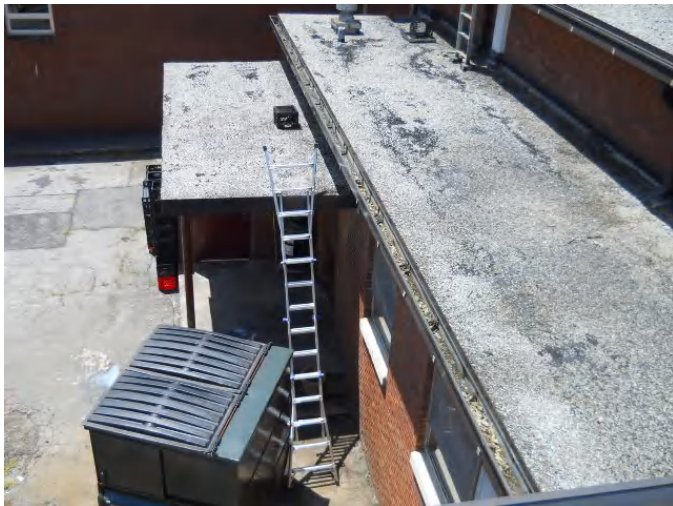
System: B3020 - Roof Openings

Location: Roof

Distress: Missing

Notes: There is no roof hatch/ladder system installed at this school. Multi-level roofs require safe access for maintenance personnel. Recommend adding three roof hatches for multi-level roofs, or install one hatch/ladder system and wall mount ladders to the other levels. Identified as a SPLOST project 101-422 to replace/repair roof openings in the 1955, 1957, and 1970 buildings.

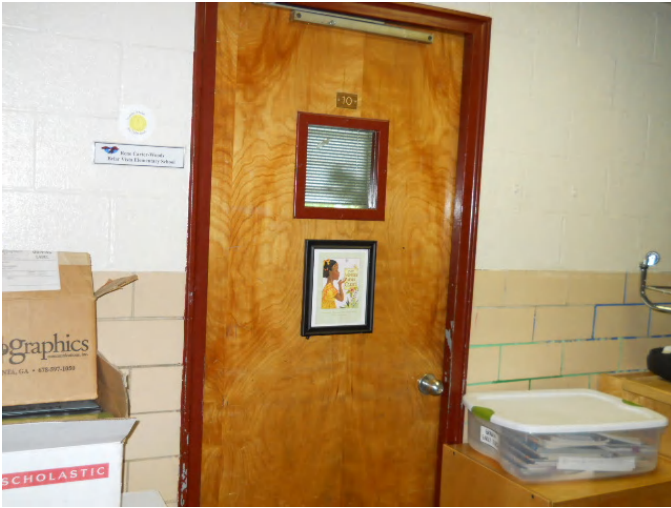
System: C1020 - Interior Doors

Location: Throughout Building

Distress: Beyond Service Life

Notes: Some interior doors had improvements made to them in 2014 for ADA compliance. The remaining interior doors are original construction, not ADA and building code compliant, and should be replaced. SPLOST IV project 101-422 to replace exterior and interior doors.

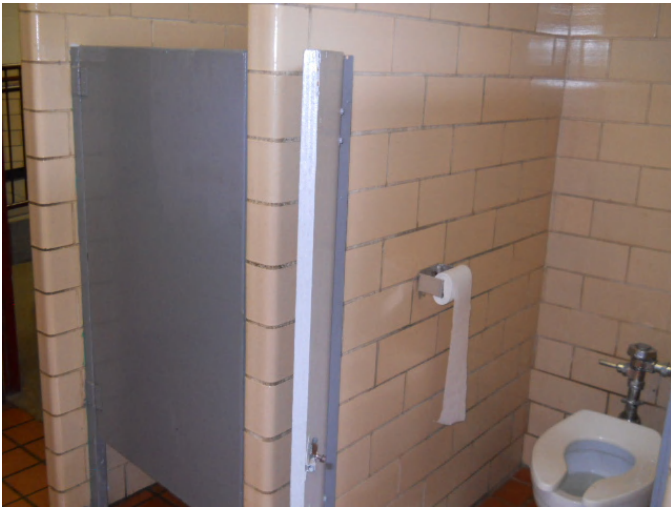
System: C1030 - Fittings

Location: Throughout Building

Distress: Beyond Service Life

Notes: Fittings, such as toilet partitions, signage and lockers, are beyond their expected service life, inadequate, not ADA compliant, and should be replaced. Many, but not all, of the toilet partitions and accessories were replaced in 2014.

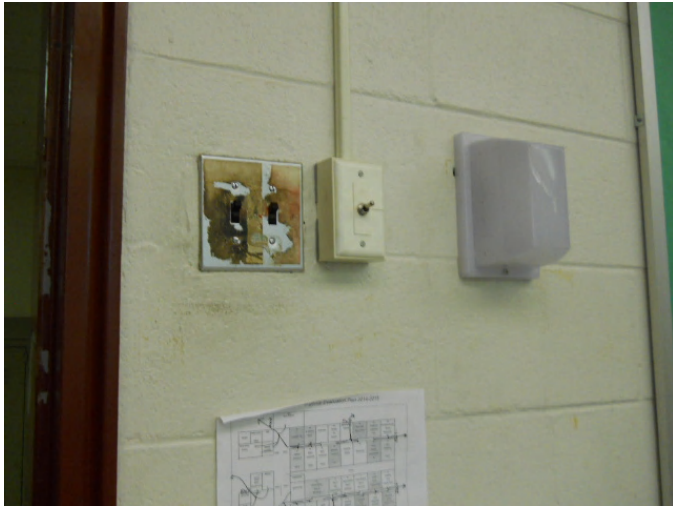
System: C3010 - Wall Finishes - Paint

Location: Throughout Building

Distress: Beyond Service Life

Notes: The painted wall finishes are beyond their expected service life, dirty, and should be replaced. SPLOST IV project 101-422 to paint interior walls.

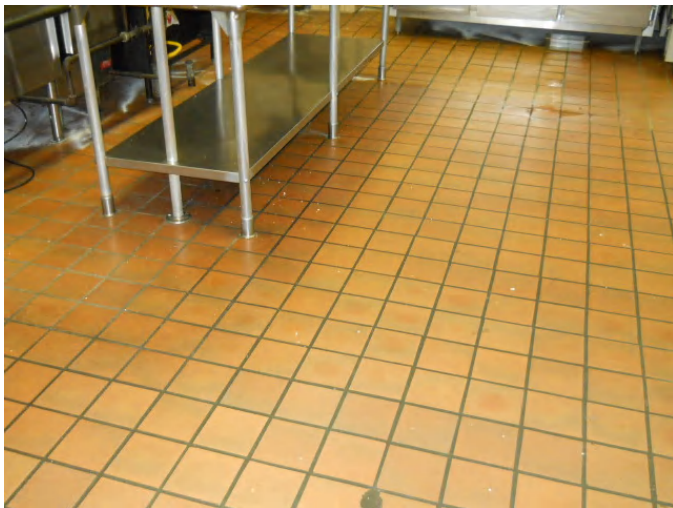
System: C3020 - Floor Finishes - Ceramic & Quarry Tile

Location: Kitchen and Restrooms

Distress: Beyond Service Life

Notes: The tile floor covering is beyond its expected service life and should be replaced.

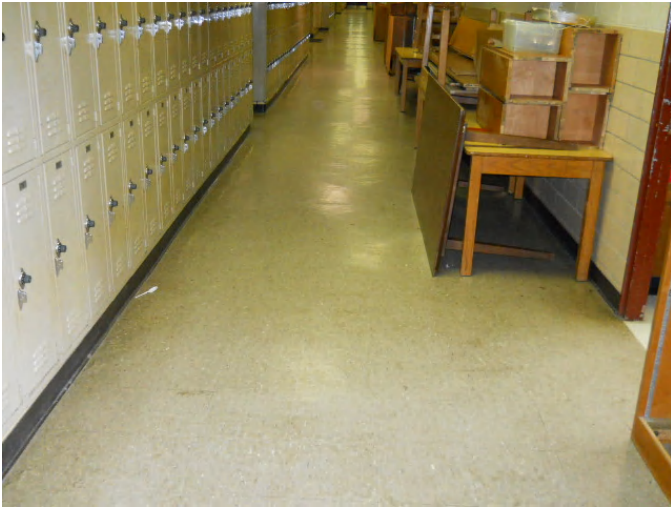
System: C3020 - Floor Finishes - VCT

Location: Throughout Building

Distress: Beyond Service Life

Notes: VCT floor finishes are beyond their service life, in some cases original construction, and should be scheduled for replacement.

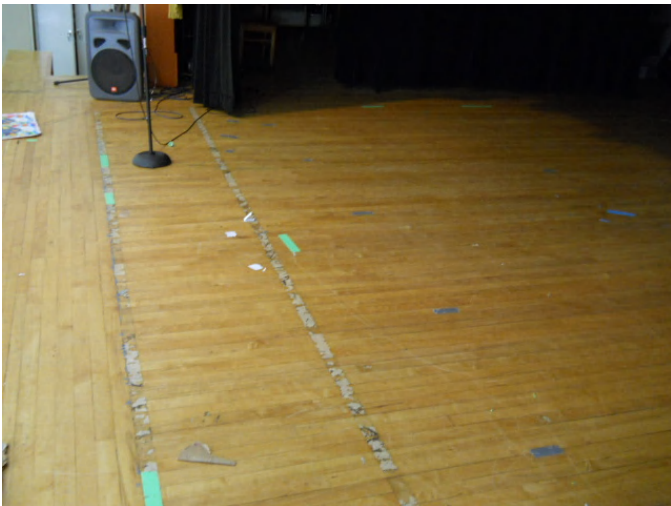
System: C3020 - Floor Finishes - Wood

Location: Stage

Distress: Beyond Service Life

Notes: The wood floor is original construction, worn, deteriorated, beyond its expected service life, and should be replaced.

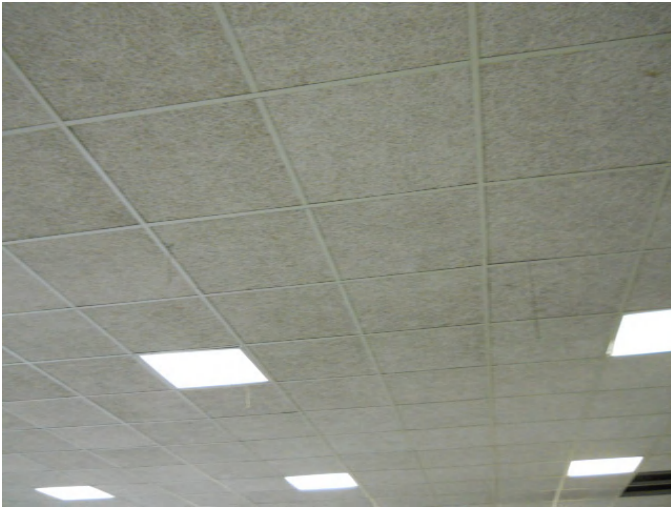
System: C3030 - Ceiling Finishes

Location: Throughout Building

Distress: Beyond Service Life

Notes: The ceiling tiles have been replaced as needed; however, the system is beyond its expected service life and should be replaced. The tiles in the kitchen and the stage area are original.

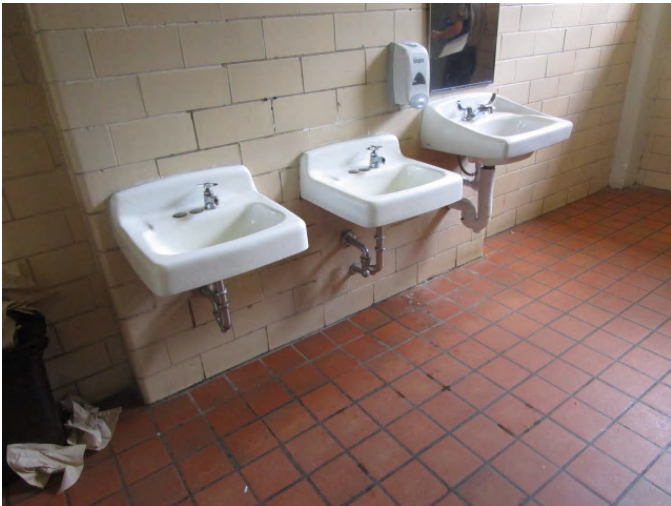
System: D2010 - Plumbing Fixtures

Location: Throughout Building

Distress: Beyond Service Life

Notes: Some, but not all of the plumbing fixtures were replaced in 2014. The remaining plumbing fixtures are beyond their expected service life; not ADA compliant, including protrusions into the hallway more than four inches; and should be scheduled for replacement. SPLOST IV project 101-422 to renovate hall restroom for ADA compliance.

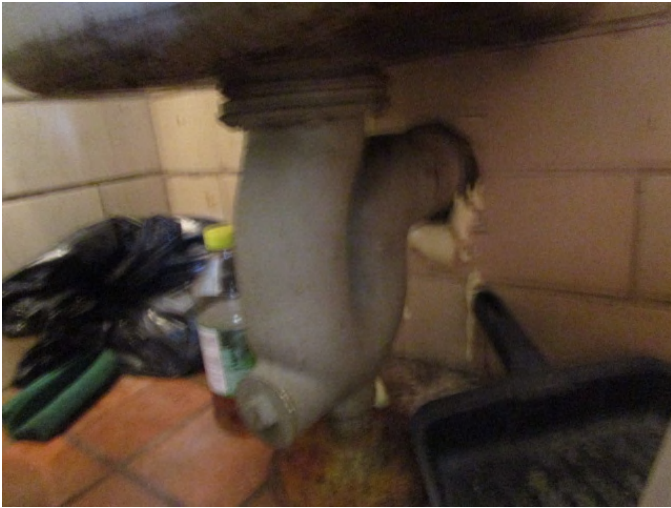
System: D2030 - Sanitary Waste

Location: Throughout Building

Distress: Beyond Service Life

Notes: The sanitary waste system is beyond its expected service life and should be scheduled for replacement. School staff reports odors in the building.

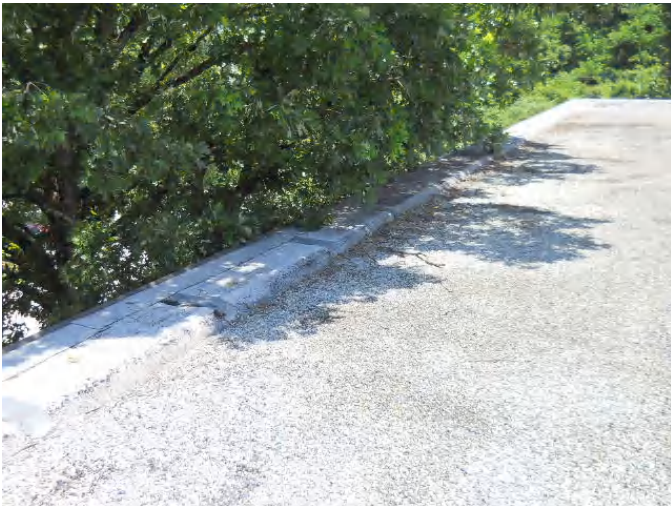
System: D2040 - Rain Water Drainage

Location: Throughout Building

Distress: Beyond Service Life

Notes: The roof rain water drainage system is beyond its expected service life, not functioning, and should be replaced. SPLOST IV project 101-422 to replace/repair roof water drainage system.

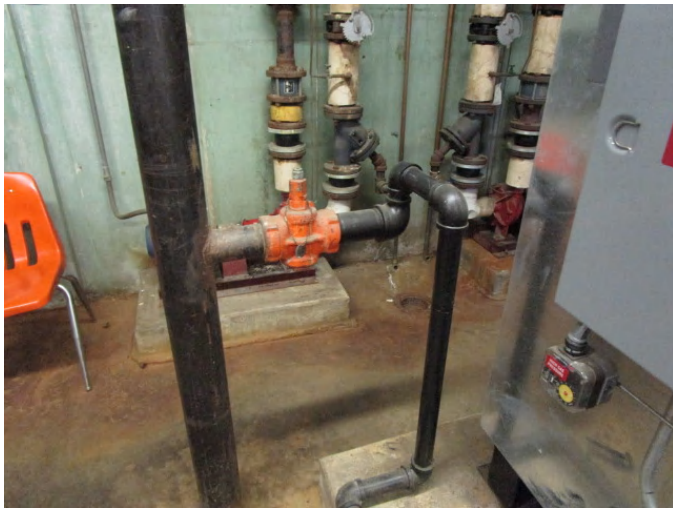
System: D2090 - Other Plumbing Systems - Natural Gas

Location: Throughout Building

Distress: Beyond Service Life

Notes: The natural gas system is beyond its expected service life and should be scheduled for replacement. SPLOST IV project 101-422 to replace grease trap and backflow preventer.

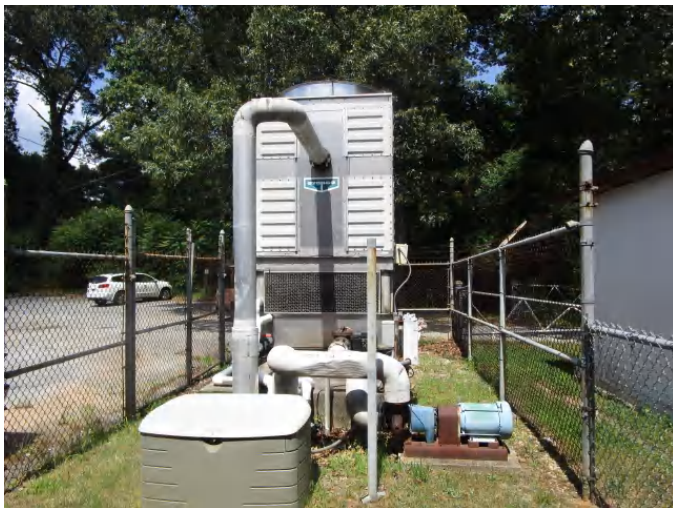
System: D3030 - Cooling Generating Systems

Location: East Side of Site

Distress: Beyond Service Life

Notes: The cooling generating system is beyond its expected service life and should be scheduled for replacement.

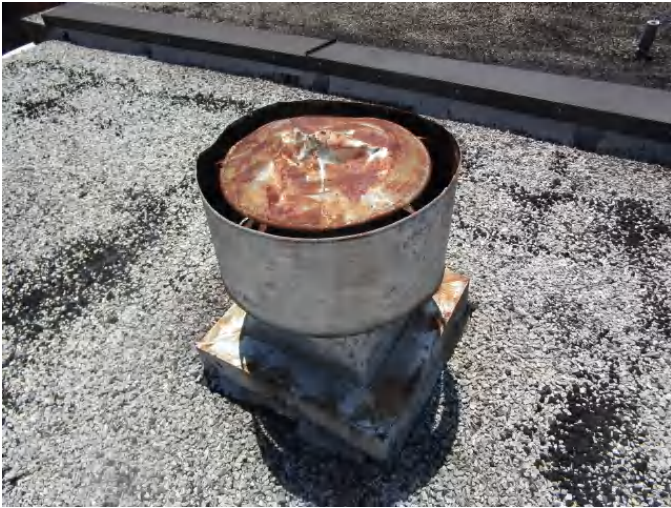
System: D3040 - Distribution & Exhaust Systems

Location: Throughout Building

Distress: Beyond Service Life

Notes: The distribution and exhaust systems are beyond their expected service life, inadequate, and should be scheduled for replacement. School staff reports indoor air-quality problems.

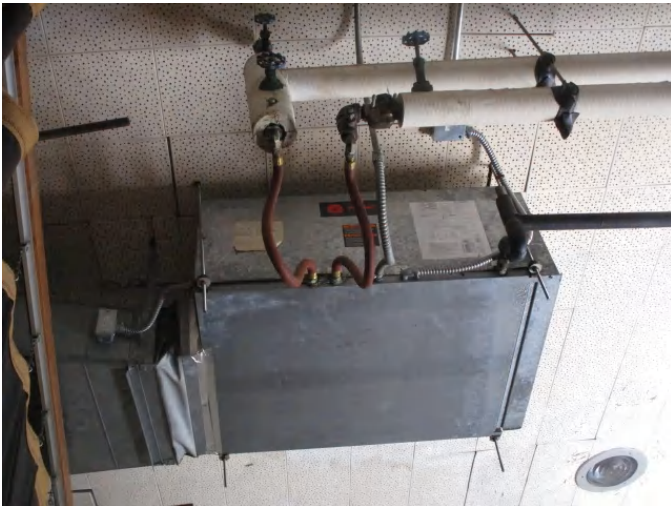
System: D3050 - Terminal & Package Units

Location: Throughout Building

Distress: Beyond Service Life

Notes: The terminal and package units are beyond their expected service life and should be scheduled for replacement. SPLOST IV project 126-422 to replace the water source heat pumps in the 1955, 1957, and 1970 buildings.

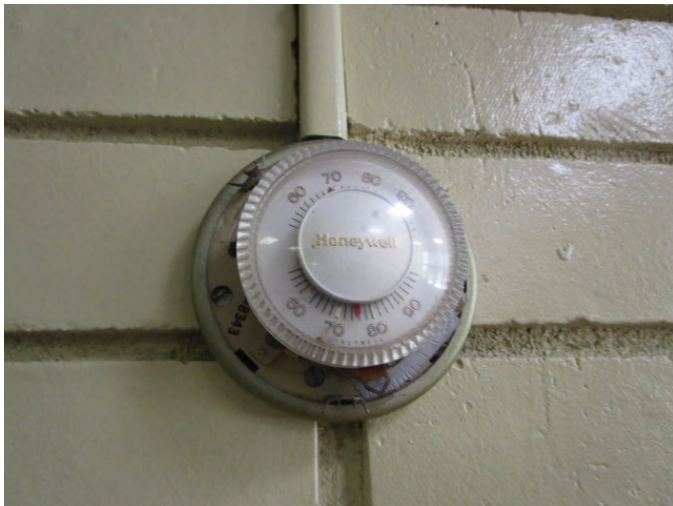
System: D3060 - Controls & Instrumentation

Location: Throughout Building

Distress: Beyond Service Life

Notes: The controls and instrumentation system is beyond its expected service life, inadequate, and should be scheduled for replacement.

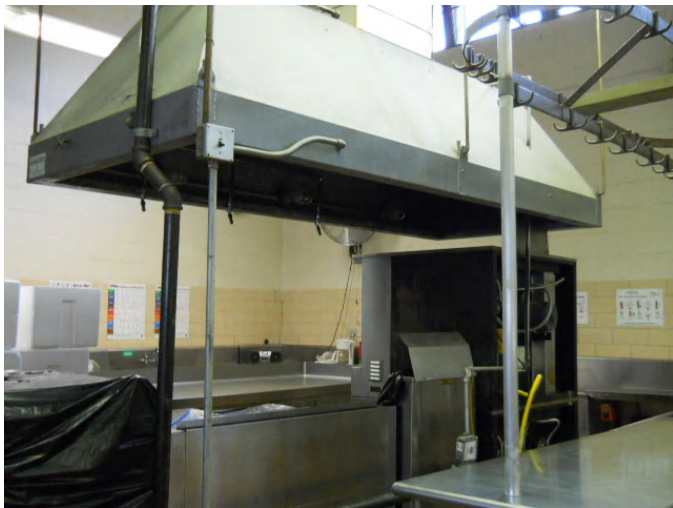
System: D3090 - Other HVAC Systems/Equip - Kitchen Hood

Location: Kitchen

Distress: Beyond Service Life

Notes: The kitchen hood system is beyond its expected service life and should be scheduled for replacement. SPLOST IV project 101 -422 to replace kitchen hood and associated equipment.

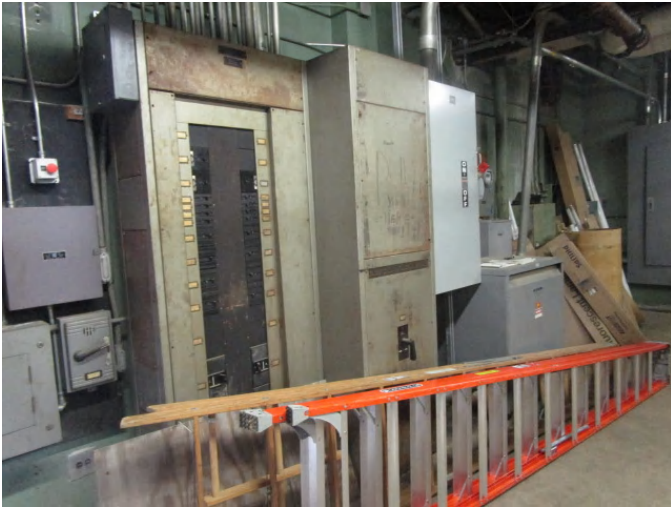
System: D5010 - Electrical Service/Distribution

Location: Main Switch Room/Throughout Building

Distress: Beyond Service Life

Notes: The electrical service/distribution system is beyond its expected service life, inadequate, and should be scheduled for replacement.

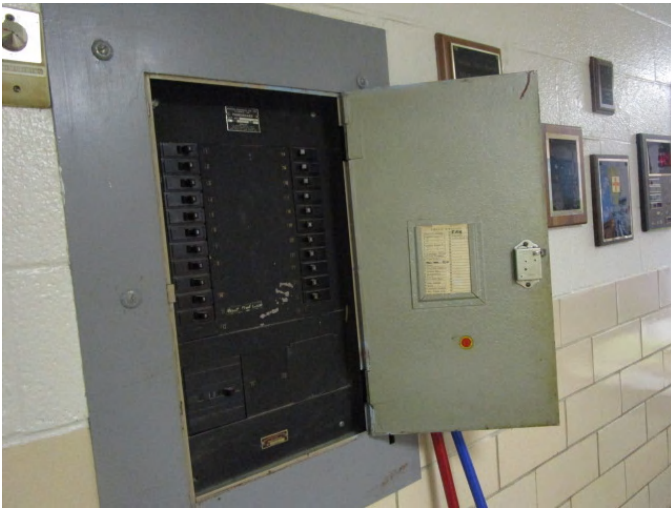
System: D5020 - Branch Wiring

Location: Throughout Building

Distress: Beyond Service Life

Notes: The branch wiring system is beyond its expected service life, inadequate, and should be scheduled for replacement. There are not enough outlets to serve current needs.

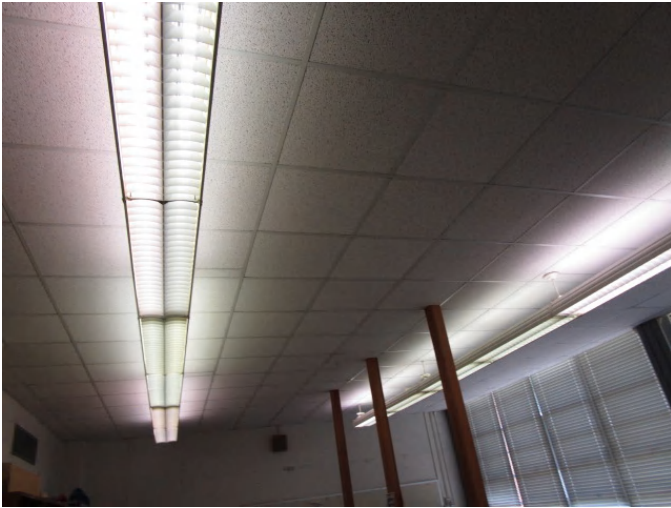
System: D5020 - Lighting

Location: Throughout Building

Distress: Beyond Service Life

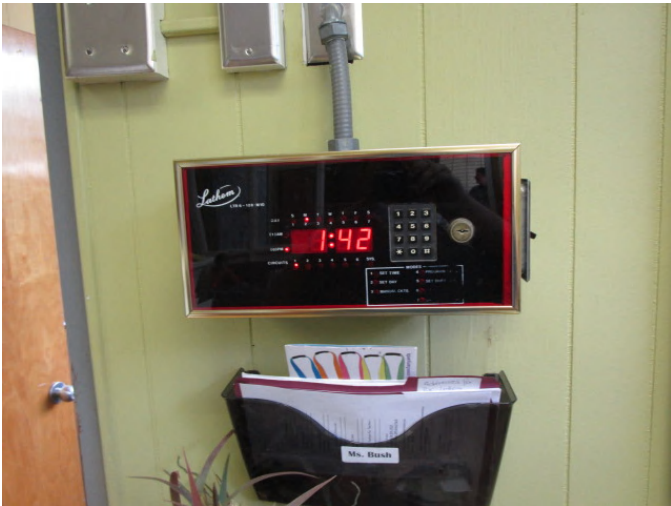
System: D5030 - Communications and Security - Clock & PA Systems

Location: Throughout Building

Distress: Beyond Service Life

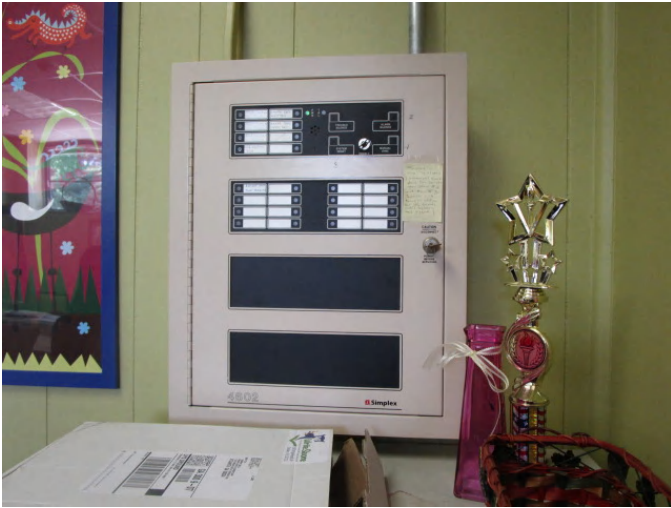
System: D5030 - Communications and Security - Fire Alarm

Location: Throughout Building

Distress: Beyond Service Life

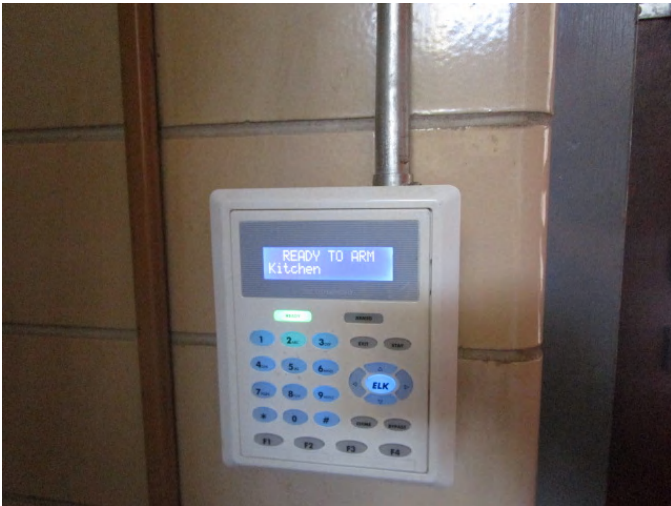
System: D5030 - Communications and Security - Security & CCTV

Location: Throughout Building

Distress: Beyond Service Life

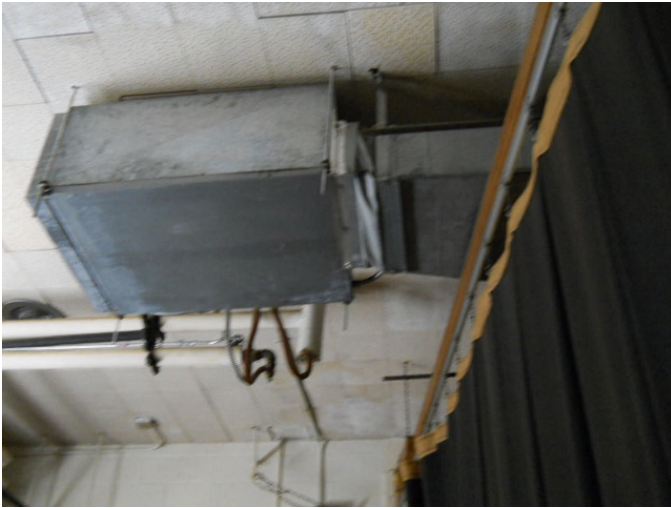
System: E1020 - Institutional Equipment

Location: Throughout Building

Distress: Beyond Service Life

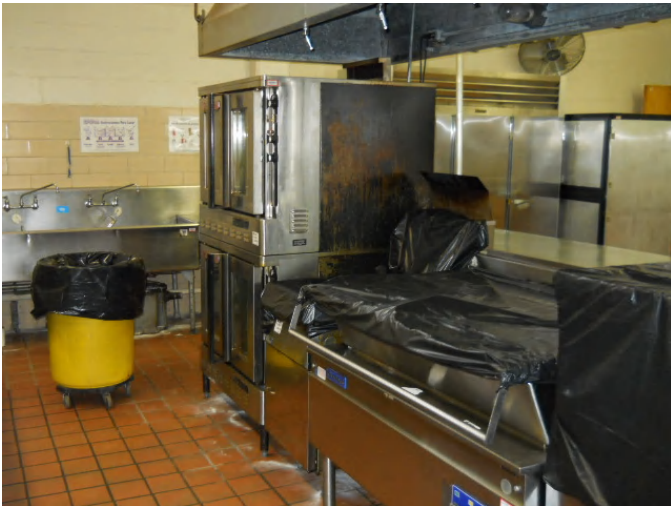
System: E1090 - Other Equipment (Kitchen Equipment)

Location: Kitchen

Distress: Beyond Service Life

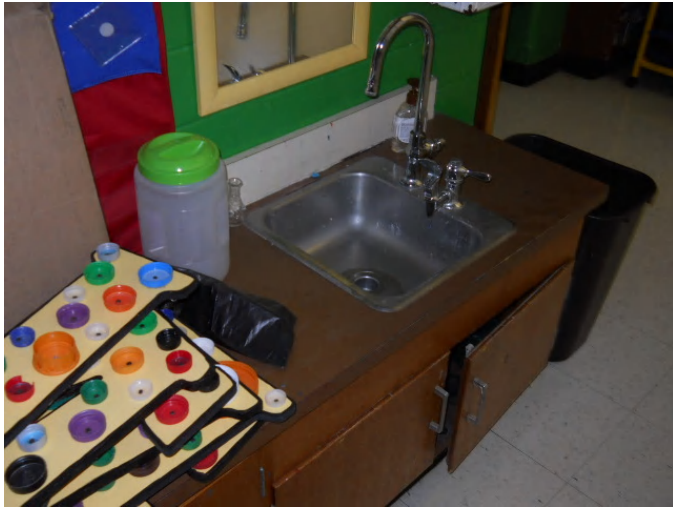
System: E2010 - Fixed Furnishings

Location: Throughout Building

Distress: Beyond Service Life

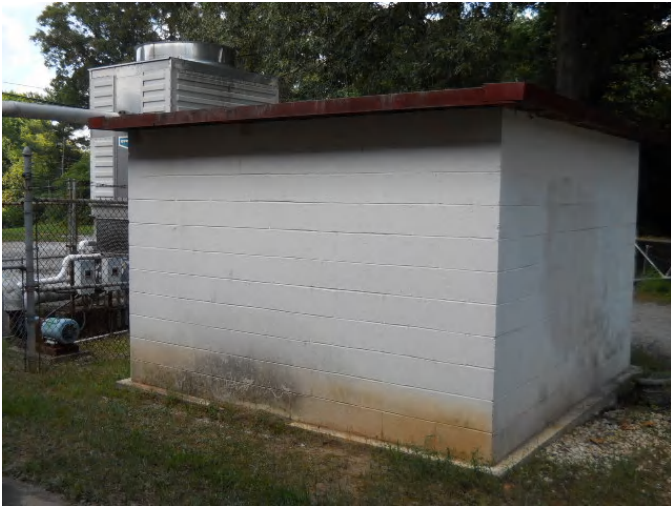
System: B2010 - Exterior Walls

Location: Exterior Wall

Distress: Damaged

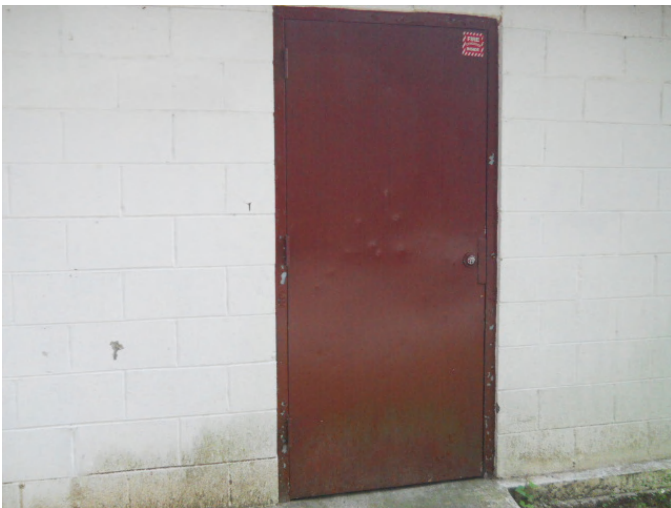
System: B2030 - Exterior Doors

Location: Exterior Wall

Distress: Beyond Service Life

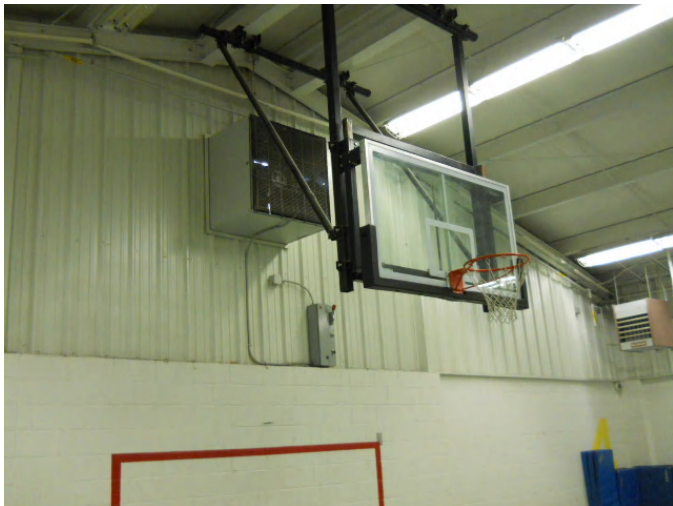
System: D3050 - Terminal & Package Units

Location: Throughout Building

Distress: Inadequate

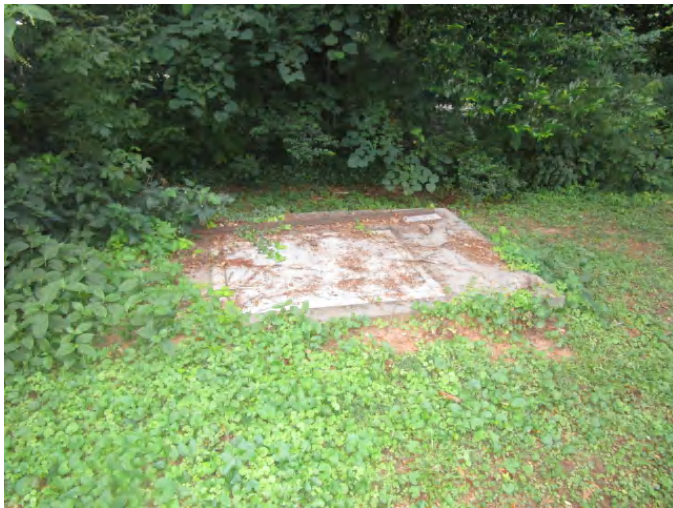
System: G3010 - Water Supply

Location: Site
Distress: Beyond Service Life
Category: Deferred Maintenance
Priority: 3 Priority
Correction: Renew System
Qty: 64,142.00
Unit of Measure: S.F.
Estimate: \$129,117.85
Assessor Name: Eduardo Lopez
Date Created: 06/28/2015

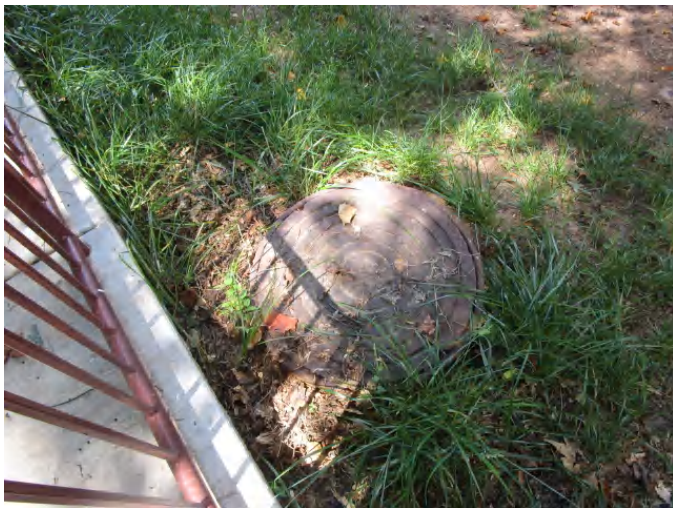
System: G3020 - Sanitary Sewer

Location: Site
Distress: Beyond Service Life
Category: Deferred Maintenance
Priority: 3 Priority
Correction: Renew System
Qty: 64,142.00
Unit of Measure: S.F.
Estimate: \$81,139.63
Assessor Name: Eduardo Lopez
Date Created: 06/28/2015

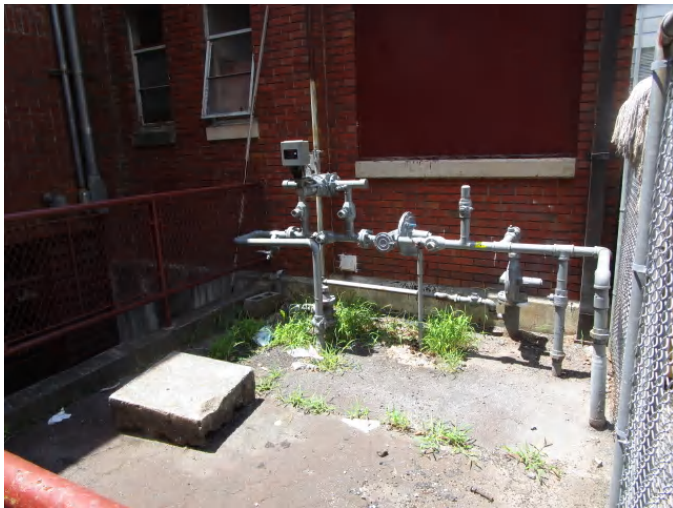
System: G3060 - Fuel Distribution

Location: Site
Distress: Beyond Service Life
Category: Deferred Maintenance
Priority: 3 Priority
Correction: Renew System
Qty: 64,142.00
Unit of Measure: S.F.
Estimate: \$55,033.84
Assessor Name: Eduardo Lopez
Date Created: 06/28/2015

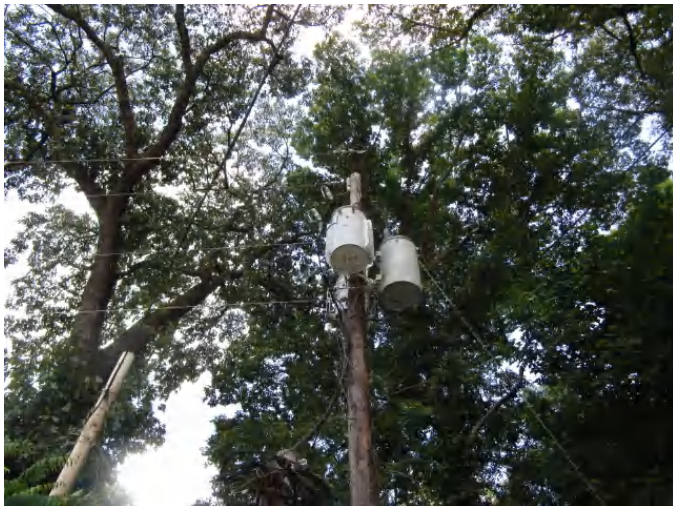
System: G4010 - Electrical Distribution

Location: Site
Distress: Beyond Service Life
Category: Deferred Maintenance
Priority: 3 Priority
Correction: Renew System
Qty: 64,142.00
Unit of Measure: S.F.
Estimate: \$131,234.53
Assessor Name: Eduardo Lopez
Date Created: 06/28/2015
