**DeKalb County School District/Elementary Schools**

# **Briarlake Elementary**

School Assessment Report
May 19, 2016

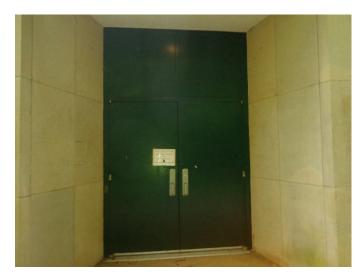
System: B2030 - Exterior Doors

**Location:** Throughout Building

**Distress:** Beyond Service Life

**Notes:** The original exterior doors are aged and should be replaced. The emergency exit doors in the cafeteria do not lock/seal properly and should also be replaced.

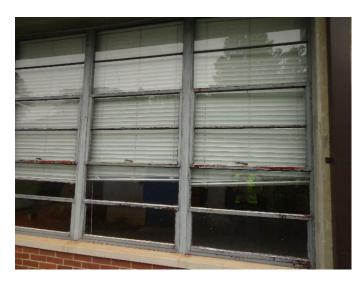
#### System: B2020 - Exterior Windows

**Location:** Throughout Building

**Distress:** Beyond Service Life

**Notes:** The aluminum frame, operable, single pane windows are aged, not energy efficient, do not lock/seal properly, and should be replaced.

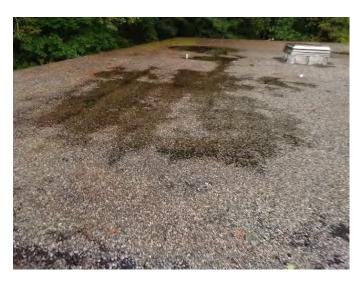
#### System: B3010 - Roof Coverings - BUR

Location: Roof

**Distress:** Beyond Service Life

**Notes:** Built-up roof covering is deteriorating with cracks, bubbling, patches, ponding and reported water leaks. SPLOST project 402-422 to replace the roof on the 1957 and 1963 buildings.

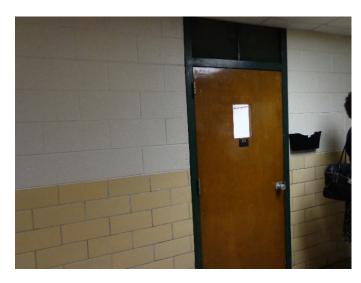
#### System: C1020 - Interior Doors

**Location:** Throughout Building

**Distress:** Beyond Service Life

Notes: Interior doors are beyond their expected service life, not ADA or building code compliant, and should be replaced.

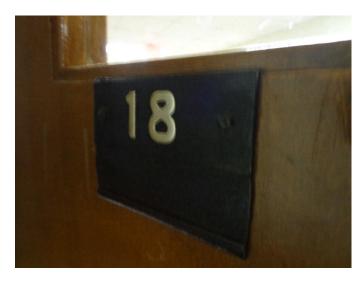
#### System: C1030 - Fittings

**Location:** Throughout Building

**Distress:** Beyond Service Life

**Notes:** Fittings, such as toilet partitions, handrails and signage, are beyond their expected service life, not ADA compliant, and should be replaced.

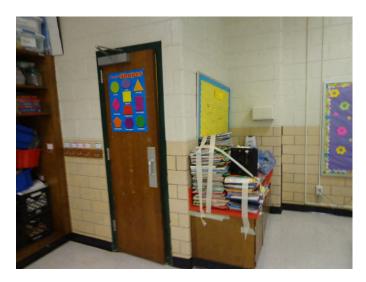
#### System: C3010 - Wall Finishes - Paint

**Location:** Throughout Building

**Distress:** Beyond Service Life

Notes: The painted wall finishes are beyond their expected service life, faded and stained, and should be replaced.

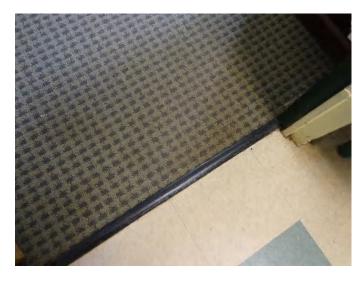
#### System: C3020 - Floor Finishes - Carpet

**Location:** Throughout Building

**Distress:** Beyond Service Life

**Notes:** The carpet is aged, stained and frayed, and should be replaced.

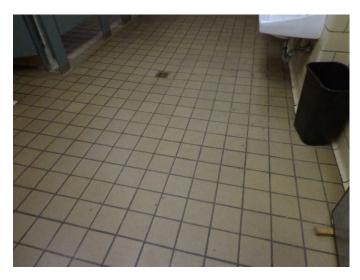
#### System: C3020 - Floor Finishes - Ceramic & Quarry Tile

**Location:** Kitchen and Restrooms

**Distress:** Beyond Service Life

Notes: The tile floor covering is beyond its expected service life, cracked, patched and worn, and should be replaced.

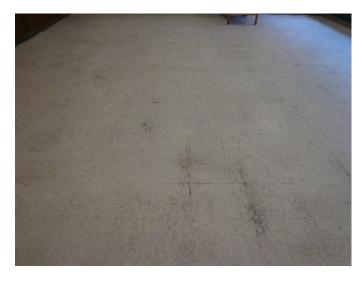
#### System: C3020 - Floor Finishes - VCT

**Location:** Throughout Building

**Distress:** Beyond Service Life

Notes: The VCT flooring is aged, cracked, worn and patched, and should be replaced. There are 9"x9" tiles in the storage rooms.

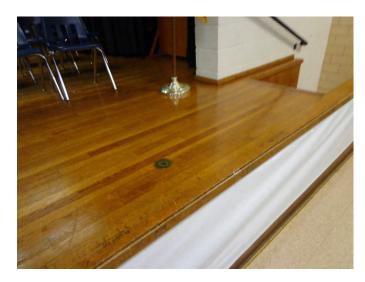
#### System: C3020 - Floor Finishes - Wood

Location: Stage

**Distress:** Beyond Service Life

**Notes:** Wood floor finish is beyond service life and should be replaced.

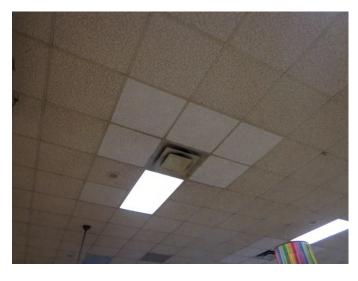
#### System: C3030 - Ceiling Finishes

**Location:** Throughout Building

**Distress:** Beyond Service Life

**Notes:** The ceiling tiles have been replaced as needed; however, the system is beyond its expected service life and should be replaced. The grid shows signs of aging and most tiles are sagging or damaged.

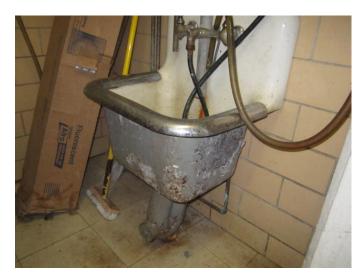
#### System: D2010 - Plumbing Fixtures

**Location:** Throughout Building

**Distress:** Beyond Service Life

Notes: The plumbing fixtures are beyond their expected service life and should be scheduled for replacement.

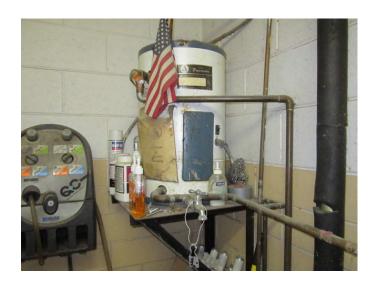
#### System: D2020 - Domestic Water Distribution

**Location:** Throughout Building

**Distress:** Beyond Service Life

**Notes:** The domestic water distribution system is beyond its expected service life, not building code compliant, and should be scheduled for replacement.

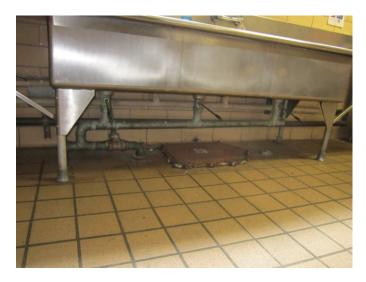
#### System: D2030 - Sanitary Waste

**Location:** Throughout Building

**Distress:** Beyond Service Life

Notes: The sanitary waste system is beyond its expected service life and should be scheduled for replacement.

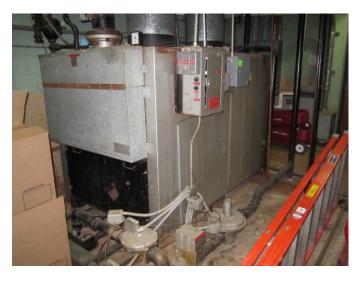
#### System: D2090 - Other Plumbing Systems - Natural Gas

**Location:** Throughout Building

**Distress:** Beyond Service Life

**Notes:** The natural gas system is beyond its expected service life and should be scheduled for replacement. SPLOST project 402-422 to replace the grease trap and backflow preventer.

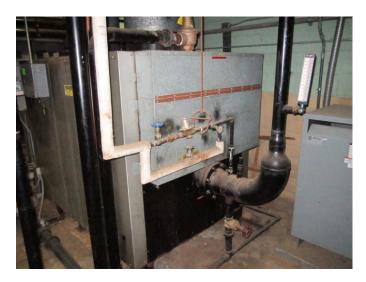
#### System: D3020 - Heat Generating Systems

**Location:** Mechanical Room

**Distress:** Beyond Service Life

Notes: The heat generating system is beyond its expected service life and should be scheduled for replacement.

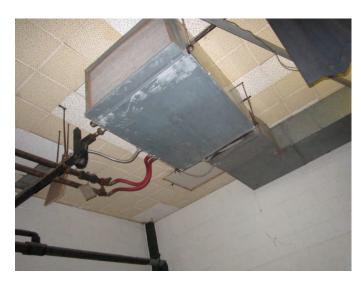
#### System: D3040 - Distribution & Exhaust Systems

**Location:** Throughout Building

**Distress:** Beyond Service Life

**Notes:** The distribution and exhaust systems are beyond their expected service life, missing in new ADA-compliant restrooms, and should be replaced/added.

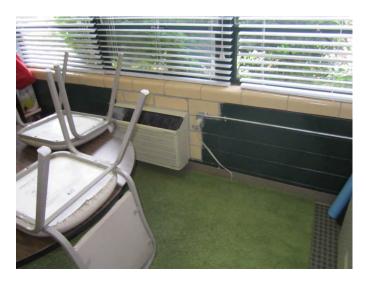
#### System: D3050 - Terminal & Package Units

**Location:** Throughout Building

**Distress:** Beyond Service Life

Notes: The terminal and package units are beyond their expected service life and should be scheduled for replacement.

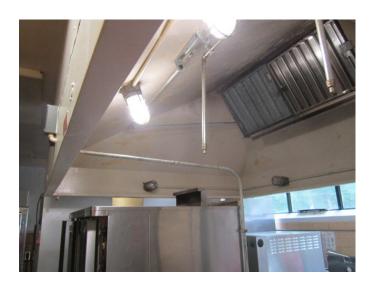
#### System: D3090 - Other HVAC Systems/Equip - Kitchen Hood

Location: Kitchen

**Distress:** Beyond Service Life

Notes: The kitchen hood system is beyond its expected service life, aged, and should be scheduled for replacement.

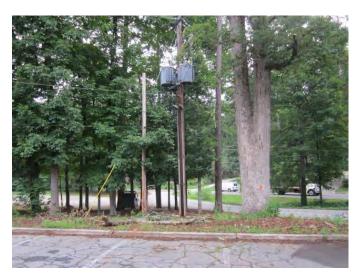
#### System: D5010 - Electrical Service/Distribution

**Location:** Main Switch Room/Throughout Building

**Distress:** Beyond Service Life

Notes: The electrical service/distribution system is beyond its expected service life, aged, and should be scheduled for replacement.

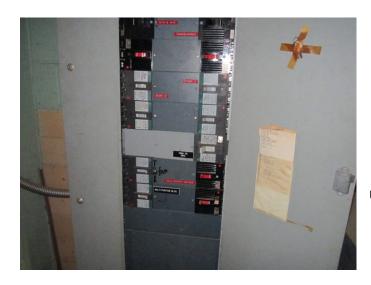
#### System: D5020 - Branch Wiring

**Location:** Throughout Building

**Distress:** Beyond Service Life

**Notes:** The branch wiring system is beyond its expected service life, inadequate, and should be scheduled for replacement. There are not enough electrical outlets in the building. Electrical outlets in wet areas are not GFI.

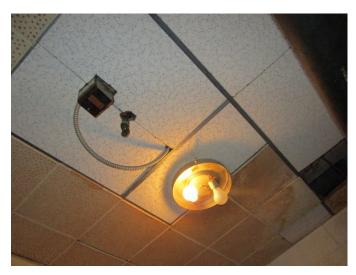
#### System: D5020 - Lighting

**Location:** Throughout Building

**Distress:** Beyond Service Life

**Notes:** The lighting system is beyond its expected service life, not code compliant, and should be scheduled for replacement. Some illuminated exit signs are not working or missing.

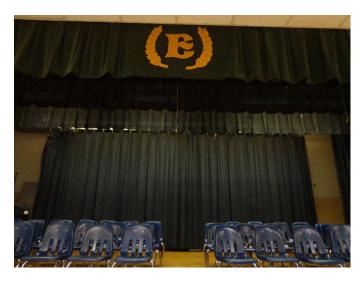
#### System: E1020 - Institutional Equipment

**Location:** Throughout Building

**Distress:** Beyond Service Life

**Notes:** Institutional equipment, such as theater and stage equipment, library equipment and audio-visual equipment, is beyond its expected service life and should be scheduled for replacement.

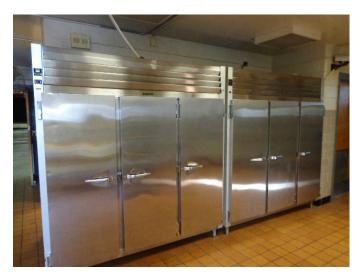
#### System: E1090 - Other Equipment - Kitchen Equipment

Location: Kitchen

**Distress:** Beyond Service Life

Notes: Kitchen equipment is beyond its expected service life and should be scheduled for replacement.

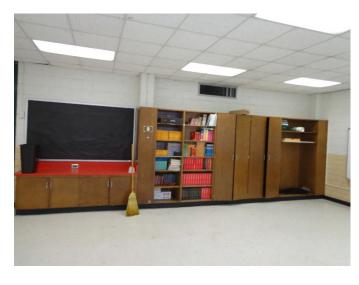
#### **System: E2010 - Fixed Furnishings**

**Location:** Throughout Building

**Distress:** Beyond Service Life

Notes: Fixed furnishings, such as built-in cabinets, are beyond their expected service life and worn, and should be replaced.

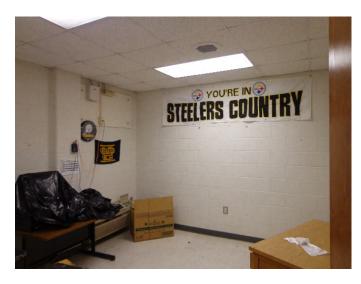
System: C3010 - Wall Finishes - Paint

**Location:** Throughout Building

**Distress:** Beyond Service Life

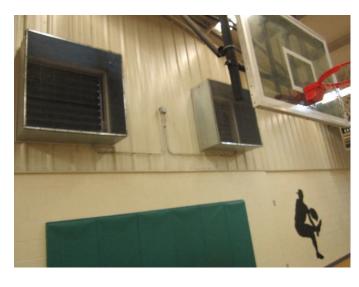
### System: D3050 - Terminal & Package Units

**Location:** Throughout Building

**Distress:** Inadequate

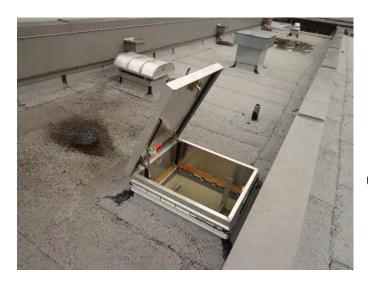
System: B3020 - Roof Openings

Location: Roof

**Distress:** Inadequate

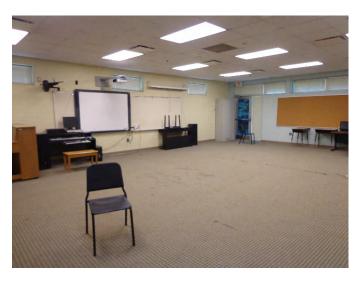
#### System: C3020 - Floor Finishes - Carpet

**Location:** Music Room

**Distress:** Beyond Service Life

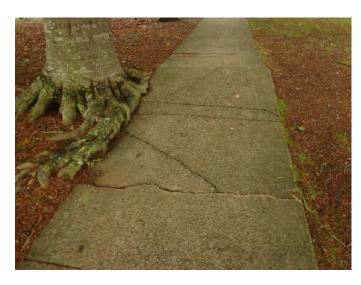
System: G2030 - Pedestrian Paving

Location: Site

**Distress:** Beyond Service Life

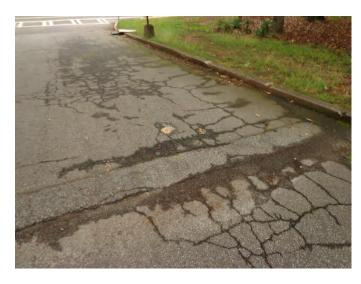
#### System: G2010 - Roadways

**Location:** Site

**Distress:** Beyond Service Life

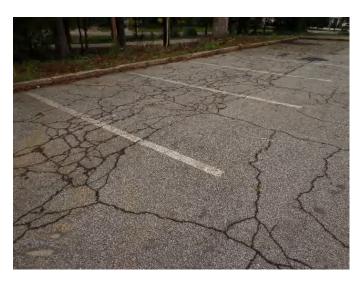
#### System: G2020 - Parking Lots

Location: Site

**Distress:** Beyond Service Life

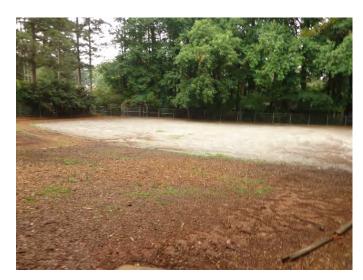
### System: G2040 - Fencing & Guardrails

Location: Site

**Distress:** Beyond Service Life

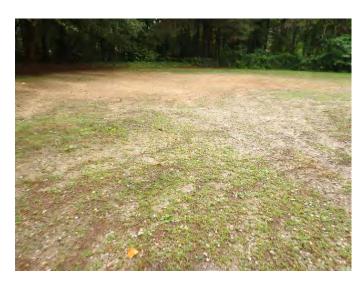
#### System: G2040 - Playing Field

Location: Site

**Distress:** Beyond Service Life

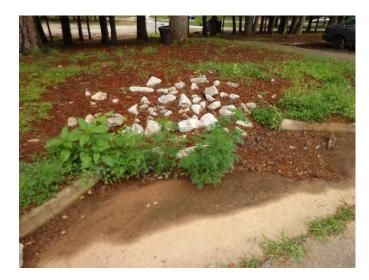
#### System: G2050 - Landscaping

Location: Site

**Distress:** Beyond Service Life

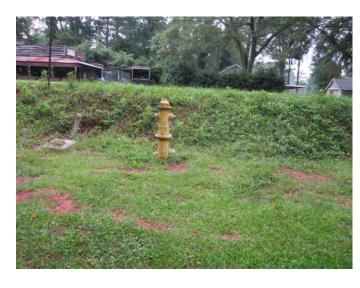
#### System: G3010 - Water Supply

Location: Site

**Distress:** Beyond Service Life

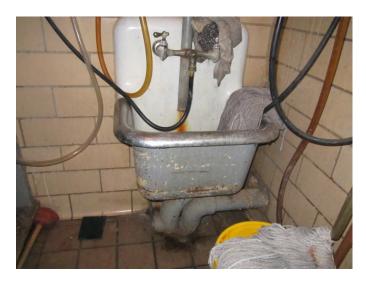
### System: G3020 - Sanitary Sewer

**Location:** Site

**Distress:** Beyond Service Life

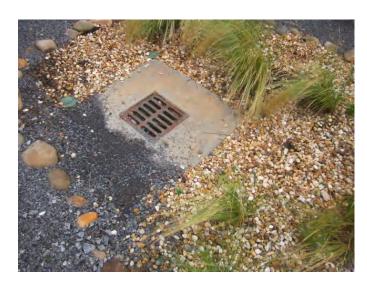
#### System: G3030 - Storm Sewer

Location: Site

**Distress:** Beyond Service Life

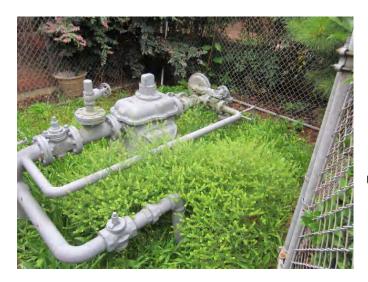
#### System: G3060 - Fuel Distribution

Location: Site

**Distress:** Beyond Service Life

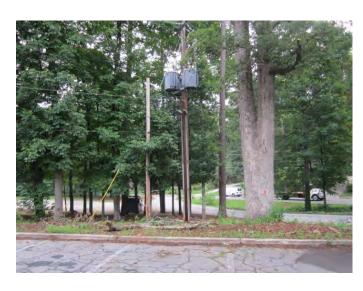
#### **System: G4010 - Electrical Distribution**

**Location:** Site

**Distress:** Beyond Service Life

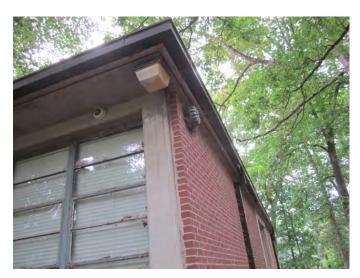
### System: G4020 - Site Lighting

Location: Site

**Distress:** Beyond Service Life

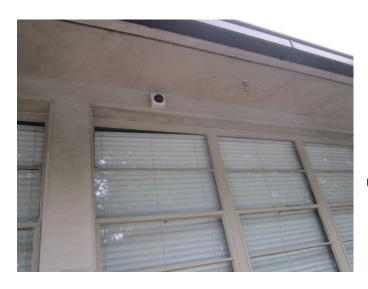
#### System: G4030 - Site Communications & Security

Location: Site

**Distress:** Beyond Service Life
