DeKalb County School District/Elementary Schools

Brockett Elementary

School Assessment Report

May 19, 2016

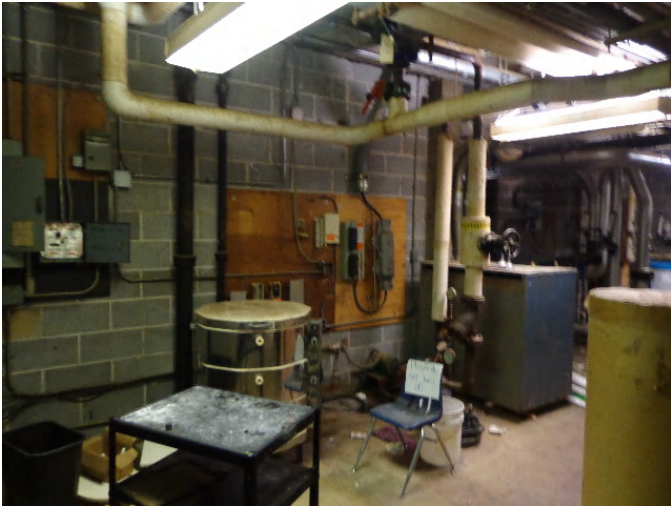
System: C1010 - Partitions

Location: Mechanical Room

Distress: Needs Remediation

Notes: The kiln is located in the mechanical room, which is off limits to students. This deficiency provides for the construction of an enclosed, ventilated space of approximately 200 square feet to allow for proper operation of the kiln. The kiln should not be used until this issue is resolved.

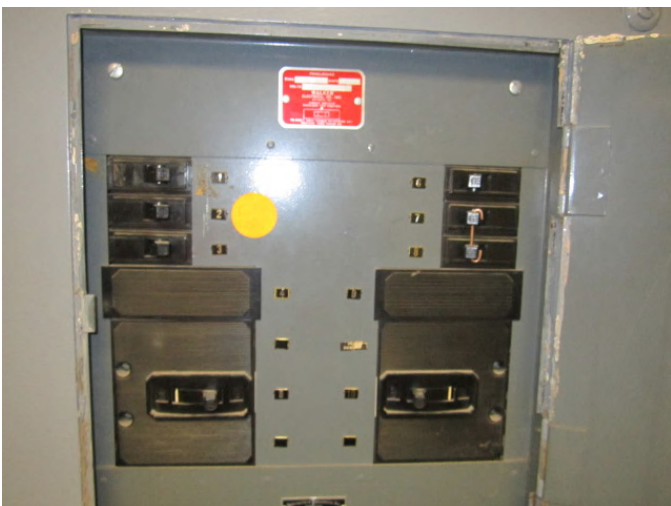
System: D5020 - Branch Wiring

Location: Throughout Building

Distress: Beyond Service Life

Notes: The branch wiring system is beyond its expected service life, inadequate, and should be scheduled for replacement. School staff reported multiple fires due to faulty electrical wiring. Recommended for immediate action to have a team of electrical engineer and licensed electrical contractor investigate, perform system-wide maintenance and remediation, and prepare a formal report on condition of the electrical system.

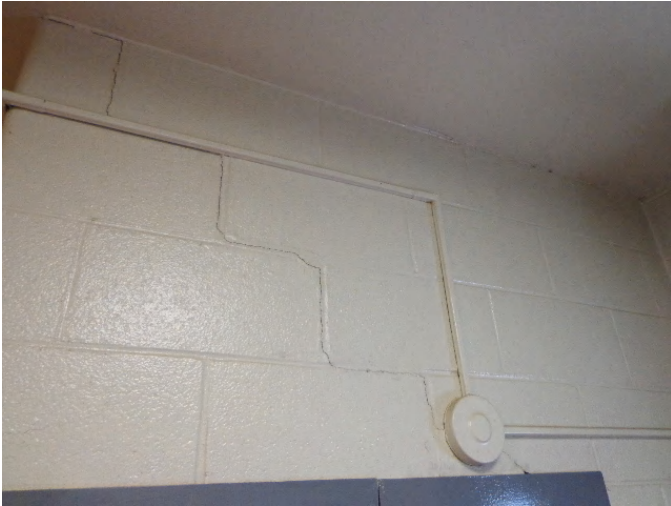
System: A1010 - Standard Foundations

Location: Throughout Building

Distress: Damaged

Notes: Differential settlement was observed throughout the building and an engineering study is recommended to determine the cause. Pricing does not include remediation measures

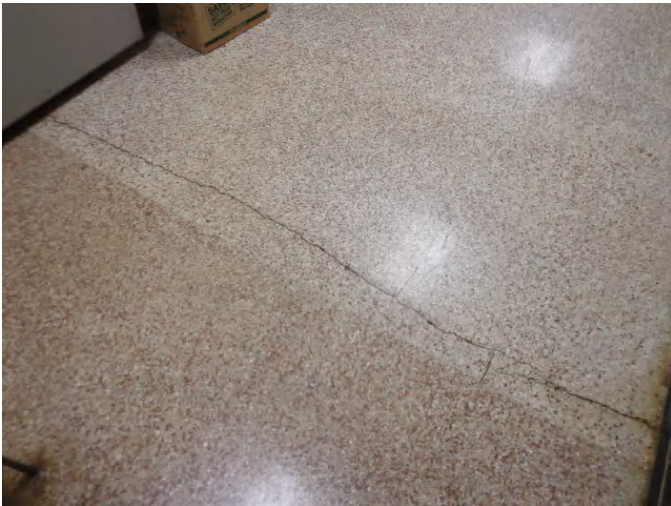
System: A1010 - Standard Foundations

Location: Throughout Building

Distress: Needs Remediation

Notes: Differential settlement was observed throughout the building and an engineering study is recommended to determine the cause. Pricing does not include remediation measures.

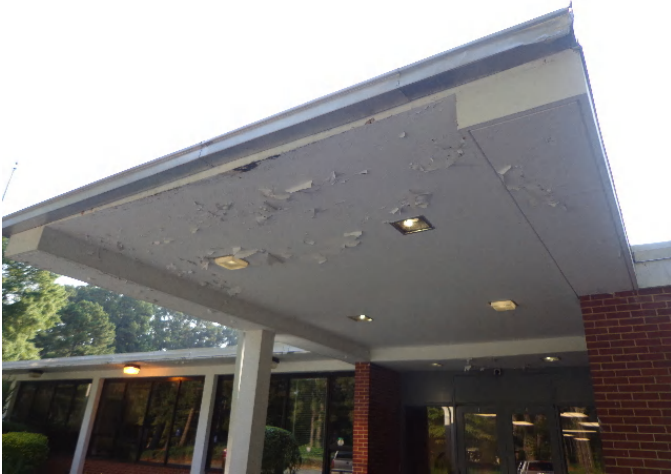
System: B2010 - Exterior Walls

Location: Soffit and Canopy

Distress: Damaged

Notes: The painted finish is peeling and should be replaced.

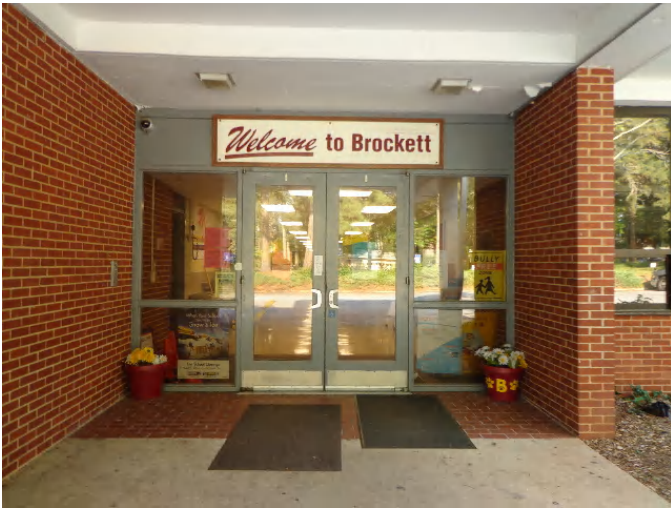
System: B2030 - Exterior Doors

Location: Throughout Building

Distress: Beyond Service Life

Notes: The original exterior doors are aged and rusted in some areas, and should be replaced.

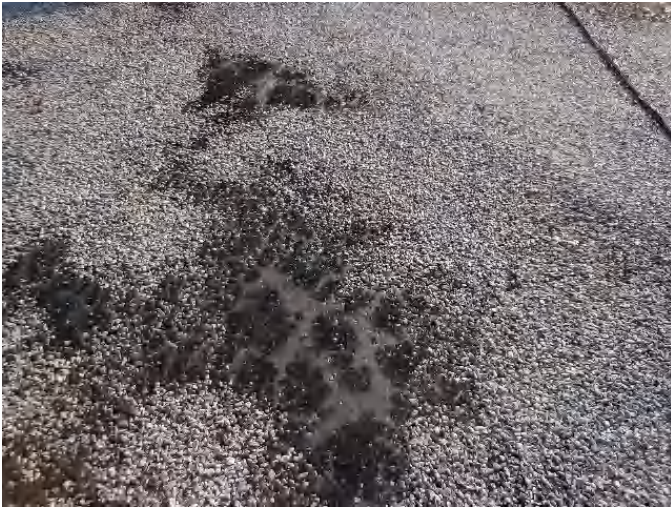
System: B3010 - Roof Coverings - BUR

Location: Roof

Distress: Beyond Service Life

Notes: The built-up roof covering is aged, showing signs of failure, with many reported leaks, and should be replaced. SPLOST IV project 403-422 to evaluate roofs/roof leaks for the 2008 roof replacements.

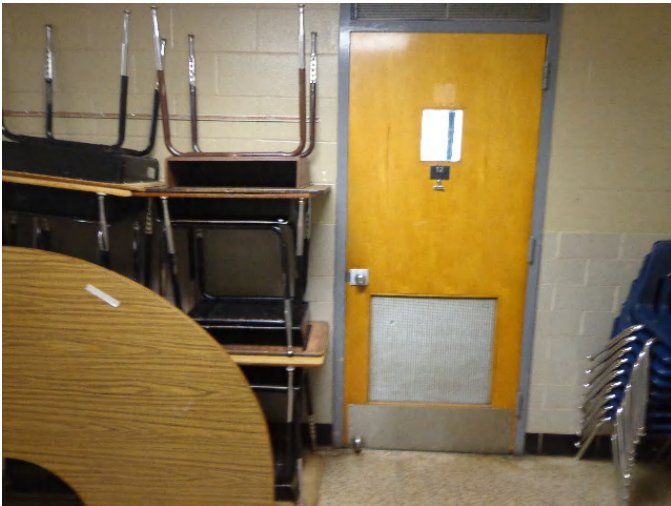
System: C1020 - Interior Doors

Location: Throughout Building

Distress: Beyond Service Life

Notes: The interior doors are aged, failing, and should be replaced to improve ADA accessibility.

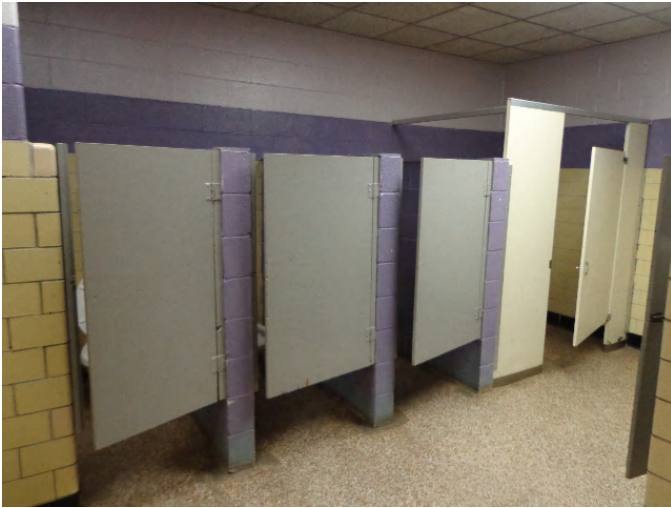
System: C1030 - Fittings

Location: Throughout Building

Distress: Beyond Service Life

Notes: Fittings, such as toilet partitions, signage and chalk and tack boards, are aged and in marginal condition. New ADA-complaint restrooms were installed in 2011 with appropriate signage, however, grab bars are missing or wrongly located, and the entire system should be replaced.

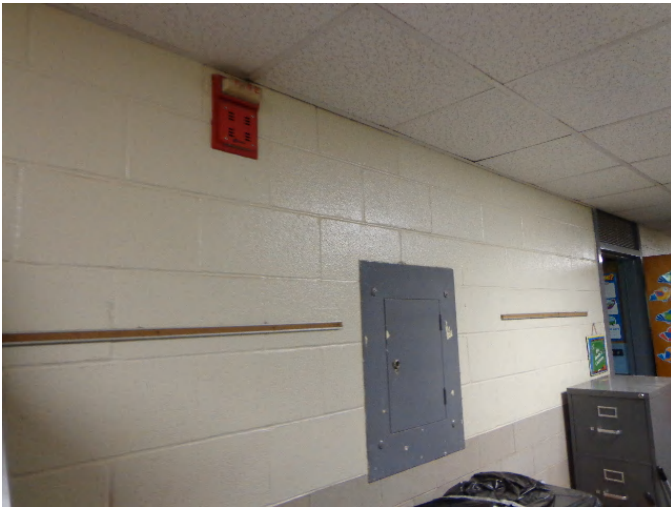
System: C3010 - Wall Finishes - Paint

Location: Throughout Building

Distress: Beyond Service Life

Notes: The painted wall finishes are beyond their expected service life, faded and stained, and should be replaced.

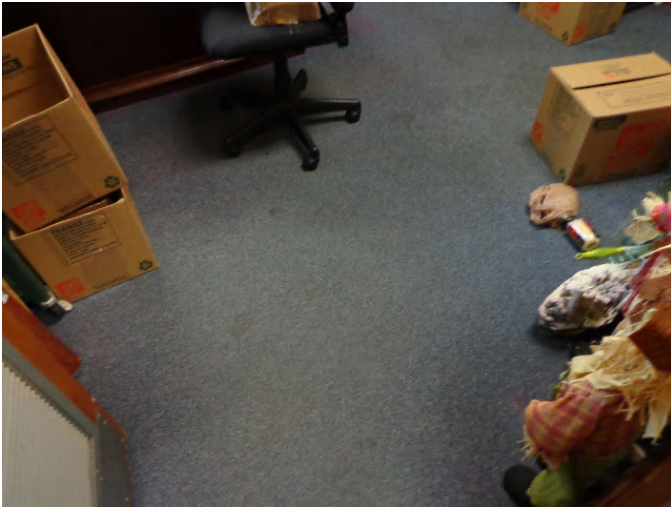
System: C3020 - Floor Finishes - Carpet

Location: Offices and Media Center

Distress: Beyond Service Life

Notes: The carpet is beyond its expected service life, stained, and should be replaced.

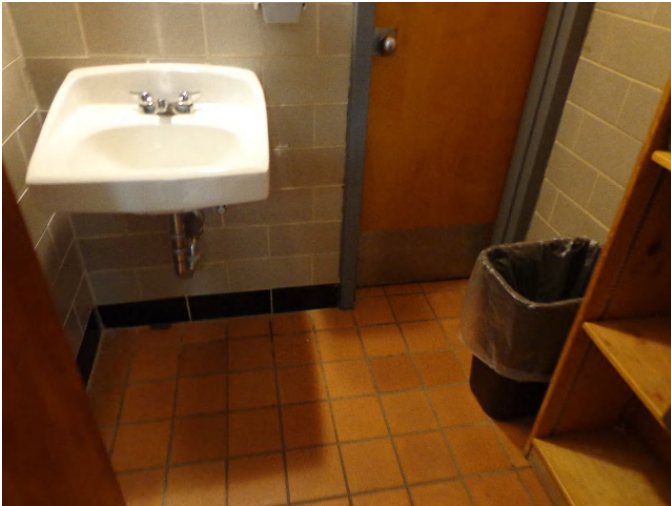
System: C3020 - Floor Finishes - Ceramic & Quarry Tile

Location: Kitchen and Restrooms

Distress: Beyond Service Life

Notes: The tile floor covering is beyond its expected service life, worn, and should be replaced.

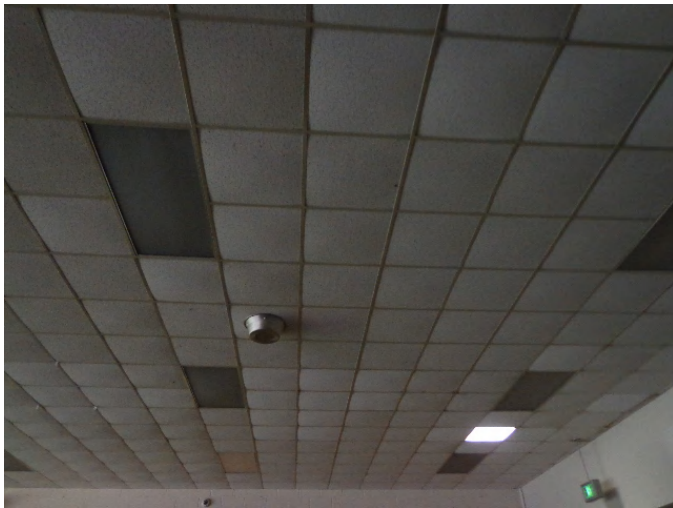
System: C3030 - Ceiling Finishes

Location: Throughout Building

Distress: Beyond Service Life

Notes: The ceiling tile and grid system shows signs of aging, with sagging and stained tiles, and should be replaced.

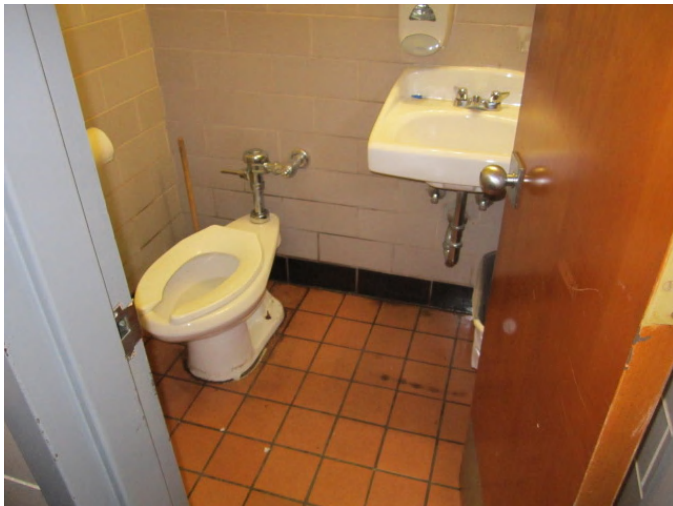
System: D2020 - Domestic Water Distribution

Location: Throughout Building

Distress: Beyond Service Life

Notes: The domestic water distribution system is beyond its expected service life and should be scheduled for replacement.

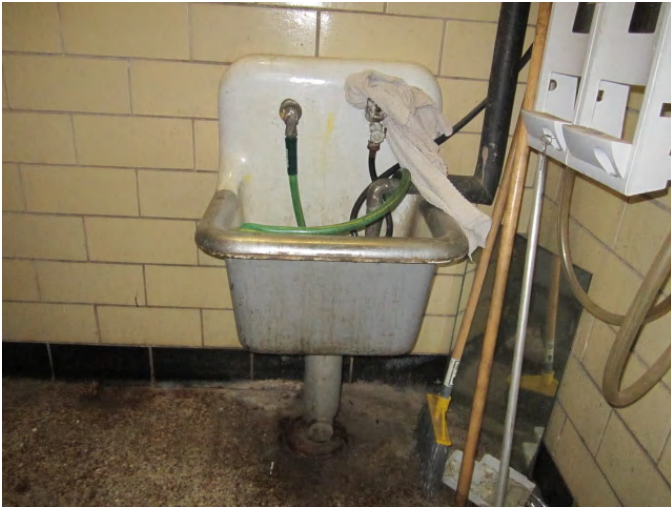
System: D2030 - Sanitary Waste

Location: Throughout Building

Distress: Beyond Service Life

Notes: The sanitary waste system is beyond its expected service life and should be scheduled for replacement.

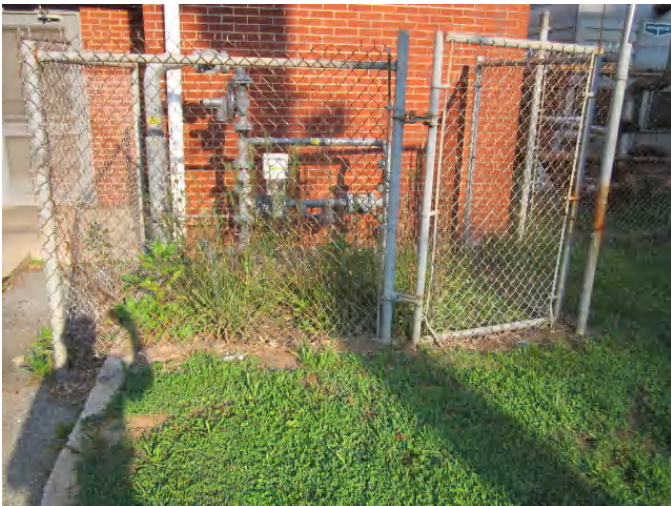
System: D2090 - Other Plumbing Systems - Natural Gas

Location: Throughout Building

Distress: Beyond Service Life

Notes: The natural gas system is beyond its expected service life and should be scheduled for replacement. SPLOST project to replace grease trap and backflow preventer.

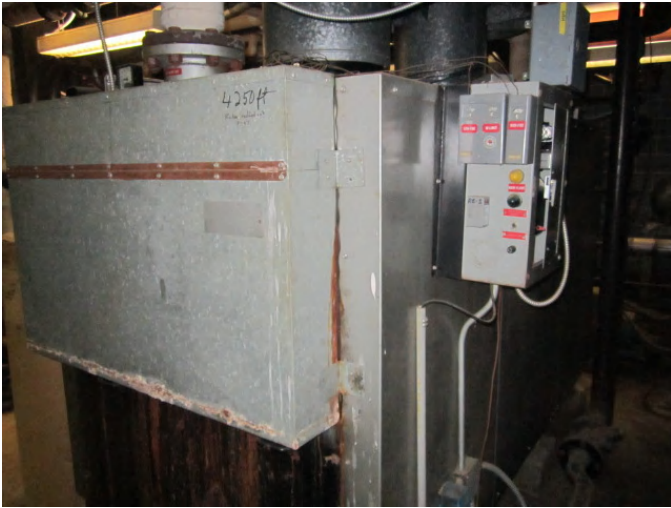
System: D3020 - Heat Generating Systems

Location: Mechanical Room

Distress: Beyond Service Life

Notes: Heating generating system is beyond its expected service life, inadequate, and should be scheduled for replacement. SPLOST project 403-422 includes replacing the heat generating system.

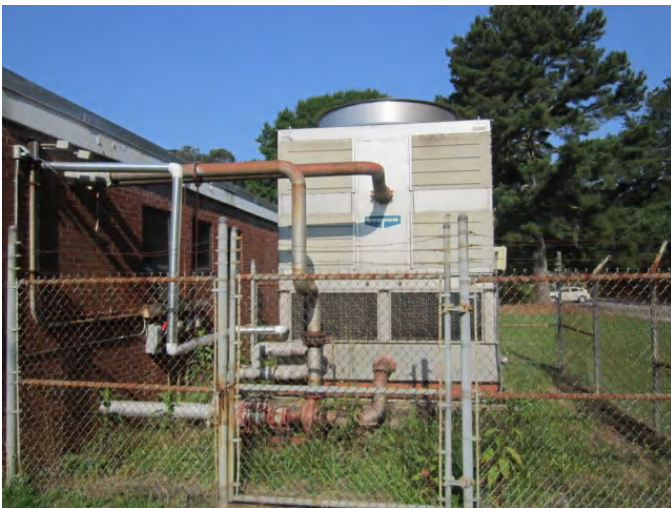
System: D3030 - Cooling Generating Systems

Location: Exterior of Building

Distress: Beyond Service Life

Notes: Cooling generating system is beyond its expected service life, inadequate, and should be scheduled for replacement.

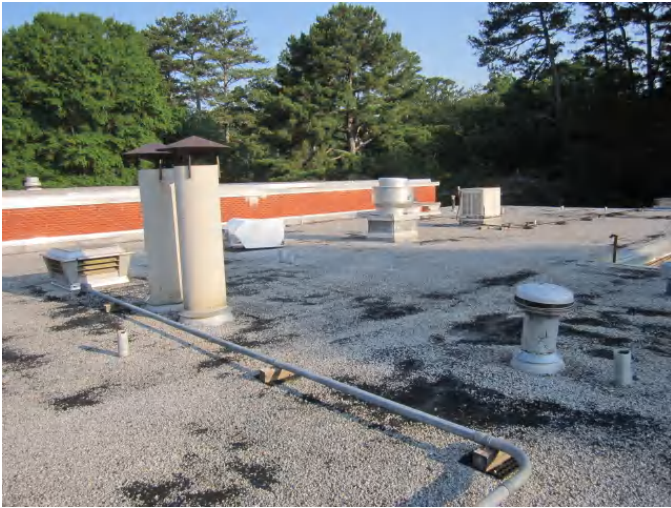
System: D3040 - Distribution & Exhaust Systems

Location: Throughout Building

Distress: Beyond Service Life

Notes: Distribution and exhaust systems are beyond their expected service life, inadequate, and should be scheduled for replacement. SPLOST project 403-422 to replace the exhaust fans throughout the building.

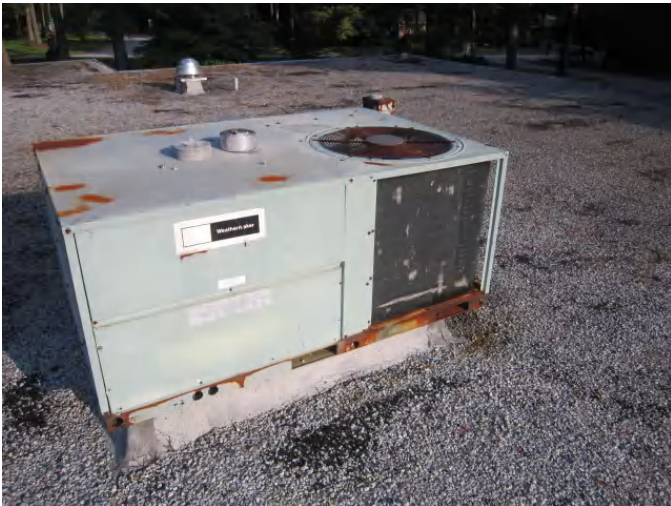
System: D3050 - Terminal & Package Units

Location: Roof

Distress: Beyond Service Life

Notes: The terminal and package units are beyond their expected service life, inefficient, and should be scheduled for replacement. SPLOST project 403-422 to evaluate all terminal and package units throughout buildings and provide partial replacement of units based on priority.

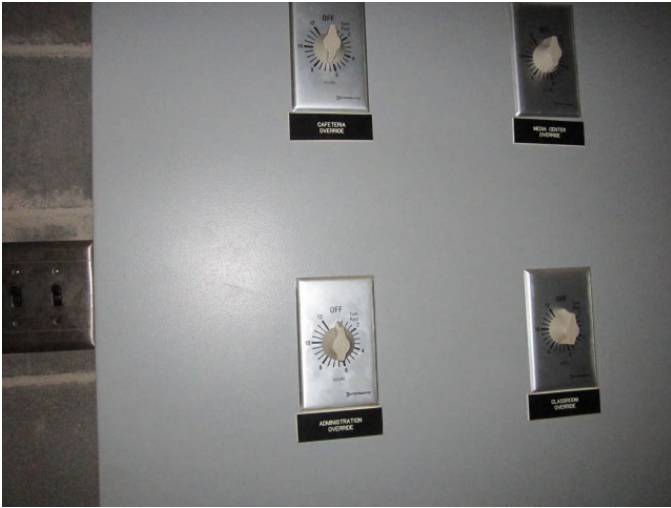
System: D3060 - Controls & Instrumentation

Location: Throughout Building

Distress: Beyond Service Life

Notes: The controls and instrumentation system is beyond its expected service life and should be scheduled for replacement.

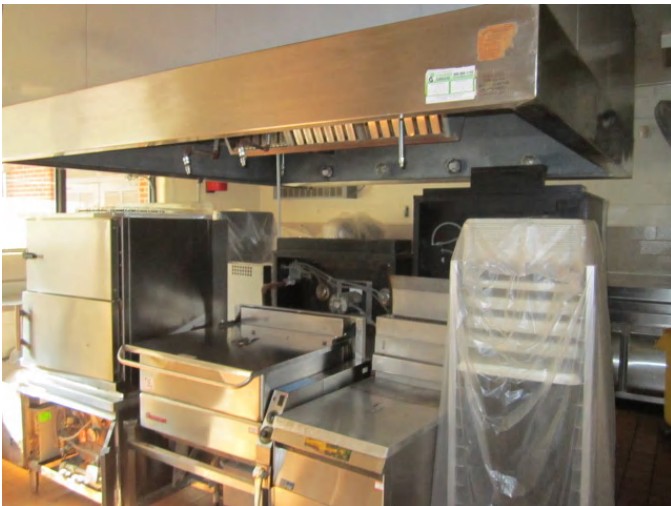
System: D3090 - Other HVAC Systems/Equip - Kitchen Hood

Location: Kitchen

Distress: Beyond Service Life

Notes: The kitchen hood system is beyond its expected service life and should be scheduled for replacement. SPLOST project 403-422 to replace the kitchen hood and associated equipment.

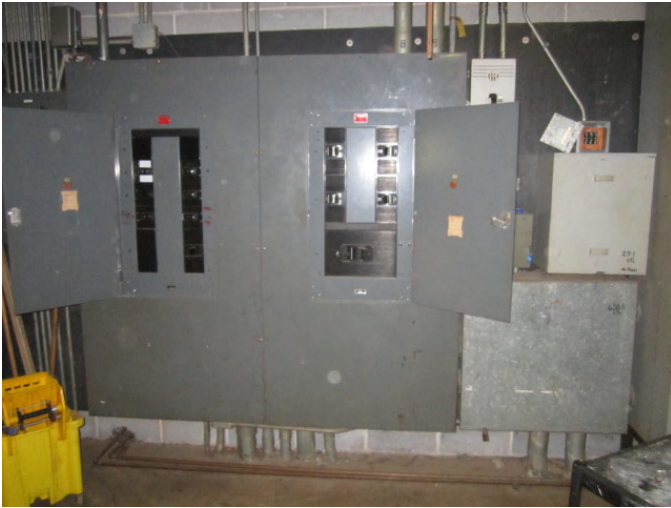
System: D5010 - Electrical Service/Distribution

Location: Main Switch Room/Throughout Building

Distress: Beyond Service Life

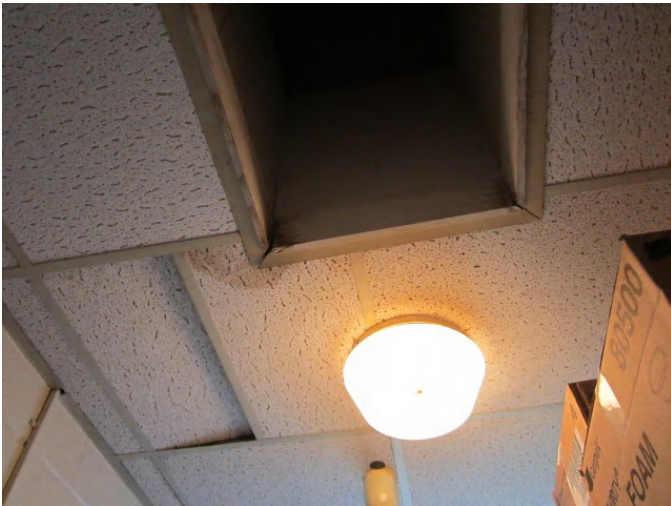
System: D5020 - Lighting

Location: Throughout Building

Distress: Beyond Service Life

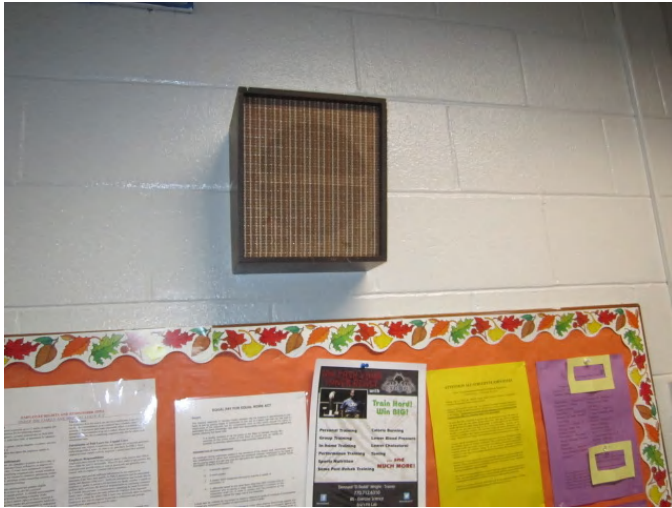
System: D5030 - Communications and Security - Clock & PA Systems

Location: Throughout Building

Distress: Beyond Service Life

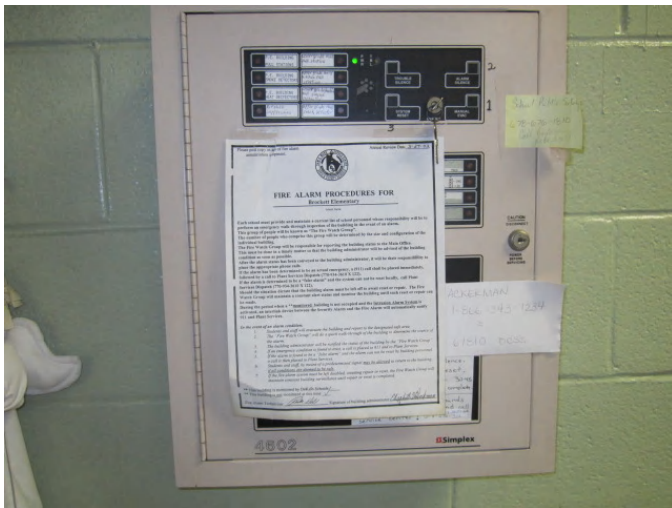
System: D5030 - Communications and Security - Fire Alarm

Location: Throughout Building

Distress: Beyond Service Life

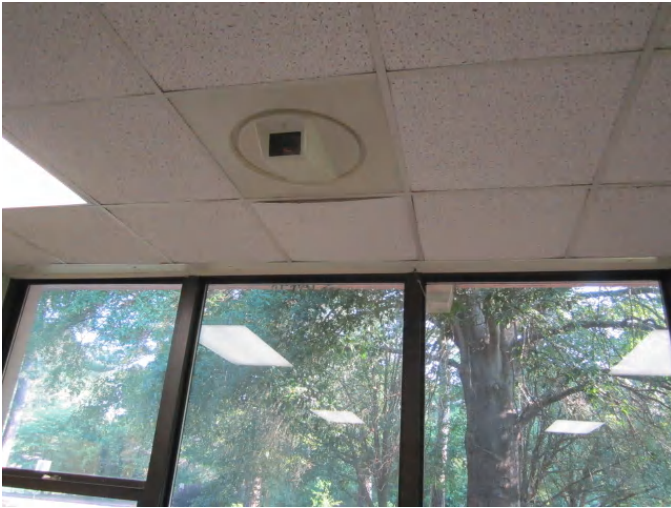
System: D5030 - Communications and Security - Security & CCTV

Location: Throughout Building

Distress: Beyond Service Life

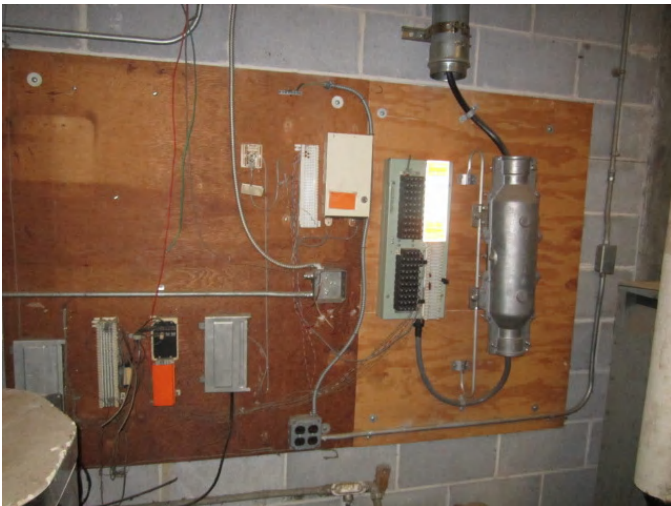
System: D5030 - Communications and Security - Telephone

Location: Throughout Building

Distress: Beyond Service Life

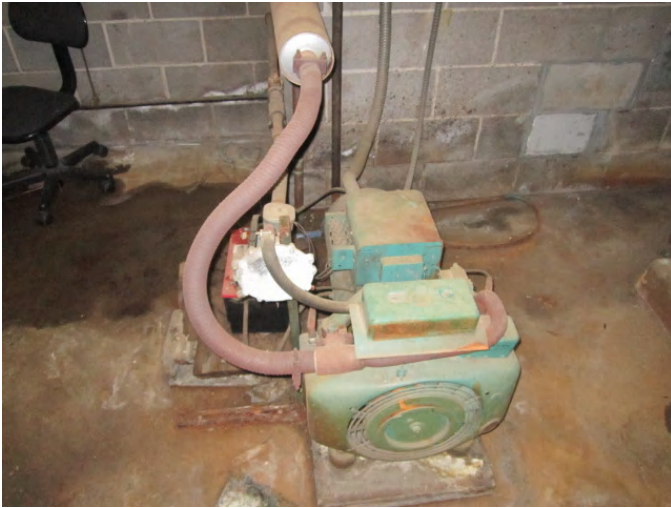
System: D5090 - Other Electrical Systems - Emergency Generator

Location: Mechanical Room

Distress: Beyond Service Life

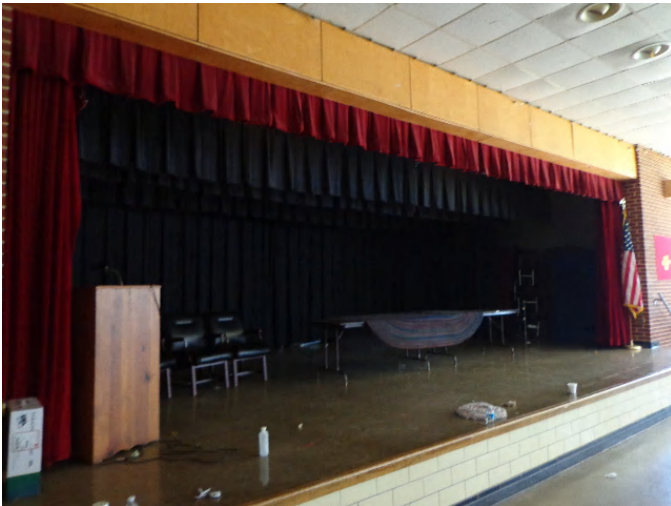
System: E1020 - Institutional Equipment

Location: Throughout Building

Distress: Beyond Service Life

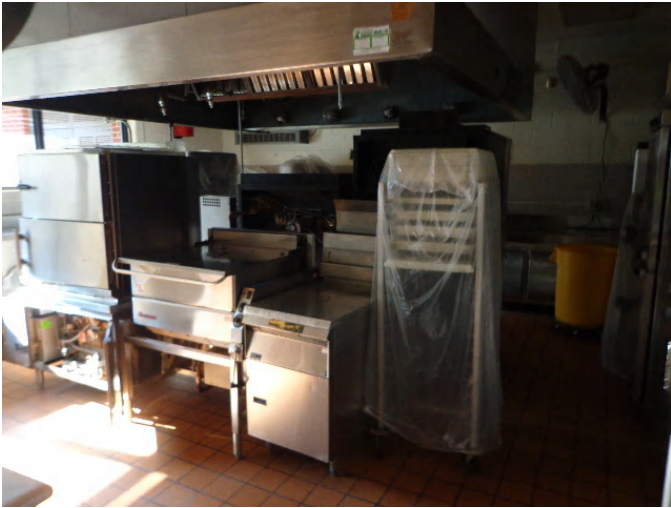
System: E1090 - Other Equipment - Kitchen Equipment

Location: Kitchen

Distress: Beyond Service Life

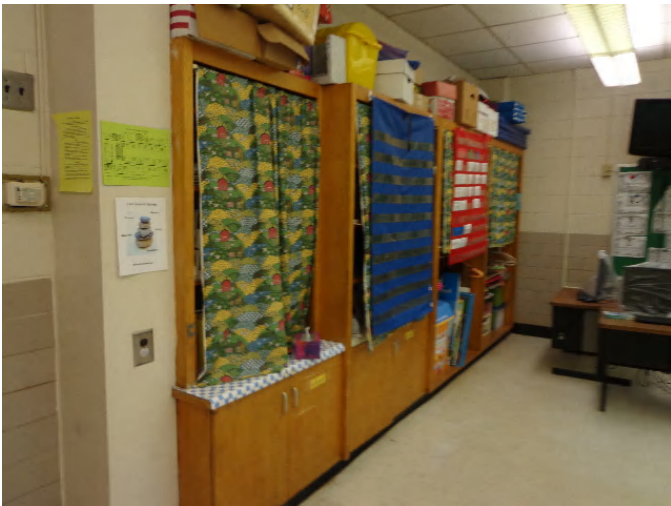
System: E2010 - Fixed Furnishings

Location: Throughout Building

Distress: Beyond Service Life

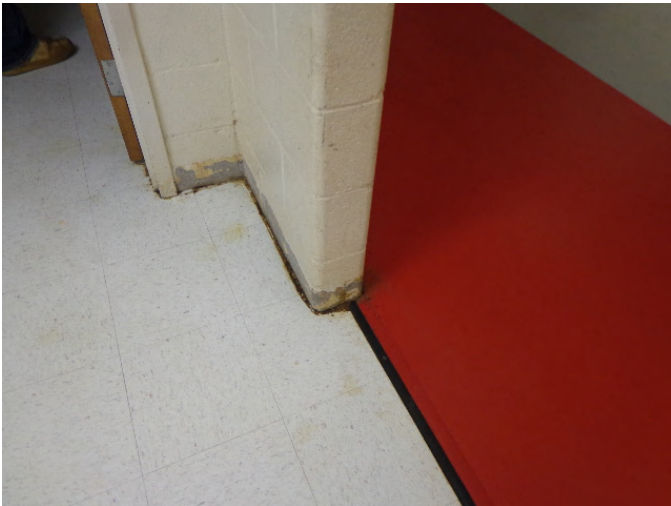
System: C3020 - Floor Finishes - VCT

Location: Entry Area and Office

Distress: Beyond Service Life

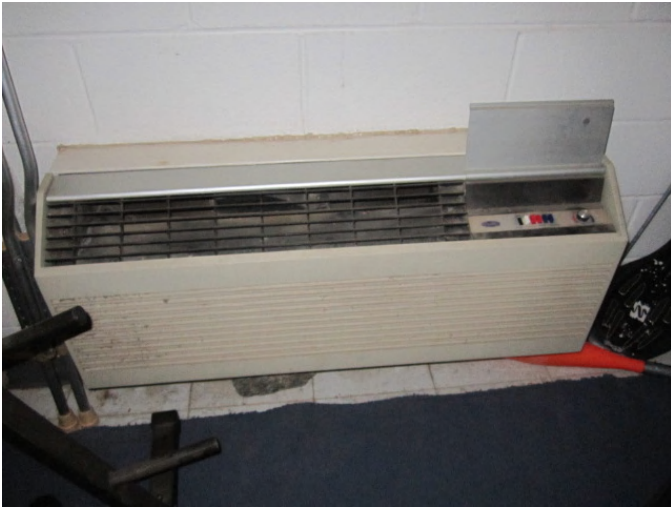
System: D3050 - Terminal & Package Units

Location: Throughout Building

Distress: Inadequate

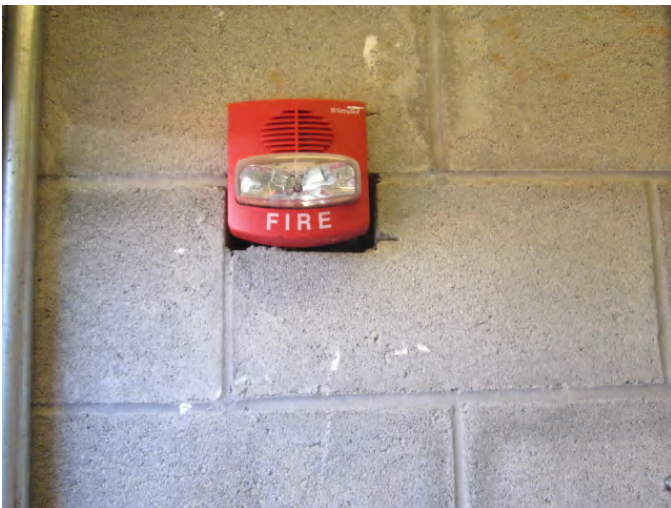
System: D5030 - Communications and Security - Fire Alarm

Location: Throughout Building

Distress: Beyond Service Life

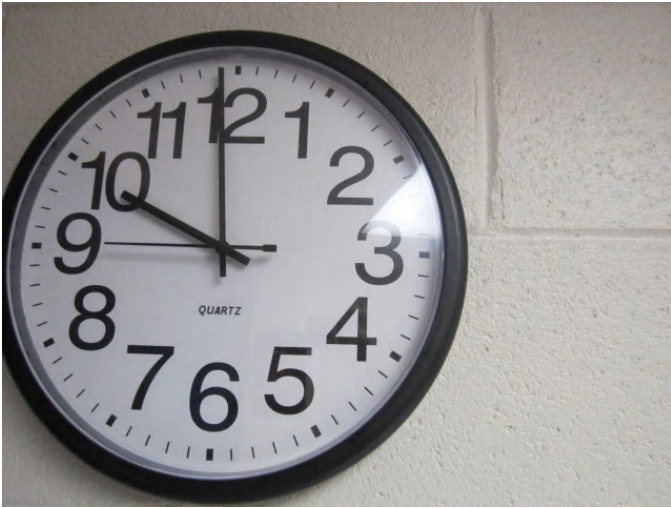
System: D5030 - Communications and Security - Public Address & Clock System

Location: Throughout Building

Distress: Beyond Service Life

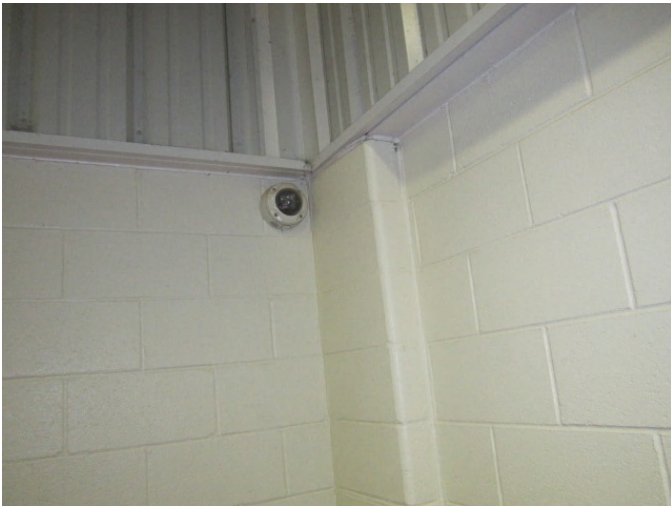
System: D5030 - Communications and Security - Security & CCTV

Location: Throughout Building

Distress: Beyond Service Life

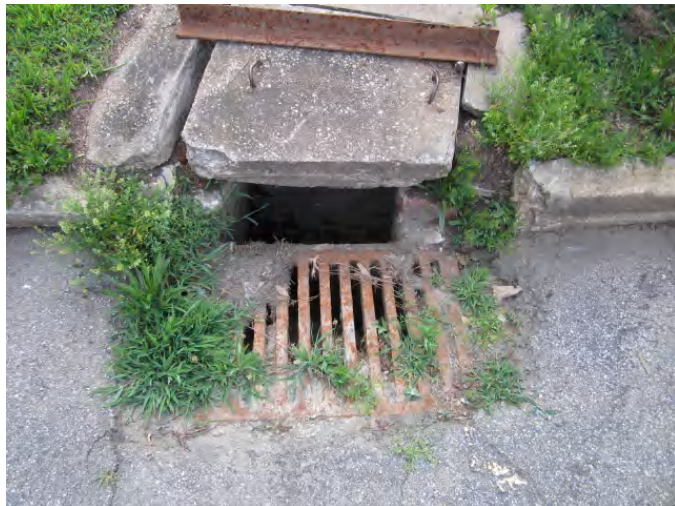
System: G3030 - Storm Sewer

Location: Site

Distress: Beyond Service Life

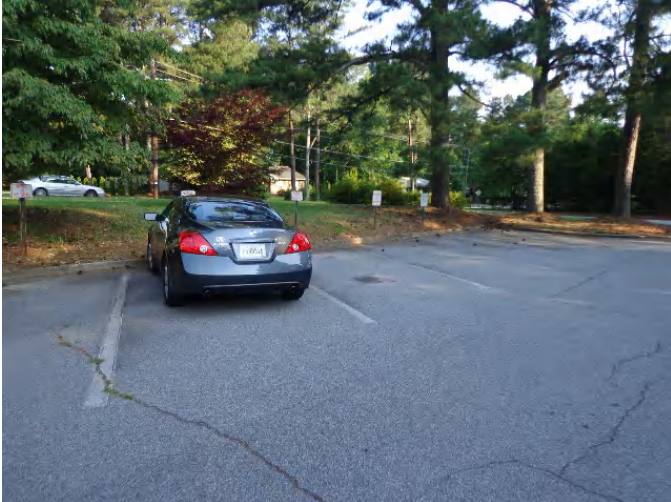
System: G2020 - Parking Lots

Location: Site

Distress: Beyond Service Life

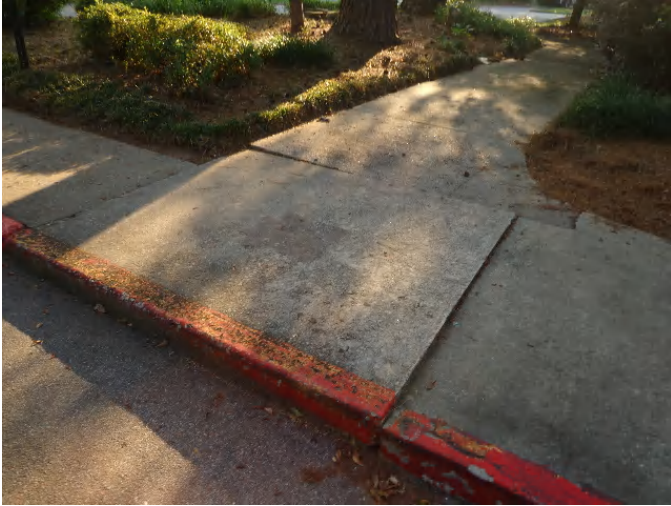
System: G2030 - Pedestrian Paving

Location: Site

Distress: Beyond Service Life
