**DeKalb County School District/Elementary Schools**

# **Canby Lane Elementary**

School Assessment Report
May 19, 2016

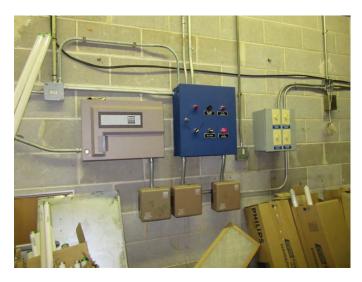
#### **System: D3060 - Controls & Instrumentation**

**Location:** Throughout Building

**Distress:** Beyond Service Life

**Notes:** The controls and instrumentation system is beyond its expected service life, aged, and should be scheduled for replacement in conjunction with the building HVAC system.

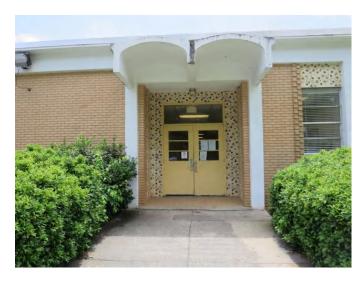
#### System: B2030 - Exterior Doors

**Location:** Throughout Building

**Distress:** Beyond Service Life

**Notes:** The exterior doors are beyond their expected service life and should be replaced.

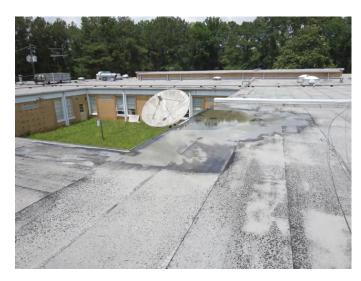
#### System: B3010 - Roof Coverings - BUR

**Location:** Roof

**Distress:** Beyond Service Life

**Notes:** The roof covering is beyond its expected service life, has reported leaks, and should be replaced. SPLOST project 102-422 to replace the roof on the 1967 and 1969 buildings.

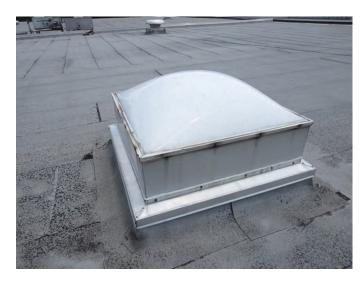
#### System: B3020 - Roof Openings

**Location:** Roof

**Distress:** Beyond Service Life

**Notes:** Roof openings are beyond their expected service life and should be scheduled for replacement in conjunction with the roof. SPLOST project 102-422 to add roof hatches and ladders to the 1967 and 1969 buildings.

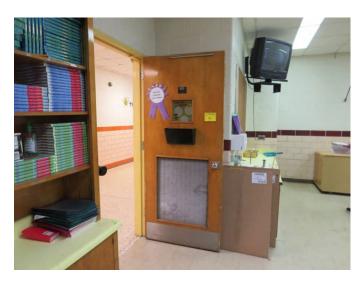
#### System: C1020 - Interior Doors

**Location:** Throughout Building

**Distress:** Beyond Service Life

**Notes:** Interior doors are beyond their expected service life, do not operate properly, are not ADA or building code compliant, and should be scheduled for replacement.

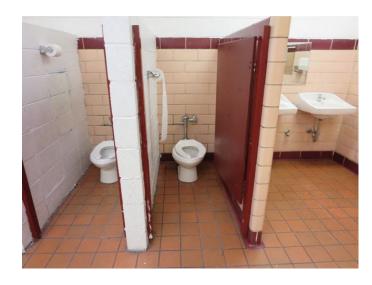
#### System: C1030 - Fittings

**Location:** Throughout Building

**Distress:** Beyond Service Life

**Notes:** Fittings, such as toilet partitions, handrails and signage, are beyond their expected service life, not ADA compliant, and should be replaced. SPLOST project 102-422 to renovate hall restrooms for ADA compliance.

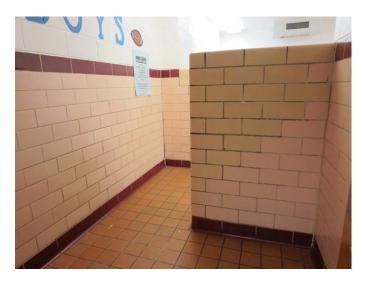
#### System: C3010 - Wall Finishes - Ceramic & Glazed

**Location:** Throughout Building

**Distress:** Beyond Service Life

Notes: Wall tiles are beyond their expected service life and should be replaced.

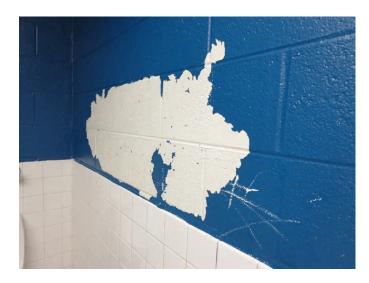
#### System: C3010 - Wall Finishes - Paint

**Location:** Throughout Building

**Distress:** Beyond Service Life

Notes: The painted wall finishes are beyond their expected service life and should be replaced.

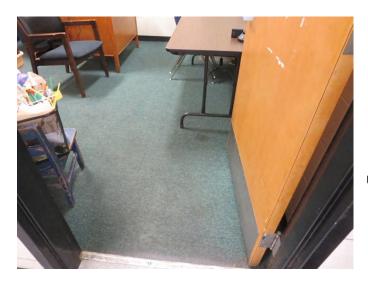
#### System: C3020 - Floor Finishes - Carpet

**Location:** Throughout Building

**Distress:** Beyond Service Life

Notes: The carpet is beyond its expected service life, worn and stained, and should be replaced.

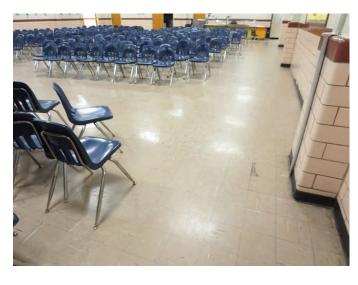
#### System: C3020 - Floor Finishes - VCT

**Location:** Throughout Building

**Distress:** Beyond Service Life

**Notes:** The VCT and VAT flooring is beyond its expected service life and should be replaced.

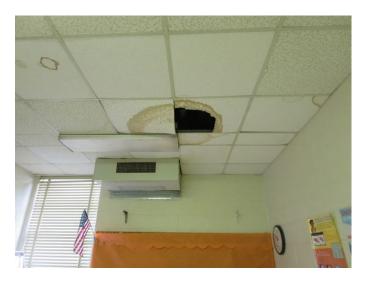
#### System: C3030 - Ceiling Finishes

**Location:** Throughout Building

**Distress:** Beyond Service Life

**Notes:** The acoustical ceiling system is beyond its expected service life, stained from roof leaks, and should be replaced.

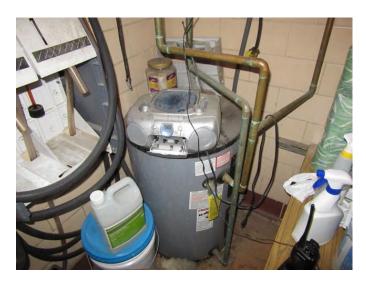
#### System: D2020 - Domestic Water Distribution

**Location:** Throughout Building

**Distress:** Beyond Service Life

Notes: The domestic water distribution system is beyond its expected service life and should be scheduled for replacement.

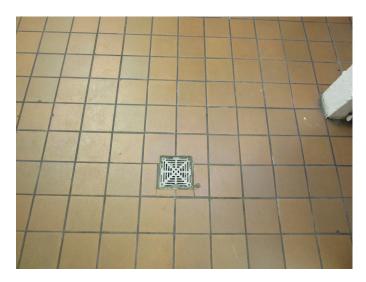
#### System: D2030 - Sanitary Waste

**Location:** Throughout Building

**Distress:** Beyond Service Life

**Notes:** The sanitary waste system is aged, failing and should be replaced. SPLOST project 102-422 to replace grease trap and backflow preventer.

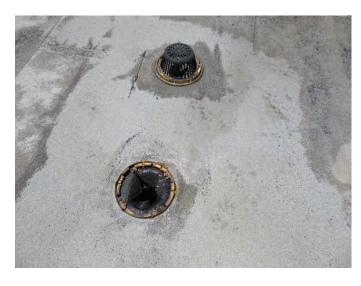
#### System: D2040 - Rain Water Drainage

**Location:** Throughout Building

**Distress:** Beyond Service Life

**Notes:** The rainwater drainage system is beyond its expected service life and should be scheduled for replacement. Rainwater drainage replacement is an add alternate scope under SPLOST IV.

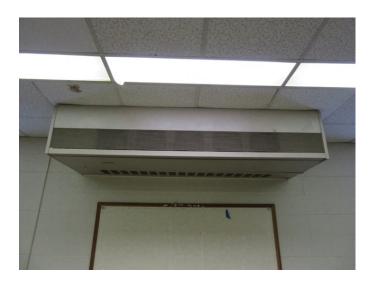
#### System: D3040 - Distribution & Exhaust Systems

**Location:** Throughout Building

**Distress:** Beyond Service Life

**Notes:** The distribution and exhaust systems are aged, failing, and should be replaced.

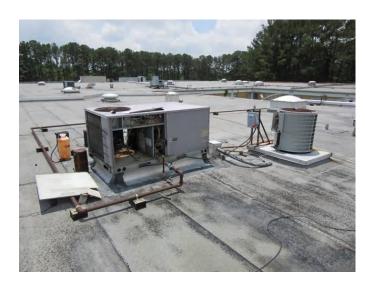
#### System: D3050 - Terminal & Package Units

Location: Roof

**Distress:** Beyond Service Life

**Notes:** The terminal and package units are beyond their expected service life, failing, and should be scheduled for replacement. SPLOST project 102-422 to replace the chiller, roof top units and fan coil units on the 1967 and 1969 buildings.

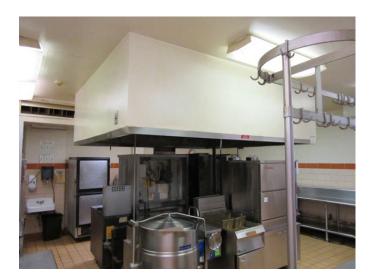
#### System: D3090 - Other HVAC Systems/Equip - Kitchen Hood

Location: Kitchen

**Distress:** Beyond Service Life

Notes: The kitchen hood system is beyond its expected service life and should be scheduled for replacement.

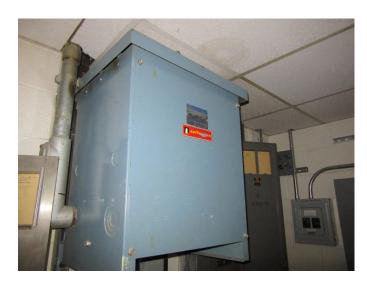
#### System: D5010 - Electrical Service/Distribution

**Location:** Main Switch Room/Throughout Building

**Distress:** Beyond Service Life

**Notes:** The electrical service/distribution system is aged, failing, and should be replaced.

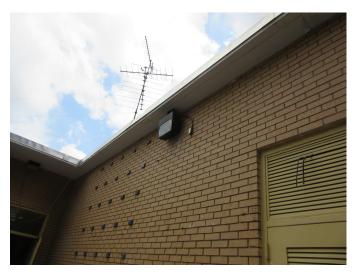
#### System: D5020 - Branch Wiring

**Location:** Throughout Building

**Distress:** Beyond Service Life

**Notes:** The branch wiring system is aged, failing or non functional, and should be replaced. Electrical outlets are not GFI in wet areas.

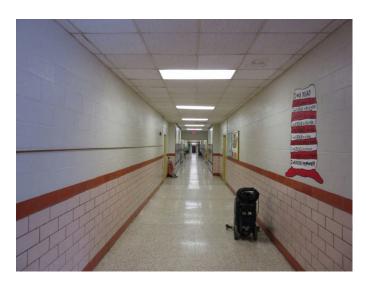
# System: D5020 - Lighting

**Location:** Throughout Building

**Distress:** Beyond Service Life

**Notes:** The lighting system is beyond its expected service life, inadequate, and should be scheduled for replacement. School staff report that lighting is not consistent throughout the building and some lights are not functioning.

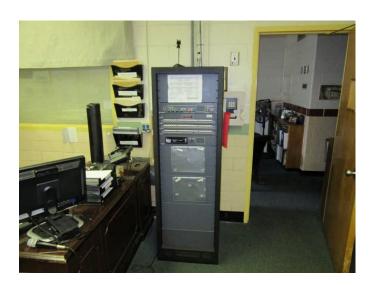
#### System: D5030 - Communications and Security - Clock & PA Systems

**Location:** Throughout Building

**Distress:** Beyond Service Life

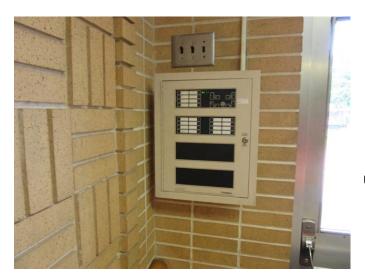
#### System: D5030 - Communications and Security - Fire Alarm

**Location:** Throughout Building

**Distress:** Beyond Service Life

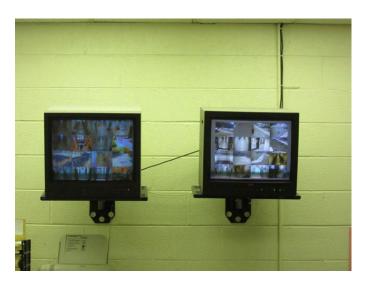
#### System: D5030 - Communications and Security - Security & CCTV

**Location:** Throughout Building

**Distress:** Beyond Service Life

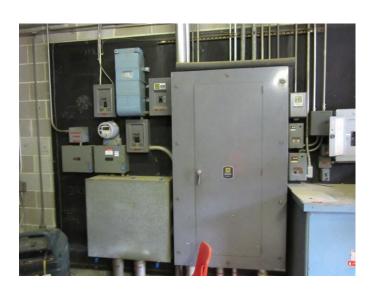
#### System: D5090 - Other Electrical Systems - Emergency Generator

**Location:** Exterior of Building

**Distress:** Missing

**Correction:** Add/Replace Generator

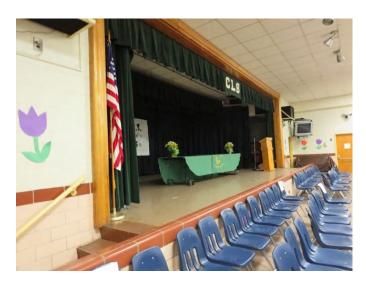
#### System: E1020 - Institutional Equipment

**Location:** Throughout Building

**Distress:** Beyond Service Life

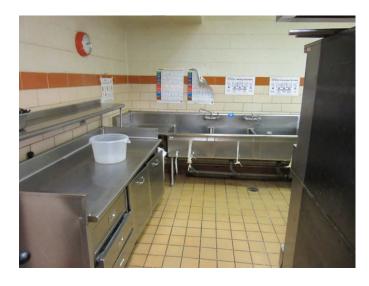
#### System: E1090 - Other Equipment (Kitchen Equipment)

**Location:** Kitchen

**Distress:** Beyond Service Life

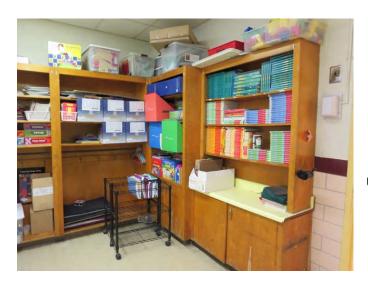
#### **System: E2010 - Fixed Furnishings**

**Location:** Throughout Building

**Distress:** Beyond Service Life

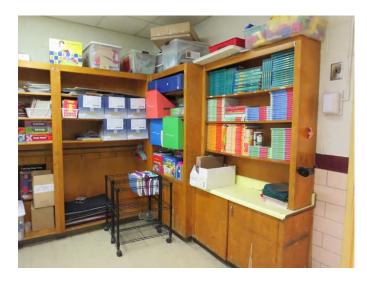
System: C1030 - Fittings

**Location:** Throughout Building

**Distress:** Beyond Service Life

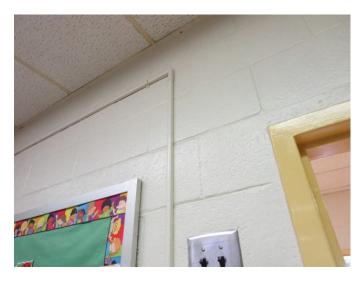
#### System: C3010 - Wall Finishes - Paint

**Location:** Throughout Building

**Distress:** Beyond Service Life

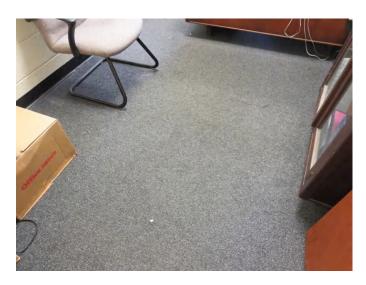
### System: C3020 - Floor Finishes - Carpet

**Location:** Throughout Building

**Distress:** Beyond Service Life

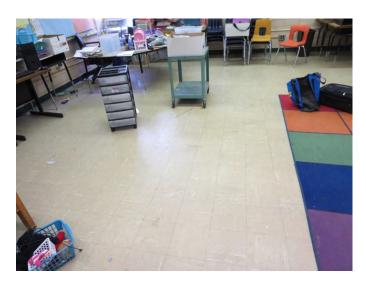
#### **System: C3020 - Floor Finishes - VCT**

**Location:** Throughout Building

**Distress:** Beyond Service Life

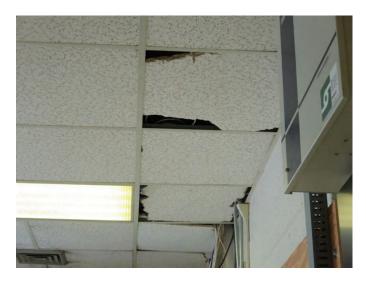
### System: C3030 - Ceiling Finishes

**Location:** Throughout Building

**Distress:** Beyond Service Life

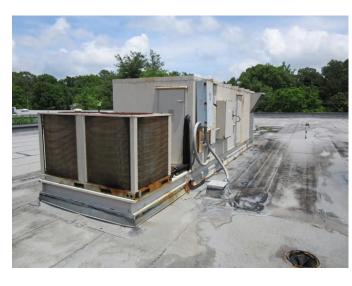
#### System: D3050 - Terminal & Package Units

Location: Roof

**Distress:** Beyond Service Life

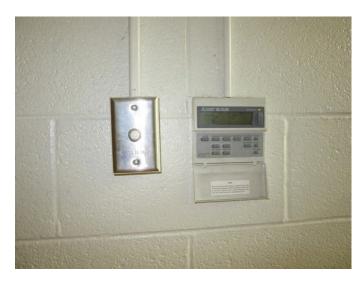
#### System: D3060 - Controls & Instrumentation

**Location:** Throughout Building

**Distress:** Beyond Service Life

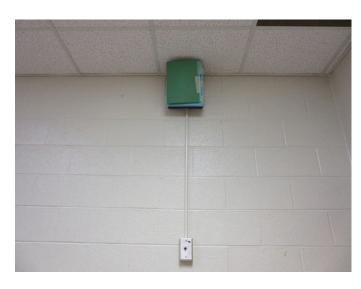
#### System: D5030 - Communications and Security - Clock & PA Systems

**Location:** Throughout Building

**Distress:** Beyond Service Life

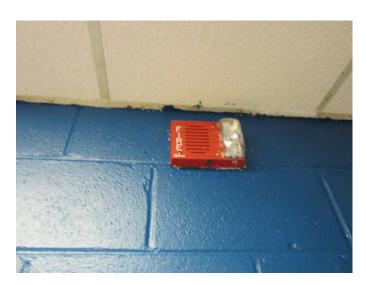
### System: D5030 - Communications and Security - Fire Alarm

**Location:** Throughout Building

**Distress:** Beyond Service Life

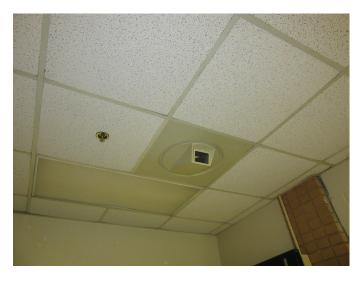
#### System: D5030 - Communications and Security - Security & CCTV

**Location:** Throughout Building

**Distress:** Beyond Service Life

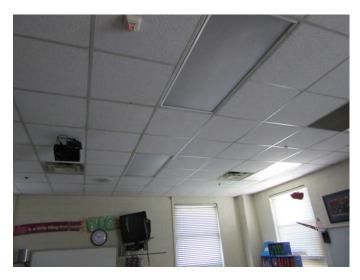
#### System: E1020 - Institutional Equipment

**Location:** Throughout Building

**Distress:** Beyond Service Life

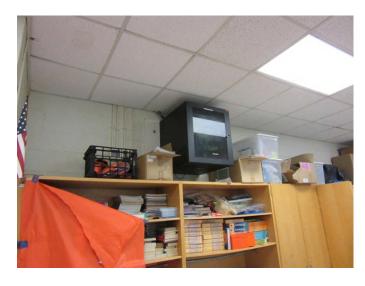
#### System: E2010 - Fixed Furnishings

**Location:** Throughout Building

**Distress:** Beyond Service Life

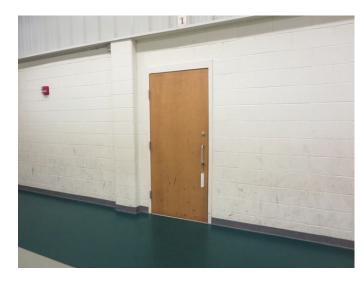
System: C3010 - Wall Finishes - Paint

**Location:** Throughout Building

**Distress:** Beyond Service Life

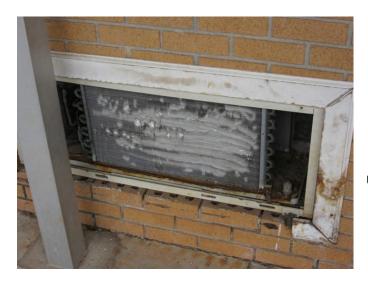
#### System: D3050 - Terminal & Package Units

**Location:** Throughout Building

**Distress:** Inadequate

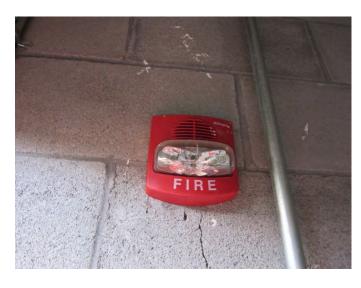
#### System: D5030 - Communications and Security - Fire Alarm

**Location:** Throughout Building

**Distress:** Beyond Service Life

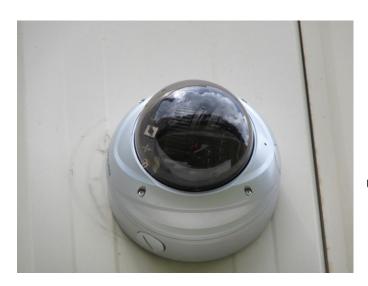
### System: D5030 - Communications and Security - Security & CCTV

**Location:** Throughout Building

**Distress:** Beyond Service Life

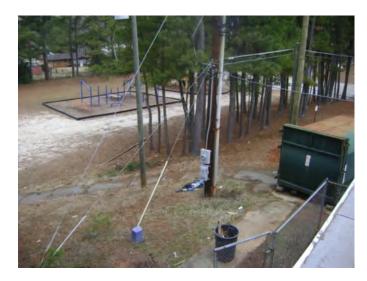
System: G4020 - Site Lighting

Location: Site

**Distress:** Beyond Service Life

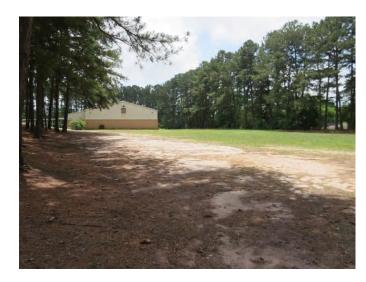
#### System: G2040 - Playing Field

Location: Site

**Distress:** Damaged
