DeKalb County School District/Elementary Schools

Cary Reynolds Elementary

School Assessment Report
May 19, 2016

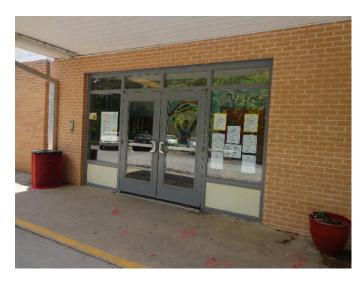
System: B2030 - Exterior Doors

Location: Throughout Building

Distress: Beyond Service Life

Notes: The original exterior doors are aged, rusted, and should be replaced.

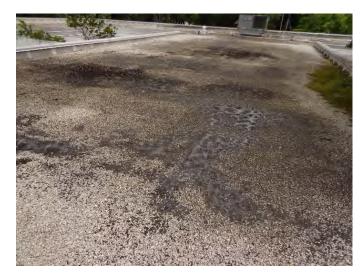
System: B3010 - Roof Coverings - BUR

Location: Roof

Distress: Beyond Service Life

Notes: The built-up roof covering is in deteriorating condition with loss of top surface, blisters, improper patches and reported water leaks, and should be replaced.

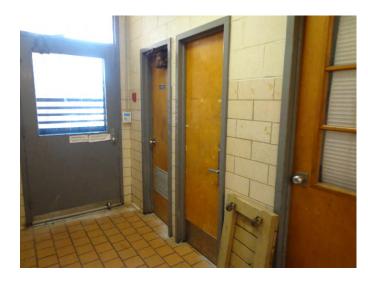
System: C1020 - Interior Doors

Location: Throughout Building

Distress: Beyond Service Life

Notes: The interior doors are aged, failing, most hardware are not ADA nor code compliant, and should be replaced.

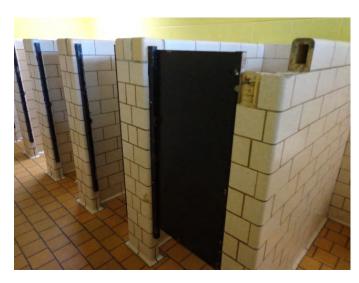
System: C1030 - Fittings

Location: Throughout Building

Distress: Beyond Service Life

Notes: New ADA-compliant restrooms were added in 2011. The remainder of the fittings are aged, in marginal condition, and should be replaced to improve ADA accessibility. SPLOST project 103-422 to provide hall restroom renovations.

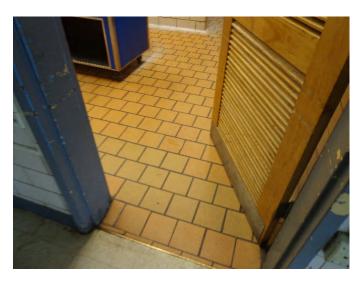
System: C3020 - Floor Finishes - Ceramic & Quarry Tile

Location: Kitchen and Restrooms

Distress: Beyond Service Life

Notes: The tile floor covering is beyond its expected service life, cracked, patched and worn, and should be replaced.

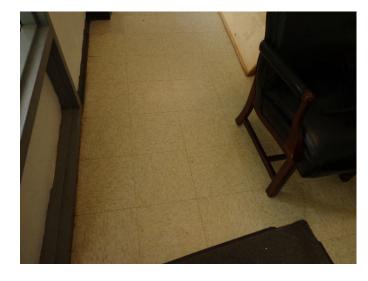
System: C3020 - Floor Finishes - VCT

Location: Throughout Building

Distress: Beyond Service Life

Notes: The VCT flooring is aged and worn, and should be replaced.

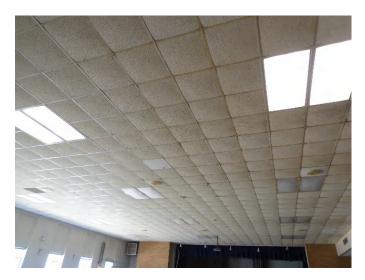
System: C3030 - Ceiling Finishes

Location: Throughout Building

Distress: Beyond Service Life

Notes: The ceiling tiles have been replaced as needed. However, the grid shows signs of aging throughout the building, the tiles are sagging or damaged and generally in poor condition, and the entire system should be replaced.

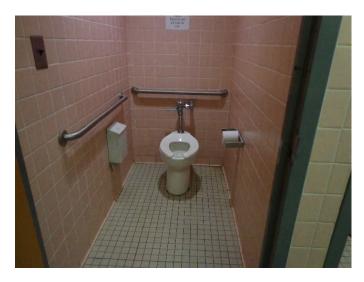
System: D2010 - Plumbing Fixtures

Location: Teachers Lounge

Distress: Needs Remediation

Notes: Restroom is not ADA compliant and should be replaced. SPLOST project 103-422 to provide unisex adult restroom

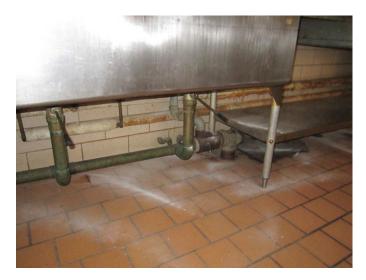
System: D2030 - Sanitary Waste

Location: Throughout Building

Distress: Beyond Service Life

Notes: The sanitary waste system is beyond its expected service life and should be scheduled for replacement.

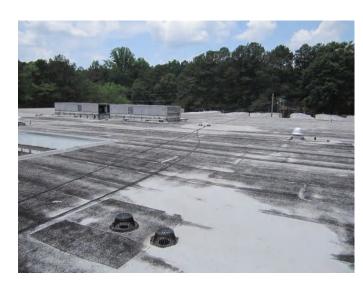
System: D2040 - Rain Water Drainage

Location: Throughout Building

Distress: Beyond Service Life

Notes: The roof drainage system is beyond its expected service life, inadequate, and should be replaced in conjunction with the roof.

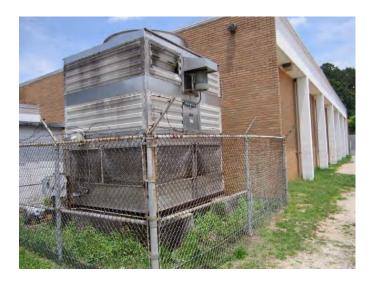
System: D3030 - Cooling Generating Systems

Location: Exterior of Building

Distress: Beyond Service Life

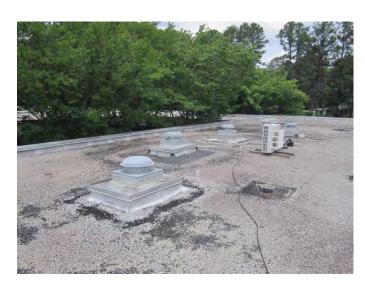
System: D3040 - Distribution & Exhaust Systems

Location: Throughout Building

Distress: Beyond Service Life

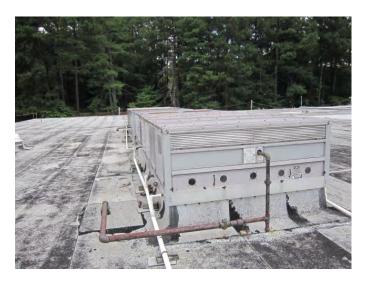
System: D3050 - Terminal & Package Units

Location: Roof

Distress: Beyond Service Life

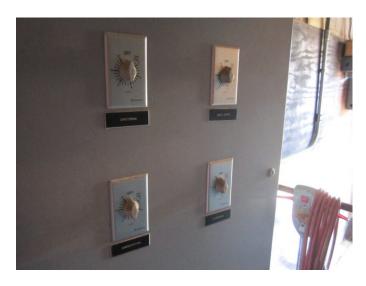
System: D3060 - Controls & Instrumentation

Location: Throughout Building

Distress: Beyond Service Life

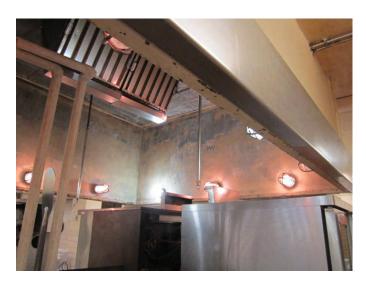
System: D3090 - Other HVAC Systems/Equip - Kitchen Hood

Location: Kitchen

Distress: Beyond Service Life

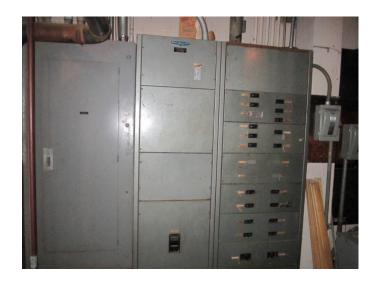
System: D5010 - Electrical Service/Distribution

Location: Main Switch Room/Throughout Building

Distress: Beyond Service Life

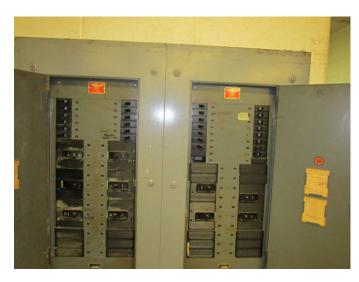
System: D5020 - Branch Wiring

Location: Throughout Building

Distress: Beyond Service Life

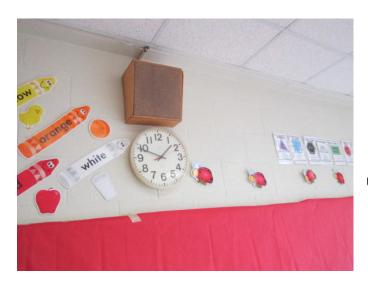
System: D5030 - Communications and Security - Clock & PA Systems

Location: Throughout Building

Distress: Beyond Service Life

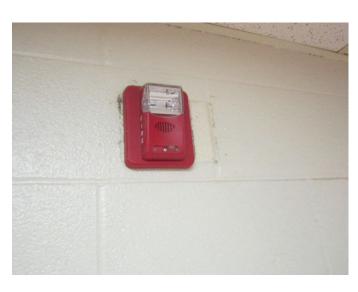
System: D5030 - Communications and Security - Fire Alarm

Location: Throughout Building

Distress: Beyond Service Life

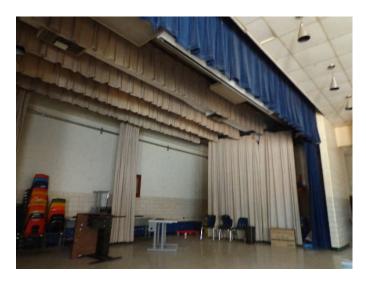
System: E1020 - Institutional Equipment

Location: Throughout Building

Distress: Beyond Service Life

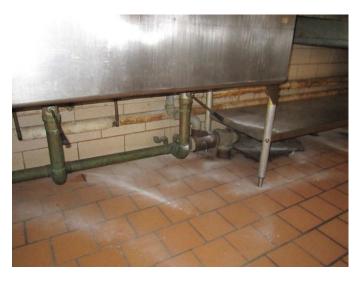
System: E1090 - Other Equipment (Kitchen Equipment)

Location: Kitchen

Distress: Beyond Service Life

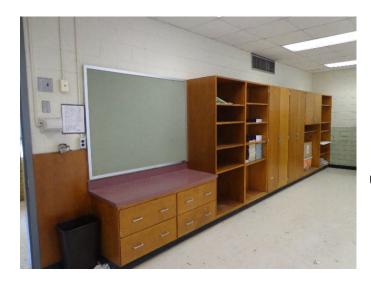
System: E2010 - Fixed Furnishings

Location: Throughout Building

Distress: Beyond Service Life

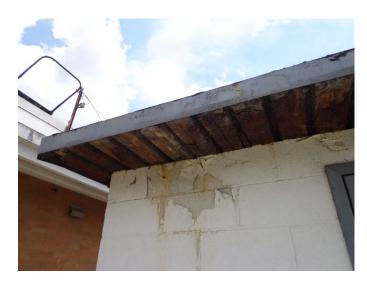
System: B1020 - Roof Construction

Location: Roof

Distress: Damaged

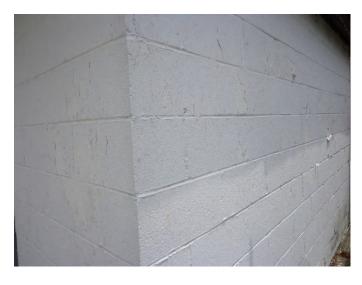
System: B2010 - Exterior Walls

Location: Exterior Walls

Distress: Damaged

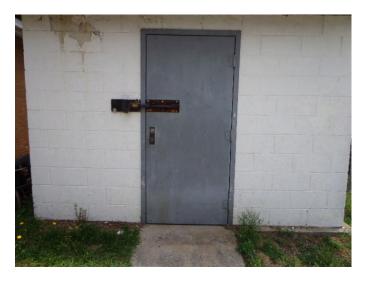
System: B2030 - Exterior Doors

Location: Exterior Wall

Distress: Beyond Service Life

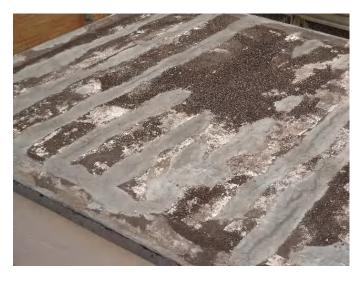
System: B3010 - Roof Coverings -BUR

Location: Roof

Distress: Beyond Service Life

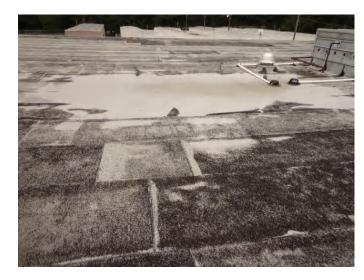
System: B3010 - Roof Coverings - BUR

Location: Roof

Distress: Damaged

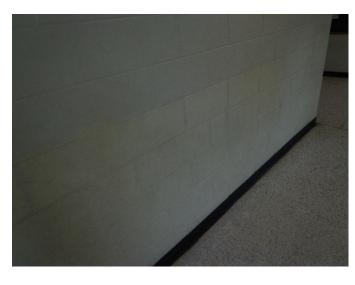
System: C3010 - Wall Finishes - Paint

Location: Throughout Building

Distress: Beyond Service Life

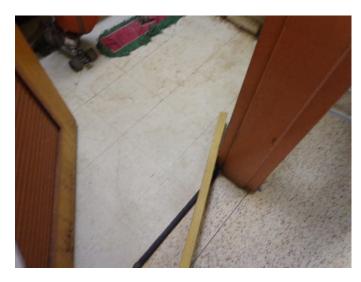
System: C3020 - Floor Finishes - VCT

Location: Throughout Building

Distress: Beyond Service Life

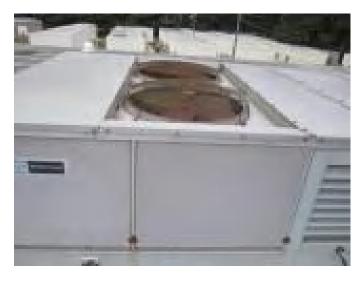
System: D3050 - Terminal & Package Units

Location: Roof

Distress: Beyond Service Life

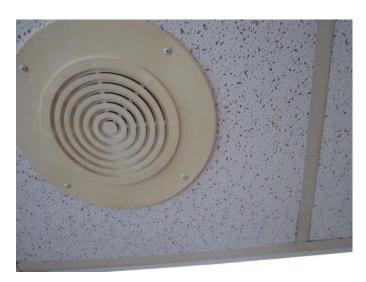
System: D5030 - Communications and Security - Clock & PA Systems

Location: Throughout Building

Distress: Beyond Service Life

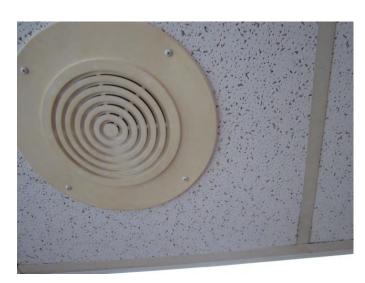
System: D5030 - Communications and Security - Security & CCTV

Location: Throughout Building

Distress: Beyond Service Life

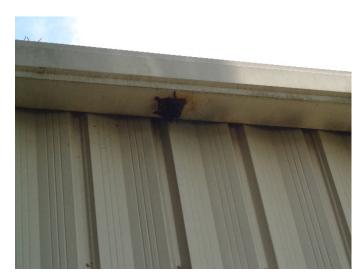
System: B3010 - Roof Coverings - Standing Seam Metal

Location: Exterior Walls

Distress: Missing

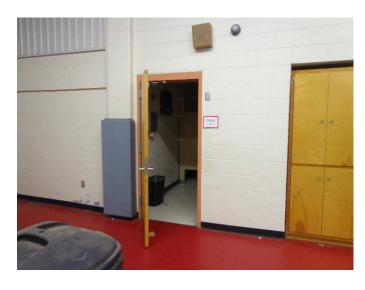
System: C1030 - Fittings

Location: Throughout Building

Distress: Missing

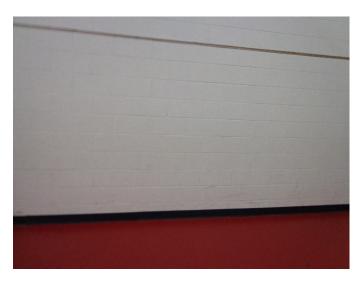
System: C3010 - Wall Finishes - Paint

Location: Throughout Building

Distress: Beyond Service Life

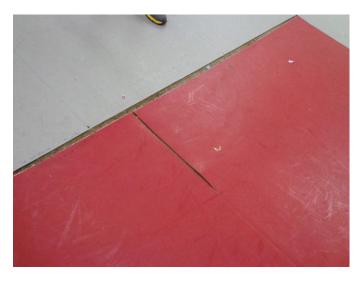
System: C3020 - Floor Finishes - Neoprene

Location: Basketball Court

Distress: Beyond Service Life

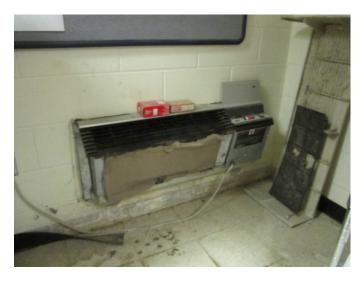
System: D3050 - Terminal & Package Units

Location: Throughout Building

Distress: Inadequate

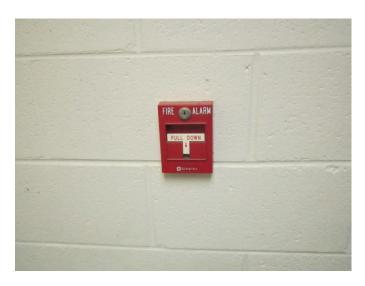
System: D5030 - Communications and Security - Fire Alarm

Location: Throughout Building

Distress: Beyond Service Life

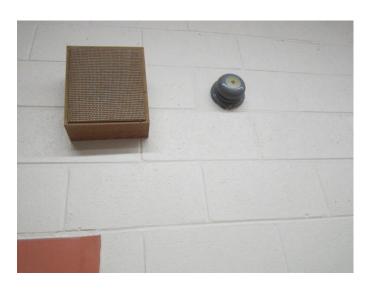
System: D5030 - Communications and Security - Public Address & Clock System

Location: Throughout Building

Distress: Beyond Service Life

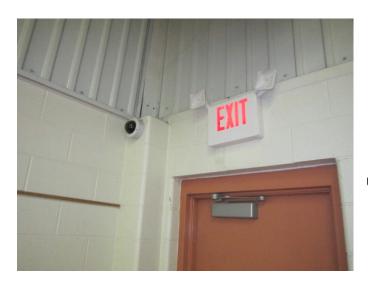
System: D5030 - Communications and Security - Security & CCTV

Location: Throughout Building

Distress: Beyond Service Life

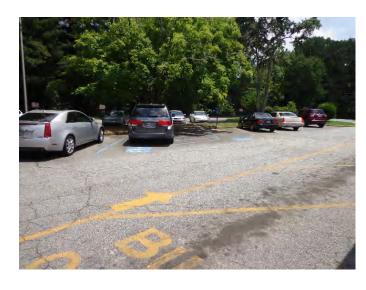
System: G2020 - Parking Lots

Location: Site

Distress: Beyond Service Life

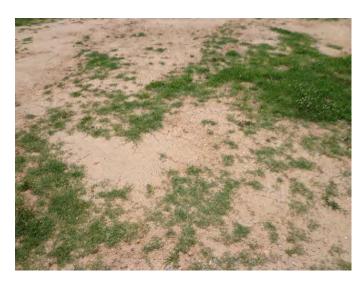
System: G2040 - Playing Field

Location: Site

Distress: Beyond Service Life

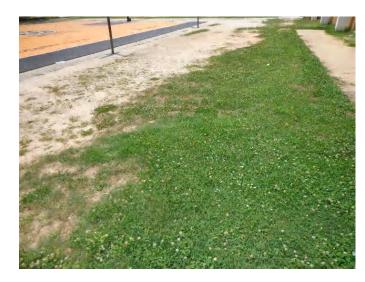
System: G2050 - Landscaping

Location: Site

Distress: Beyond Service Life

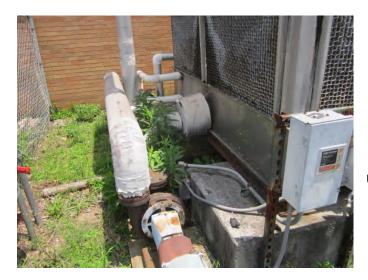
System: G3020 - Sanitary Sewer

Location: Site

Distress: Beyond Service Life

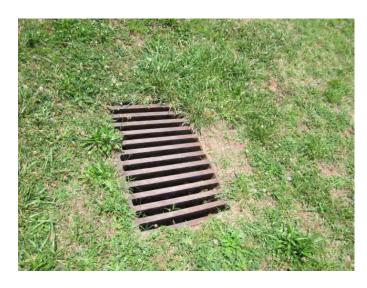
System: G3030 - Storm Sewer

Location: Site

Distress: Beyond Service Life

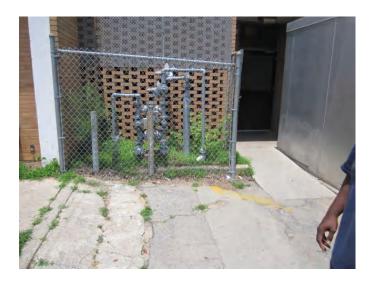
System: G3060 - Fuel Distribution

Location: Site

Distress: Beyond Service Life

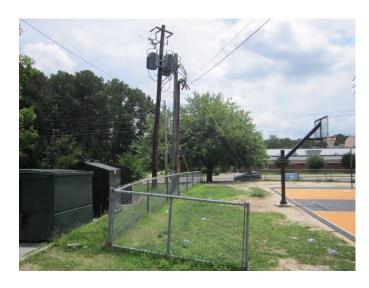
System: G4010 - Electrical Distribution

Location: Site

Distress: Beyond Service Life

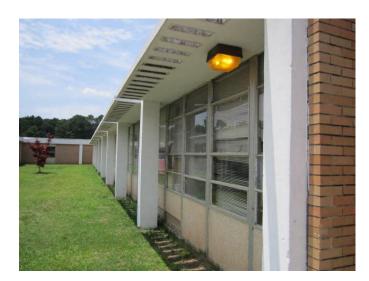
System: G4020 - Site Lighting

Location: Site

Distress: Beyond Service Life

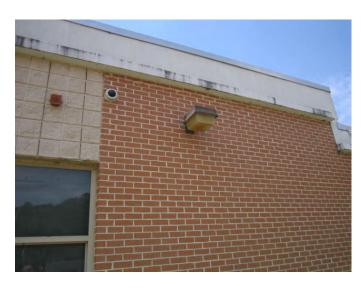
System: G4030 - Site Communications & Security

Location: Site

Distress: Beyond Service Life
