**DeKalb County School District/Elementary Schools**

# **Cedar Grove Elementary**

School Assessment Report
May 19, 2016

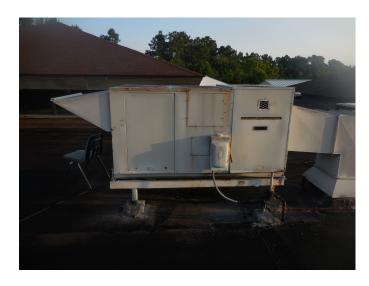
System: D3050 - Terminal & Package Units

**Location:** Roof/Mezzanine Areas

**Distress:** Beyond Service Life

**Notes:** Package unit and make up air system is rusted and reported to operate intermittently. Heat pumps in the hallway mezzanine areas were installed in 1998 and are constantly requiring maintenance. System is beyond its expected service life and should be replaced. SPLOST project 104-422 to replace terminal and package units.

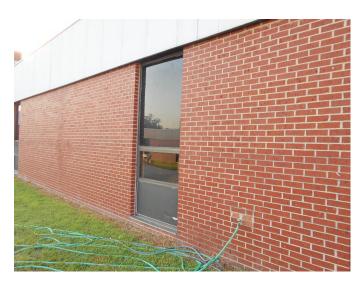
#### **System: B2020 - Exterior Windows**

**Location:** Throughout Building

**Distress:** Beyond Service Life

**Notes:** The exterior windows are original construction, beyond their expected service life, not energy efficient, and should be replaced.

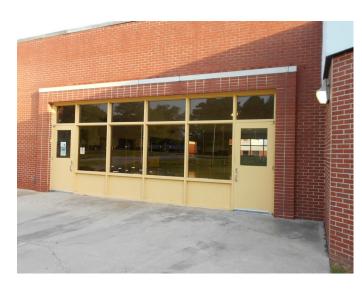
#### System: B2030 - Exterior Doors

**Location:** Throughout Building

**Distress:** Beyond Service Life

Notes: The exterior door system is original, beyond their expected service life, and should be replaced.

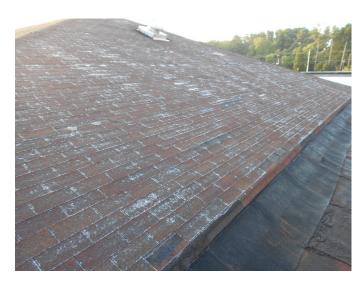
#### System: B3010 - Roof Coverings - Asphalt Shingles

**Location:** Roof

**Distress:** Beyond Service Life

**Notes:** The asphalt shingles are damaged, worn, beyond their expected service life, and should be replaced. SPLOST 104-422 to replace roof coverings.

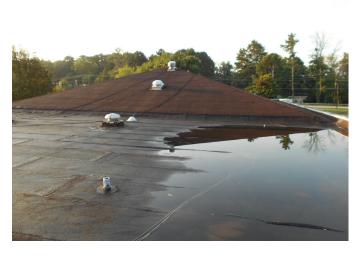
#### System: B3010 - Roof Coverings - BUR

Location: Roof

**Distress:** Beyond Service Life

**Notes:** The roof is beyond its expected service life, worn, delaminating, leaking, and should be replaced. SPLOST 104-422 to replace roof coverings..

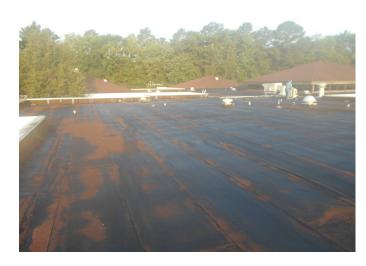
#### System: B3020 - Roof Openings

**Location:** Roof

**Distress:** Missing

**Notes:** There is no safe roof access for maintenance personnel. Recommend installation of an OSHA-compliant roof hatch/ladder system for safe access. SPLOST 104-422 to added roof opening.

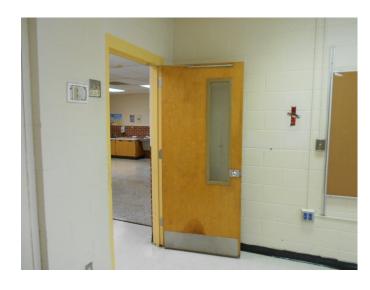
#### System: C1020 - Interior Doors

**Location:** Throughout Building

**Distress:** Beyond Service Life

**Notes:** The interior doors are original, beyond their expected service life, not ADA or building code compliant, and should be replaced.

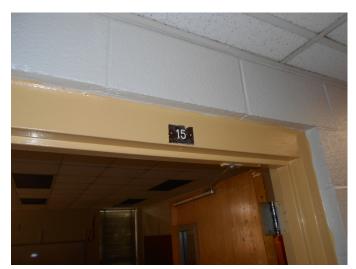
#### System: C1030 - Fittings

**Location:** Throughout Building

**Distress:** Inadequate

Notes: Signage is not ADA compliant, beyond its expected service life, and should be replaced.

Correction: Remove and replace the signage w/ADA

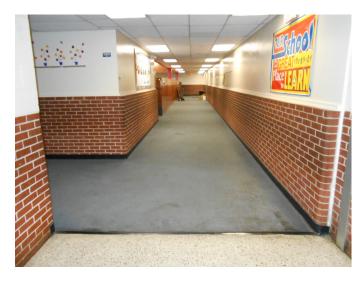
#### System: C3020 - Floor Finishes - Carpet

**Location:** Media Center, Offices, Hallway

**Distress:** Beyond Service Life

**Notes:** The carpet is worn, dirty, beyond its expected service life, and should be replaced.

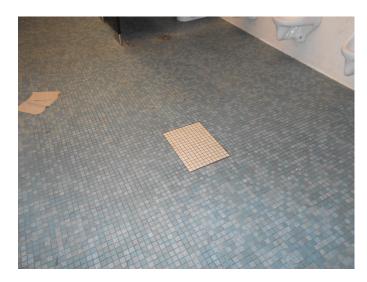
#### System: C3020 - Floor Finishes - Ceramic & Quarry Tile

**Location:** Kitchen and Restrooms

**Distress:** Damaged

Notes: The ceramic tile flooring in the restrooms is damaged and should be repaired or replaced.

Correction: Replace vinyl tile flooring

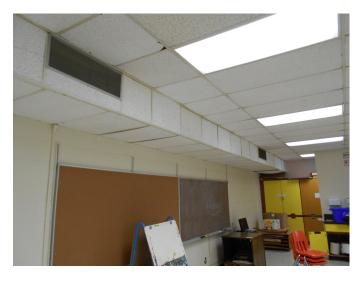
#### **System: C3030 - Ceiling Finishes**

**Location:** Throughout Building

**Distress:** Beyond Service Life

Notes: The acoustical ceiling system is beyond its expected service life. stained, and should be replaced.

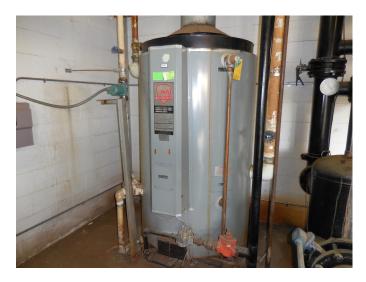
#### System: D2020 - Domestic Water Distribution

**Location:** Throughout Building

**Distress:** Beyond Service Life

**Notes:** The domestic water distribution system is beyond its expected service life and should be scheduled for replacement. The water piping and hot water heater is rusting and pipe line patches have been made to areas which were leaking.

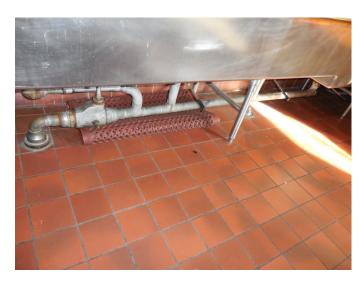
#### System: D2030 - Sanitary Waste

**Location:** Throughout Building

**Distress:** Beyond Service Life

**Notes:** The sanitary waste system is beyond its expected service life and should be scheduled for replacement. Staff reported odors and numerous backups in the kitchen and restrooms. Several classrooms have the old drum trap, which is causing unpleasant smells. The kitchen grease trap is not functional. Staff hand carries buckets of grease that is dumped into two 55 gal drums sitting on dock.

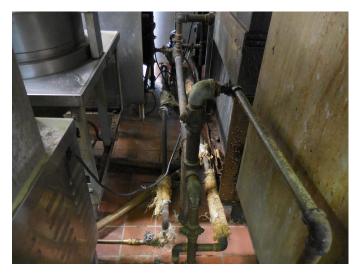
#### System: D2090 - Other Plumbing Systems - Natural Gas

**Location:** Throughout Building

**Distress:** Beyond Service Life

**Notes:** The natural gas system is beyond its expected service life and should be scheduled for replacement.

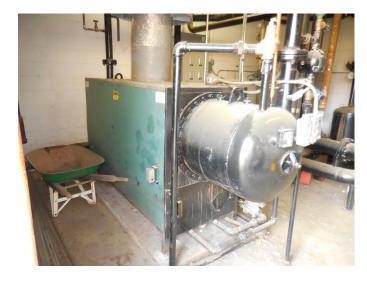
#### System: D3020 - Heat Generating Systems

**Location:** Mechanical Room

**Distress:** Beyond Service Life

**Notes:** The heat generating system to include gas boiler, pumps, valves and piping are beyond their expected service life and should be replaced.

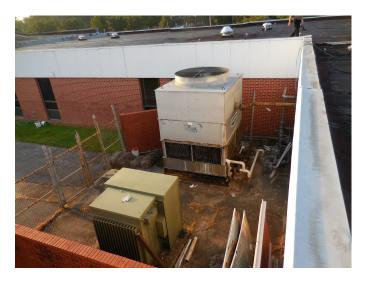
#### System: D3030 - Cooling Generating Systems

Location: Mechanical Room/Throughout Building

**Distress:** Beyond Service Life

**Notes:** The cooling tower, pumps, piping and valves are beyond their expected service and should be replaced. SPLOST project 104-422 to replace the cooling generation system.

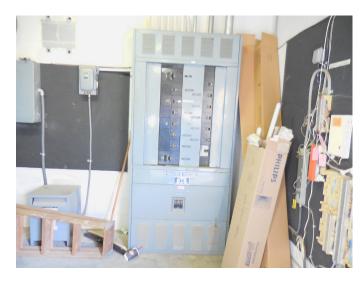
#### System: D5010 - Electrical Service/Distribution

**Location:** Main Switch Room/Throughout Building

**Distress:** Beyond Service Life

**Notes:** School staff reported numerous outages due to breakers tripping and insufficient power. The electrical service/distribution system has reached the end of its expected service life and should be scheduled for replacement.

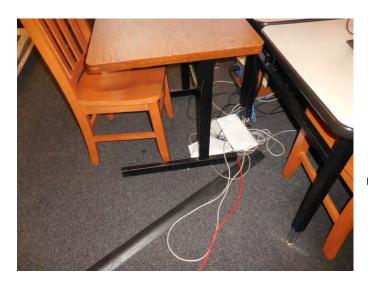
#### System: D5020 - Branch Wiring

**Location:** Throughout Building

**Distress:** Beyond Service Life

**Notes:** The branch wiring system is original, beyond its expected service life, and should be scheduled for replacement. School staff reported numerous outages and breakers tripping because of insufficient power.

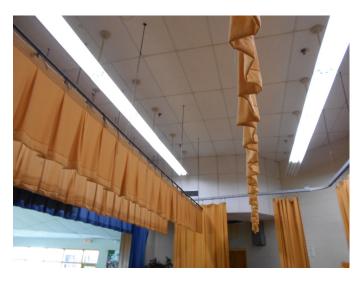
#### System: E1020 - Institutional Equipment

**Location:** Throughout Building

**Distress:** Beyond Service Life

**Notes:** Institutional equipment, such as theater and stage equipment, is beyond its expected service life and should be scheduled for replacement.

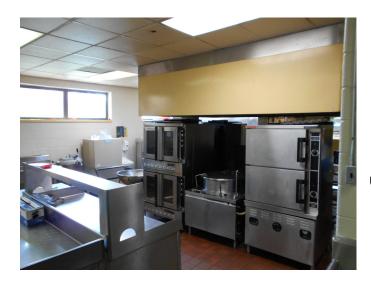
#### System: E1090 - Other Equipment (Kitchen Equipment)

Location: Kitchen

**Distress:** Beyond Service Life

**Notes:** Kitchen equipment is beyond its expected service life and should be scheduled for replacement. Kitchen equipment replacement is reportedly a part of SPLOST IV.

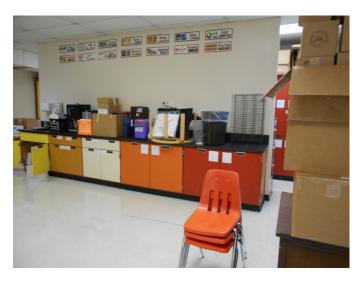
#### System: E2010 - Fixed Furnishings

**Location:** Throughout Building

**Distress:** Beyond Service Life

**Notes:** Fixed furnishings, such as built-in cabinets, are beyond their expected service life and worn, and should be replaced.

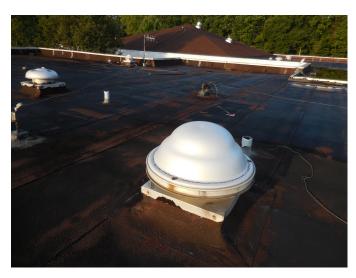
#### System: D3040 - Distribution & Exhaust Systems

**Location:** Throughout Building

**Distress:** Beyond Service Life

**Notes:** Roof top exhaust systems are rusted and beyond their expected service life. Ductwork is original and dirty, causing restrooms and other areas to be inadequately ventilated. The entire system needs to be replaced.

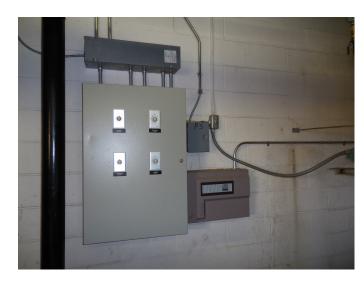
#### System: D3060 - Controls & Instrumentation

**Location:** Throughout Building

**Distress:** Beyond Service Life

**Notes:** The controls and instrumentation system is beyond its expected service life, inadequate, and should be scheduled for replacement. SPLOST project 104-422 to replace controls and instrumentation system.

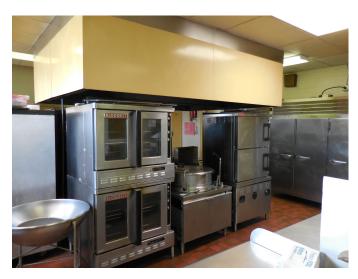
#### System: D3090 - Other HVAC Systems/Equip - Kitchen Hood

Location: Kitchen

**Distress:** Beyond Service Life

**Notes:** The kitchen hood system is original, beyond its expected service life, and should be scheduled for replacement. SPLOST project 104-422 to replace the kitchen hood.

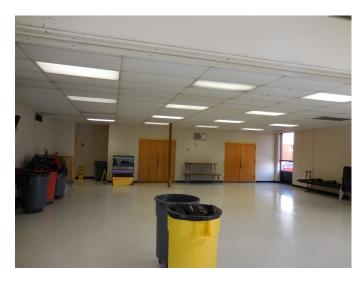
#### System: D5020 - Lighting

**Location:** Throughout Building

**Distress:** Beyond Service Life

**Notes:** The lighting system is original with T-12 bulbs and should be scheduled for replacement with more energy efficient fixtures. SPLOST project 104-422 to replace lighting system.

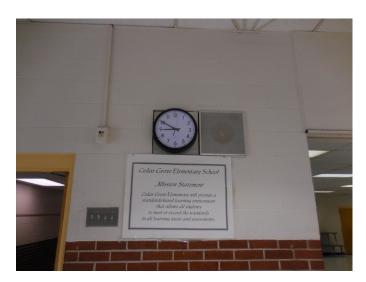
#### System: D5030 - Communications and Security - Clock & PA Systems

**Location:** Throughout Building

**Distress:** Beyond Service Life

Notes: Clock and PA systems are beyond their expected service life and should be scheduled for replacement.

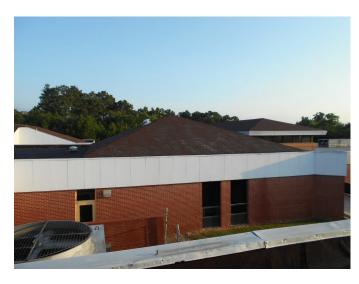
System: B3010 - Roof Coverings - Asphalt Shingles

Location: Roof

**Distress:** Beyond Service Life

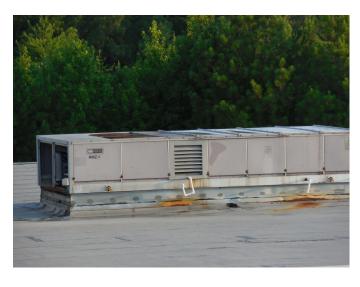
### System: D3050 - Terminal & Package Units

**Location:** Throughout Building

**Distress:** Beyond Service Life

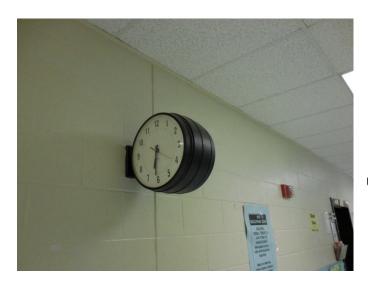
#### System: D5030 - Communications and Security - Clock & PA Systems

**Location:** Throughout Building

**Distress:** Beyond Service Life

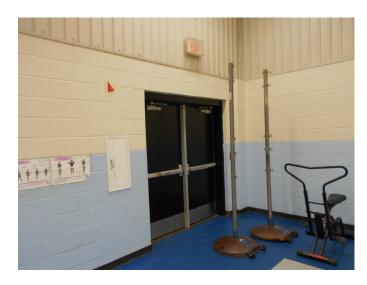
System: C3010 - Wall Finishes - Paint

**Location:** Throughout Building

**Distress:** Beyond Service Life

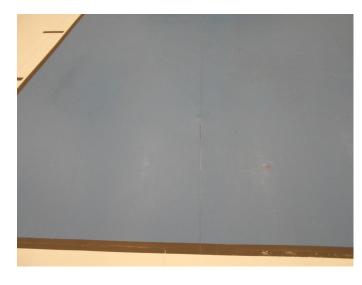
#### System: C3020 - Floor Finishes - Neoprene

**Location:** Basketball Court

**Distress:** Beyond Service Life

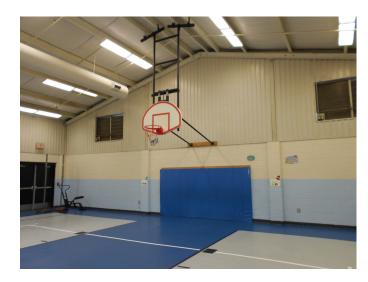
#### System: D3050 - Terminal & Package Units

**Location:** Throughout Building

**Distress:** Inadequate

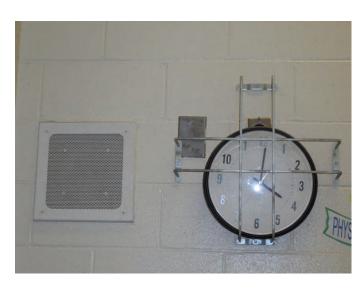
### System: D5030 - Communications and Security - Public Address & Clock System

**Location:** Throughout Building

**Distress:** Beyond Service Life

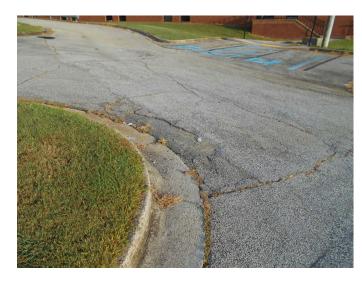
System: G2010 - Roadways

Location: Site

**Distress:** Beyond Service Life

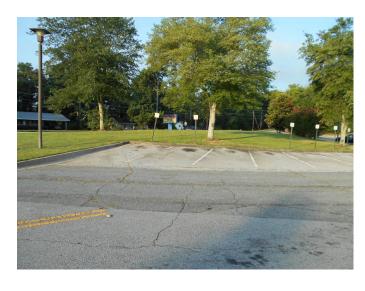
#### System: G2020 - Parking Lots

Location: Site

**Distress:** Beyond Service Life
