DeKalb County School District/High Schools

Cedar Grove High

School Assessment Report

May 19, 2016

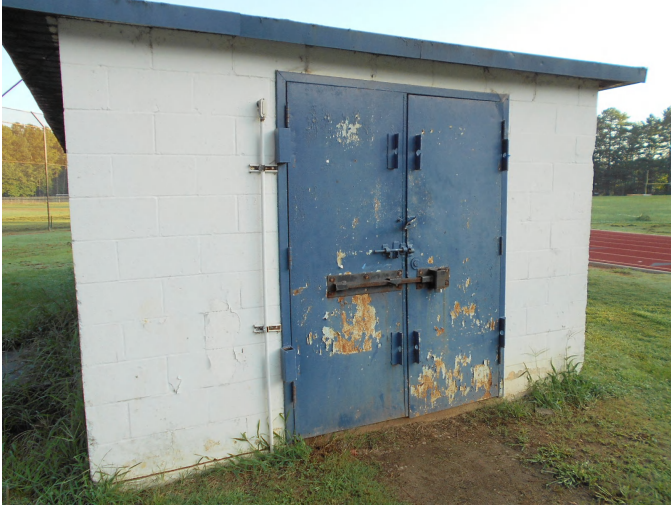
System: B2030 - Exterior Doors

Location: Exterior Walls

Distress: Beyond Service Life

Notes: The exterior doors are beyond their expected service life, damaged, and should be replaced. SPLOST project 404-422 to conduct exterior walls (remediation study) for the football storage building, baseball dugout, and 1998 building. A determination has been made to replace the footballs storage building.

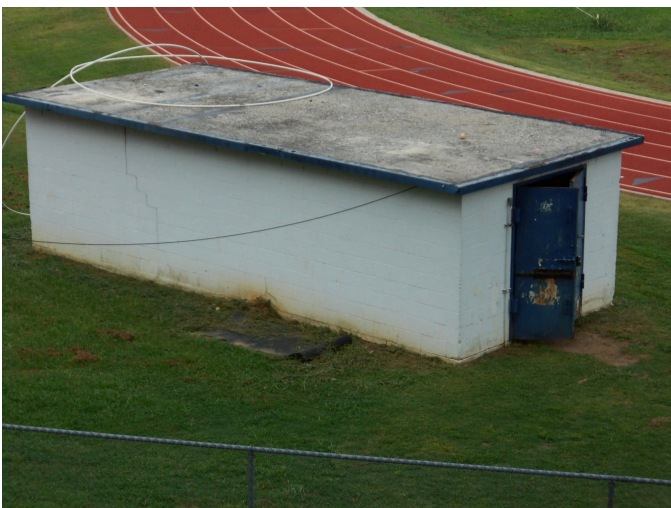
System: B3010 - Roof Coverings

Location: Roof

Distress: Beyond Service Life

Notes: The roof covering is beyond expected service life and should be replaced. SPLOST project 404-422 to conduct exterior walls (remediation study) for the football storage building, baseball dugout, and 1998 building. A determination has been made to replace the footballs storage building.

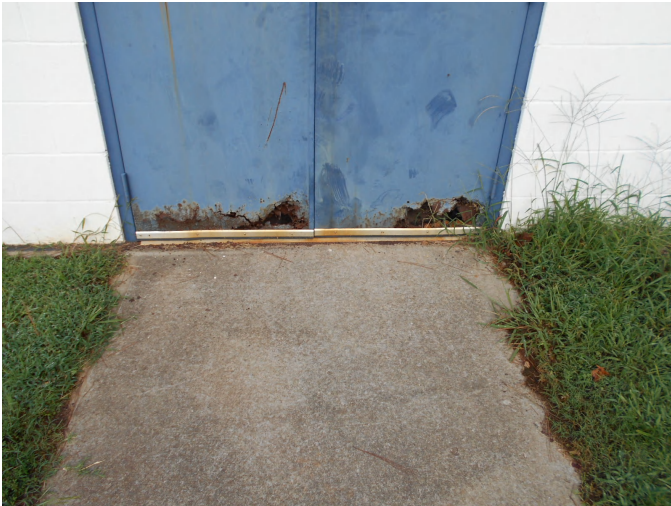
System: B2030 - Exterior Doors

Location: Exterior Wall

Distress: Beyond Service Life

Notes: The exterior doors are original, rusted, and should be replaced.

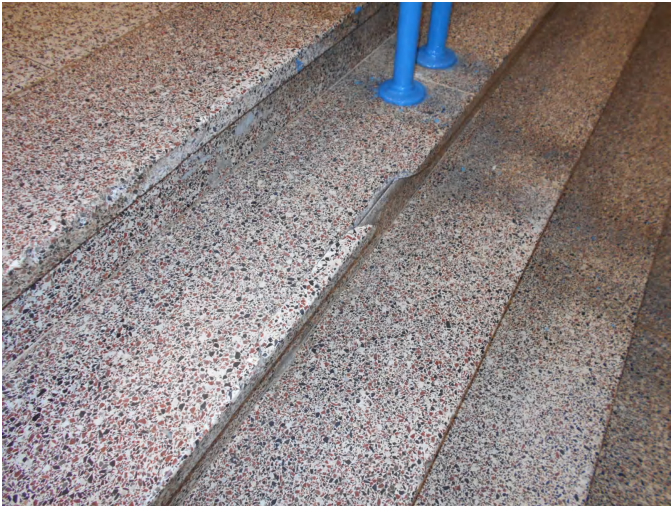
System: C2010 - Stair Construction

Location: Stairs

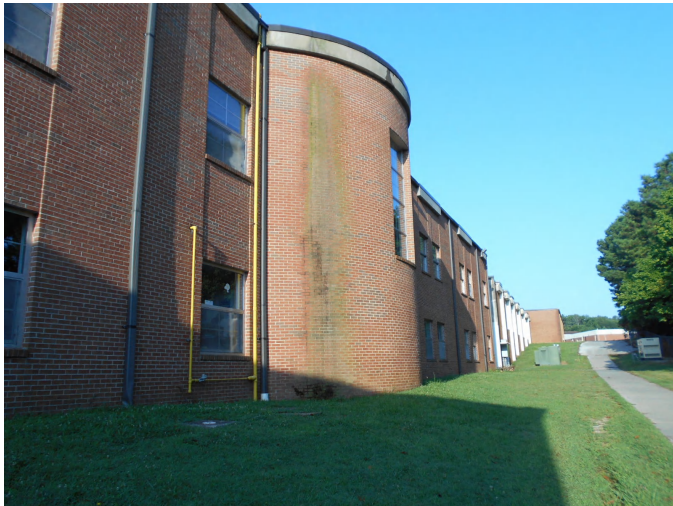
System: B2010 - Exterior Walls

Location: Exterior Walls

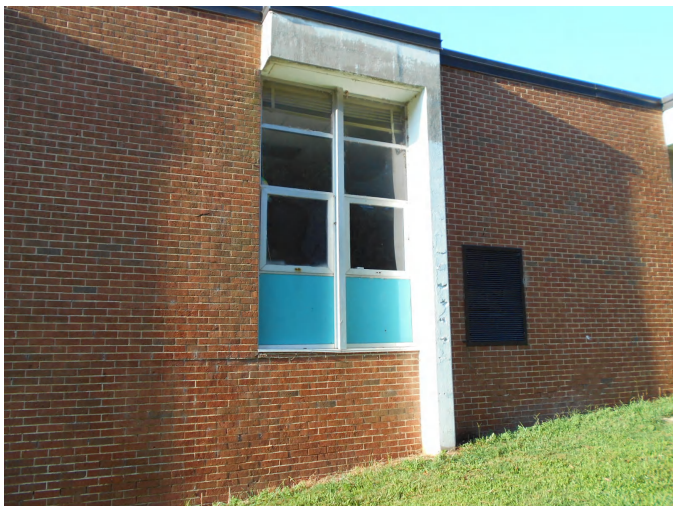
System: B2020 - Exterior Windows

Location: Throughout Building

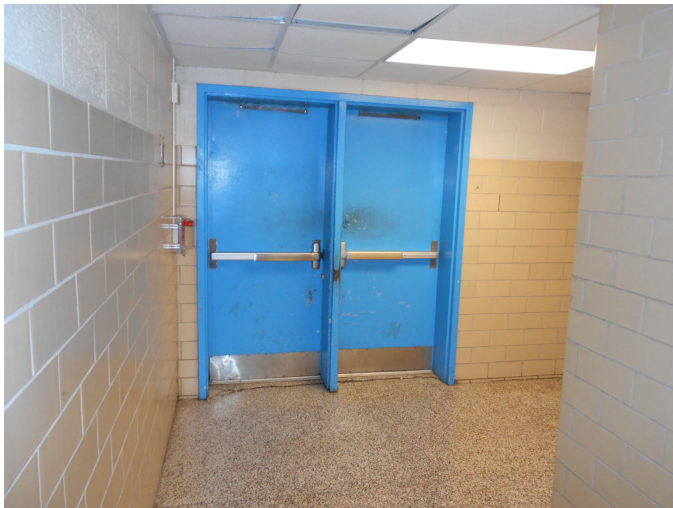
System: B2030 - Exterior Doors

Location: Throughout Building
Distress: Beyond Service Life
Category: Deferred Maintenance / Energy
Priority: 3 Priority
Correction: Renew System
Qty: 134,200.00
Unit of Measure: S.F.
Estimate: \$97,429.00
Assessor Name: Eduardo Lopez
Date Created: 04/11/2015

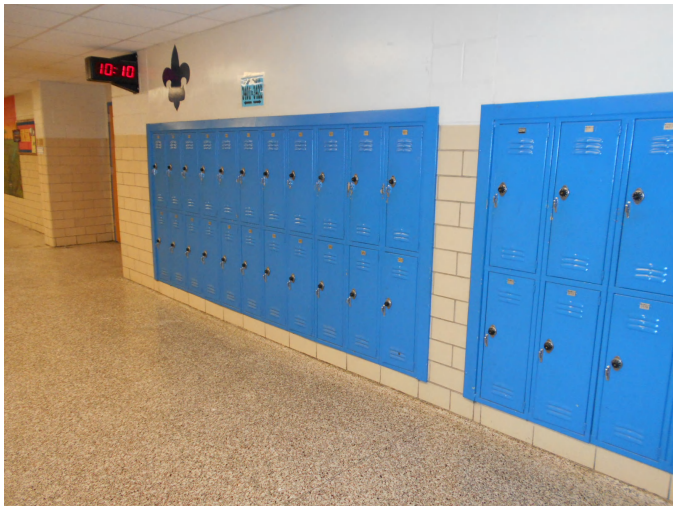
System: C1030 - Fittings

Location: Throughout Building
Distress: Damaged
Category: Deferred Maintenance
Priority: 3 Priority
Correction: Replace metal lockers, single tier
Qty: 1,925.00
Unit of Measure: Ea.
Estimate: \$1,107,494.85
Assessor Name: Sam Mandola
Date Created: 07/27/2015

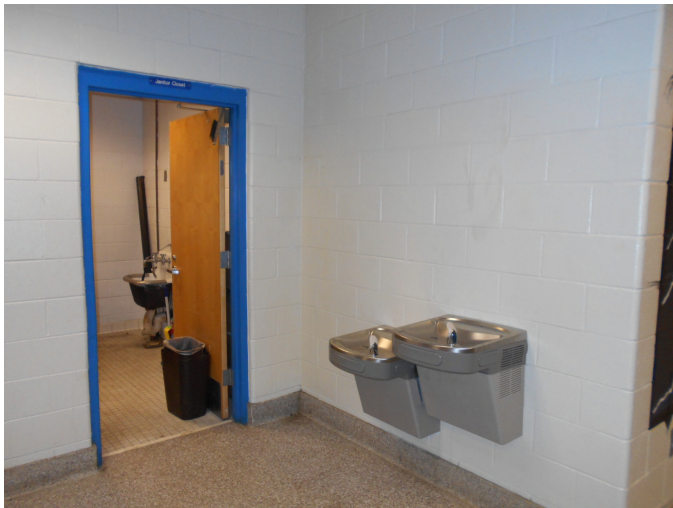
System: C3010 - Wall Finishes - Paint

Location: Throughout Building

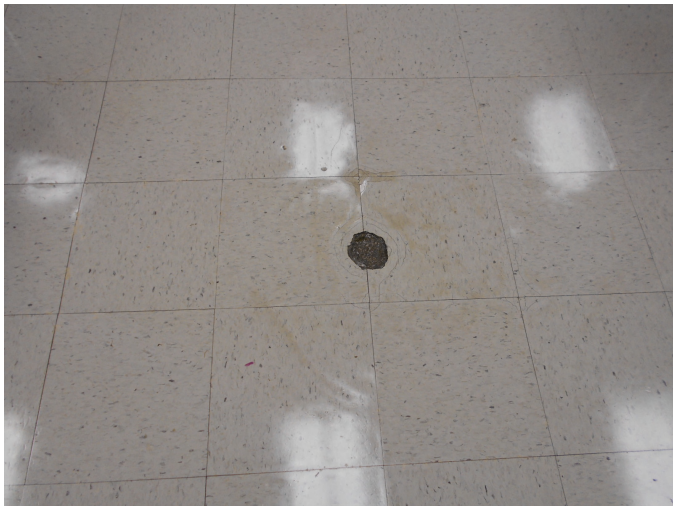
System: C3020 - Floor Finishes - VCT

Location: Throughout Building

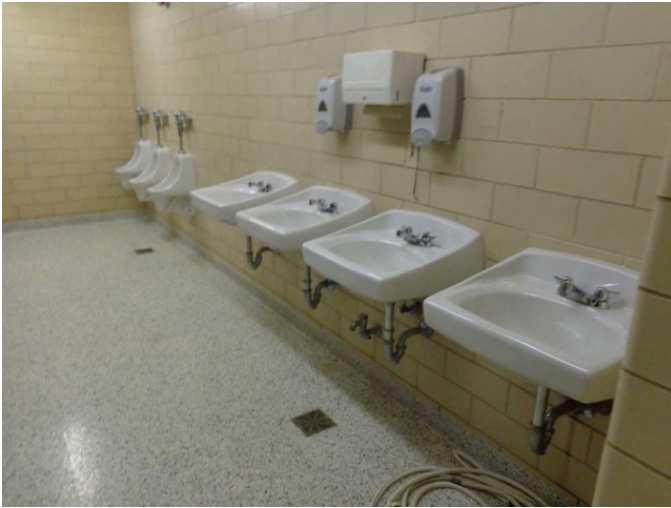
System: D2010 - Plumbing Fixtures

Location: Locker Room Restrooms

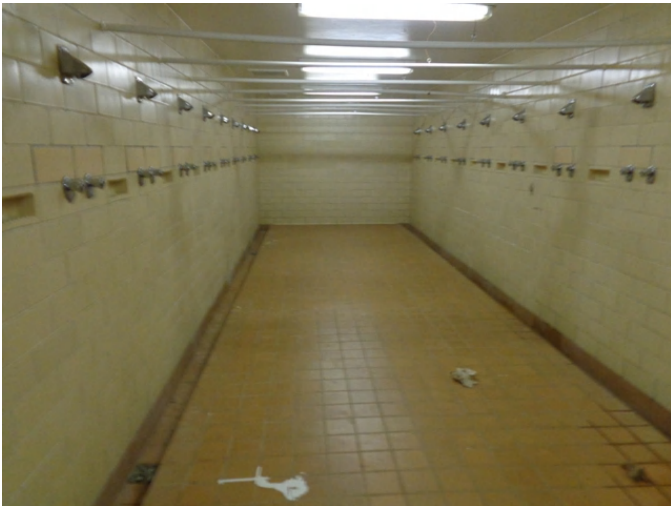
System: D2010 - Plumbing Fixtures

Location: Locker Room Showers

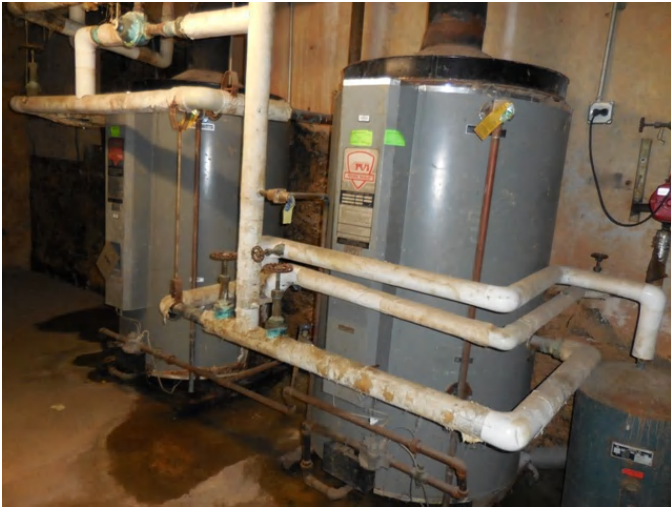
System: D2020 - Domestic Water Distribution

Location: Mechanical Room/Throughout Building

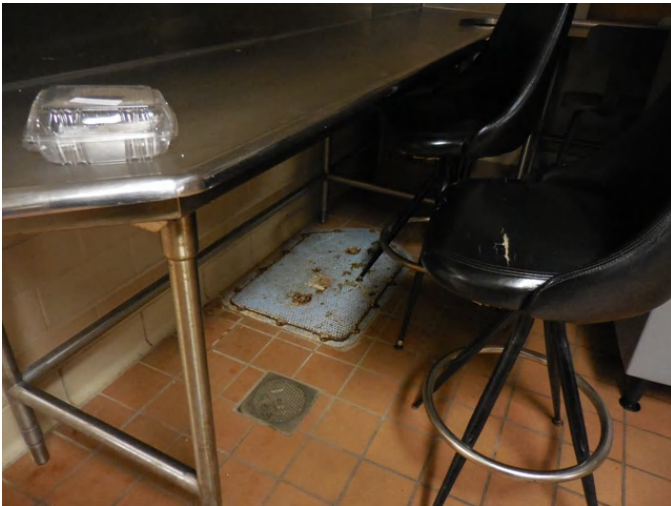
System: D2030 - Sanitary Waste

Location: Throughout Building

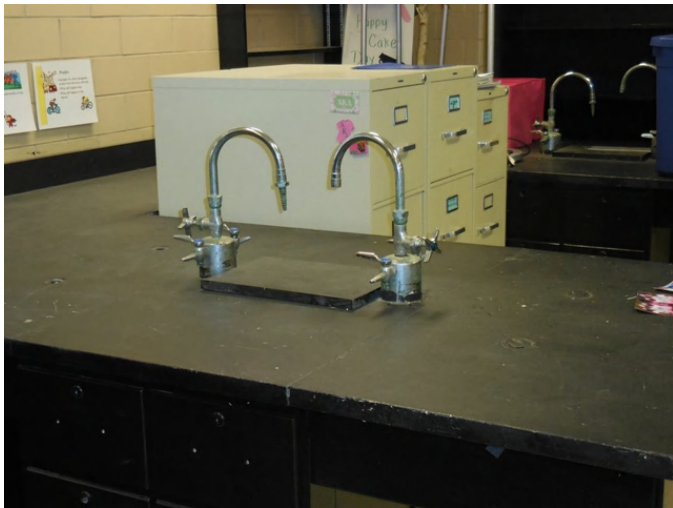
System: D2090 - Other Plumbing Systems - Acid Waste

Location: Classrooms

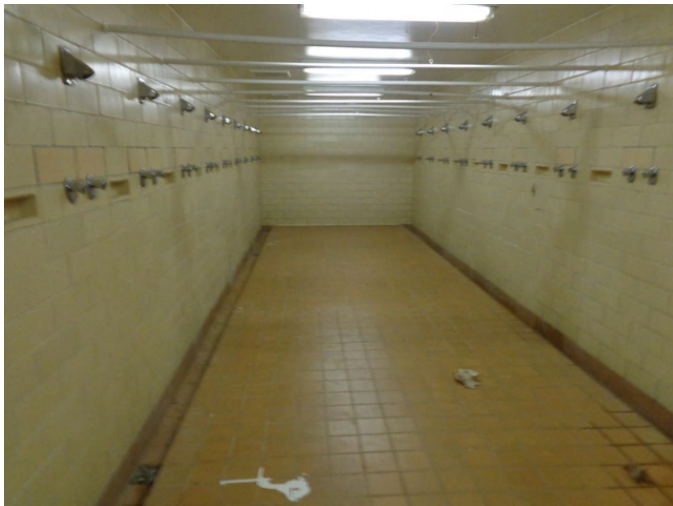
System: D3040 - Distribution Systems & Exhaust Systems

Location: Locker Room/Roof Top

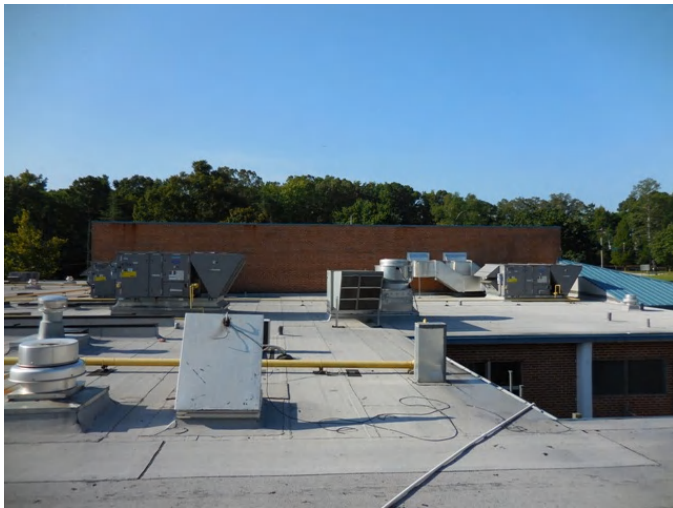
System: D3070 - System Test & Balance

Location: Throughout Building

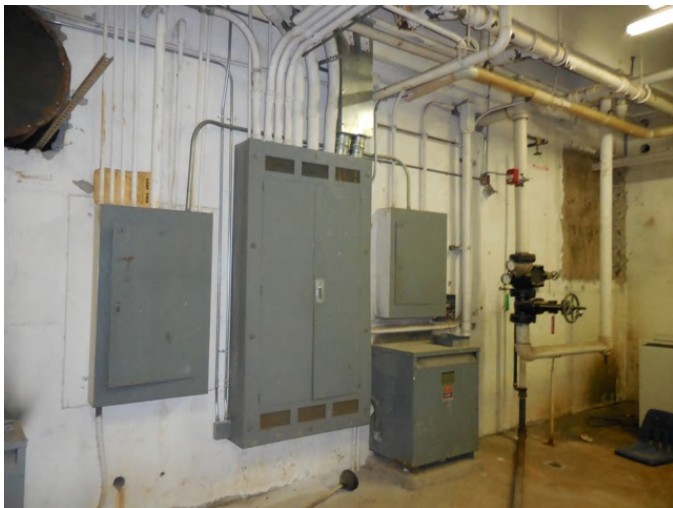
System: D5020 - Branch Wiring

Location: Throughout Building

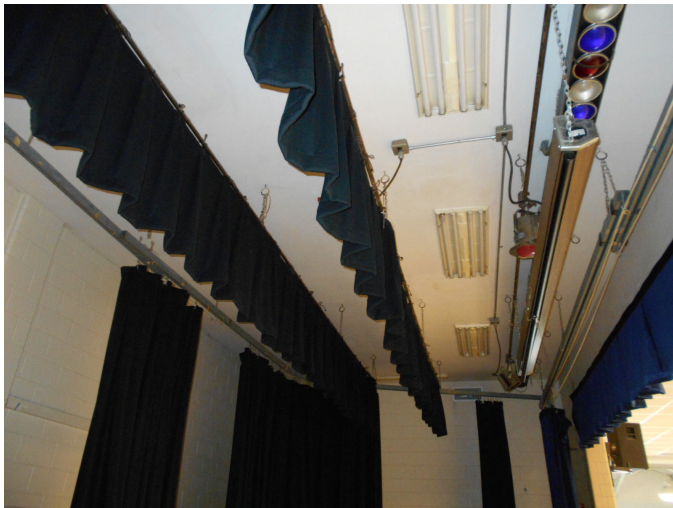
System: E1020 - Institutional Equipment

Location: Throughout Building
Distress: Beyond Service Life
Category: Deferred Maintenance
Priority: 3 Priority
Correction: Renew System
Qty: 134,200.00
Unit of Measure: S.F.
Estimate: \$112,191.00
Assessor Name: Eduardo Lopez
Date Created: 12/08/2015

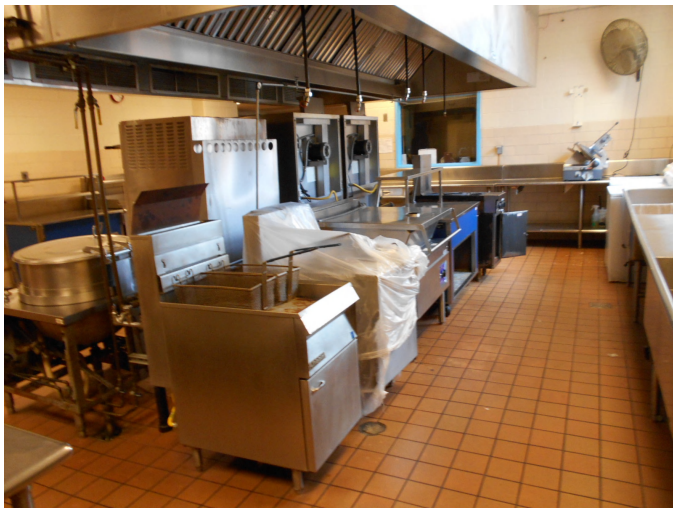
System: E1090 - Other Equipment - Kitchen Equipment

Location: Kitchen
Distress: Beyond Service Life
Category: Deferred Maintenance
Priority: 3 Priority
Correction: Renew System
Qty: 135,200.00
Unit of Measure: S.F.
Estimate: \$333,133.00
Assessor Name: Eduardo Lopez
Date Created: 04/11/2015

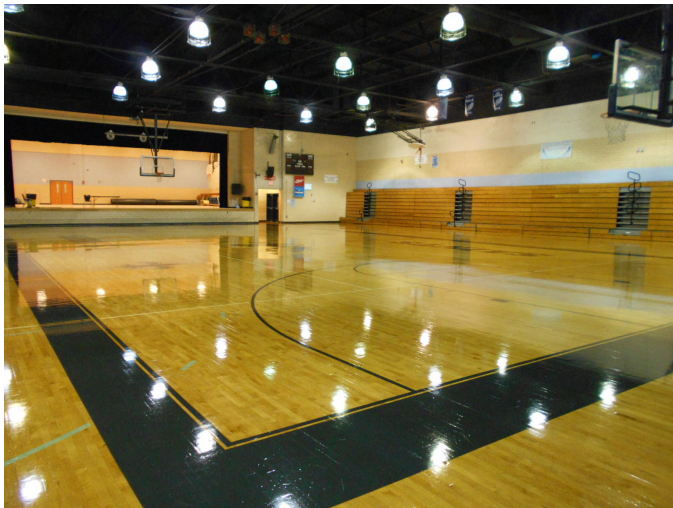
System: E1090 - Other Equipment - Sports Equipment

Location: Gym

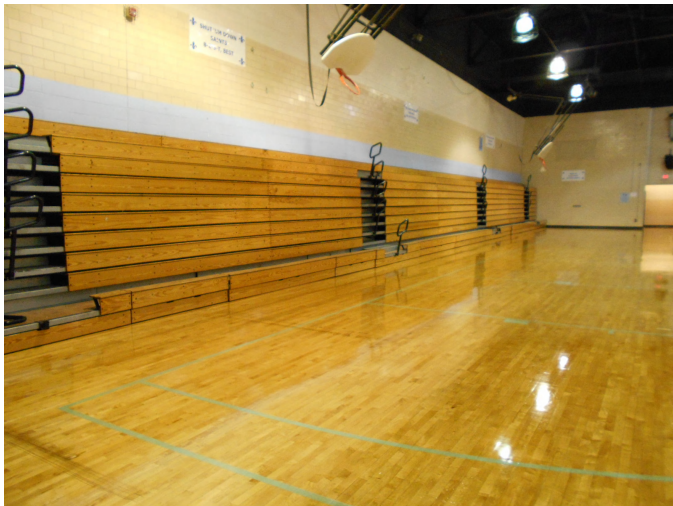
System: E2020 - Moveable Furnishings

Location: Gym

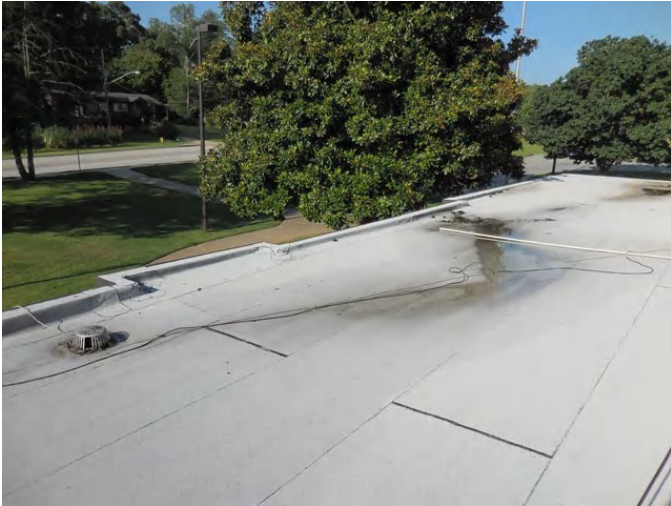
System: D2040 - Rain Water Drainage

Location: Throughout Building

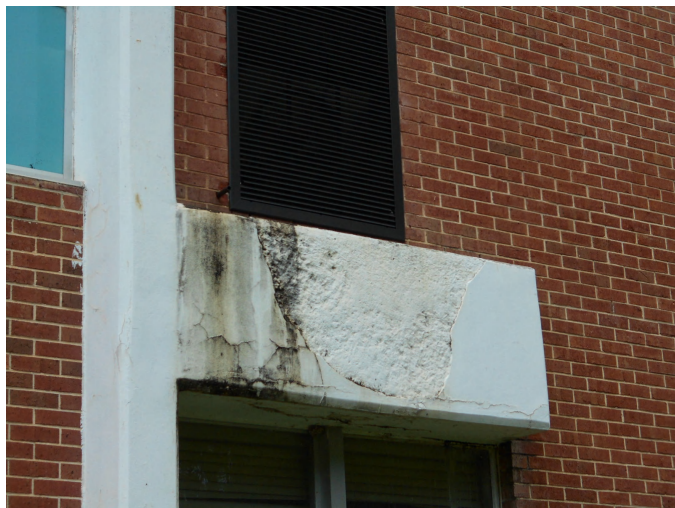
System: B2010 - Exterior Walls

Location: Exterior Walls

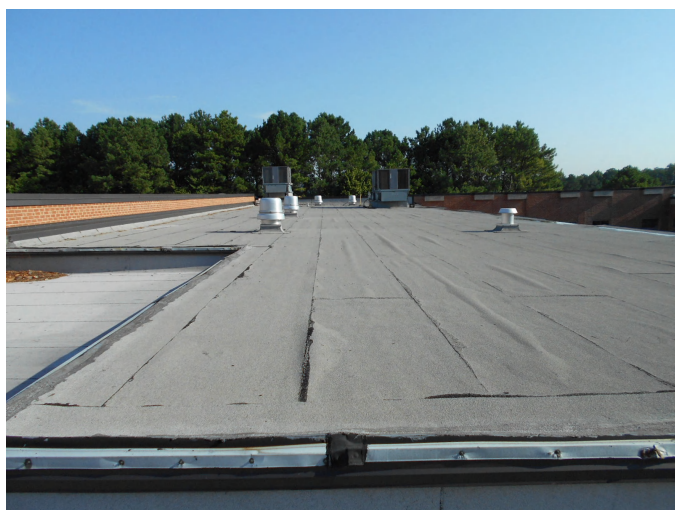
System: B3010 - Roof Coverings - BUR

Location: Roof

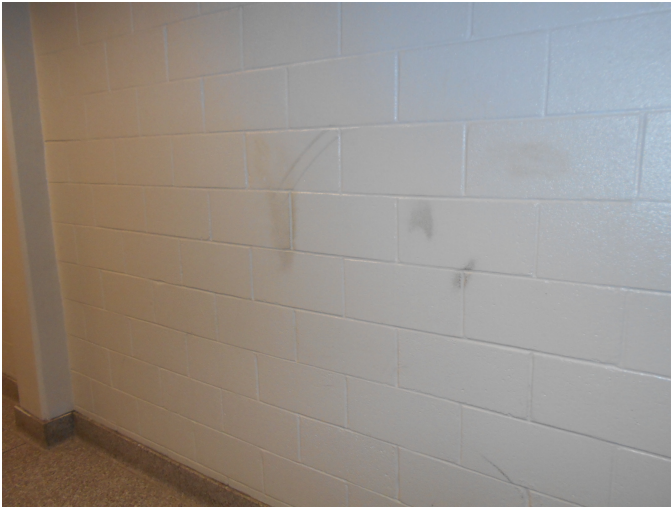
System: C3010 - Wall Finishes - Paint

Location: Throughout Building

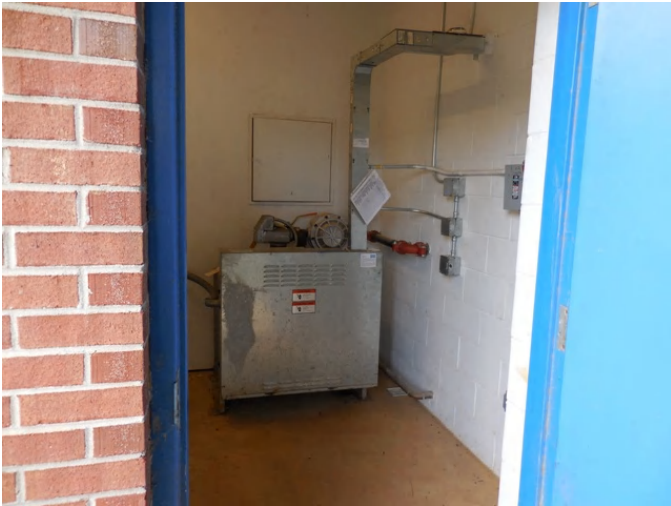
System: D1010 - Elevators and Lifts

Location: East Elevator

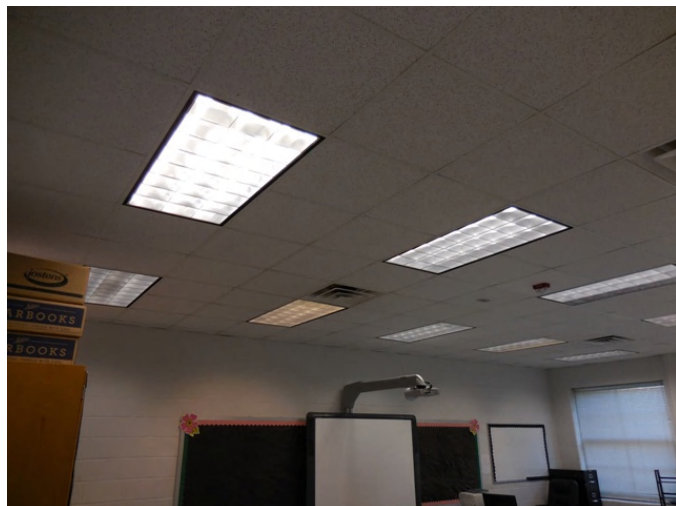
System: D3070 - System Test & Balance

Location: Throughout Building

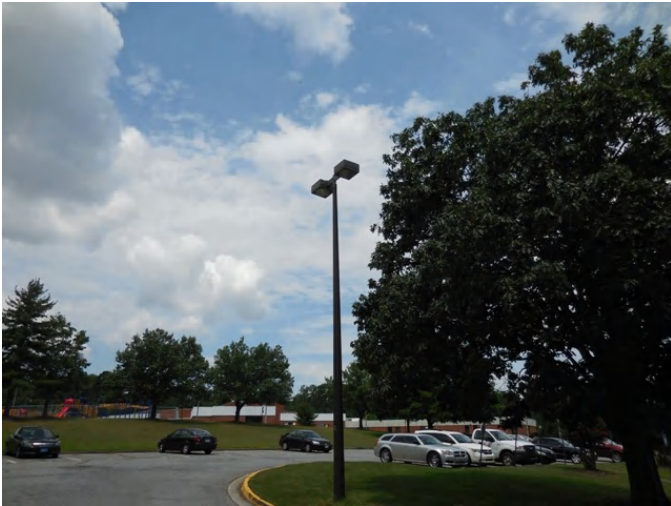
System: G4020 - Site Lighting

Location: Site

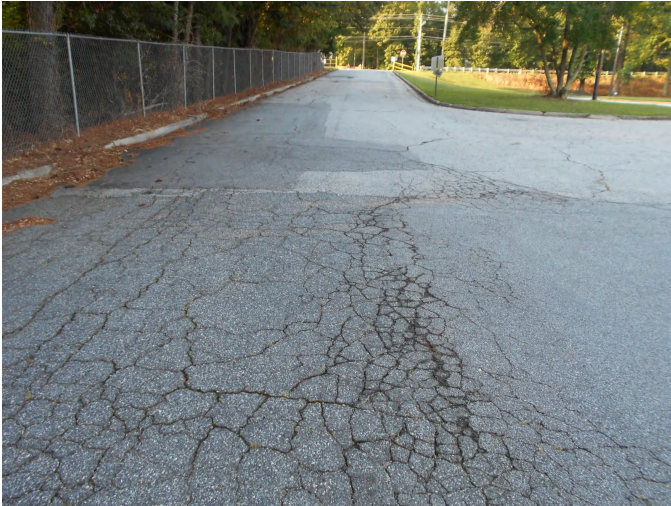
System: G2010 - Roadways

Location: Site

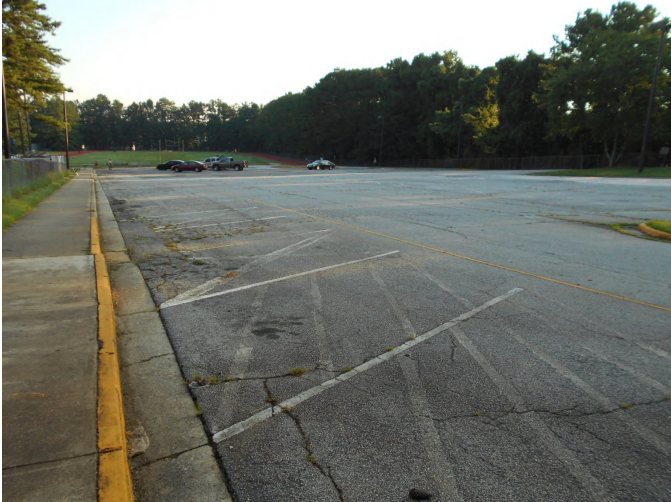
System: G2020 - Parking Lots

Location: Site

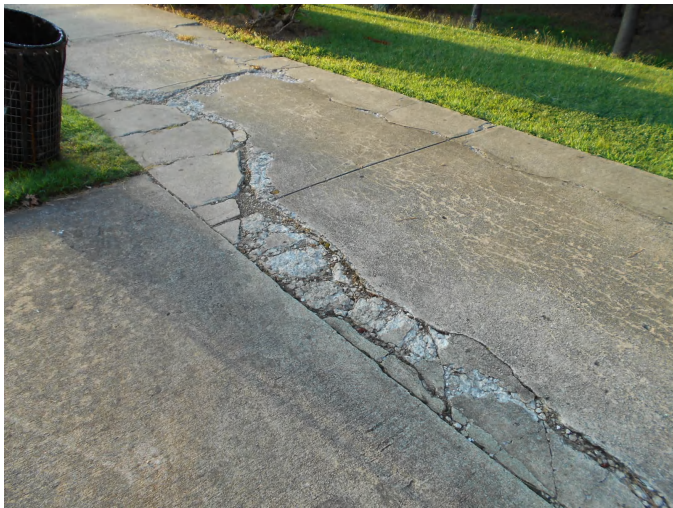
System: G2030 - Pedestrian Paving

Location: Site
Distress: Beyond Service Life
Category: Deferred Maintenance
Priority: 3 Priority
Correction: Renew System
Qty: 181,705.00
Unit of Measure: S.F.
Estimate: \$299,813.25
Assessor Name: Sam Mandola
Date Created: 07/27/2015

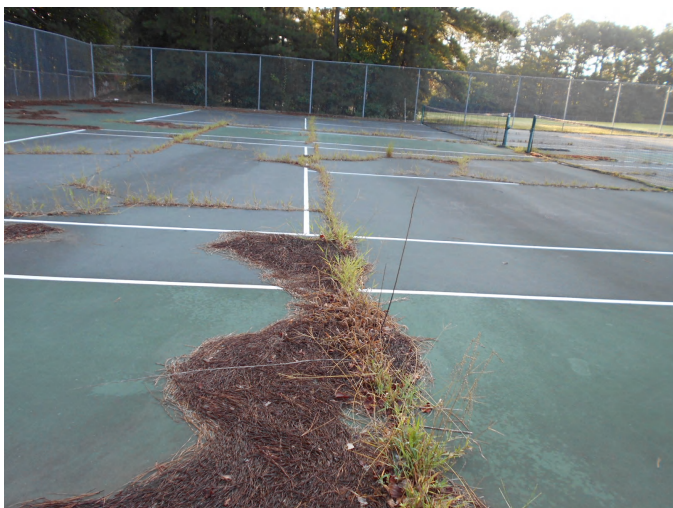
System: G2040 - Tennis Courts

Location: Site
Distress: Beyond Service Life
Category: Deferred Maintenance
Priority: 3 Priority
Correction: Renew System
Qty: 12,867.00
Unit of Measure: S.F.
Estimate: \$261,418.84
Assessor Name: Eduardo Lopez
Date Created: 07/27/2015

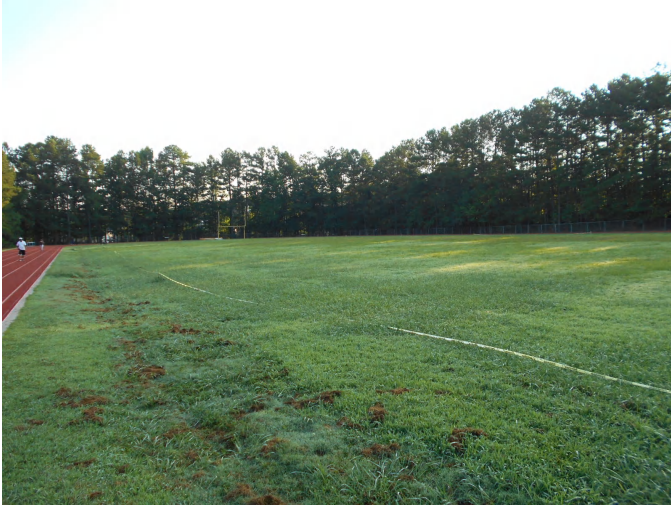
System: G2050 - Landscaping

Location: Football, Baseball, and Softball Fields

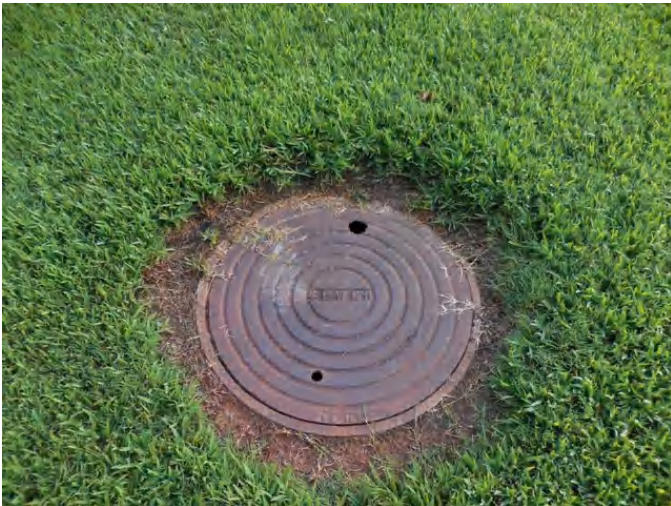
System: G3020 - Sanitary Sewer

Location: Site

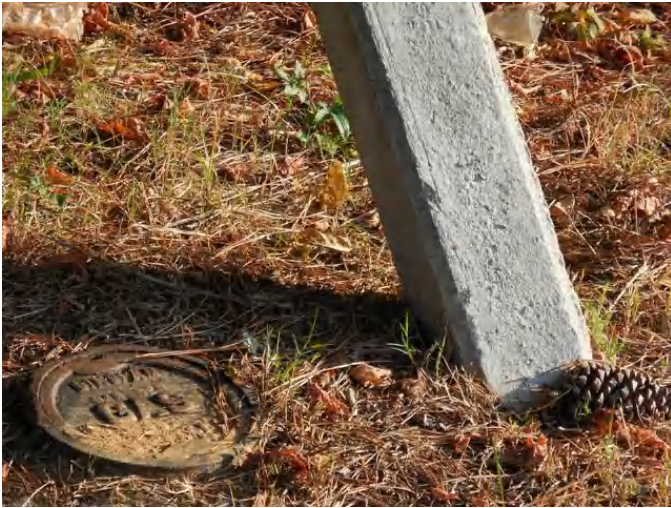
System: G3060 - Fuel Distribution

Location: Site
