DeKalb County School District/Middle Schools

# Champion Theme Middle

## School Assessment Report

May 20, 2016

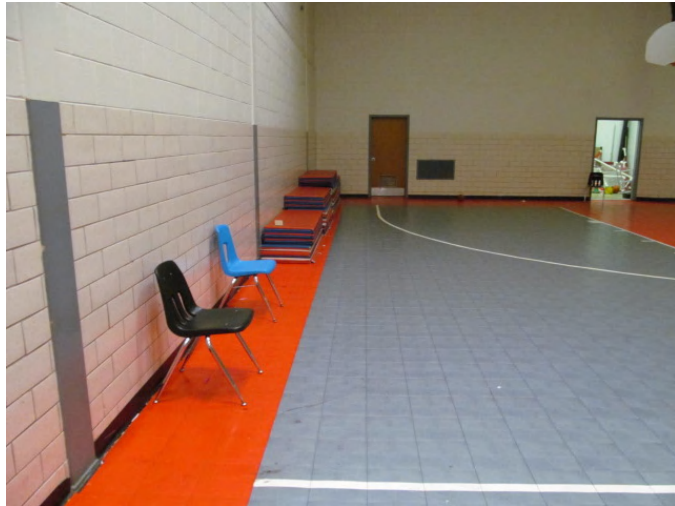
#### System: C3020 - Floor Finishes - Neoprene

**Location:** Gym

**Notes:** The neoprene flooring is loose, damaged, has tripping hazards, and should be replaced.

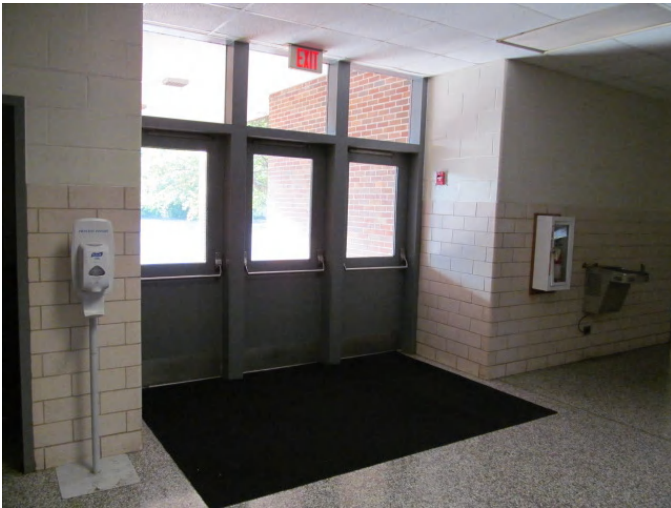
**System: B2030 - Exterior Doors**

**Location:** Throughout Building

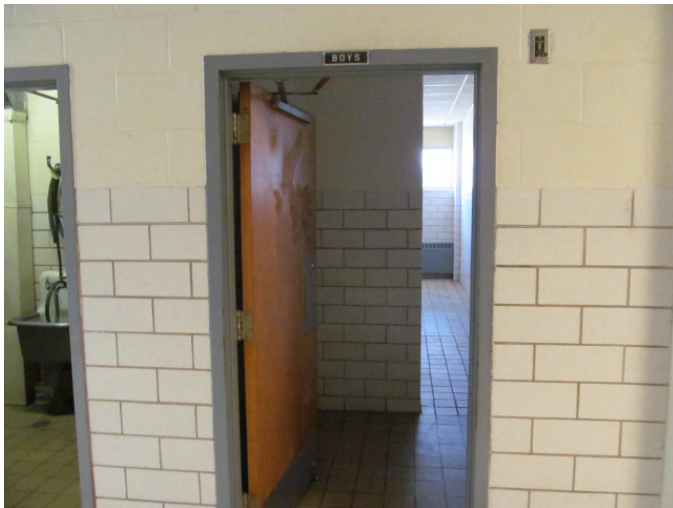
**System: C1020 - Interior Doors**

**Location:** Throughout Building

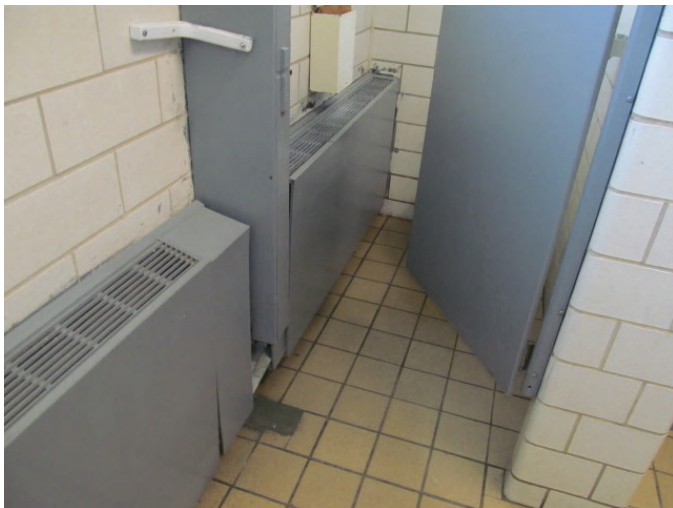
**System: C1030 - Fittings**

**Location:** Throughout Building

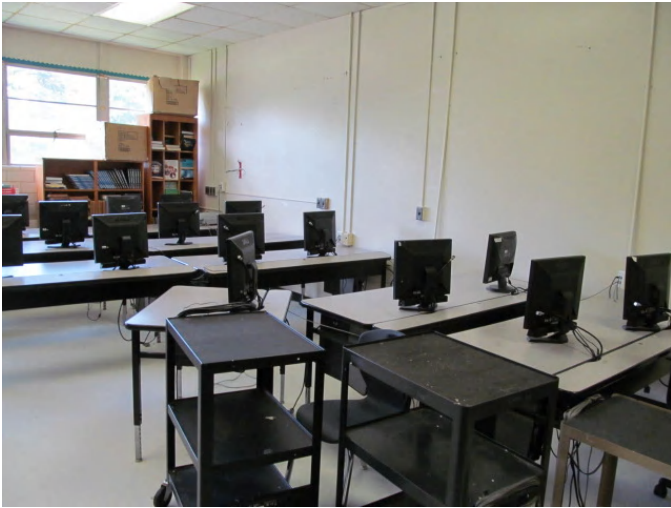
**System: C3010 - Wall Finishes - Paint**

**Location:** Throughout Building

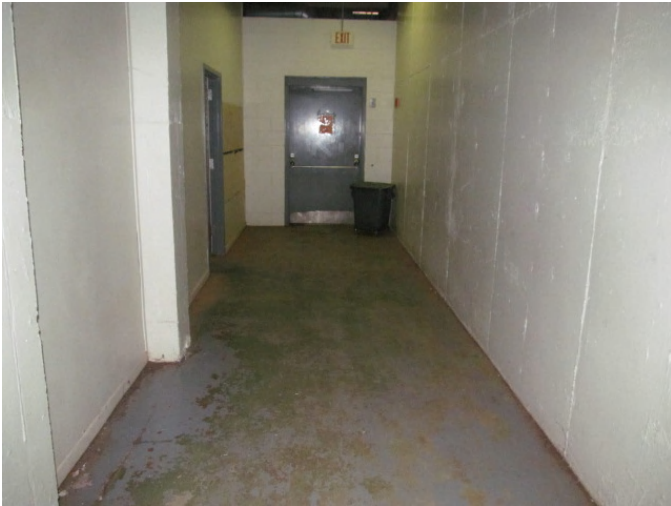
**System: C3020 - Floor Finishes - Epoxy**

**Location:** Locker Room and Weight Room

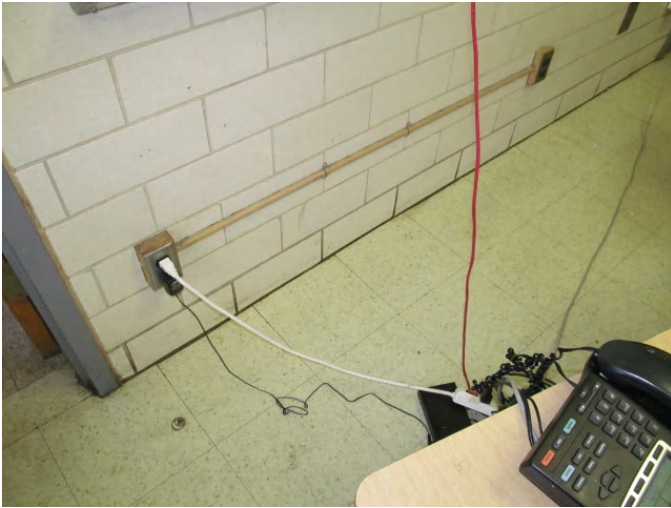
**System: C3020 - Floor Finishes - VCT**

**Location:** Throughout Building

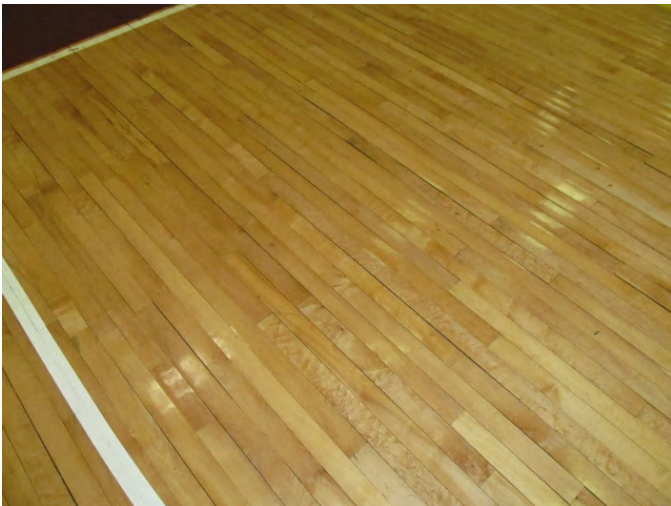
**System: C3020 - Floor Finishes - Wood**

**Location:** Gym

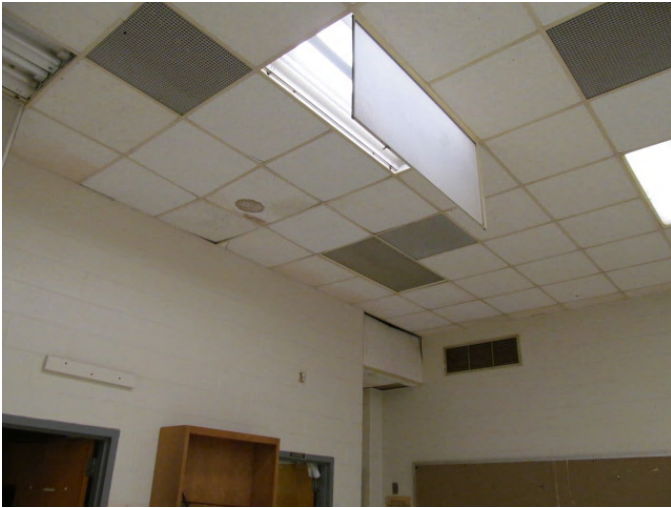
**System: C3030 - Ceiling Finishes**

**Location:** Throughout Building

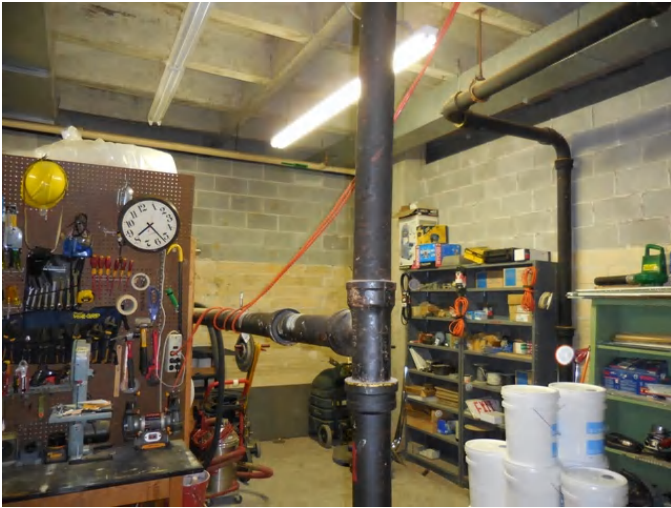
**System: D2030 - Sanitary Waste**

**Location:** Throughout Building

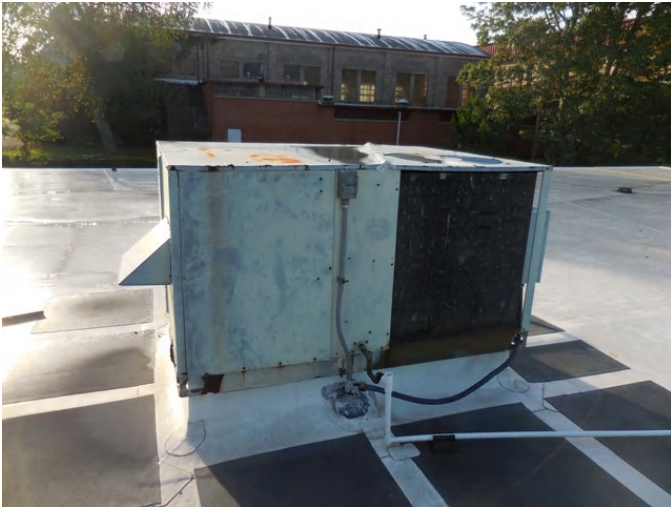
**System: D3050 - Terminal & Package Units**

**Location:** Roof

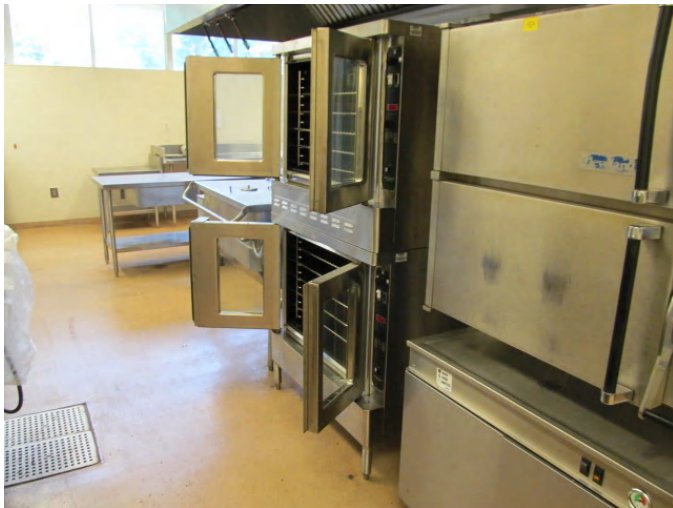
**System: E1090 - Other Equipment (Kitchen Equipment)**

**Location:** Kitchen  
**Distress:** Beyond Service Life  
**Category:** Deferred Maintenance  
**Priority:** 3 Priority  
**Correction:** Renew System  
**Qty:** 88,721.00  
**Unit of Measure:** S.F.  
**Estimate:** \$836,373.00  
**Assessor Name:** Eduardo Lopez  
**Date Created:** 09/29/2015

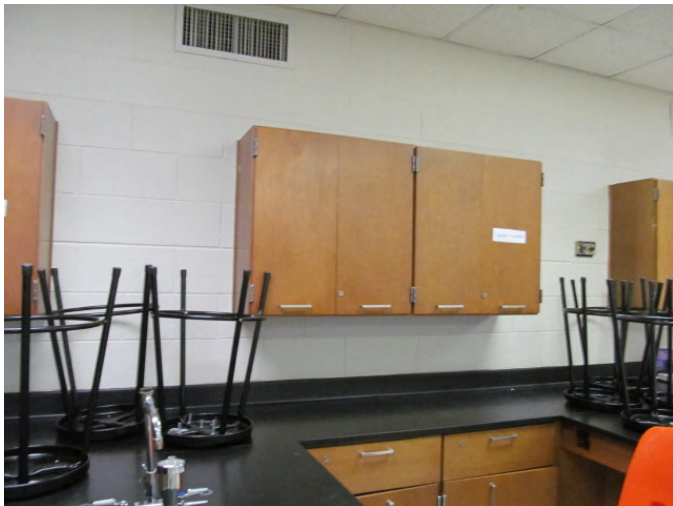
**System: E2010 - Fixed Furnishings**

**Location:** Throughout Building  
**Distress:** Beyond Service Life  
**Category:** Deferred Maintenance  
**Priority:** 3 Priority  
**Correction:** Renew System  
**Qty:** 88,721.00  
**Unit of Measure:** S.F.  
**Estimate:** \$641,187.00  
**Assessor Name:** Eduardo Lopez  
**Date Created:** 04/11/2015

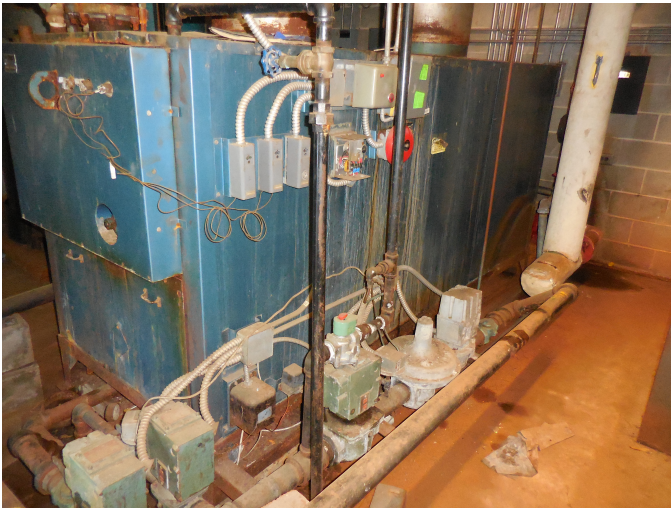
**System: D3020 - Heat Generating Systems**

**Location:** Mechanical Room

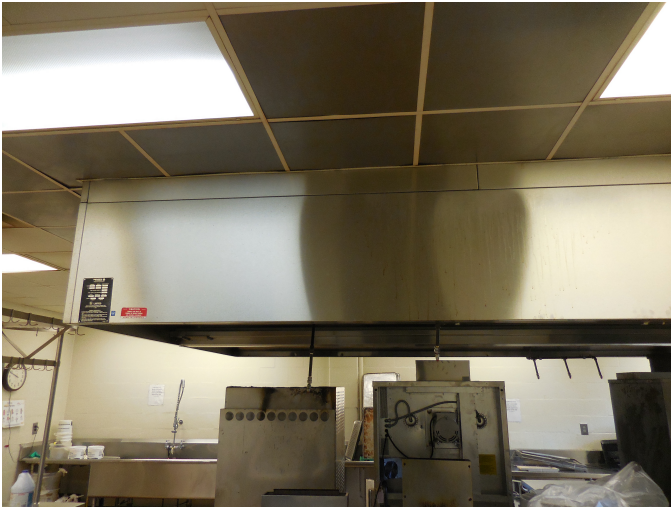
**System: D3090 - Other HVAC Systems/Equip - Kitchen Hood**

**Location:** Kitchen

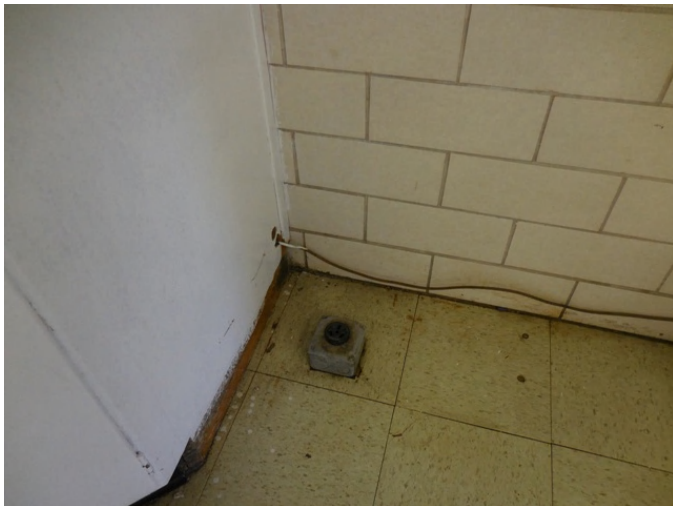
**System: D5020 - Branch Wiring**

**Location:** Throughout Building  
**Distress:** Beyond Service Life  
**Category:** Deferred Maintenance  
**Priority:** 4 Priority  
**Correction:** Renew System  
**Qty:** 88,721.00  
**Unit of Measure:** S.F.  
**Estimate:** \$539,690.00  
**Assessor Name:** Eduardo Lopez  
**Date Created:** 04/11/2015

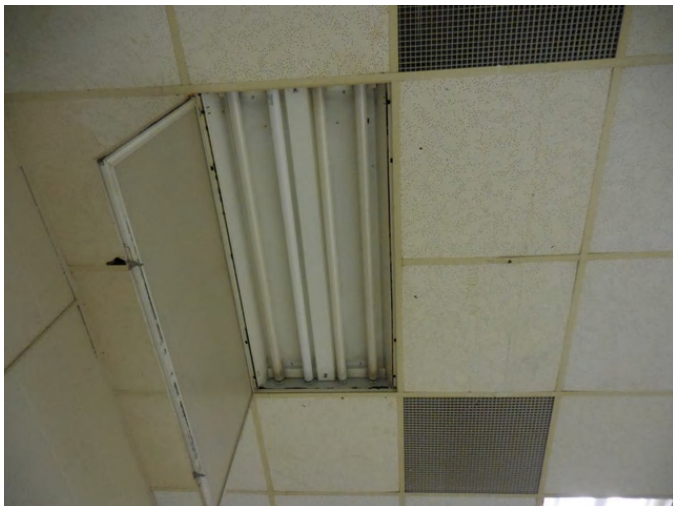
**System: D5020 - Lighting**

**Location:** Throughout Building  
**Distress:** Beyond Service Life  
**Category:** Deferred Maintenance / Energy  
**Priority:** 4 Priority  
**Correction:** Renew System  
**Qty:** 88,721.00  
**Unit of Measure:** S.F.  
**Estimate:** \$815,878.00  
**Assessor Name:** Eduardo Lopez  
**Date Created:** 06/30/2015

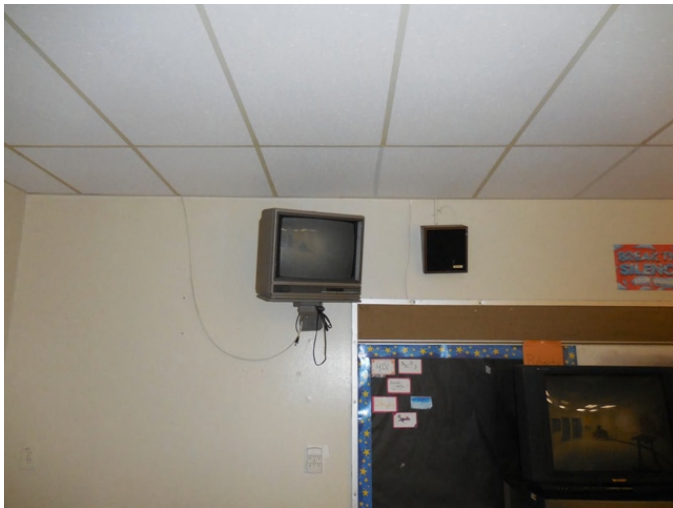
**System: D5030 - Communications and Security - PA & Clock Systems**

**Location:** Throughout Building  
**Distress:** Beyond Service Life  
**Category:** Deferred Maintenance  
**Priority:** 4 Priority  
**Correction:** Renew System  
**Qty:** 88,721.00  
**Unit of Measure:** S.F.  
**Estimate:** \$324,985.00  
**Assessor Name:** Eduardo Lopez  
**Date Created:** 04/11/2015

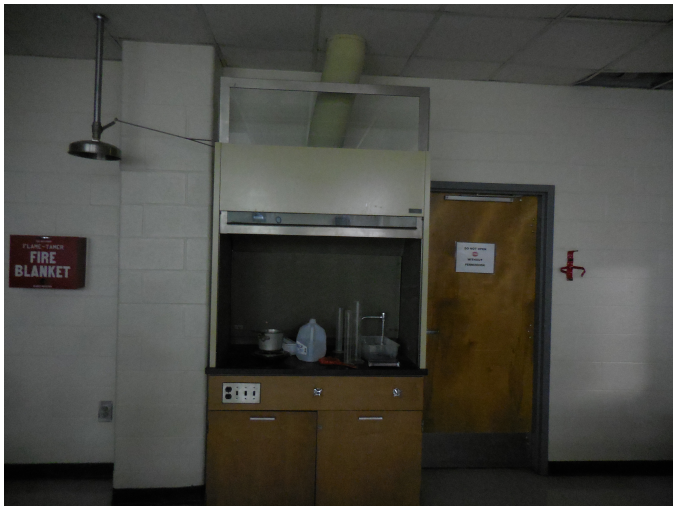
**System: E1020 - Institutional Equipment**

**Location:** Throughout Building  
**Distress:** Beyond Service Life  
**Category:** Deferred Maintenance  
**Priority:** 4 Priority  
**Correction:** Renew System  
**Qty:** 88,721.00  
**Unit of Measure:** S.F.  
**Estimate:** \$275,213.00  
**Assessor Name:** Eduardo Lopez  
**Date Created:** 04/11/2015

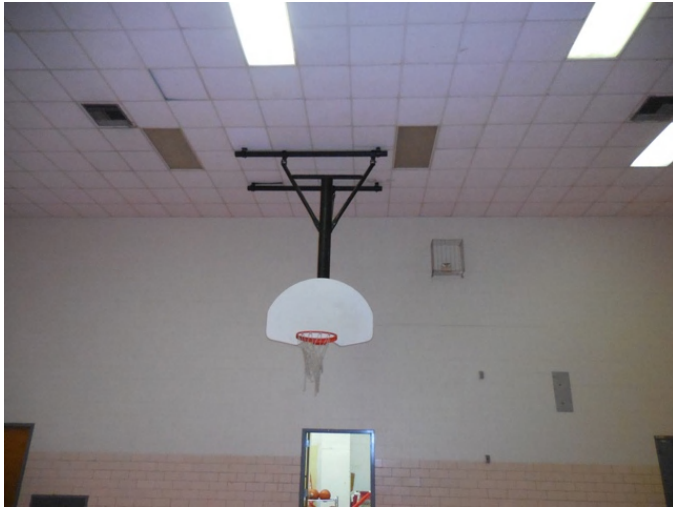
**System: E1090 - Other Equipment (Sports Equipment)**

**Location:** Gym

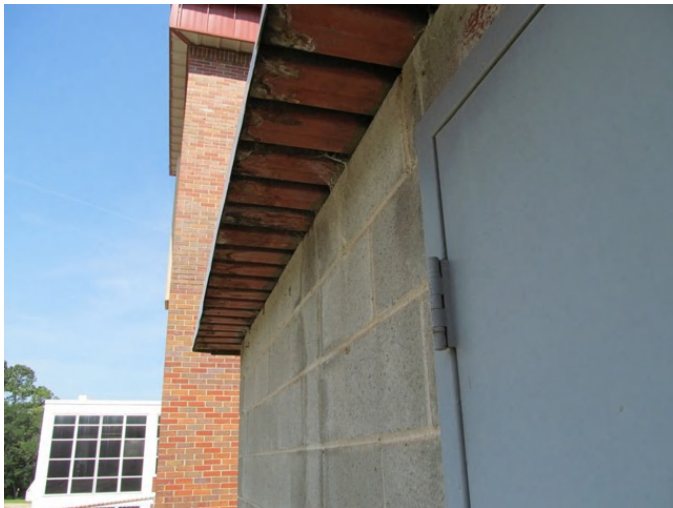
#### System: B1020 - Roof Construction

**Location:** Roof

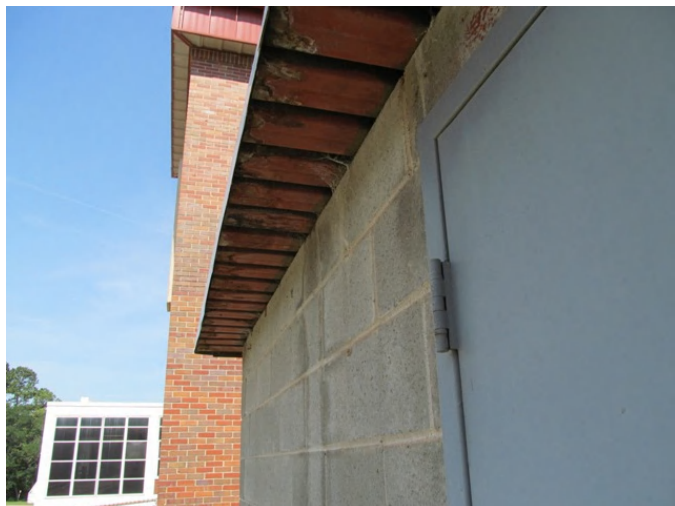
**System: B3010 - Roof Coverings**

**Location:** Roof

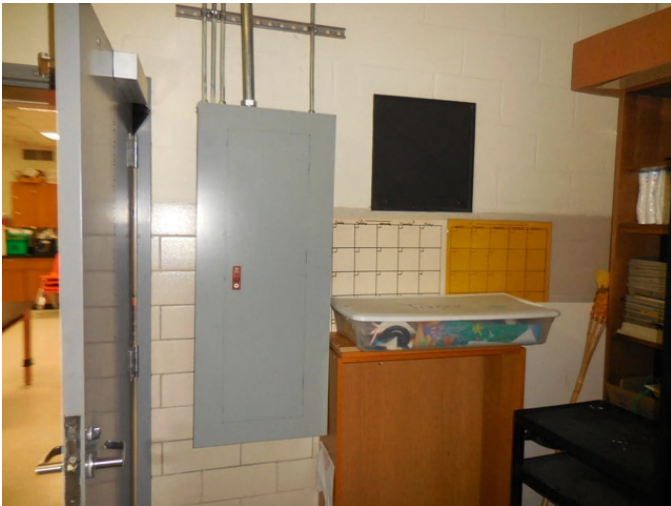
#### System: D5020 - Branch Wiring

**Location:** Room 102, 103, 104, 105, 106, 107, 208, 210

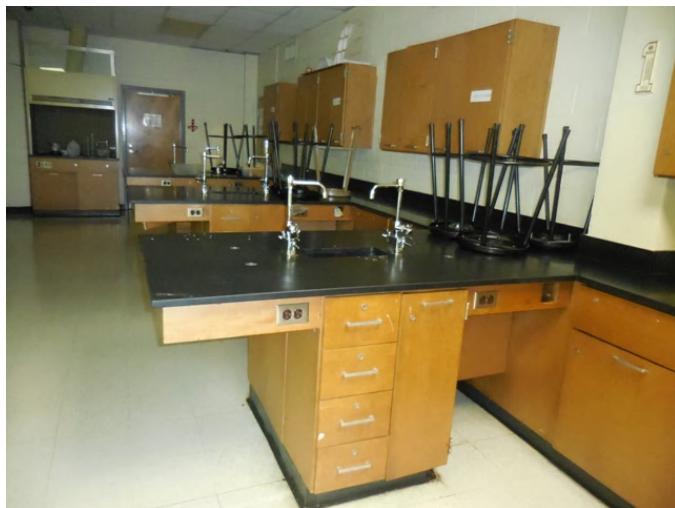
**System: D5020 - Branch Wiring**

**Location:** Room 102, 104, 105, 106, 107, 210

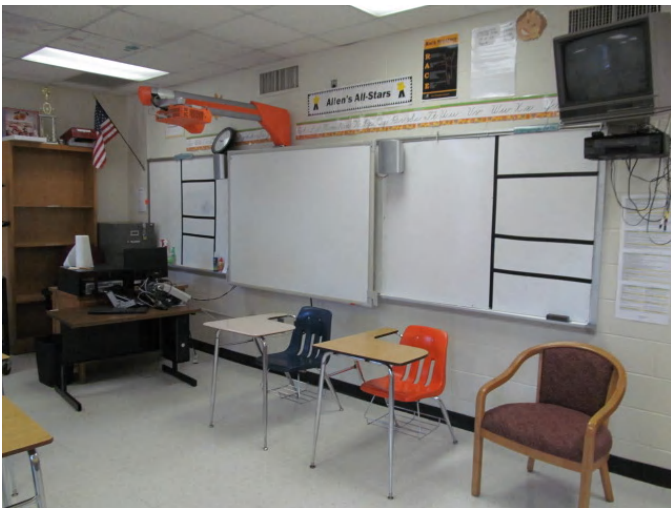
**System: C3010 - Wall Finishes - Paint**

**Location:** Throughout Building

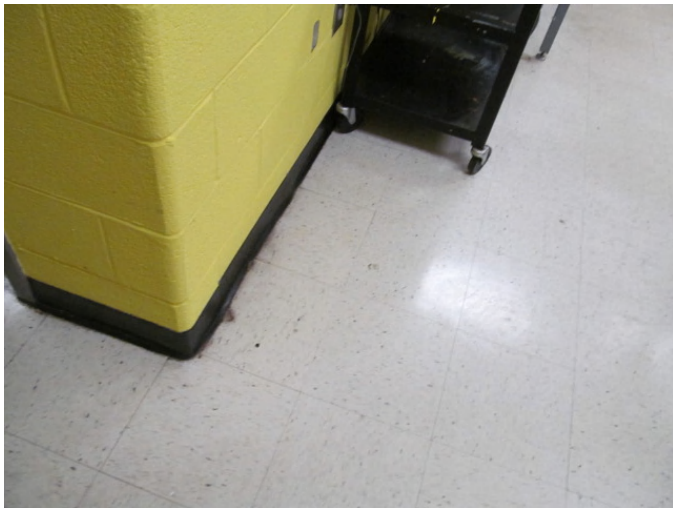
**System: C3020 - Floor Finishes - VCT**

**Location:** Throughout Building

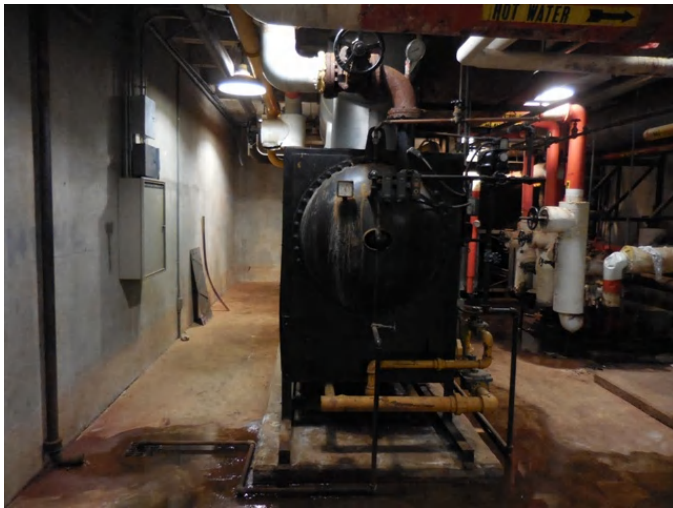
**System: D3020 - Heat Generating Systems**

**Location:** Boiler Room  
**Distress:** Beyond Service Life  
**Category:** Deferred Maintenance  
**Priority:** 3 Priority  
**Correction:** Renew System  
**Qty:** 46,444.00  
**Unit of Measure:** S.F.  
**Estimate:** \$232,452.00  
**Assessor Name:** Eduardo Lopez  
**Date Created:** 09/29/2015

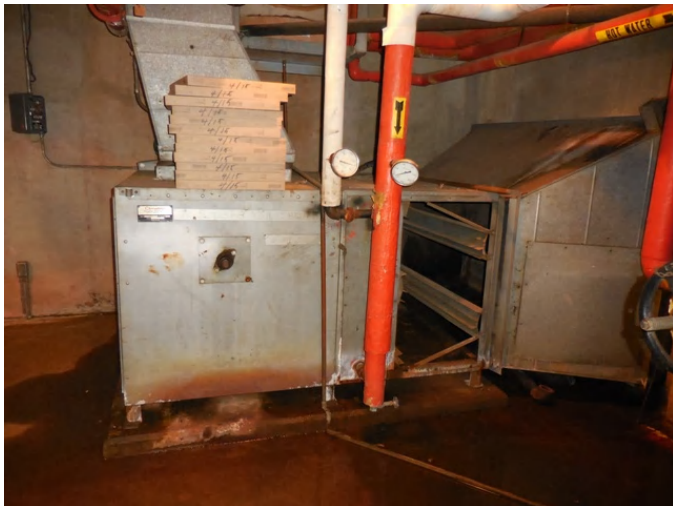
**System: D3040 - Distribution Systems & Exhaust Systems**

**Location:** Throughout Building  
**Distress:** Beyond Service Life  
**Category:** Deferred Maintenance  
**Priority:** 3 Priority  
**Correction:** Renew System  
**Qty:** 46,444.00  
**Unit of Measure:** S.F.  
**Estimate:** \$281,497.00  
**Assessor Name:** Eduardo Lopez  
**Date Created:** 09/29/2015

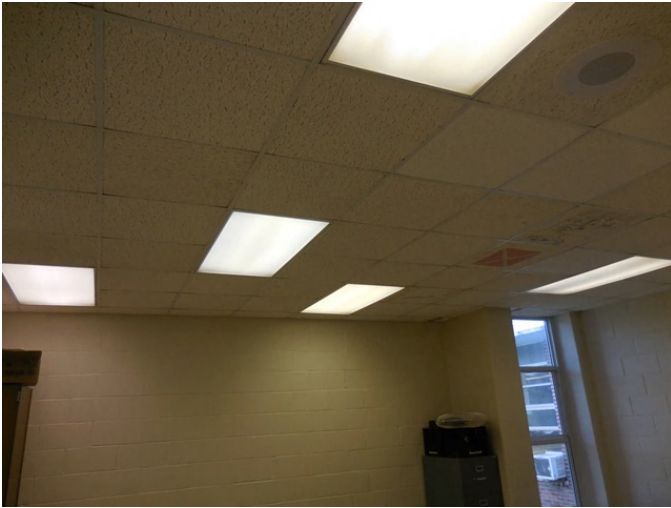
**System: D5020 - Lighting**

**Location:** Throughout Building

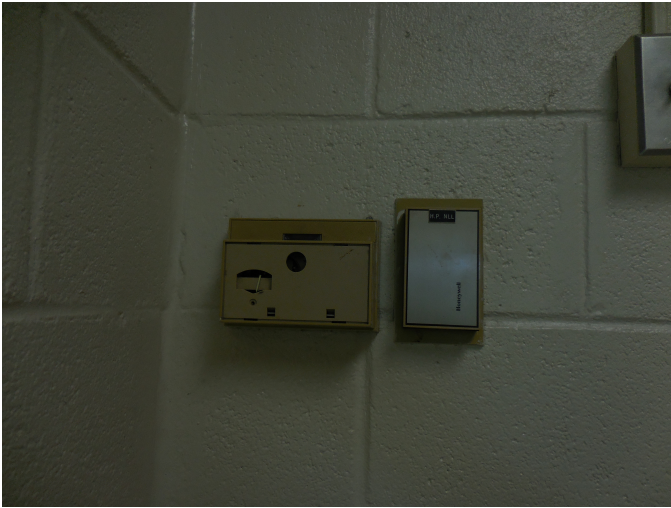
**System: D3060 - Controls & Instrumentation**

**Location:** Throughout Building

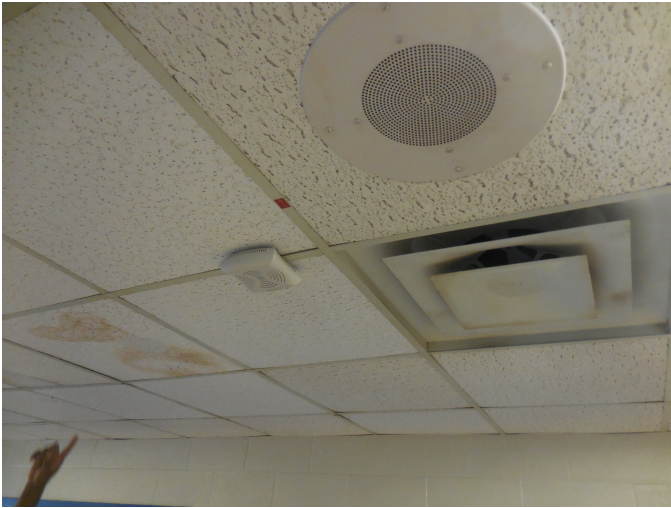
**System: D5030 - Communications and Security - PA & Clock Systems**

**Location:** Office/Throughout Building

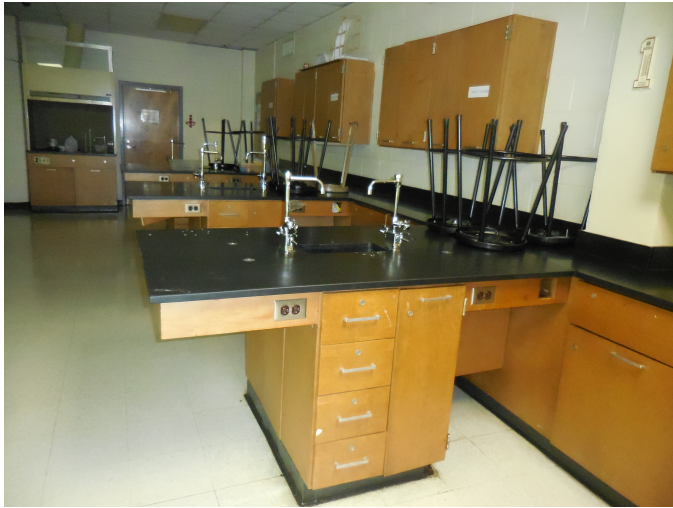
**System: E1020 - Institutional Equipment - Lab**

**Location:** Throughout Building

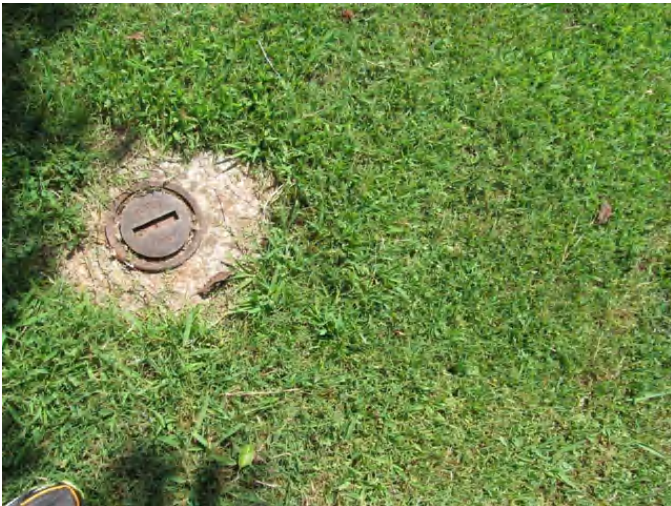
#### System: G3020 - Sanitary Sewer

**Location:** Site

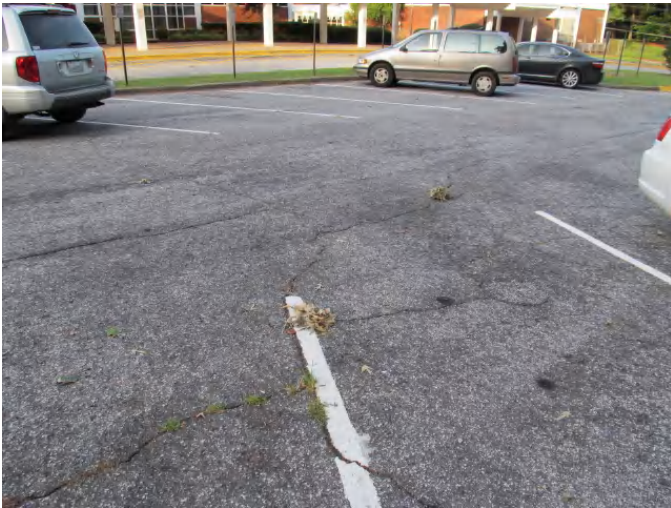
**System: G2020 - Parking Lots**

**Location:** Site

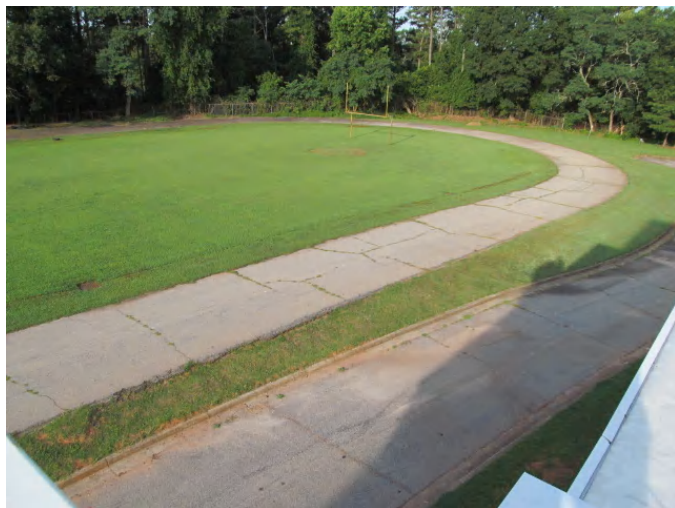
**System: G2040 - Football Field**

**Location:** Football Field

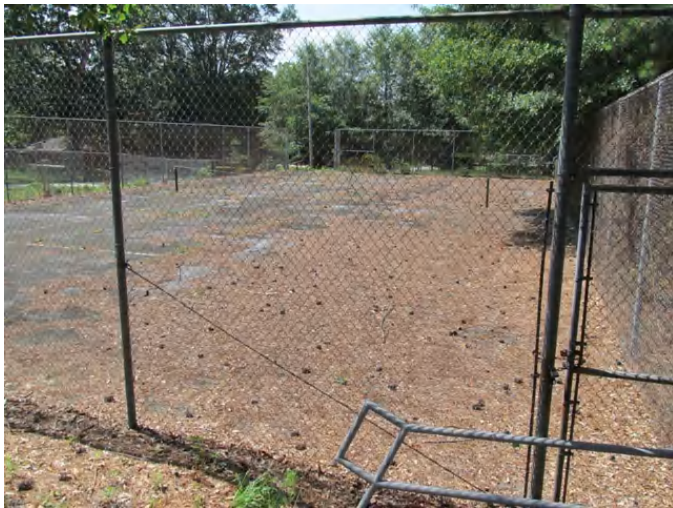
**System: G2040 - Tennis Courts**

**Location:** Site

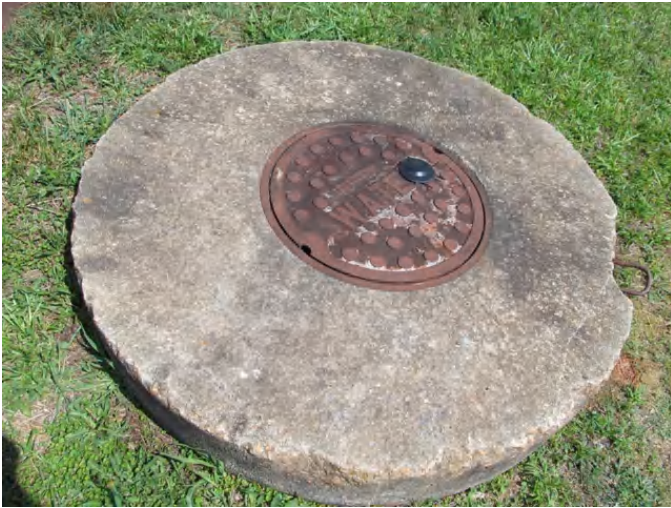
**System: G3010 - Water Supply**

**Location:** Site
