DeKalb County School District/Elementary Schools

Chapel Hill Elementary

School Assessment Report
May 19, 2016

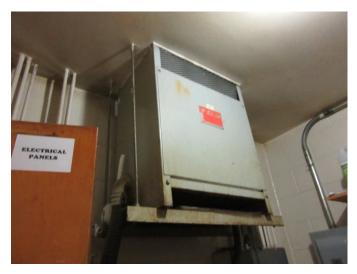
System: D5010 - Electrical Service/Distribution

Location: Main Switch Room/Throughout Building

Distress: Beyond Service Life

Notes: The electrical service/distribution system is beyond its expected service life and should be scheduled for replacement. School staff reports that a service sink floods near a transformer in an electrical closet between the girls restroom and kitchen area. This condition is hazardous and should be resolved immediately.

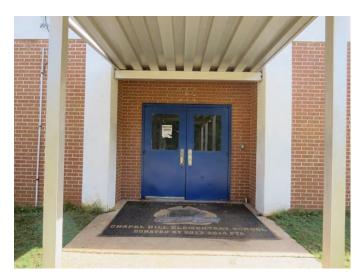
System: B2030 - Exterior Doors

Location: Throughout Building

Distress: Beyond Service Life

Notes: The original exterior doors are deteriorating due to age, weather and use, do not close properly, and should be replaced. An ADA accessible entrance door and hardware was provided under SPLOST project 421-305.

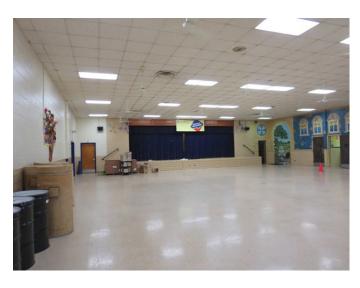
System: D5030 - Communications and Security - Security & CCTV

Location: Throughout Building

Distress: Beyond Service Life

Notes: The security and CCTV system is nearing the end of its expected service life, inadequate, and should be replaced and expanded to provide full coverage.

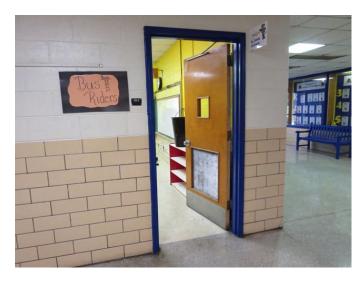
System: C1020 - Interior Doors

Location: Throughout Building

Distress: Beyond Service Life

Notes: The interior doors are aged, failing, not ADA or building code compliant, and should be replaced. School staff reports that cafeteria doors are unsafe, hard to open/close in case of emergencies.

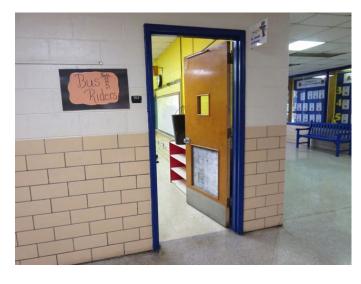
System: C3010 - Wall Finishes - Ceramic & Glazed

Location: Throughout Building

Distress: Beyond Service Life

Notes: The wall tiles have some deterioration due to age and use, and should be replaced.

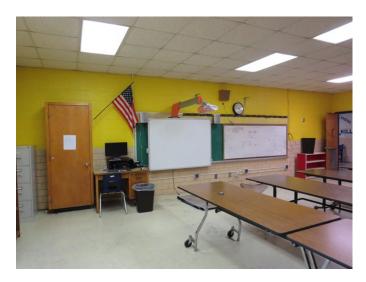
System: C3010 - Wall Finishes - Paint

Location: Throughout Building

Distress: Beyond Service Life

Notes: The painted wall finish has some deterioration due to age and use, and should be replaced.

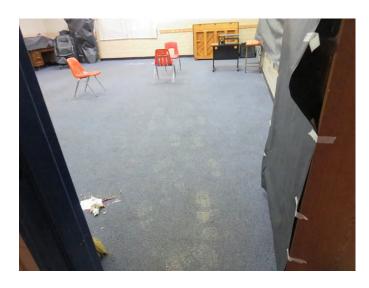
System: C3020 - Floor Finishes - Carpet

Location: Music Room

Distress: Beyond Service Life

Notes: The carpet in the music room is stained, showing signs of failure, and should be replaced.

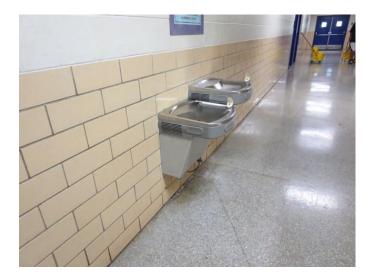
System: D2010 - Plumbing Fixtures

Location: Hallway

Distress: Inadequate

Notes: Water fountains protrude into the hallway more than four inches. Protrusion is not ADA compliant if more than four inches.

Correction: Remove/replace drinking fountain w/recessed

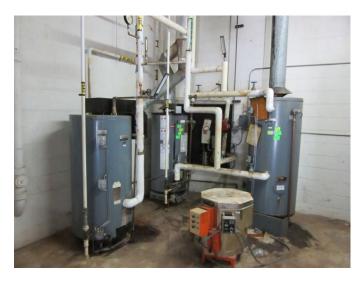
System: D2020 - Domestic Water Distribution

Location: Throughout Building

Distress: Beyond Service Life

Notes: The domestic water distribution system is beyond its expected service life, has water quality issues, and should be scheduled for replacement. School staff reports that there is no hot water in restrooms.

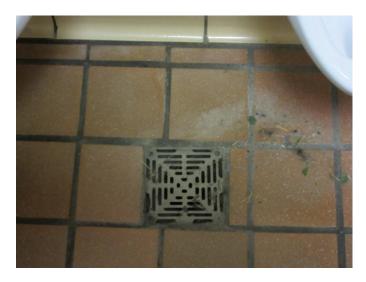
System: D2030 - Sanitary Waste

Location: Throughout Building

Distress: Beyond Service Life

Notes: The sanitary waste system is beyond its expected service life and should be scheduled for replacement. School staff reports odors from restroom drains.

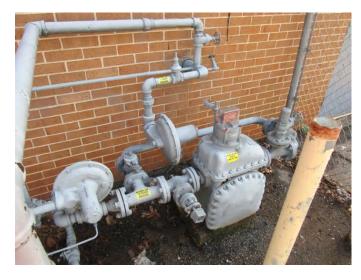
System: D2090 - Other Plumbing Systems - Natural Gas

Location: West Side of Building

Distress: Beyond Service Life

Notes: The natural gas system is beyond its expected service life and should be scheduled for replacement.

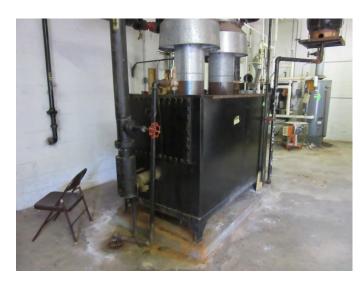
System: D3020 - Heat Generating Systems

Location: Mechanical Room

Distress: Beyond Service Life

Notes: The boiler is beyond its expected service life, inadequate, and should be scheduled for replacement.

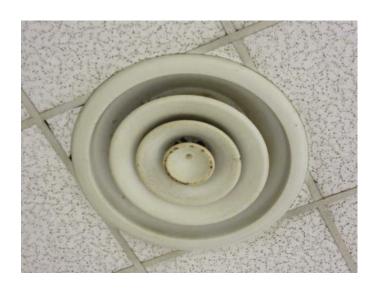
System: D3040 - Distribution & Exhaust Systems

Location: Throughout Building

Distress: Beyond Service Life

Notes: The distribution and exhaust systems are beyond their expected service life, failing or non-functional, and should be scheduled for replacement. Room exhaust modification scheduled under SPLOST project 307-422.

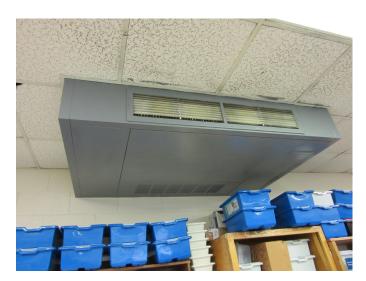
System: D3050 - Terminal & Package Units

Location: Throughout Building

Distress: Beyond Service Life

Notes: The terminal and package units are beyond their expected service life, noisy/disruptive, and failing throughout the facility, and should be replaced. SPLOST project 307-422 to replace existing gas fired HVAC rooftop unit.

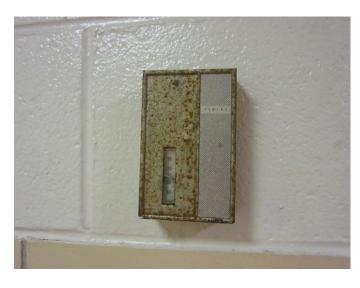
System: D3060 - Controls & Instrumentation

Location: Throughout Building

Distress: Beyond Service Life

Notes: The controls and instrumentation system is beyond its expected service life, inadequate, and should be scheduled for replacement.

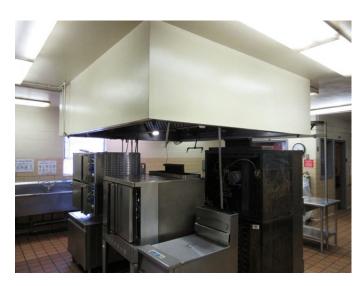
System: D3090 - Other HVAC Systems/Equip - Kitchen Hood

Location: Kitchen

Distress: Beyond Service Life

Notes: The kitchen hood system is beyond its expected service life and should be scheduled for replacement.

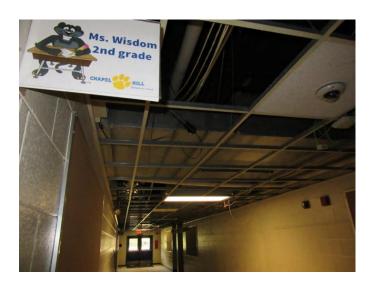
System: D5020 - Branch Wiring

Location: Throughout Building

Distress: Beyond Service Life

Notes: The branch wiring system is beyond its expected service life, inadequate, and should be scheduled for replacement. SPLOST project 307-422 to add GFCI receptacles.

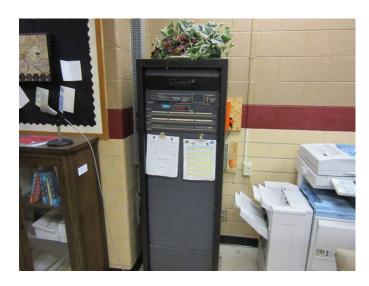
System: D5030 - Communications and Security - Clock & PA Systems

Location: Throughout Building

Distress: Beyond Service Life

Notes: Clock and PA systems are beyond their expected service life, do not always work, and should be scheduled for replacement. School staff reports that sound system in cafeteria needs to be updated.

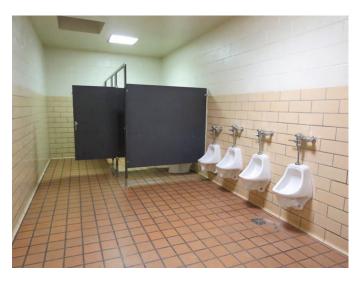
System: D5030 - Communications and Security - Fire Alarm

Location: Throughout Building

Distress: Beyond Service Life

Notes: The fire alarm system is nearing the end of its expected service life, not building code compliant, and should be replaced. Visible alarms (strobes) are missing in the restrooms.

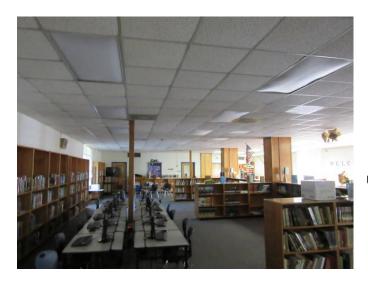
System: E1020 - Institutional Equipment

Location: Throughout Building

Distress: Beyond Service Life

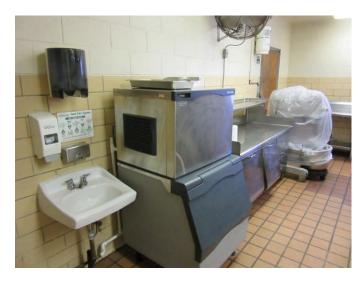
System: E1090 - Other Equipment - Kitchen Equipment

Location: Kitchen

Distress: Beyond Service Life

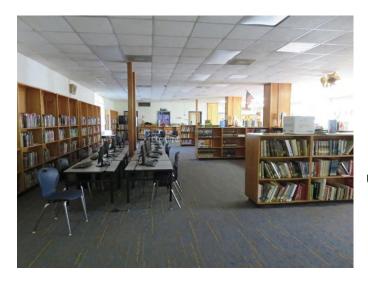
System: E2010 - Fixed Furnishings

Location: Throughout Building

Distress: Beyond Service Life

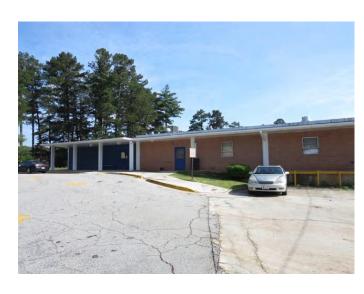
System: F1010 - Special Structures - Canopies

Location: Exterior Walls

Distress: Beyond Service Life

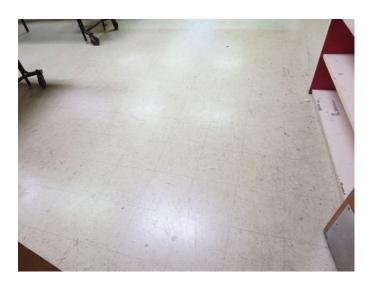
System: C3020 - Floor Finishes - VCT

Location: Most Classrooms

Distress: Beyond Service Life

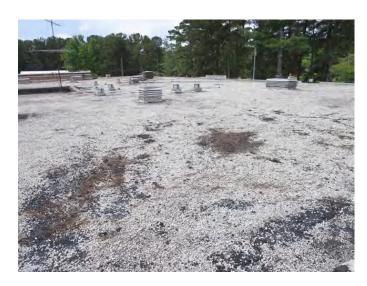
System: B3010 - Roof Coverings - BUR

Location: Roof

Distress: Beyond Service Life

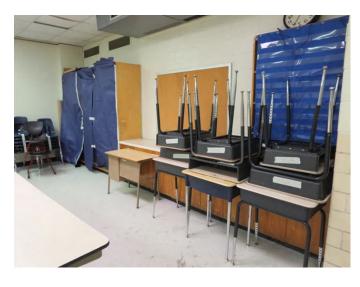
System: C1030 - Fittings

Location: Throughout Building

Distress: Beyond Service Life

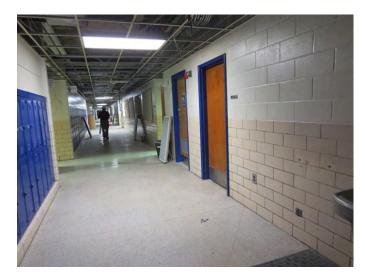
System: C3010 - Wall Finishes - Paint

Location: Throughout Building

Distress: Beyond Service Life

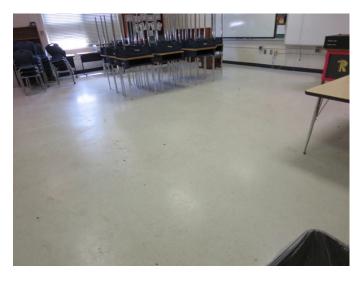
System: C3020 - Floor Finishes - VCT

Location: Throughout Building

Distress: Beyond Service Life

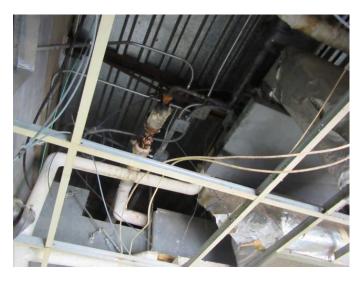
System: D3050 - Terminal & Package Units

Location: Throughout Building

Distress: Beyond Service Life

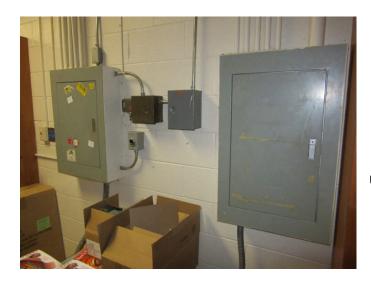
System: D3060 - Controls & Instrumentation

Location: Throughout Building

Distress: Beyond Service Life

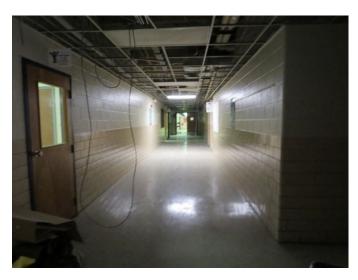
System: D5030 - Communications and Security - Clock & PA Systems

Location: Throughout Building

Distress: Beyond Service Life

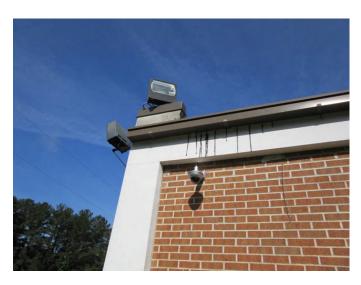
System: D5030 - Communications and Security - Security & CCTV

Location: Throughout Building

Distress: Beyond Service Life

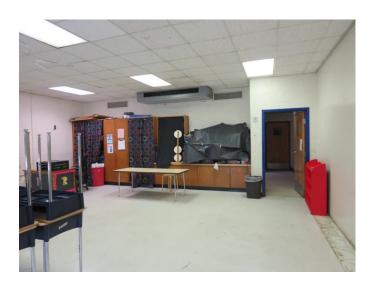
System: E2010 - Fixed Furnishings

Location: Throughout Building

Distress: Beyond Service Life

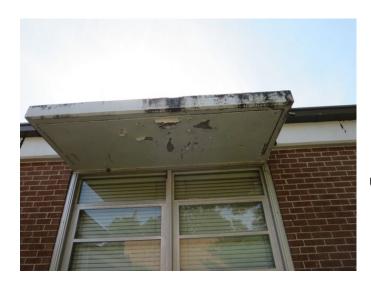
System: F1010 - Special Structures - Canopies

Location: Exterior Walls

Distress: Beyond Service Life

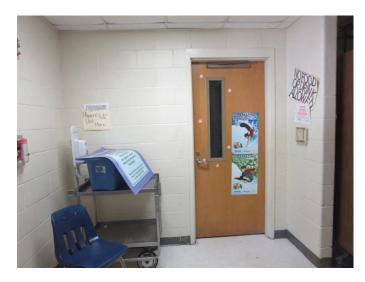
System: C3010 - Wall Finishes - Paint

Location: Throughout Building

Distress: Beyond Service Life

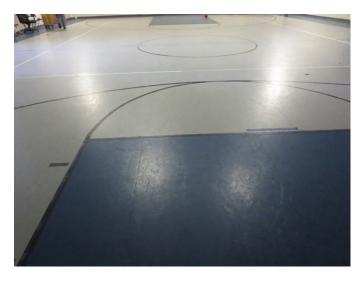
System: C3020 - Floor Finishes - Neoprene

Location: Gym

Distress: Beyond Service Life

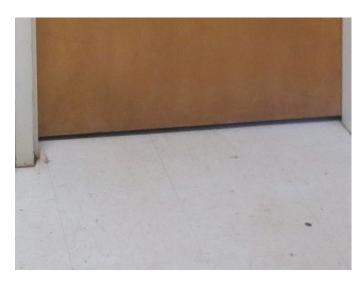
System: C3020 - Floor Finishes - VCT

Location: Entrance Area and Offices

Distress: Beyond Service Life

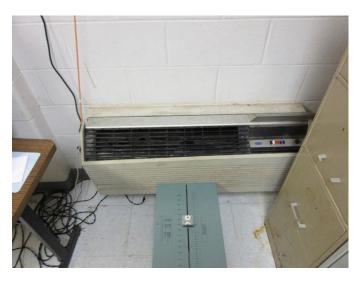
System: D3050 - Terminal & Package Units

Location: Throughout Building

Distress: Inadequate

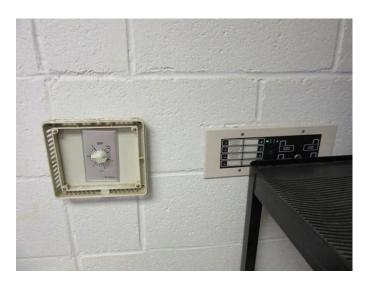
System: D5030 - Communications and Security - Fire Alarm

Location: Throughout Building

Distress: Beyond Service Life

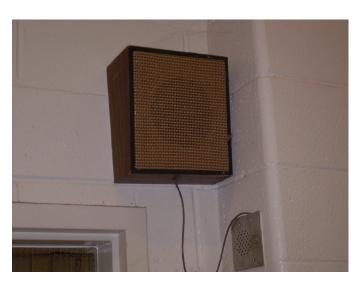
System: D5030 - Communications and Security - Public Address & Clock System

Location: Throughout Building

Distress: Beyond Service Life

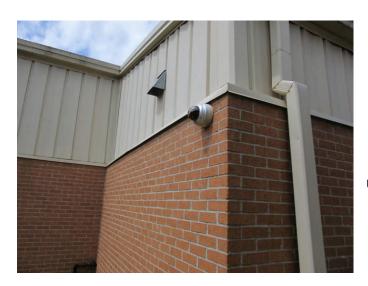
System: D5030 - Communications and Security - Security & CCTV

Location: Throughout Building

Distress: Beyond Service Life

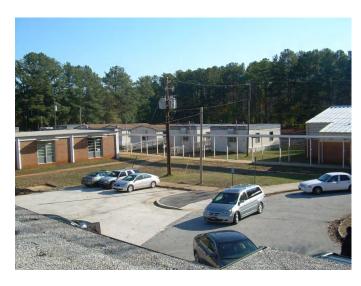
System: G4030 - Site Communications & Security

Location: Site

Distress: Beyond Service Life

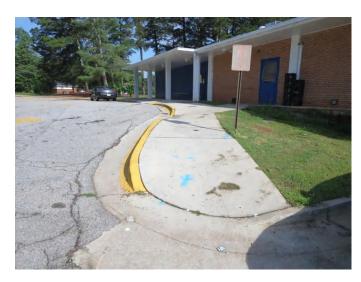
System: G2030 - Pedestrian Paving

Location: Site

Distress: Beyond Service Life

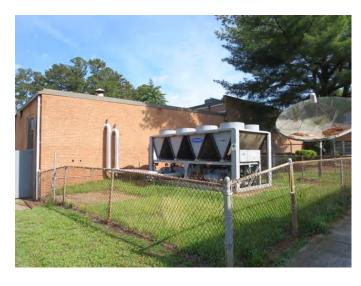
System: G2040 - Fencing & Guardrails

Location: Site

Distress: Beyond Service Life

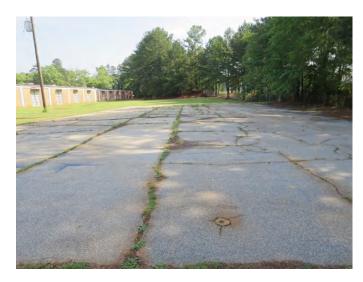
System: G2040 - Hard Surface Play Area

Location: Site

Distress: Beyond Service Life

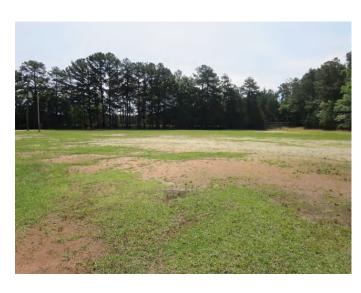
System: G2040 - Playing Field

Location: Site

Distress: Beyond Service Life

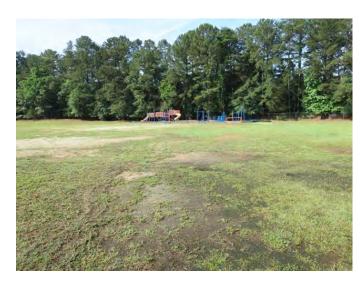
System: G2050 - Landscaping

Location: Site

Distress: Beyond Service Life

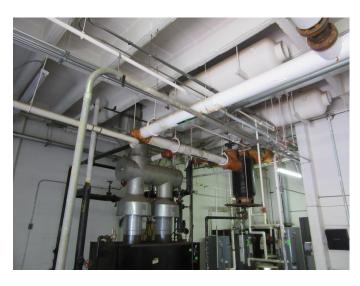
System: G3060 - Fuel Distribution

Location: Site

Distress: Beyond Service Life

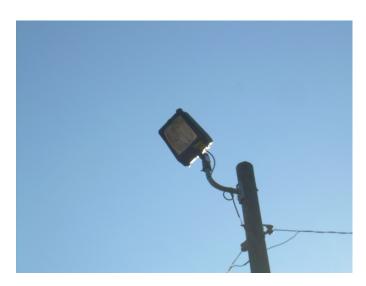
System: G4020 - Site Lighting

Location: Site

Distress: Beyond Service Life
