DeKalb County School District/Elementary Schools

Chesnut Elementary

School Assessment Report

May 19, 2016

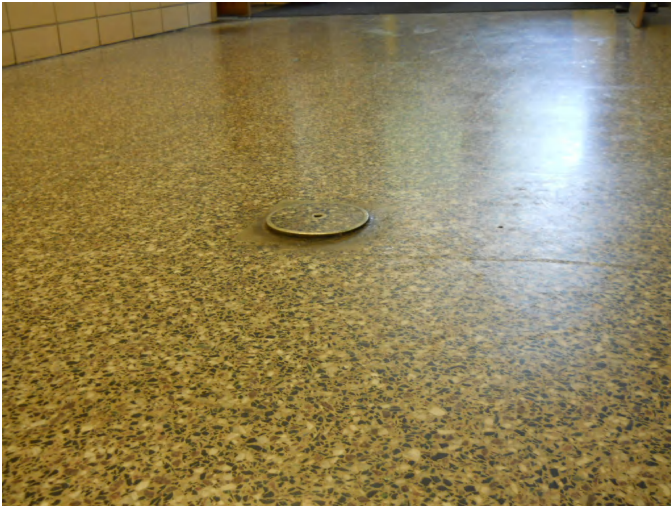
System: D2030 - Sanitary Waste

Location: Hallway, Room 120

Distress: Needs Remediation

Notes: The clean out access in the hallway is a trip/fall hazard for students and staff. Remove the cleanout cap, cut the pipe to slab level, and reinstall the cap.

Correction: Clean Out, Repair

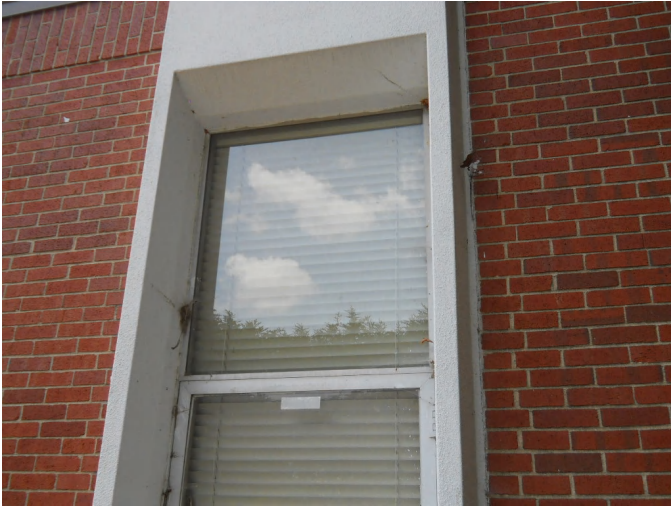
System: B2020 - Exterior Windows

Location: Throughout Building

Distress: Beyond Service Life

Notes: The exterior windows are original construction, beyond their expected service life, and should be replaced.

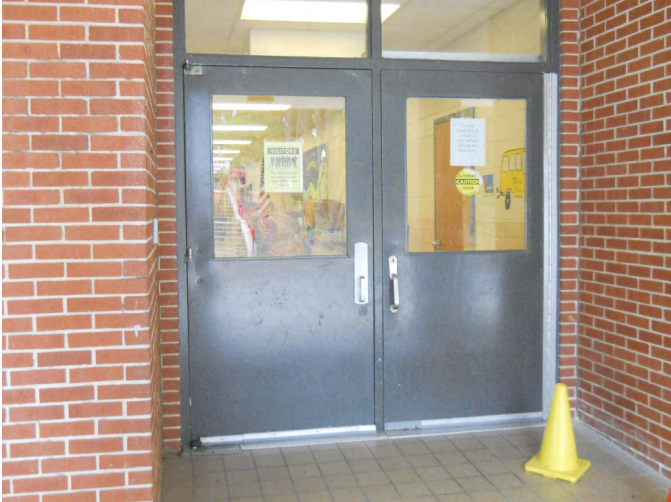
System: B2030 - Exterior Doors

Location: Throughout Building

Distress: Beyond Service Life

Notes: The exterior doors are beyond their expected service life and should be replaced.

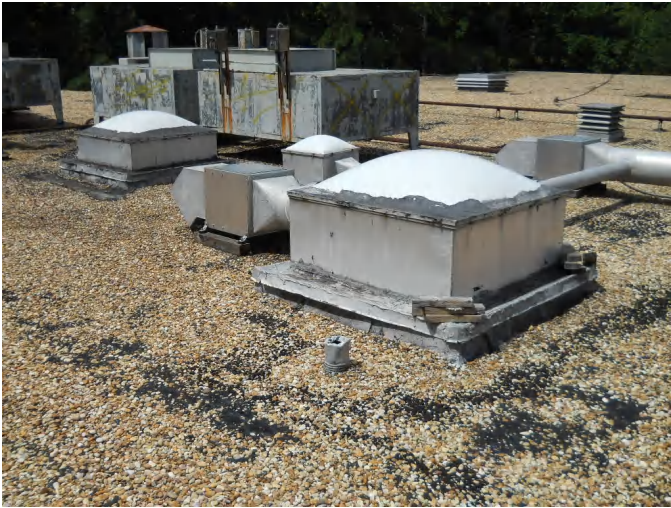
System: B3010 - Roof Coverings - BUR

Location: Roof

Distress: Beyond Service Life

Notes: The roof is worn, leaking, beyond its expected service life, and should be replaced. SPLOST project 405-422 to replace the roof on the 1969 building.

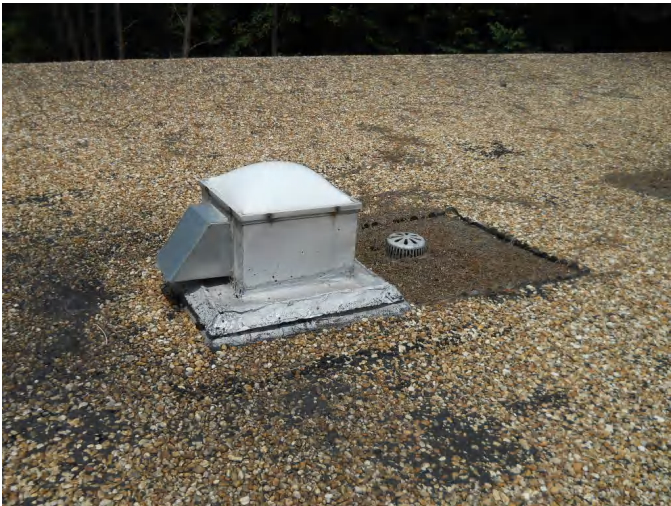
System: B3020 - Roof Openings

Location: Roof

Distress: Beyond Service Life

Notes: The skylights leak during rain storms and there is no safe access to the roof for maintenance personnel. Recommend installation of an OSHA-complaint roof hatch/ladder system and replacement of the skylights. SPLOST project 405-422 to install roof hatch and ladder as appropriate.

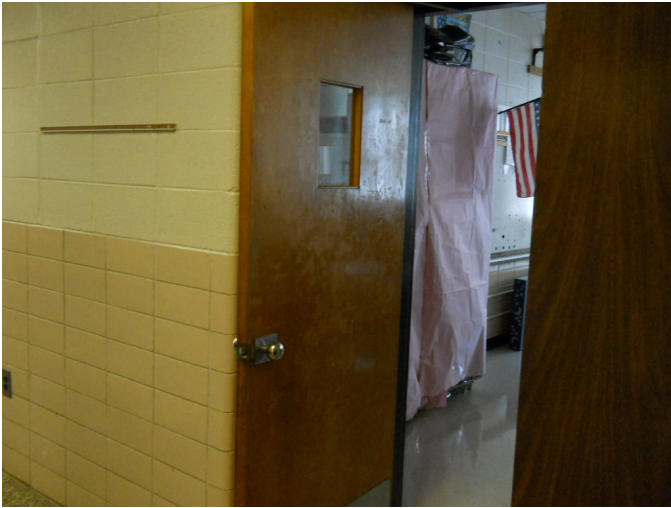
System: C1020 - Interior Doors

Location: Throughout Building

Distress: Beyond Service Life

Notes: The interior doors are original, beyond their expected service life, not ADA compliant, and should be replaced.

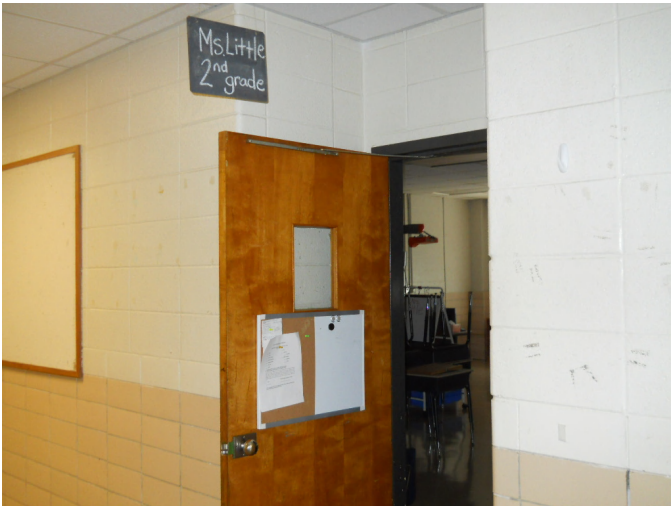
System: C3010 - Wall Finishes - Paint

Location: Throughout Building

Distress: Beyond Service Life

Notes: The painted wall finishes are beyond their expected service life, dirty and worn, and should be replaced.

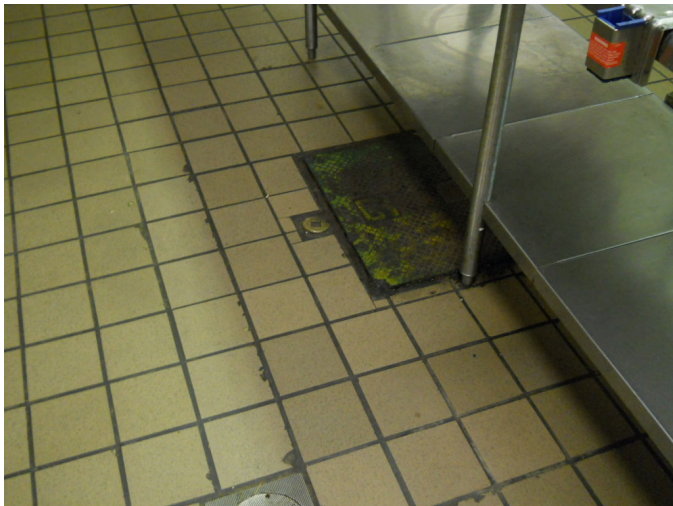
System: C3020 - Floor Finishes - Ceramic & Quarry Tile

Location: Kitchen

Distress: Damaged

Notes: The tile floor covering is damaged and patched, and should be replaced.

Correction: Replace quarry tile floor

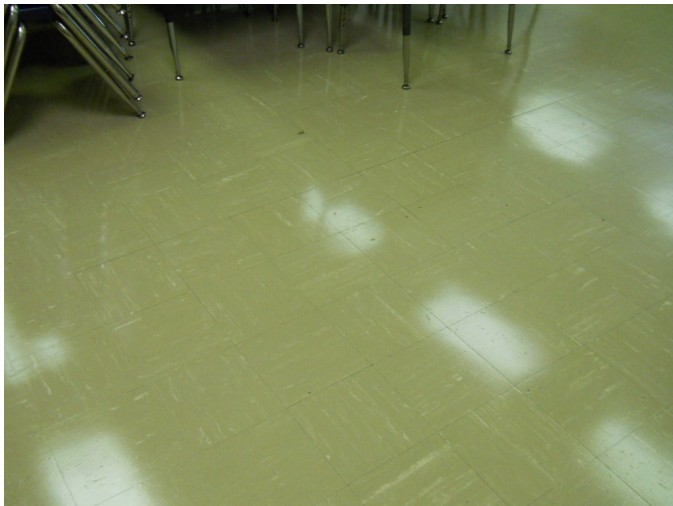
System: C3020 - Floor Finishes - VCT

Location: Throughout building

Distress: Beyond Service Life

Notes: The VCT and VAT flooring is beyond its expected service life and should be replaced.

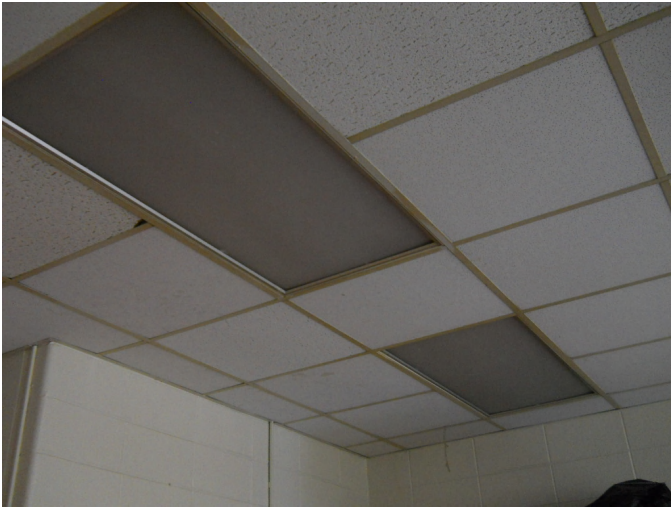
System: C3030 - Ceiling Finishes

Location: Throughout Building

Distress: Beyond Service Life

Notes: The acoustical ceiling system is beyond its expected service life and should be replaced.

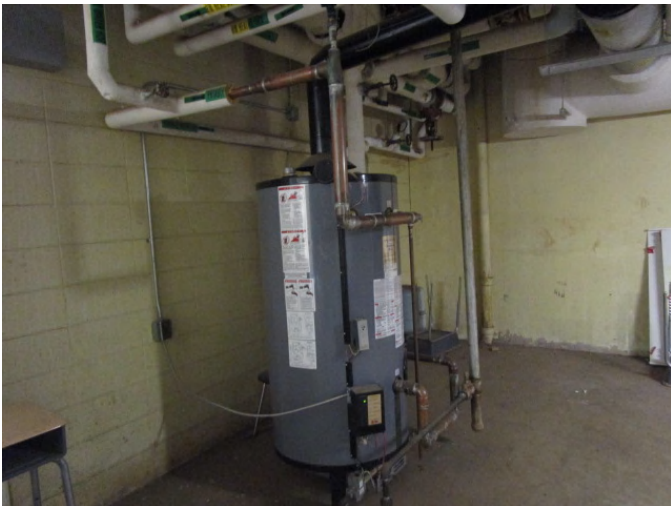
System: D2020 - Domestic Water Distribution

Location: Throughout Building

Distress: Beyond Service Life

Notes: The domestic water distribution system is beyond its expected service life and should be scheduled for replacement. SPLOST project 405-422 to replace the backflow preventer.

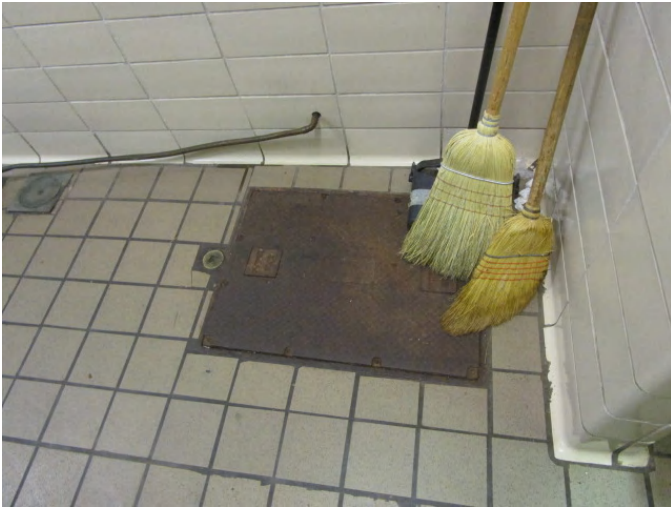
System: D2030 - Sanitary Waste

Location: Throughout Building

Distress: Beyond Service Life

Notes: The sanitary waste system is beyond its expected service life and should be scheduled for replacement.

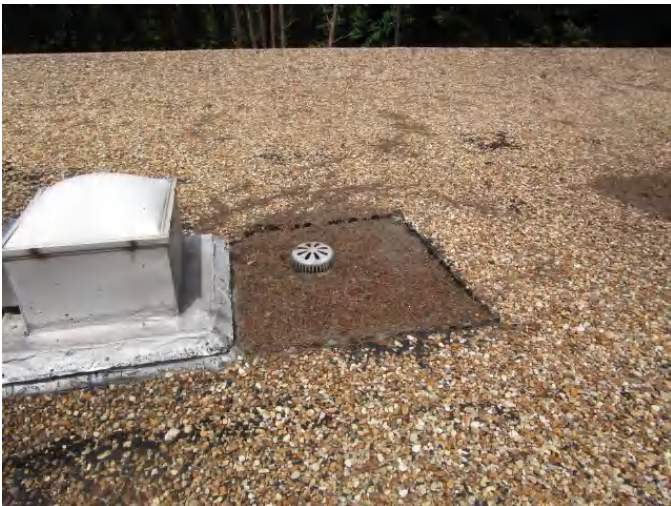
System: D2040 - Rain Water Drainage

Location: Throughout Building

Distress: Beyond Service Life

Notes: The rainwater drainage system is beyond its expected service life and should be scheduled for replacement.

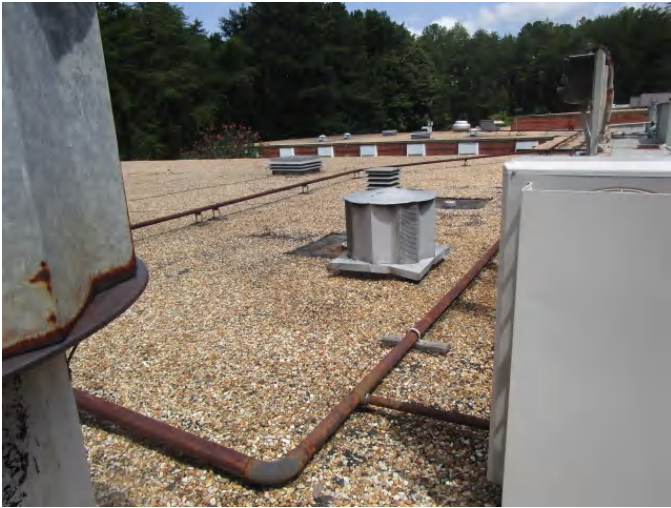
System: D2090 - Other Plumbing Systems - Natural Gas

Location: Throughout Building

Distress: Beyond Service Life

Notes: The natural gas system is beyond its expected service life and should be scheduled for replacement. SPLOST project 405-422 to replace grease trap.

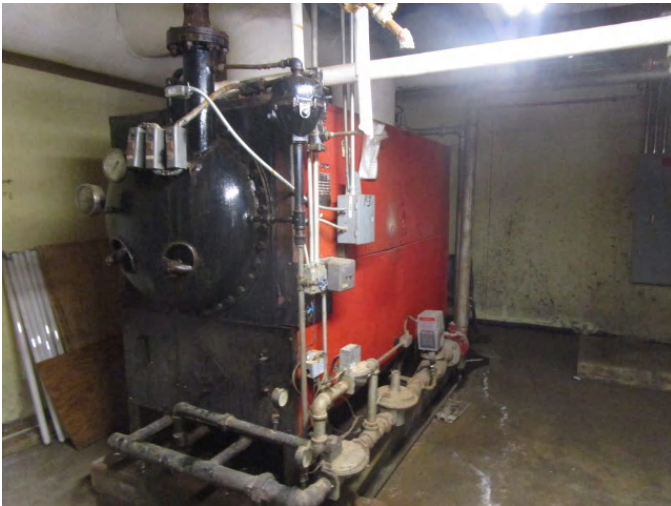
System: D3020 - Heat Generating Systems

Location: Mechanical Room

Distress: Beyond Service Life

Notes: The heat generating system is beyond its expected service life and should be scheduled for replacement.

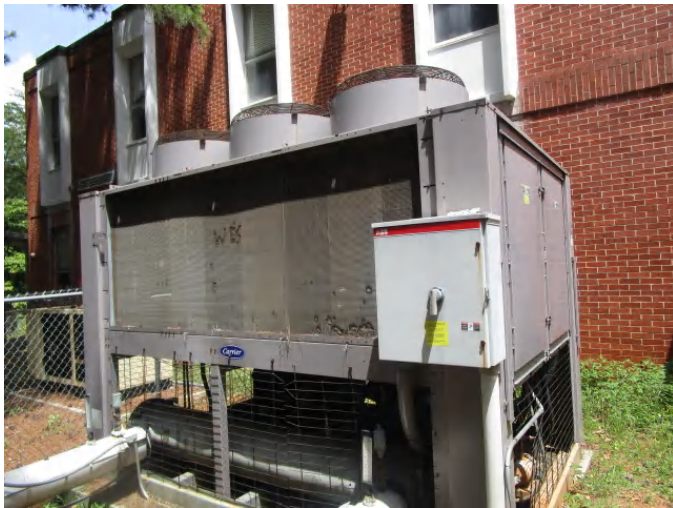
System: D3030 - Cooling Generating Systems

Location: Outside Mechanical Room

Distress: Beyond Service Life

Notes: The cooling generating system is beyond its expected service life and should be scheduled for replacement.

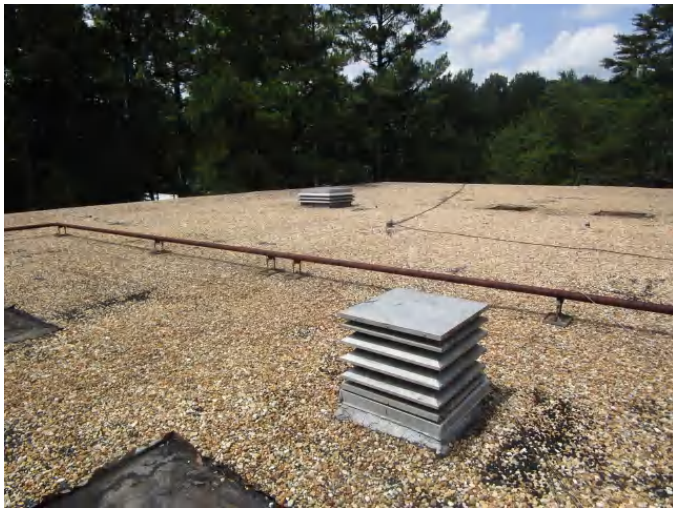
System: D3040 - Distribution & Exhaust Systems

Location: Throughout Building

Distress: Beyond Service Life

Notes: The distribution and exhaust systems are beyond their expected service life and should be scheduled for replacement.

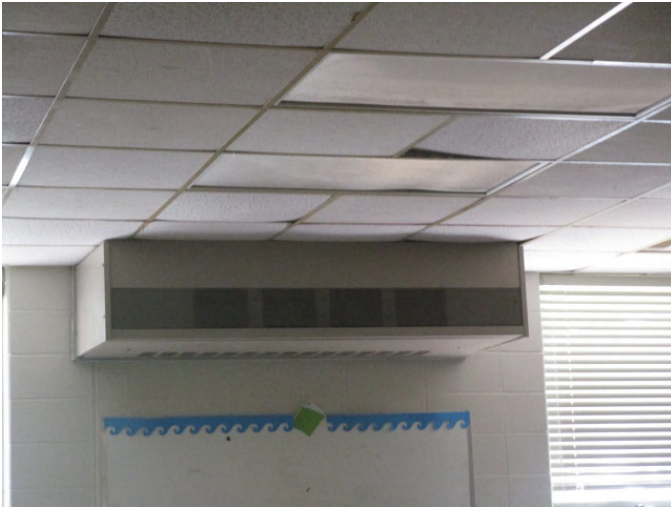
System: D3050 - Terminal & Package Units

Location: Throughout Building

Distress: Beyond Service Life

Notes: The terminal and package units are beyond their expected service life and should be scheduled for replacement.

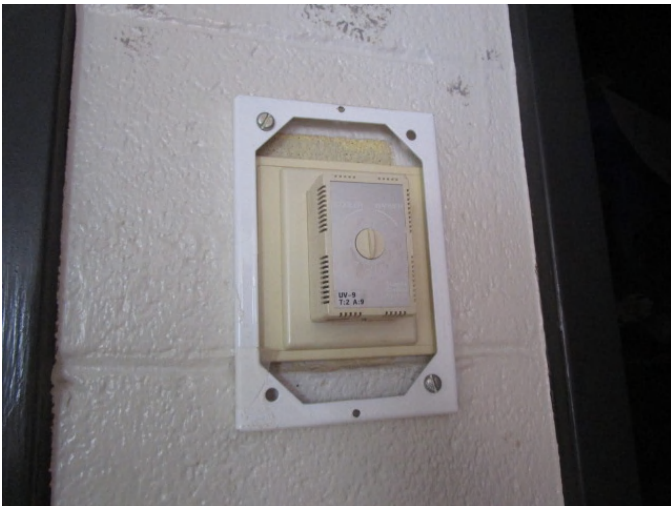
System: D3060 - Controls & Instrumentation

Location: Throughout Building

Distress: Beyond Service Life

Notes: The controls and instrumentation system is beyond its expected service life and should be scheduled for replacement.

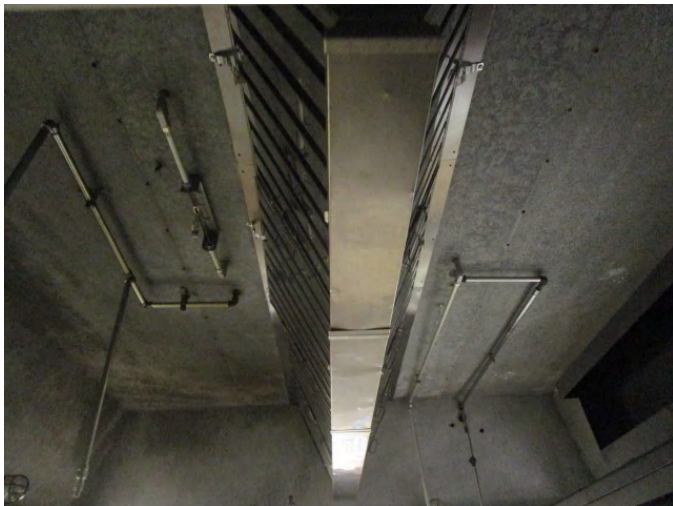
System: D3090 - Other HVAC Systems/Equip - Kitchen Hood

Location: Kitchen

Distress: Beyond Service Life

Notes: The kitchen hood system is beyond its expected service life and should be scheduled for replacement.

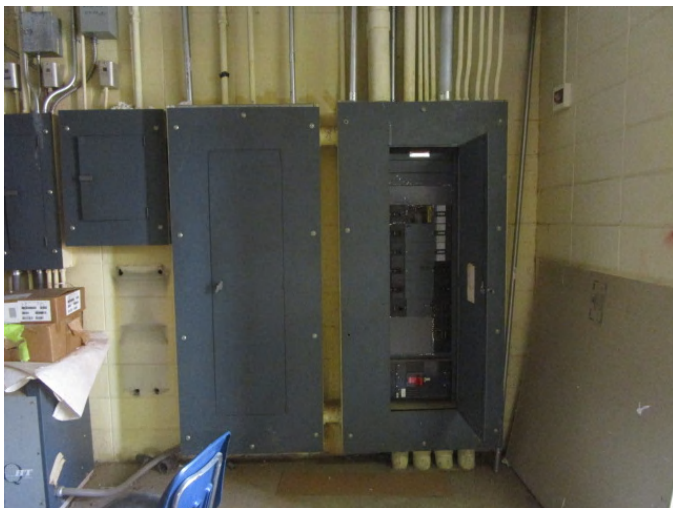
System: D5010 - Electrical Service/Distribution

Location: Main Switch Room/Throughout Building

Distress: Beyond Service Life

Notes: The electrical service/distribution system is beyond its expected service life and should be scheduled for replacement.

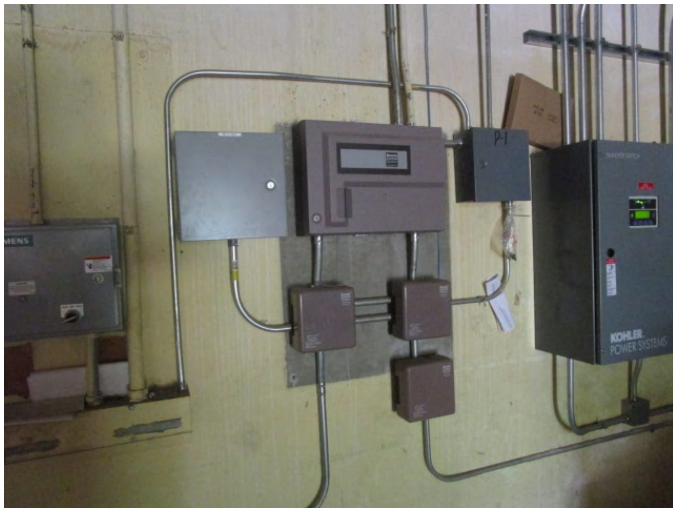
System: D5020 - Branch Wiring

Location: Throughout Building

Distress: Beyond Service Life

Notes: The branch wiring system is beyond its expected service life and should be scheduled for replacement.

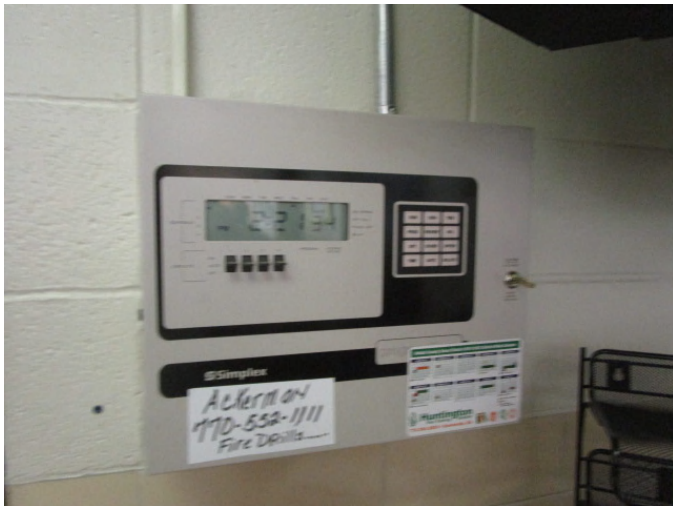
System: D5030 - Communications and Security - Clock & PA Systems

Location: Throughout Building

Distress: Beyond Service Life

Notes: Clock and PA systems are beyond their expected service life and should be scheduled for replacement.

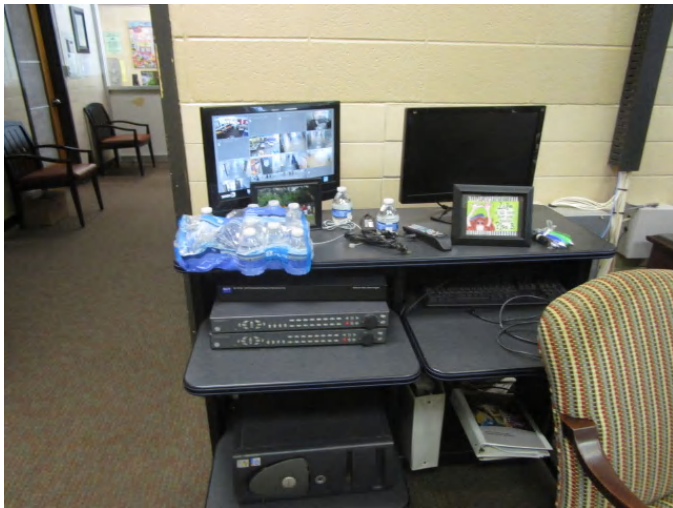
System: D5030 - Communications and Security - Security & CCTV

Location: Throughout Building
Distress: Beyond Service Life
Category: Deferred Maintenance
Priority: 3 Priority
Correction: Renew System
Qty: 46,540.00
Unit of Measure: S.F.
Estimate: \$31,228.00
Assessor Name: Ben Nixon
Date Created: 04/11/2015

Notes: The security and CCTV systems are beyond their expected service life and should be scheduled for replacement.

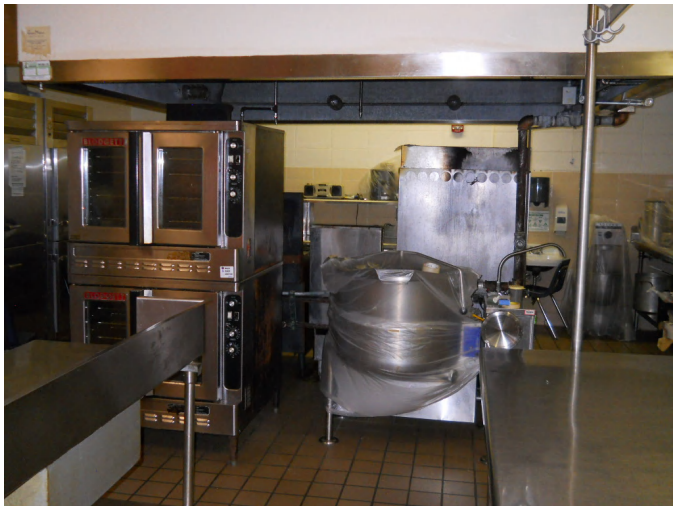
System: E1090 - Other Equipment - Kitchen Equipment

Location: Kitchen
Distress: Beyond Service Life
Category: Deferred Maintenance
Priority: 3 Priority
Correction: Renew System
Qty: 46,540.00
Unit of Measure: S.F.
Estimate: \$497,606.00
Assessor Name: Ben Nixon
Date Created: 04/11/2015

Notes: Kitchen equipment is beyond its expected service life and should be scheduled for replacement.

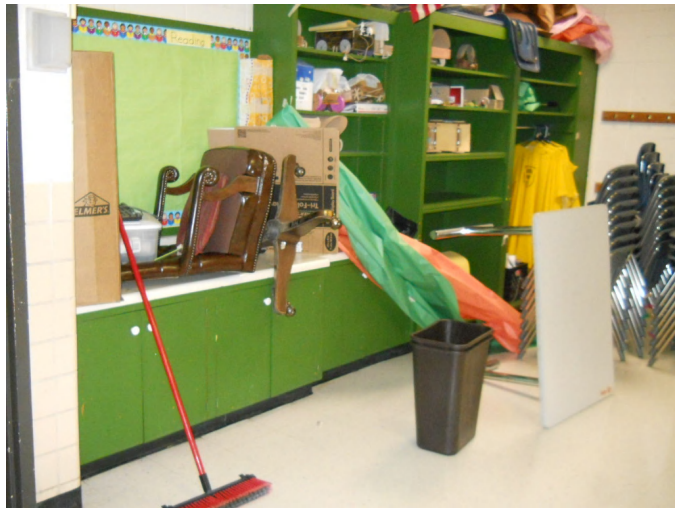
System: E2010 - Fixed Furnishings

Location: Throughout Building

Distress: Beyond Service Life

Notes: Fixed furnishings, such as built-in cabinets, are beyond their expected service life and worn, and should be replaced.

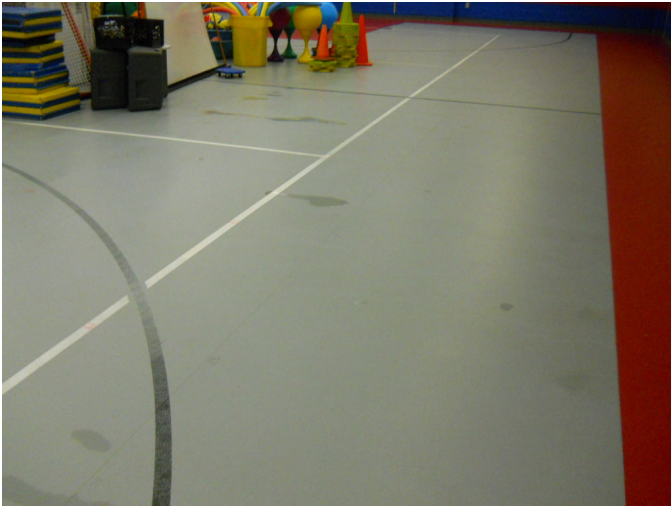
System: C3020 - Floor Finishes - Neoprene

Location: Basketball Court

Distress: Beyond Service Life

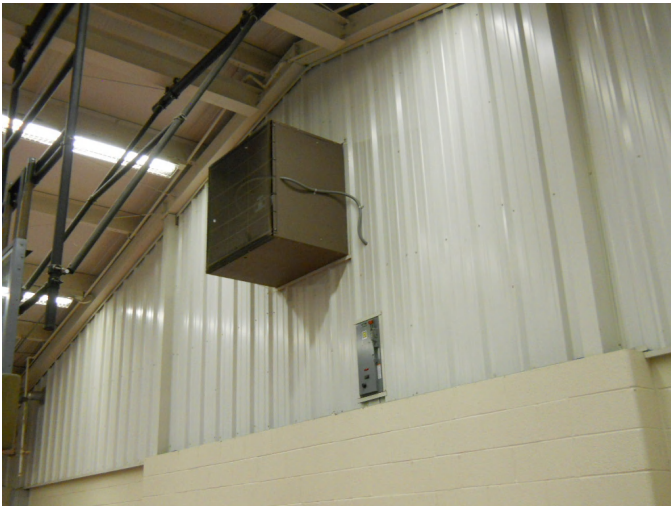
System: D3050 - Terminal & Package Units

Location: Throughout Building

Distress: Inadequate

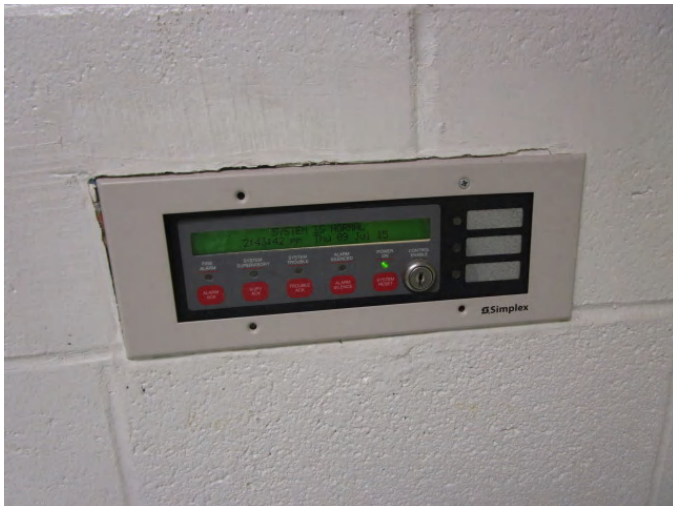
System: D5030 - Communications and Security - Fire Alarm

Location: Throughout Building

Distress: Beyond Service Life

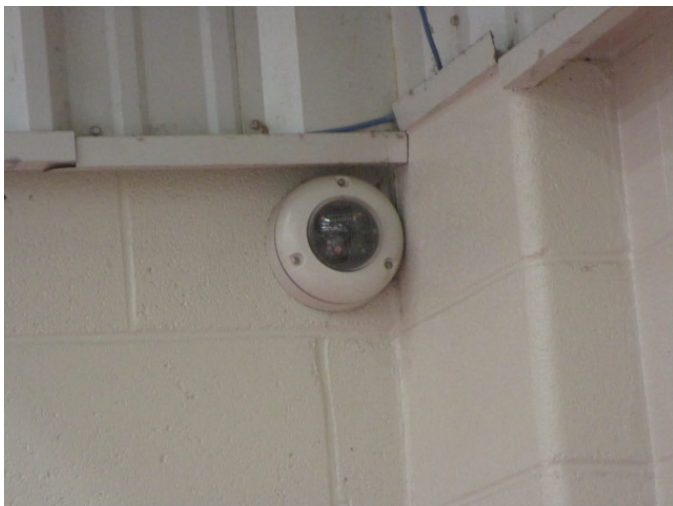
System: D5030 - Communications and Security - Security & CCTV

Location: Throughout Building

Distress: Beyond Service Life

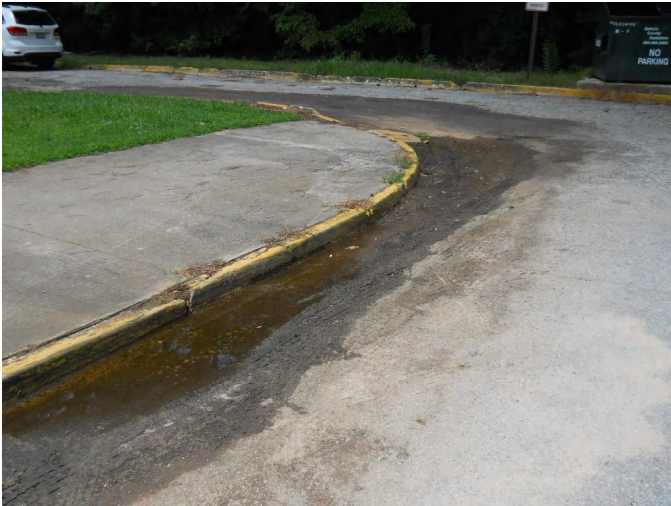
System: G2010 - Roadways

Location: Site

Distress: Beyond Service Life

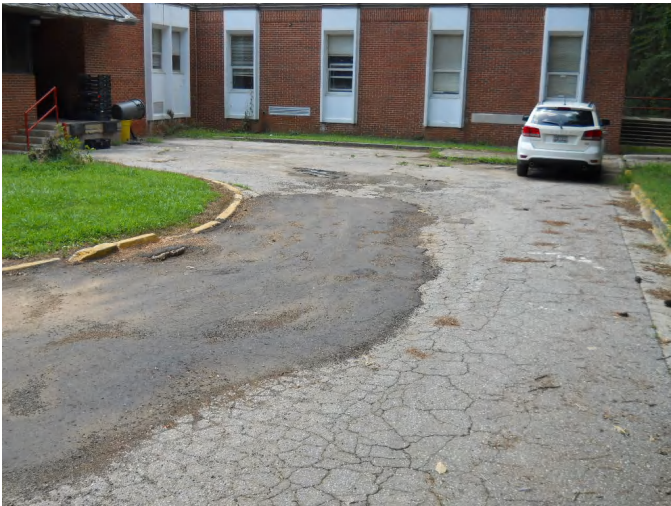
System: G2020 - Parking Lots

Location: Site

Distress: Beyond Service Life

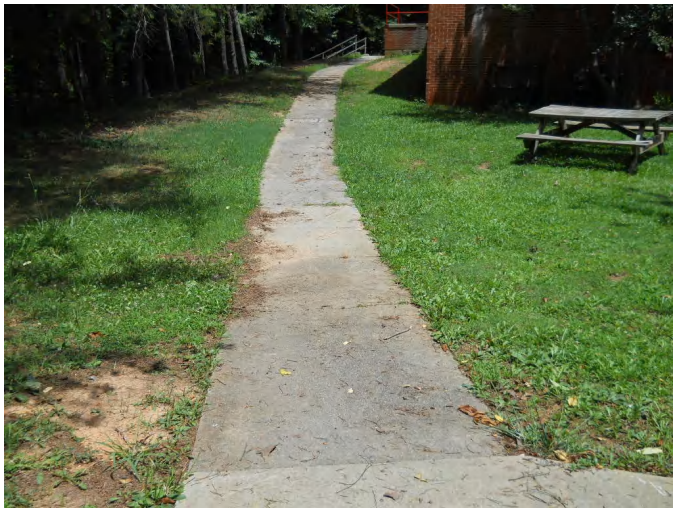
System: G2030 - Pedestrian Paving

Location: Site

Distress: Beyond Service Life

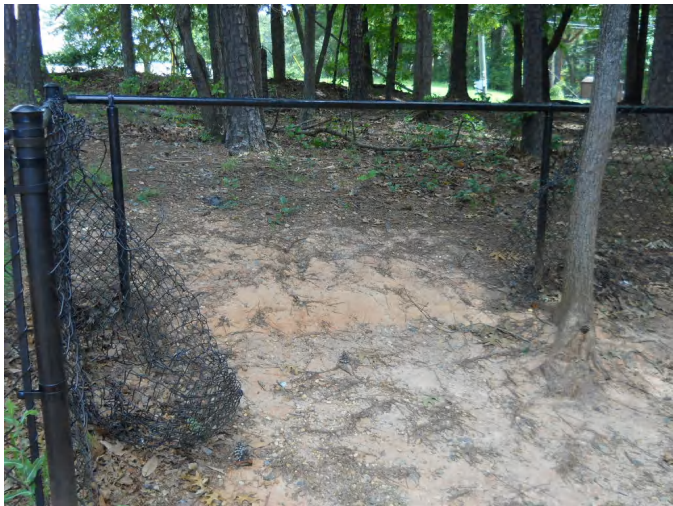
System: G2040 - Fencing & Guardrails

Location: Multiple Locations on Site

Distress: Damaged

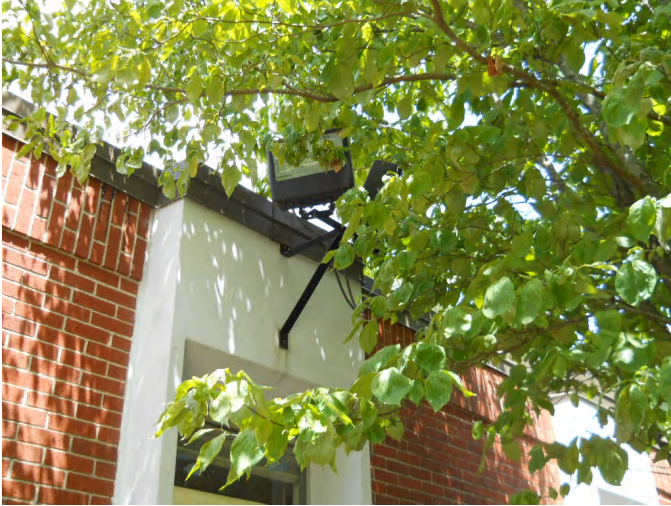
System: G2050 - Landscaping

Location: Site

Distress: Beyond Service Life

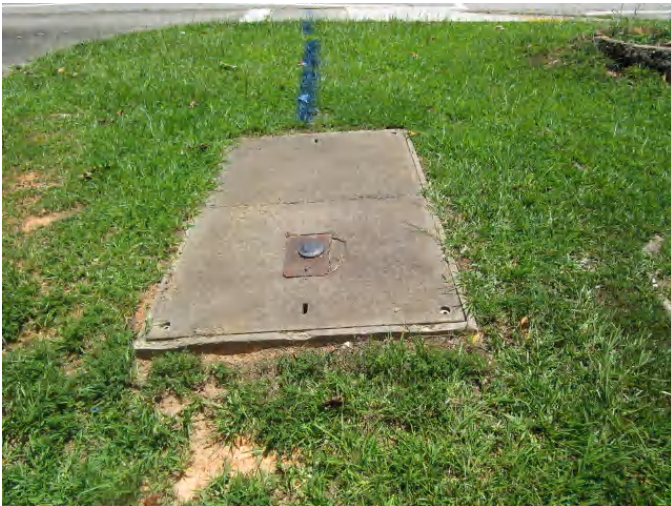
System: G3010 - Water Supply

Location: Site

Distress: Needs Remediation

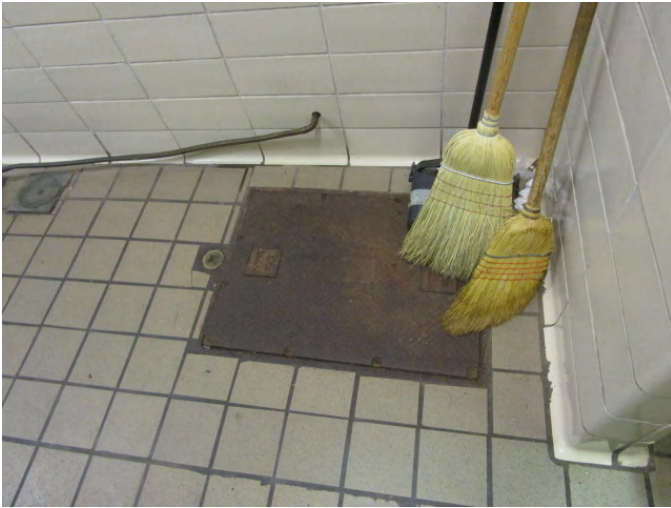
System: G3020 - Sanitary Sewer

Location: Site

Distress: Needs Remediation

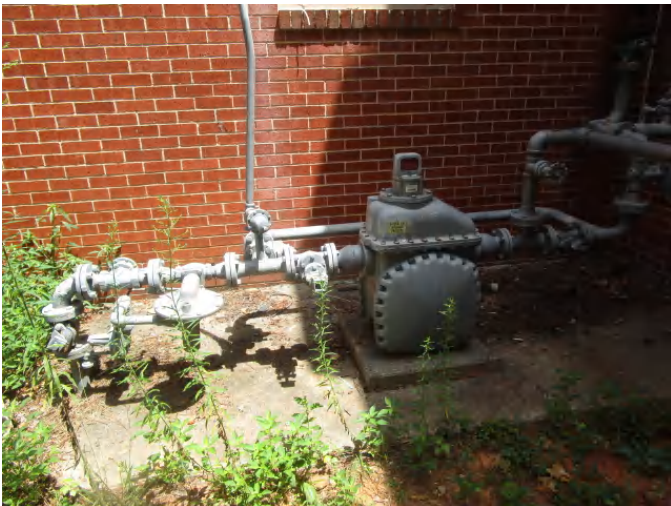
System: G3060 - Fuel Distribution

Location: Site

Distress: Beyond Service Life

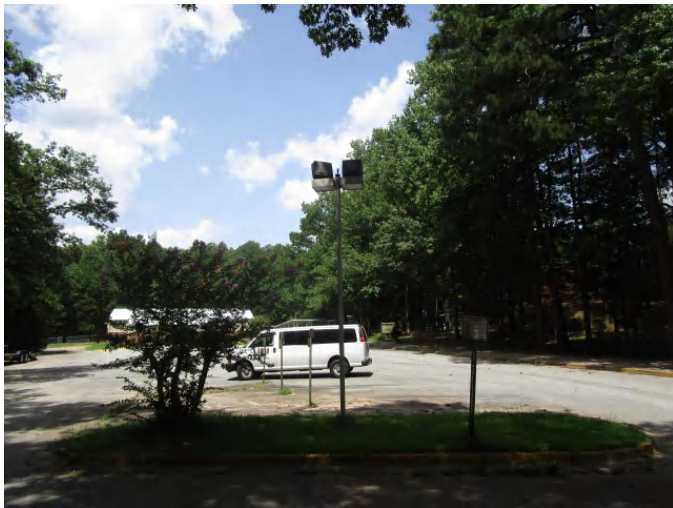
System: G4020 - Site Lighting

Location: Site

Distress: Beyond Service Life

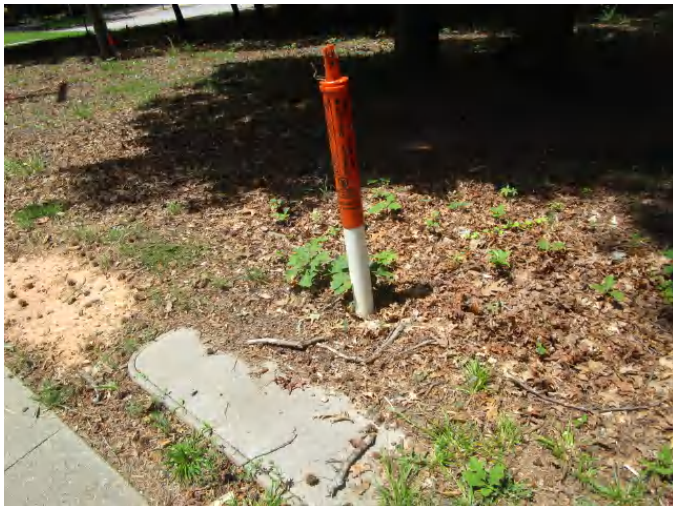
System: G4030 - Site Communications & Security

Location: Site

Distress: Beyond Service Life
