DeKalb County School District/High Schools

Clarkston High

School Assessment Report

May 19, 2016

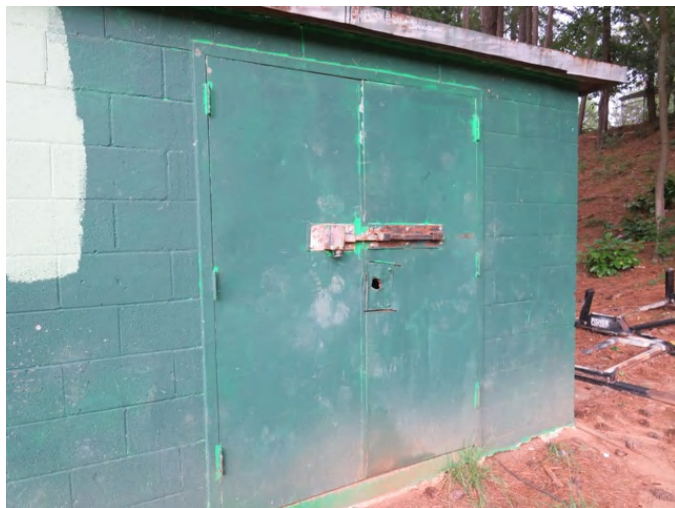
System: B2030 - Exterior Doors

Location: Exterior Wall
Distress: Beyond Service Life
Category: Deferred Maintenance
Priority: 3 Priority
Correction: Renew System
Qty: 400.00
Unit of Measure: S.F.
Estimate: \$352.00
Assessor Name: Sam Mandola
Date Created: 04/11/2015

Notes: The original exterior doors are aged, rusted, and should be replaced.

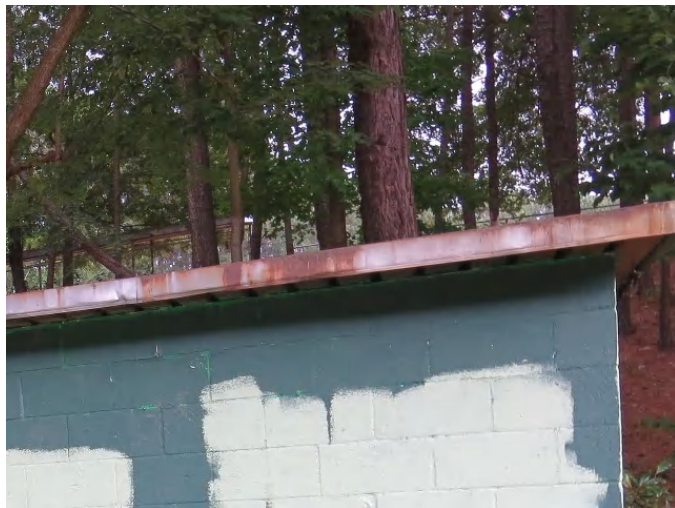
System: B3010 - Roof Coverings

Location: Roof
Distress: Beyond Service Life
Category: Deferred Maintenance
Priority: 3 Priority
Correction: Renew System
Qty: 400.00
Unit of Measure: S.F.
Estimate: \$7,388.00
Assessor Name: Sam Mandola
Date Created: 04/11/2015

Notes: Roof covering is aging, showing signs of failure, and should be replaced.

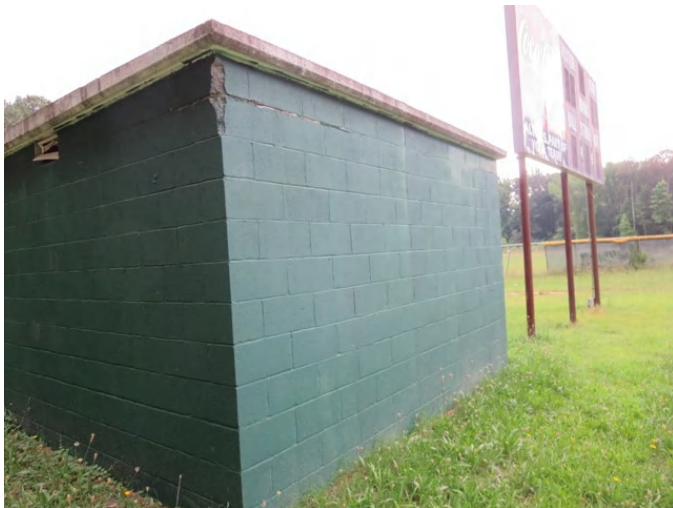
System: B3010 - Roof Coverings

Location: Roof

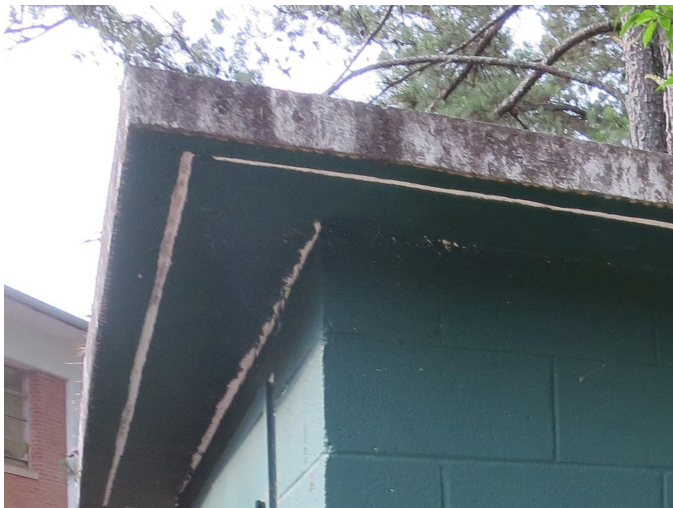
System: B3010 - Roof Coverings

Location: Roof

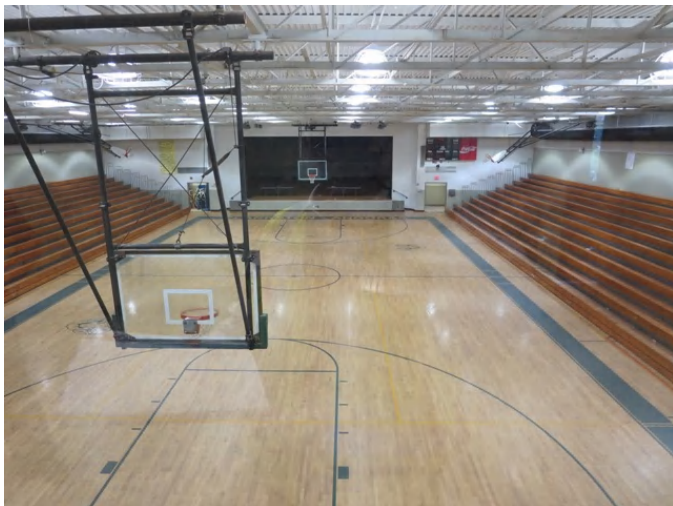
System: E1020 - Institutional Equipment

Location: Gym

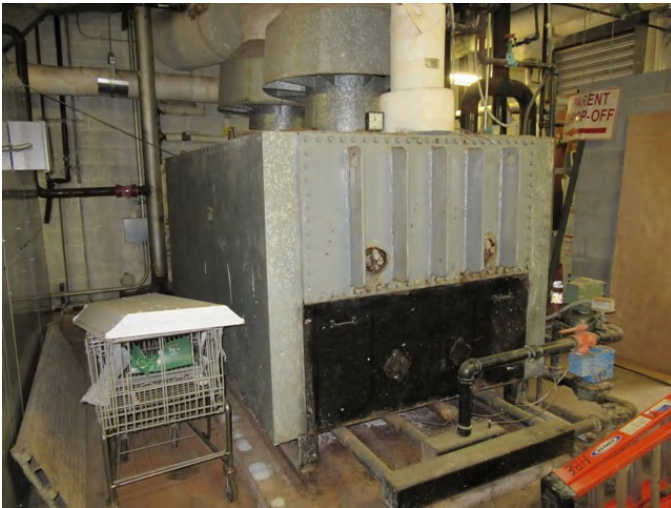
System: D3020 - Heat Generating Systems

Location: Mechanical Room

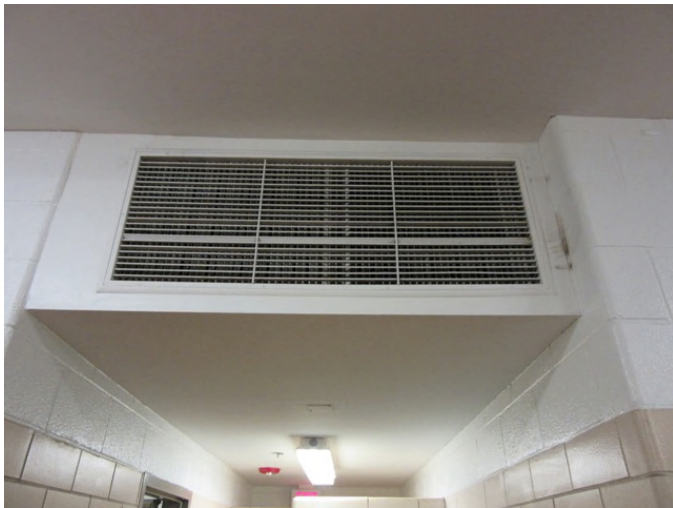
System: D3040 - Distribution Systems & Exhaust Systems

Location: Throughout Building

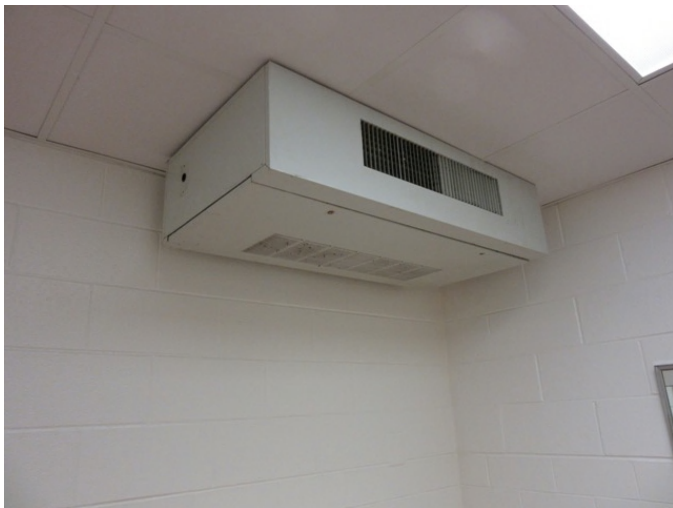
System: D3050 - Terminal & Package Units

Location: Throughout Building

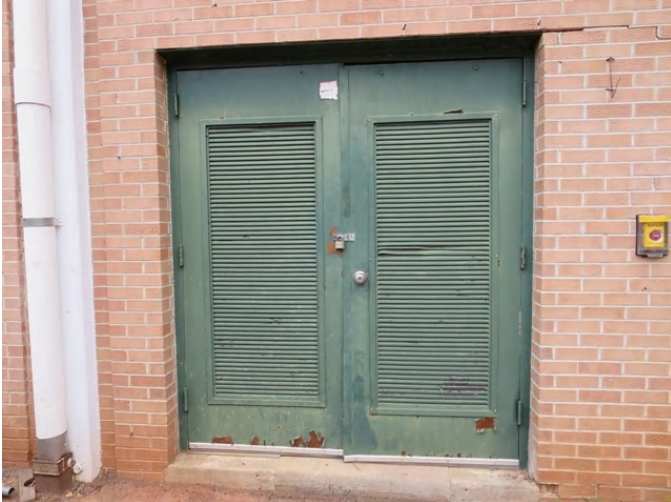
System: B2030 - Exterior Doors

Location: Throughout Building

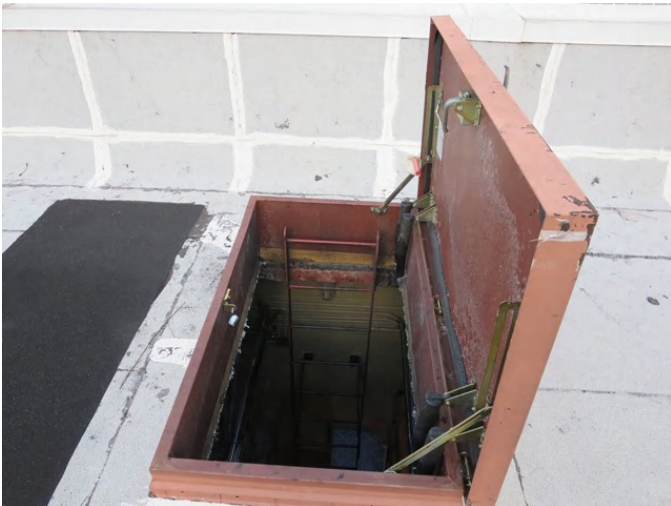
System: B3020 - Roof Openings

Location: Roof

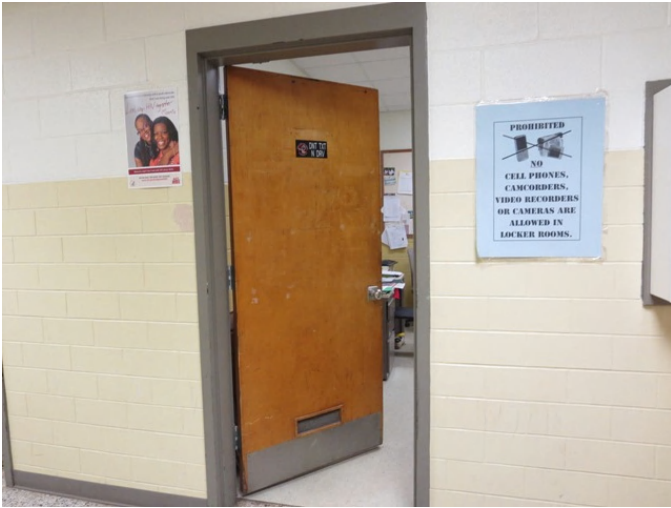
System: C1020 - Interior Doors

Location: Throughout Building

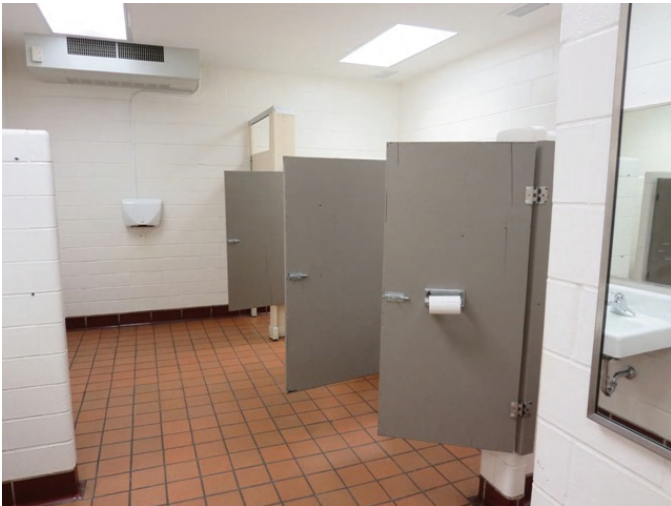
System: C1030 - Fittings

Location: Throughout Building

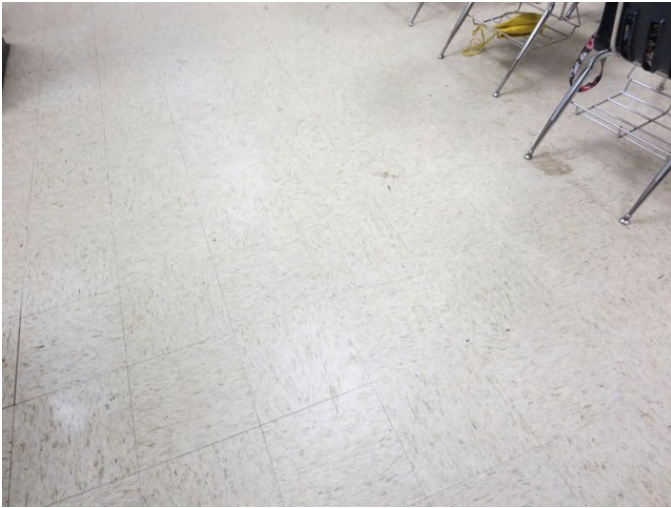
System: C3020 - Floor Finishes - VCT

Location: Throughout Building

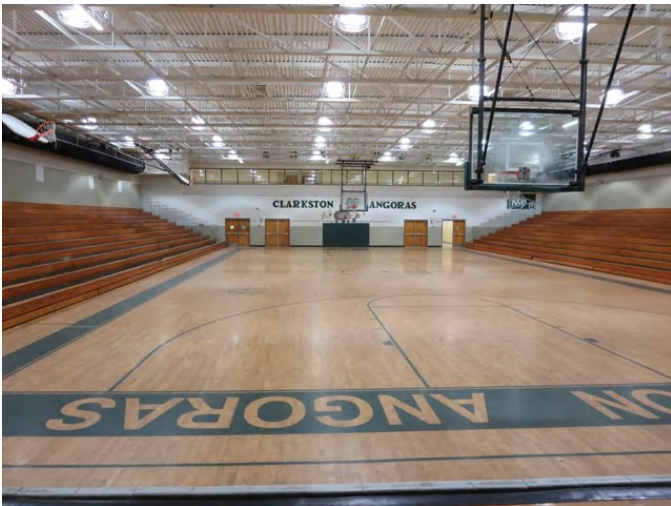
System: C3020 - Floor Finishes - Wood

Location: Gym

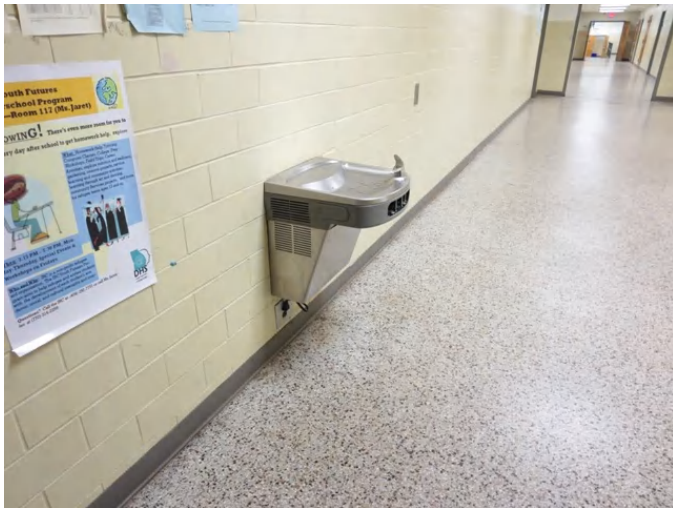
System: D2010 - Plumbing Fixtures

Location: Hallways

Distress: Needs Remediation

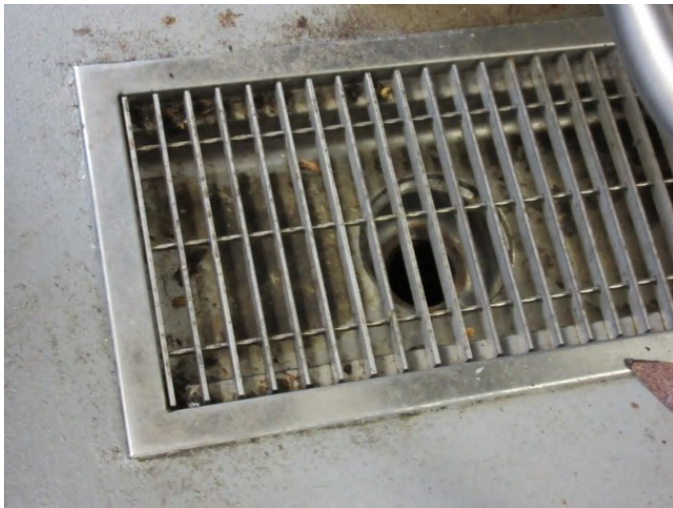
System: D2090 - Other Plumbing Systems - Acid Waste

Location: Throughout Building

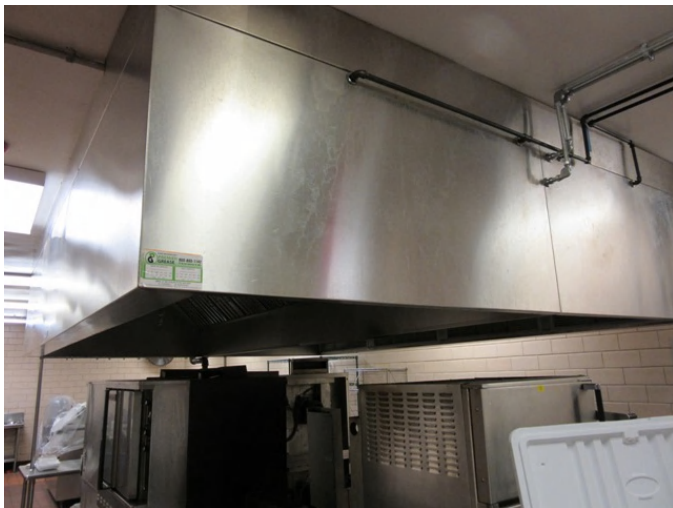
System: D3090 - Other HVAC Systems/Equip - Kitchen Hood

Location: Kitchen

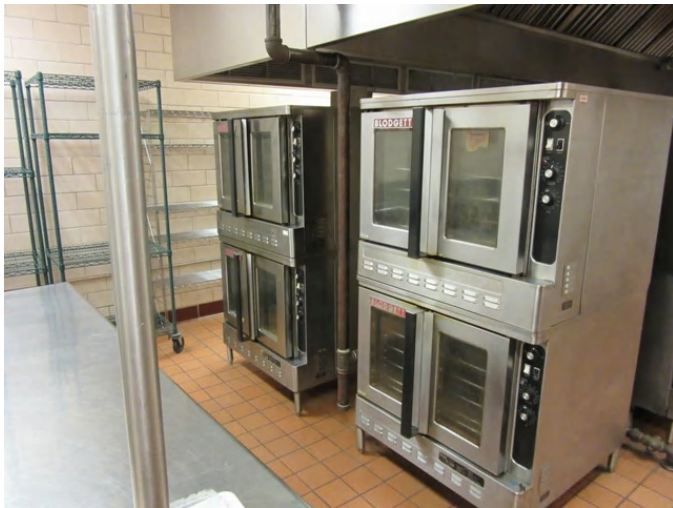
System: E1090 - Other Equipment - Kitchen Equipment

Location: Kitchen

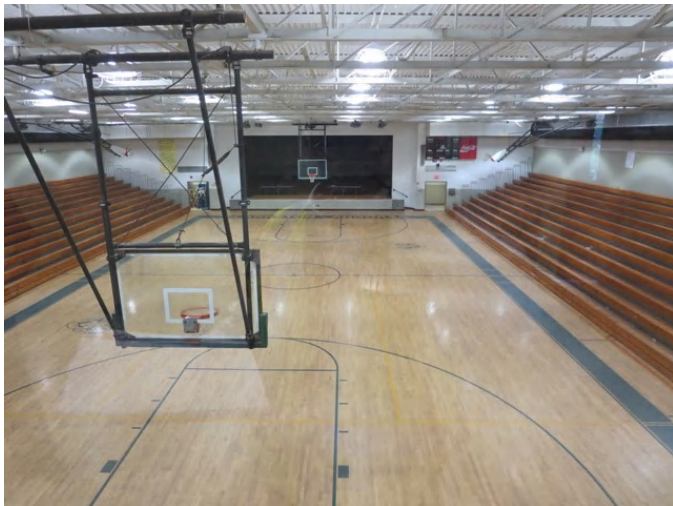
System: E1090 - Other Equipment - Sports Equipment

Location: Gym

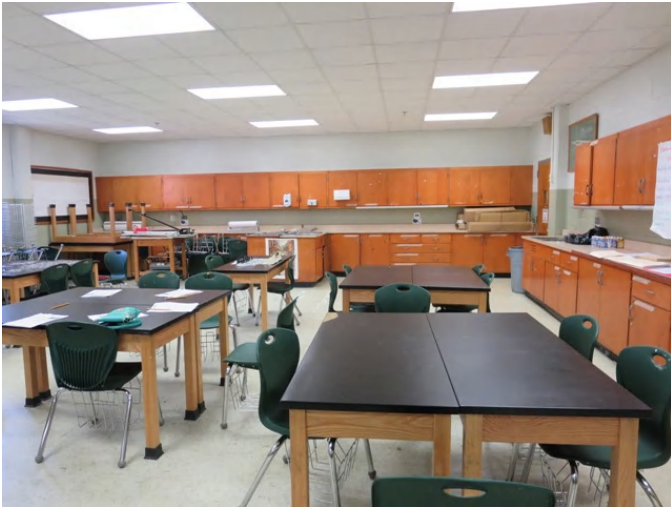
System: E2010 - Fixed Furnishings

Location: Throughout Building

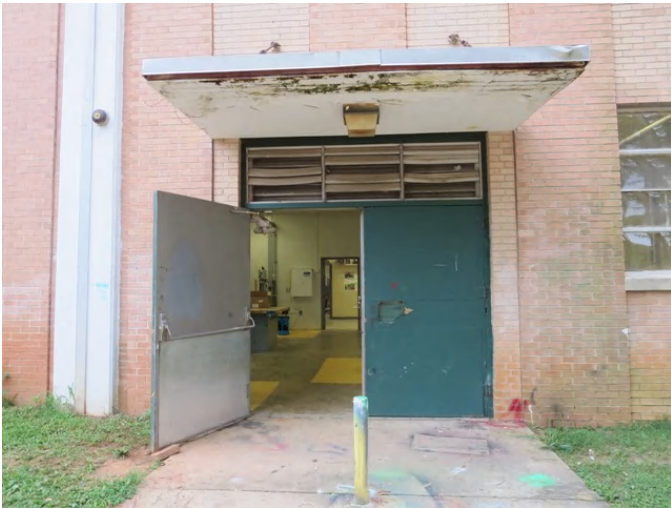
System: F1010 - Special Structures - Canopies

Location: Exterior Walls

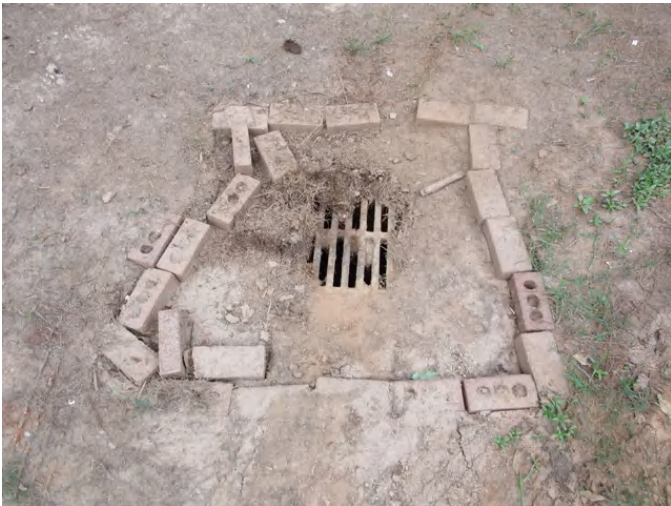
System: G3030 - Storm Sewer

Location: Site

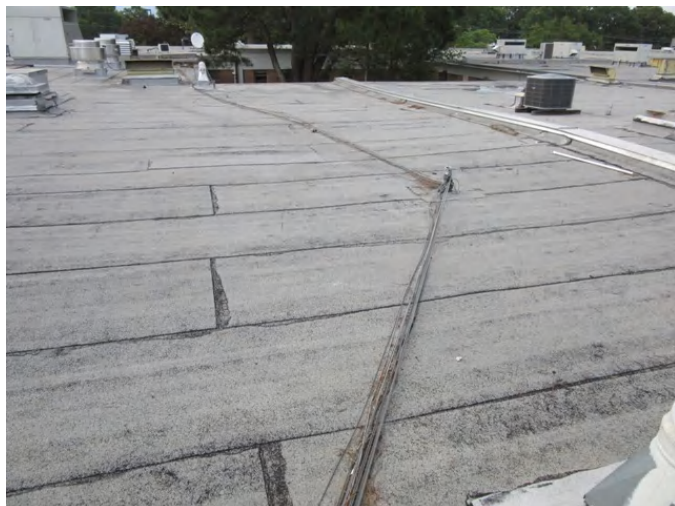
System: G4030 - Site Communications & Security

Location: Site

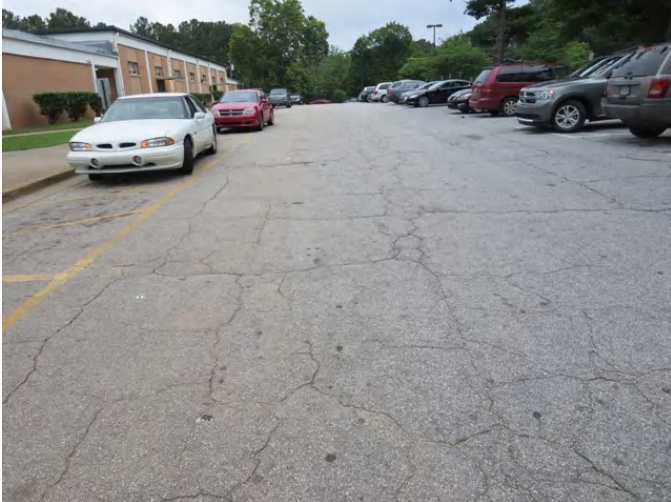
System: G2020 - Parking Lots

Location: Site

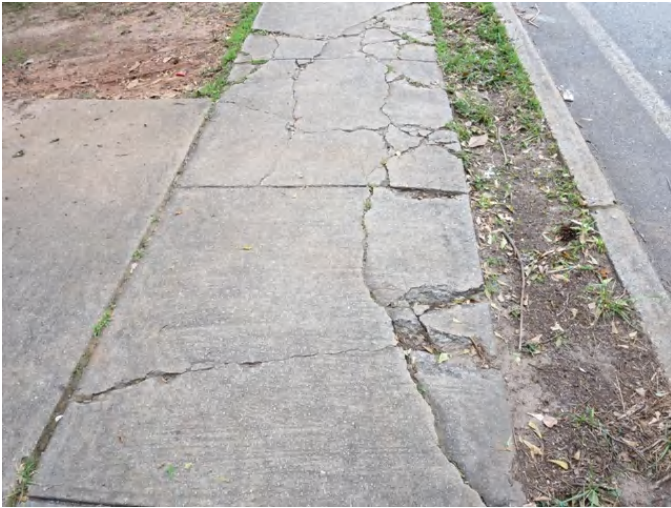
System: G2030 - Pedestrian Paving

Location: Site

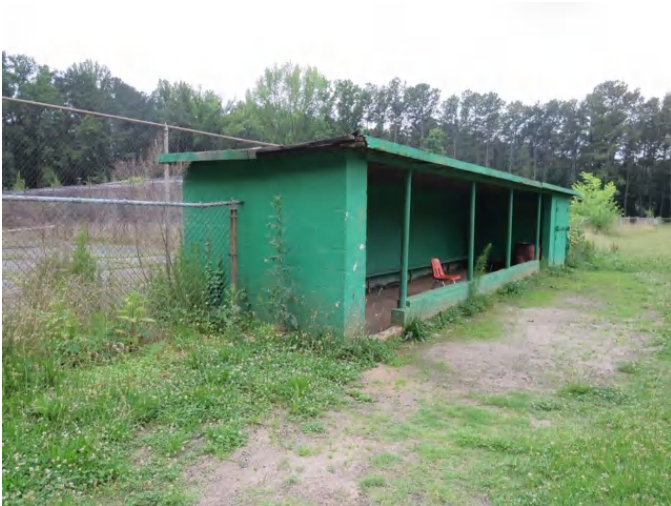
System: G2040 - Baseball Field

Location: Site

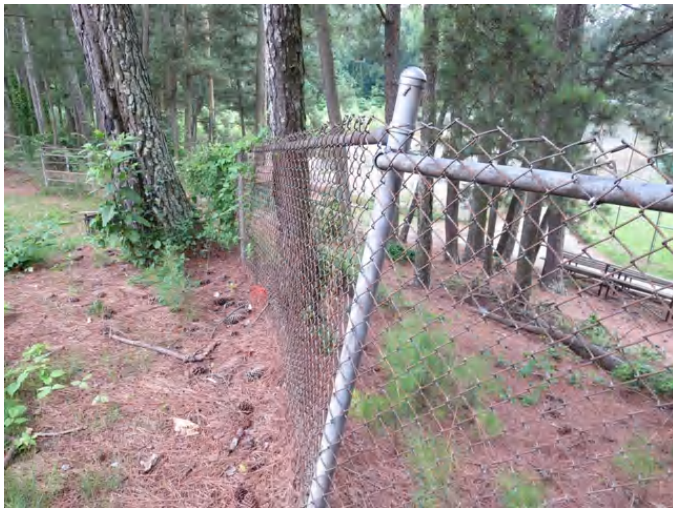
System: G2040 - Fencing & Guardrails

Location: Site

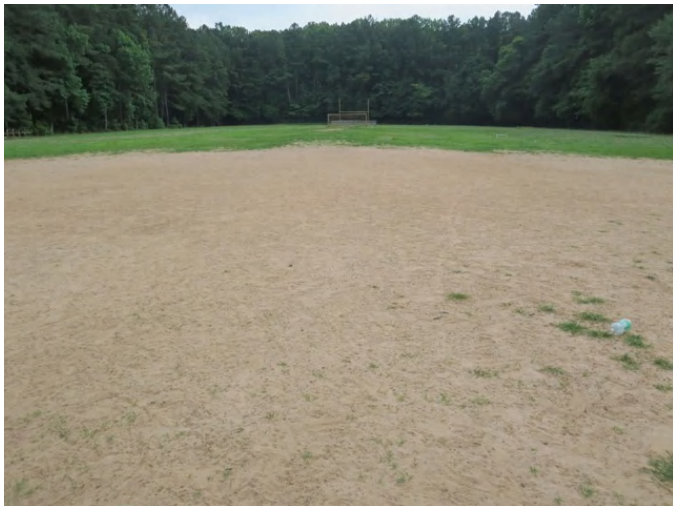
System: G2040 - Football Field

Location: Site

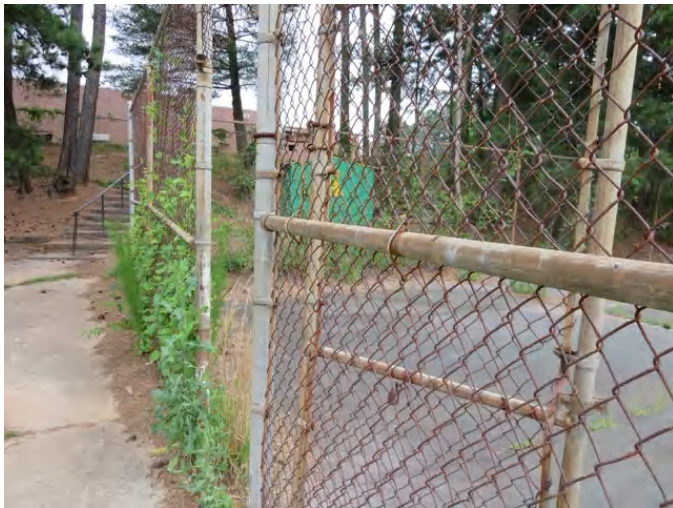
System: G2040 - Hard Surface Play Area

Location: Site

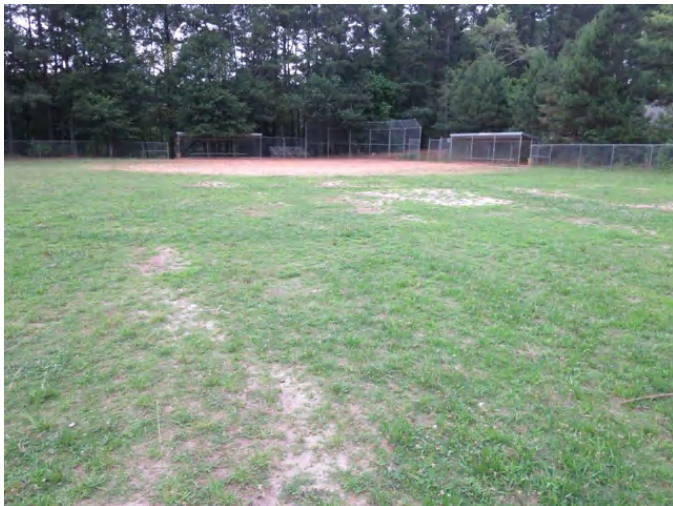
System: G2040 - Softball Field

Location: Site

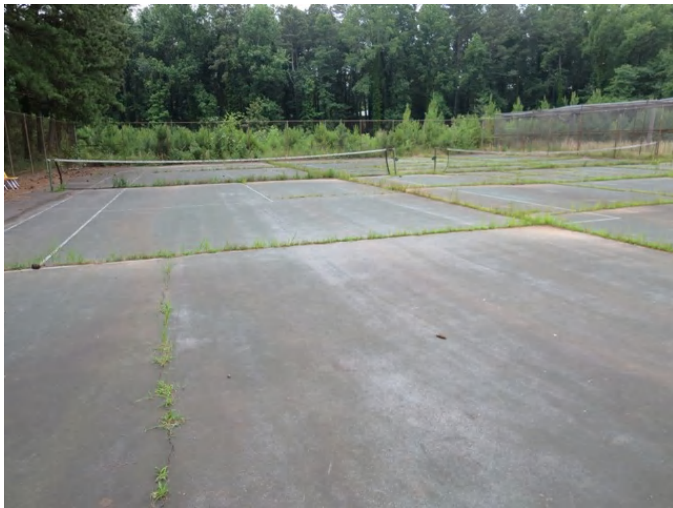
System: G2040 - Tennis Courts

Location: Site
Distress: Beyond Service Life
Category: Deferred Maintenance
Priority: 3 Priority
Correction: Renew System
Qty: 13,460.00
Unit of Measure: S.F.
Estimate: \$273,466.82
Assessor Name: Eduardo Lopez
Date Created: 06/18/2015

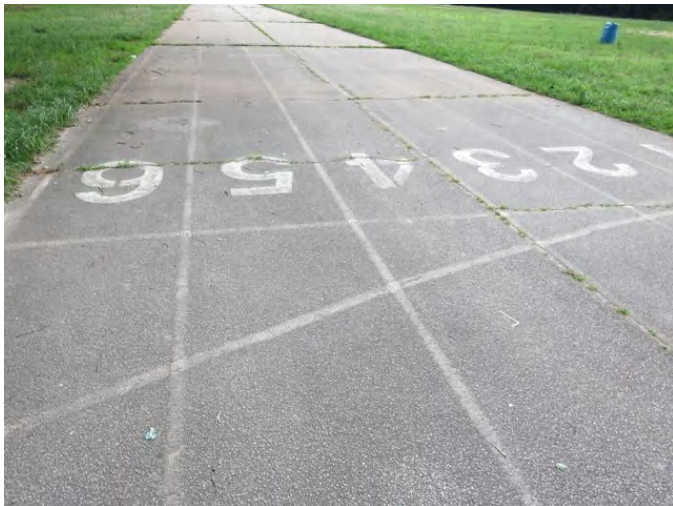
System: G2040 - Track

Location: Site
Distress: Beyond Service Life
Category: Deferred Maintenance
Priority: 3 Priority
Correction: Renew System
Qty: 36,126.00
Unit of Measure: S.F.
Estimate: \$279,759.74
Assessor Name: Eduardo Lopez
Date Created: 06/18/2015

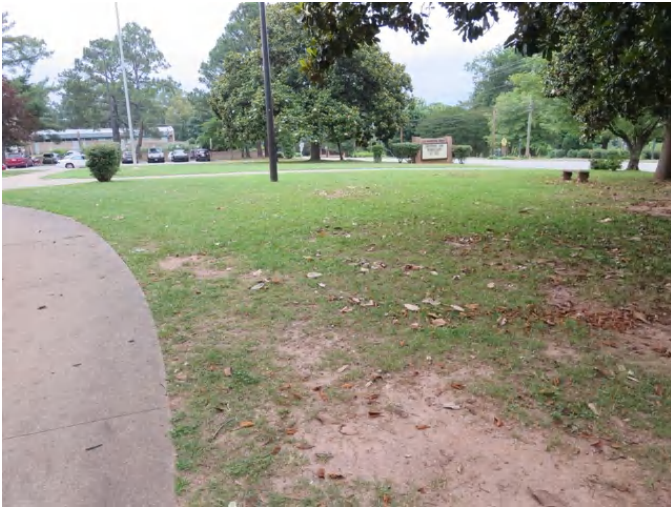
System: G2050 - Landscaping

Location: Site
Distress: Beyond Service Life
Category: Deferred Maintenance
Priority: 3 Priority
Correction: Renew System
Qty: 193,692.00
Unit of Measure: S.F.
Estimate: \$308,938.74
Assessor Name: Eduardo Lopez
Date Created: 06/18/2015

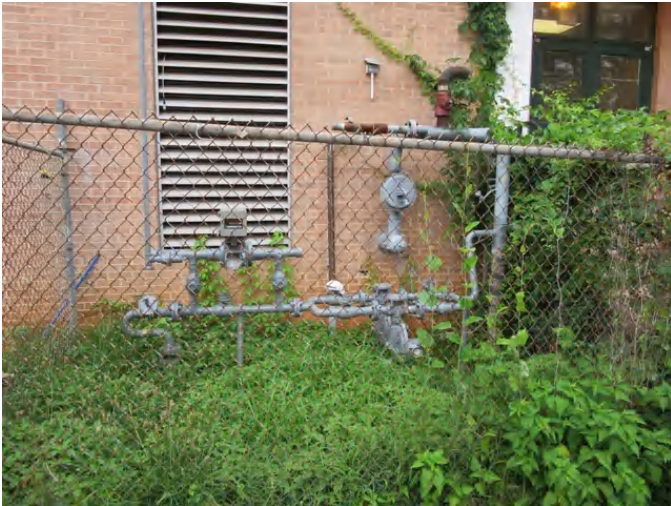
System: G3060 - Fuel Distribution

Location: Site
Distress: Beyond Service Life
Category: Deferred Maintenance
Priority: 3 Priority
Correction: Renew System
Qty: 193,692.00
Unit of Measure: S.F.
Estimate: \$166,187.74
Assessor Name: Eduardo Lopez
Date Created: 06/17/2015

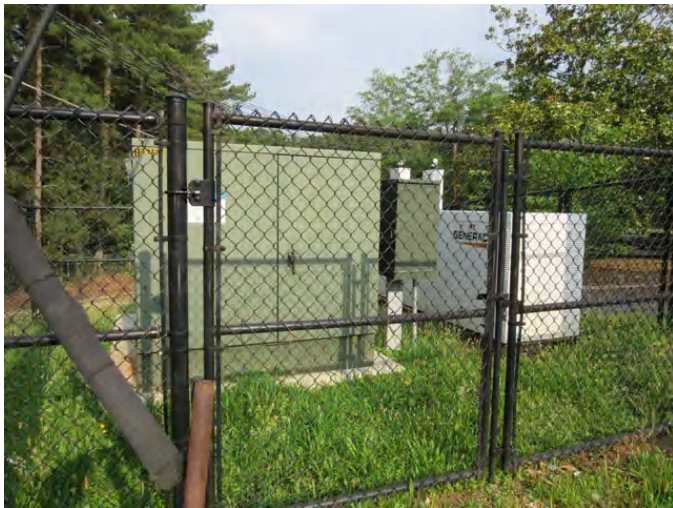
System: G4010 - Electrical Distribution

Location: Site
Distress: Beyond Service Life
Category: Deferred Maintenance
Priority: 3 Priority
Correction: Renew System
Qty: 193,692.00
Unit of Measure: S.F.
Estimate: \$396,293.83
Assessor Name: Eduardo Lopez
Date Created: 06/17/2015

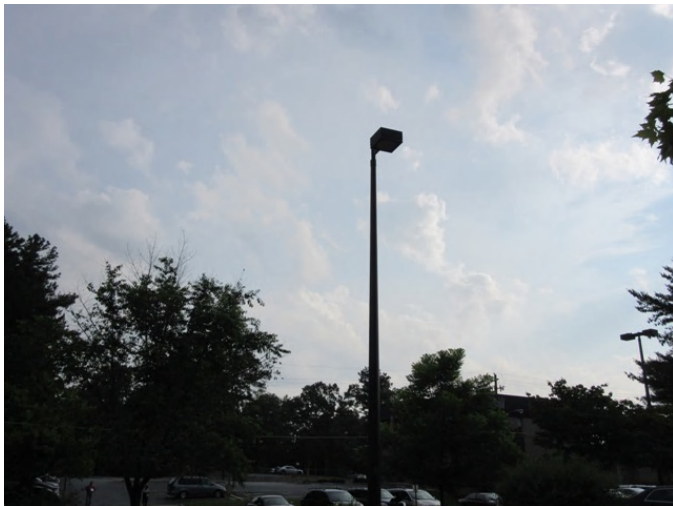
System: G4020 - Site Lighting

Location: Site
Distress: Inadequate
Category: Deferred Maintenance
Priority: 3 Priority
Correction: Renew System
Qty: 193,692.00
Unit of Measure: S.F.
Estimate: \$245,020.38
Assessor Name: Eduardo Lopez
Date Created: 06/17/2015
