**DeKalb County School District/Elementary Schools**

# **Columbia Elementary**

## **School Assessment Report**

**May 19, 2016**

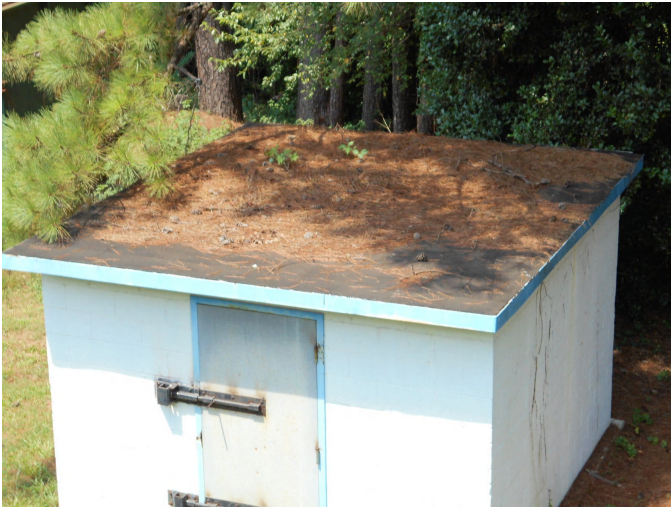
#### **System: B3010 - Roof Coverings**

**Location:** Roof

**Distress:** Beyond Service Life

**Notes:** The roof covering is leaking, beyond its expected service life, and should be replaced.

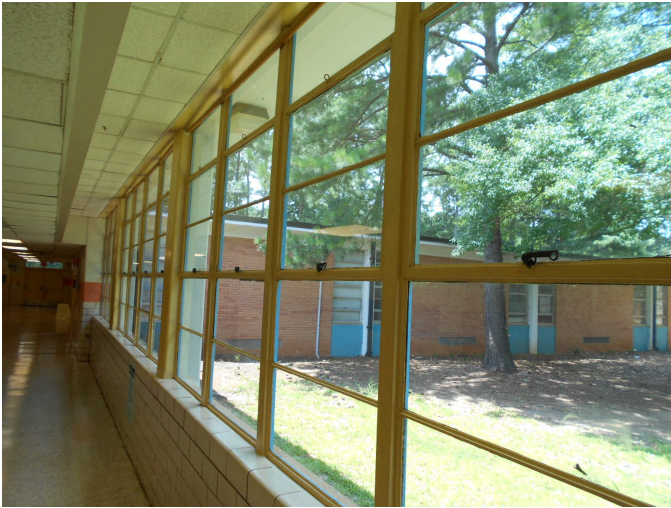
#### System: B2020 - Exterior Windows

**Location:** Throughout Building

**Notes:** The exterior window system is beyond its expected service life, not energy efficient, and should be replaced.

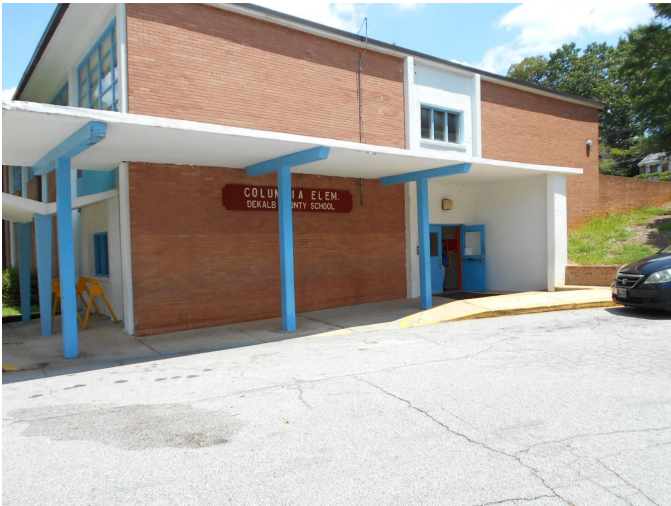
#### System: B2030 - Exterior Doors

**Location:** Throughout Building

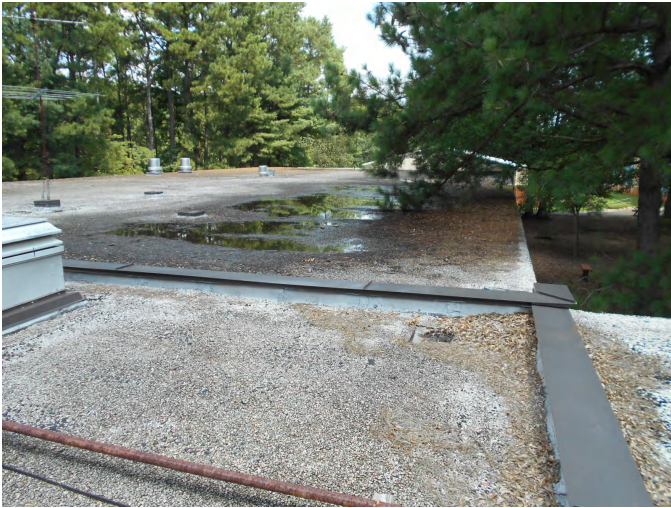
**System: B3010 - Roof Coverings - BUR**

**Location:** Roof

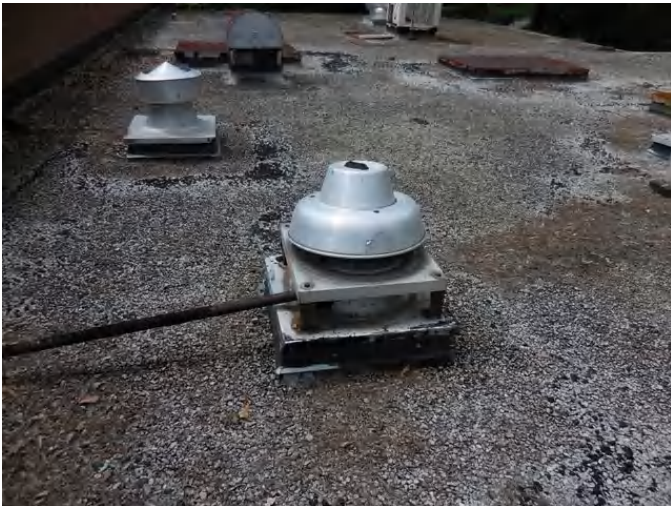
**System: B3020 - Roof Openings**

**Location:** Roof

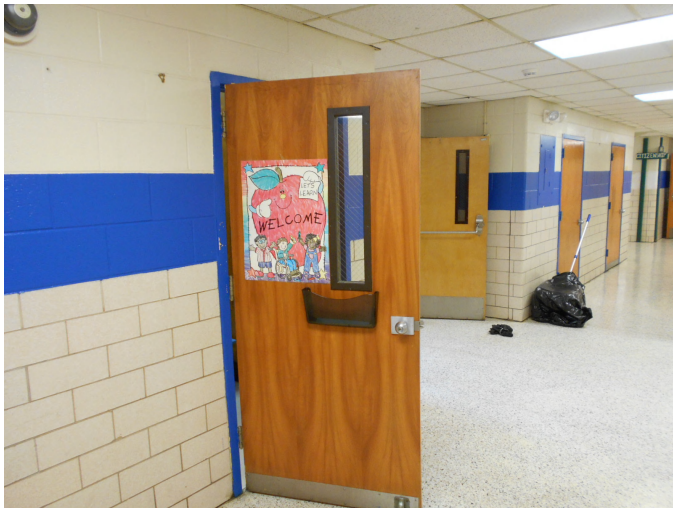
### **System: C1020 - Interior Doors**

**Location:** Throughout Building

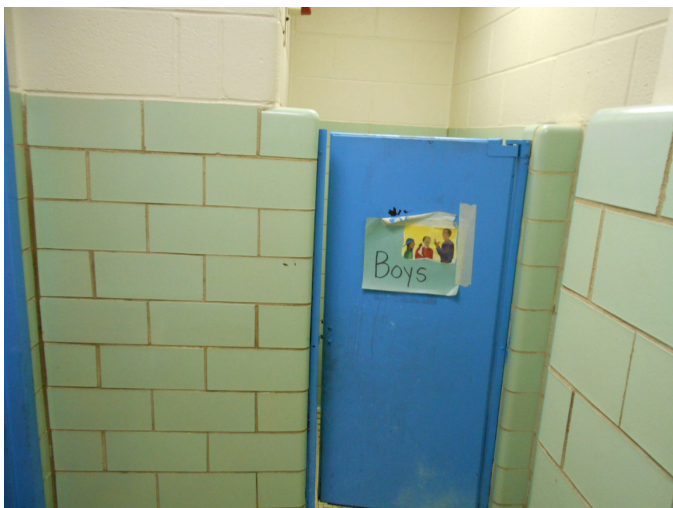
### **System: C1030 - Fittings**

**Location:** Throughout Building

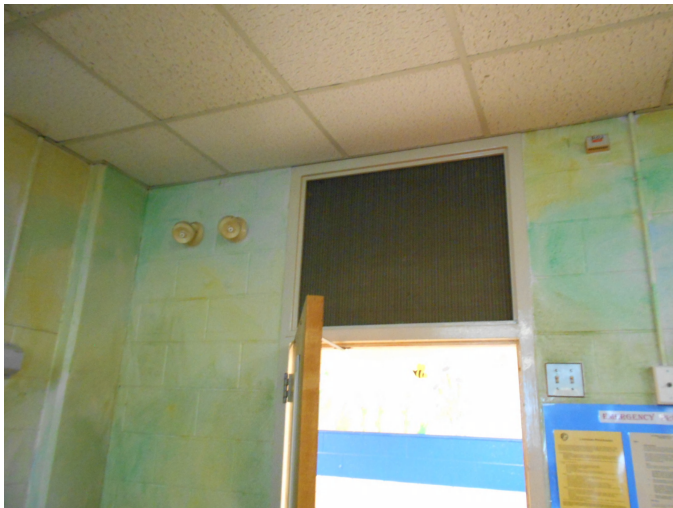
**System: C3010 - Wall Finishes - Paint**

**Location:** Throughout Building

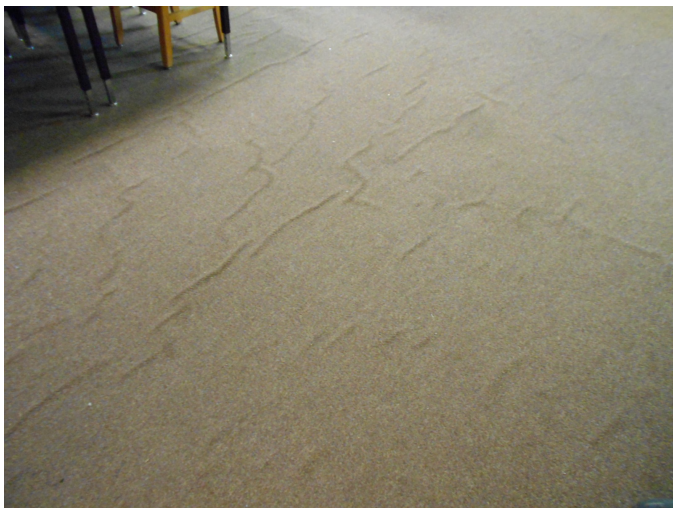
**System: C3020 - Floor Finishes - Carpet**

**Location:** Media Center, Offices

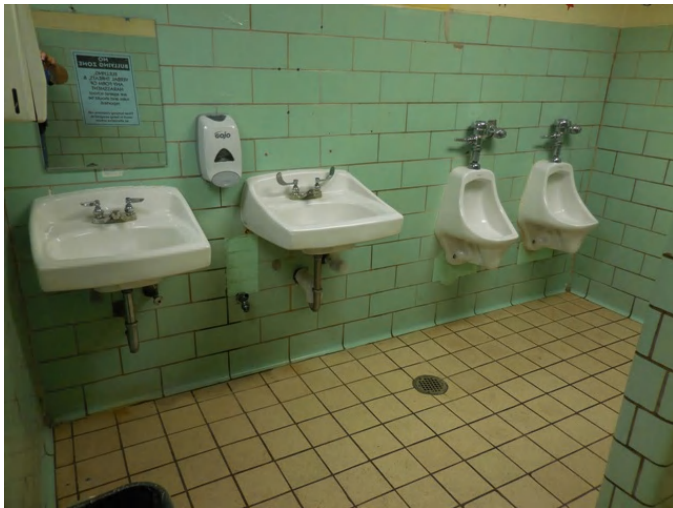
**System: D2010 - Plumbing Fixtures**

**Location:** Restrooms

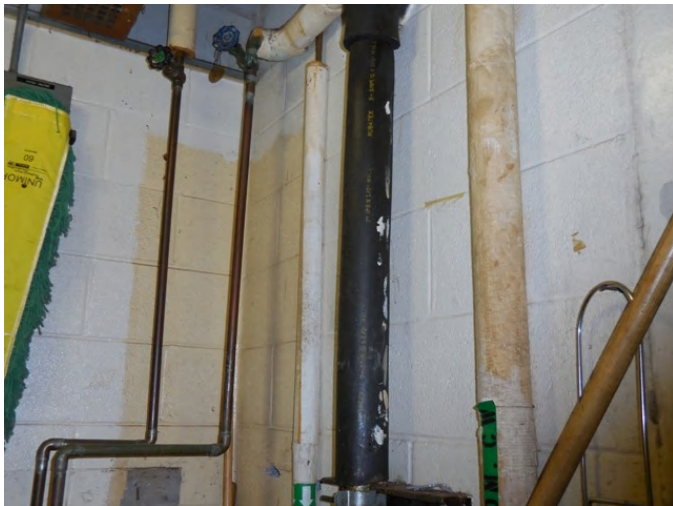
**System: D2020 - Domestic Water Distribution**

**Location:** Throughout Building

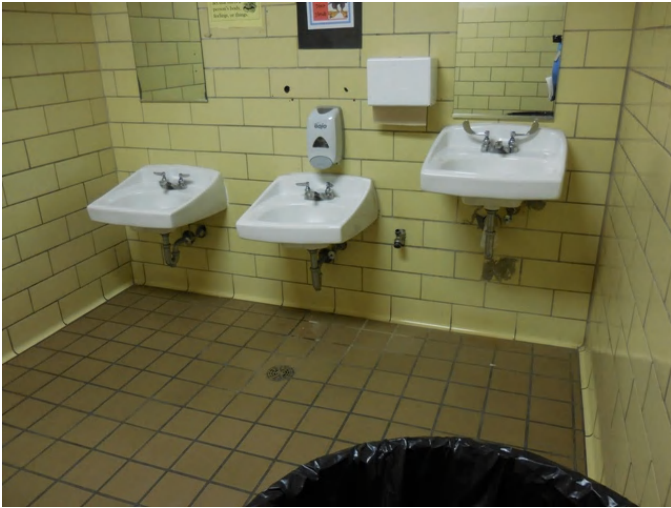
**System: D2030 - Sanitary Waste**

**Location:** Throughout Building

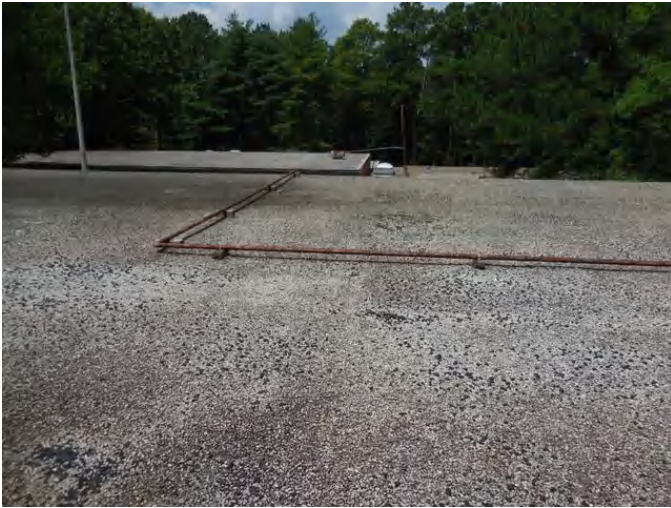
**System: D2090 - Other Plumbing Systems - Natural Gas**

**Location:** Throughout Building

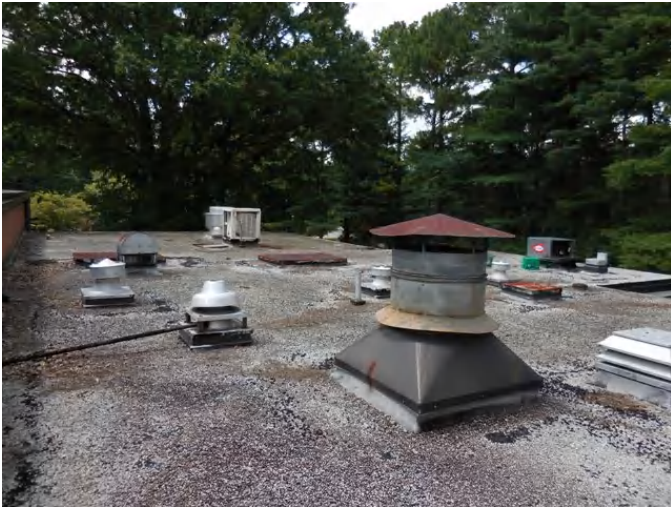
**System: D3040 - Distribution & Exhaust Systems**

**Location:** Throughout Building  
**Distress:** Beyond Service Life  
**Category:** Deferred Maintenance / Environmental  
**Priority:** 3 Priority  
**Correction:** Renew System  
**Qty:** 50,930.00  
**Unit of Measure:** S.F.  
**Estimate:** \$308,687.00  
**Assessor Name:** Ben Nixon  
**Date Created:** 04/11/2015

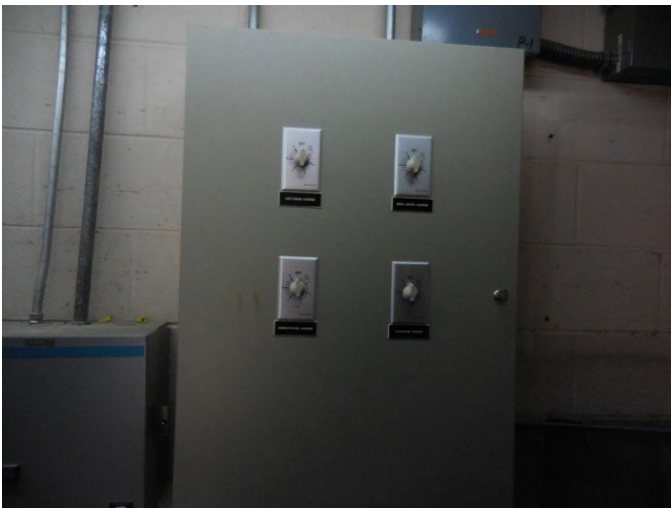
**System: D3060 - Controls & Instrumentation**

**Location:** Throughout Building  
**Distress:** Beyond Service Life  
**Category:** Deferred Maintenance / Energy  
**Priority:** 3 Priority  
**Correction:** Renew System  
**Qty:** 50,930.00  
**Unit of Measure:** S.F.  
**Estimate:** \$201,683.00  
**Assessor Name:** Ben Nixon  
**Date Created:** 04/11/2015

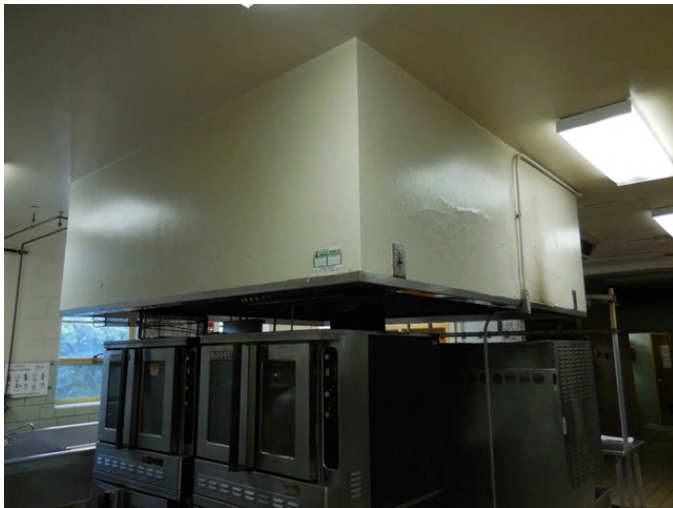
**System: D3090 - Other HVAC Systems/Equip - Kitchen Hood**

**Location:** Kitchen

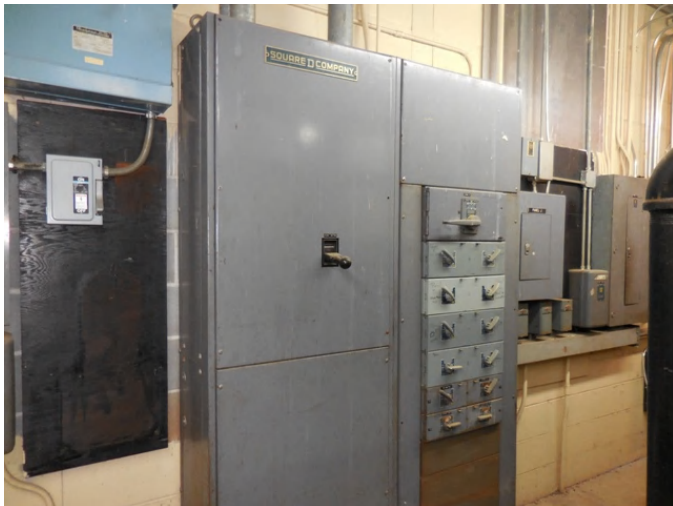
**System: D5010 - Electrical Service/Distribution**

**Location:** Main Switch Room/Throughout Building

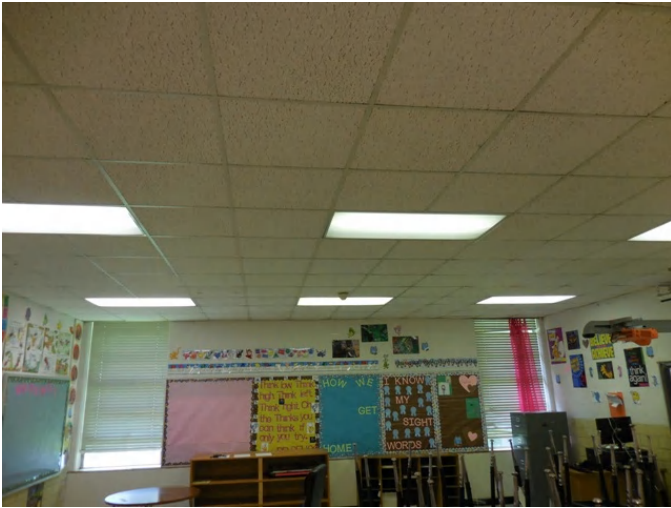
### **System: D5020 - Lighting**

**Location:** Throughout Building

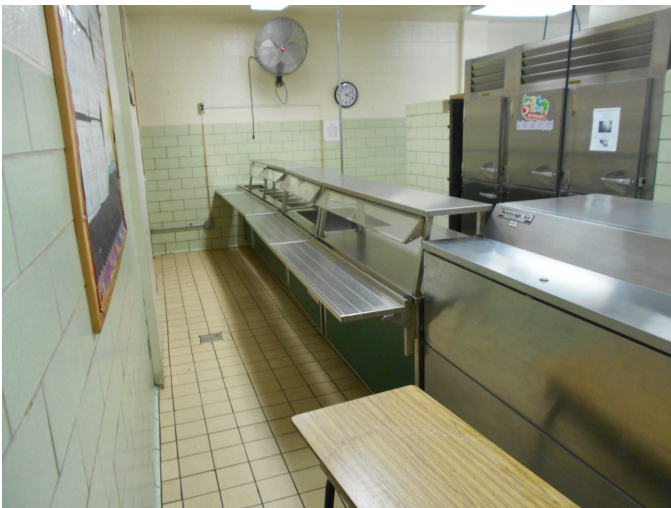
### **System: E1090 - Other Equipment (Kitchen Equipment)**

**Location:** Kitchen

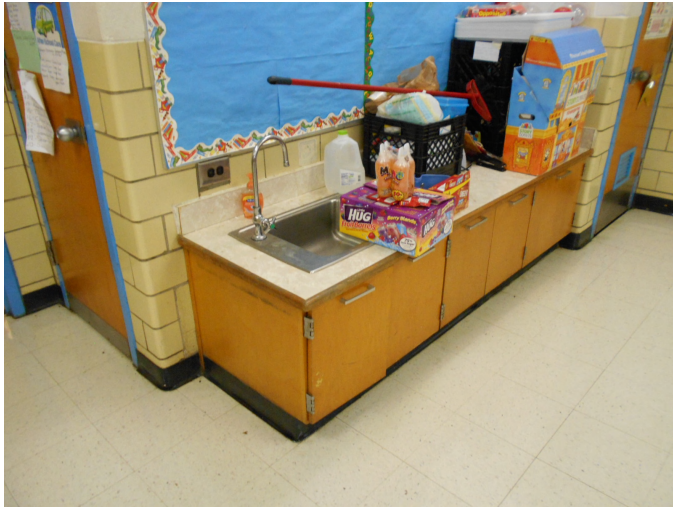
**System: E2010 - Fixed Furnishings**

**Location:** Throughout Building

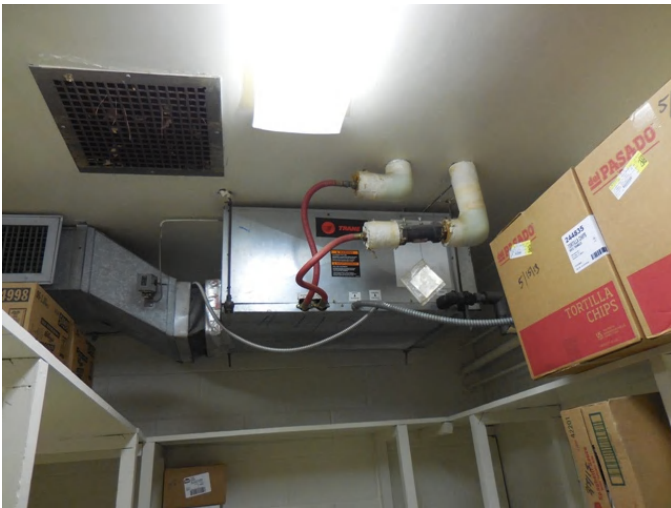
**System: D3050 - Terminal & Package Units**

**Location:** Roof/Throughout Building

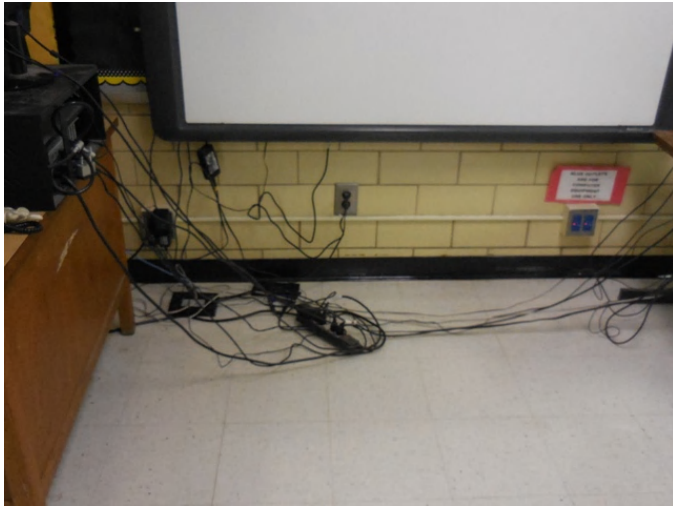
**System: D5020 - Branch Wiring**

**Location:** Throughout Building

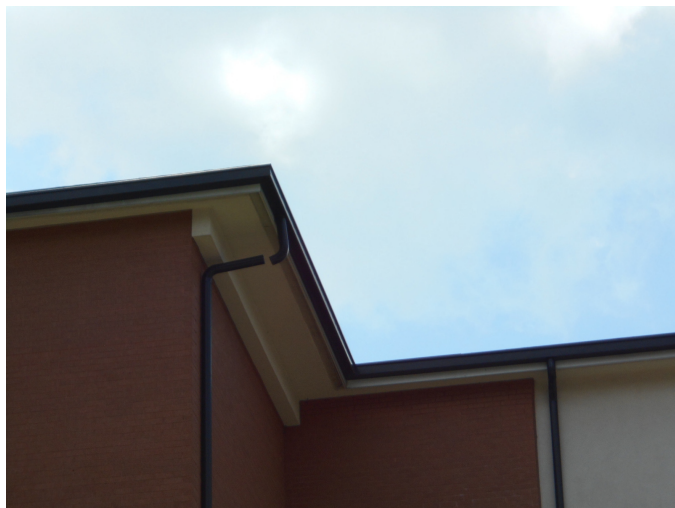
#### **System: B3010 - Roof Coverings - BUR**

**Location:** Roof

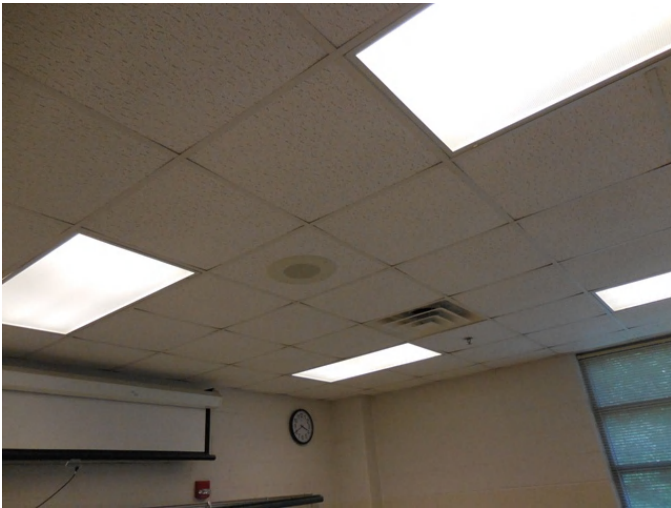
**System: D5030 - Communications and Security - Clock & PA Systems**

**Location:** Throughout Building

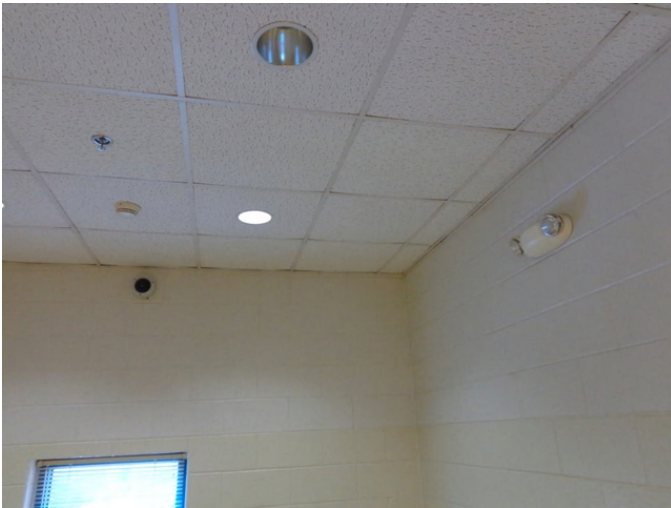
**System: D5030 - Communications and Security - Security & CCTV**

**Location:** Throughout Building

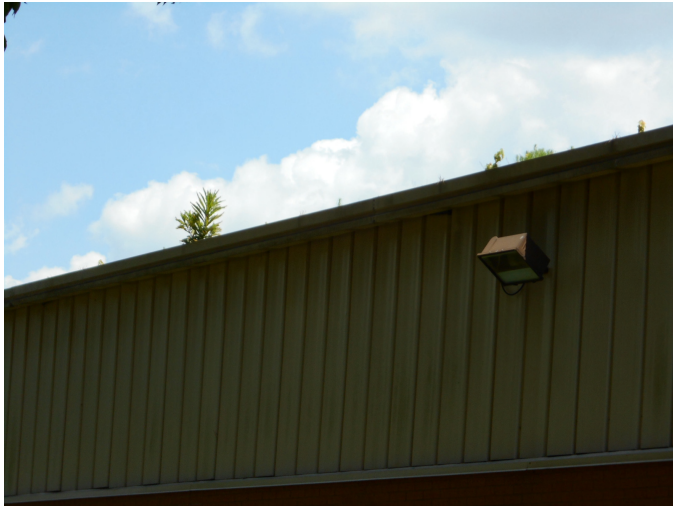
#### **System: B3010 - Roof Coverings - Standing Seam Metal**

**Location:** West Side of Building

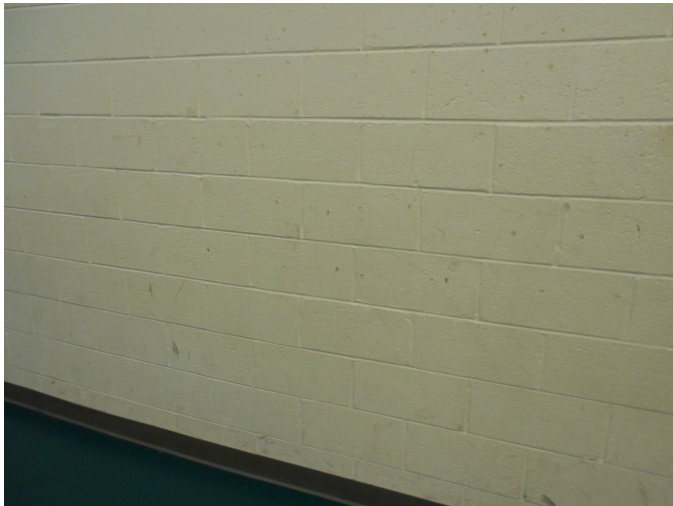
**System: C3010 - Wall Finishes - Paint**

**Location:** Throughout Building

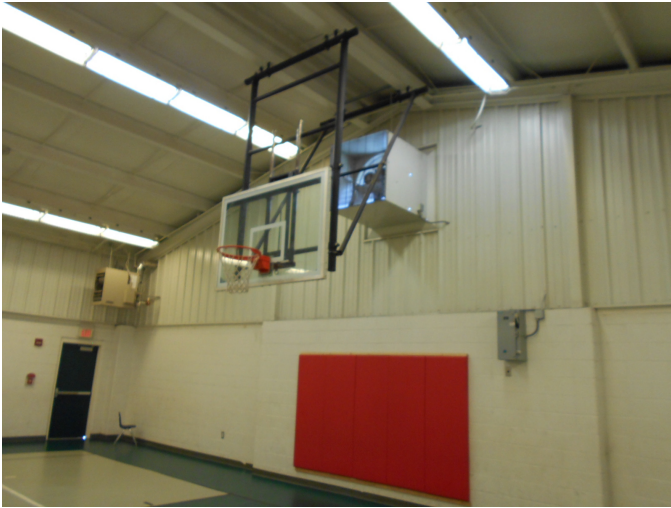
**System: D3050 - Terminal & Package Units**

**Location:** Throughout Building

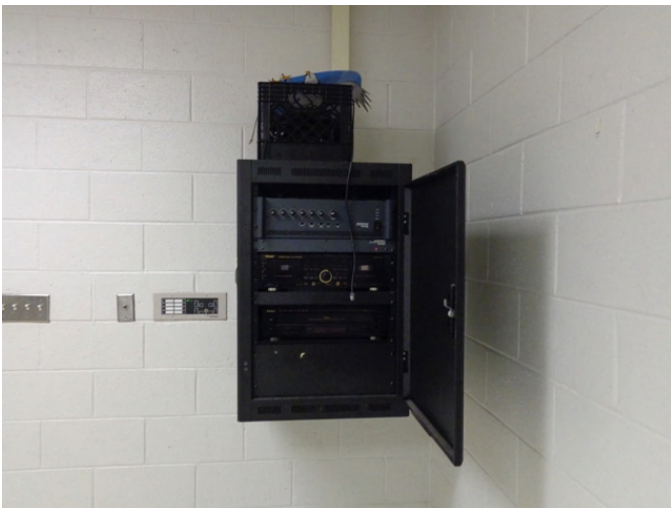
**System: D5030 - Communications and Security - Public Address & Clock System**

**Location:** Throughout Building

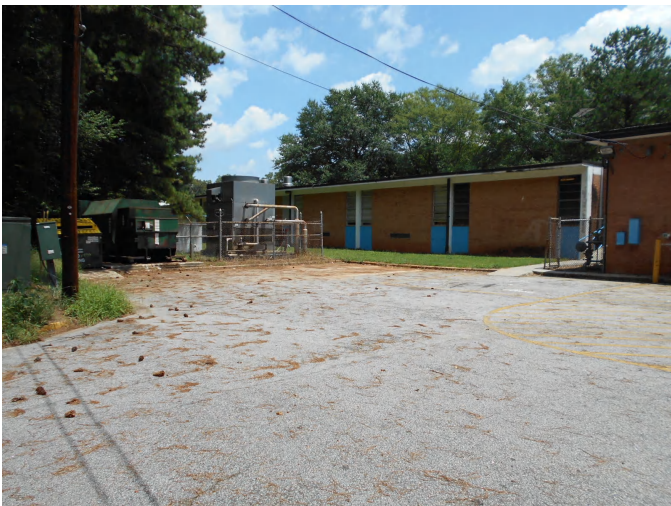
#### System: G4030 - Site Communications & Security

**Location:** Site

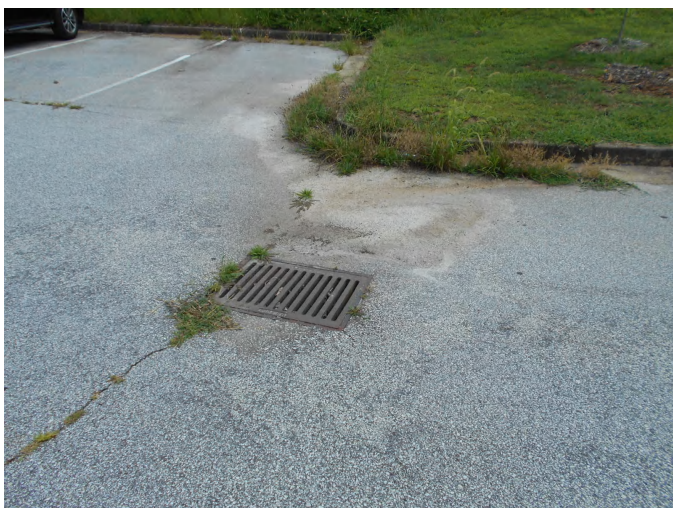
**System: G2020 - Parking Lots**

**Location:** Site

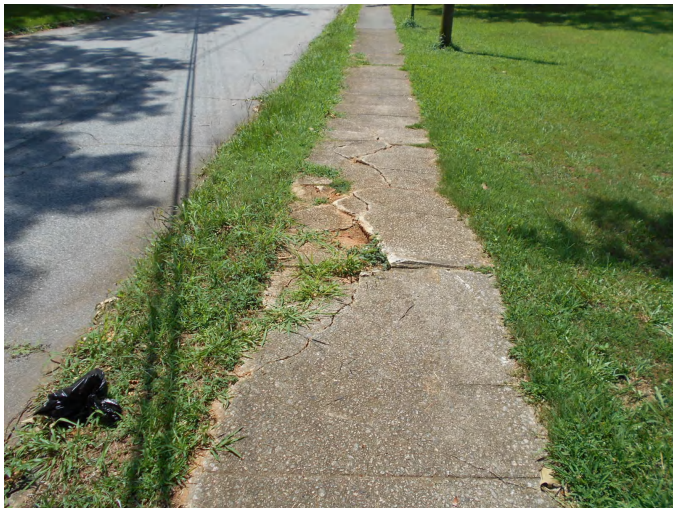
**System: G2030 - Pedestrian Paving**

**Location:** Site  
**Distress:** Beyond Service Life  
**Category:** Deferred Maintenance  
**Priority:** 3 Priority  
**Correction:** Renew System  
**Qty:** 75,903.00  
**Unit of Measure:** S.F.  
**Estimate:** \$125,240.00  
**Assessor Name:** Sam Mandola  
**Date Created:** 07/27/2015

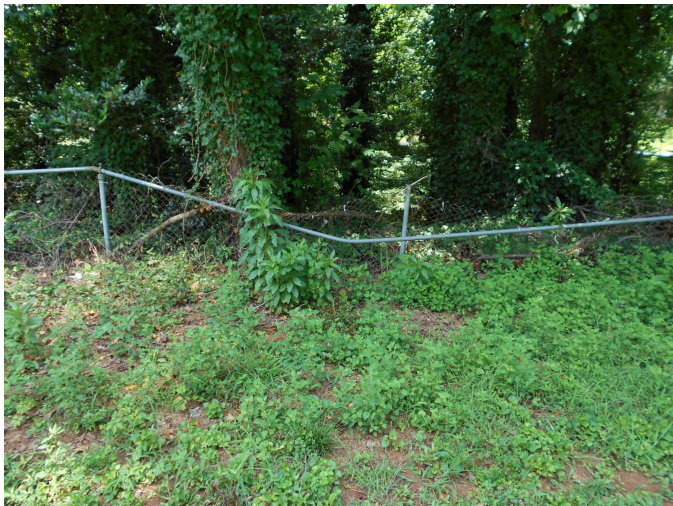
**System: G2040 - Fencing & Guardrails**

**Location:** Site  
**Distress:** Beyond Service Life  
**Category:** Deferred Maintenance  
**Priority:** 3 Priority  
**Correction:** Renew System  
**Qty:** 75,903.00  
**Unit of Measure:** S.F.  
**Estimate:** \$75,979.00  
**Assessor Name:** Sam Mandola  
**Date Created:** 07/27/2015

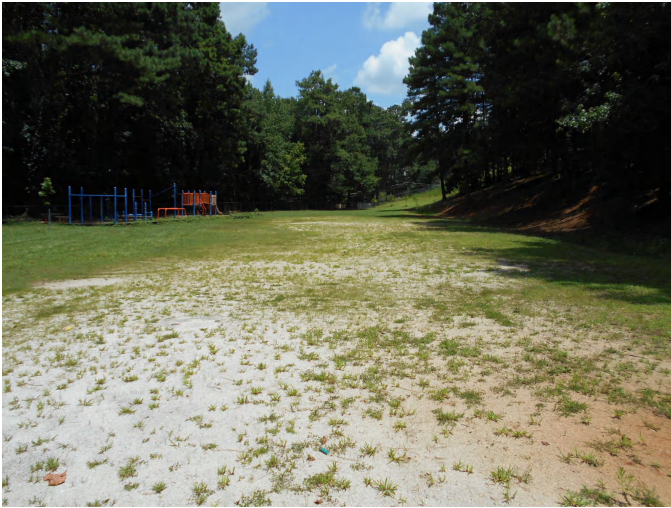
### **System: G2050 - Landscaping**

**Location:** Site

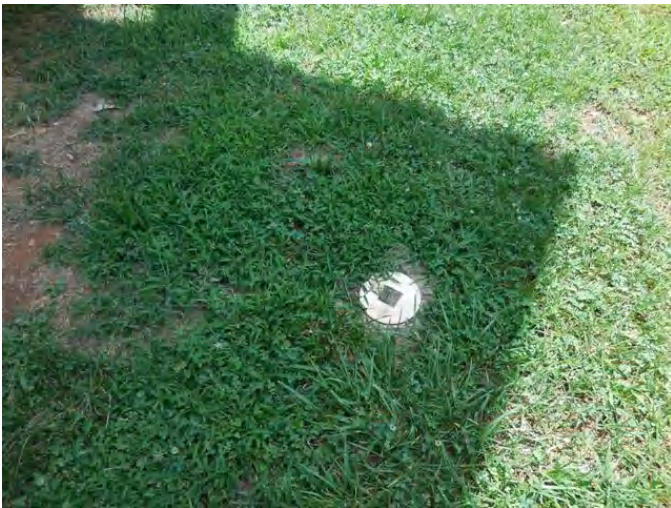
### **System: G3020 - Sanitary Sewer**

**Location:** Site

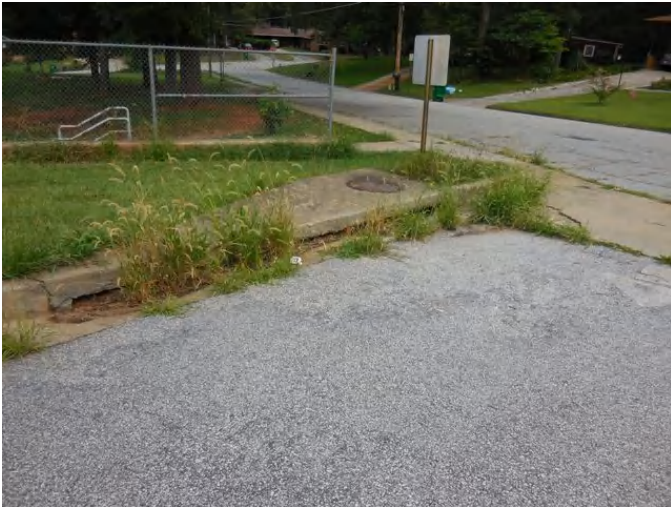
### **System: G3030 - Storm Sewer**

**Location:** Site

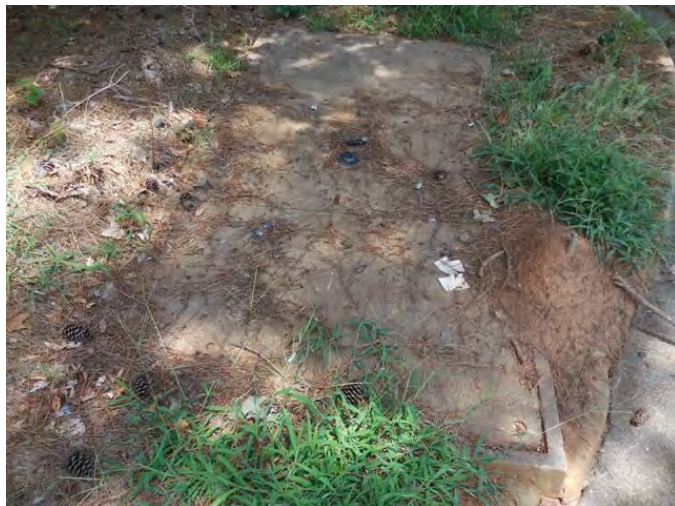
**System: G3010 - Water Supply**

**Location:** Site
