DeKalb County School District/High Schools

Columbia High

School Assessment Report

May 19, 2016

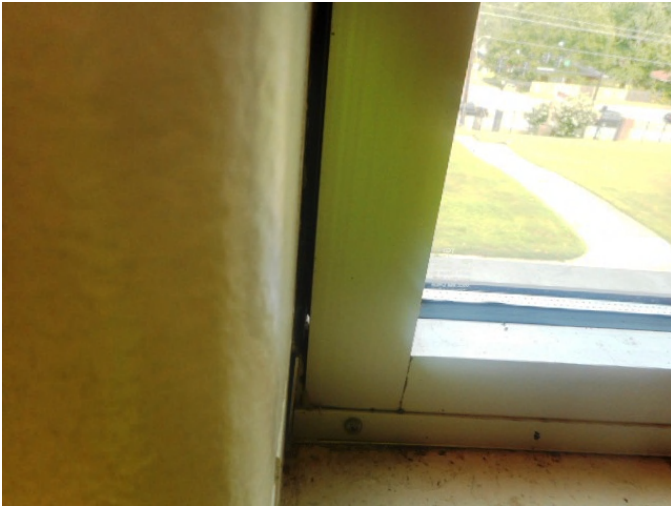
System: B2020 - Exterior Windows

Location: Throughout Building

Distress: Needs Remediation

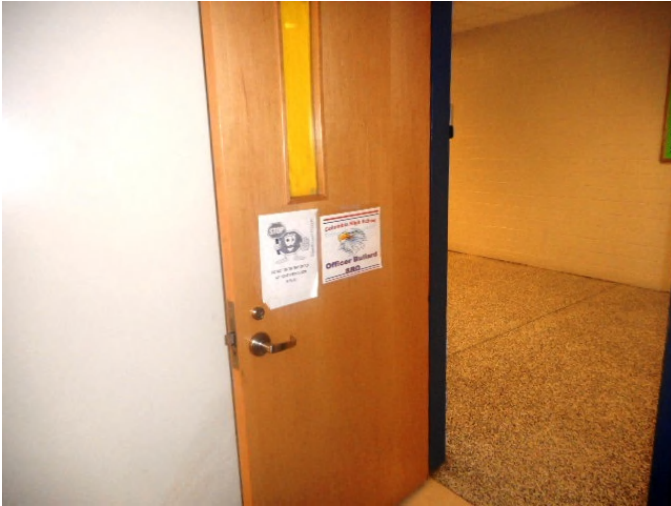
System: C1020 - Interior Doors

Location: Throughout Building

Distress: Beyond Service Life

Notes: The interior doors have been shaved to fit, which may impact their fire retardant properties. The interior doors need to be replaced.

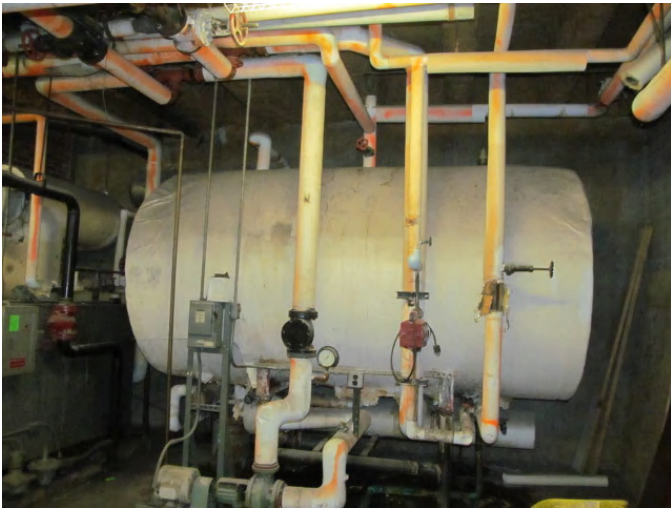
System: D2020 - Domestic Water Distribution

Location: Mechanical Room / Throughout Building

Distress: Damaged

Notes: The domestic water distribution system is beyond its expected service life, has a failing water boiler for hot water, appears to have hazardous materials, and should be replaced with appropriate care for the hazardous materials.

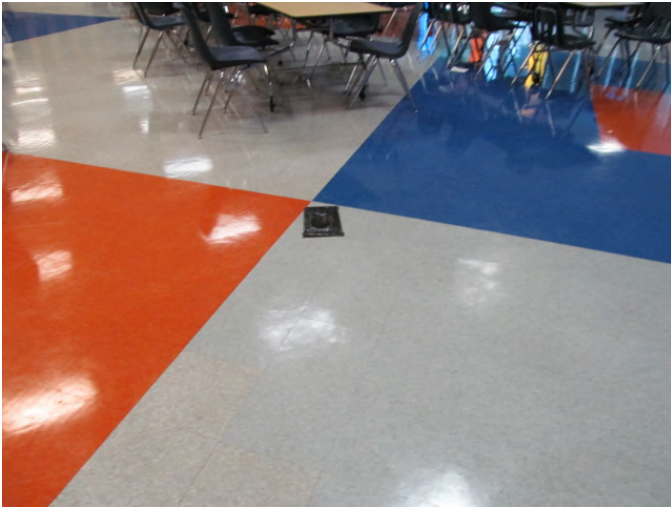
System: D2030 - Sanitary Waste

Location: Throughout Building

Distress: Damaged

Notes: The sanitary sewer drain line is reported as routinely clogged, causing backups in the kitchen, cafeteria, and the original building. Recommend replacing the entire sewer system.

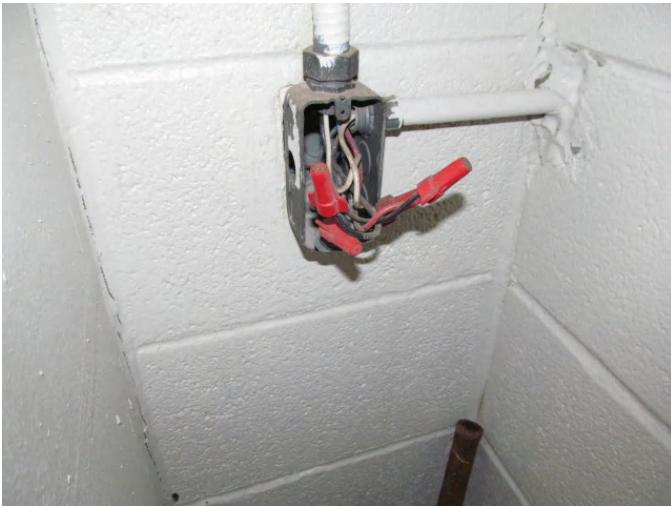
System: D5020 - Branch Wiring

Location: Throughout Building

Distress: Inadequate

Notes: Fifty percent of branch wiring in the building is original, beyond its expected service life, reported as intermittent with multiple circuit breaker failures due to heavy technology loads, and should be replaced. There are also instances of wires exposed or not enclosed in conduit and/or junction boxes.

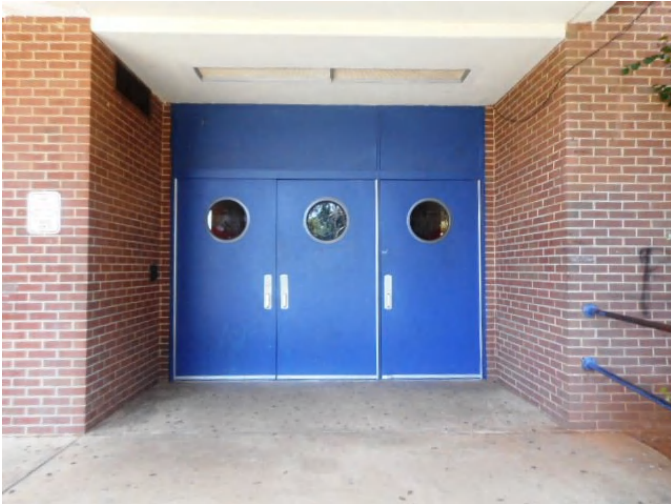
System: B2030 - Exterior Doors

Location: Throughout Building

Distress: Beyond Service Life

Notes: The original exterior doors are aged, rusted, and should be replaced. The exterior doors at auditorium do not seal properly.

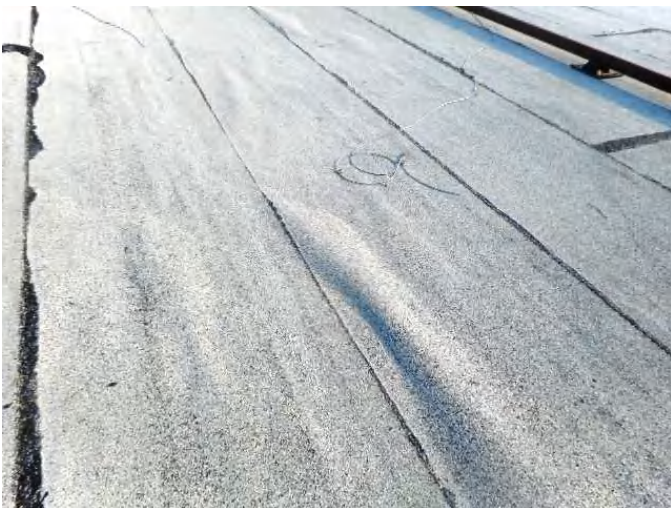
System: B3010 - Roof Coverings - BUR

Location: Roof

Distress: Beyond Service Life

Notes: Built-up roof covering is in deteriorating condition, with cracks, bubbling, patches and reported water leaks.

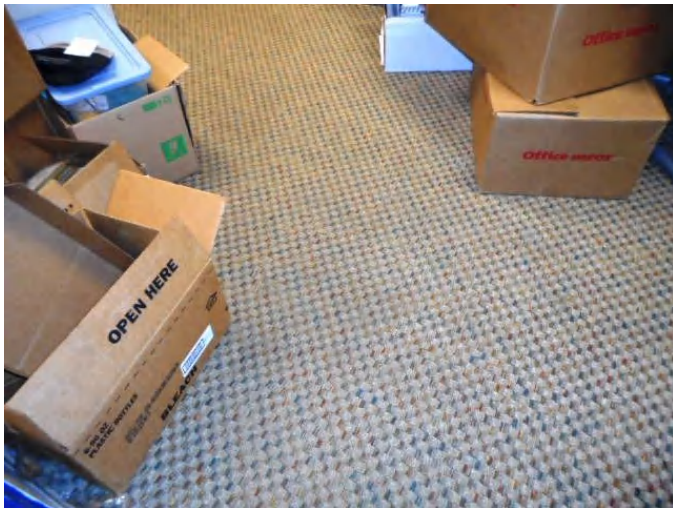
System: C3020 - Floor Finishes - Carpet

Location: Throughout Building

Distress: Beyond Service Life

Notes: The carpet is aged, stained and frayed, and should be replaced.

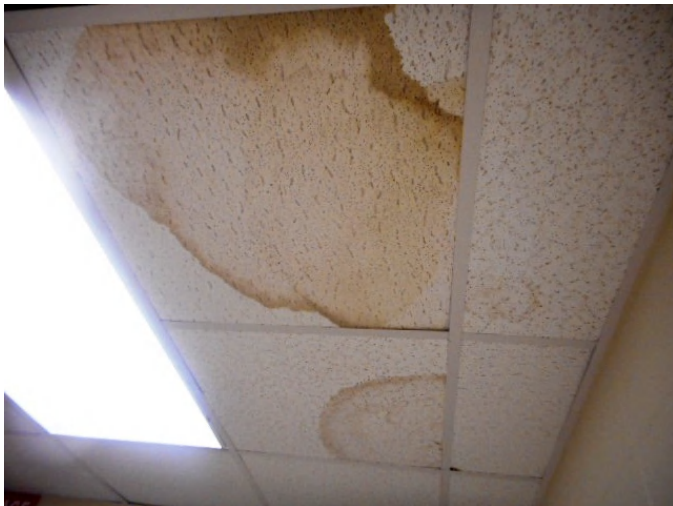
System: C3030 - Ceiling Finishes

Location: Throughout Building

Distress: Damaged

Notes: Some of the acoustical tiles are stained and destroyed due to roof leaks, and should be replaced.

Correction: Acoustic tile repairs - (2% of ceilings)

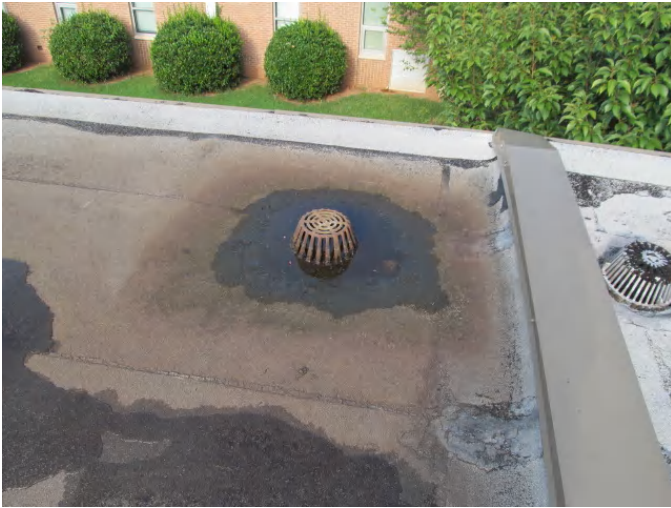
System: D2040 - Rain Water Drainage

Location: Throughout Building
Distress: Damaged
Category: Deferred Maintenance
Priority: 3 Priority
Correction: Renew System
Qty: 174,882.00
Unit of Measure: S.F.
Estimate: \$176,981.00
Assessor Name: Eduardo Lopez
Date Created: 04/11/2015

Notes: The roof drains are reported to not drain rain water and should be replaced.

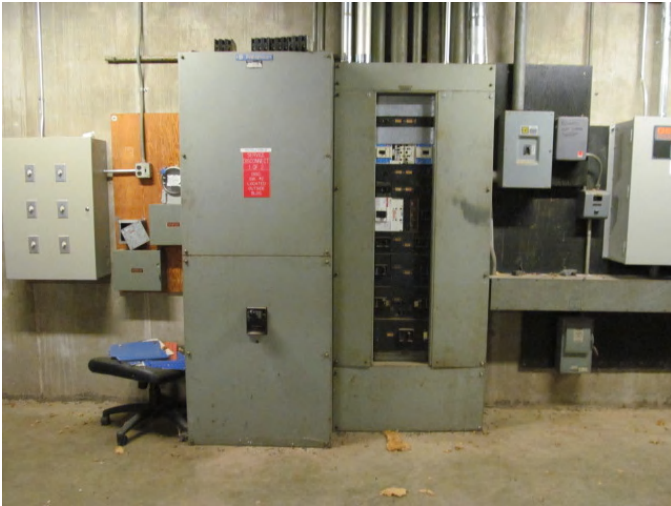
System: D5010 - Electrical Service/Distribution

Location: Main Switch Room/Throughout Building
Distress: Beyond Service Life
Category: Deferred Maintenance
Priority: 3 Priority
Correction: Renew System
Qty: 174,882.00
Unit of Measure: S.F.
Estimate: \$151,273.00
Assessor Name: Eduardo Lopez
Date Created: 04/11/2015

Notes: The original switchgear is beyond its expected service life, reported as intermittent, not properly integrated with the new (2006) switchgear installed externally, and should be replaced.

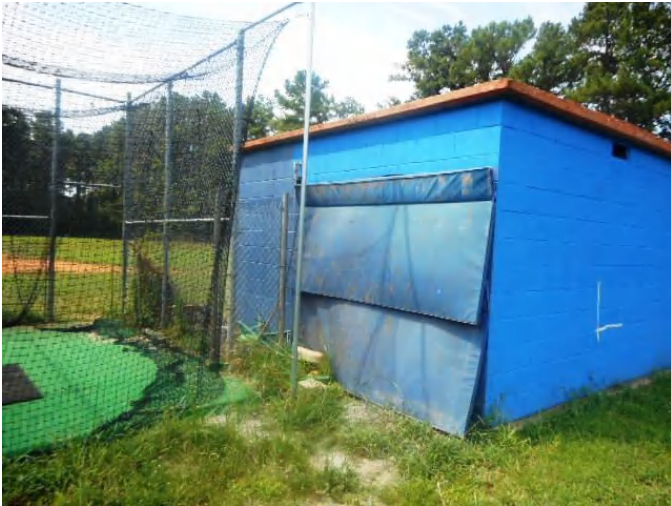
System: B3010 - Roof Coverings

Location: Roof

Distress: Beyond Service Life

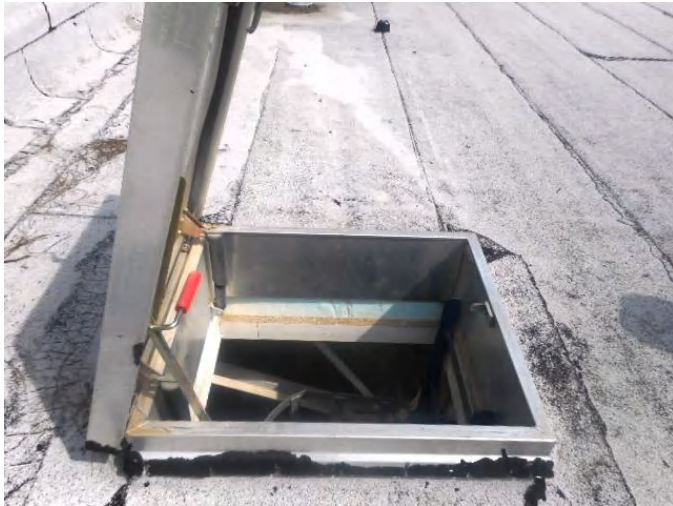
System: B3020 - Roof Openings

Location: Roof

Distress: Inadequate

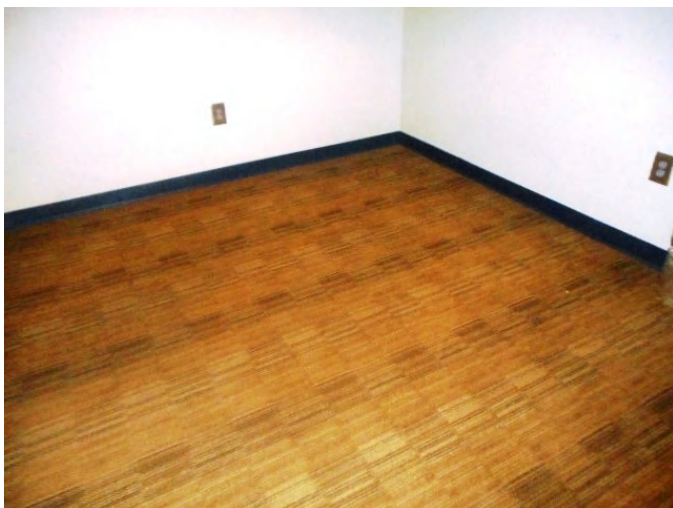
System: C3020 - Floor Finishes - Carpet

Location: Throughout Building

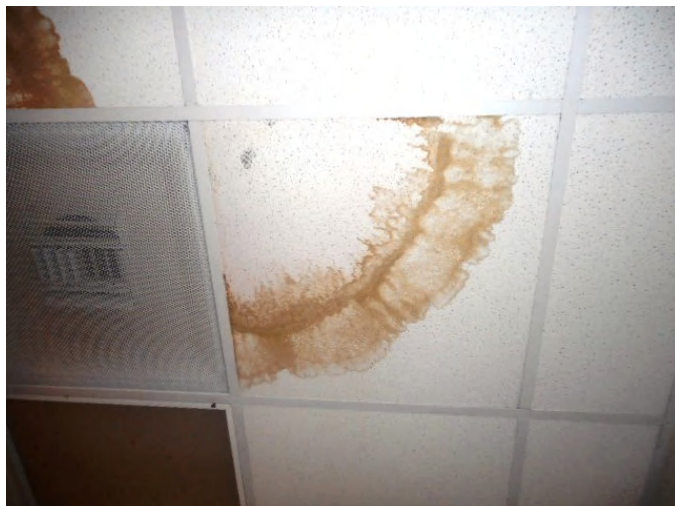
System: C3030 - Ceiling Finishes

Location: Throughout Building

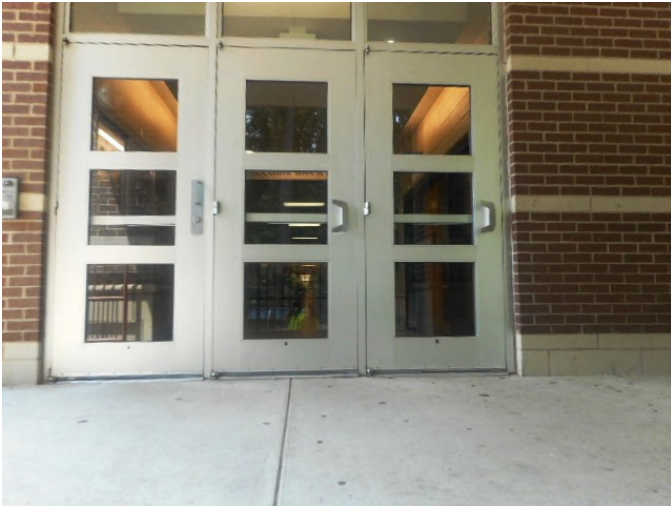
System: B2030 - Exterior Doors

Location: Throughout Building

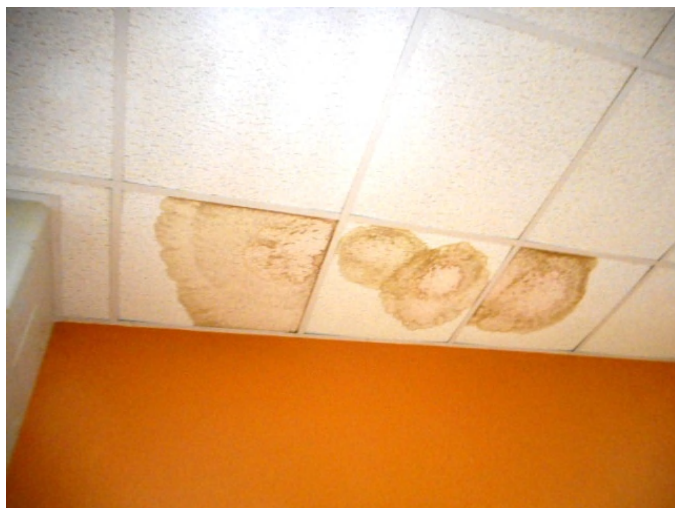
System: C3030 - Ceiling Finishes

Location: Throughout Building

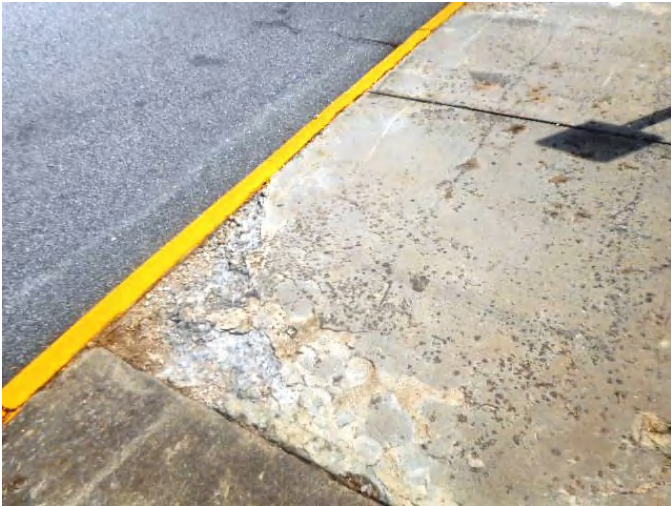
System: G2030 - Pedestrian Paving

Location: Site

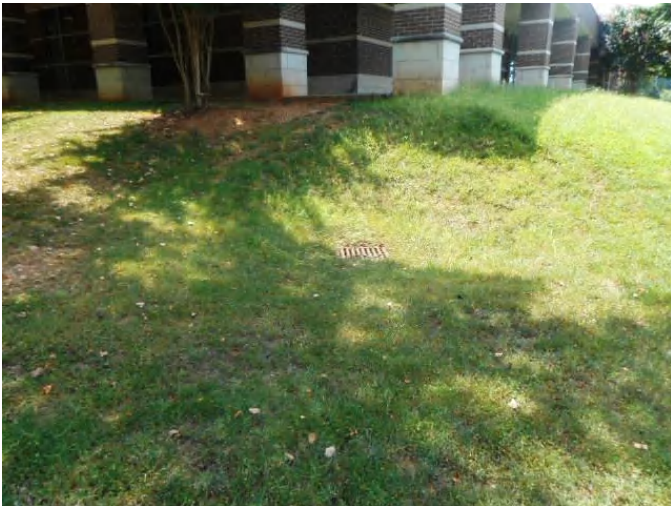
System: G2050 - Landscaping

Location: Site
