DeKalb County School District/Education Other

# DeKalb High of Technology, South Campus

Final  
School Assessment Report

May 19, 2016

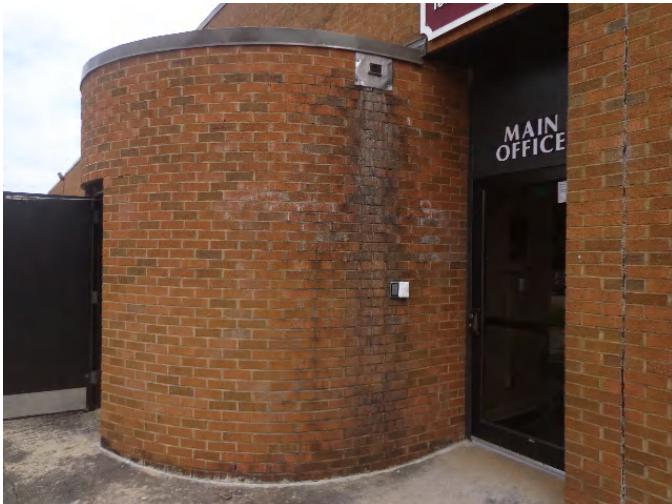
#### System: B2030 - Exterior Doors

**Location:** Throughout Building

**Distress:** Beyond Service Life

**Notes:** The original exterior doors are aged, rusted, inadequate and should be scheduled for replacement. The main entrance door does not comply with ADA standards and other emergency exit doors do not comply with building code, are missing panic hardware. The exterior storage room is inadequately ventilated and the exterior door could include a louver to prevent moisture built-up.

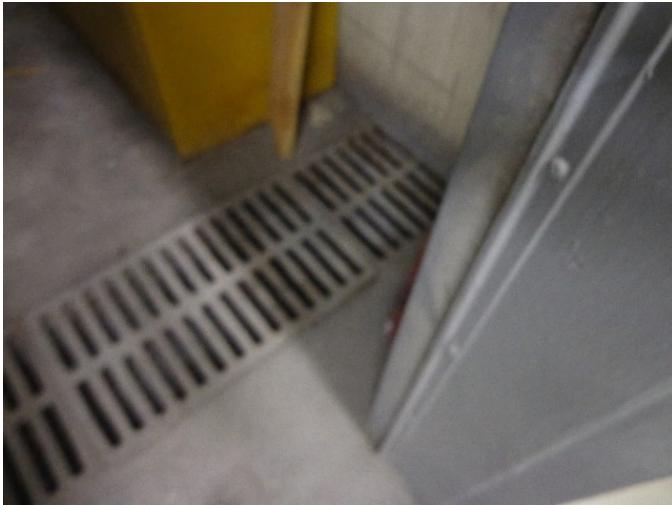
#### System: D2090 - Other Plumbing Systems - Acid Waste

**Location:** Vehicle Garage

**Distress:** Inadequate

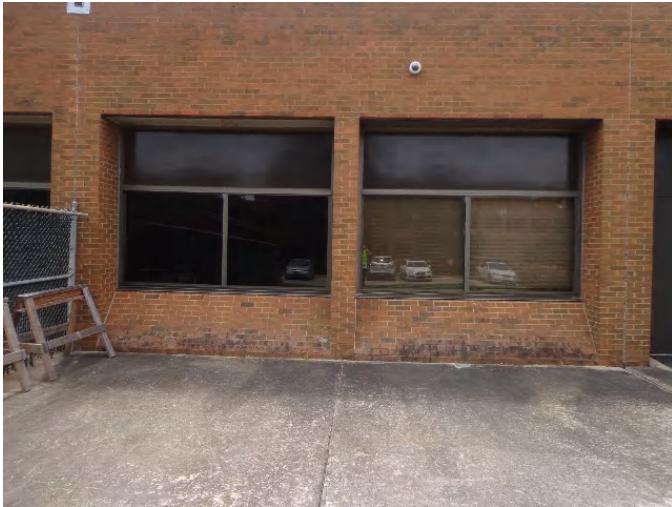
#### System: B2020 - Exterior Windows

**Location:** Throughout Building

**Distress:** Beyond Service Life

**Notes:** The aluminum frame, operable, single pane windows are aged, rusted, not energy efficient and should be replaced. The windows reportedly leak when it rains and do not lock/seal properly.

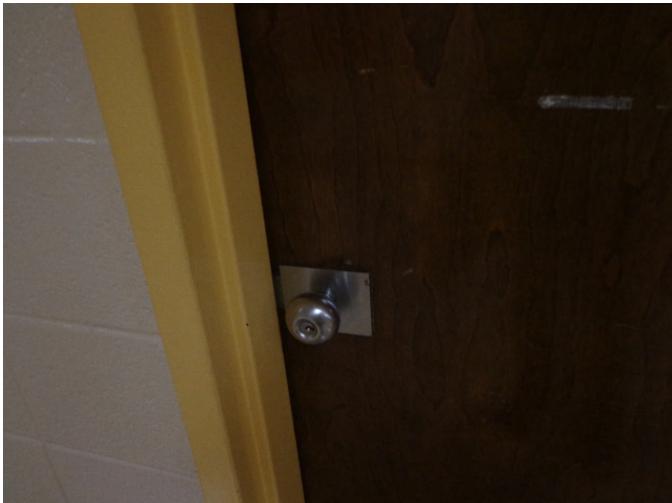
#### System: C1020 - Interior Doors

**Location:** Throughout Building

**Distress:** Beyond Service Life

**Notes:** The interior doors are aged, failing, not building code or ADA compliant, and should be replaced.

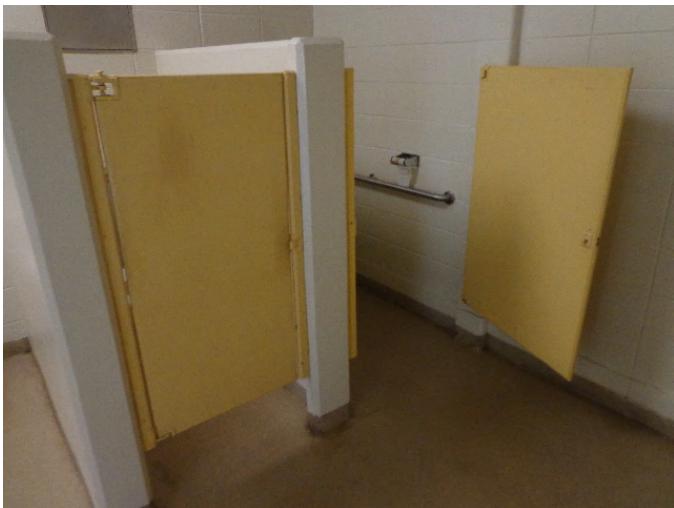
**System: C1030 - Fittings**

**Location:** Throughout Building

**Distress:** Beyond Service Life

**Notes:** Fittings, such as toilet partitions, handrails, and signage, are in marginal condition; toilet partitions and guardrails are missing; handrails and room signage are not ADA compliant and should be replaced.

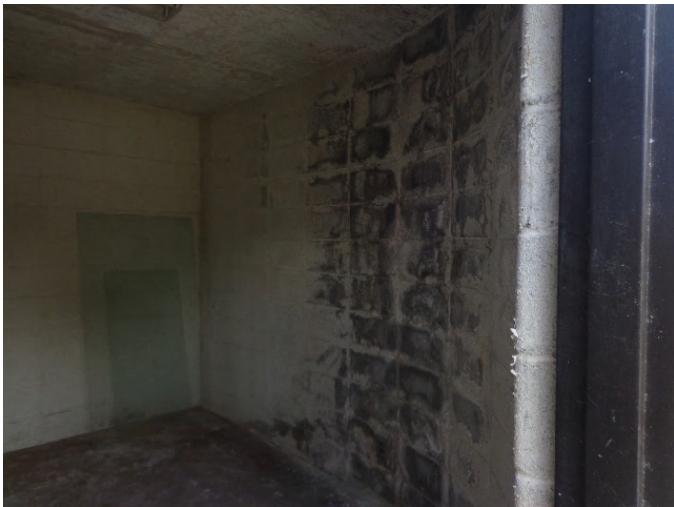
**System: C3010 - Wall Finishes - Paint**

**Location:** Throughout Building

**Distress:** Beyond Service Life

**Notes:** The painted wall finishes are aged, scuffed, fading, and stained, and should be replaced.

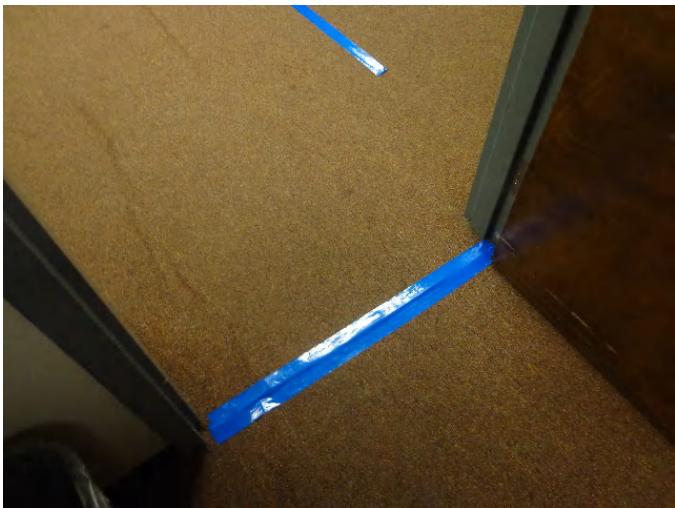
**System: C3020 - Floor Finishes - Carpet**

**Location:** Throughout Building

**Distress:** Beyond Service Life

**Notes:** The carpet is aged, stained, and torn, and should be replaced.

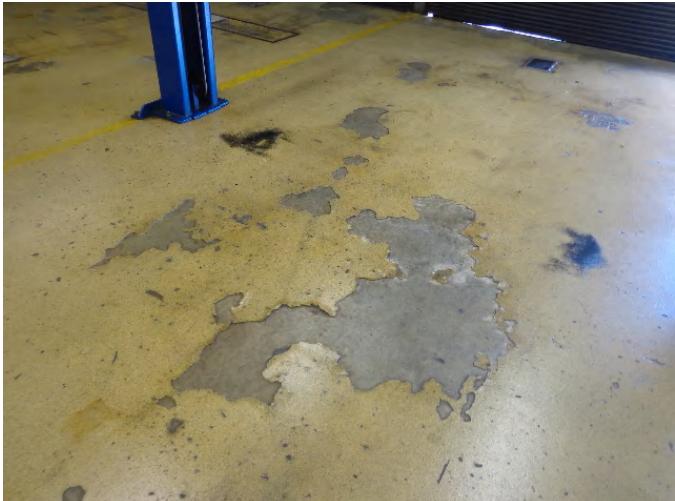
**System: C3020 - Floor Finishes - Epoxy Coating**

**Location:** Labs, Mechanical Rooms, and Restrooms

**Distress:** Beyond Service Life

**Notes:** The original epoxy floor finish is aged, cracked and worn, and should be replaced.

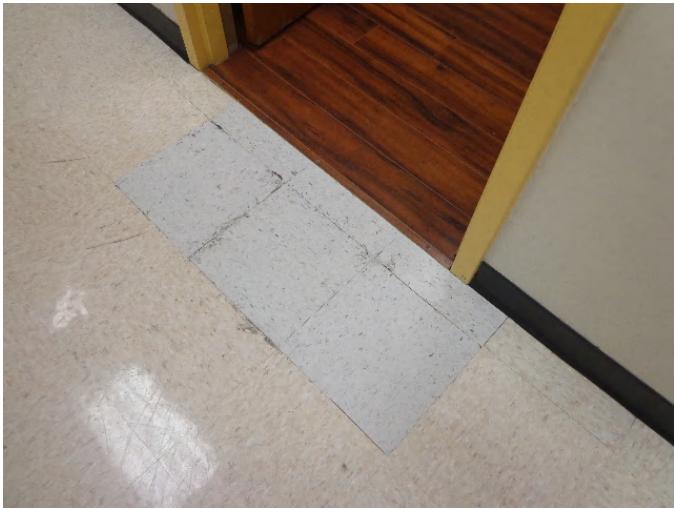
**System: C3020 - Floor Finishes - VCT**

**Location:** Throughout Building

**Distress:** Beyond Service Life

**Notes:** The VCT flooring is aged, cracked, and worn, and should be replaced.

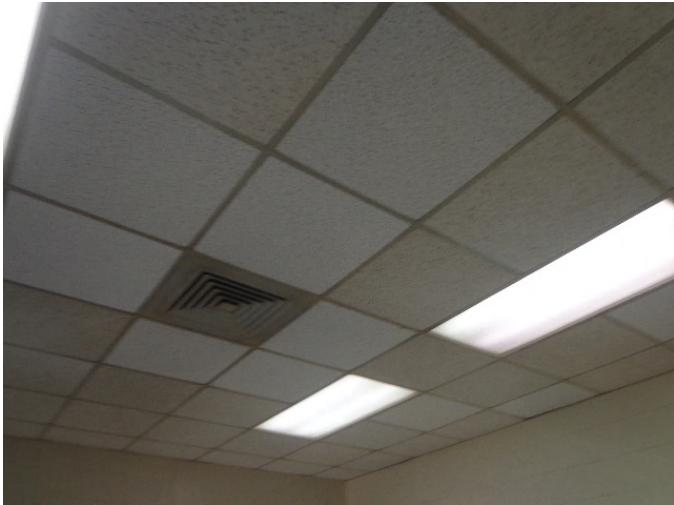
**System: C3030 - Ceiling Finishes**

**Location:** Throughout Building

**Distress:** Beyond Service Life

**Notes:** The acoustical ceiling tiles have been replaced as needed. However, the grid and most tiles are aged, sagging or damaged and should be replaced. In other areas, the ceiling paint is flaking or peeling and should also be replaced.

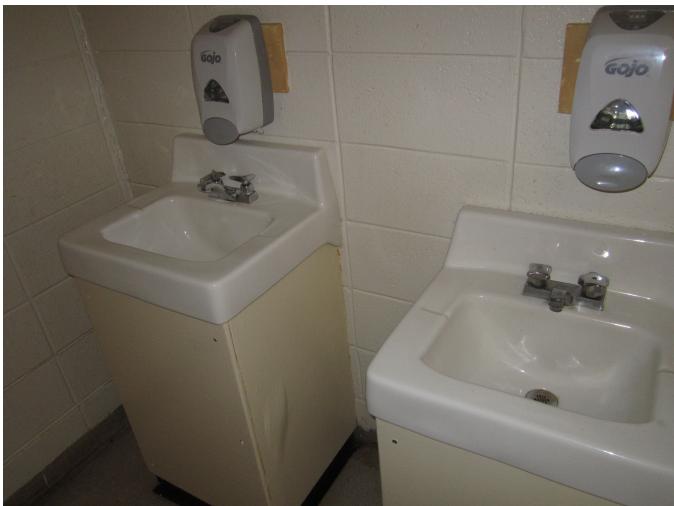
**System: D2010 - Plumbing Fixtures**

**Location:** Throughout Building

**Distress:** Beyond Service Life

**Notes:** Plumbing fixtures are beyond their expected service life, inadequate, inefficient, not ADA compliant, and should be scheduled for replacement.

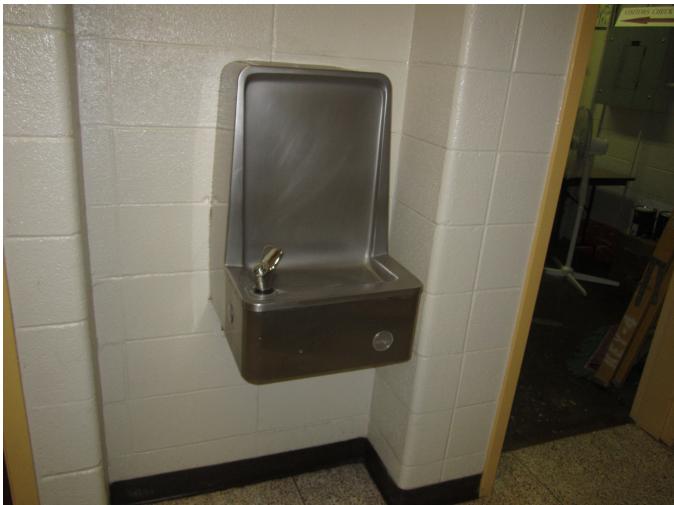
**System: D2020 - Domestic Water Distribution**

**Location:** Throughout Building

**Distress:** Beyond Service Life

**Notes:** Domestic water distribution is beyond its expected service life, not code compliant, has reported low pressure and line breaks, and should be scheduled for replacement.

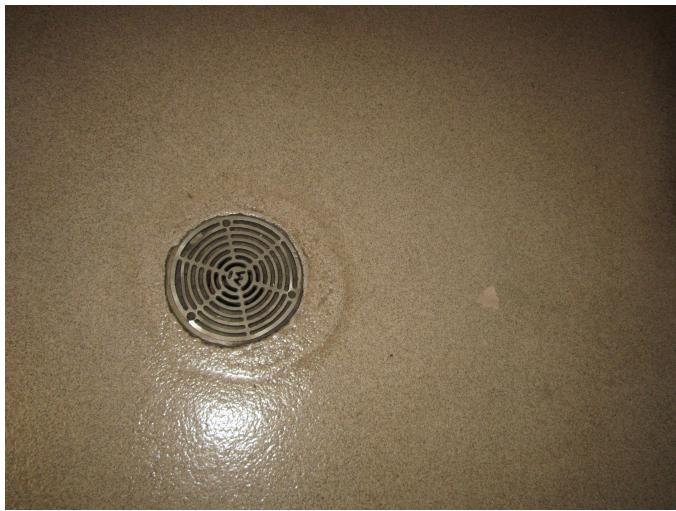
**System: D2030 - Sanitary Waste**

**Location:** Throughout Building

**Distress:** Beyond Service Life

**Notes:** The sanitary waste system is beyond its expected service life and should be scheduled for replacement. SPLOST 409-422 project to replace the grease trap and backflow preventer.

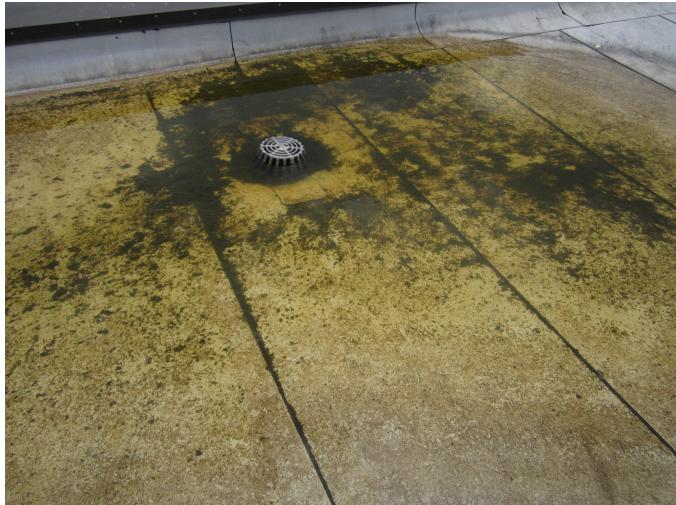
**System: D2040 - Rain Water Drainage**

**Location:** Roof

**Distress:** Beyond Service Life

**Notes:** Rain water drainage is beyond its expected service life, clogged with standing water, and should be scheduled for replacement.

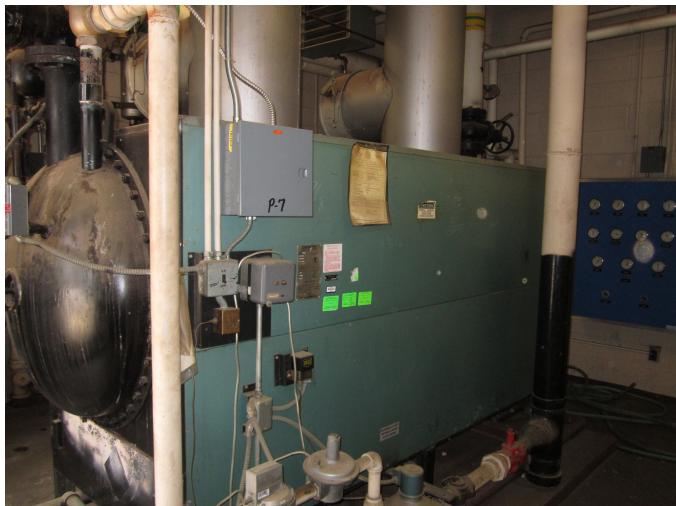
**System: D3020 - Heat Generating Systems**

**Location:** Rooftop Boiler Room

**Distress:** Beyond Service Life

**Notes:** The heat generating system is beyond its expected service life, not code compliant, and should be scheduled for replacement.

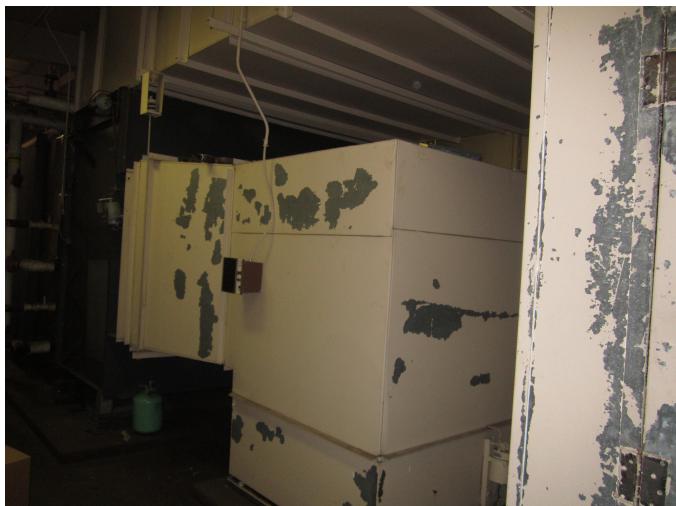
**System: D3040 - Distribution Systems & Exhaust Systems**

**Location:** Throughout Building

**Distress:** Beyond Service Life

**Notes:** Distribution and exhaust systems are beyond their expected service life, inadequate, and should be scheduled for replacement.

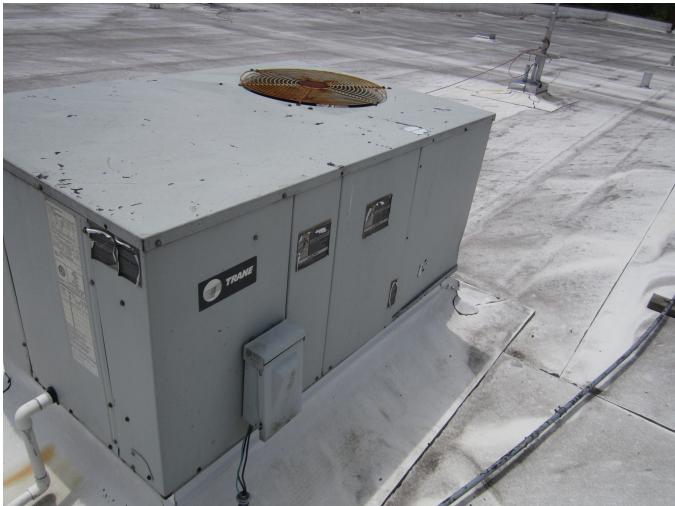
**System: D3050 - Terminal & Package Units**

**Location:** Roof

**Distress:** Beyond Service Life

**Notes:** Terminal and package units are beyond their expected service life and should be scheduled for replacement.

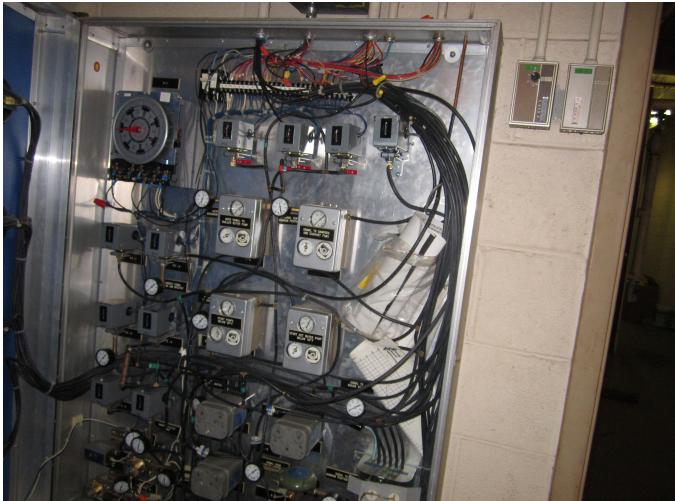
**System: D3060 - Controls & Instrumentation**

**Location:** Throughout Building

**Distress:** Beyond Service Life

**Notes:** Controls and instrumentation are beyond their expected service life, do not function properly, and should be scheduled for replacement.

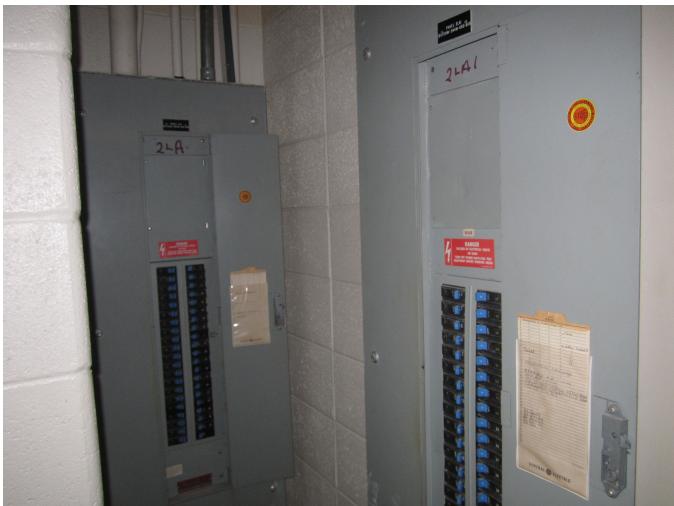
**System: D5020 - Branch Wiring**

**Location:** Throughout Building

**Distress:** Beyond Service Life

**Notes:** Branch wiring is beyond its expected service life, not code compliant, and should be scheduled for replacement. GFI outlets are missing in wet areas.

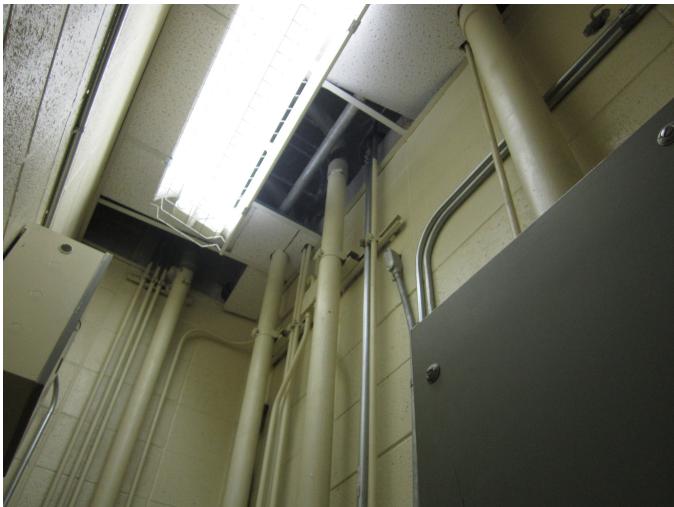
**System: D5020 - Lighting**

**Location:** Throughout Building

**Distress:** Beyond Service Life

**Notes:** Lighting is beyond its expected service life, inadequate, not energy efficient, and should be scheduled for replacement. SPLOST IV project 409-422 to upgrade all lighting fixture from T12 to T8 by November 2016.

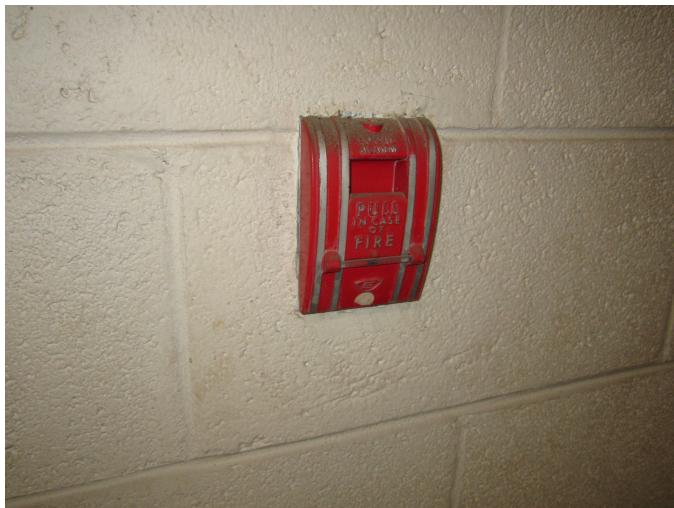
**System: D5030 - Communications and Security - Fire Alarm**

**Location:** Throughout Building

**Distress:** Beyond Service Life

**Notes:** The fire alarm system is beyond its expected service life, not code compliant, and should be scheduled for replacement.

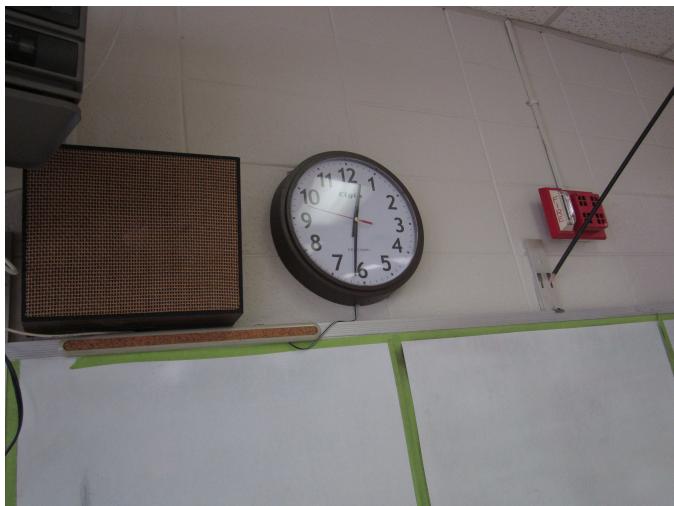
**System: D5030 - Communications and Security - PA & Clock Systems**

**Location:** Throughout Building

**Distress:** Beyond Service Life

**Notes:** PS and clock systems are beyond their expected service life and should be scheduled for replacement.

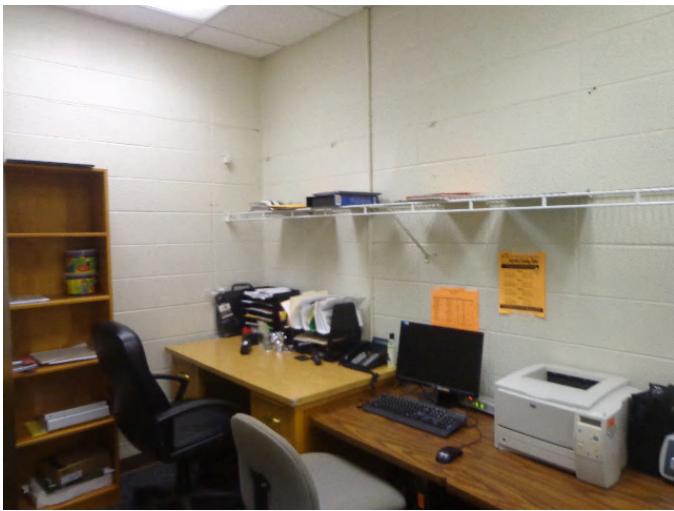
**System: D5030 - Communications and Security - Telephone Systems**

**Location:** Throughout Building

**Distress:** Beyond Service Life

**Notes:** Telephone systems are beyond their expected service life and should be scheduled for replacement.

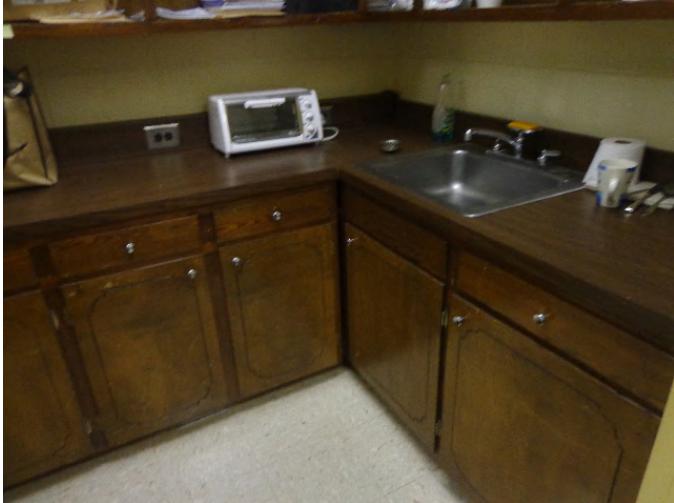
**System: E2010 - Fixed Furnishings**

**Location:** Throughout Building

**Distress:** Beyond Service Life

**Notes:** The fixed furnishings are aged, in marginal condition, and should be scheduled for replacement. Window treatment is also needed for all windows.

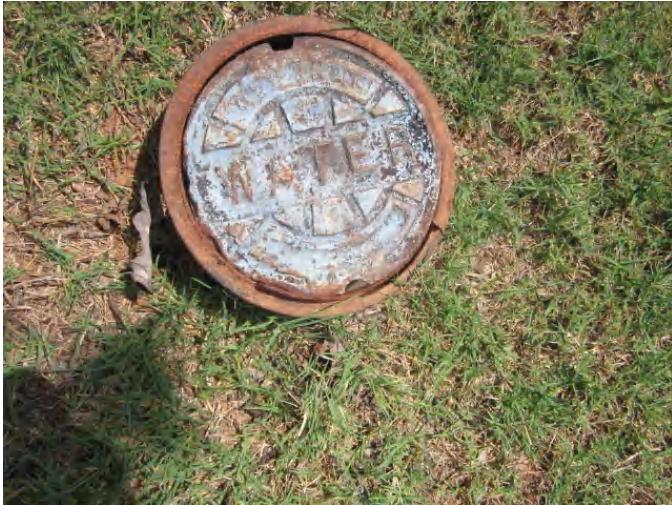
#### System: G3010 - Water Supply

**Location:** Site

**Distress:** Missing

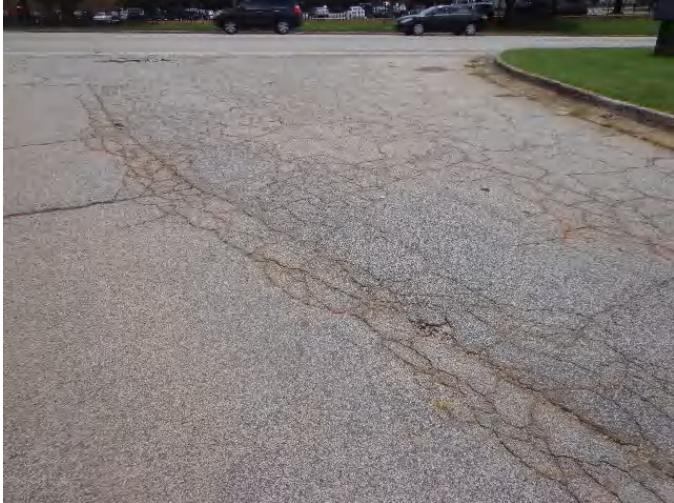
### System: G2010 - Roadways

**Location:** Site

**Distress:** Beyond Service Life

**Notes:** Roadways are aged, have many road cuts, cracks, and potholes, and should be repaved.

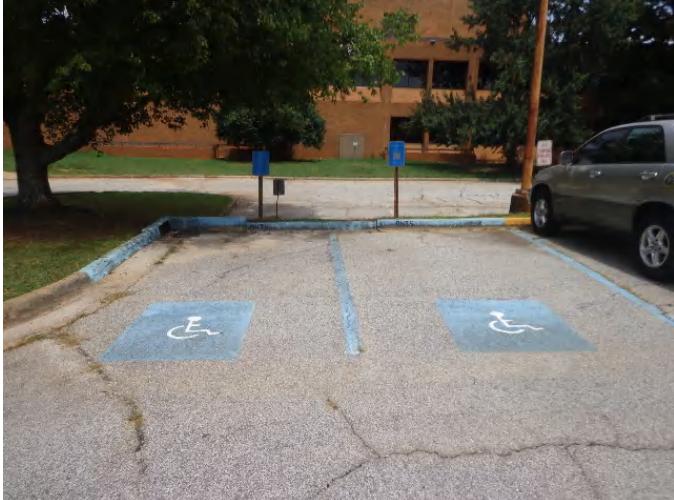
### System: G2020 - Parking Lots

**Location:** Site

**Distress:** Beyond Service Life

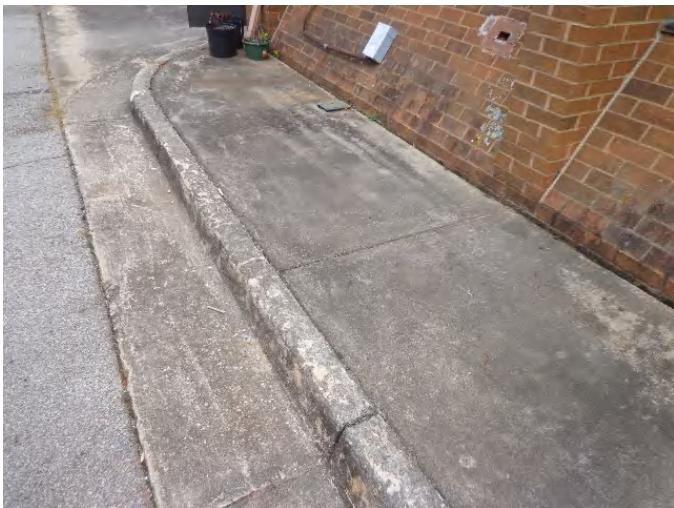
## **System: G2030 - Pedestrian Paving**

**Location:** Site

**Distress:** Beyond Service Life

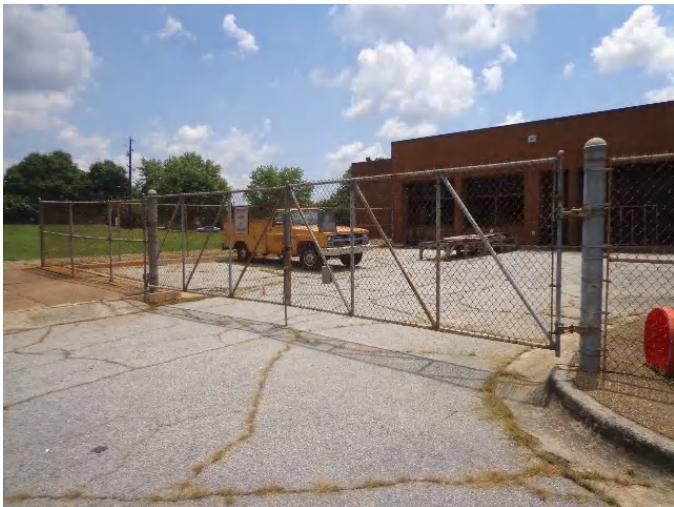
## **System: G2040 - Fencing & Guardrails**

**Location:** Site

**Distress:** Beyond Service Life

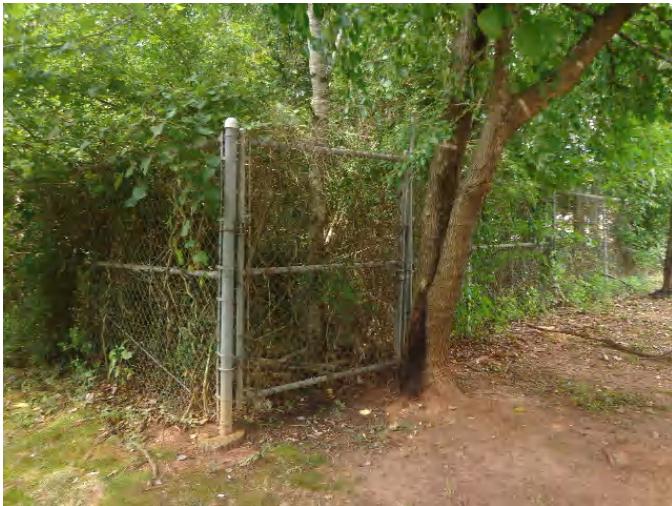
### **System: G3030 - Storm Sewer**

**Location:** Retention Pond

**Distress:** Inadequate

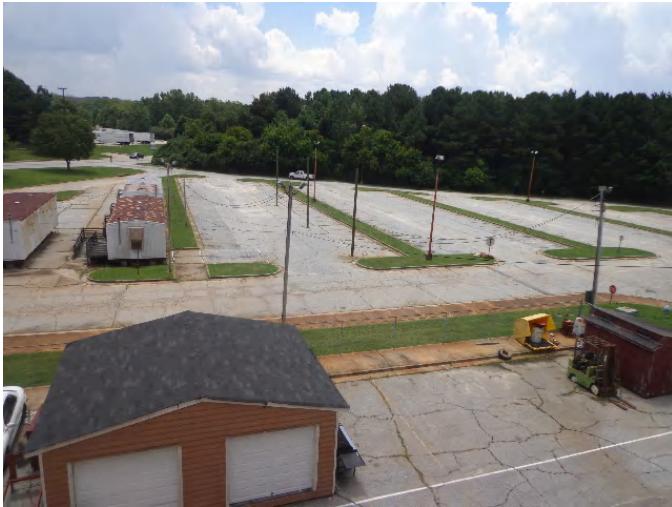
### **System: G4020 - Site Lighting**

**Location:** Site

**Distress:** Beyond Service Life

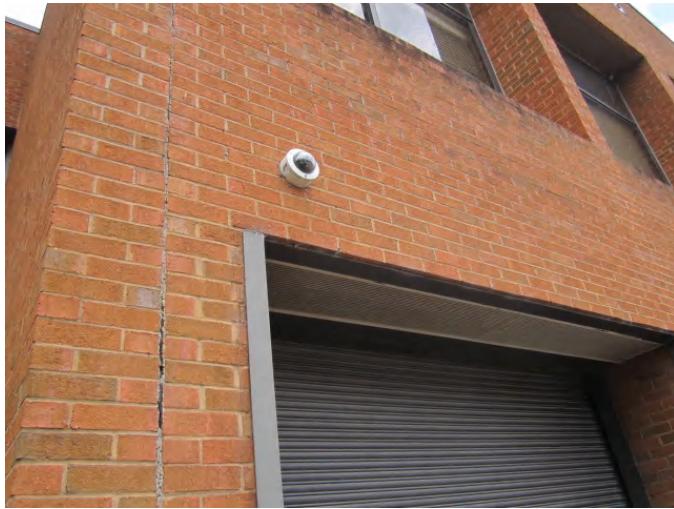
### **System: G4030 - Site Communications & Security**

**Location:** Site

**Distress:** Beyond Service Life
