DeKalb County School District/High Schools

Druid Hills High

School Assessment Report
May 19, 2016

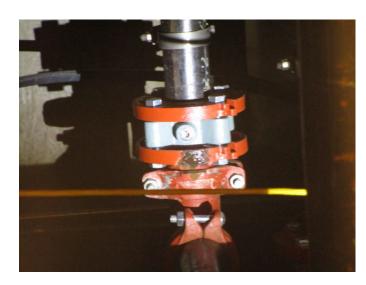
System: D4010 - Sprinklers

Location: Hallway Near Room 303

Distress: Damaged

Notes: The sprinkler system has reportedly leaked for an extended period in the hallway near room 303. Estimate is for repairs.

Correction: Replace sprinkler head

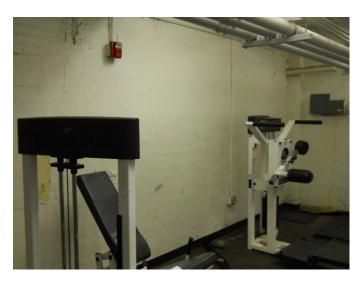
System: A2020 - Basement Walls

Location: Gym Basement, Multiple Locations

Distress: Damaged

Correction: Repair Seepage

Notes: Repair seepage in basement walls at multiple locations.

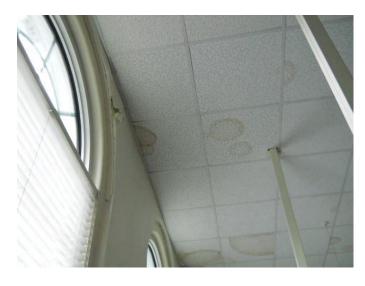
System: B2010 - Exterior Walls

Location: Exterior Walls in Rooms 307 and Chorus 105

Distress: Damaged

Notes: Water leaks through the exterior walls/parapets into the rooms. Estimate to repair the exterior wall and interior damage. Repairs will require a truck with a boom lift.

Correction: Replace clay brick wall, 3rd floor

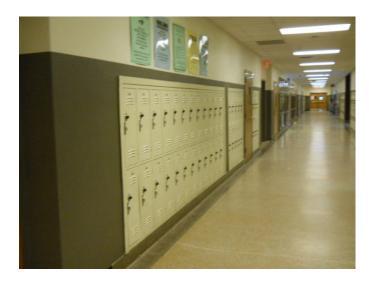
System: C1030 - Fittings

Location: Throughout Building

Distress: Beyond Service Life

Notes: Fittings, such as toilet partitions, handrails, signage and lockers, are beyond their expected service life and should be replaced. Handrails not code compliant at stairwells.

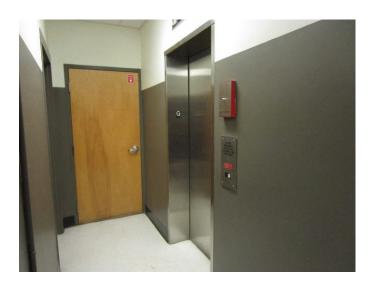
System: D1010 - Elevators and Lifts

Location: Northwest Side of Building

Distress: Beyond Service Life

Notes: The elevator is reported as unreliable and should be repaired or replaced.

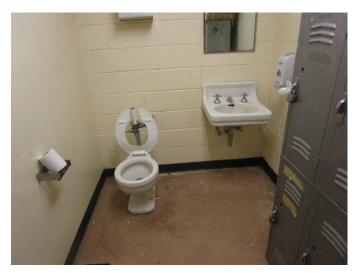
System: D2010 - Plumbing Fixtures

Location: Throughout Building

Distress: Beyond Service Life

Notes: The plumbing fixtures are beyond their expected service life and should be scheduled for replacement. SPLOST project 410-422 to replace plumbing fixtures as needed throughout the building.

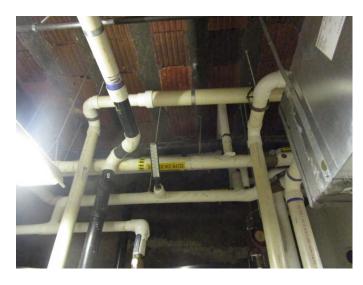
System: D2020 - Domestic Water Distribution

Location: Throughout Building

Distress: Beyond Service Life

Notes: The domestic water distribution system is beyond its expected service life, has water quality issues, and should be scheduled for replacement. SPLOST project 410-422 to replace the interior building domestic water piping mains in the 1950, 1953, 1961 and 1965 buildings.

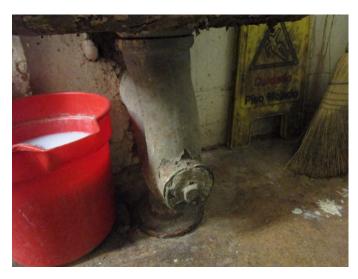
System: D2030 - Sanitary Waste

Location: Throughout Building

Distress: Beyond Service Life

Notes: The sanitary waste system is beyond its expected service life and should be scheduled for replacement. SPLOST project 410-422 to replace grease trap and backflow preventer.

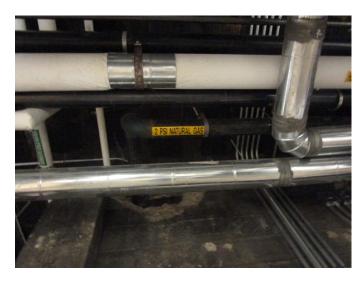
System: D2090 - Other Plumbing Systems - Natural Gas

Location: Throughout Building

Distress: Beyond Service Life

Notes: The natural gas system is beyond its expected service life and should be scheduled for replacement.

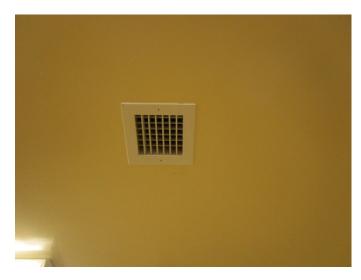
System: D3040 - Distribution Systems & Exhaust Systems

Location: Throughout Building

Distress: Inadequate

Notes: The distribution and exhaust systems are inadequate and should be scheduled for replacement.

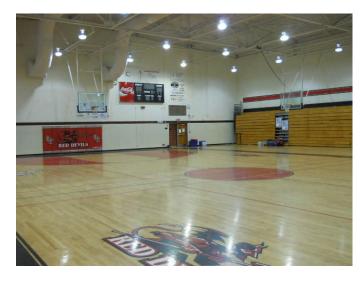
System: E1090 - Other Equipment - Sports Equipment

Location: Gym

Distress: Beyond Service Life

Notes: Sports equipment is beyond its expected service life and should be scheduled for replacement.

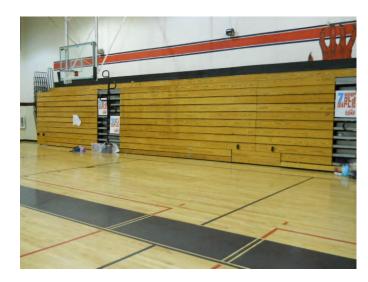
System: E2020 - Moveable Furnishings

Location: Gym

Distress: Beyond Service Life

Notes: The movable bleacher seating system is beyond its expected service life and should be scheduled for replacement.

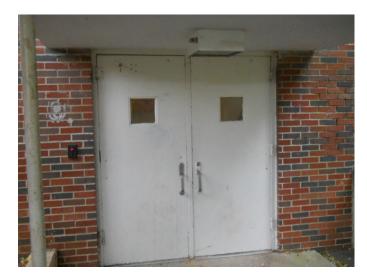
System: B2030 - Exterior Doors

Location: Throughout Building

Distress: Beyond Service Life

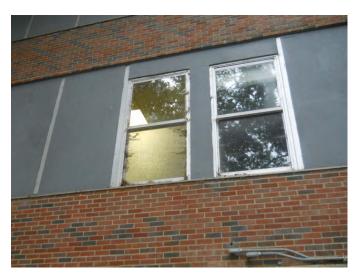
System: B2020 - Exterior Windows

Location: Throughout Building

Distress: Beyond Service Life

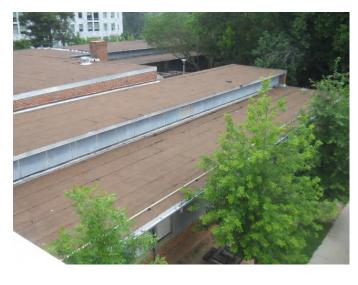
System: B3010 - Roof Coverings - BUR

Location: Roof

Distress: Beyond Service Life

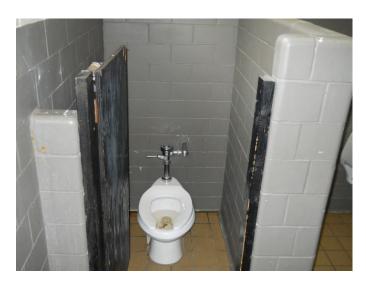
System: C1030 - Fittings

Location: Throughout Building

Distress: Beyond Service Life

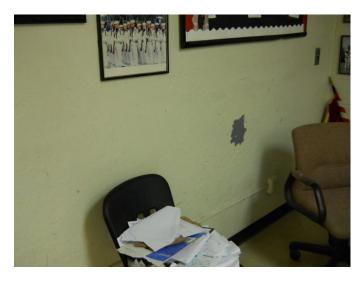
System: C3010 - Wall Finishes - Paint

Location: Throughout Building

Distress: Beyond Service Life

Notes: The painted wall finishes are beyond their expected service life and should be replaced.

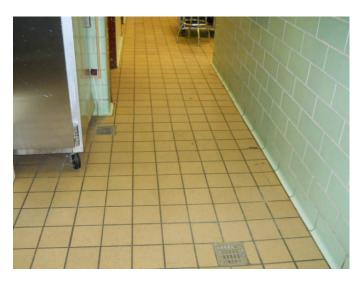
System: C3020 - Floor Finishes - Ceramic & Quarry Tile

Location: Kitchen and Restrooms

Distress: Beyond Service Life

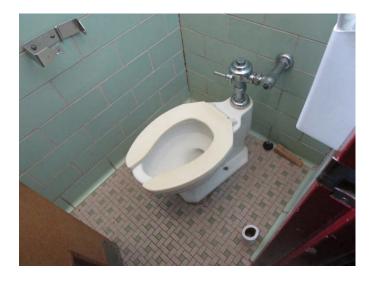
System: D2010 - Plumbing Fixtures

Location: Throughout Building

Distress: Beyond Service Life

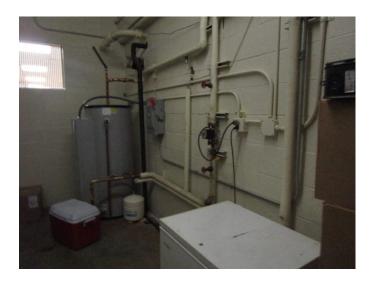
System: D2020 - Domestic Water Distribution

Location: Throughout Building

Distress: Beyond Service Life

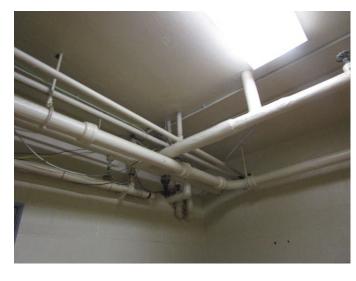
System: D2030 - Sanitary Waste

Location: Throughout Building

Distress: Beyond Service Life

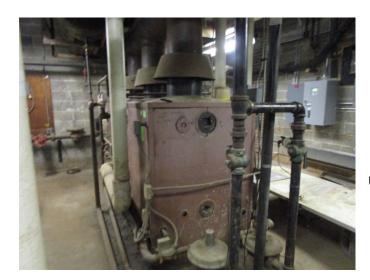
System: D3020 - Heat Generating Systems

Location: Mechanical Room

Distress: Beyond Service Life

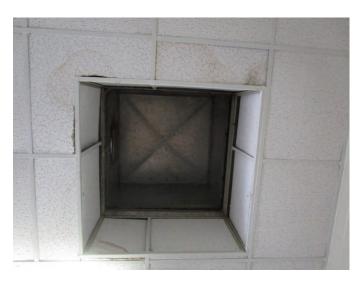
System: D3040 - Distribution Systems & Exhaust Systems

Location: Throughout Building

Distress: Beyond Service Life

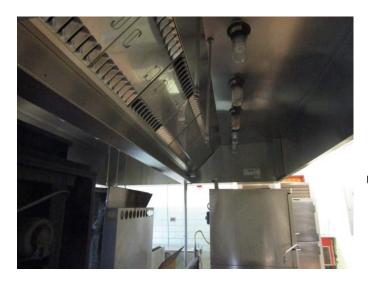
System: D3090 - Other HVAC Systems/Equip - Kitchen Hood

Location: Kitchen

Distress: Beyond Service Life

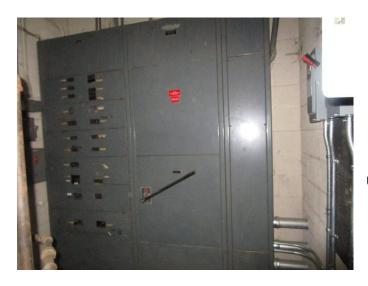
System: D5010 - Electrical Service/Distribution

Location: Main Switch Room/Throughout Building

Distress: Beyond Service Life

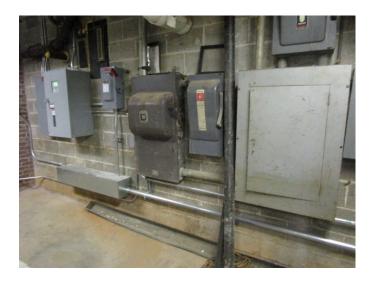
System: D5020 - Branch Wiring

Location: Throughout Building

Distress: Beyond Service Life

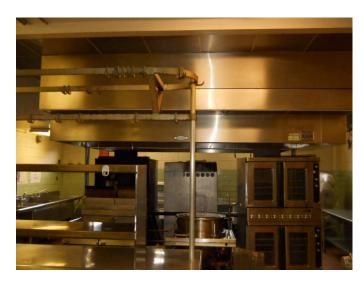
System: E1090 - Other Equipment - Kitchen Equipment

Location: Kitchen

Distress: Beyond Service Life

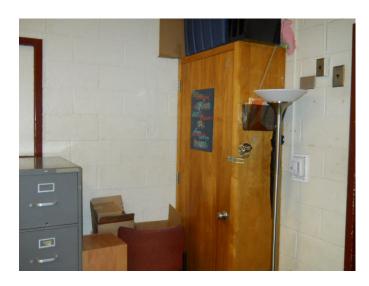
System: E2010 - Fixed Furnishings

Location: Throughout Building

Distress: Beyond Service Life

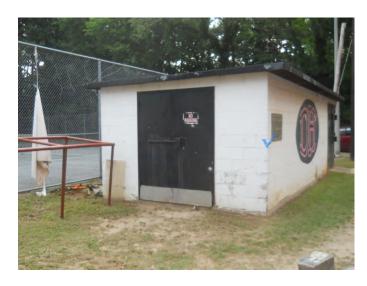
System: B2030 - Exterior Doors

Location: Exterior Walls

Distress: Beyond Service Life

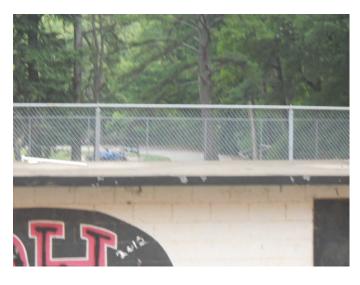
System: B3010 - Roof Coverings

Location: Roof

Distress: Beyond Service Life

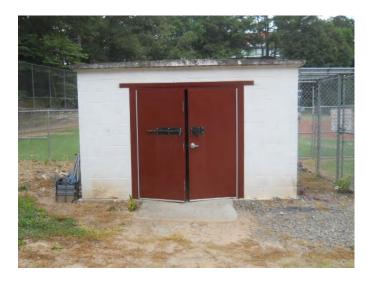
System: B2030 - Exterior Doors

Location: Exterior Wall

Distress: Beyond Service Life

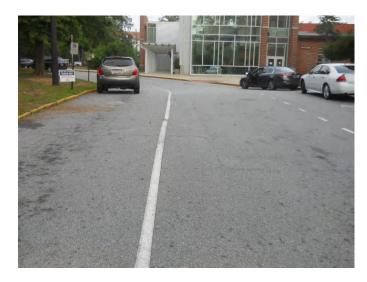
System: G2010 - Roadways

Location: Site

Distress: Beyond Service Life

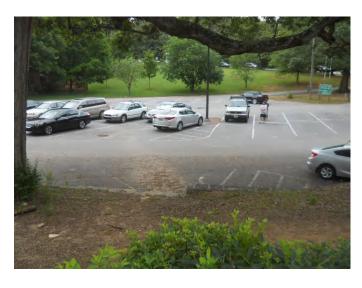
System: G2020 - Parking Lots

Location: Site

Distress: Beyond Service Life

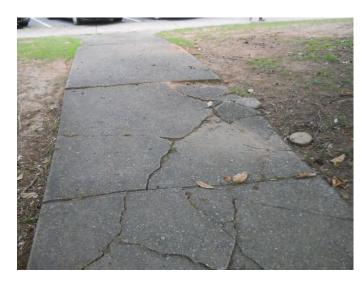
System: G2030 - Pedestrian Paving

Location: Site

Distress: Beyond Service Life

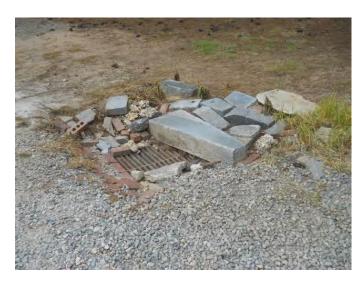
System: G3030 - Storm Sewer

Location: Site

Distress: Beyond Service Life

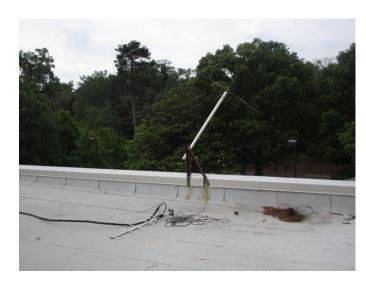
System: G4030 - Site Communications & Security

Location: Site

Distress: Beyond Service Life

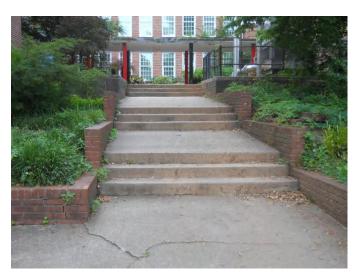
System: G2040 - Covered Walkways

Location: Site

Distress: Beyond Service Life

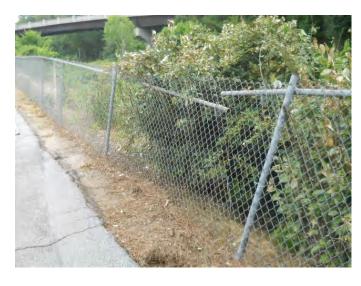
System: G2040 - Fencing & Guardrails

Location: Site

Distress: Beyond Service Life

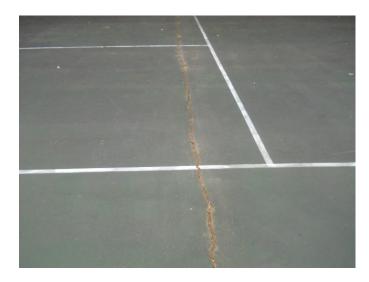
System: G2040 - Tennis Courts

Location: Site

Distress: Beyond Service Life

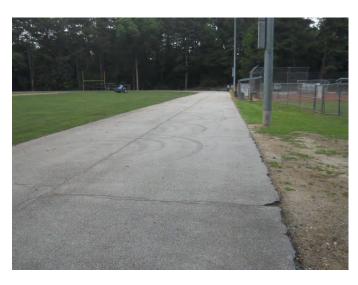
System: G2040 - Track

Location: Site

Distress: Beyond Service Life

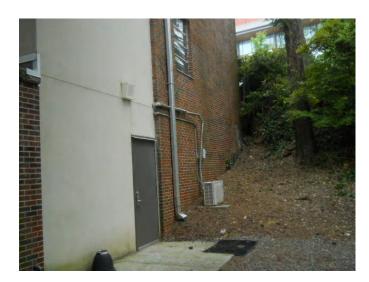
System: G2050 - Landscaping

Location: Site

Distress: Beyond Service Life

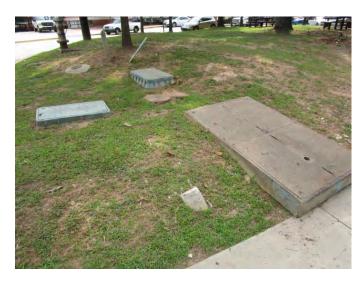
System: G3010 - Water Supply

Location: Site

Distress: Beyond Service Life

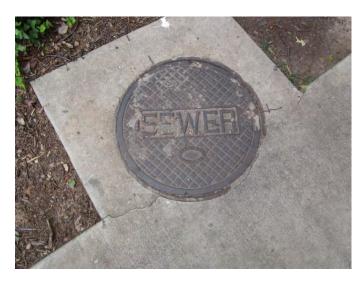
System: G3020 - Sanitary Sewer

Location: Site

Distress: Beyond Service Life

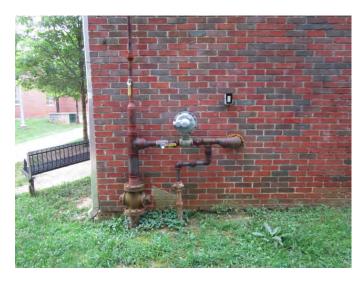
System: G3060 - Fuel Distribution

Location: Site

Distress: Beyond Service Life

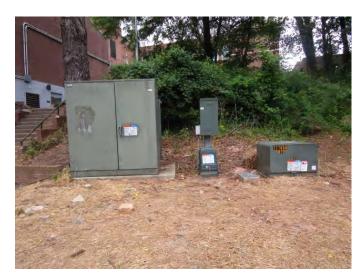
System: G4010 - Electrical Distribution

Location: Site

Distress: Beyond Service Life
