**DeKalb County School District/Middle Schools**

# **Druid Hills Middle**

School Assessment Report
May 20, 2016

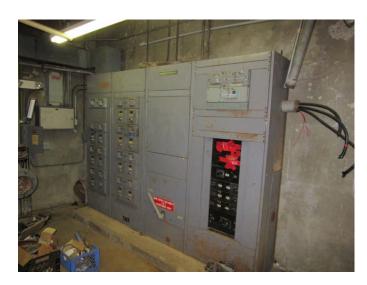
#### System: D5010 - Electrical Service/Distribution

**Location:** Electrical Room

**Distress:** Beyond Service Life

**Notes:** The primary service for the building is beyond its expected service life, inadequate, does not support current needs, such as modern security cameras, and should be scheduled for replacement.

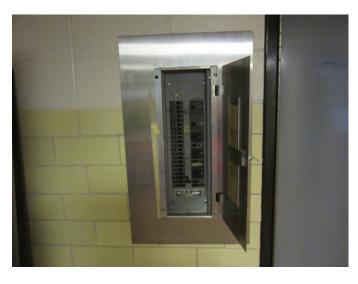
#### System: D5020 - Branch Wiring

**Location:** Throughout Building

**Distress:** Beyond Service Life

**Notes:** Branch wiring is aged, no longer supports current needs, and should be scheduled for replacement. Rooms do not have sufficient electrical outlets and many power strips are used, causing potentially unsafe situations.

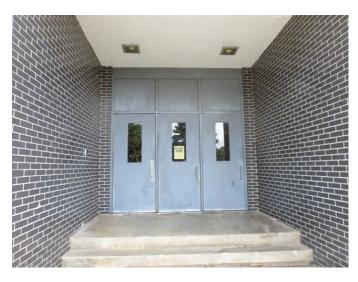
#### System: B2030 - Exterior Doors

**Location:** Throughout Building

**Distress:** Beyond Service Life

Notes: The original exterior doors are aged, rusted, not energy efficient, and should be replaced.

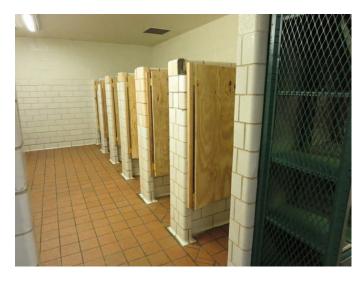
#### System: C1030 - Fittings

**Location:** Throughout Building

**Distress:** Beyond Service Life

**Notes:** Fittings, such as toilet partitions, handrails, lockers and signage, are aged, damaged, and should be replaced.

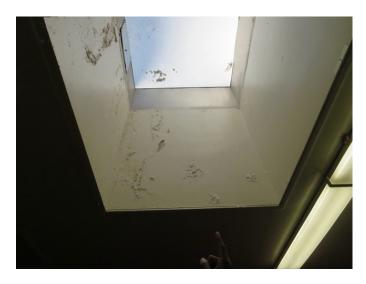
#### System: C3010 - Wall Finishes - Paint

**Location:** Throughout Building

**Distress:** Beyond Service Life

**Notes:** Painted wall finishes are beyond their expected service life, damaged in areas, and should be replaced.

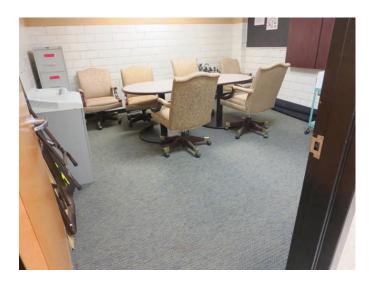
### System: C3020 - Floor Finishes - Carpet

Location: Offices, Band Room and Media Center

**Distress:** Beyond Service Life

**Notes:** The carpet is aged and frayed and should be replaced.

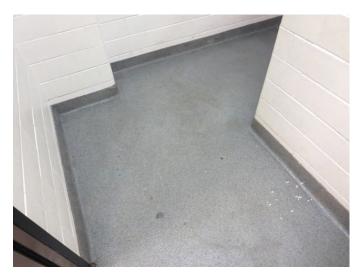
#### System: C3020 - Floor Finishes - Epoxy

**Location:** Restrooms

**Distress:** Beyond Service Life

**Notes:** The epoxy flooring is in poor condition and should be replaced.

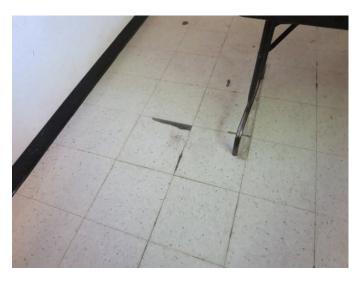
#### System: C3020 - Floor Finishes - VCT

**Notes:** The VCT is aged, cracking and should be replaced.

**Location:** Throughout Building

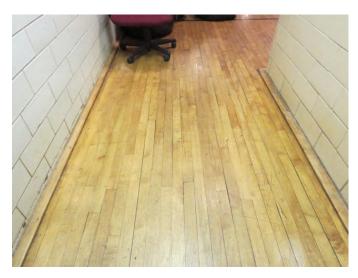
#### System: C3020 - Floor Finishes - Wood

Location: Gym

**Distress:** Beyond Service Life

**Notes:** The wood flooring is aged, worn due to extensive use, and should be replaced.

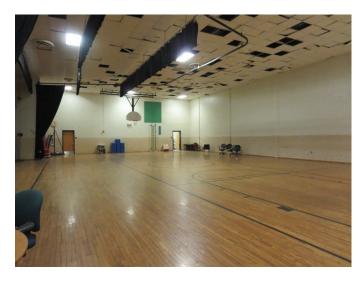
#### System: C3030 - Ceiling Finishes

Location: Gym

**Distress:** Damaged

**Notes:** The acoustical ceiling system in the gym is in poor condition, poses a significant safety hazard, and should be replaced with a more suitable ceiling system.

**Correction:** Replace acoustic tile ceiling, non fire-rated

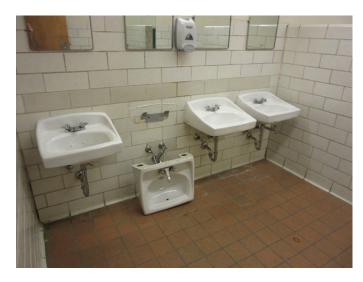
#### System: D2010 - Plumbing Fixtures

**Location:** Throughout Building

**Distress:** Beyond Service Life

**Notes:** Some plumbing fixtures have been recently replaced; however, the rest are beyond their expected service life, in poor condition, and should be scheduled for replacement. Showers in the locker rooms do not work.

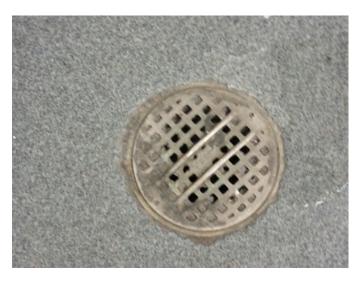
#### System: D2030 - Sanitary Waste

**Location:** Throughout Building

**Distress:** Beyond Service Life

**Notes:** The sanitary waste system is beyond its expected service life and should be scheduled for replacement. SPLOST project 427-422 to replace grease trap and backflow preventer.

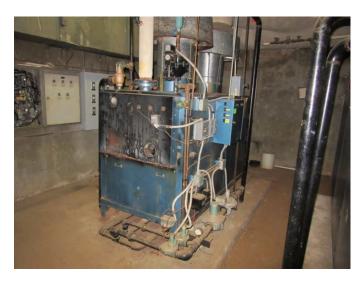
#### System: D3020 - Heat Generating Systems

**Location:** Boiler Room

**Distress:** Beyond Service Life

**Notes:** The boilers are beyond their expected service life, contain material identified to be hazardous, and should be scheduled for replacement.

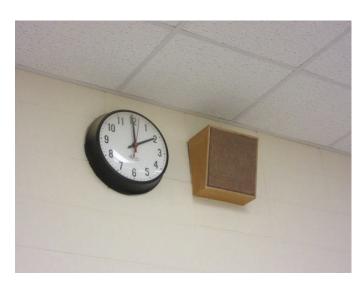
#### System: D5030 - Communications and Security - PA & Clock Systems

**Location:** Throughout Building

**Distress:** Beyond Service Life

**Notes:** PA and clock systems are beyond their expected service life, inadequate, and should be replaced. School staff reports that the sound is poor/non-existent in the hallways and gym.

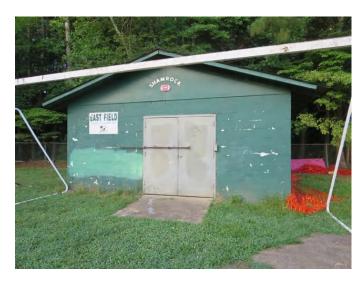
**System: B2010 - Exterior Walls**

**Location:** Exterior Walls

**Distress:** Beyond Service Life

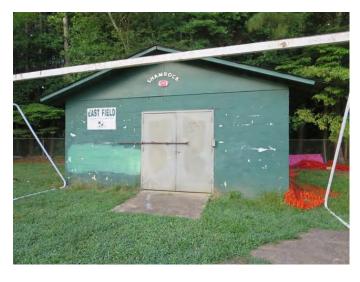
#### System: B2030 - Exterior Doors

**Location:** Exterior Wall

**Distress:** Beyond Service Life

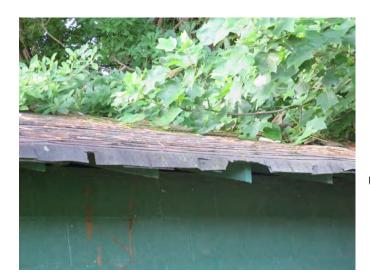
#### System: B3010 - Roof Coverings

**Location:** Roof

**Distress:** Beyond Service Life

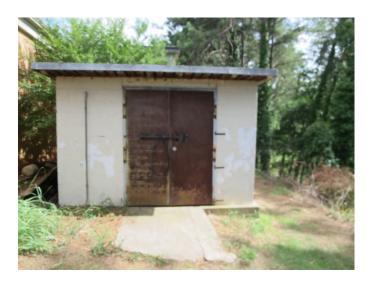
System: B2030 - Exterior Doors

**Location:** Exterior Wall

**Distress:** Beyond Service Life

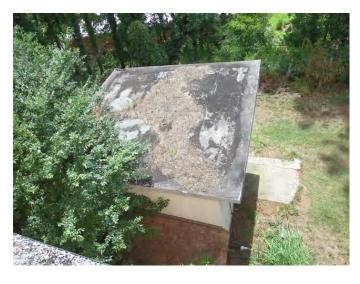
### System: B3010 - Roof Coverings

Location: Roof

**Distress:** Beyond Service Life

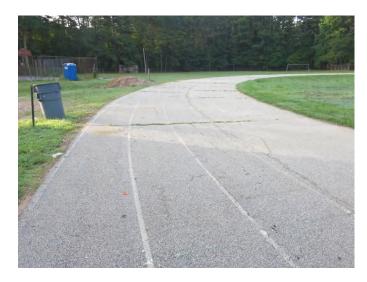
System: G2040 - Track

Location: Site

**Distress:** Beyond Service Life

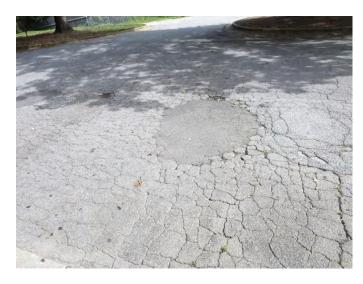
## System: G2010 - Roadways

**Location:** Site

**Distress:** Damaged

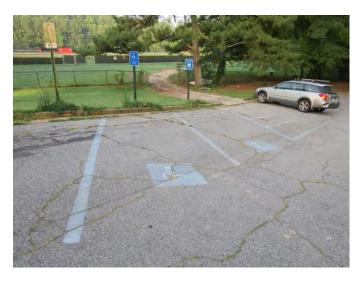
#### System: G2020 - Parking Lots

Location: Site

**Distress:** Beyond Service Life

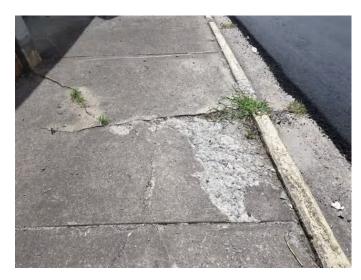
### System: G2030 - Pedestrian Paving

Location: Site

**Distress:** Beyond Service Life

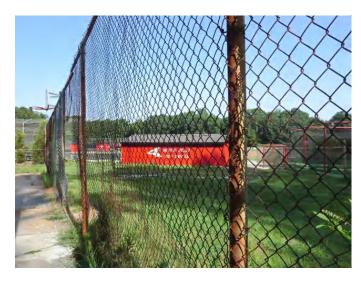
#### System: G2040 - Fencing & Guardrails

Location: Site

**Distress:** Beyond Service Life

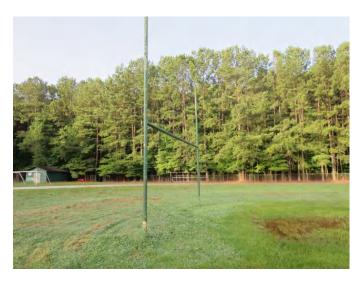
### System: G2040 - Football Field

Location: Football Field

**Distress:** Damaged

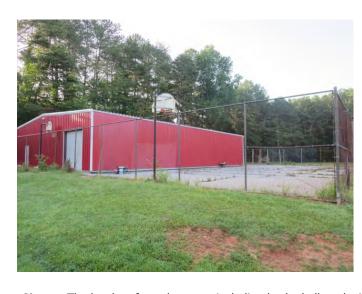
## System: G2040 - Hard Surface Play Area

**Location:** Site

**Distress:** Beyond Service Life

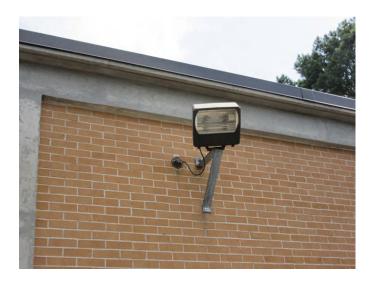
### System: G4020 - Site Lighting

Location: Site

**Distress:** Beyond Service Life

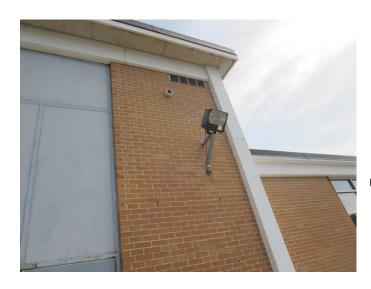
#### System: G4030 - Site Communications & Security

Location: Site

**Distress:** Beyond Service Life
