DeKalb County School District/High Schools

Dunwoody High

School Assessment Report

May 19, 2016

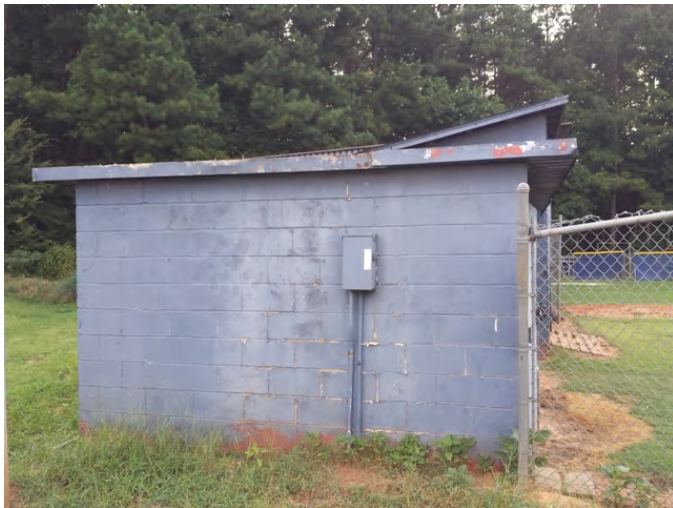
System: B2010 - Exterior Walls

Location: Exterior Walls

Distress: Damaged

Notes: The painted exterior wall finish is aged, fading and stained, and should be replaced.

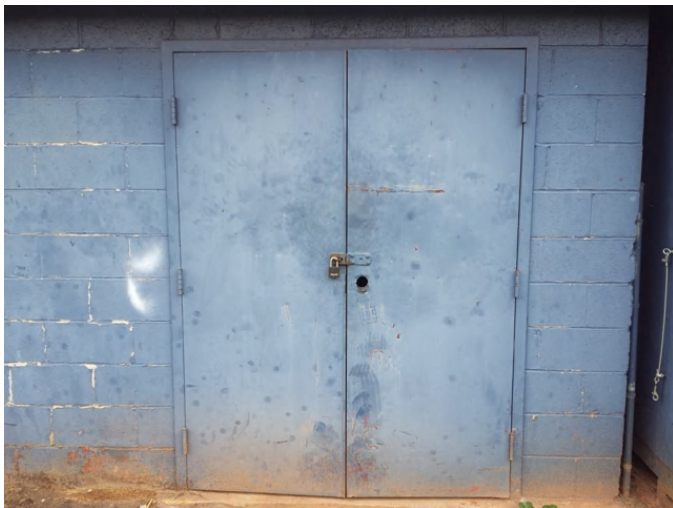
System: B2030 - Exterior Doors

Location: Exterior Walls

Notes: The original exterior doors are aged, rusted, and should be replaced.

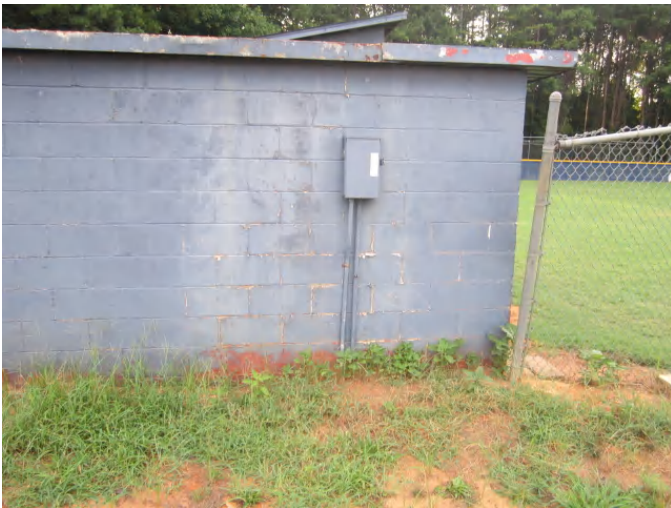
System: D5010 - Electrical Service/Distribution

Location: Throughout Building

Notes: The electrical service/distribution system is beyond its expected service life, aged, and should be scheduled for replacement.

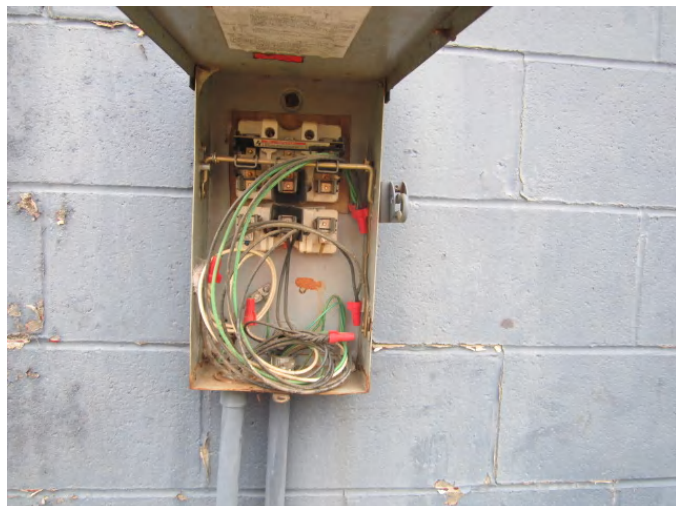
System: D5020 - Lighting and Branch Wiring

Location: Throughout Building

Notes: Lighting and branch wiring are beyond their expected service life, aged, and should be replaced.

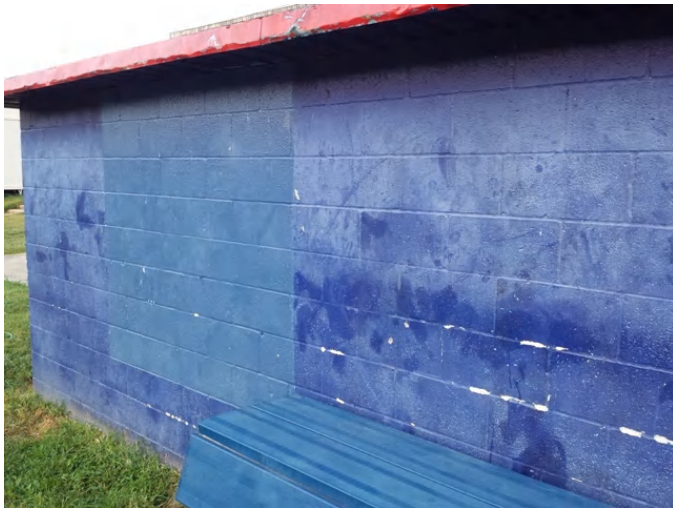
System: B2010 - Exterior Walls

Location: Exterior Walls

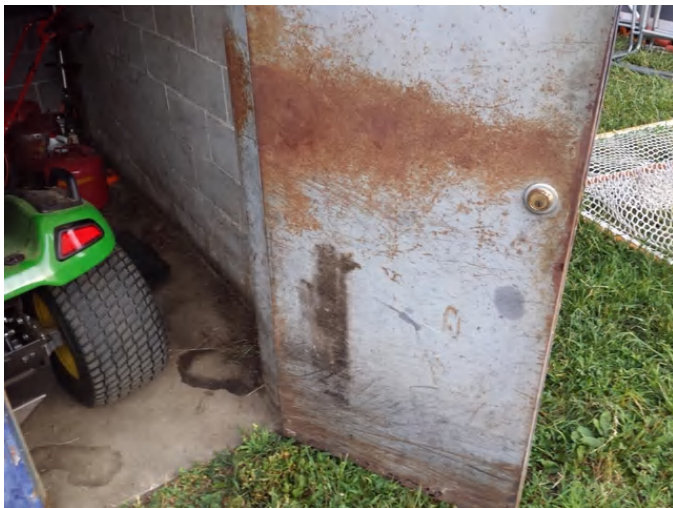
System: B2030 - Exterior Doors

Location: Exterior Walls

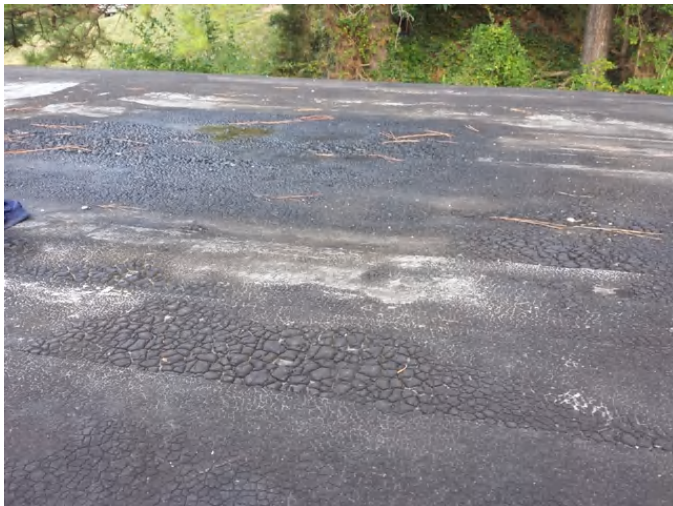
System: B3010 - Roof Coverings -BUR

Location: Roof
Distress: Beyond Service Life
Category: Deferred Maintenance
Priority: 3 Priority
Correction: Renew System
Qty: 400.00
Unit of Measure: S.F.
Estimate: \$9,108.00
Assessor Name: Ben Nixon
Date Created: 04/11/2015

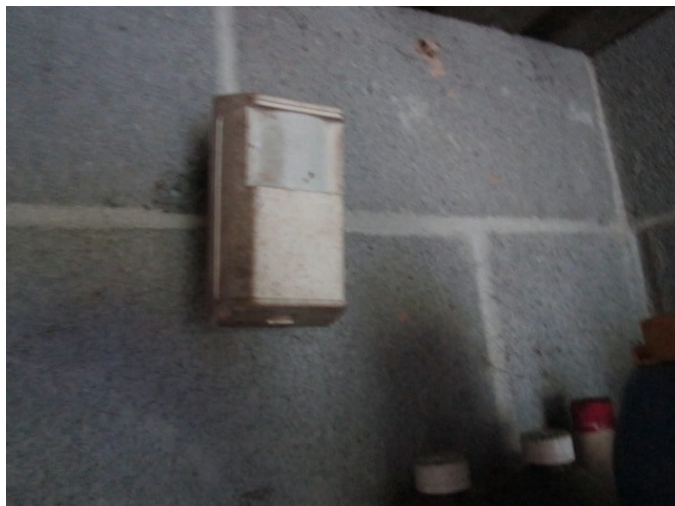
System: D5020 - Lighting and Branch Wiring

Location: Throughout Building

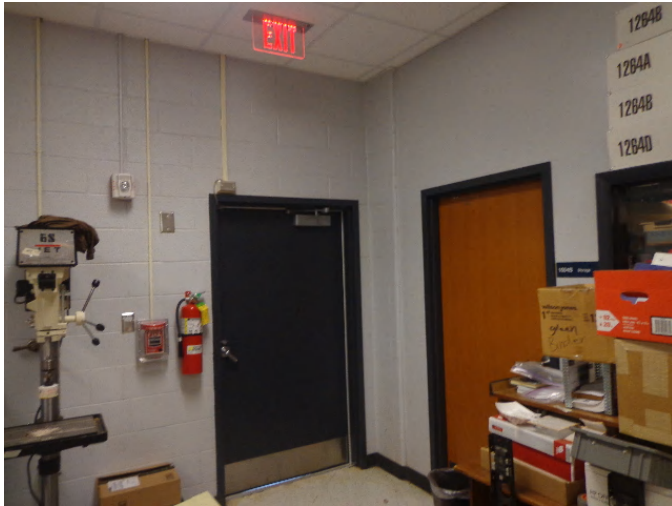
System: B2030 - Exterior Doors

Location: 1604 Technology Lab, 1606 Electrical

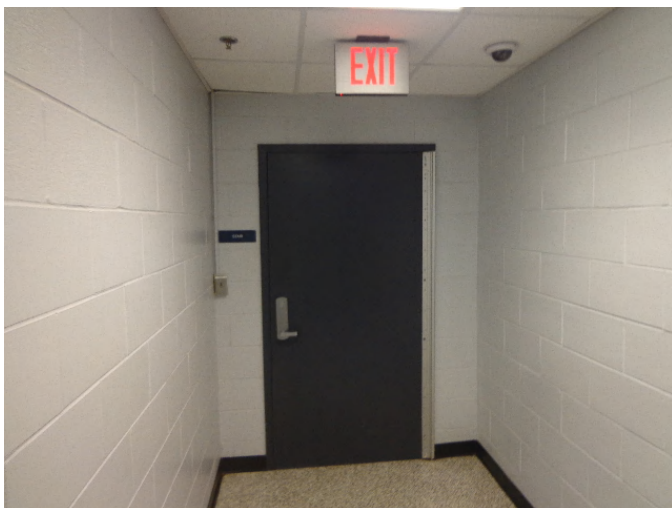
System: D5020 - Lighting

Location: Staircase - Lower Level South Exit

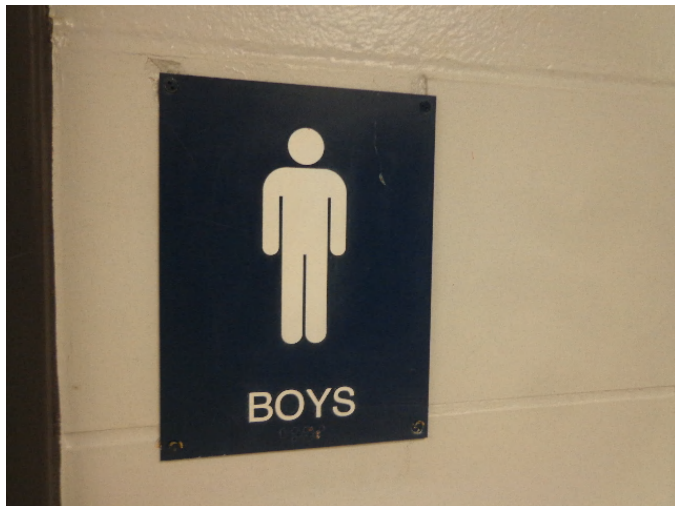
System: C1030 - Fittings

Location: Restrooms

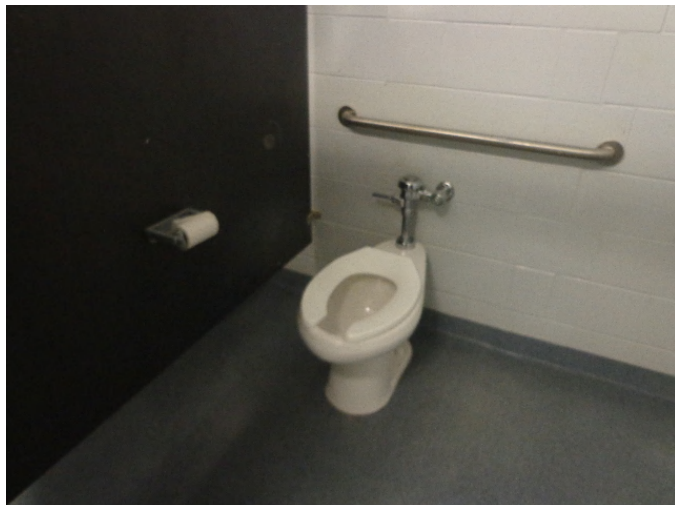
System: C1030 - Fittings

Location: 1108 Boys Restroom

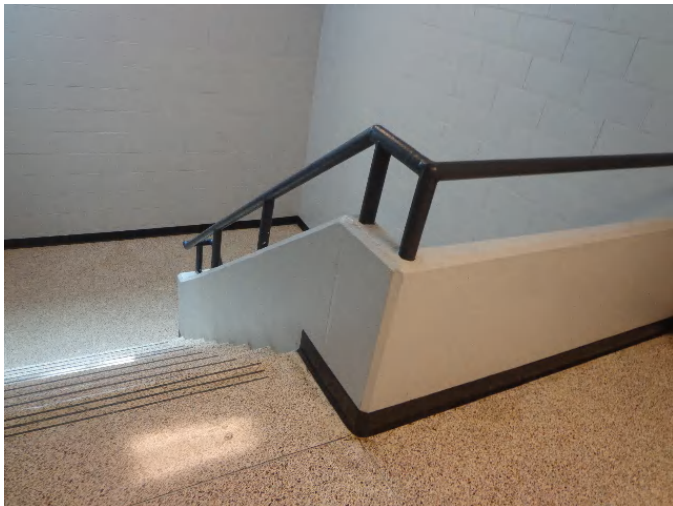
System: C2010 - Stair Construction

Location: Staircase

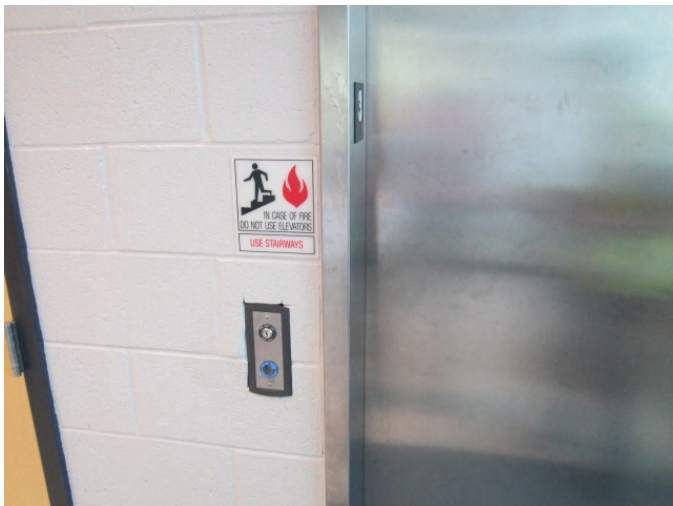
System: D1010 - Elevators and Lifts

Location: Southwest Corner of Building

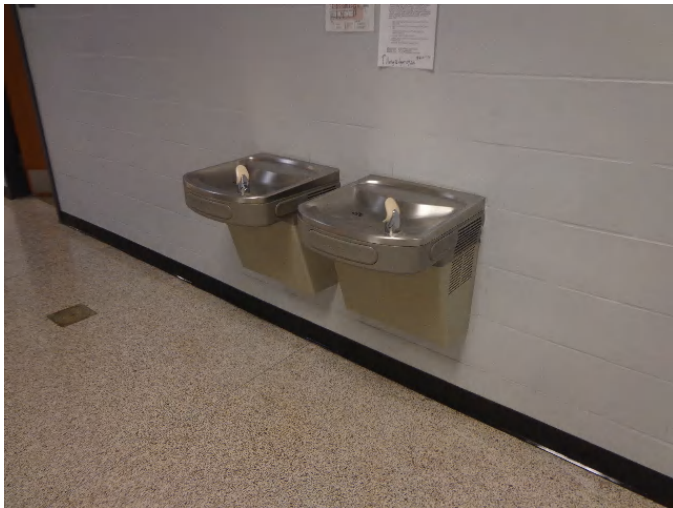
System: D2010 - Plumbing Fixtures

Location: Throughout Building

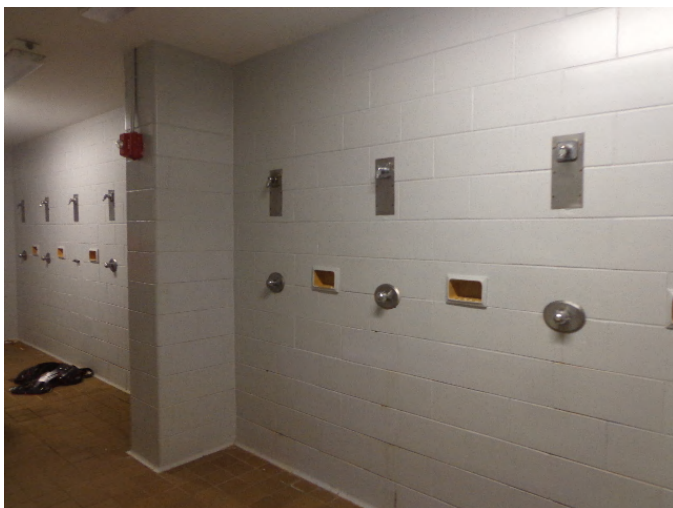
System: D2010 - Plumbing Fixtures

Location: 113, 119 and 123 Shower

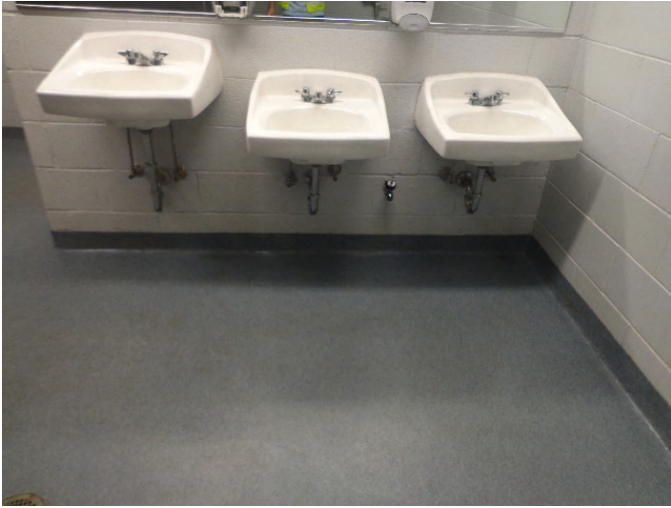
System: D2010 - Plumbing Fixtures

Location: 1310 Boys RR, 1010 Boys RR, and 1013 Girls RR

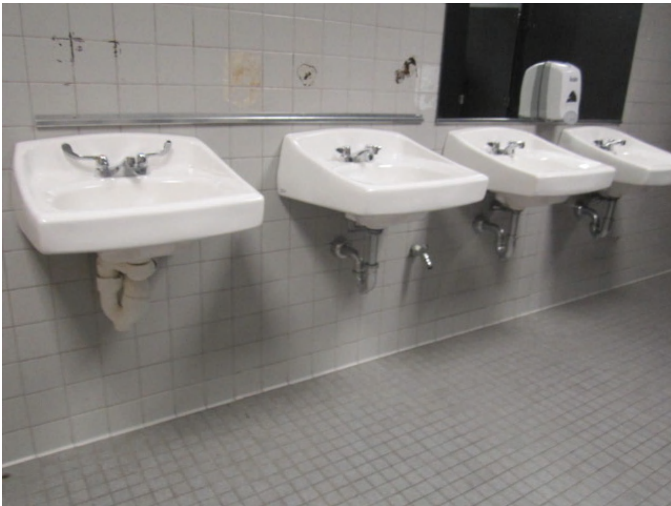
System: D2020 - Domestic Water Distribution

Location: Throughout Building

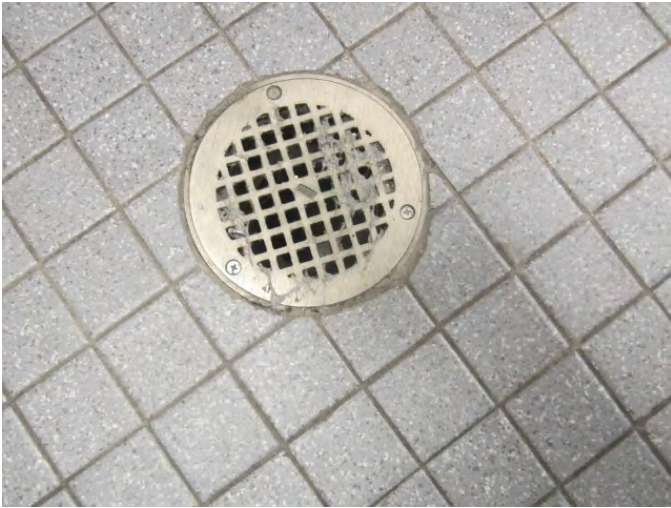
System: D2030 - Sanitary Waste

Location: Throughout Building
Distress: Beyond Service Life
Category: Deferred Maintenance
Priority: 3 Priority
Correction: Renew System
Qty: 171,090.00
Unit of Measure: S.F.
Estimate: \$903,355.00
Assessor Name: Eduardo Lopez
Date Created: 04/11/2015

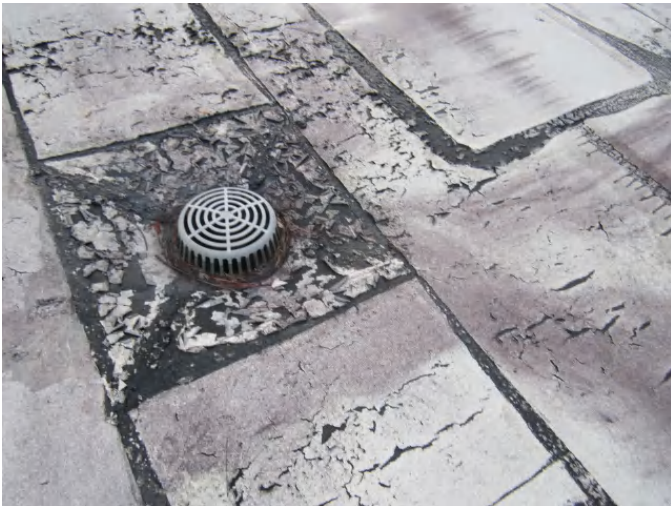
System: D2040 - Rain Water Drainage

Location: Throughout Building
Distress: Beyond Service Life
Category: Deferred Maintenance
Priority: 3 Priority
Correction: Renew System
Qty: 171,090.00
Unit of Measure: S.F.
Estimate: \$173,143.00
Assessor Name: Eduardo Lopez
Date Created: 04/11/2015

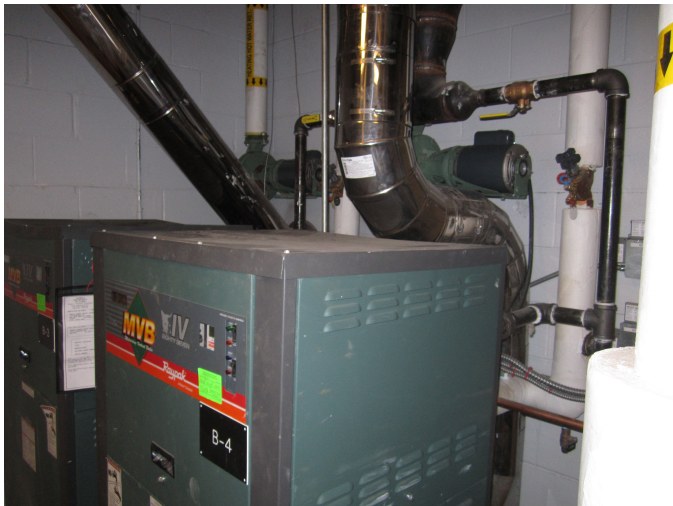
System: D2090 - Other Plumbing Systems - Natural Gas

Location: Throughout Building
Distress: Beyond Service Life
Category: Deferred Maintenance
Priority: 3 Priority
Correction: Renew System
Qty: 171,090.00
Unit of Measure: S.F.
Estimate: \$144,913.00
Assessor Name: Eduardo Lopez
Date Created: 04/11/2015

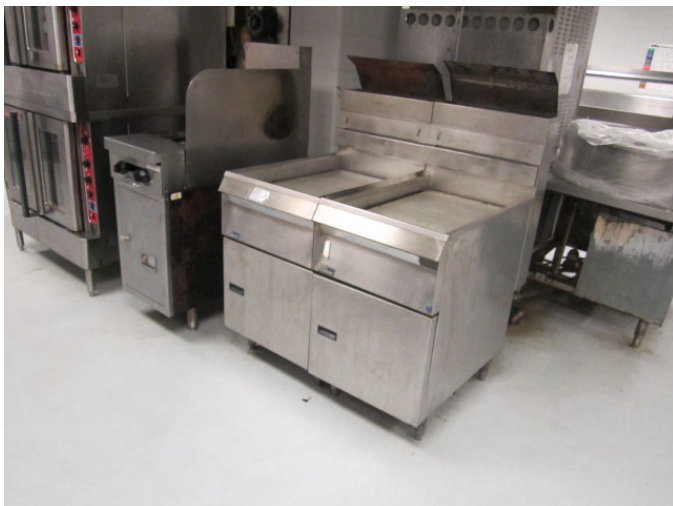
System: E1090 - Other Equipment - Kitchen Equipment

Location: Kitchen
Distress: Beyond Service Life
Category: Deferred Maintenance
Priority: 3 Priority
Correction: Renew System
Qty: 171,090.00
Unit of Measure: S.F.
Estimate: \$421,566.00
Assessor Name: Eduardo Lopez
Date Created: 08/06/2015

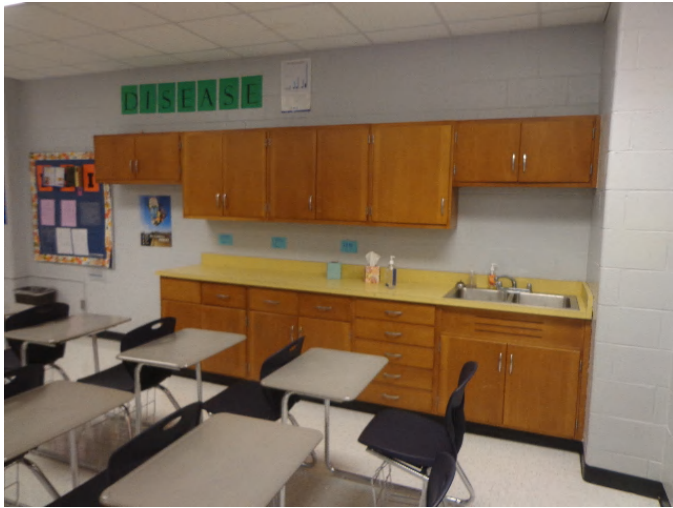
System: E2010 - Fixed Furnishings

Location: Throughout Building

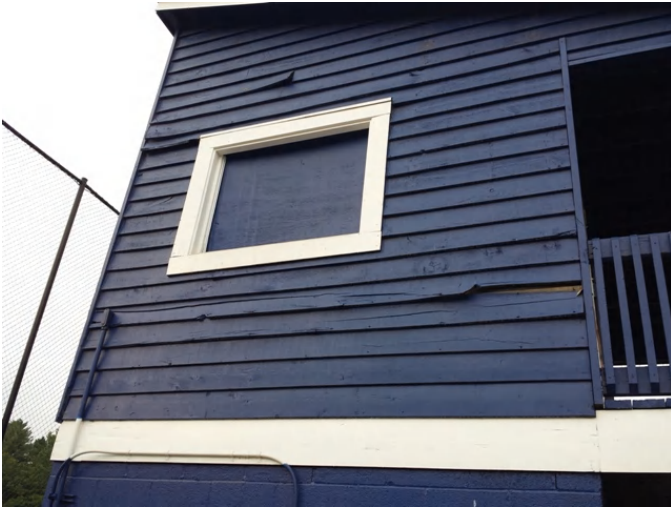
System: B2010 - Exterior Walls

Location: Exterior Walls

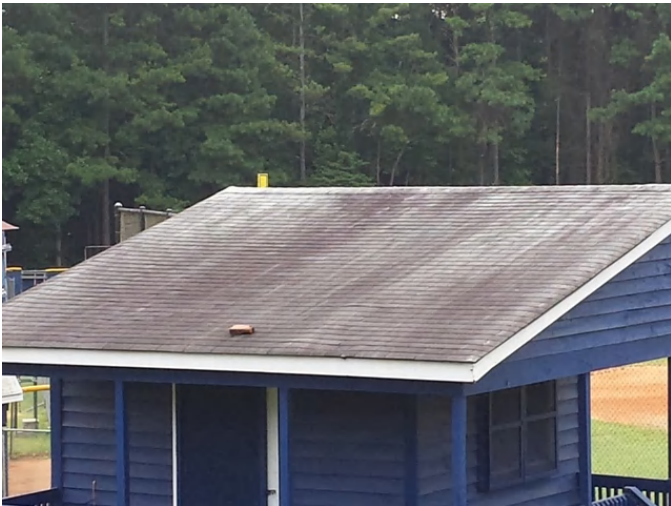
System: B3010 - Roof Coverings - Asphalt Shingles

Location: Roof

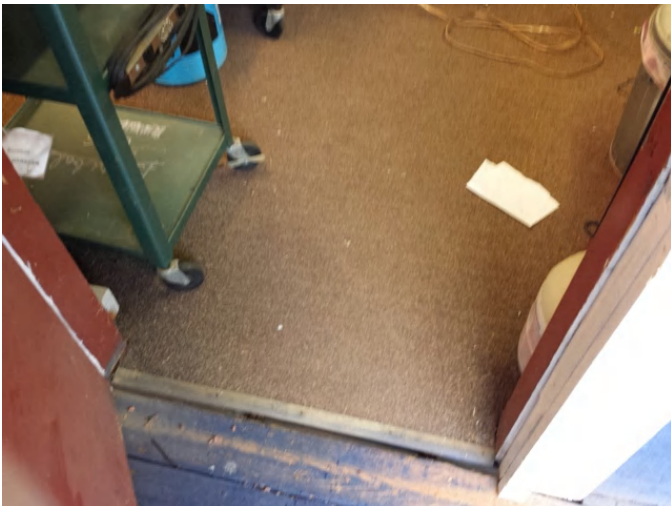
System: C3020 - Floor Finishes -Carpet

Location: Press Box

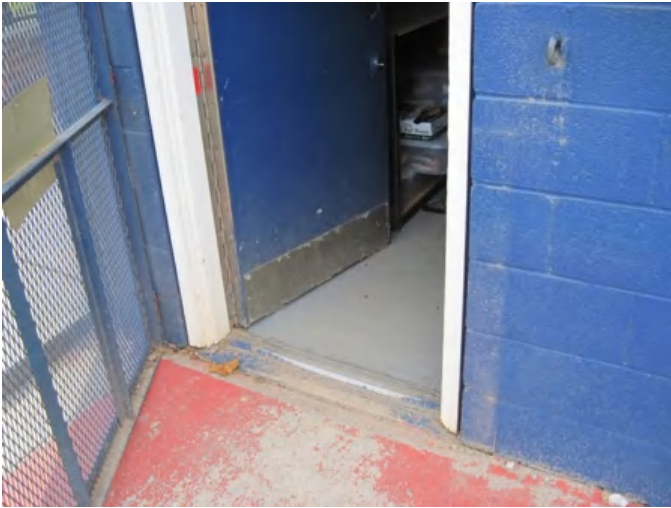
System: C3020 - Floor Finishes -Epoxy

Location: Concession Area

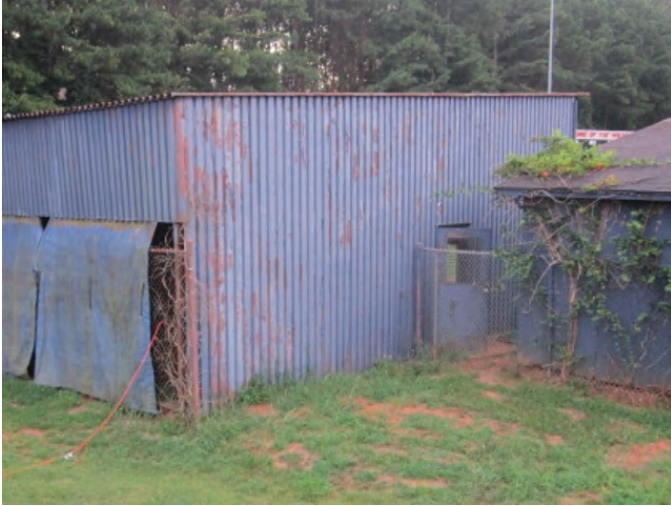
System: B2010 - Exterior Walls

Location: Exterior Walls

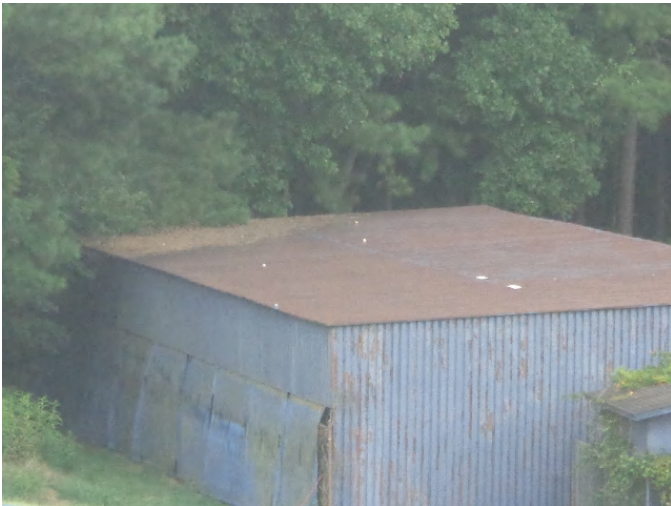
System: B3010 - Roof Coverings - Preformed Metal

Location: Roof

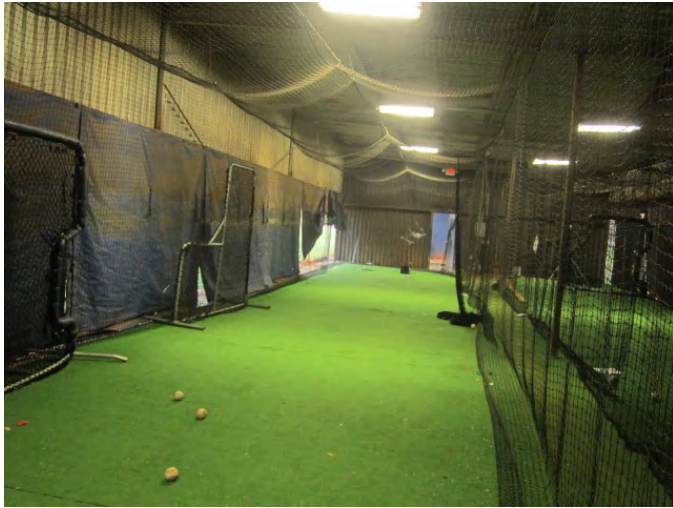
System: C3020 - Floor Finishes - Carpet Turf

Location: Throughout Building

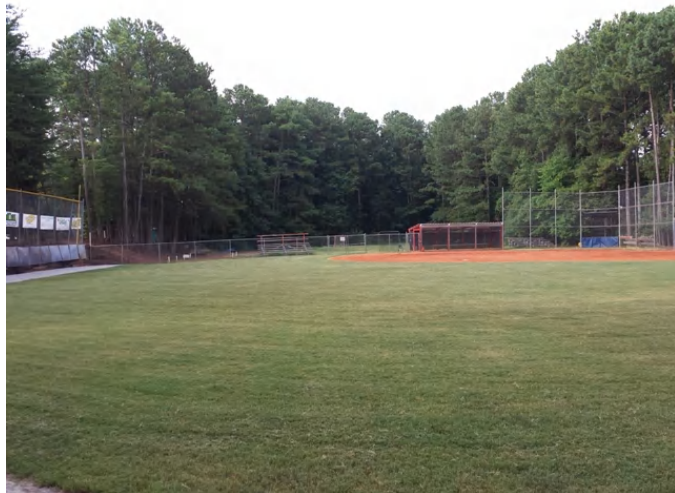
System: G4020 - Site Lighting

Location: Back of School and Sport Fields

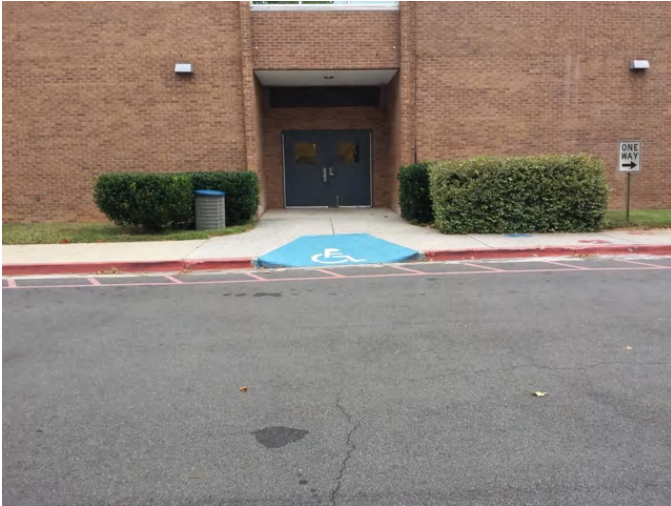
System: G2010 - Roadways

Location: Site

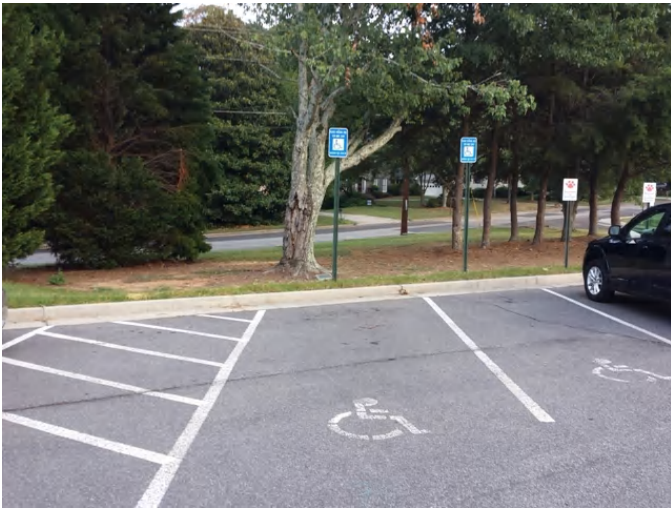
System: G2020 - Parking Lots

Location: West Parking

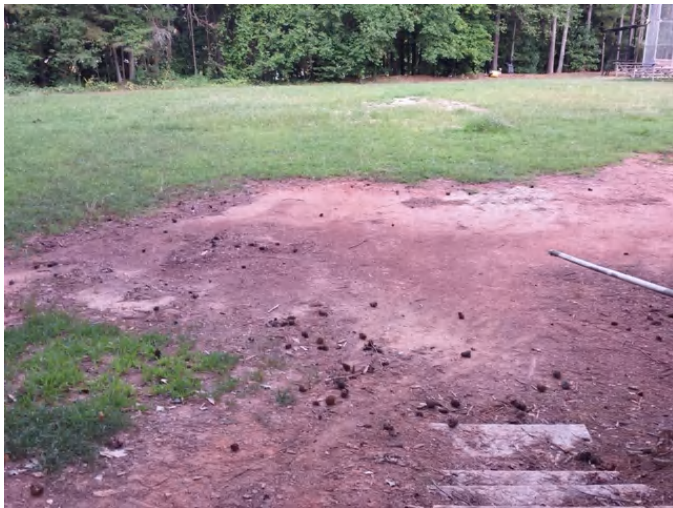
System: G2040 - Playing Field

Location: Site

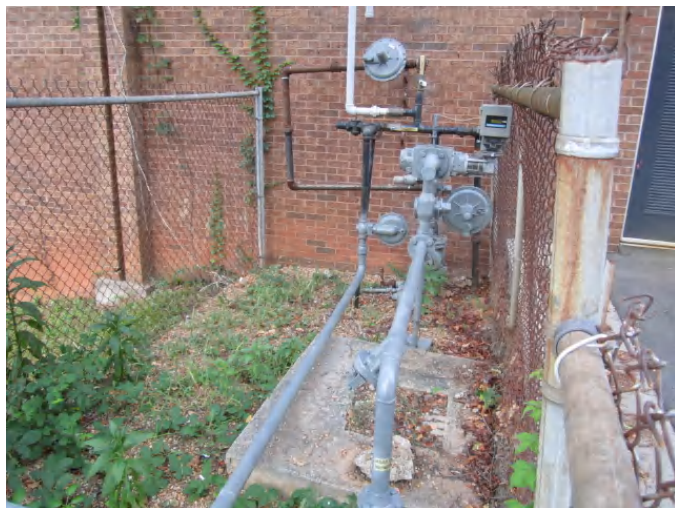
System: G3060 - Fuel Distribution

Location: Site
