DeKalb County School District/Elementary Schools

Eldridge L. Miller Elementary

School Assessment Report

May 19, 2016

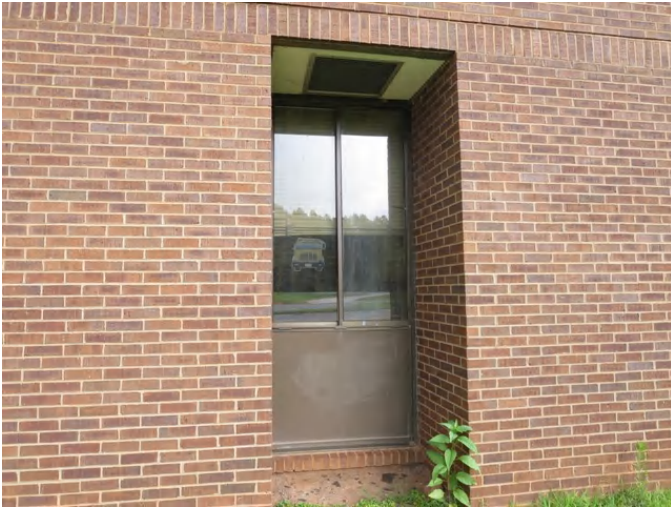
System: B2020 - Exterior Windows

Location: Throughout Building

Distress: Beyond Service Life

Notes: The aluminum frame, operable, double pane windows are aged, have failing seals, and should be replaced.

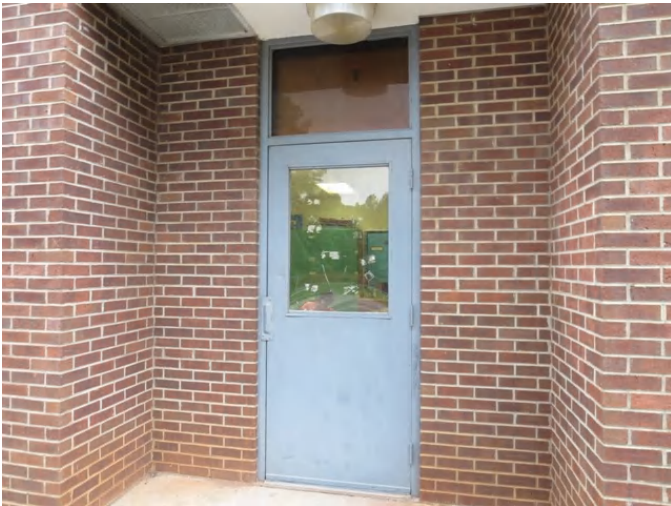
System: B2030 - Exterior Doors

Location: Throughout Building

Distress: Beyond Service Life

Notes: The original exterior doors are beyond their expected service life, have some deterioration due, and should be replaced.

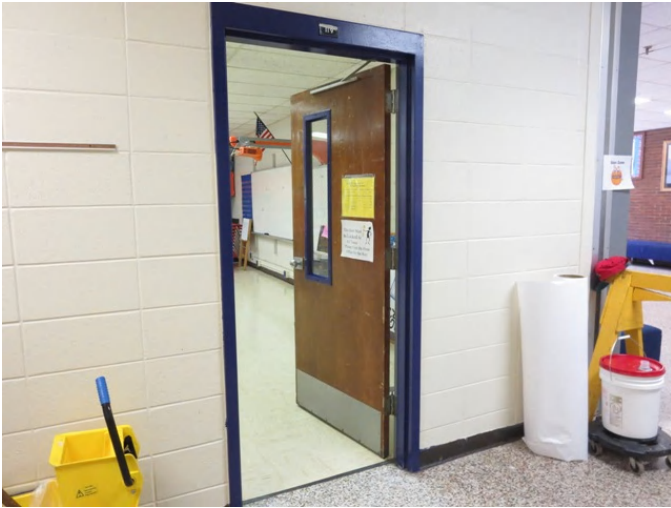
System: C1020 - Interior Doors

Location: Throughout Building

Distress: Beyond Service Life

Notes: The interior doors are aged, failing, not ADA compliant, and should be replaced.

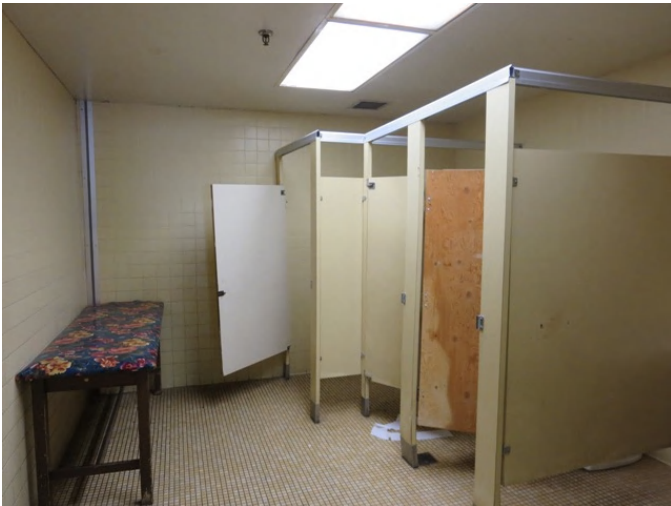
System: C1030 - Fittings

Location: Throughout Building

Distress: Beyond Service Life

Notes: Fittings, such as toilet partitions, handrails and signage, are beyond their expected service life and should be replaced. SPLOST project 108-422 to update ADA compliance in the hall restroom.

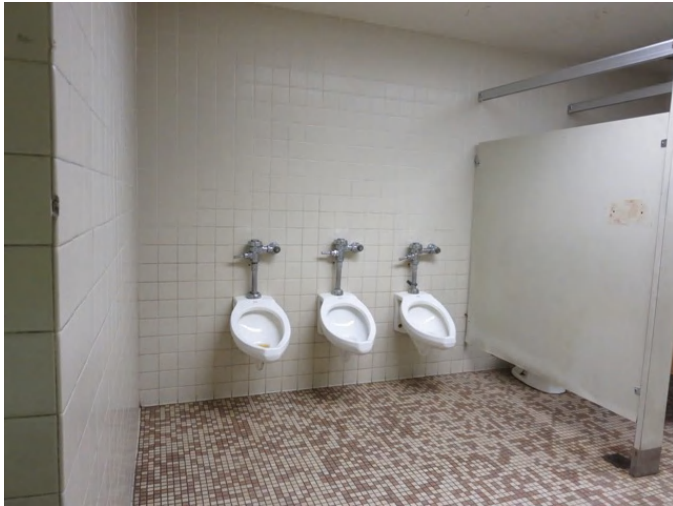
System: C3010 - Wall Finishes - Ceramic & Glazed

Location: Restrooms
Distress: Beyond Service Life
Category: Deferred Maintenance
Priority: 3 Priority
Correction: Renew System
Qty: 5,965.00
Unit of Measure: S.F.
Estimate: \$67,387.00
Assessor Name: Sam Mandola
Date Created: 04/11/2015

Notes: The wall tiles are aged, scuffed and faded, and should be replaced.

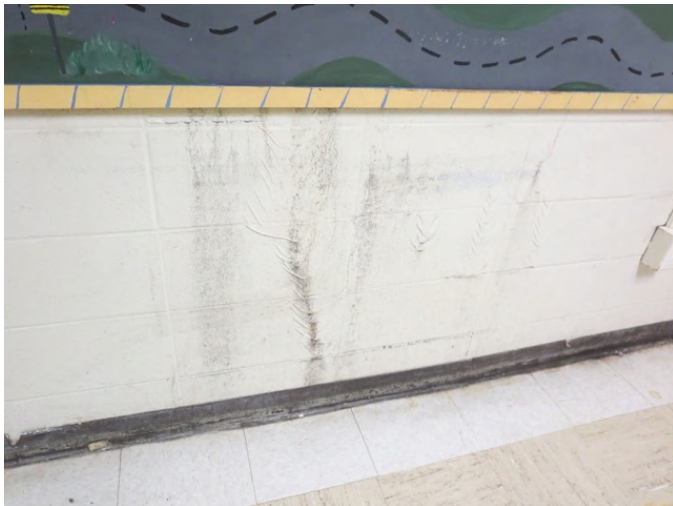
System: C3010 - Wall Finishes - Paint

Location: Throughout Building
Distress: Beyond Service Life
Category: Deferred Maintenance
Priority: 3 Priority
Correction: Renew System
Qty: 53,080.00
Unit of Measure: S.F.
Estimate: \$112,689.00
Assessor Name: Sam Mandola
Date Created: 04/11/2015

Notes: The painted wall finish is deteriorating due to age and numerous layers of paint, which is now easy to peel off.

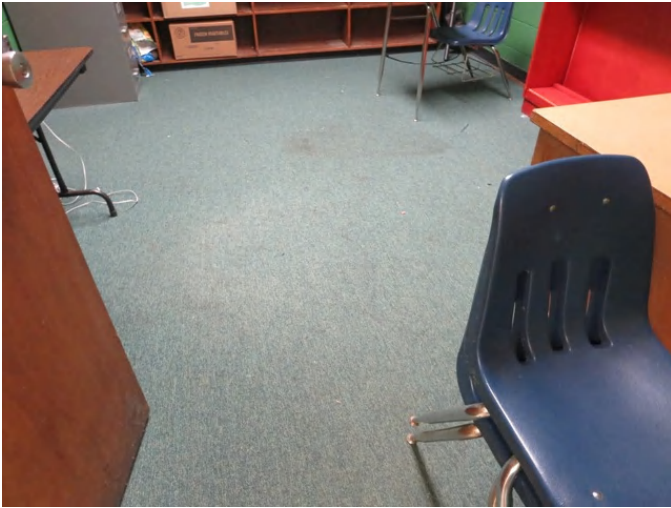
System: C3020 - Floor Finishes - Carpet

Location: Office and Teachers Lounge

Distress: Beyond Service Life

Notes: The carpet is stained, showing signs of failure, and should be replaced.

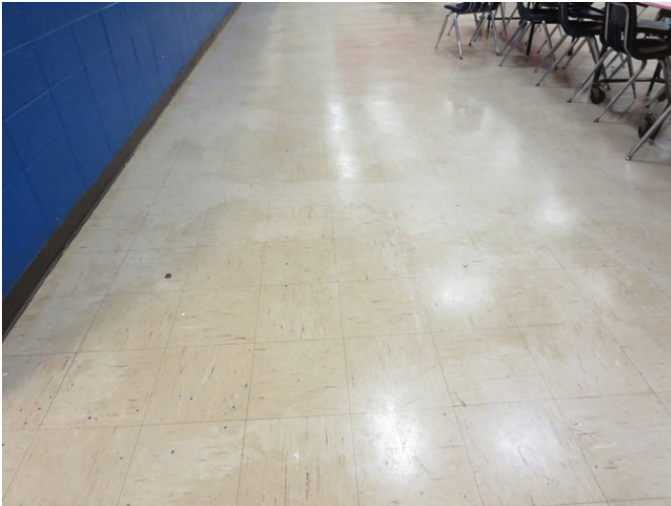
System: C3020 - Floor Finishes - VCT

Location: Cafeteria and Classrooms

Distress: Beyond Service Life

Notes: The VCT flooring is aged, cracked and worn, and should be replaced.

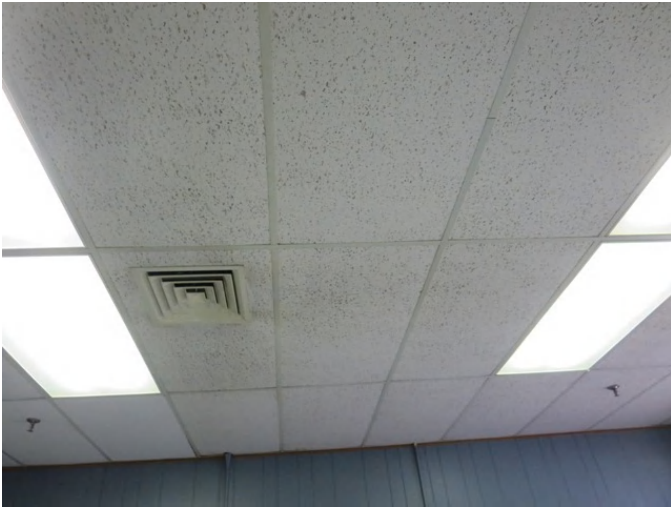
System: C3030 - Ceiling Finishes

Location: Throughout Building

Distress: Beyond Service Life

Notes: The acoustical ceiling system is deteriorating due to age and the environment, and should be replaced.

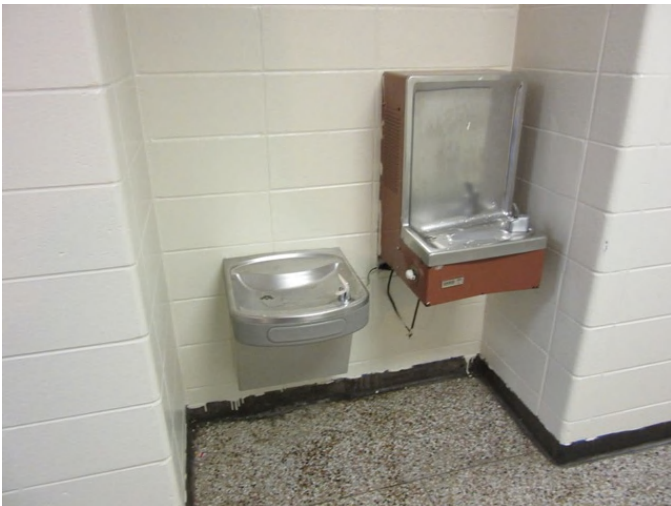
System: D2010 - Plumbing Fixtures

Location: Throughout Building

Distress: Beyond Service Life

Notes: Plumbing fixtures are beyond service life, damaged, not ADA compliant, and should be scheduled for replacement. SPLOST project 108-422 to update ADA compliance in the hall restroom.

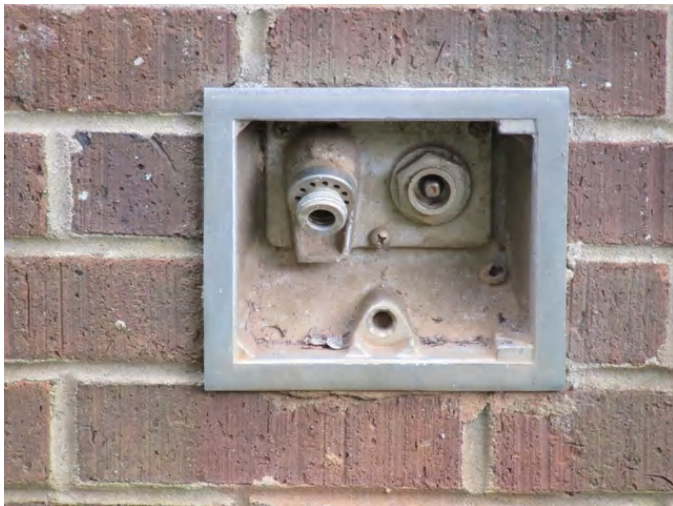
System: D2020 - Domestic Water Distribution

Location: Throughout Building

Distress: Beyond Service Life

Notes: The domestic water distribution system is beyond its expected service life and should be scheduled for replacement.

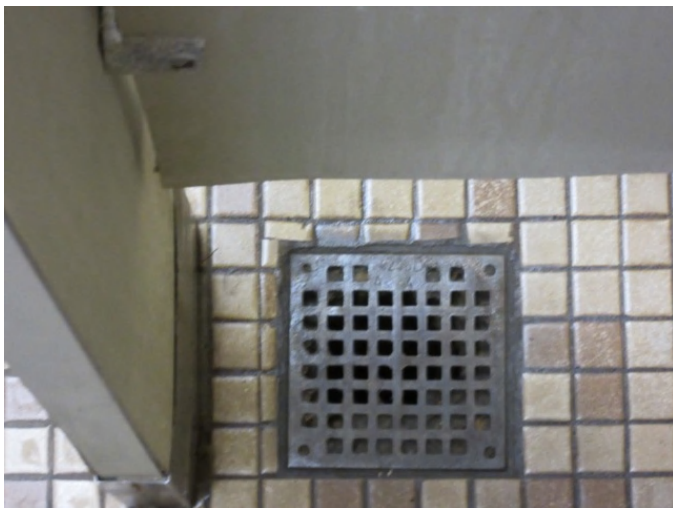
System: D2030 - Sanitary Waste

Location: Throughout Building

Distress: Beyond Service Life

Notes: The sanitary waste system is beyond its expected service life and should be scheduled for replacement. SPLOST project 108-422 to replace grease trap.

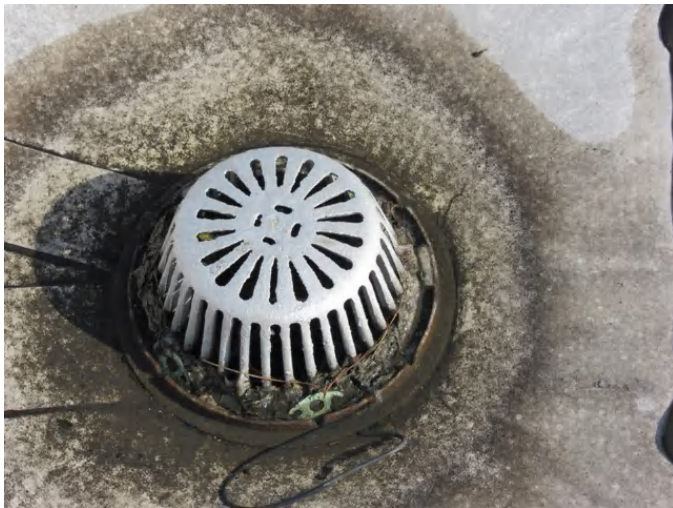
System: D2040 - Rain Water Drainage

Location: Throughout Building

Distress: Beyond Service Life

Notes: The rainwater drainage system is beyond its expected service life and should be scheduled for replacement.

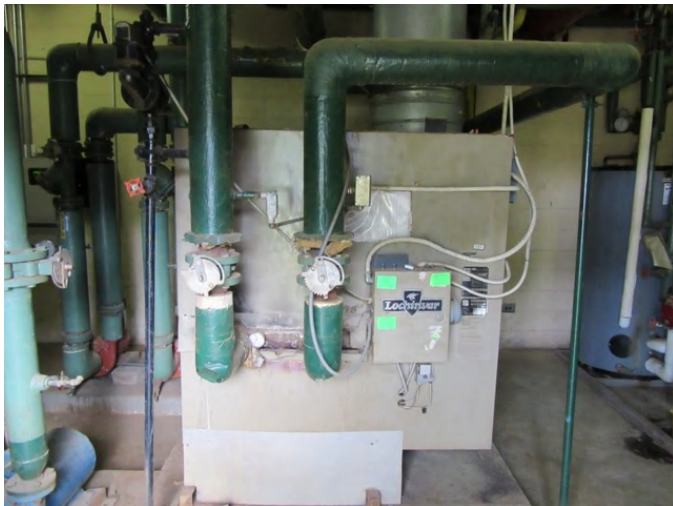
System: D3020 - Heat Generating Systems

Location: Mechanical Room

Distress: Beyond Service Life

Notes: The boiler is beyond its expected service life and should be scheduled for replacement.

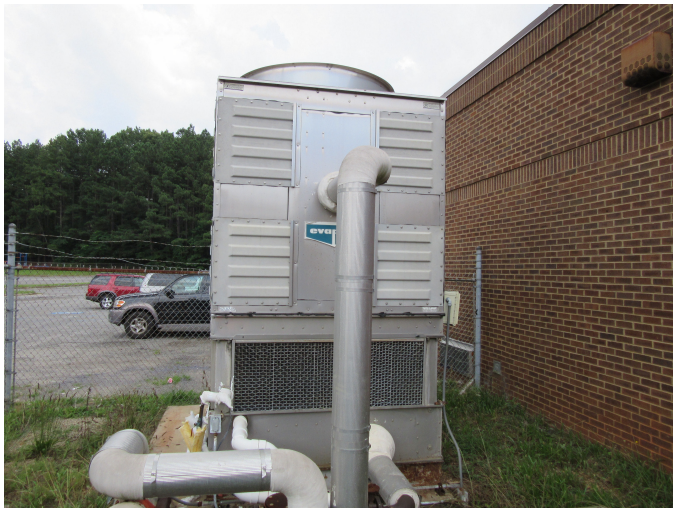
System: D3030 - Cooling Generating Systems

Location: Northwest Side of Building
Distress: Beyond Service Life
Category: Deferred Maintenance / Energy
Priority: 3 Priority
Correction: Renew System
Qty: 59,645.00
Unit of Measure: S.F.
Estimate: \$310,333.00
Assessor Name: Sam Mandola
Date Created: 07/04/2015

Notes: The cooling generating system is beyond its expected service life, noisy, and should be scheduled for replacement.

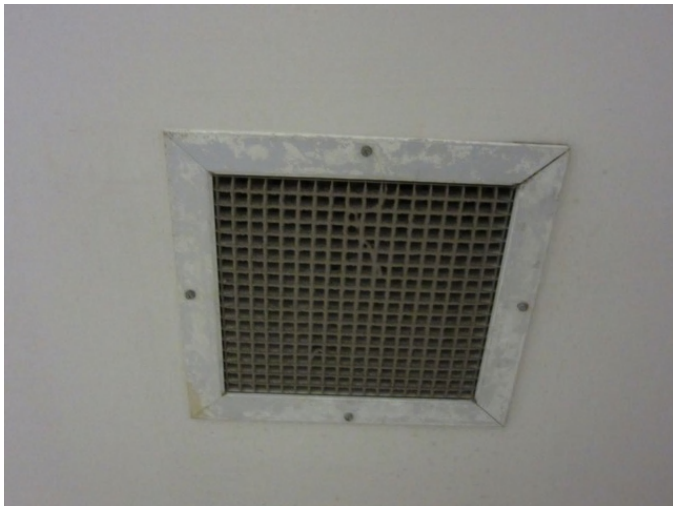
System: D3040 - Distribution & Exhaust Systems

Location: Throughout Building
Distress: Beyond Service Life
Category: Deferred Maintenance / Energy
Priority: 3 Priority
Correction: Renew System
Qty: 59,645.00
Unit of Measure: S.F.
Estimate: \$361,508.00
Assessor Name: Sam Mandola
Date Created: 04/11/2015

Notes: The distribution and exhaust systems are beyond their expected service life and should be scheduled for replacement.

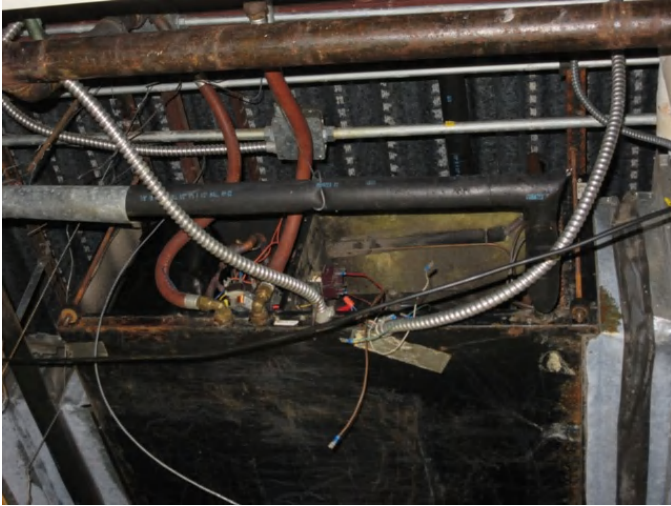
System: D3050 - Terminal & Package Units

Location: Throughout Building

Distress: Beyond Service Life

Notes: The primary water source heat pumps and factory integrated controls are beyond their expected service life and should be scheduled for replacement.

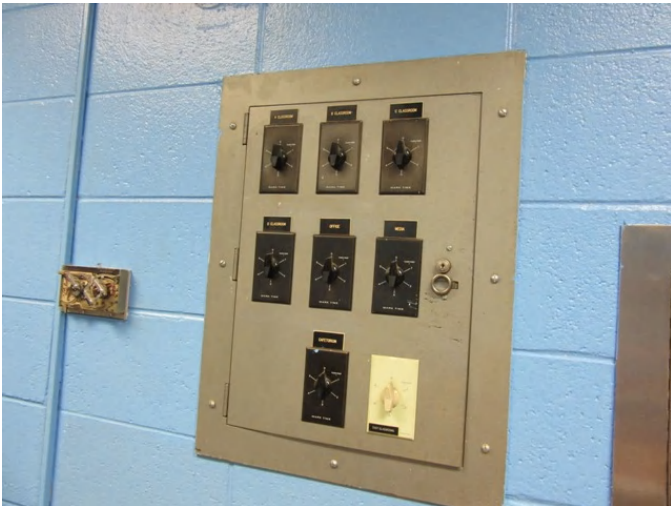
System: D3060 - Controls & Instrumentation

Location: Throughout Building

Distress: Beyond Service Life

Notes: The controls and instrumentation system is beyond its expected service life and should be scheduled for replacement.

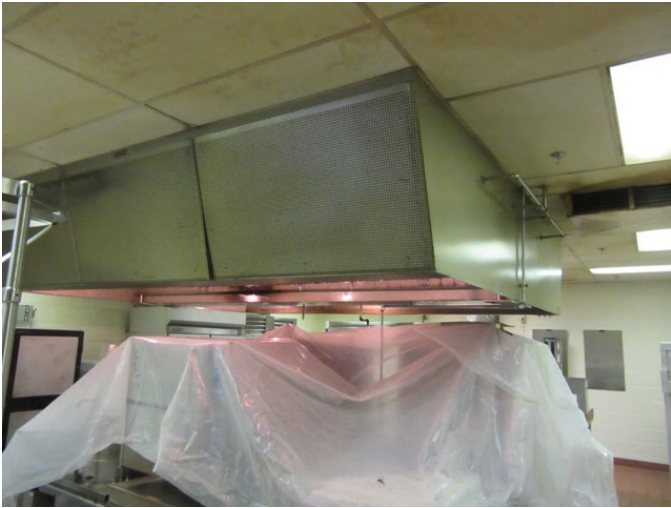
System: D3090 - Other HVAC Systems/Equip - Kitchen Hood

Location: Kitchen

Distress: Beyond Service Life

Notes: The kitchen hood system is beyond its expected service life and should be scheduled for replacement.

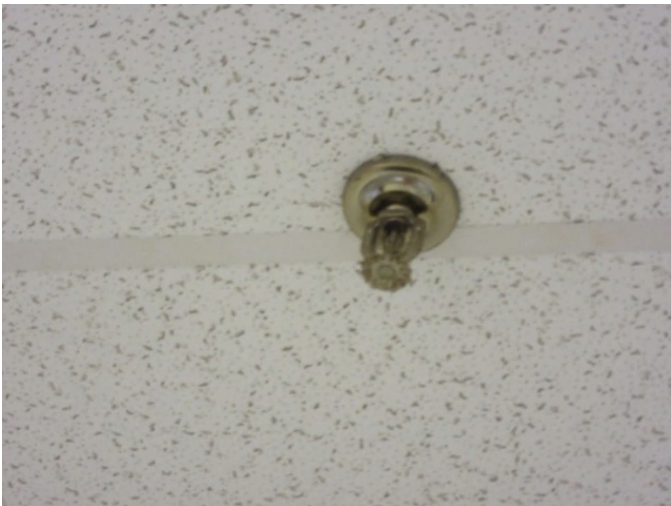
System: D4010 - Sprinklers

Location: Throughout Building

Distress: Beyond Service Life

Notes: The sprinkler system is beyond its expected service life and should be scheduled for replacement.

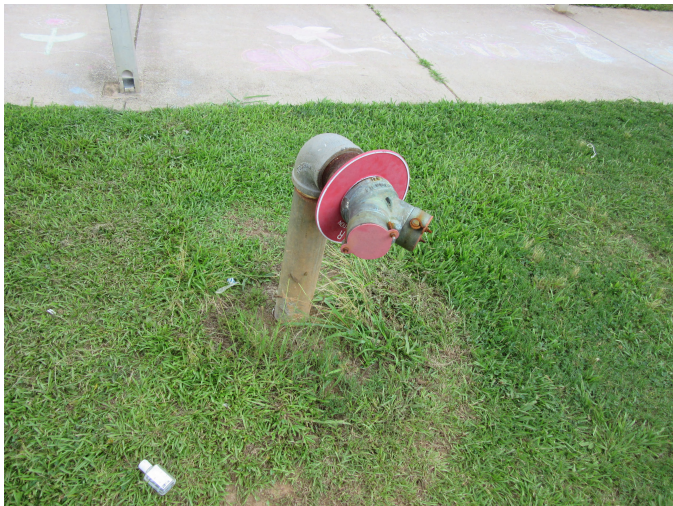
System: D4020 - Standpipes

Location: Northwest Side of Building
Distress: Beyond Service Life
Category: Deferred Maintenance
Priority: 3 Priority
Correction: Renew System
Qty: 59,645.00
Unit of Measure: S.F.
Estimate: \$33,461.00
Assessor Name: Sam Mandola
Date Created: 07/04/2015

Notes: Standpipes are beyond their expected service life and should be scheduled for replacement.

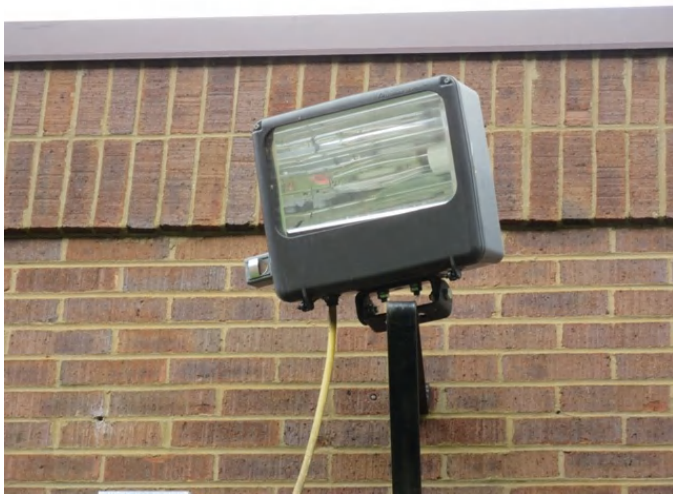
System: D5020 - Branch Wiring

Location: Throughout Building
Distress: Beyond Service Life
Category: Deferred Maintenance
Priority: 3 Priority
Correction: Renew System
Qty: 59,645.00
Unit of Measure: S.F.
Estimate: \$444,832.00
Assessor Name: Sam Mandola
Date Created: 04/11/2015

Notes: The branch wiring system is beyond its expected service life and should be scheduled for replacement.

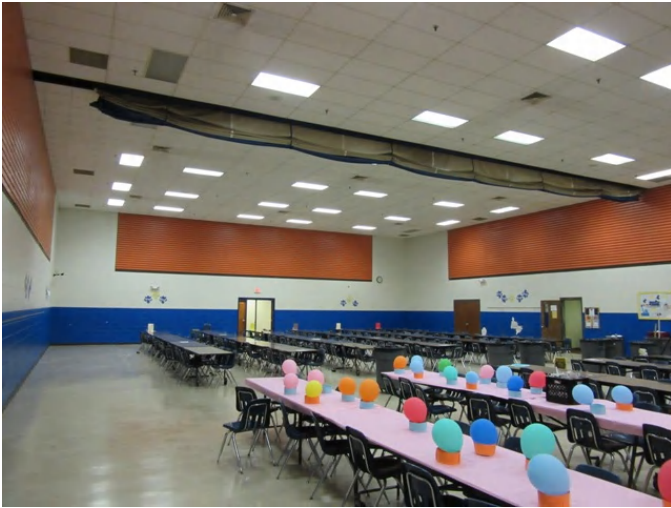
System: D5020 - Lighting

Location: Throughout Building

Notes: The lighting system is beyond its expected service life and should be scheduled for replacement.

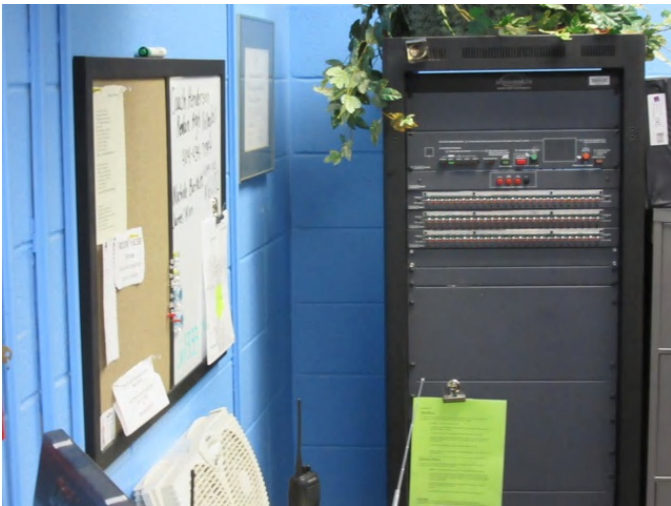
System: D5030 - Communications and Security - Clock & PA Systems

Location: Throughout Building

Notes: Clock and PA systems are beyond their expected service life and should be scheduled for replacement.

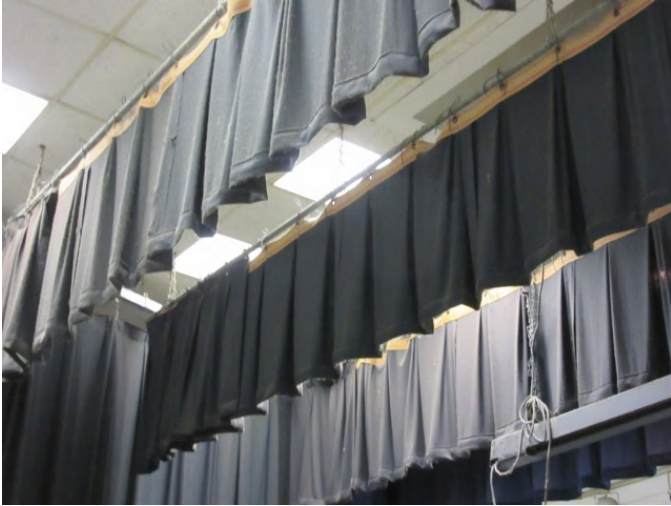
System: E1020 - Institutional Equipment

Location: Throughout Building

Notes: Institutional equipment, such as theater and stage equipment, is beyond its expected service life and should be scheduled for replacement.

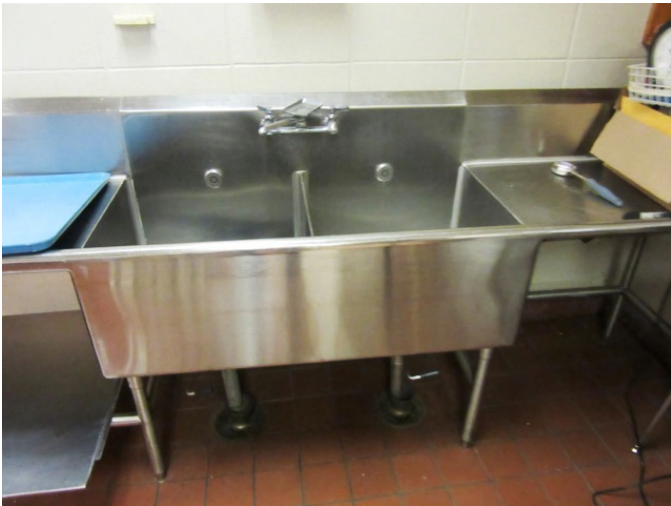
System: E1090 - Other Equipment

Location: Kitchen

Notes: Under the Capital Improvements program the grease trap is scheduled for replacement.

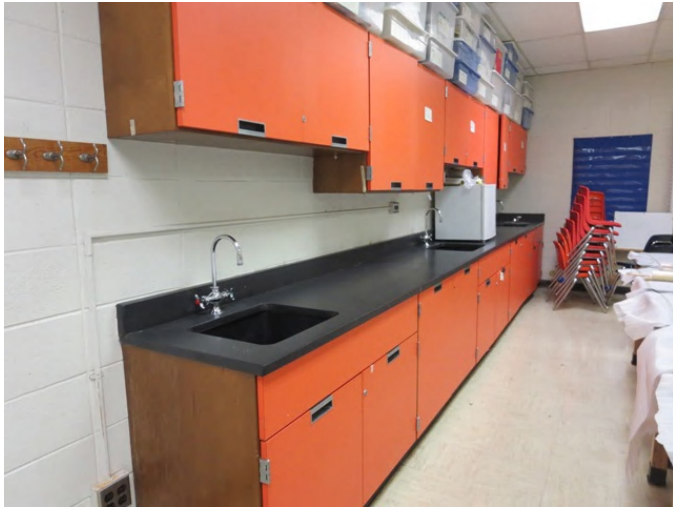
System: E2010 - Fixed Furnishings

Location: Throughout Building

Notes: Fixed furnishings, such as built-in cabinets, are beyond their expected service life and worn, and should be replaced.

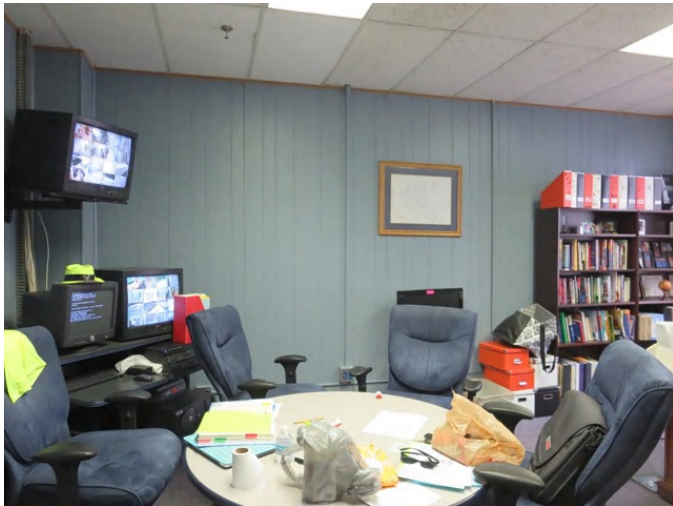
System: C3010 - Wall Finishes - Wood Panelling

Location: Principal's Office

Notes: Panels are beyond their expected service and should be replaced or refinished.

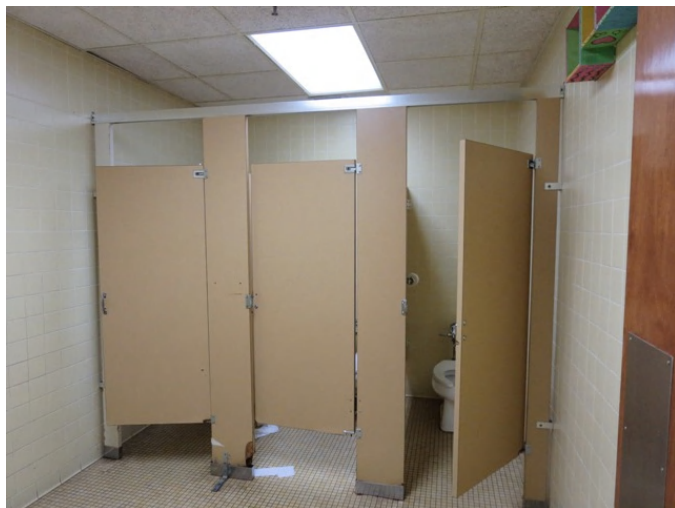
System: C1030 - Fittings

Location: Throughout Building

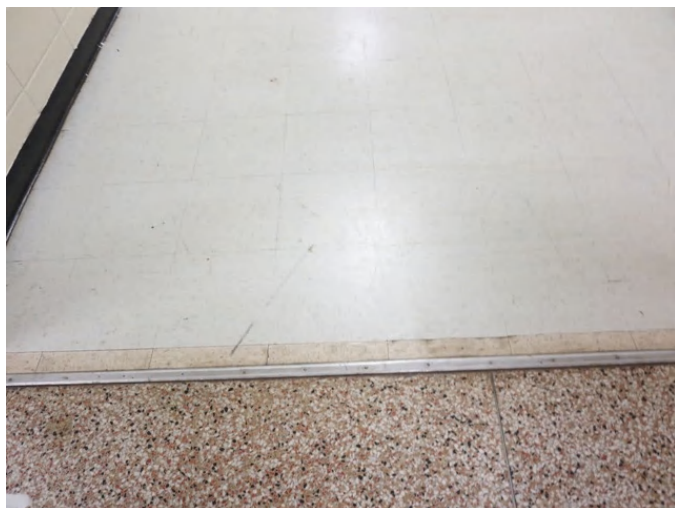
System: C3020 - Floor Finishes - VCT

Location: Corridors and Classrooms

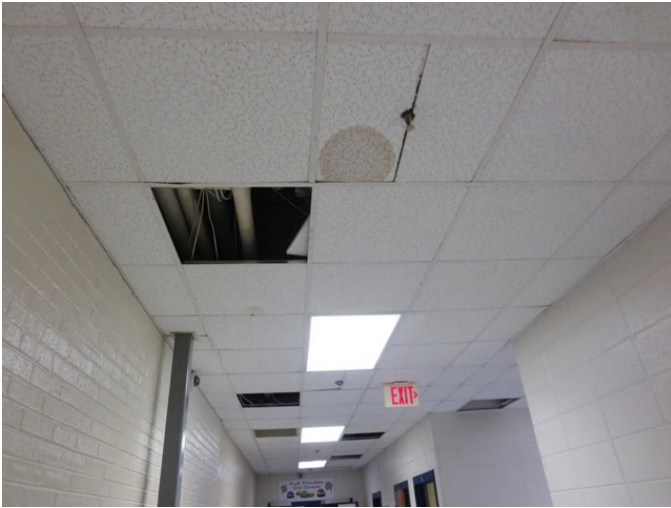
System: C3030 - Ceiling Finishes

Location: Throughout Building

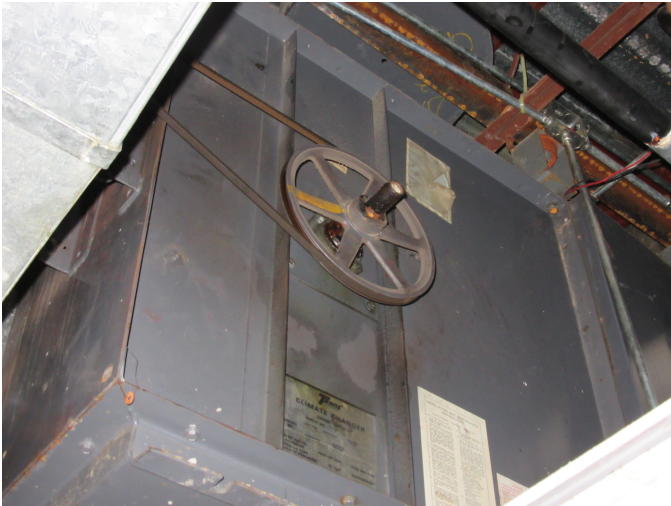
System: D3050 - Terminal & Package Units

Location: Mechanical Room

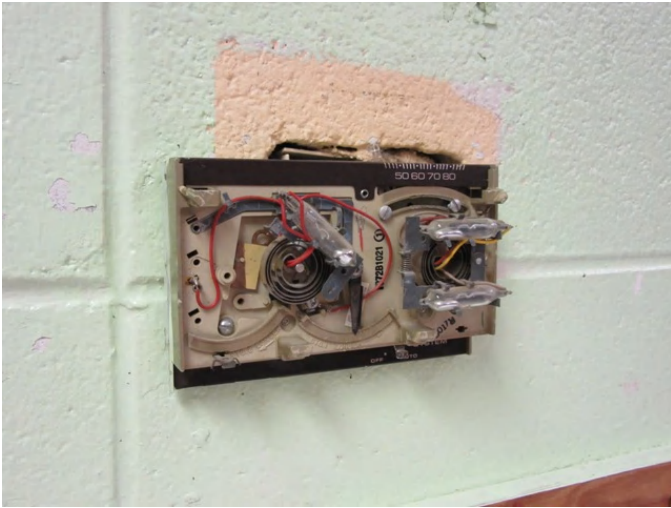
System: D3060 - Controls & Instrumentation

Location: Throughout Building

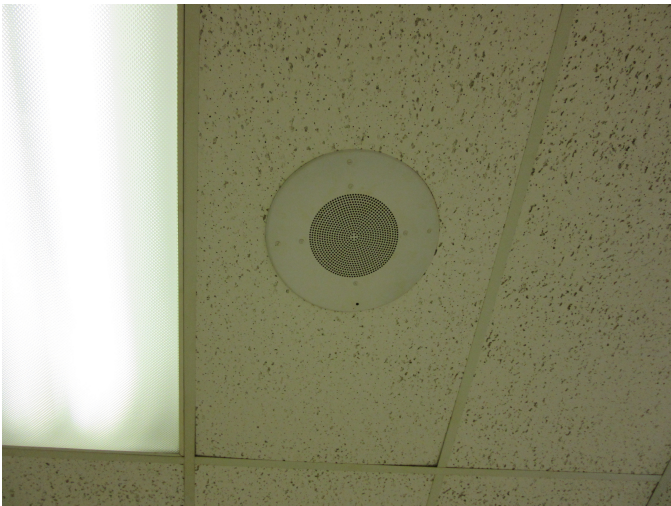
System: D5030 - Communications and Security - Clock & PA Systems

Location: Throughout Building

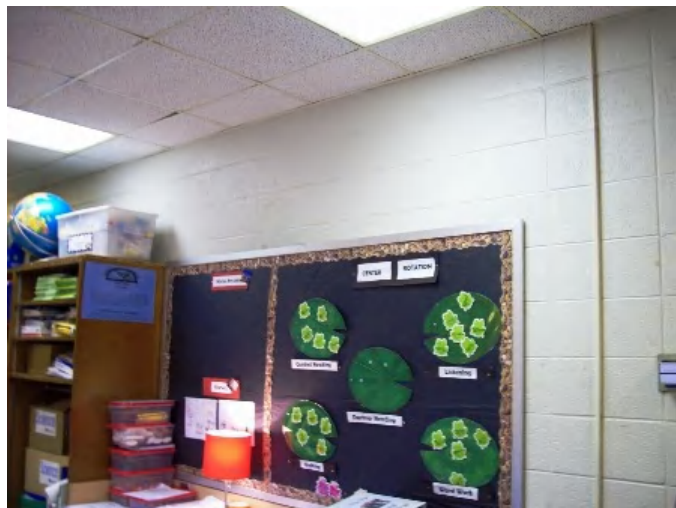
System: E2010 - Fixed Furnishings

Location: Throughout Building

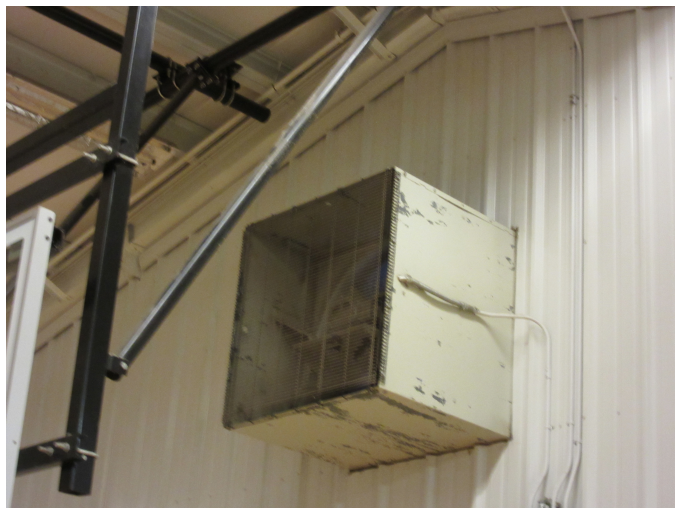
System: D3050 - Terminal & Package Units

Location: Throughout Building

Distress: Inadequate

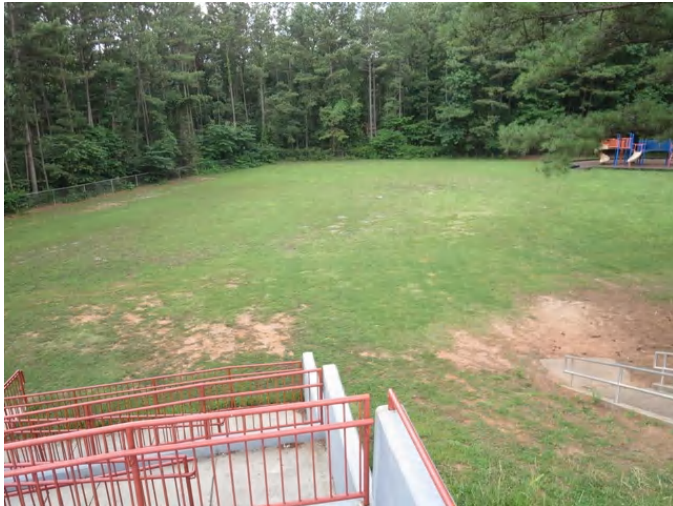
System: G2040 - Playing Field

Location: Site

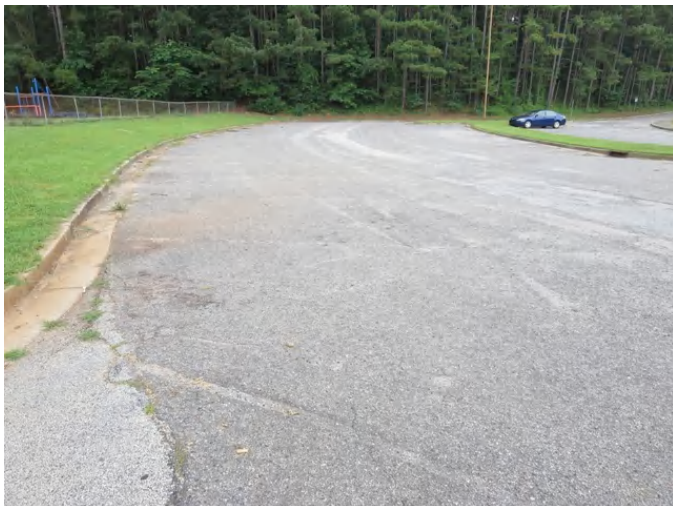
System: G2010 - Roadways

Location: Site

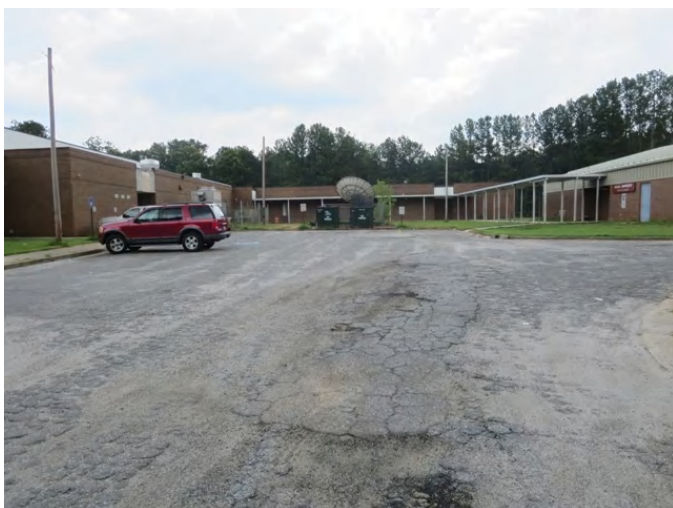
System: G2020 - Parking Lots

Location: North and East Parking Lots

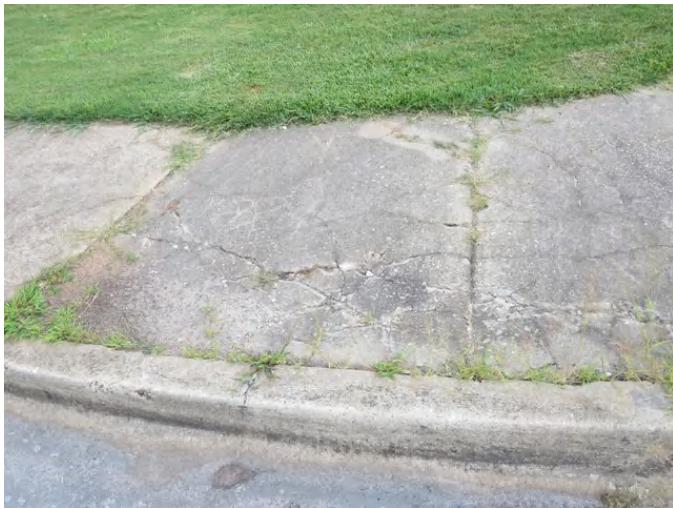
System: G2030 - Pedestrian Paving

Location: Site

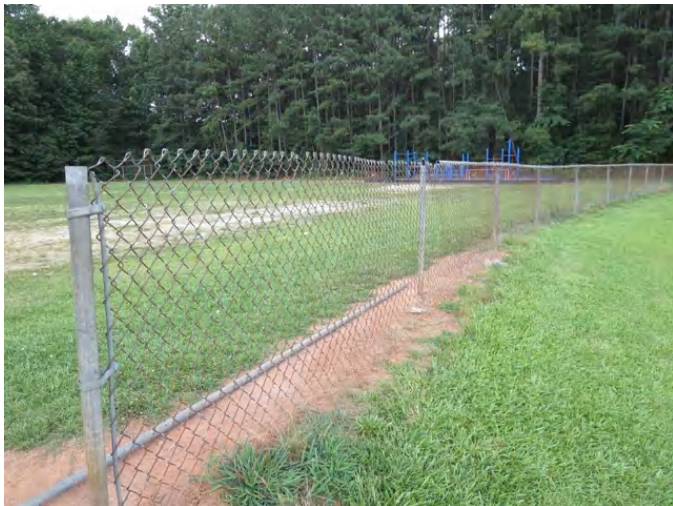
System: G2040 - Fencing & Guardrails

Location: Site

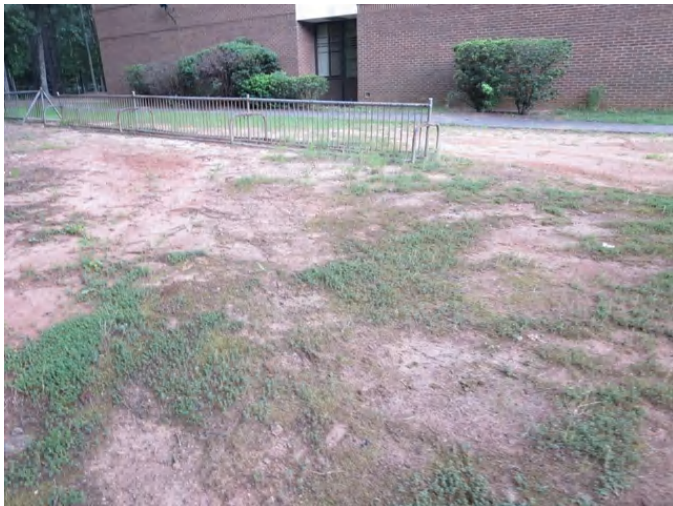
System: G2050 - Landscaping

Location: Site

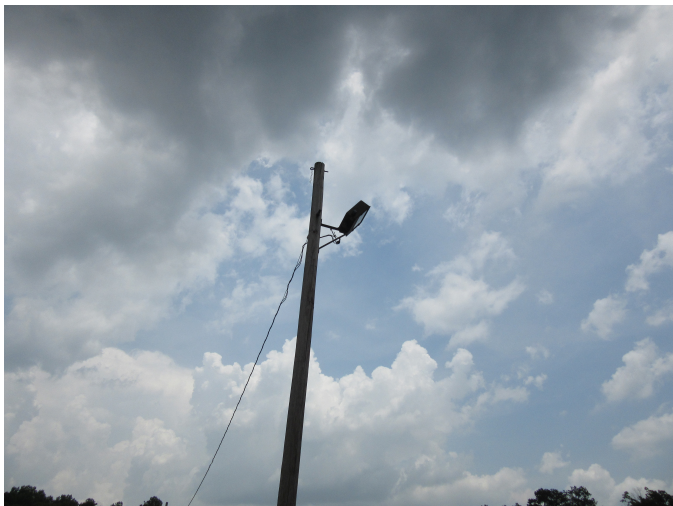
System: G4020 - Site Lighting

Location: Site
