DeKalb County School District/Elementary Schools

Flat Shoals Elementary

School Assessment Report

May 19, 2016

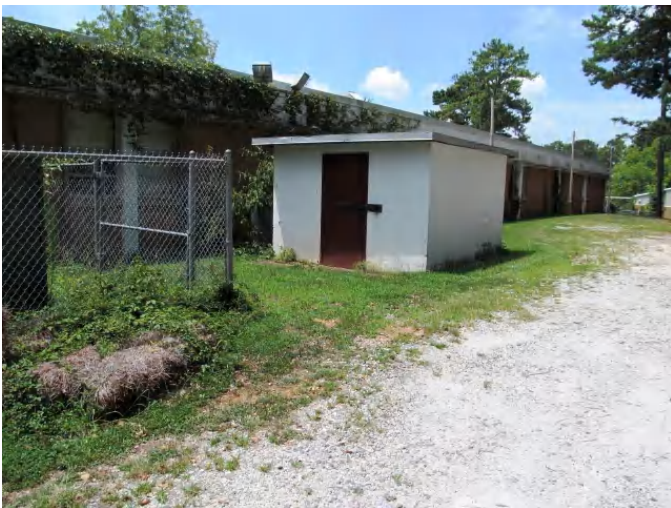
System: B2030 - Exterior Doors

Location: Exterior Wall

Distress: Beyond Service Life

Notes: The exterior door is beyond its expected service life and should be replaced.

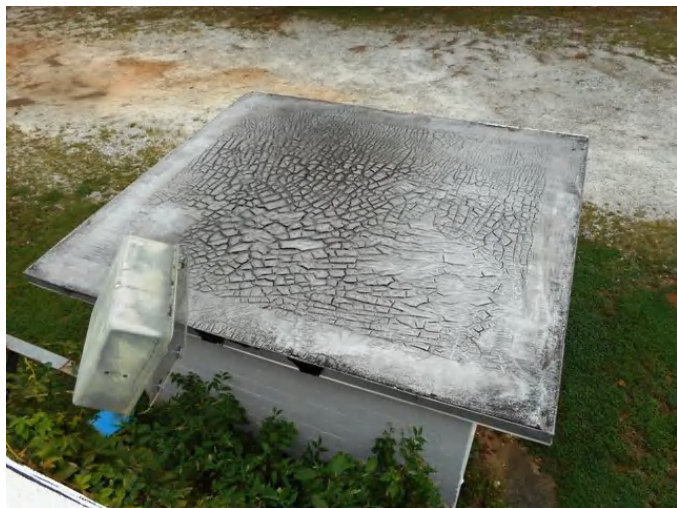
System: B3010 - Roof Coverings

Location: Roof

Distress: Beyond Service Life

Notes: Built-up roof covering is in deteriorating condition, with signs of cracks and bubbling.

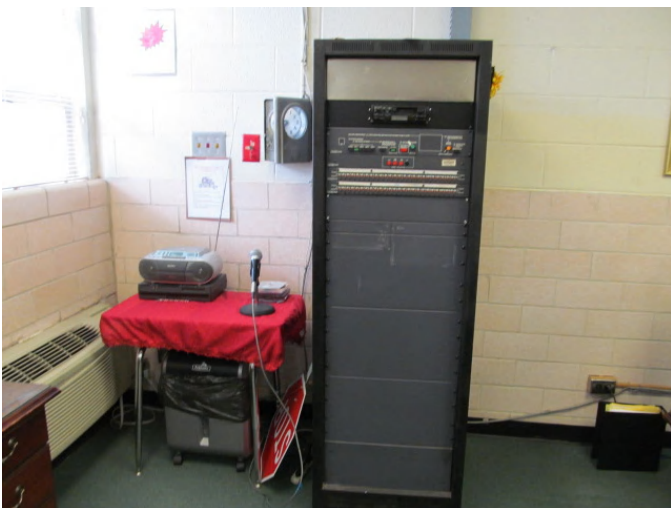
System: D5030 - Communications and Security - Clock & PA Systems

Location: Throughout Building

Distress: Damaged

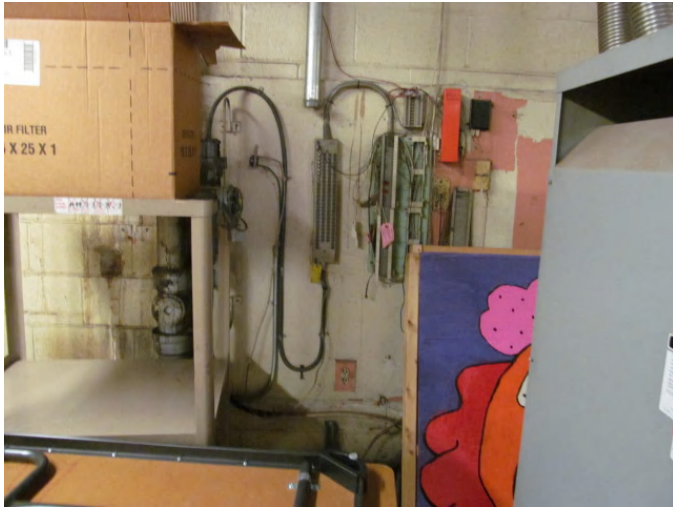
System: D5030 - Communications and Security - Teleco & Data

Location: Mechanical Room and MDF Room

Distress: Inadequate

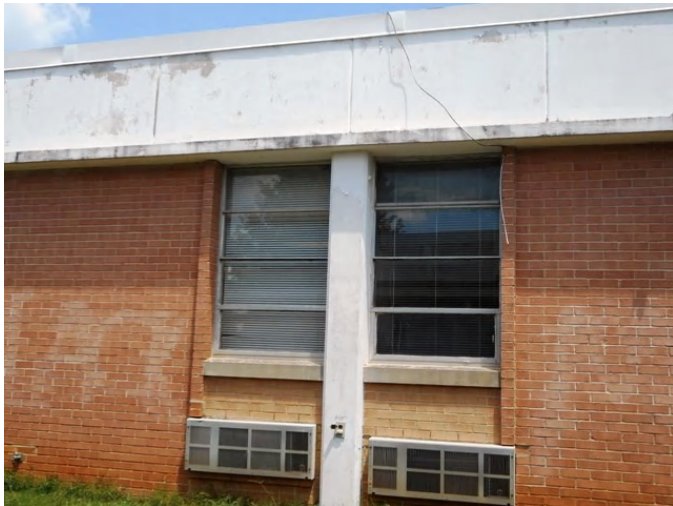
System: B2010 - Exterior Walls

Location: Exterior Walls

Distress: Damaged

Correction: Repair painted clay brick wall, 1st floor

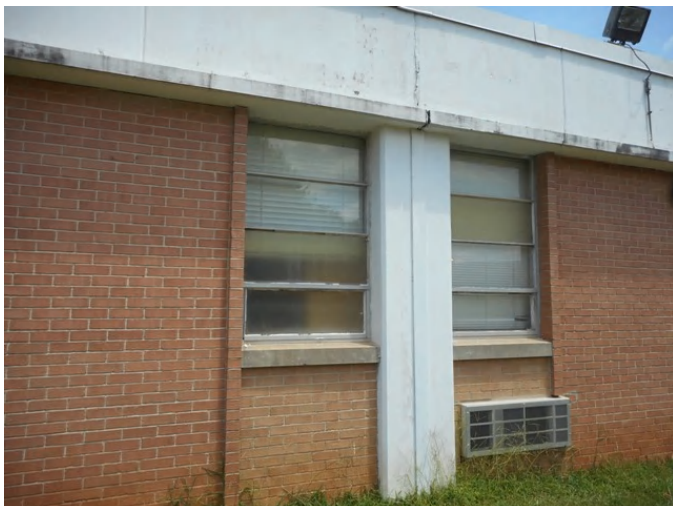
System: B2010 - Exterior Walls

Location: Exterior Walls

Distress: Beyond Service Life

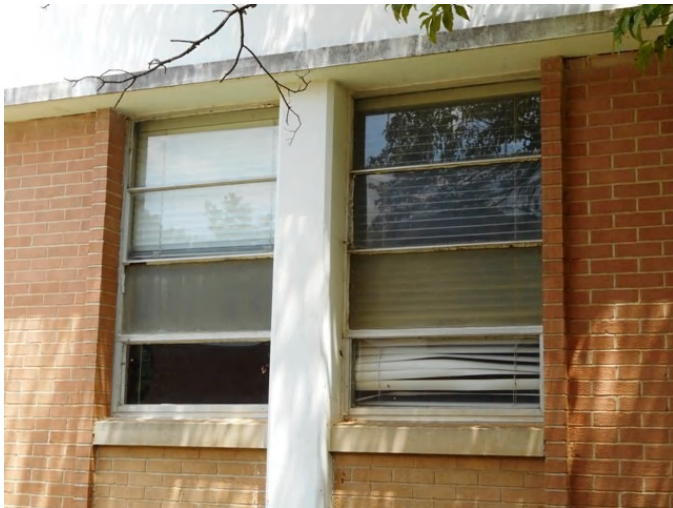
System: B2020 - Exterior Windows

Location: Throughout Building

Distress: Beyond Service Life

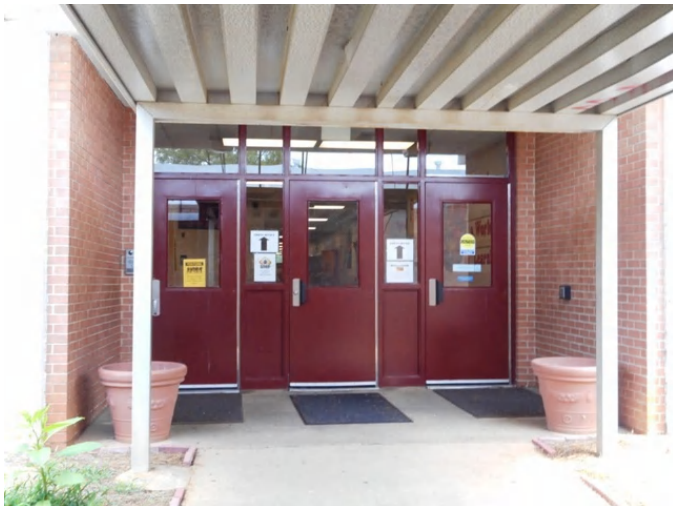
System: B2030 - Exterior Doors

Location: Throughout Building

Distress: Beyond Service Life

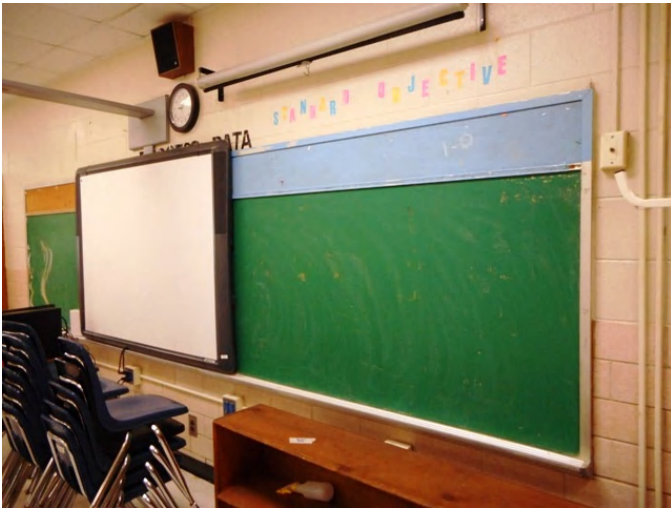
System: C1030 - Fittings

Location: Throughout Building

Distress: Beyond Service Life

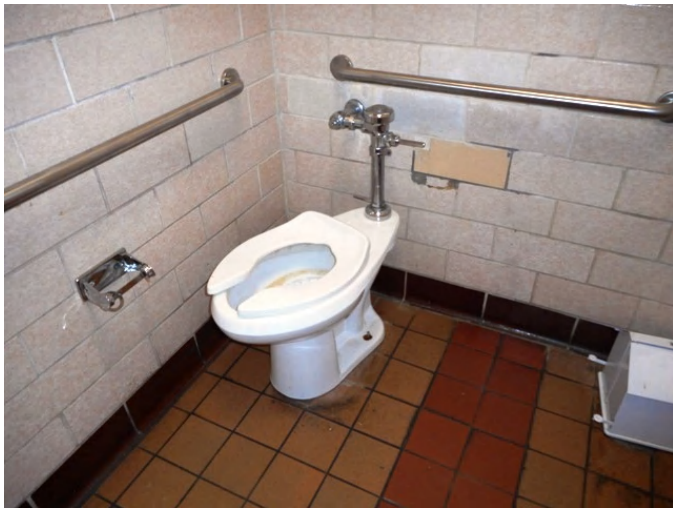
System: C3010 - Wall Finishes - Ceramic & Glazed

Location: Throughout Building

Distress: Beyond Service Life

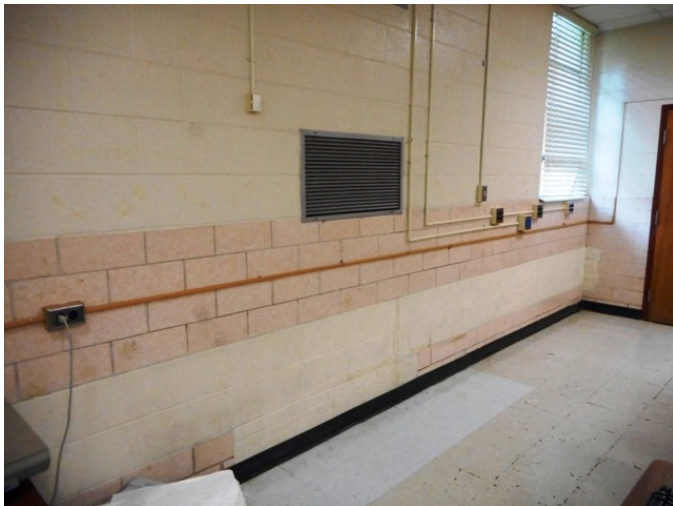
System: C3010 - Wall Finishes - Paint

Location: Throughout Building

Distress: Beyond Service Life

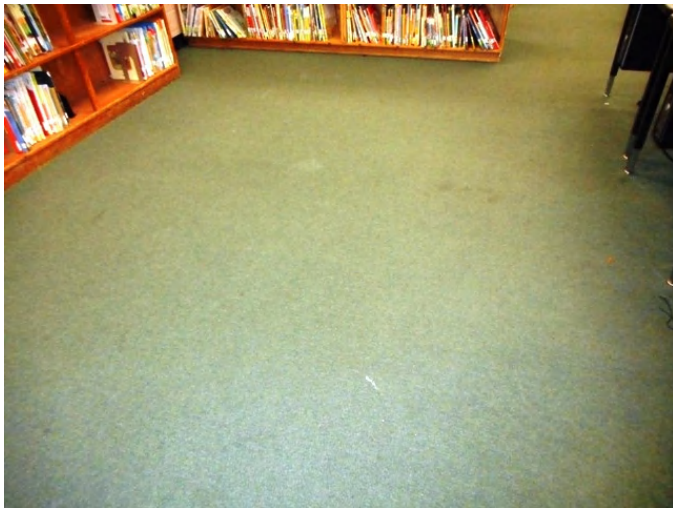
System: C3020 - Floor Finishes - Carpet

Location: Throughout Building

Distress: Beyond Service Life

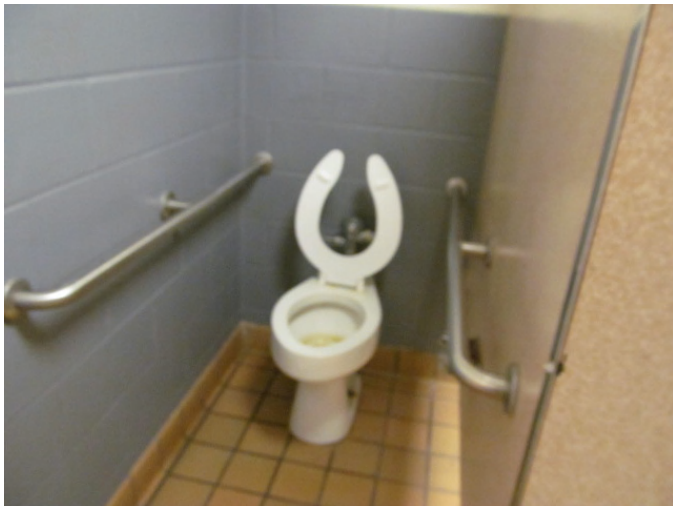
System: D2010 - Plumbing Fixtures

Location: Restrooms

Distress: Needs Remediation

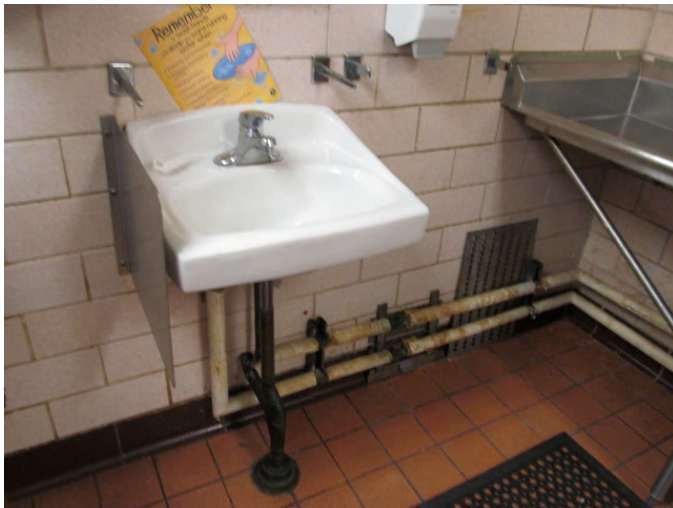
System: D2020 - Domestic Water Distribution

Location: Throughout Building

Distress: Beyond Service Life

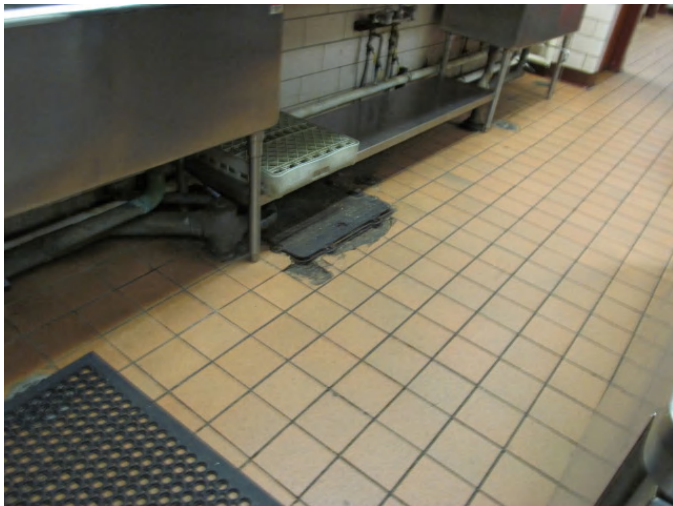
System: D2030 - Sanitary Waste

Location: Throughout Building

Distress: Beyond Service Life

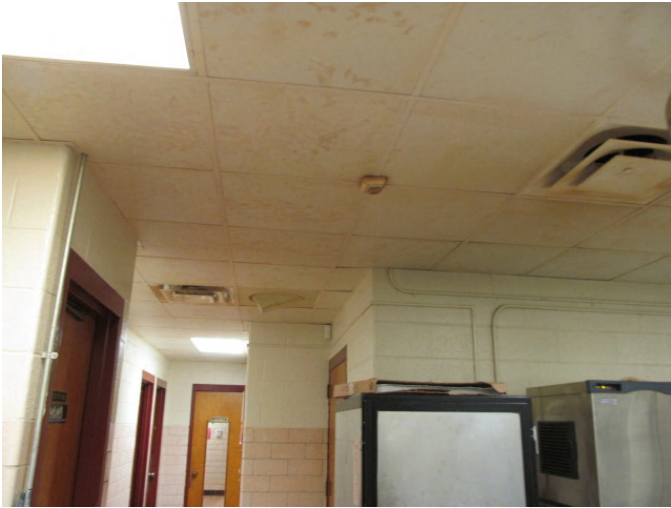
System: D3040 - Distribution & Exhaust Systems

Location: Throughout Building

Distress: Beyond Service Life

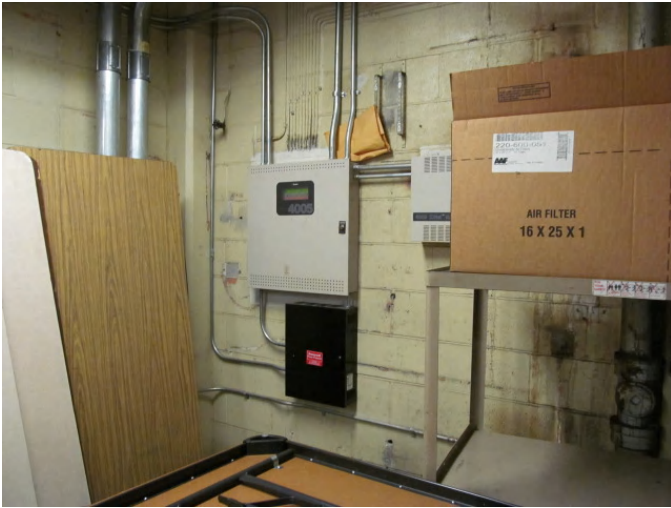
System: D5030 - Communications and Security - Fire Alarm

Location: Throughout Building

Distress: Beyond Service Life

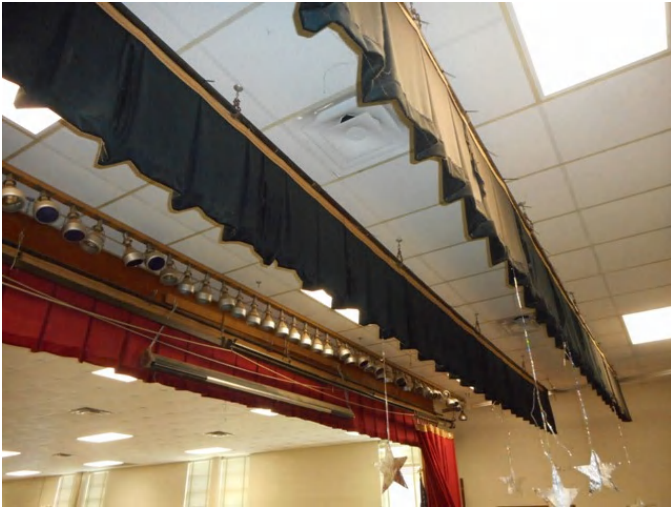
System: E1020 - Institutional Equipment

Location: Throughout Building

Distress: Beyond Service Life

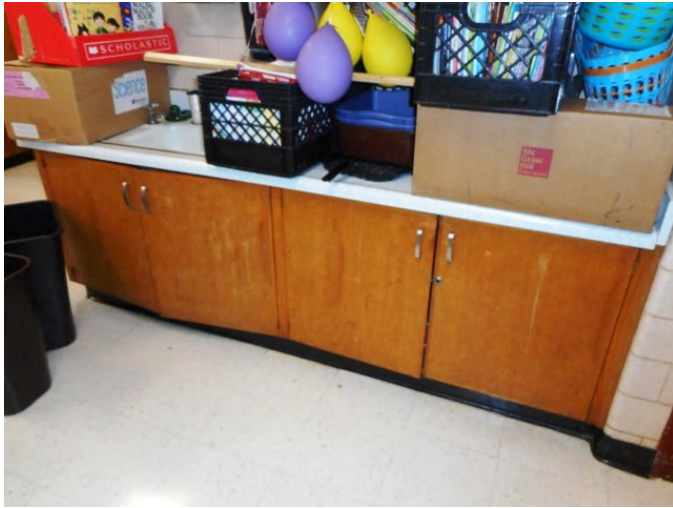
System: E2010 - Fixed Furnishings

Location: Throughout Building

Distress: Beyond Service Life

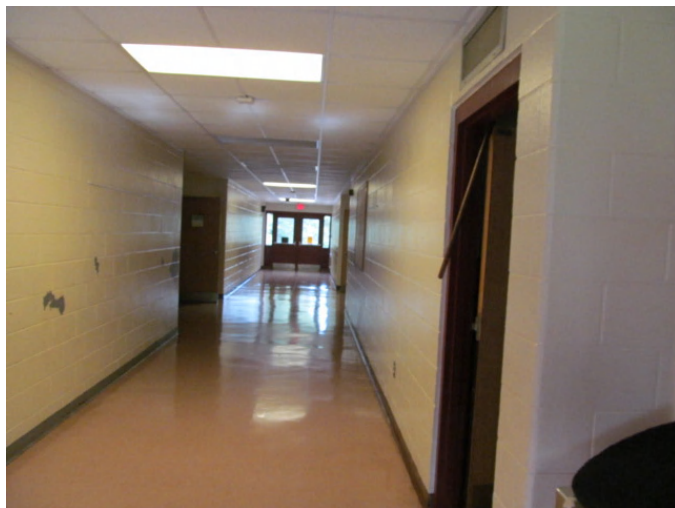
System: D5030 - Communications and Security - Fire Alarm

Location: Throughout Building

Distress: Inadequate

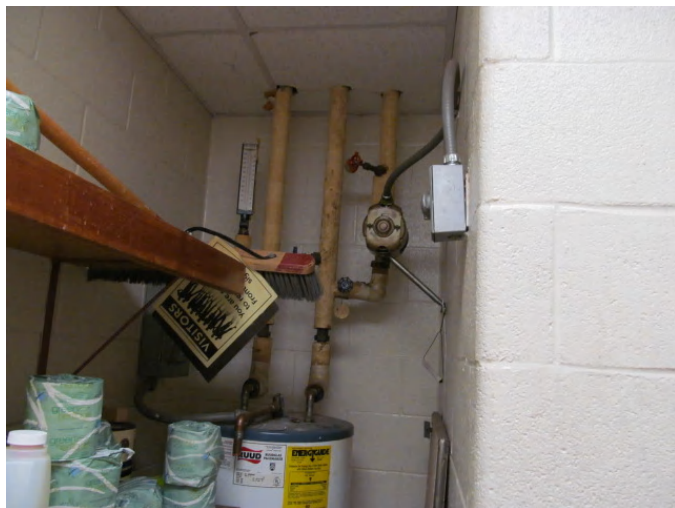
System: D2020 - Domestic Water Distribution

Location: Throughout Building
Distress: Beyond Service Life
Category: Deferred Maintenance
Priority: 3 Priority
Correction: Renew System
Qty: 5,440.00
Unit of Measure: S.F.
Estimate: \$23,876.00
Assessor Name: Ben Nixon
Date Created: 07/29/2015

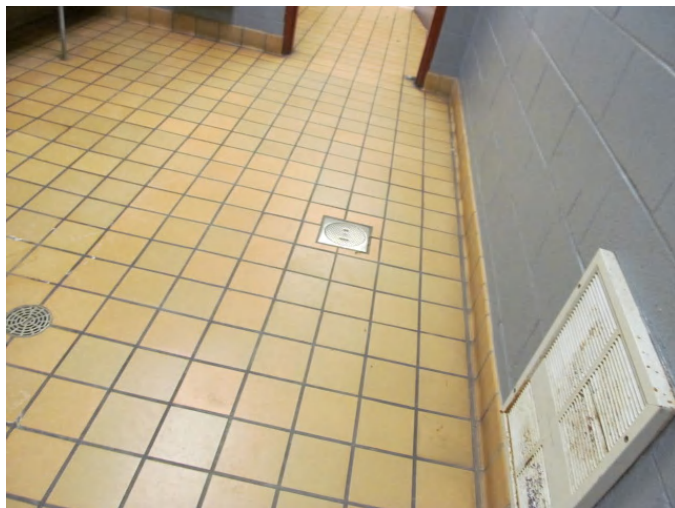
System: D2030 - Sanitary Waste

Location: Throughout Building
Distress: Beyond Service Life
Category: Deferred Maintenance
Priority: 3 Priority
Correction: Renew System
Qty: 5,440.00
Unit of Measure: S.F.
Estimate: \$20,405.00
Assessor Name: Ben Nixon
Date Created: 07/29/2015

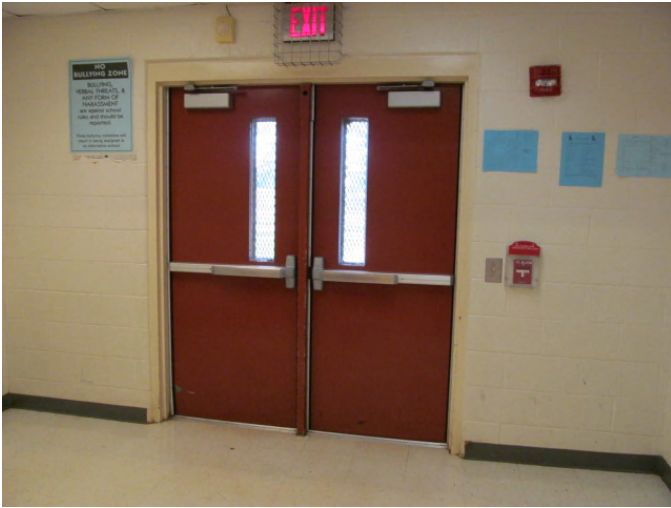
System: D5030 - Communications and Security - Fire Alarm

Location: Throughout Building
Distress: Beyond Service Life
Category: Deferred Maintenance
Priority: 3 Priority
Correction: Renew System
Qty: 5,478.00
Unit of Measure: S.F.
Estimate: \$12,835.00
Assessor Name: Ben Nixon
Date Created: 04/11/2015
