DeKalb County School District/Vacant

Former Briarcliff HS (Open Campus)

School Assessment Report

May 20, 2016

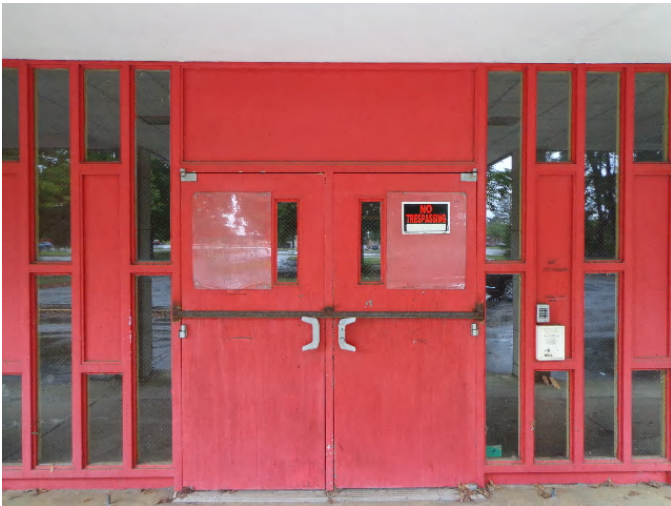
System: B2030 - Exterior Doors

Location: Throughout Building

Distress: Beyond Service Life

Notes: The original exterior doors are aged, rusted, inefficient, and should be replaced.

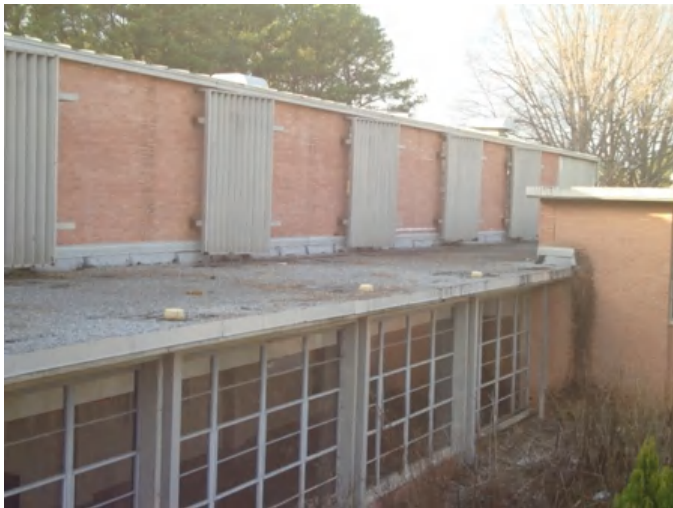
System: B3010 - Roof Coverings - BUR

Location: Roof

Distress: Beyond Service Life

Notes: Built-up roof covering is in deteriorating condition with cracks, bubbling, loss of surface, patches, ponding and reported water leaks.

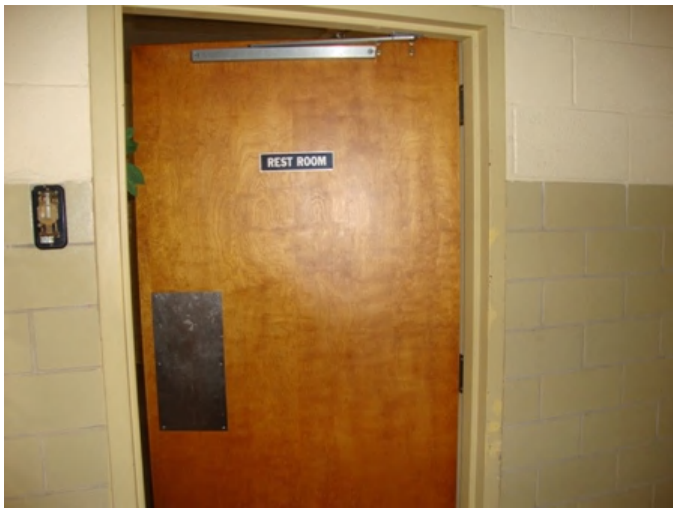
System: C1020 - Interior Doors

Location: Throughout Building

Distress: Beyond Service Life

Notes: The interior doors are aged and failing, the hardware is not ADA compliant, and should be replaced.

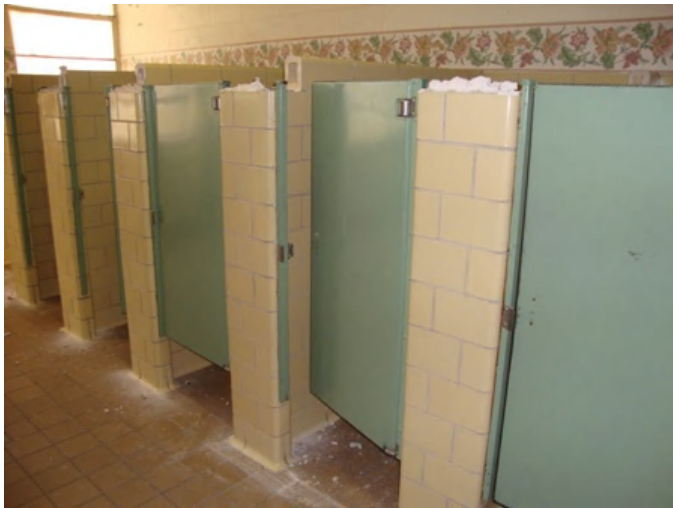
System: C1030 - Fittings

Location: Throughout Building

Distress: Beyond Service Life

Notes: Fittings throughout the building are in marginal condition, handrails and room signage are not ADA compliant, and the system should be replaced.

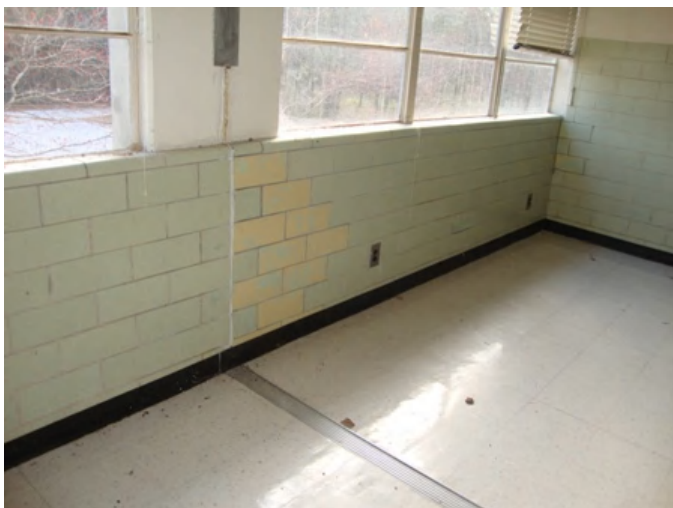
System: C3010 - Wall Finishes - Ceramic & Glazed

Location: Throughout Building

Distress: Beyond Service Life

Notes: Wall tiles are aged, scuffed, stained and patched, and should be replaced.

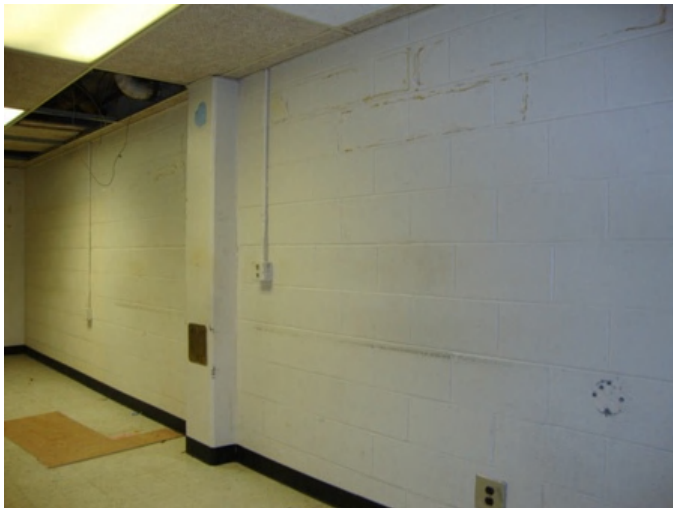
System: C3010 - Wall Finishes - Paint

Location: Throughout Building

Distress: Beyond Service Life

Notes: Painted wall finishes are aged, scuffed, faded and stained, and should be replaced.

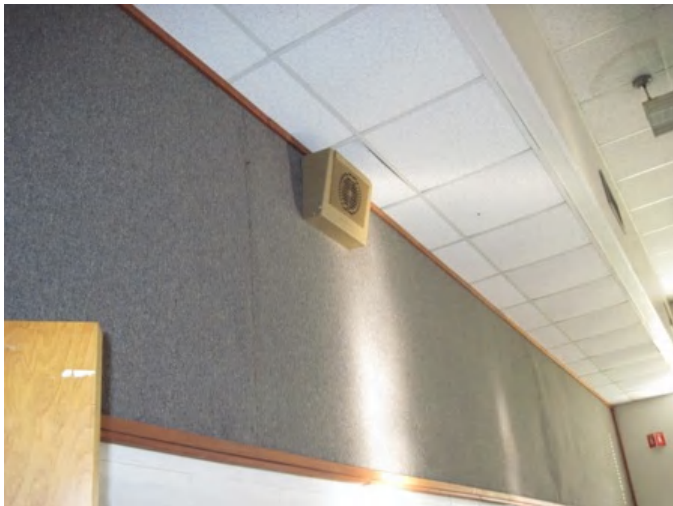
System: C3010 - Wall Finishes - Wall Coverings

Location: Throughout Building

Distress: Beyond Service Life

Notes: Wall coverings are aged, scuffed, faded and stained, and should be replaced.

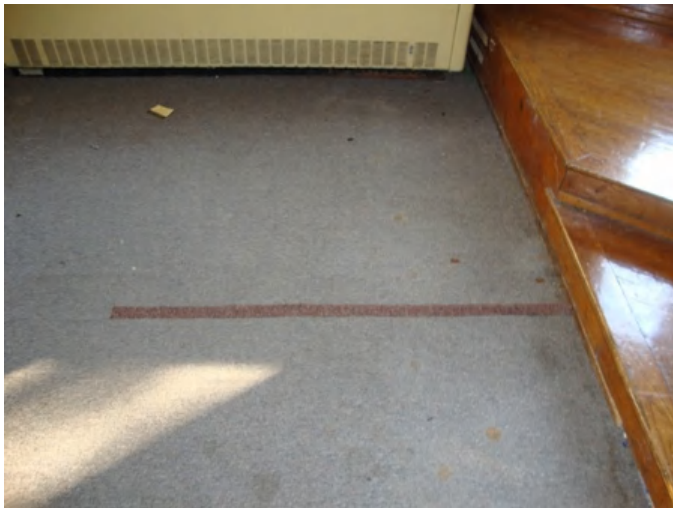
System: C3020 - Floor Finishes - Carpet

Location: Library and Administrative Area

Distress: Beyond Service Life

Notes: The carpet is aged, stained, frayed and torn, and should be replaced.

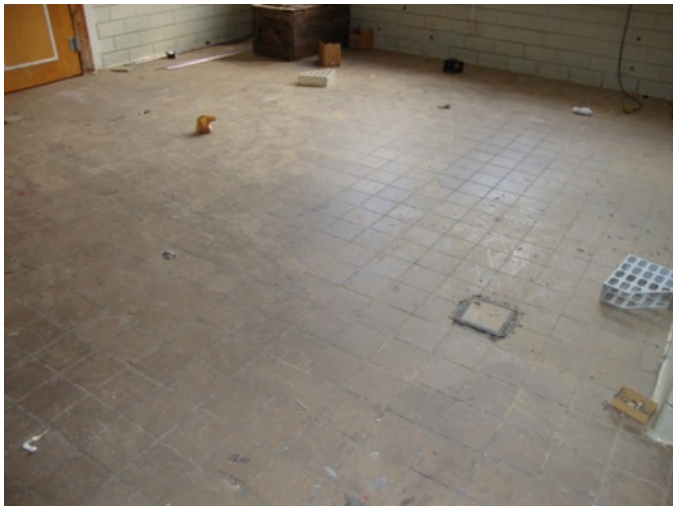
System: C3020 - Floor Finishes - Ceramic & Quarry Tile

Location: Kitchen and Restrooms

Distress: Beyond Service Life

Notes: The original tile is aged, chipped, cracked, patched, worn and should be replaced.

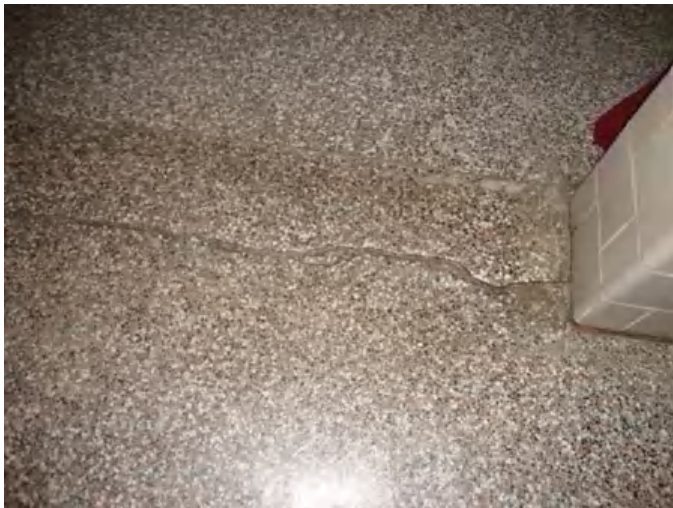
System: C3020 - Floor Finishes - Terrazzo

Location: Hallways
Distress: Beyond Service Life
Category: Deferred Maintenance
Priority: 3 Priority
Correction: Renew System
Qty: 18,345.00
Unit of Measure: S.F.
Estimate: \$932,898.00
Assessor Name: Eduardo Lopez
Date Created: 07/30/2015

Notes: The terrazzo floor system is beyond its expected life and should be scheduled for replacement.

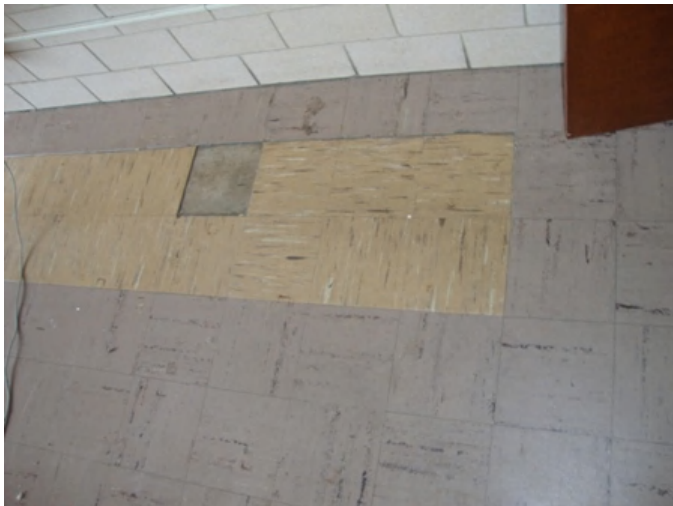
System: C3020 - Floor Finishes - VCT

Location: Throughout Building
Distress: Beyond Service Life
Category: Deferred Maintenance
Priority: 3 Priority
Correction: Renew System
Qty: 101,434.00
Unit of Measure: S.F.
Estimate: \$923,861.00
Assessor Name: Eduardo Lopez
Date Created: 07/30/2015

Notes: The VCT flooring is aged, cracked and worn, and should be replaced.

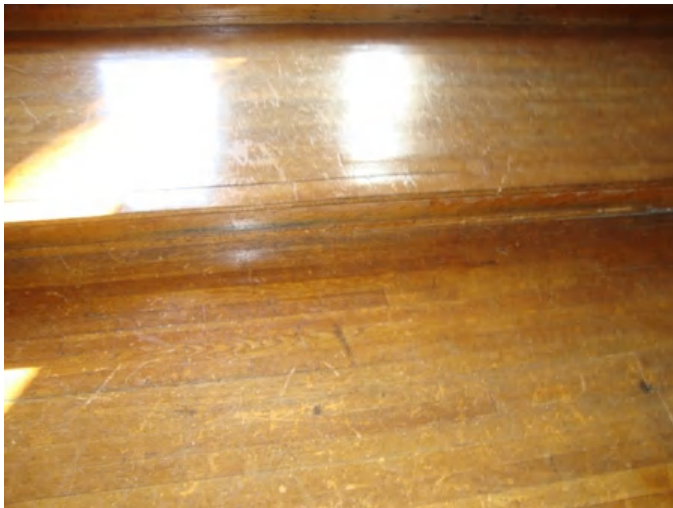
System: C3020 - Floor Finishes - Wood

Location: Gym

Distress: Beyond Service Life

Notes: The wood flooring system is beyond its expected life and should be scheduled for replacement.

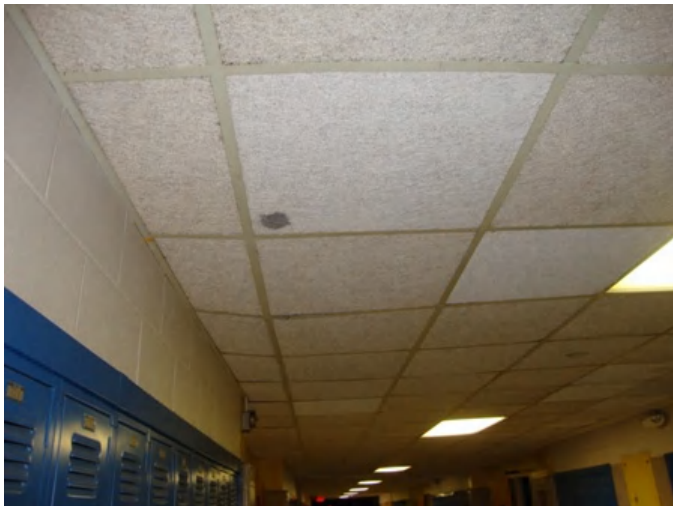
System: C3030 - Ceiling Finishes

Location: Throughout Building

Distress: Beyond Service Life

Notes: The acoustical ceiling tiles and grid are showing signs of aging and should be replaced.

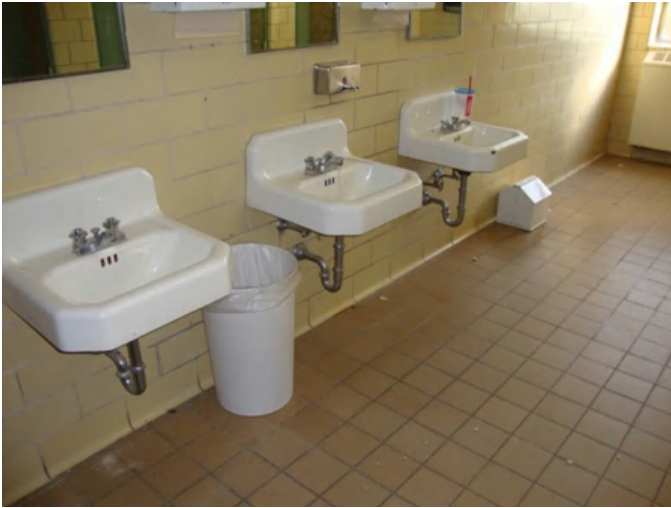
System: D2010 - Plumbing Fixtures

Location: Throughout Building

Distress: Beyond Service Life

Notes: Plumbing fixtures are beyond their expected service life, inefficient, and should be replaced to improve ADA accessibility.

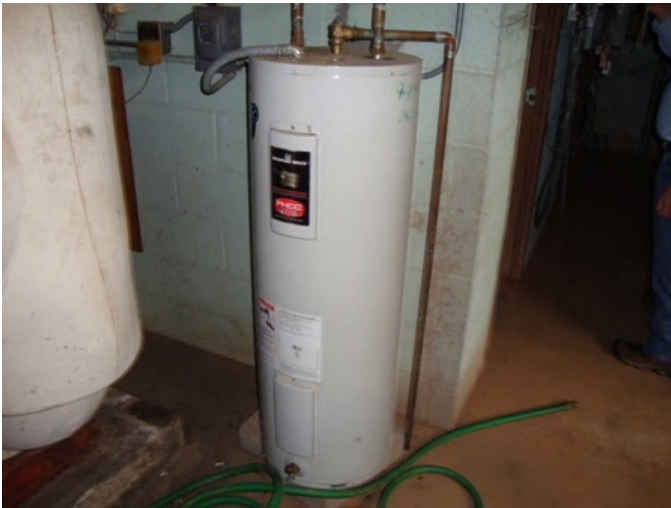
System: D2020 - Domestic Water Distribution

Location: Throughout Building

Distress: Beyond Service Life

Notes: The domestic water distribution system is beyond its expected service life and should be scheduled for replacement.

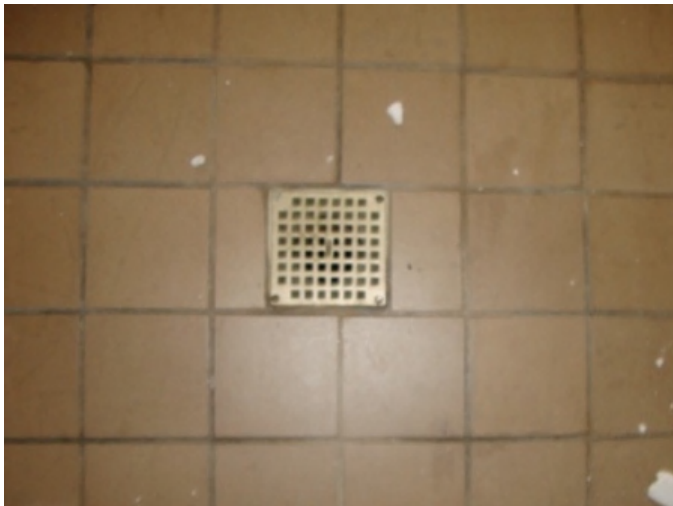
System: D2030 - Sanitary Waste

Location: Throughout Building

Distress: Beyond Service Life

Notes: The sanitary waste system is beyond its expected service life and should be scheduled for replacement.

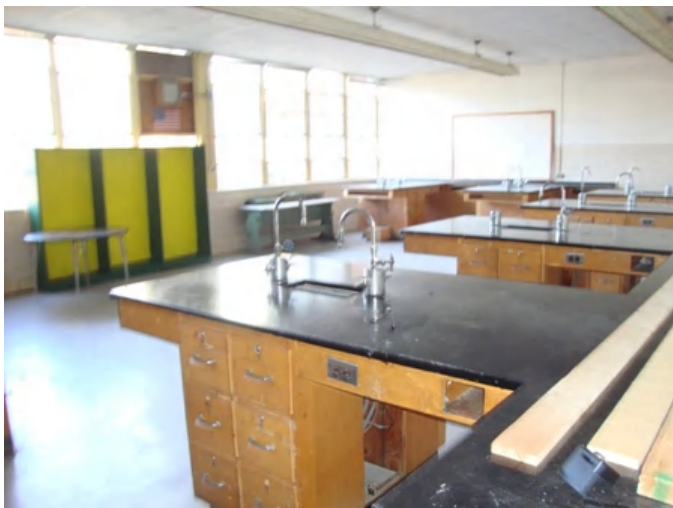
System: D2090 - Other Plumbing Systems - Acid Waste

Location: Throughout Building

Distress: Beyond Service Life

Notes: The acid waste distribution system is beyond its expected service life and should be scheduled for replacement.

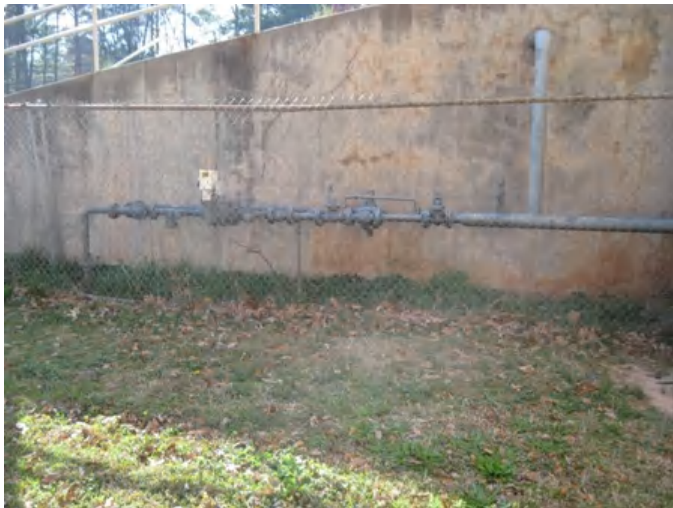
System: D2090 - Other Plumbing Systems - Natural Gas

Location: Throughout Building
Distress: Beyond Service Life
Category: Deferred Maintenance
Priority: 3 Priority
Correction: Renew System
Qty: 154,155.00
Unit of Measure: S.F.
Estimate: \$117,004.00
Assessor Name: Eduardo Lopez
Date Created: 07/30/2015

Notes: The natural gas distribution system is beyond its expected service life and should be scheduled for replacement.

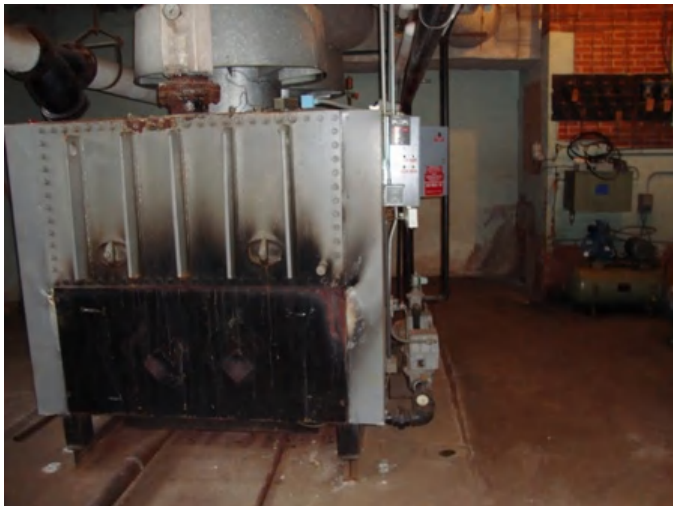
System: D3020 - Heat Generating Systems

Location: Mechanical Room
Distress: Beyond Service Life
Category: Deferred Maintenance / Energy
Priority: 3 Priority
Correction: Renew System
Qty: 154,155.00
Unit of Measure: S.F.
Estimate: \$771,546.00
Assessor Name: Eduardo Lopez
Date Created: 07/30/2015

Notes: The heat generating system is beyond its expected service life and should be scheduled for replacement.

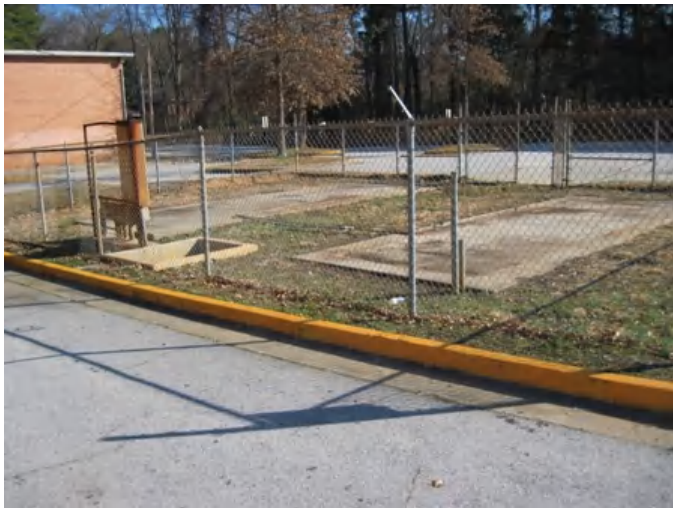
System: D3030 - Cooling Generating Systems

Location: Throughout Building

Distress: Missing

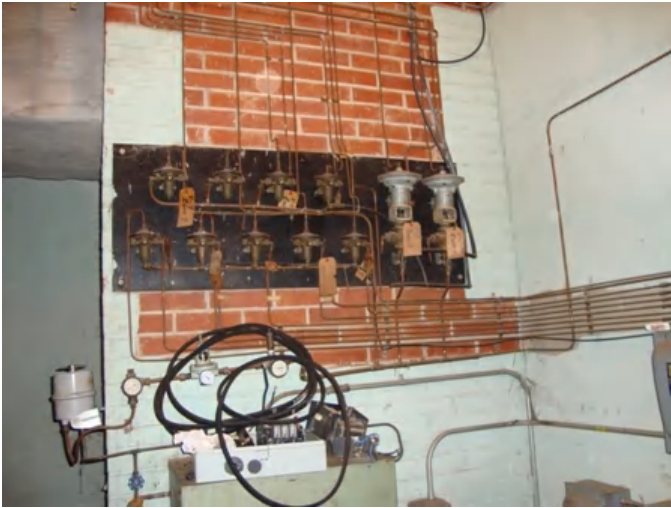
System: D3060 - Controls & Instrumentation

Location: Throughout Building

Distress: Beyond Service Life

Notes: The controls and instrumentation system is beyond its expected service life and should be scheduled for replacement.

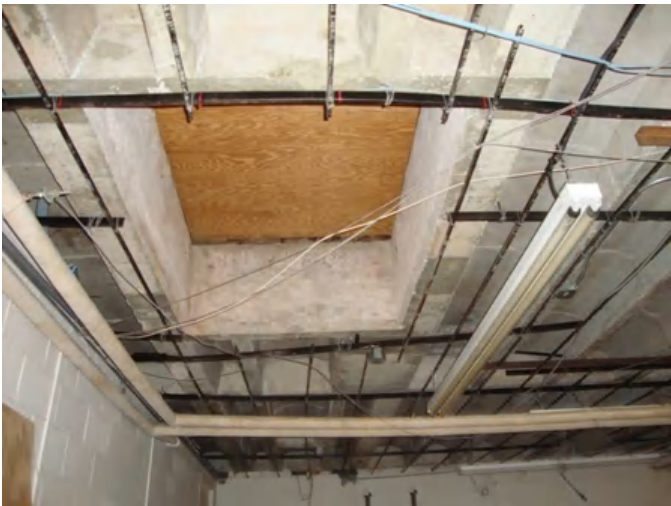
System: D3090 - Other HVAC Systems/Equip - Kitchen Hood

Location: Kitchen

Distress: Missing

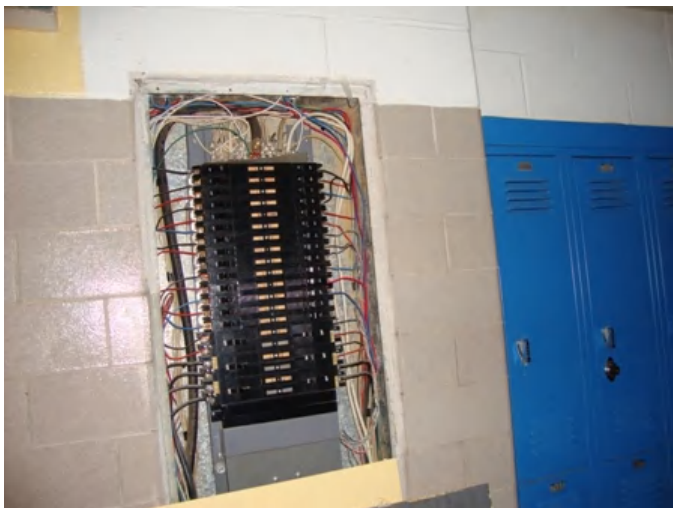
System: D5020 - Branch Wiring

Location: Throughout Building

Distress: Beyond Service Life

Notes: Branch wiring is beyond its expected service life and should be scheduled for replacement.

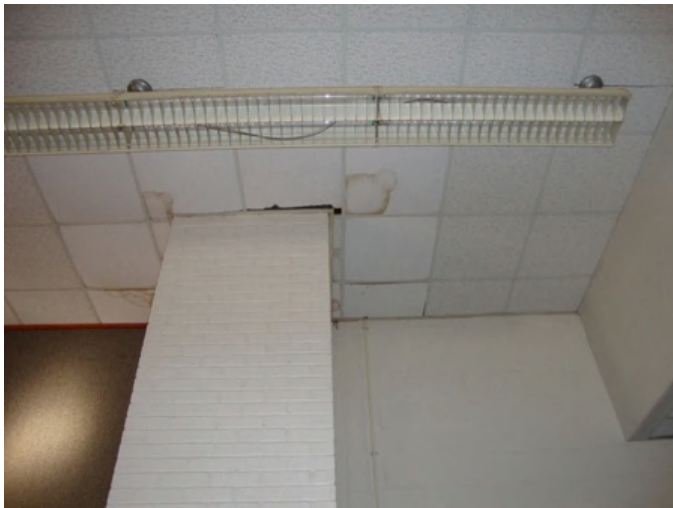
System: D5020 - Lighting

Location: Throughout Building

Distress: Beyond Service Life

Notes: Lighting is beyond its expected service life, inefficient, and should be scheduled for replacement.

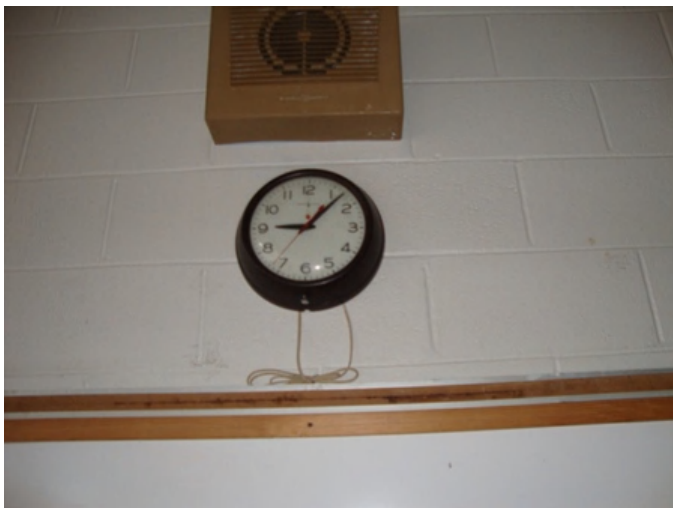
System: D5030 - Communications and Security

Location: Throughout Building

Distress: Beyond Service Life

Notes: Communications and security systems, including fire alarm, clock and PA, telephone, and security systems, are beyond their expected service life and should be scheduled for replacement.

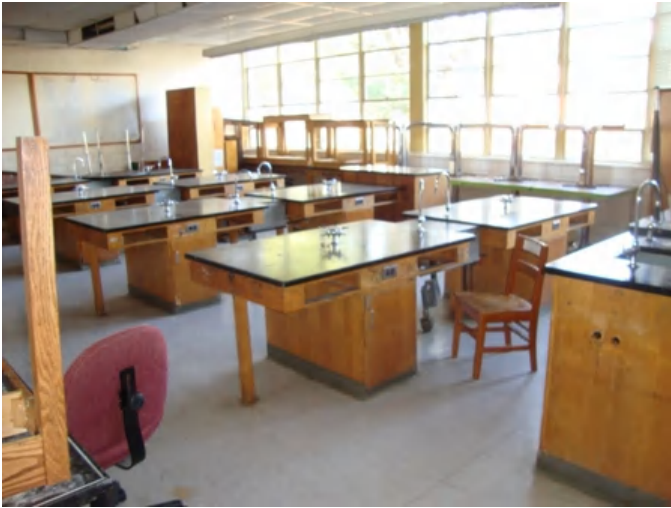
System: E1020 - Institutional Equipment

Location: Throughout Building
Distress: Beyond Service Life
Category: Deferred Maintenance
Priority: 3 Priority
Correction: Renew System
Qty: 154,155.00
Unit of Measure: S.F.
Estimate: \$127,178.00
Assessor Name: Eduardo Lopez
Date Created: 07/30/2015

Notes: Institutional equipment, such as laboratory equipment and theater and stage equipment, is beyond its expected life and should be scheduled for replacement.

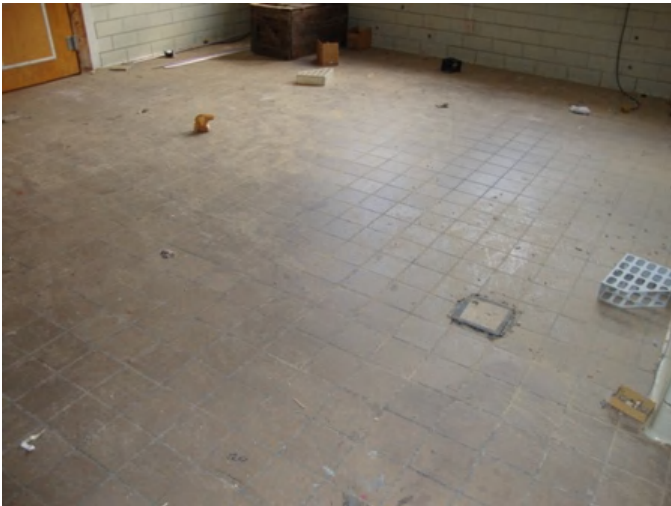
System: E1090 - Other Equipment (Kitchen Equipment)

Location: Kitchen
Distress: Missing
Category: Deferred Maintenance
Priority: 3 Priority
Correction: Renew System
Qty: 154,155.00
Unit of Measure: S.F.
Estimate: \$954,682.00
Assessor Name: Eduardo Lopez
Date Created: 07/31/2015

Notes: Kitchen equipment has been removed. New equipment should be installed if building is reoccupied.

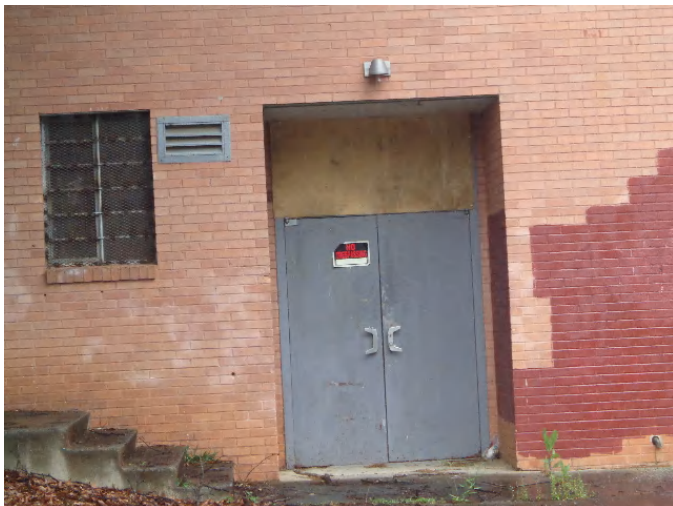
System: B2030 - Exterior Doors

Location: Throughout Building

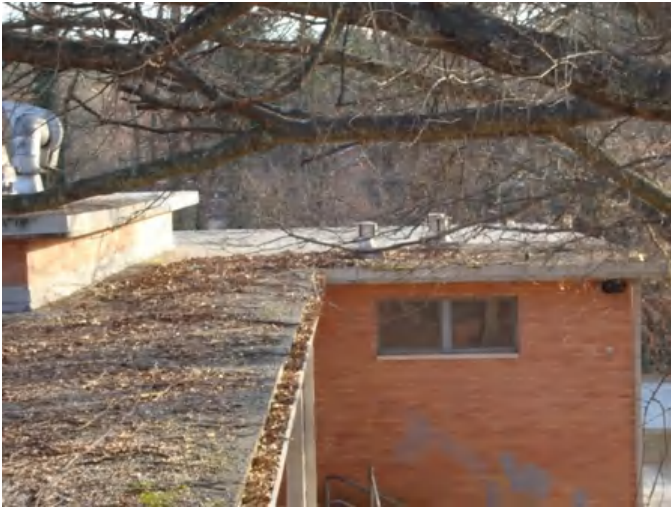
System: B3010 - Roof Coverings - BUR

Location: Roof

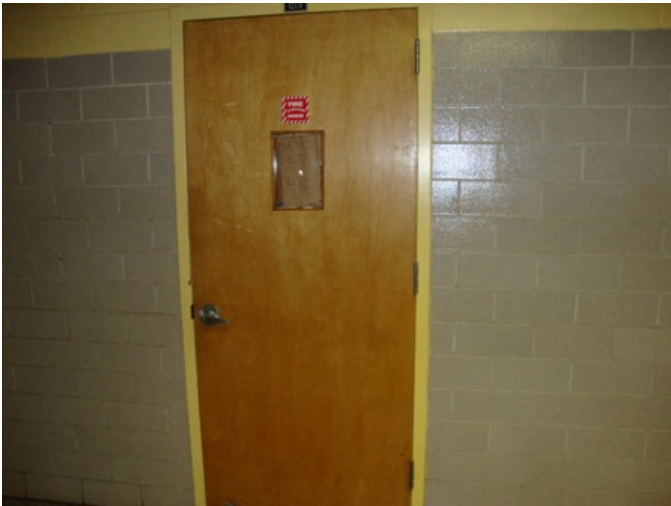
System: C1020 - Interior Doors

Location: Throughout Building

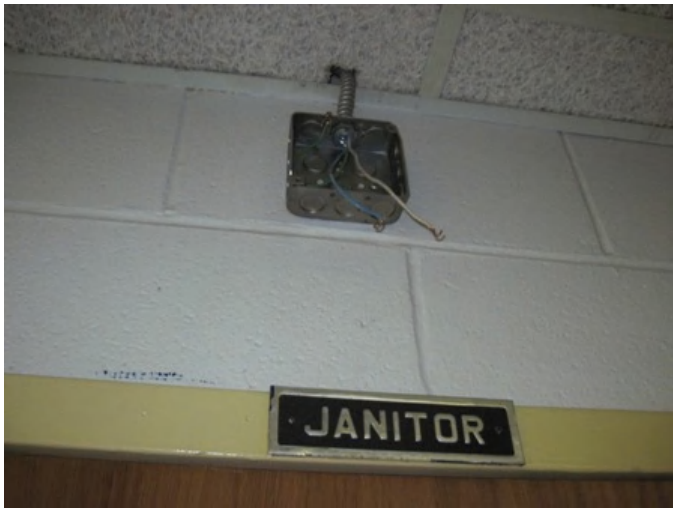
System: C1030 - Fittings

Location: Throughout Building

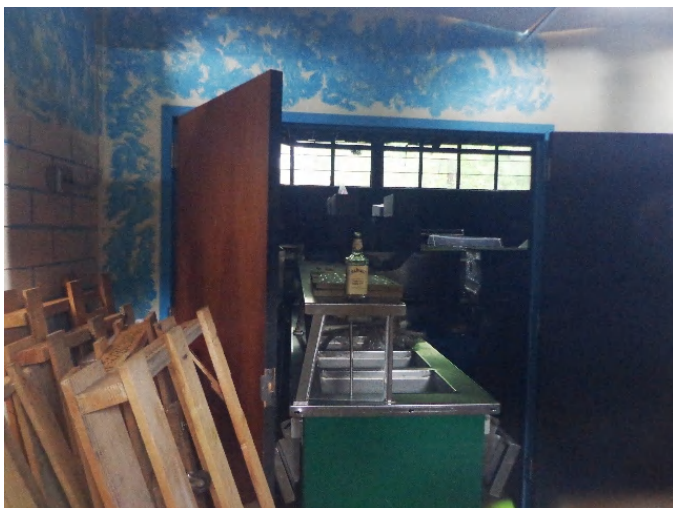
System: C3010 - Wall Finishes - Paint

Location: Throughout Building

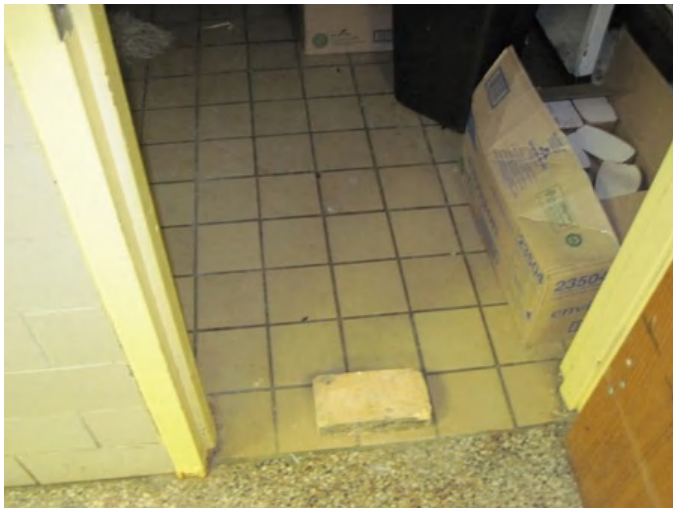
System: C3020 - Floor Finishes - Ceramic & Quarry Tile

Location: Restrooms and Custodian Closets

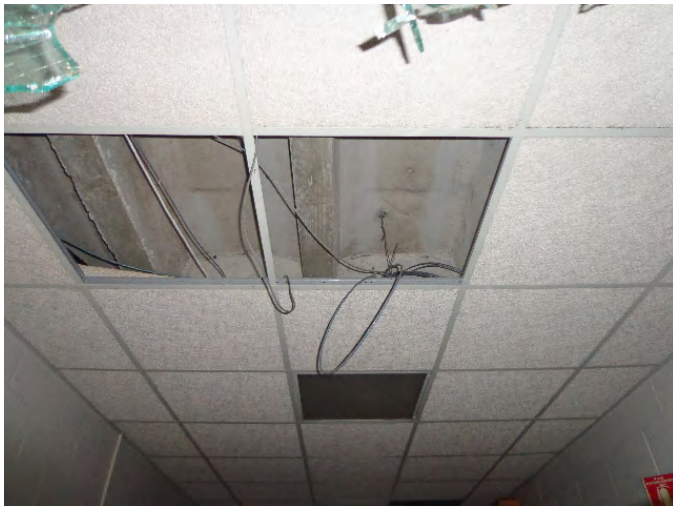
System: C3030 - Ceiling Finishes

Location: Throughout Building

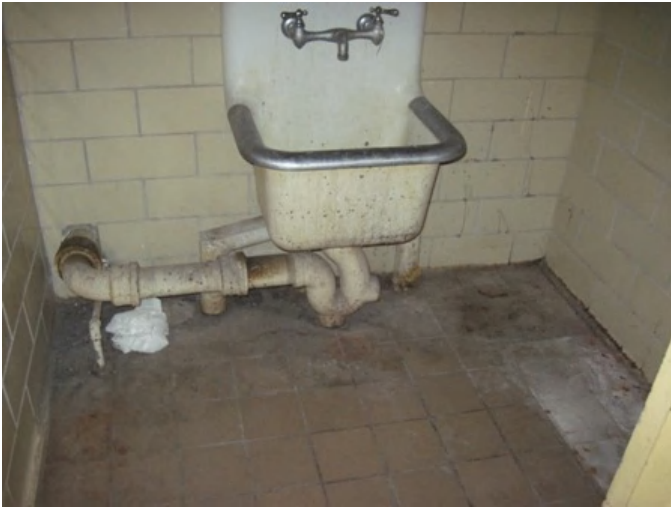
System: D2010 - Plumbing Fixtures

Location: Throughout Building

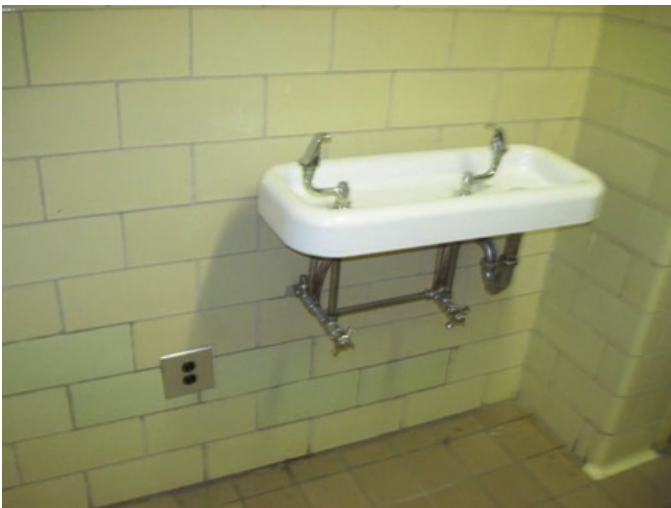
System: D2020 - Domestic Water Distribution

Location: Throughout Building

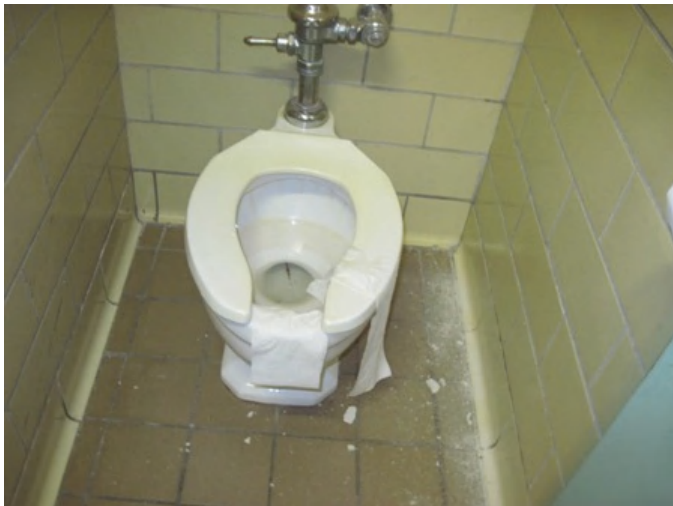
System: D2030 - Sanitary Waste

Location: Throughout Building
Distress: Beyond Service Life
Category: Deferred Maintenance
Priority: 3 Priority
Correction: Renew System
Qty: 8,750.00
Unit of Measure: S.F.
Estimate: \$41,195.00
Assessor Name: Eduardo Lopez
Date Created: 07/30/2015

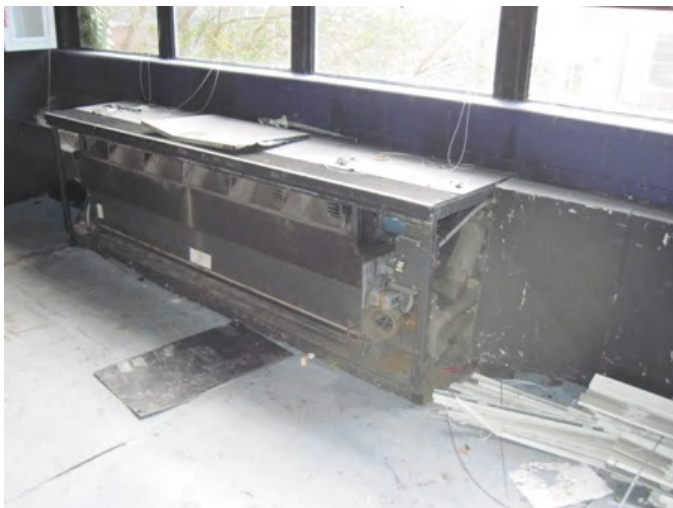
System: D3040 - Distribution Systems & Exhaust Systems

Location: Throughout Building
Distress: Beyond Service Life
Category: Deferred Maintenance
Priority: 3 Priority
Correction: Renew System
Qty: 8,750.00
Unit of Measure: S.F.
Estimate: \$50,339.00
Assessor Name: Eduardo Lopez
Date Created: 07/30/2015

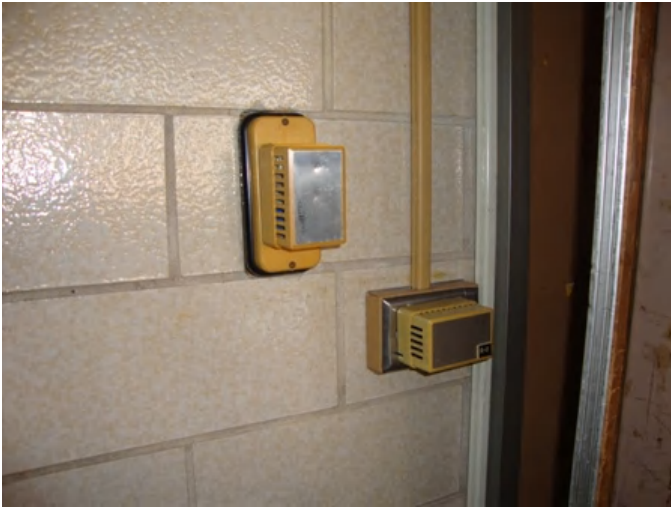
System: D3060 - Controls & Instrumentation

Location: Throughout Building

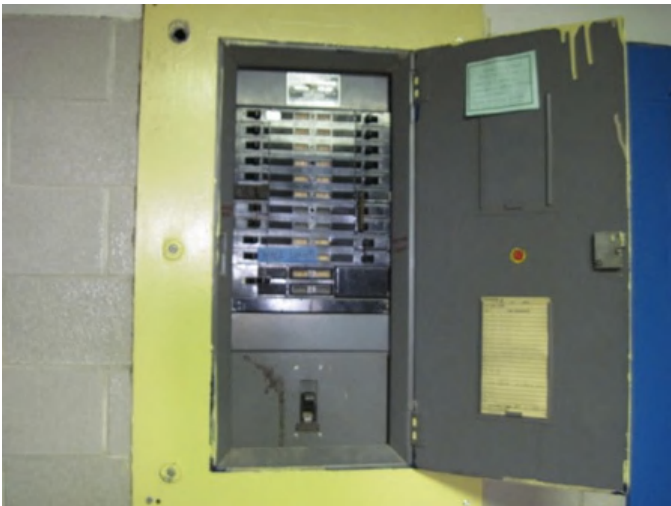
System: D5010 - Electrical Service/Distribution

Location: Throughout Building

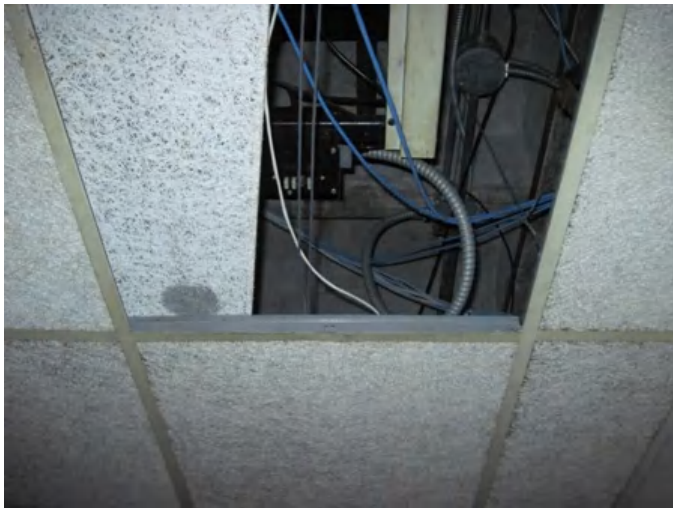
System: D5020 - Branch Wiring

Location: Throughout Building

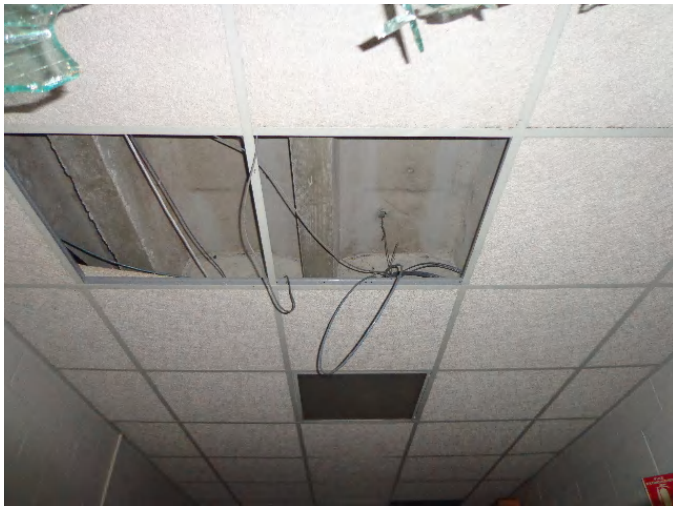
System: D5020 - Lighting

Location: Throughout Building

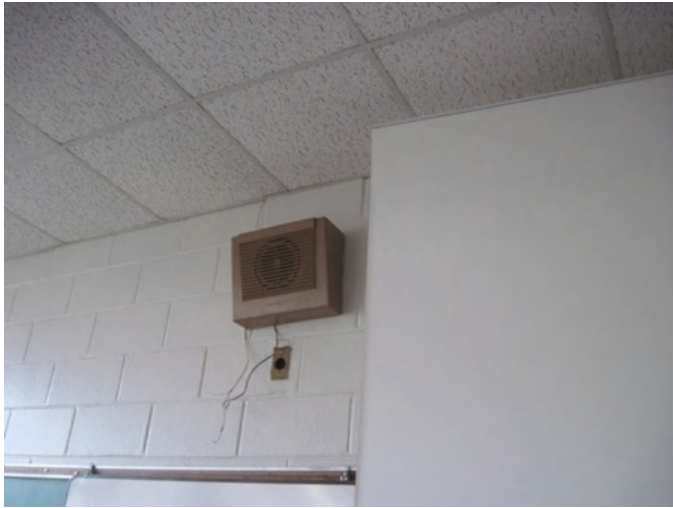
System: D5030 - Communications and Security

Location: Throughout Building

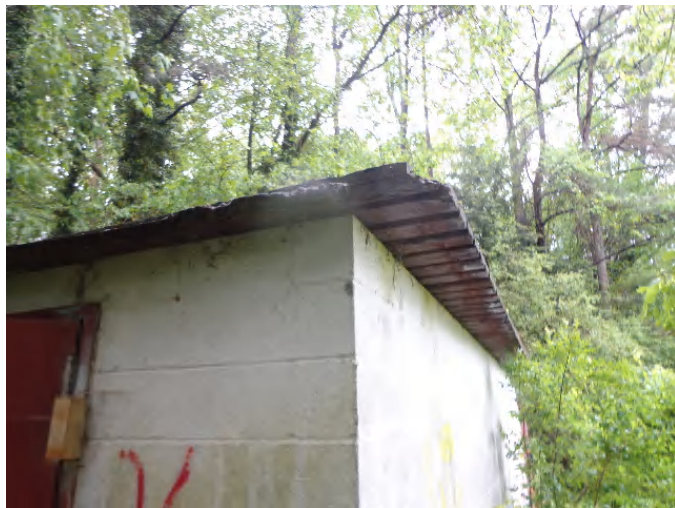
System: B3010 - Roof Coverings

Location: Roof

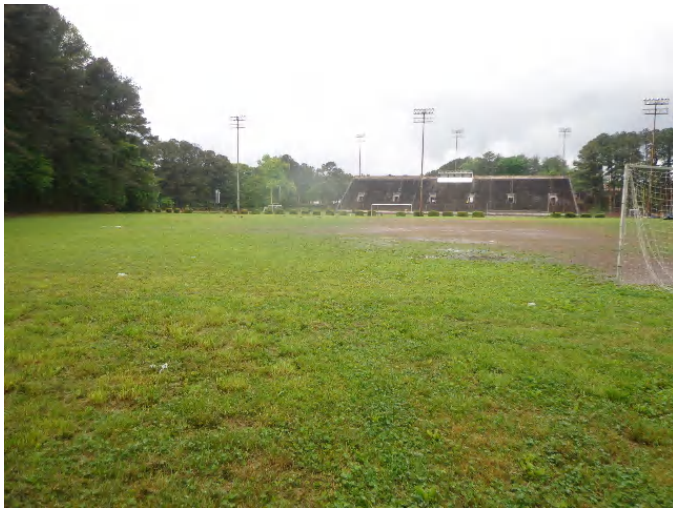
System: G2040 - Playing Field

Location: Site

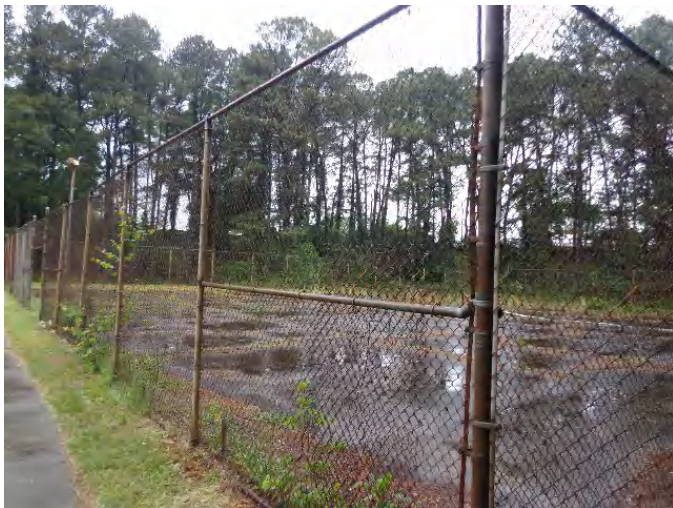
System: G2040 - Tennis Courts

Location: Site

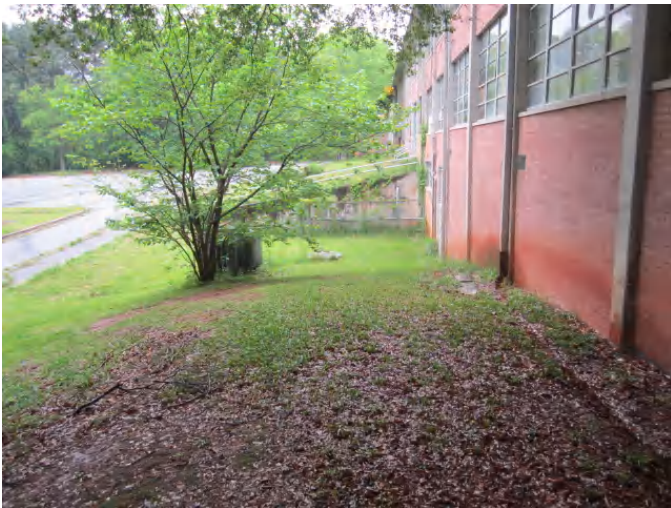
System: G2050 - Landscaping

Location: Site

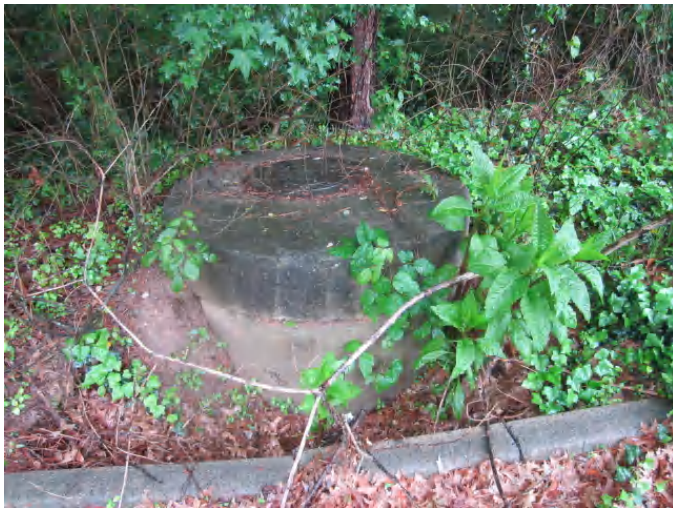
System: G3020 - Sanitary Sewer

Location: Site
Distress: Beyond Service Life
Category: Deferred Maintenance
Priority: 3 Priority
Correction: Renew System
Qty: 159,005.00
Unit of Measure: S.F.
Estimate: \$201,141.33
Assessor Name: Eduardo Lopez
Date Created: 07/30/2015

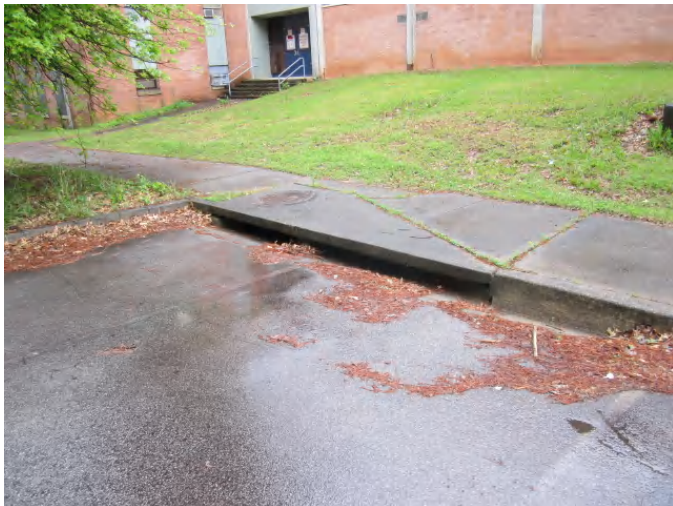
System: G3030 - Storm Sewer

Location: Site
Distress: Beyond Service Life
Category: Deferred Maintenance
Priority: 3 Priority
Correction: Renew System
Qty: 159,005.00
Unit of Measure: S.F.
Estimate: \$620,914.53
Assessor Name: Eduardo Lopez
Date Created: 07/30/2015

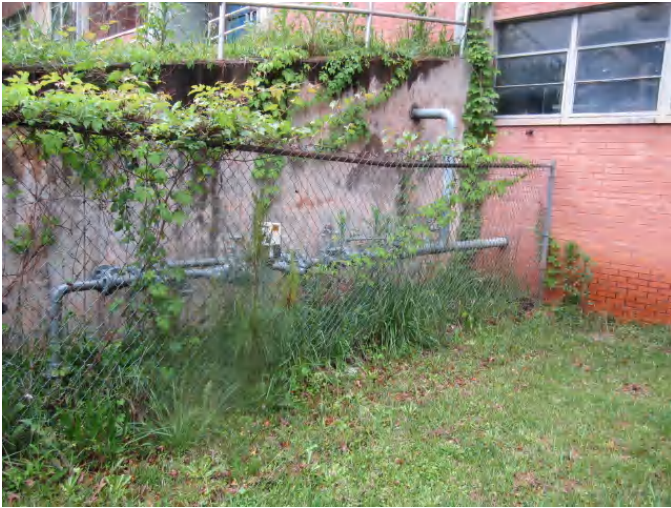
System: G3060 - Fuel Distribution

Location: Site

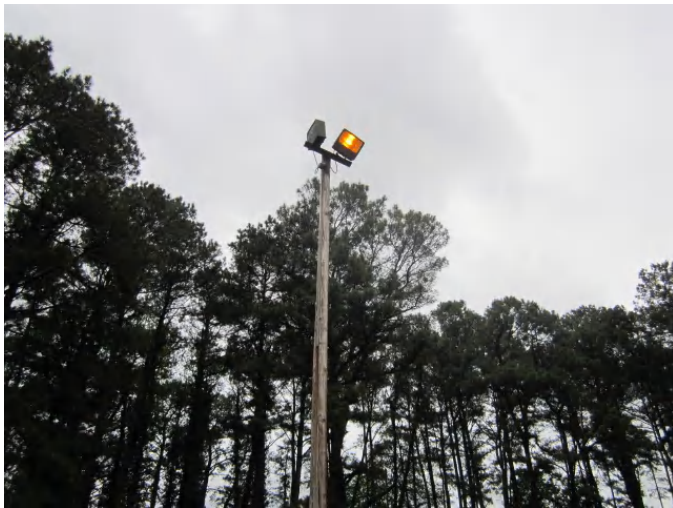
System: G4020 - Site Lighting

Location: Site

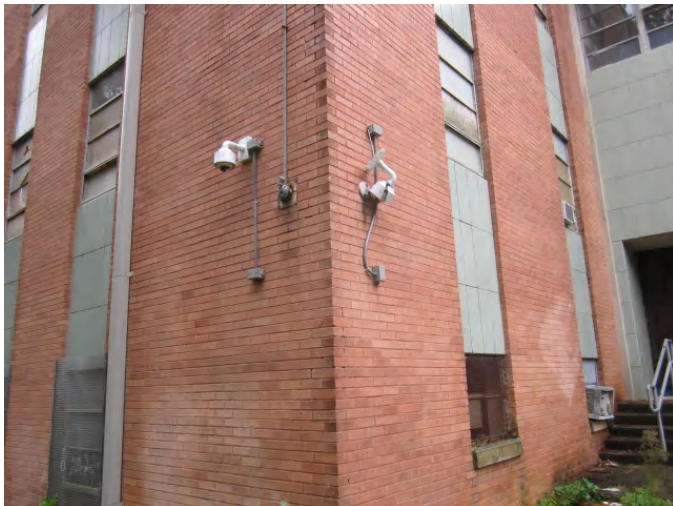
System: G4030 - Site Communications & Security

Location: Site
