DeKalb County School District/Vacant

# Former Central Office Building A and B

## School Assessment Report

May 20, 2016

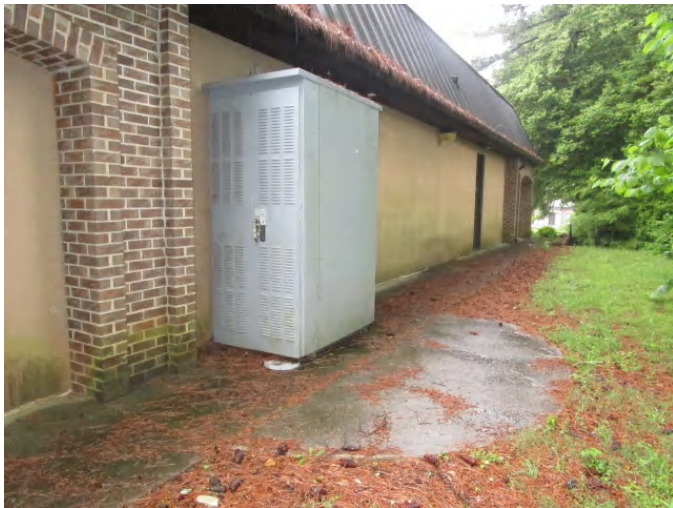
#### **System: D5010 - Electrical Service/Distribution**

**Location:** Throughout Building

**Distress:** Beyond Service Life

**Notes:** Electrical service/distribution is beyond its expected service life, has been vandalized and damaged, and should be replaced.

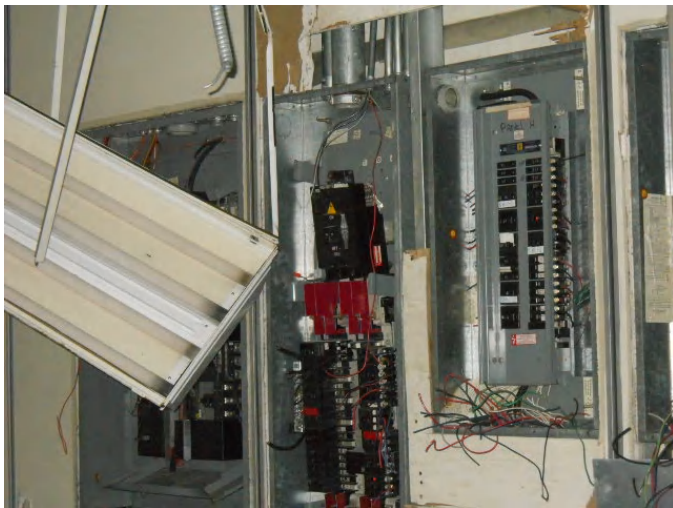
#### **System: D5020 - Branch Wiring**

**Location:** Throughout Building

**Distress:** Beyond Service Life

**Notes:** The branch wiring system is beyond its expected service life, has been vandalized, and should be replaced.

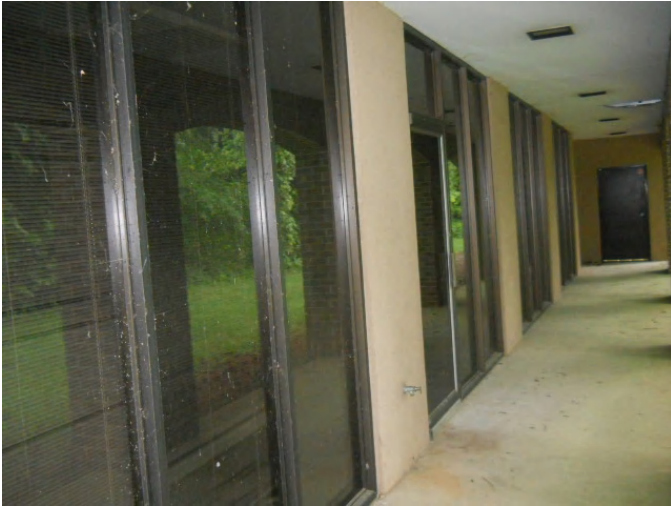
**System: B2020 - Exterior Windows**

**Location:** Exterior Walls

**Distress:** Beyond Service Life

**Notes:** The aluminum frame windows are beyond their expected service life, inefficient, and should be replaced.

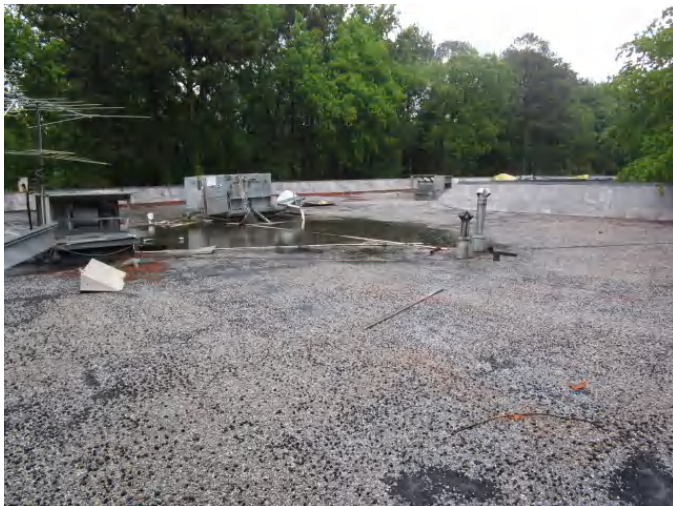
**System: B3010 - Roof Coverings - BUR**

**Location:** Roof

**Distress:** Beyond Service Life

**Notes:** The built-up roof covering is beyond its expected service life and should be replaced.

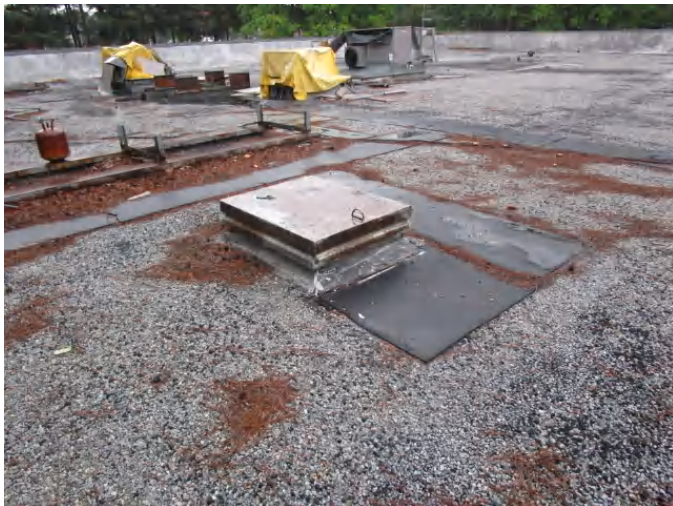
**System: B3020 - Roof Openings**

**Location:** Roof

**Distress:** Beyond Service Life

**Notes:** Roof openings, including roof hatch, are beyond their expected service life and should be replaced along with the roof covering.

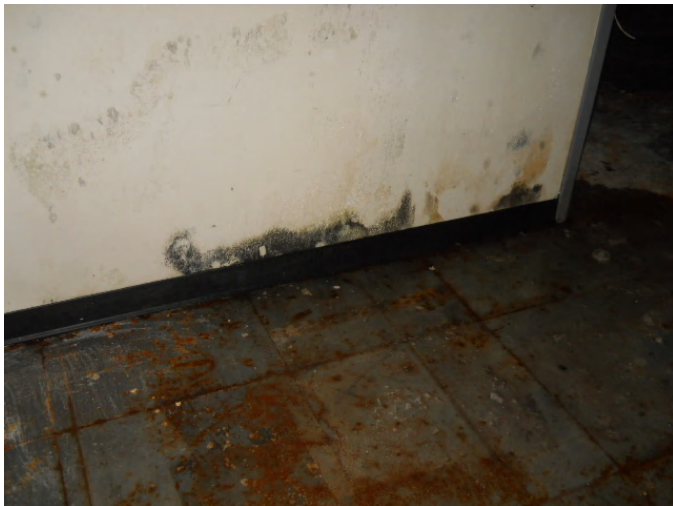
**System: C1010 - Partitions**

**Location:** Throughout Building

**Distress:** Beyond Service Life

**Notes:** Interior wall partitions are beyond their expected service life, damaged, missing in some cases, and should be replaced.

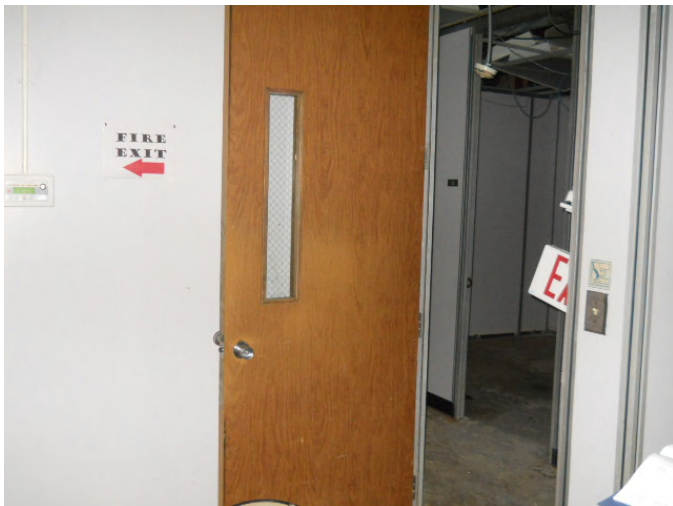
**System: C1020 - Interior Doors**

**Location:** Throughout Building

**Distress:** Beyond Service Life

**Notes:** The interior doors are aged, failing, not ADA compliant, and should be replaced.

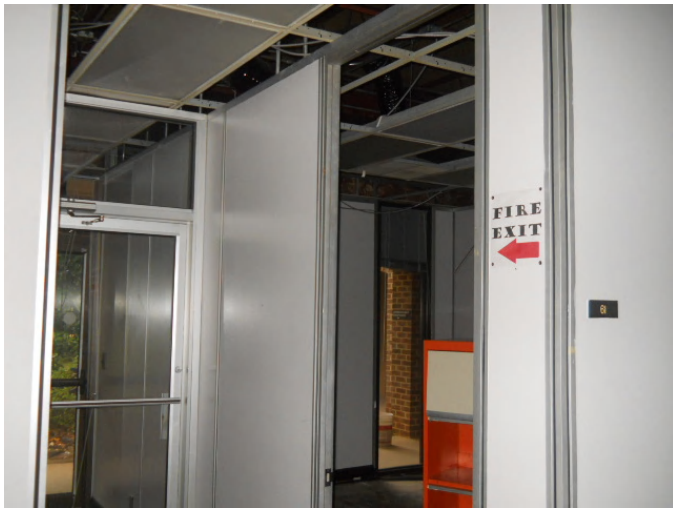
**System: C1030 - Fittings**

**Location:** Throughout Building

**Distress:** Beyond Service Life

**Notes:** Fittings, such as signage and toilet partitions, are beyond expected service life, not ADA compliant, and should be replaced.

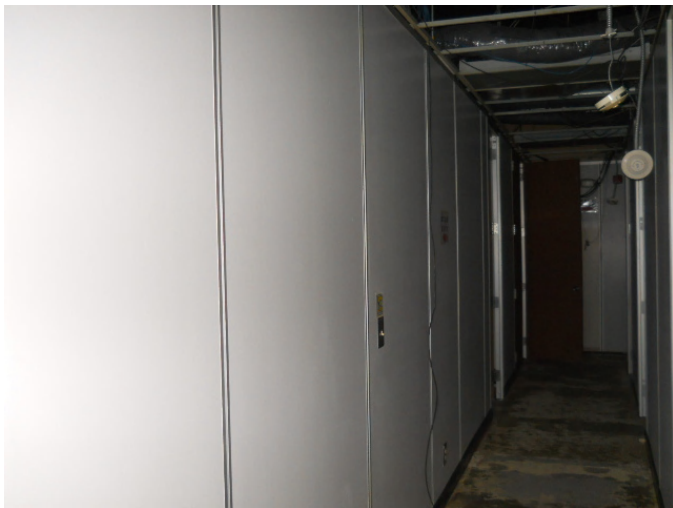
**System: C3010 - Wall Finishes - Paint**

**Location:** Throughout Building

**Distress:** Beyond Service Life

**Notes:** The painted wall finishes are beyond service life and damaged, and should be replaced.

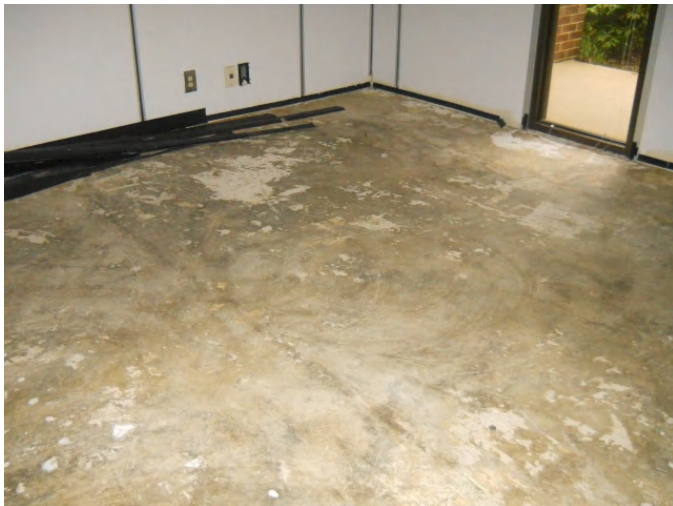
**System: C3020 - Floor Finishes - Carpet**

**Location:** Throughout Building

**Distress:** Beyond Service Life

**Notes:** The carpet floor finishes have been removed due to damage and age, and should be replaced.

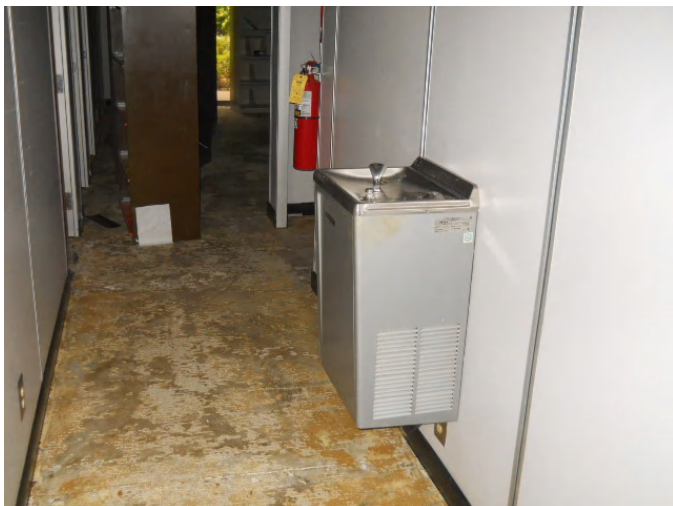
**System: C3020 - Floor Finishes - VCT**

**Location:** Throughout Building

**Distress:** Beyond Service Life

**Notes:** The VCT floor finishes have been removed due to damage and age, and should be replaced.

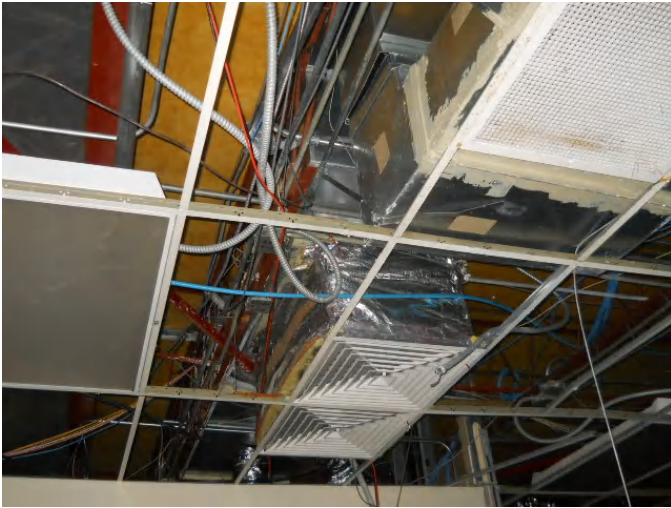
**System: C3030 - Ceiling Finishes**

**Location:** Throughout Building

**Distress:** Beyond Service Life

**Notes:** The acoustical ceiling tiles and grid system are beyond expected service life, damaged, and should be replaced.

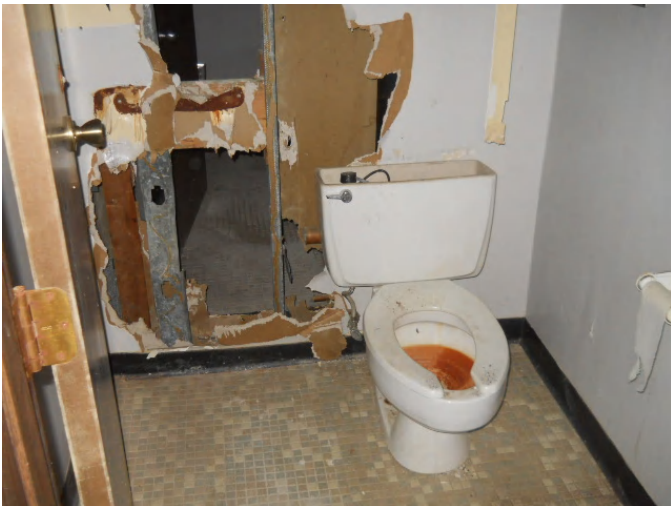
**System: D2010 - Plumbing Fixtures**

**Location:** Throughout Building

**Distress:** Beyond Service Life

**Notes:** The plumbing fixtures are beyond expected service life, damaged, not ADA compliant, and should be replaced.

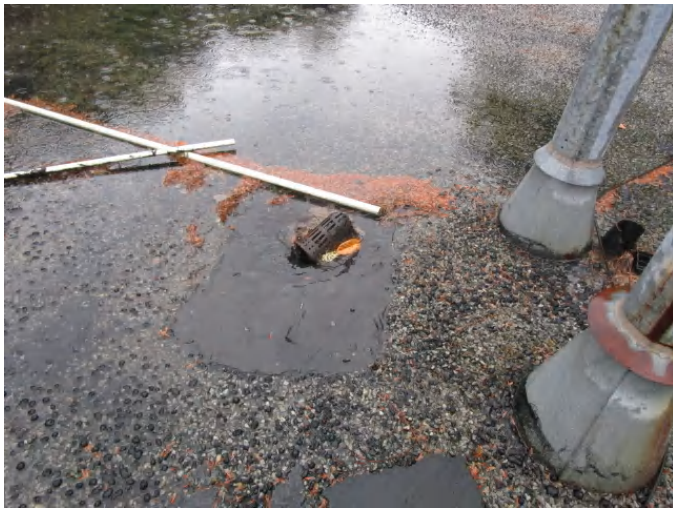
**System: D2040 - Rain Water Drainage**

**Location:** Roof  
**Distress:** Beyond Service Life  
**Category:** Deferred Maintenance  
**Priority:** 3 Priority  
**Correction:** Renew System  
**Qty:** 20,000.00  
**Unit of Measure:** S.F.  
**Estimate:** \$21,340.00  
**Assessor Name:** Ben Nixon  
**Date Created:** 05/05/2015

**Notes:** The roof rain water drainage system is beyond its expected service life, inadequate, and should be replaced with the roof.

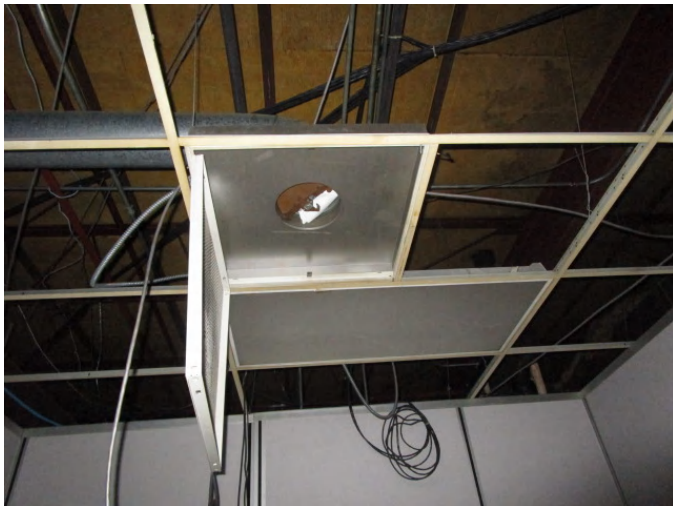
**System: D3040 - Distribution Systems & Exhaust Systems**

**Location:** Throughout Building  
**Distress:** Beyond Service Life  
**Category:** Deferred Maintenance  
**Priority:** 3 Priority  
**Correction:** Renew System  
**Qty:** 20,000.00  
**Unit of Measure:** S.F.  
**Estimate:** \$134,860.00  
**Assessor Name:** Ben Nixon  
**Date Created:** 04/11/2015

**Notes:** Distribution and exhaust systems have been vandalized and damaged, are beyond their expected service life, and should be replaced.

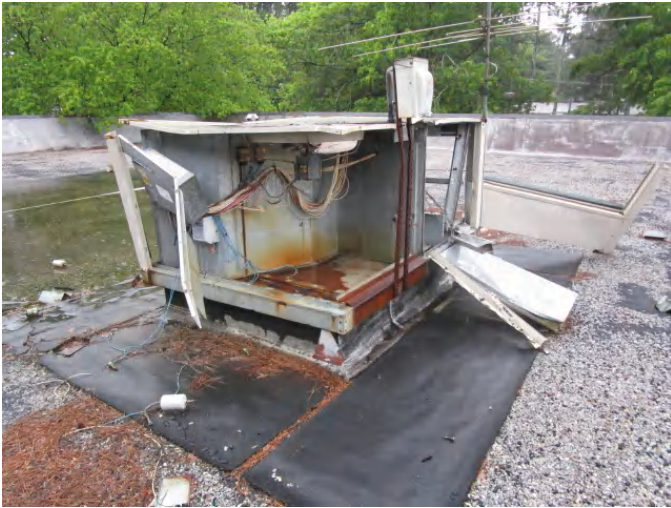
**System: D3050 - Terminal & Package Units**

**Location:** Roof  
**Distress:** Beyond Service Life  
**Category:** Deferred Maintenance  
**Priority:** 3 Priority  
**Correction:** Renew System  
**Qty:** 20,000.00  
**Unit of Measure:** S.F.  
**Estimate:** \$678,260.00  
**Assessor Name:** Ben Nixon  
**Date Created:** 04/11/2015

**Notes:** The HVAC system is beyond its expected service life, has been vandalized and damaged, and should be replaced.

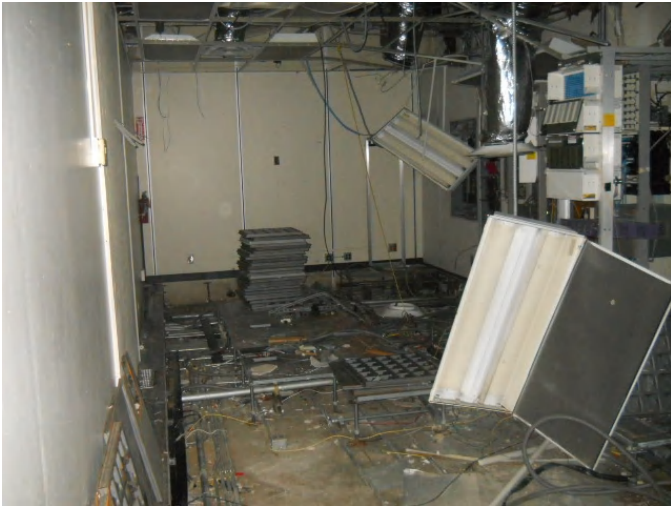
**System: D5020 - Lighting**

**Location:** Throughout Building  
**Distress:** Beyond Service Life  
**Category:** Deferred Maintenance / Energy  
**Priority:** 3 Priority  
**Correction:** Renew System  
**Qty:** 20,000.00  
**Unit of Measure:** S.F.  
**Estimate:** \$246,180.00  
**Assessor Name:** Ben Nixon  
**Date Created:** 04/11/2015

**Notes:** The lighting system is beyond its service life, has been vandalized and damaged, and should be replaced.

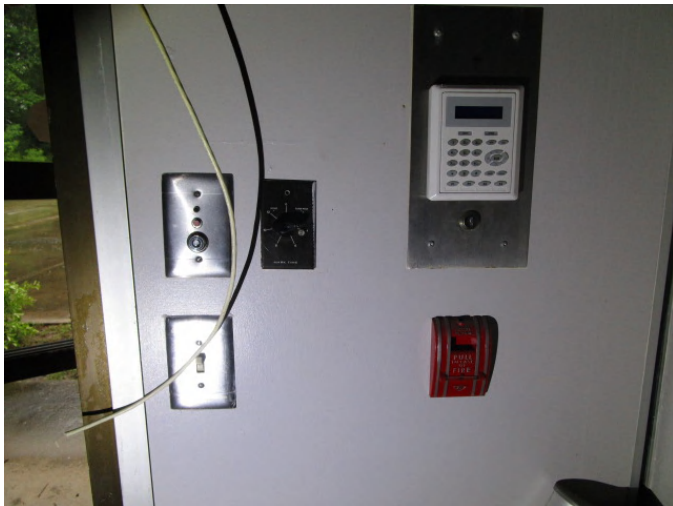
**System: D5030 - Communications and Security - Security & CCTV**

**Location:** Throughout Building

**Distress:** Beyond Service Life

**Notes:** The security and CCTV system is beyond expected service life, has been vandalized, and should be replaced.

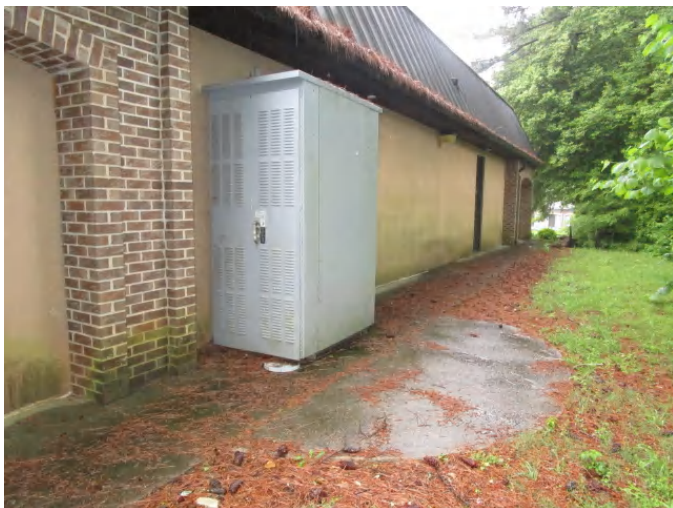
**System: D5090 - Other Electrical Systems - Emergency Generator**

**Location:** Site

**Distress:** Missing

**Notes:** The emergency generator has been removed and should be replaced prior to reoccupation of the building.

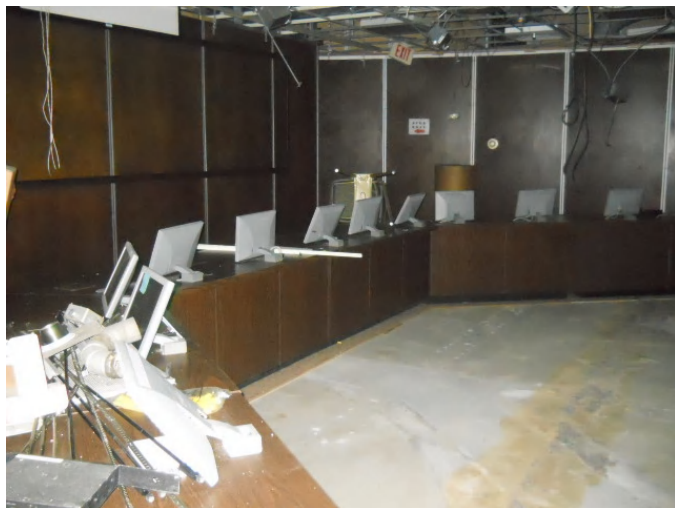
**System: E2010 - Fixed Furnishings**

**Location:** Throughout Building

**Distress:** Beyond Service Life

**Notes:** The fixed furnishings are beyond their expected service life, damaged, and should be replaced.

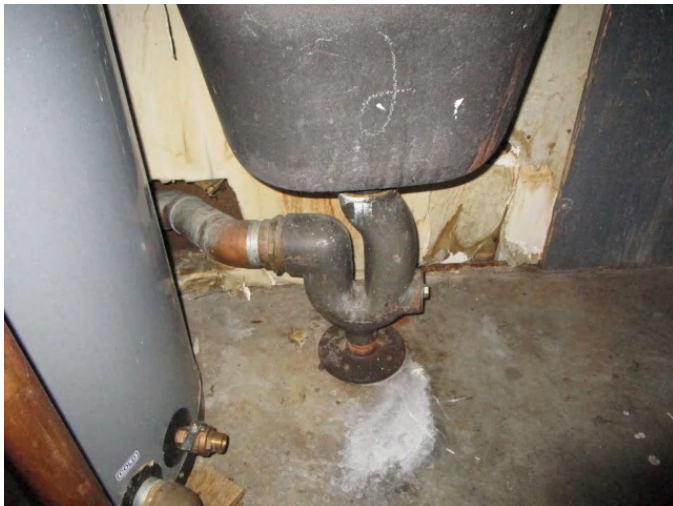
**System: D2030 - Sanitary Waste**

**Location:** Throughout Building  
**Distress:** Beyond Service Life  
**Category:** Deferred Maintenance  
**Priority:** 3 Priority  
**Correction:** Renew System  
**Qty:** 61,000.00  
**Unit of Measure:** S.F.  
**Estimate:** \$373,076.00  
**Assessor Name:** Eduardo Lopez  
**Date Created:** 05/12/2015

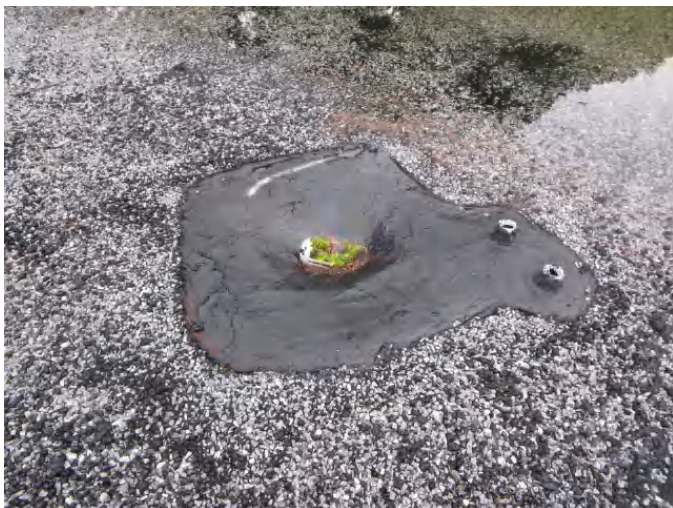
**System: D2040 - Rain Water Drainage**

**Location:** Roof  
**Distress:** Beyond Service Life  
**Category:** Deferred Maintenance  
**Priority:** 3 Priority  
**Correction:** Renew System  
**Qty:** 61,000.00  
**Unit of Measure:** S.F.  
**Estimate:** \$75,823.00  
**Assessor Name:** Eduardo Lopez  
**Date Created:** 05/12/2015
