**DeKalb County School District/Education Other**

# **International Student Center (Druid Hills)**

School Assessment Report
May 19, 2016

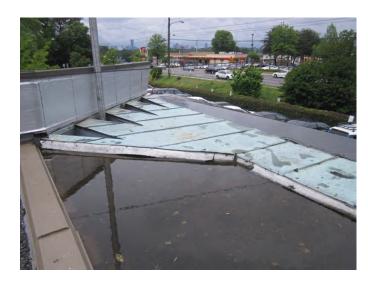
System: D2040 - Rain Water Drainage

Location: Roof

**Distress:** Needs Remediation

**Notes:** Water ponds on roof, posing risk of structural failure due to the weight of the water. Roof drainage is not functioning properly. The roof will be replaced and the rainwater drainage system will be cleaned and repaired to eliminate ponding and standing water under SPLOST project 314-422.

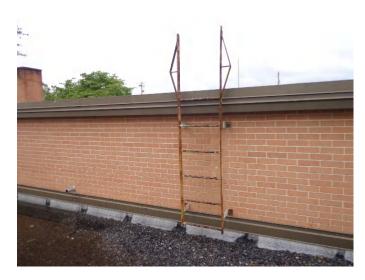
#### **System: B1010 - Floor Construction**

**Location:** Roof Parapet Wall

**Distress:** Inadequate

Notes: Fixed parapet ladders with top access are rusted and inadequate, and should be replaced to comply with OSHA standards.

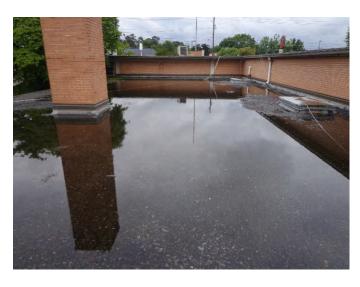
#### System: B3010 - Roof Coverings - BUR

**Location:** Roof

**Distress:** Beyond Service Life

**Notes:** Roof covering is in deteriorating condition, with standing water. The main canopy does not have a drain system between upturn beams and this has caused damage; the extra weight has increased the canopy deflection, water is seeping through the concrete structure and rusting the reinforcement, and some areas the concrete has spalled away exposing reinforcement. The roof covering is scheduled for replacement under SPLOST project 314-422.

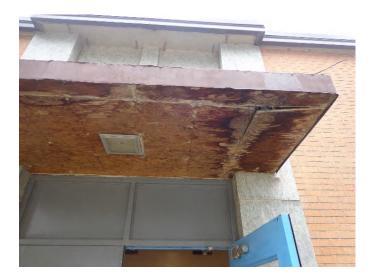
#### System: C3030 - Ceiling Finishes

**Location:** Cafeteria Canopy

**Distress:** Damaged

**Notes:** The canopy is in deteriorating condition and should be repaired.

Correction: Replace wood ceiling

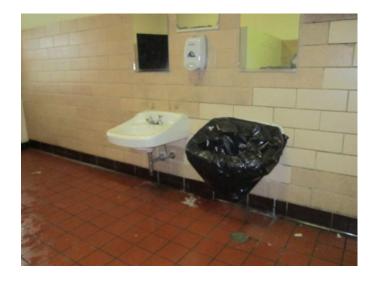
#### System: D2010 - Plumbing Fixtures

**Location:** Throughout Building

**Distress:** Beyond Service Life

**Notes:** Plumbing fixtures are aged, inefficient, damaged and missing, and should be scheduled for replacement/upgrade to improve ADA accessibility. The school is experiencing maintenance problems with fixtures.

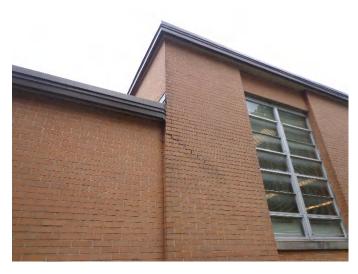
#### **System: B2010 - Exterior Walls**

**Location:** Exterior Wall of Cafeteria

**Distress:** Damaged

**Notes:** Repoint mortar joints.

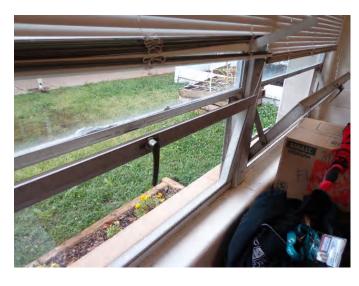
#### **System: B2020 - Exterior Windows**

**Location:** Throughout Walls

**Distress:** Beyond Service Life

**Notes:** The original single pane windows are aged, inefficient, and should be scheduled for replacement.

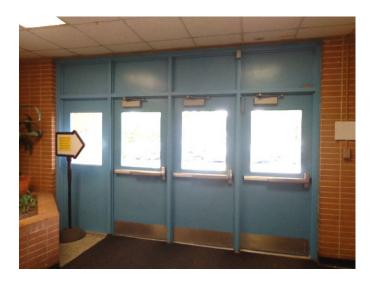
#### System: B2030 - Exterior Doors

**Location:** Throughout Walls

**Distress:** Beyond Service Life

**Notes:** The original exterior doors are beyond expected service life, rusted, damaged, and inefficient, and should be scheduled for replacement.

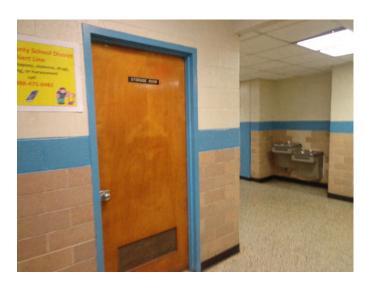
#### System: C1020 - Interior Doors

**Location:** Throughout Building

**Distress:** Beyond Service Life

Notes: The interior doors are aged and failing, hardware is not ADA compliant, and should be replaced.

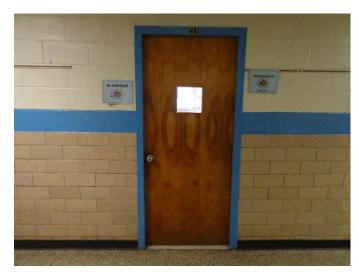
#### System: C1030 - Fittings

**Location:** Throughout Building

**Distress:** Beyond Service Life

**Notes:** Fittings, such as toilet partitions, signage, and chalk and tack boards are aged, in marginal condition, not ADA compliant, and should be replaced.

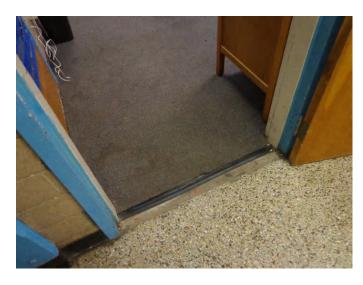
#### System: C3020 - Floor Finishes - Carpet

**Location:** Offices and Media Center

**Distress:** Beyond Service Life

**Notes:** The carpet is aged, stained and frayed, and should be replaced.

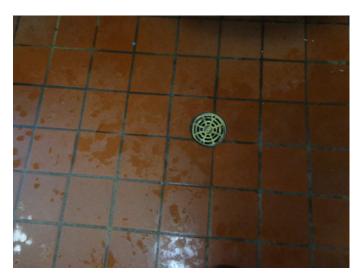
#### System: C3020 - Floor Finishes - Ceramic & Quarry Tile

**Location:** Restrooms, Janitor Closets, and Kitchen

**Distress:** Beyond Service Life

Notes: The ceramic tile is original to the building's construction and should be scheduled for replacement.

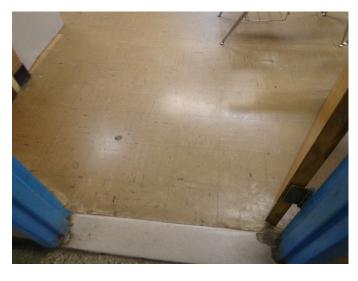
#### System: C3020 - Floor Finishes - VCT

**Location:** Throughout Building

**Distress:** Beyond Service Life

**Notes:** The VCT floor finishes have been replaced in the cafeteria and few classrooms. However, the VCT is original in most of the school and damaged, and should be replaced.

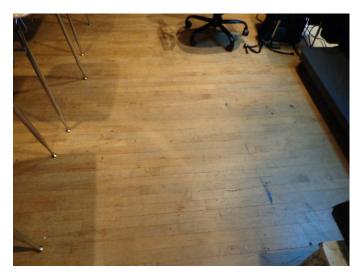
#### System: C3020 - Floor Finishes - Wood

**Location:** Stage

**Distress:** Beyond Service Life

**Notes:** The wood flooring is aged, worn, and should be replaced.

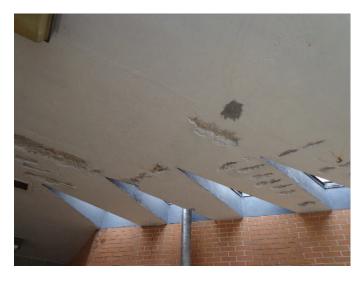
#### System: C3030 - Ceiling Finishes

**Location:** Main Canopy

**Distress:** Damaged

Notes: Concrete has spalled away in different areas under the main canopy and should be repaired.

**Correction:** Repair plaster ceiling - (2% of ceilings)

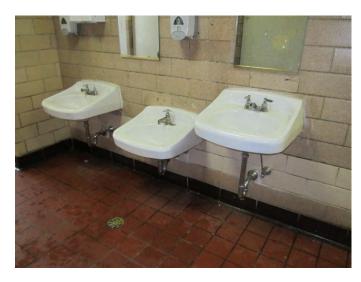
#### System: D2020 - Domestic Water Distribution

**Location:** Throughout Building

**Distress:** Beyond Service Life

**Notes:** The domestic water distribution system is beyond its expected service life, has water quality issues, and should be scheduled for replacement.

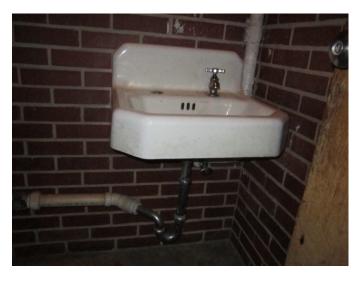
#### System: D2030 - Sanitary Waste

**Location:** Throughout Building

**Distress:** Beyond Service Life

**Notes:** The sanitary waste system is beyond its expected service life and should be scheduled for replacement.

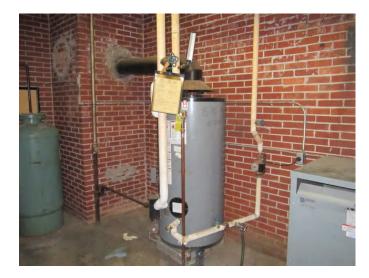
#### System: D2090 - Other Plumbing Systems - Natural Gas

**Location:** Mechanical Room

**Distress:** Beyond Service Life

**Notes:** Natural gas service is beyond its expected service life and should be scheduled for replacement. SPLOST project 314-422 to replace grease trap and backflow preventer.

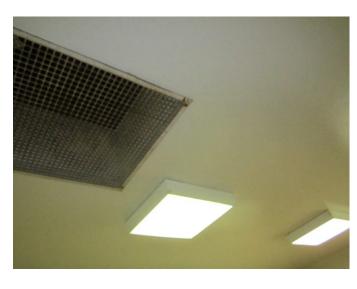
#### System: D3040 - Distribution Systems & Exhaust Systems

**Location:** Throughout Building

**Distress:** Beyond Service Life

**Notes:** Distribution and exhaust systems are beyond their expected service life, inadequate, and should be scheduled for replacement.

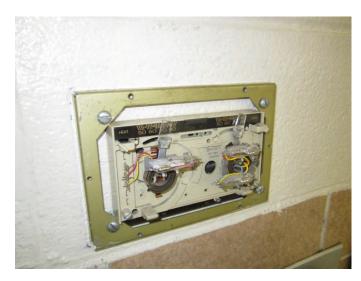
#### System: D3060 - Controls & Instrumentation

**Location:** Throughout Building

**Distress:** Beyond Service Life

Notes: Controls and instrumentation are beyond their expected service life and should be scheduled for replacement.

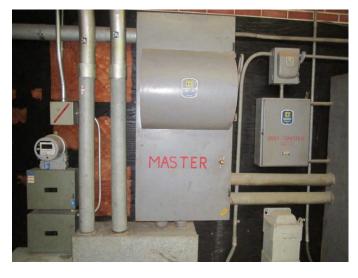
#### System: D5010 - Electrical Service/Distribution

**Location:** Throughout Building

**Distress:** Beyond Service Life

Notes: Electrical service/distribution is beyond its expected service life, inadequate, and should be scheduled for replacement.

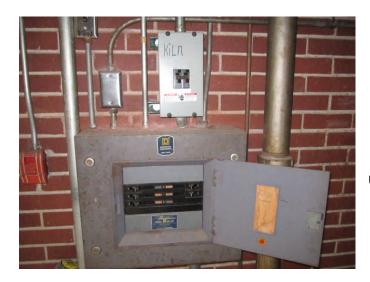
#### System: D5020 - Branch Wiring

**Location:** Throughout Building

**Distress:** Beyond Service Life

Notes: Brach wiring is beyond its expected service life, inadequate, and should be scheduled for replacement.

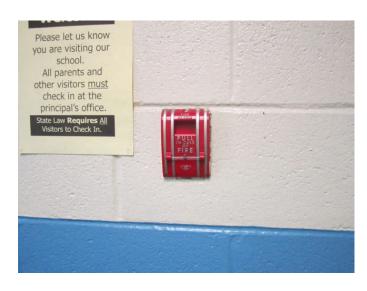
#### System: D5030 - Communications and Security - Fire Alarm

**Location:** Throughout Building

**Distress:** Beyond Service Life

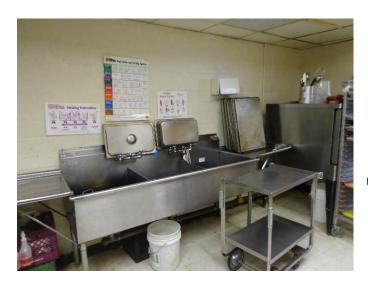
#### System: E1090 - Other Equipment - Kitchen Equipment

Location: Kitchen

**Distress:** Beyond Service Life

Notes: The original kitchen equipment is operational, but is aged and inadequate, and should be scheduled for replacement.

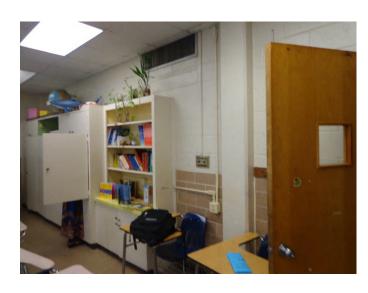
#### **System: E2010 - Fixed Furnishings**

**Location:** Throughout Building

**Distress:** Beyond Service Life

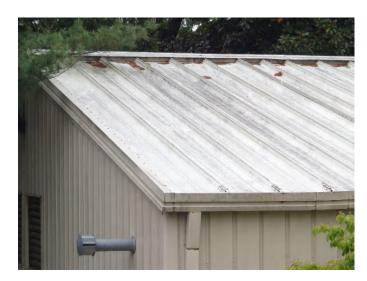
### System: B3010 - Roof Coverings - Standing Seam Metal

Location: Roof

**Distress:** Inadequate

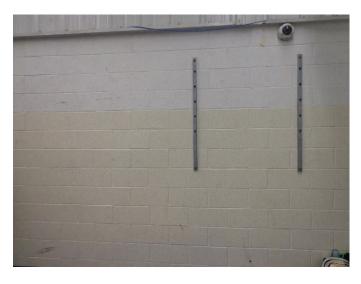
### System: C3010 - Wall Finishes - Paint

**Location:** Throughout Building

**Distress:** Beyond Service Life

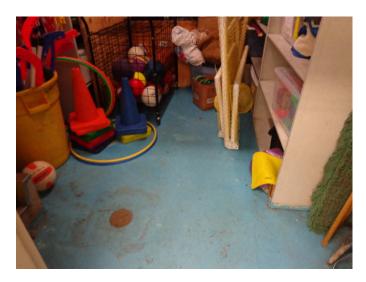
### System: C3020 - Floor Finishes - Epoxy

**Location:** Storage Room

**Distress:** Beyond Service Life

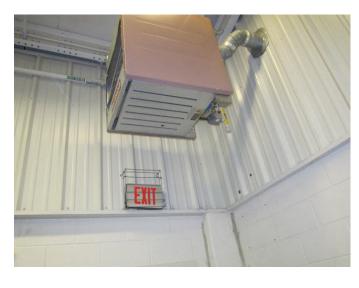
### System: D3050 - Terminal & Package Units

**Location:** Throughout Building

**Distress:** Beyond Service Life

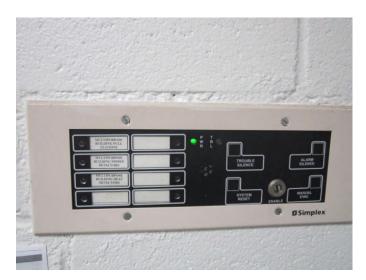
### System: D5030 - Communications and Security - Fire Alarm

**Location:** Throughout Building

**Distress:** Beyond Service Life

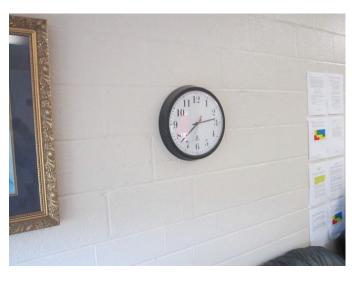
### System: D5030 - Communications and Security - Public Address & Clock System

**Location:** Throughout Building

**Distress:** Beyond Service Life

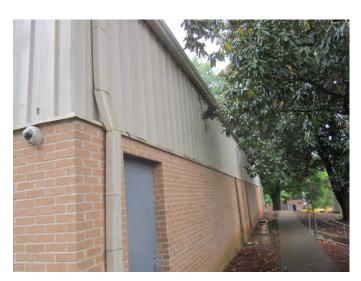
## System: D5030 - Communications and Security - Security & CCTV

**Location:** Throughout Building

**Distress:** Beyond Service Life

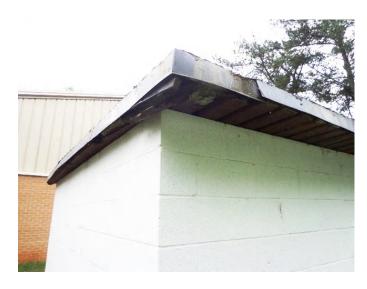
System: B1020 - Roof Construction

Location: Roof

**Distress:** Beyond Service Life

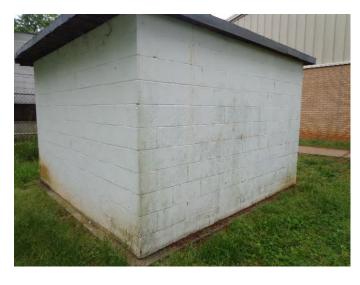
### System: B2010 - Exterior Walls

**Location:** Exterior Walls

**Distress:** Inadequate

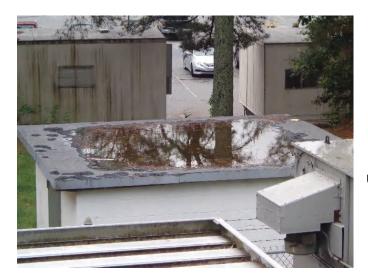
### System: B3010 - Roof Coverings

**Location:** Roof

**Distress:** Beyond Service Life

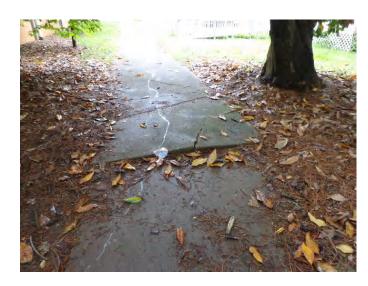
System: G2030 - Pedestrian Paving

Location: Site

**Distress:** Beyond Service Life

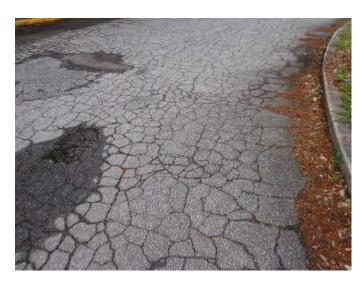
### System: G2010 - Roadways

**Location:** Site

**Distress:** Beyond Service Life

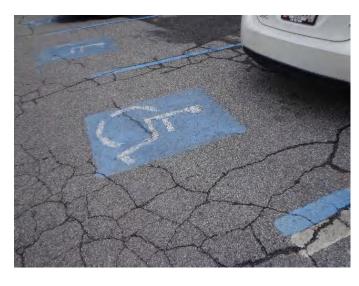
#### System: G2020 - Parking Lots

Location: Site

**Distress:** Beyond Service Life

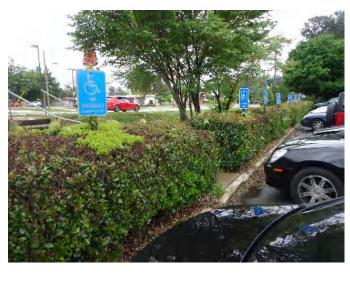
#### System: G2050 - Landscaping

**Location:** Site

**Distress:** Beyond Service Life

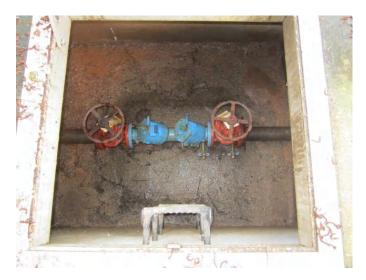
### System: G3010 - Water Supply

**Location:** Site

**Distress:** Beyond Service Life

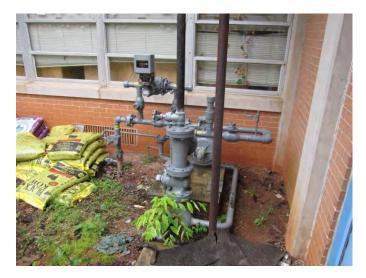
#### System: G3060 - Fuel Distribution

**Location:** Site

**Distress:** Beyond Service Life

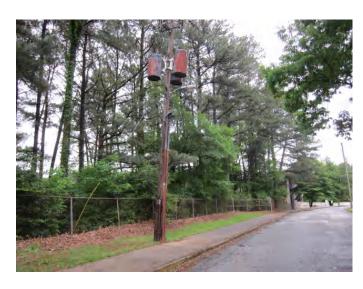
#### **System: G4010 - Electrical Distribution**

Location: Site

**Distress:** Beyond Service Life

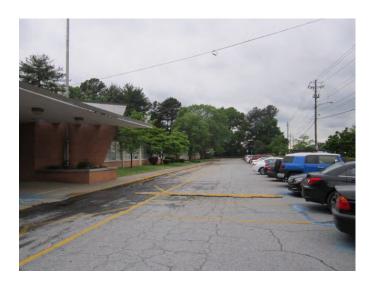
### System: G4020 - Site Lighting

Location: Site

**Distress:** Beyond Service Life
