DeKalb County School District/Elementary Schools

Henderson Mill Elementary

School Assessment Report
May 19, 2016

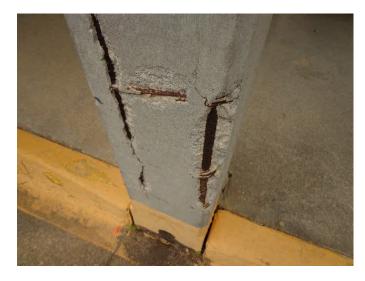
System: B2010 - Exterior Walls

Location: Canopy Columns and West Corner of Building

Distress: Damaged

Notes: Insufficient thickness of concrete covering the columns has spalled away, exposing the reinforced bars and ties. Correction is needed to prevent rust and further degradation of columns.

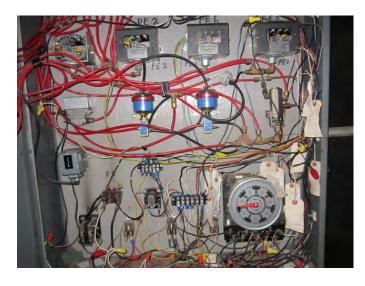
System: D3060 - Controls & Instrumentation

Location: Throughout Building

Distress: Beyond Service Life

Notes: The individual terminal units in each room are turned on and off manually by teachers and staff. Controls to these units should be evaluated and repaired as necessary. The entire system should be evaluated for repair and or replacement. Unit ventilator controls may be replaced under SPLOST IV, budget dependent.

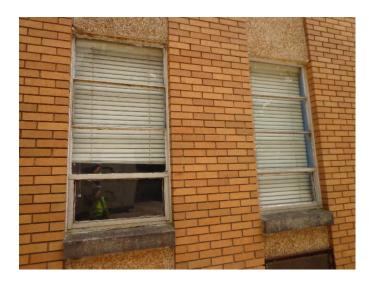
System: B2020 - Exterior Windows

Location: Throughout Building

Distress: Beyond Service Life

Notes: The aluminum frame, operable, single pane windows are aged, not energy efficient, do not lock/seal properly, and should be replaced.

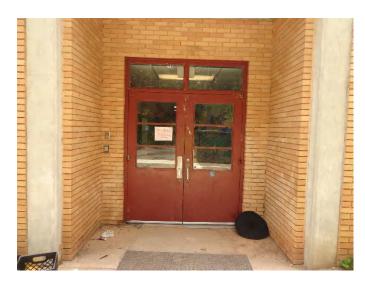
System: B2030 - Exterior Doors

Location: Throughout Building

Distress: Beyond Service Life

Notes: The original exterior doors are aged, rusted, do not lock/seal properly, and should be replaced.

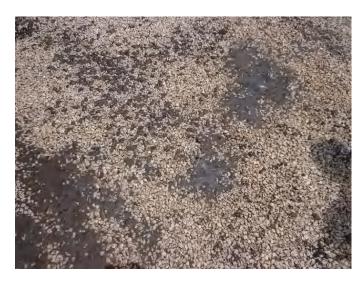
System: B3010 - Roof Coverings - BUR

Location: Roof

Distress: Beyond Service Life

Notes: Built-up roof covering is in deteriorating condition, with loss of top surface, patches and with reported water leaks, and should be replaced.

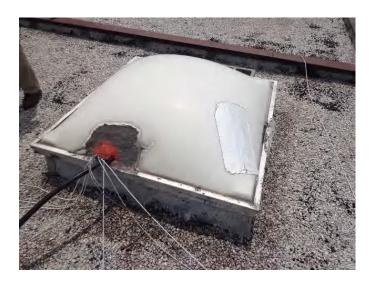
System: B3020 - Roof Openings

Location: Roof

Distress: Beyond Service Life

Notes: Roof openings are damaged, patched and leaking, and should be replaced in conjunction with the roof.

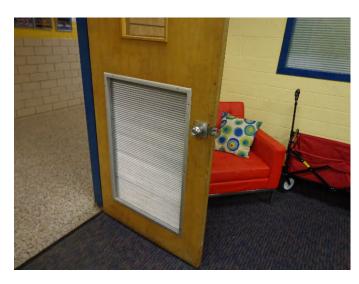
System: C1020 - Interior Doors

Location: Throughout Building

Distress: Beyond Service Life

Notes: The interior doors are aged, failing, and the entire system should be replaced to improve ADA accessibility.

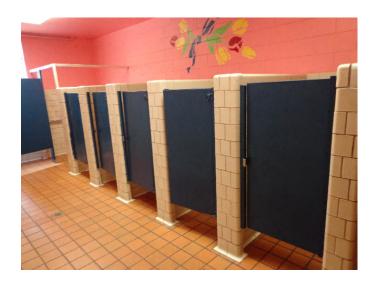
System: C1030 - Fittings

Location: Throughout Building

Distress: Beyond Service Life

Notes: Fittings, such as toilet partitions, handrails and signage, are beyond their expected service life, and should be replaced to improve ADA accessibility.

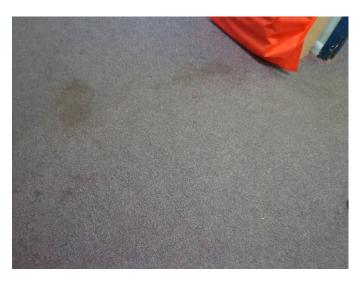
System: C3020 - Floor Finishes - Carpet

Location: Throughout Building

Distress: Beyond Service Life

Notes: The carpet is aged, stained and frayed, and should be replaced.

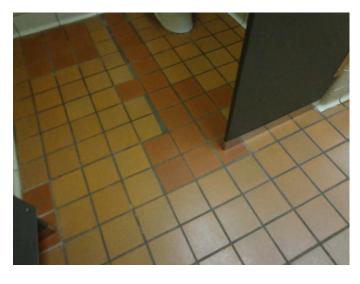
System: C3020 - Floor Finishes - Ceramic & Quarry Tile

Location: Kitchen and Restrooms

Distress: Beyond Service Life

Notes: The tile floor covering is beyond its expected service life, cracked, patched and worn, and should be replaced.

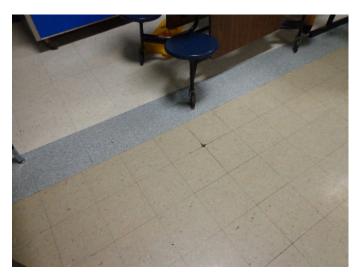
System: C3020 - Floor Finishes - VCT

Location: Throughout Building

Distress: Beyond Service Life

Notes: The original VCT and VAT flooring is in poor condition, cracked, worn and detaching, and should be replaced.

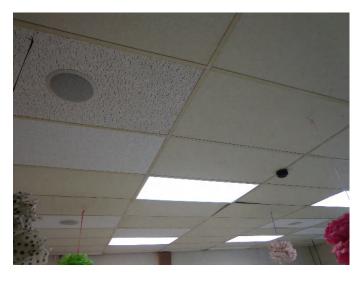
System: C3030 - Ceiling Finishes

Location: Throughout Building

Distress: Beyond Service Life

Notes: The ceiling tiles and grid system has been replaced in the ground level classrooms. However, the remaining system is aged, sagging, damaged and patched, and should be replaced.

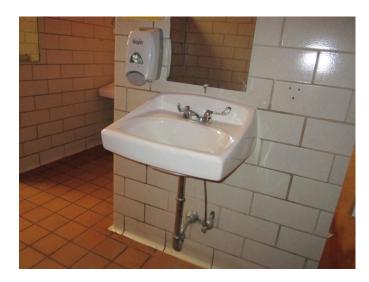
System: D2010 - Plumbing Fixtures

Location: Throughout Building

Distress: Beyond Service Life

Notes: The plumbing fixtures are beyond their expected service life, inadequate, and should be scheduled for replacement.

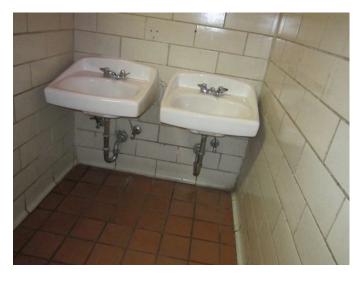
System: D2020 - Domestic Water Distribution

Location: Throughout Building

Distress: Beyond Service Life

Notes: The domestic water distribution system is beyond its expected service life, has water quality issues, and should be scheduled for replacement. Some restrooms are without hot water.

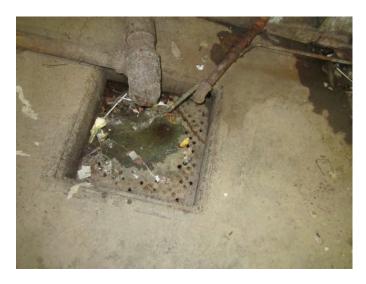
System: D2030 - Sanitary Waste

Location: Throughout Building

Distress: Beyond Service Life

Notes: The sanitary waste system is beyond its expected service life and should be scheduled for replacement.

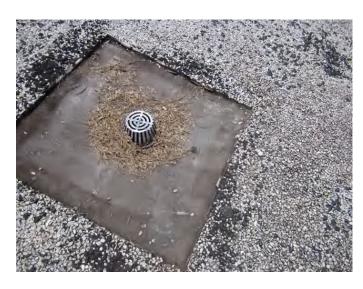
System: D2040 - Rain Water Drainage

Location: Throughout Building

Distress: Beyond Service Life

Notes: The rainwater drainage system is beyond its expected service life and should be replaced in conjunction with the roof covering. Principal reports that roof drains must frequently be unclogged.

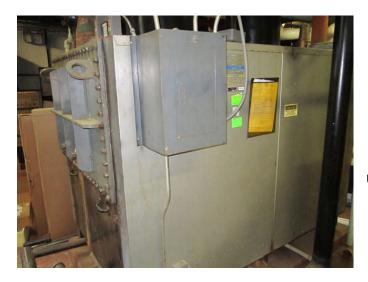
System: D2090 - Other Plumbing Systems - Natural Gas

Location: Throughout Building

Distress: Beyond Service Life

Notes: The natural gas system is beyond its expected service life and should be scheduled for replacement.

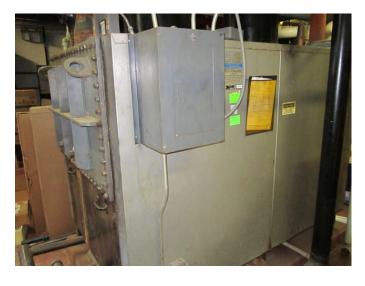
System: D3020 - Heat Generating Systems

Location: Mechanical Room

Distress: Beyond Service Life

Notes: The heat generating system is beyond its expected service life, breaks down often, and should be scheduled for replacement.

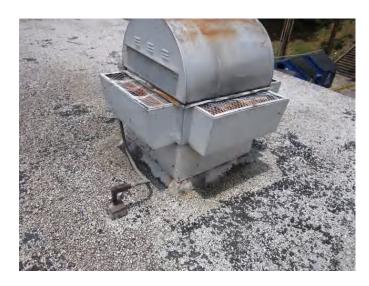
System: D3040 - Distribution & Exhaust Systems

Location: Throughout Building

Distress: Beyond Service Life

Notes: The distribution and exhaust systems are beyond their expected service life, inadequate, and should be scheduled for replacement.

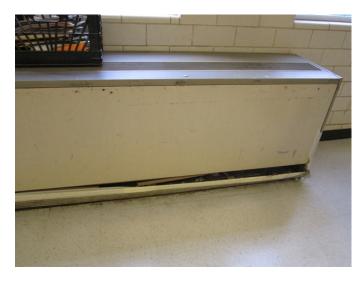
System: D3050 - Terminal & Package Units

Location: Throughout Building

Distress: Beyond Service Life

Notes: The terminal and package units are beyond their expected service life, intermittent, and should be scheduled for replacement. Unit ventilators and controls may be replaced under SPLOST IV, budget dependent.

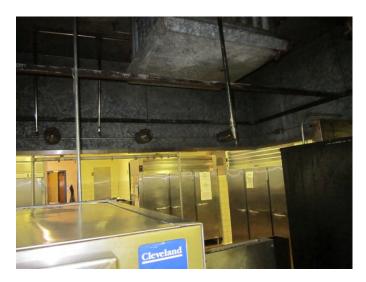
System: D3090 - Other HVAC Systems/Equip - Kitchen Hood

Location: Kitchen

Distress: Beyond Service Life

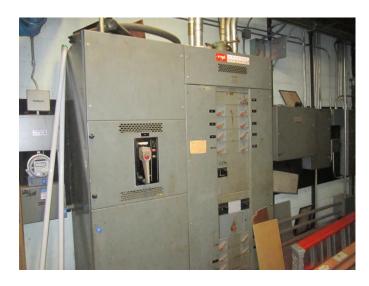
System: D5010 - Electrical Service/Distribution

Location: Main Switch Room/Throughout Building

Distress: Beyond Service Life

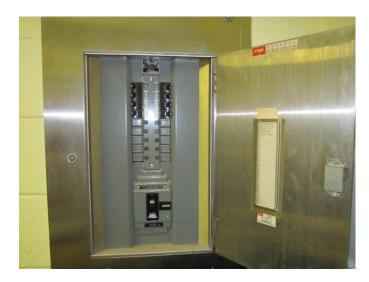
System: D5020 - Branch Wiring

Location: Throughout Building

Distress: Beyond Service Life

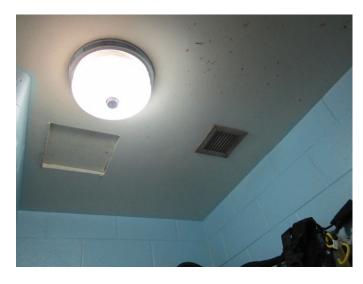
System: D5020 - Lighting

Location: Throughout Building

Distress: Beyond Service Life

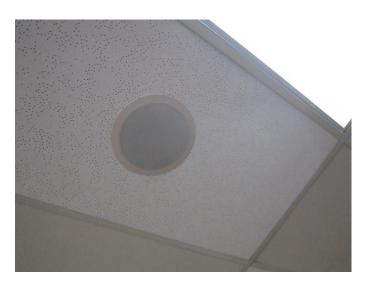
System: D5030 - Communications and Security - Clock & PA Systems

Location: Throughout Building

Distress: Beyond Service Life

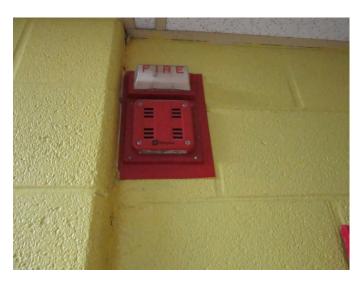
System: D5030 - Communications and Security - Fire Alarm

Location: Throughout Building

Distress: Beyond Service Life

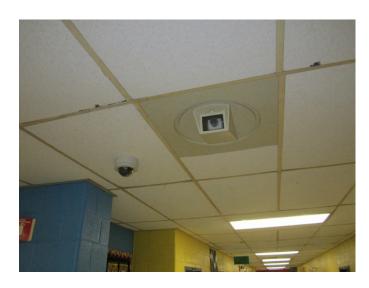
System: D5030 - Communications and Security - Security & CCTV

Location: Throughout Building

Distress: Beyond Service Life

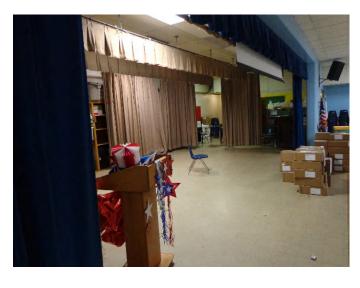
System: E1020 - Institutional Equipment

Location: Throughout Building

Distress: Beyond Service Life

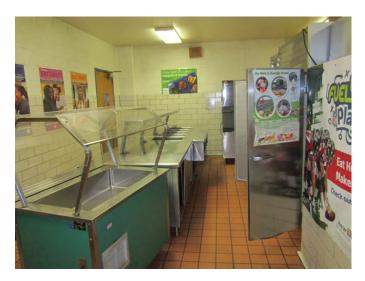
System: E1090 - Other Equipment - Kitchen Equipment

Location: Kitchen

Distress: Beyond Service Life

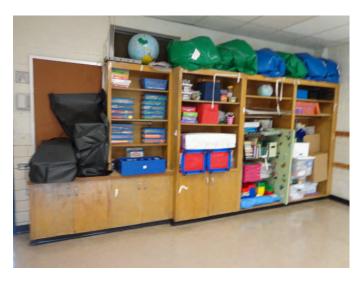
System: E2010 - Fixed Furnishings

Location: Throughout Building

Distress: Beyond Service Life

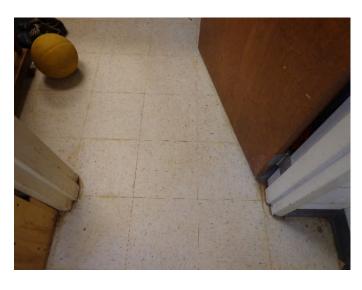
System: C3020 - Floor Finishes - VCT

Location: Entrance Area and Offices

Distress: Beyond Service Life

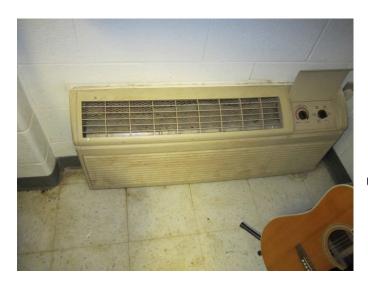
System: D3050 - Terminal & Package Units

Location: Throughout Building

Distress: Inadequate

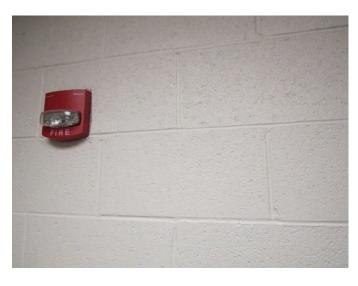
System: D5030 - Communications and Security - Fire Alarm

Location: Throughout Building

Distress: Beyond Service Life

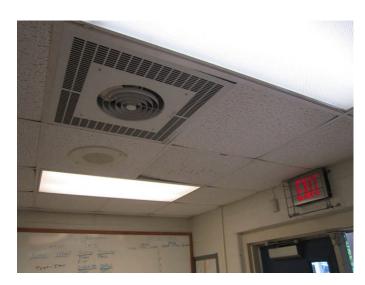
System: D5030 - Communications and Security - Public Address & Clock System

Location: Throughout Building

Distress: Beyond Service Life

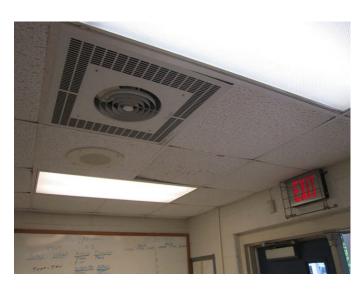
System: D5030 - Communications and Security - Security & CCTV

Location: Throughout Building

Distress: Beyond Service Life

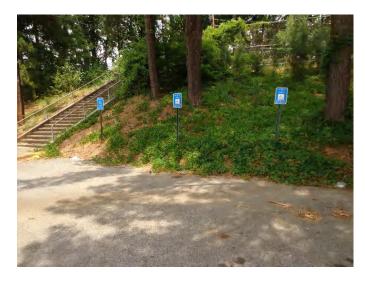
System: G2020 - Parking Lots

Location: Site

Distress: Beyond Service Life

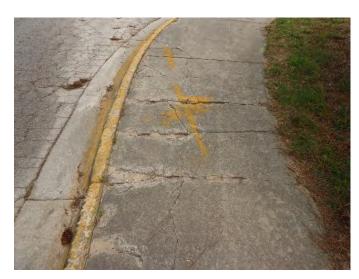
System: G2030 - Pedestrian Paving

Location: Site

Distress: Beyond Service Life

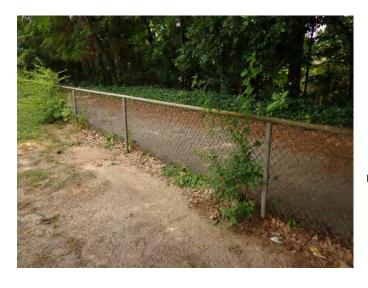
System: G2040 - Fencing & Guardrails

Location: Site

Distress: Beyond Service Life

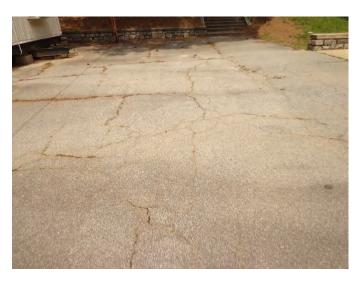
System: G2040 - Hard Surface Play Area

Location: Site

Distress: Beyond Service Life

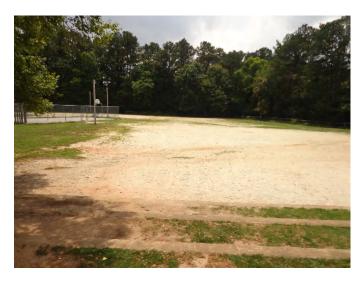
System: G2040 - Playing Field

Location: Site

Distress: Beyond Service Life

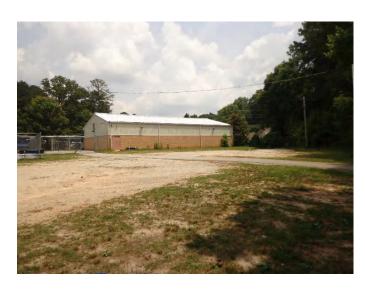
System: G2050 - Landscaping

Location: Site

Distress: Beyond Service Life

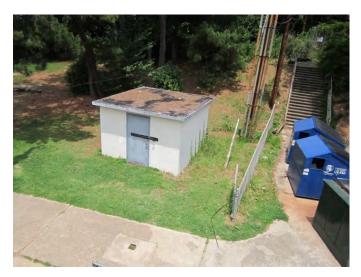
System: G3010 - Water Supply

Location: Site

Distress: Beyond Service Life

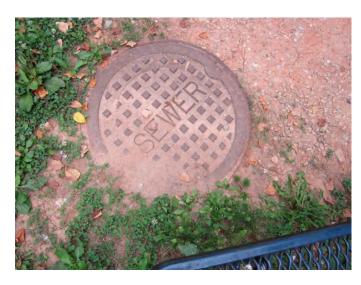
System: G3020 - Sanitary Sewer

Location: Site

Distress: Beyond Service Life

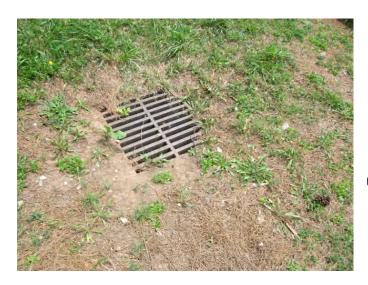
System: G3030 - Storm Sewer

Location: Site

Distress: Beyond Service Life

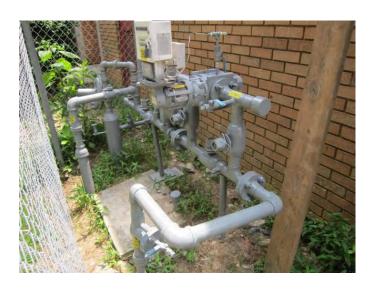
System: G3060 - Fuel Distribution

Location: Site

Distress: Beyond Service Life

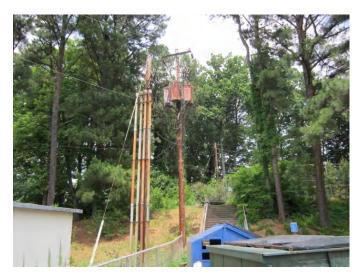
System: G4010 - Electrical Distribution

Location: Site

Distress: Beyond Service Life

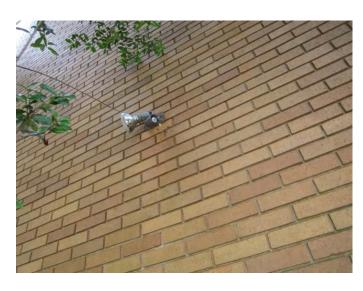
System: G4020 - Site Lighting

Location: Site

Distress: Beyond Service Life

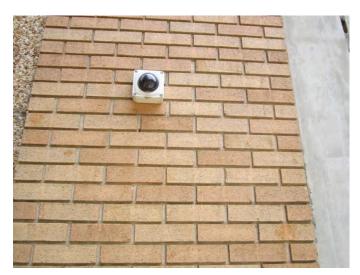
System: G4030 - Site Communications & Security

Location: Site

Distress: Beyond Service Life

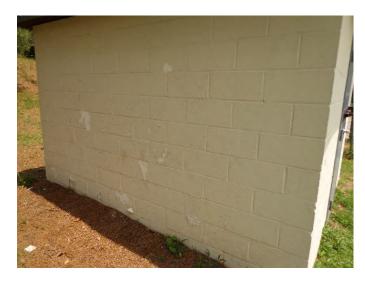
System: B2010 - Exterior Walls

Location: Exterior Walls

Distress: Damaged

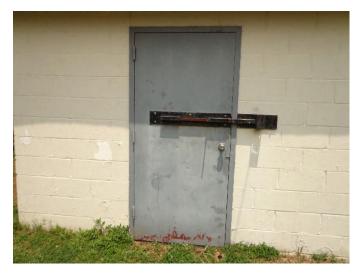
System: B2030 - Exterior Doors

Location: Exterior Wall

Distress: Beyond Service Life

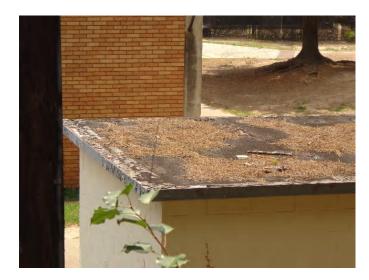
System: B3010 - Roof Coverings

Location: Roof

Distress: Beyond Service Life
