DeKalb County School District/Leased/Charter

International Community Charter at Medlock

School Assessment Report

May 20, 2016

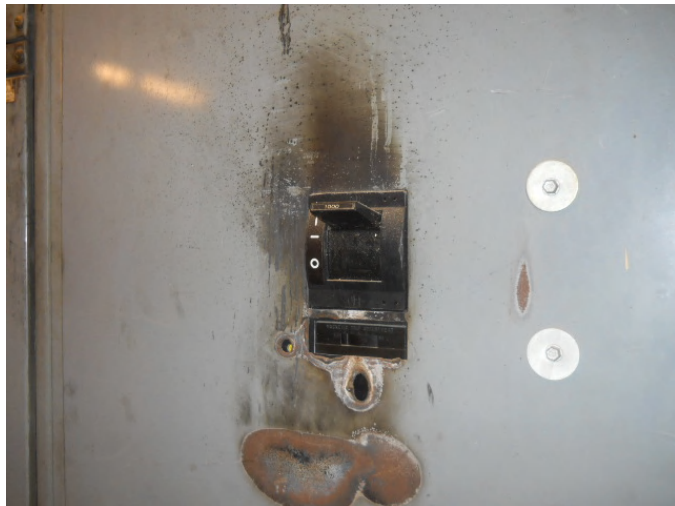
System: D5010 - Electrical Service/Distribution

Location: Boiler Room

Distress: Beyond Service Life

Notes: The electrical service switchgear is operational, but is in poor condition with visible damage and should be replaced in order to ensure safety of building occupants.

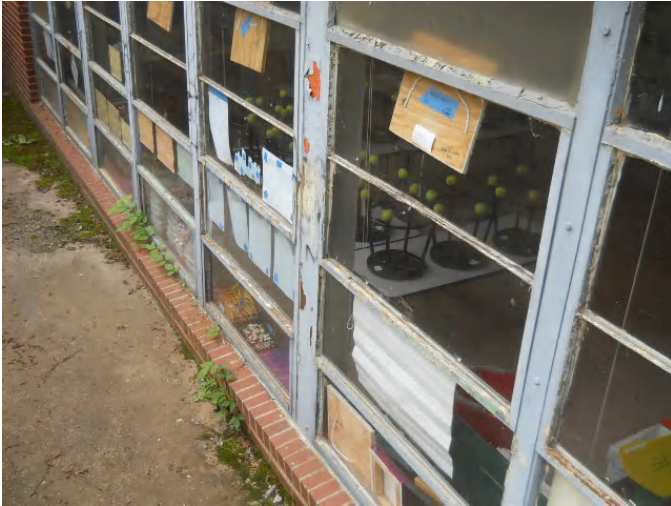
System: B2020 - Exterior Windows

Location: Throughout Building

Distress: Beyond Service Life

Notes: The steel frame, operable, single pane windows are aged, rusted, and not energy efficient, and should be replaced.

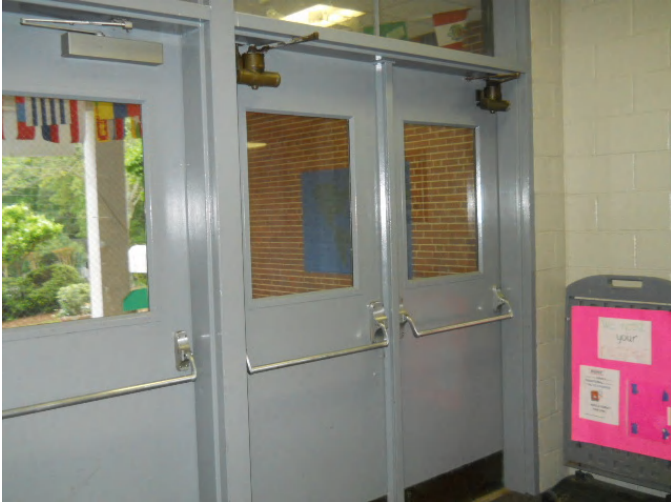
System: B2030 - Exterior Doors

Location: Throughout Building

Distress: Beyond Service Life

Notes: The exterior doors are are aged, rusted, and should be replaced.

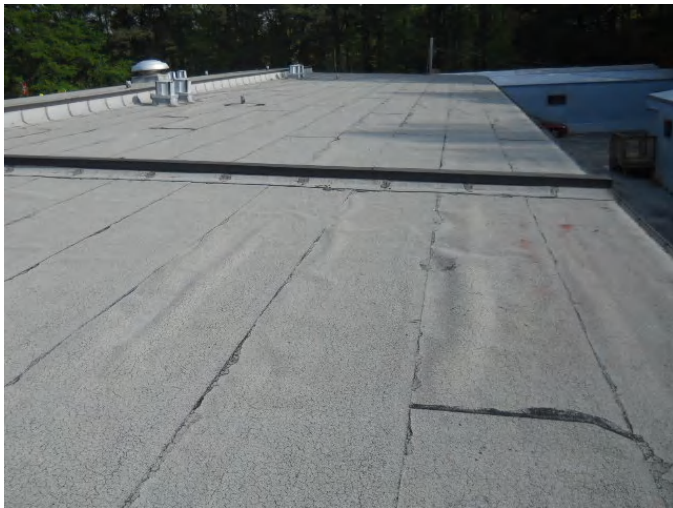
System: B3010 - Roof Coverings - BUR

Location: Roof
Distress: Beyond Service Life
Category: Deferred Maintenance / Energy
Priority: 3 Priority
Correction: Renew System
Qty: 38,251.00
Unit of Measure: S.F.
Estimate: \$870,975.00
Assessor Name: Sam Mandola
Date Created: 04/11/2015

Notes: The built-up roof covering is aged, showing signs of failure, and should be replaced.

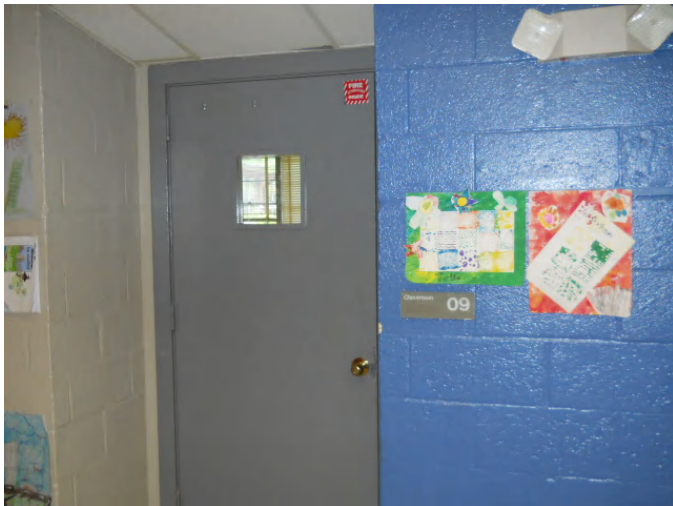
System: C1020 - Interior Doors

Location: Throughout Building
Distress: Beyond Service Life
Category: Deferred Maintenance / Accessibility Code Compliance
Priority: 3 Priority
Correction: Renew System
Qty: 38,251.00
Unit of Measure: S.F.
Estimate: \$79,868.00
Assessor Name: Sam Mandola
Date Created: 04/11/2015

Notes: The interior doors and hardware are not ADA compliant, are aged and failing, and should be replaced.

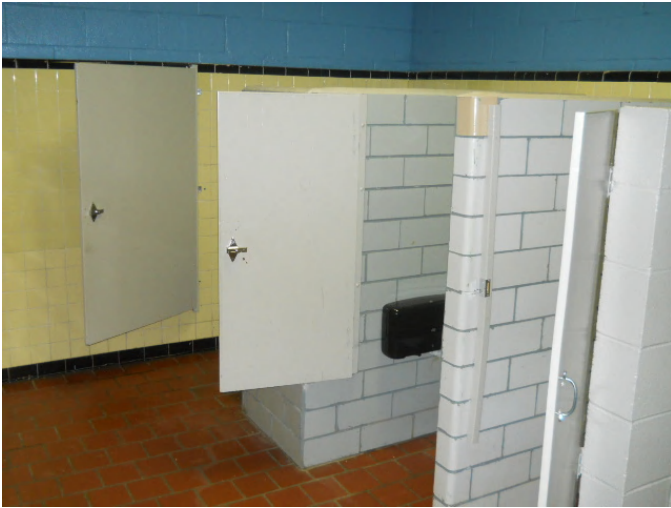
System: C1030 - Fittings

Location: Throughout Building

Distress: Beyond Service Life

Notes: Fittings, such as restroom partitions, toilet accessories and signage, are aged, in marginal condition, and should be replaced. Signage and toilet accessories are not ADA compliant.

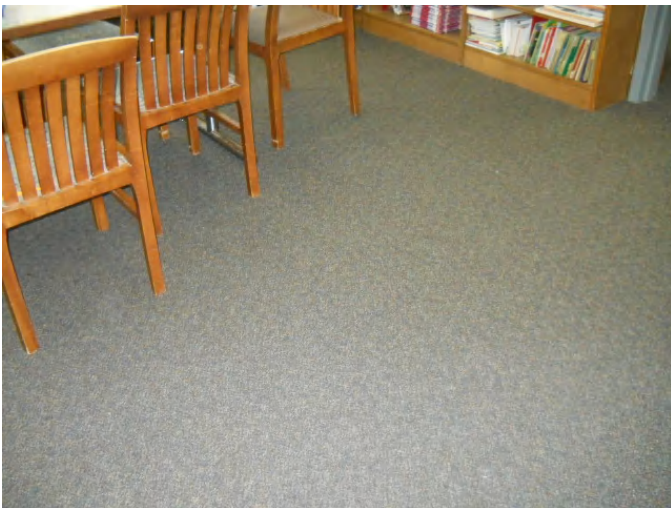
System: C3020 - Floor Finishes - Carpet

Location: Office Areas

Distress: Beyond Service Life

Notes: The carpet in the office areas is aged, stained and frayed, and should be replaced.

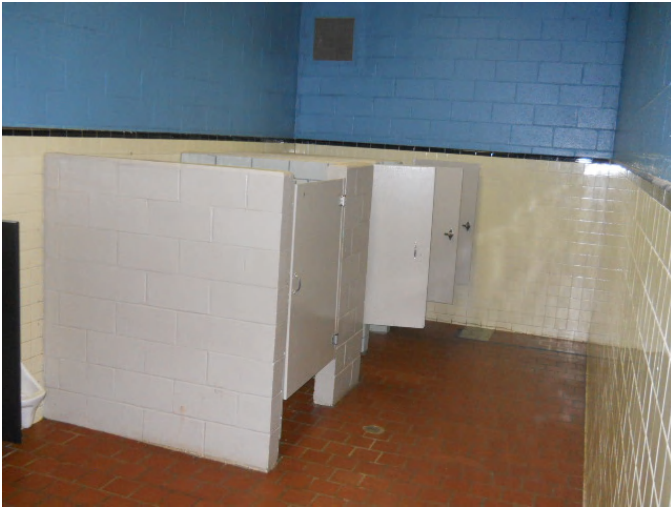
System: C3020 - Floor Finishes - Ceramic & Quarry Tile

Location: Kitchen and Restrooms

Distress: Beyond Service Life

Notes: The quarry tile and ceramic tile floor finishes are beyond their expected service life and should be scheduled for replacement.

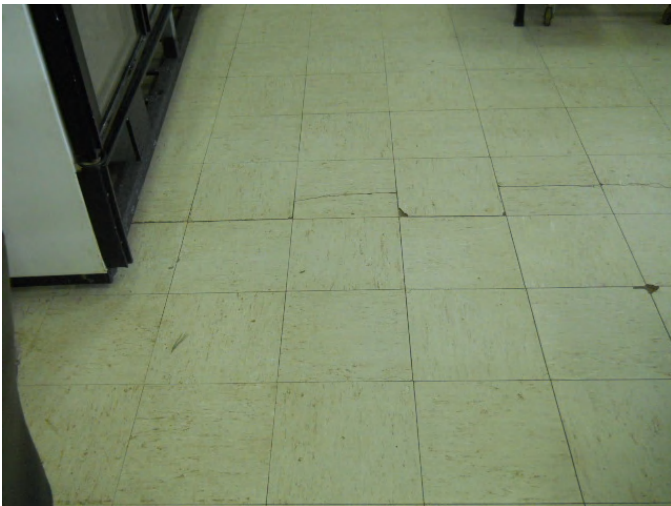
System: C3020 - Floor Finishes - VCT

Location: Throughout Building

Distress: Beyond Service Life

Notes: The VCT flooring is aged, cracked and worn, and should be replaced. The floors were partially replaced following the assessment.

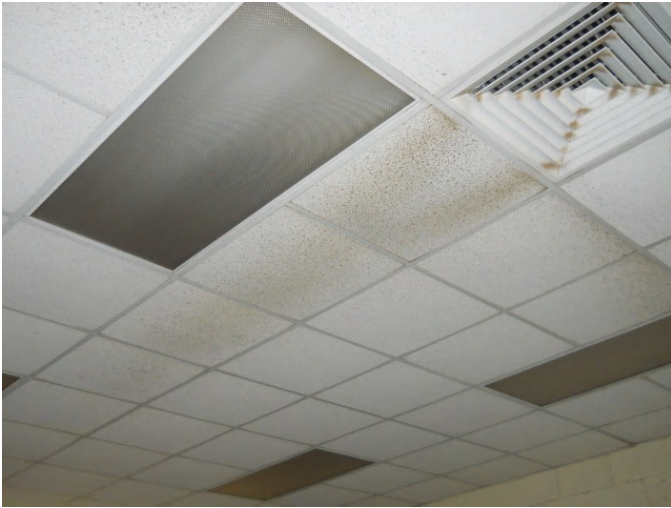
System: C3030 - Ceiling Finishes

Location: Throughout Building

Distress: Beyond Service Life

Notes: The acoustical ceiling tiles and grid system is aged, worn and damaged, and should be replaced. Most ceiling tiles were reportedly replaced in 2015; however, the system is still beyond its expected service life.

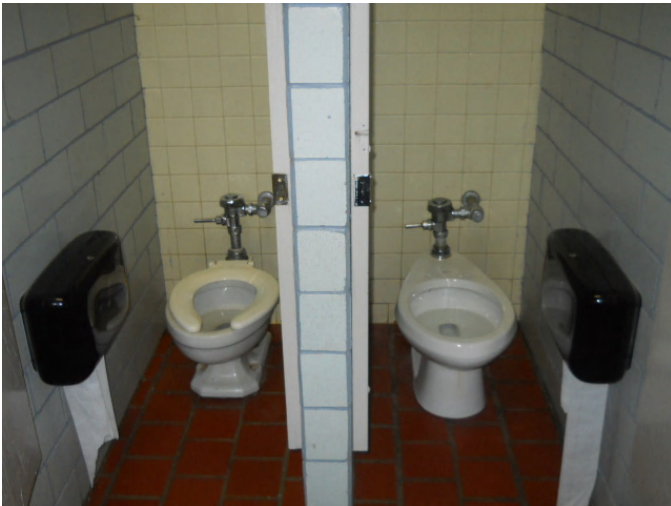
System: D2010 - Plumbing Fixtures

Location: Throughout Building

Distress: Beyond Service Life

Notes: The plumbing fixtures are old, possibly original in some cases, and inefficient. Restrooms and fixtures are not ADA compliant. SPLOST IV, Project 319-422 identifies some improvements/replacements of the plumbing system.

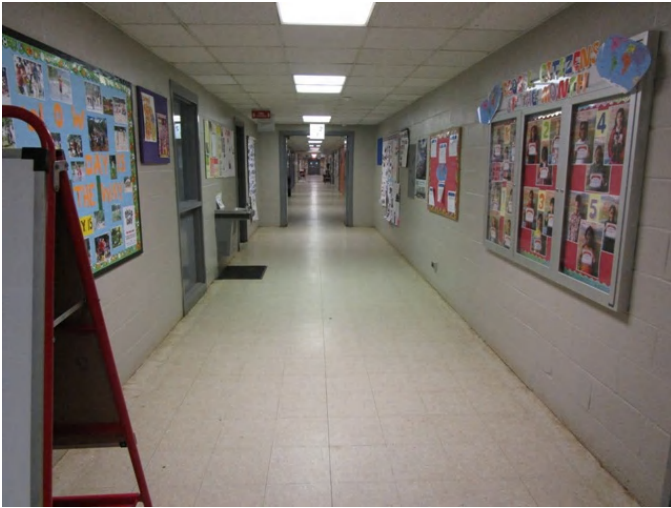
System: D2010 - Plumbing Fixtures

Location: Hallway

Distress: Needs Remediation

Correction: Remove/replace drinking fountain w/recessed ADA compliant drinking fountain

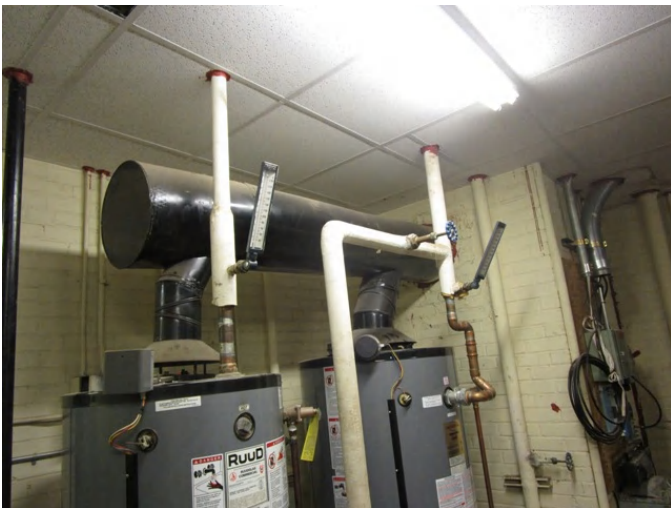
System: D2020 - Domestic Water Distribution

Location: Throughout Building

Distress: Beyond Service Life

Notes: The domestic water distribution system is beyond its expected service life, has water quality issues, and should be scheduled for replacement.

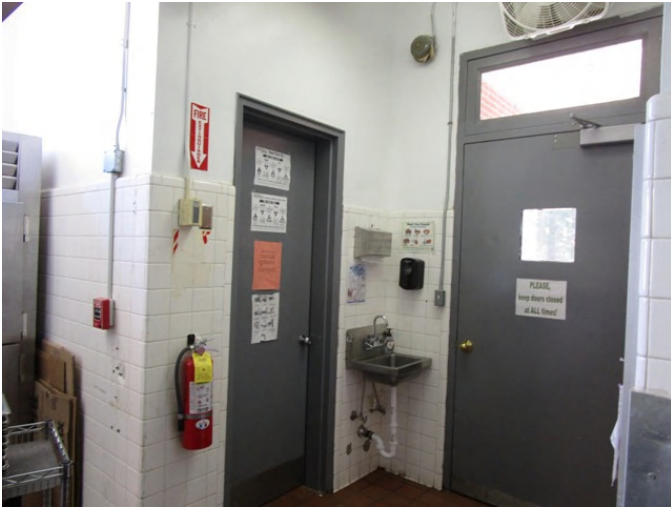
System: D2030 - Sanitary Waste

Location: Throughout Building

Distress: Beyond Service Life

Notes: The sanitary waste system is beyond its expected service life and should be scheduled for replacement.

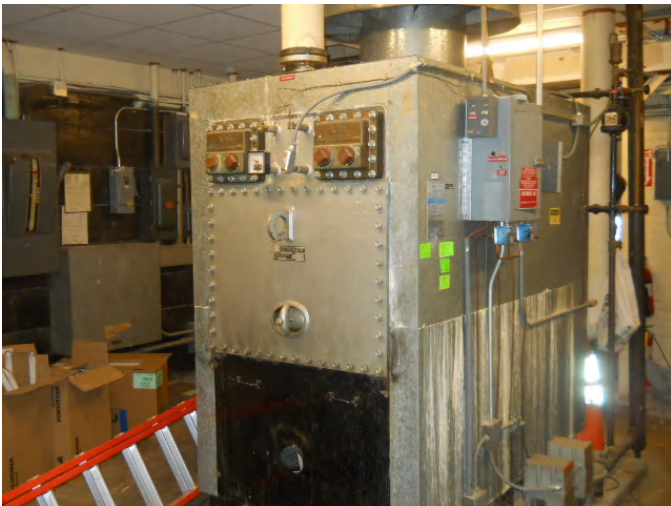
System: D3040 - Distribution & Exhaust Systems

Location: Mechanical Room

Distress: Missing

Notes: The mechanical room does not have a fresh air supply to the systems. Recommend installation of ducted outside air to the room.

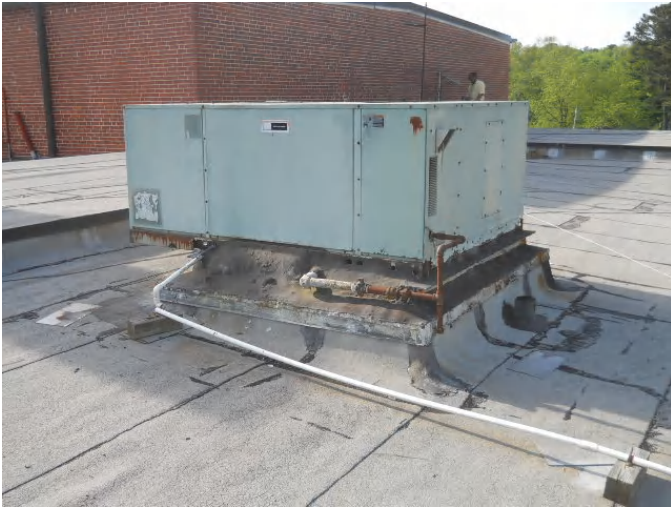
System: D3050 - Terminal & Package Units

Location: Roof

Distress: Beyond Service Life

Notes: The RTU that serves the administrative area is not functional and should be replaced. The RTU was serviced in the fall of 2015 and is currently functioning, but should be scheduled for replacement.

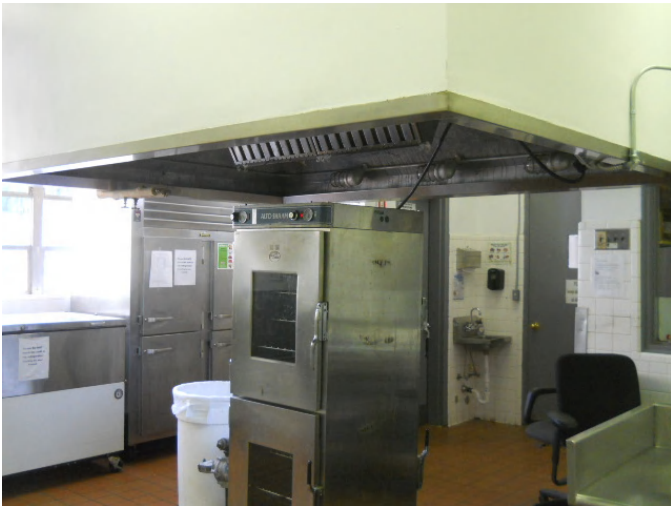
System: D3090 - Other HVAC Systems/Equip - Kitchen Hood

Location: Kitchen

Distress: Beyond Service Life

Notes: The kitchen hood and exhaust system is operational, but is aged, and should be replaced. The kitchen at this location is only partially used for serving, warming tables, and refrigerators. There is no "cooking" at this site.

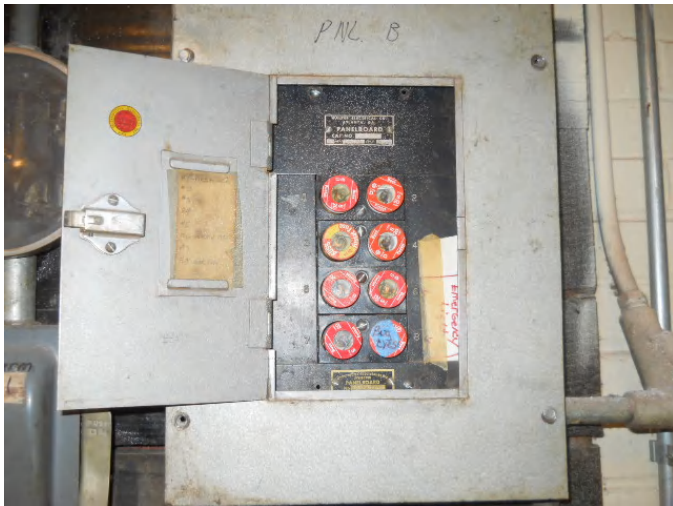
System: D5020 - Branch Wiring

Location: Throughout Building

Distress: Beyond Service Life

Notes: The electrical distribution system is aged, becoming logistically unsupportable, and should be replaced.

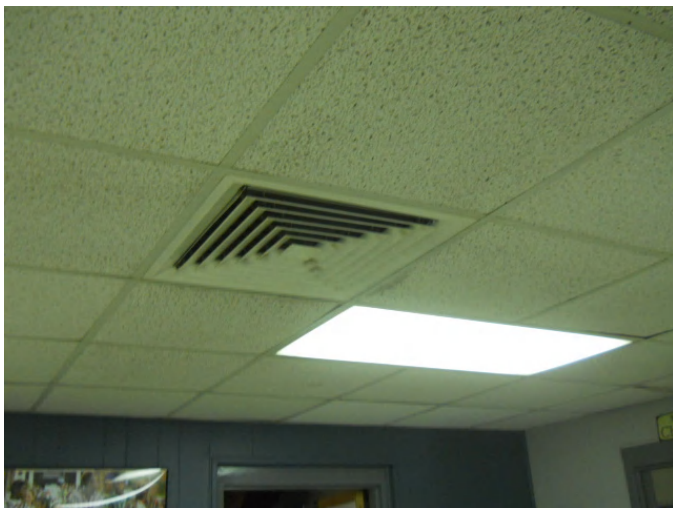
System: D5020 - Lighting

Location: Throughout Building

Distress: Beyond Service Life

Notes: The lighting system is beyond its expected service life and should be replaced along with branch wiring.

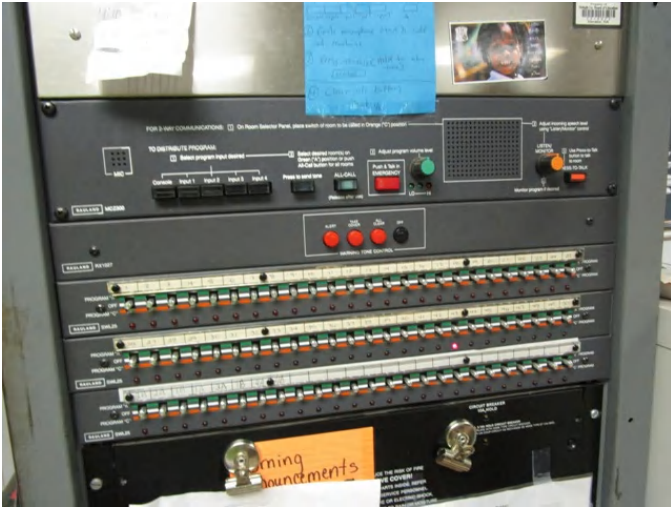
System: D5030 - Communications and Security - Clock & PA Systems

Location: Throughout Building

Distress: Beyond Service Life

Notes: The PA and clock system is beyond its expected service life and should be replaced. PA system was serviced in fall 2015 and is currently functioning.

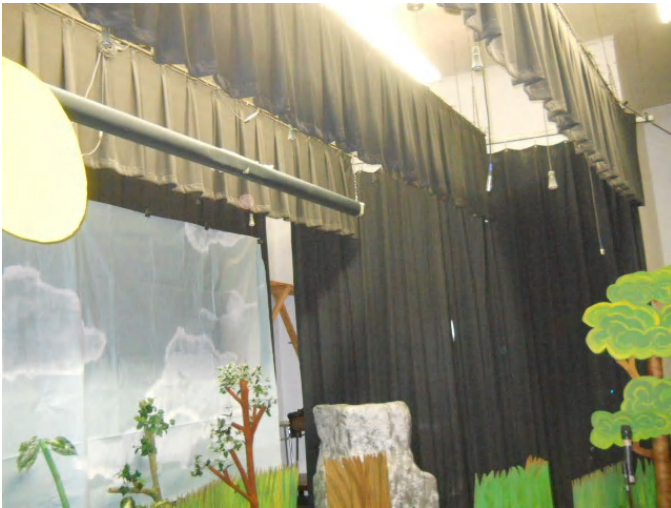
System: F1020 - Institutional Equipment

Location: Throughout Building

Distress: Beyond Service Life

Notes: Institutional equipment, such as theater and stage equipment, is beyond its expected service life and should be scheduled for replacement.

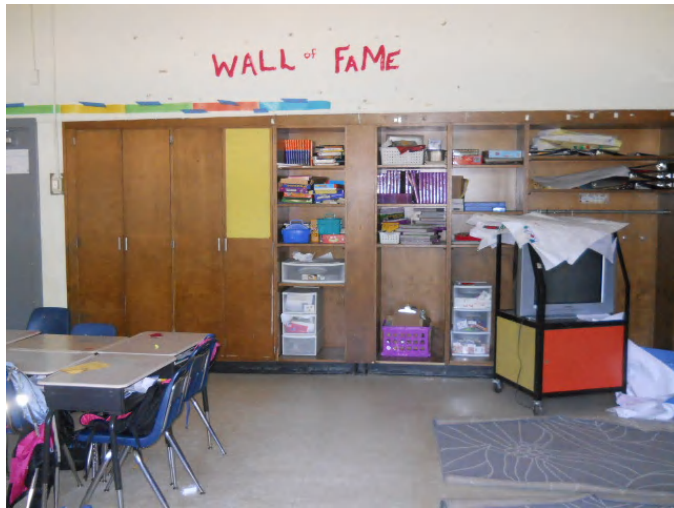
System: E2010 - Fixed Furnishings

Location: Throughout Building
Distress: Beyond Service Life
Category: Deferred Maintenance
Priority: 3 Priority
Correction: Renew System
Qty: 38,251.00
Unit of Measure: S.F.
Estimate: \$247,407.00
Assessor Name: Sam Mandola
Date Created: 04/11/2015

Notes: Fixed furnishings, such as fixed casework and window treatment, are aged, worn and in poor condition, and should be replaced.

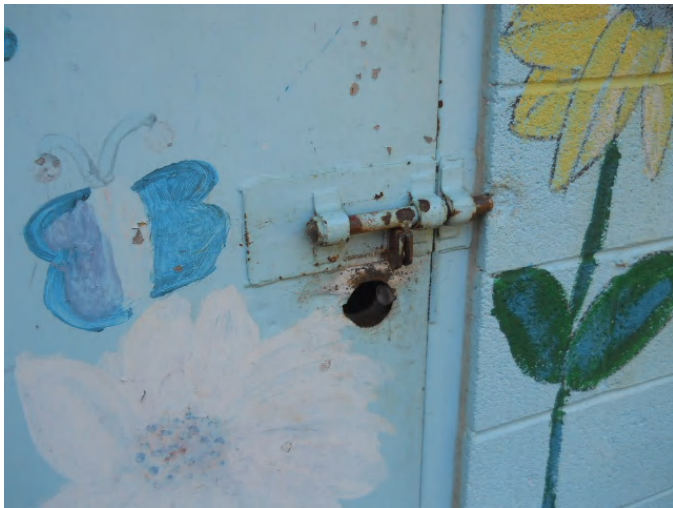
System: B2030 - Exterior Doors

Location: Exterior Wall

Distress: Beyond Service Life

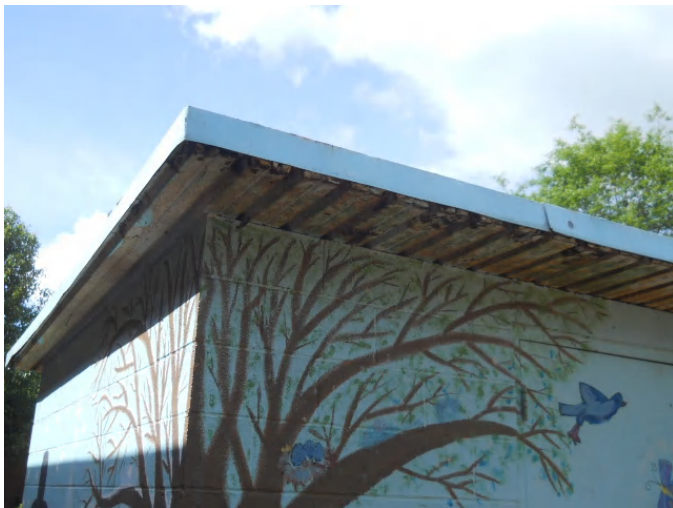
System: B3010 - Roof Coverings - BUR

Location: Roof

Distress: Beyond Service Life
