# James R. Hallford Stadium

## School Assessment Report

May 20, 2016

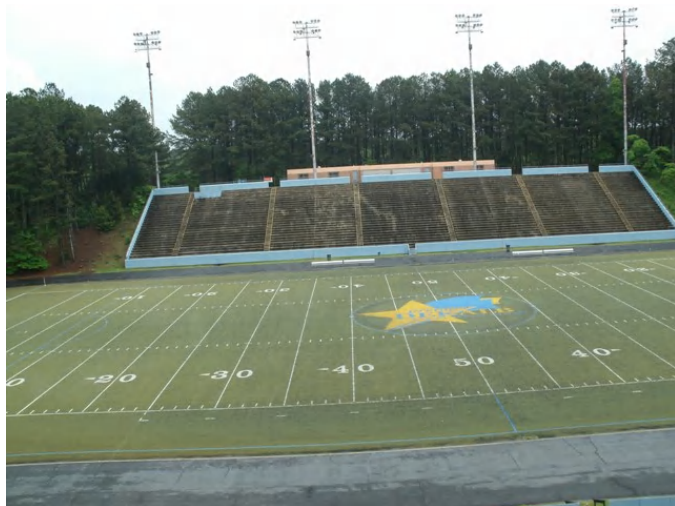
#### System: C2010 - Stair Construction

**Location:** East Stand Stadium

**Distress:** Inadequate

**Notes:** The stadium steps, access ramps, and stairs are unsafe, do not have adequate railing, are damaged, and do not provide ADA accessibility to all areas.

**Correction:** Replace stadium stairs (\$2.08/sf)

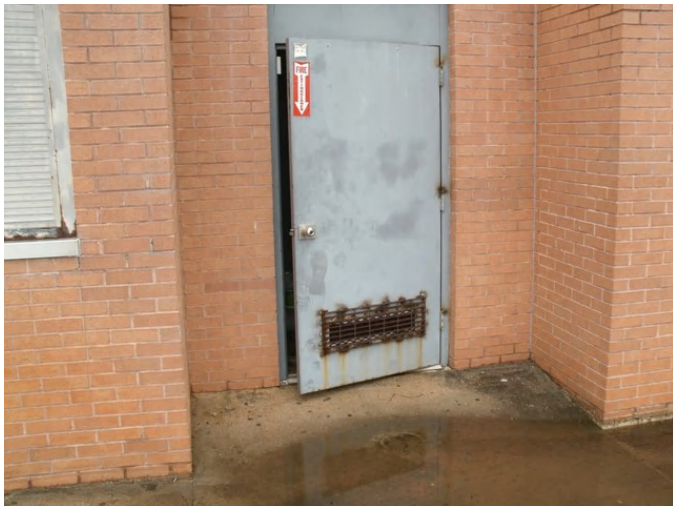
**System: B2030 - Exterior Doors**

**Location:** East Stand

**Distress:** Beyond Service Life

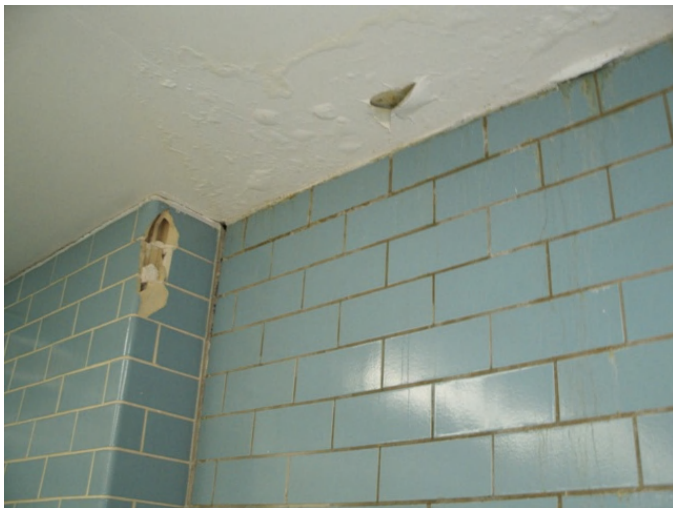
**System: C1010 - Partitions**

**Location:** East Stand

**Distress:** Damaged

**Notes:** The glazed partitions are broken and cracked in several locations and should be scheduled for replacement.

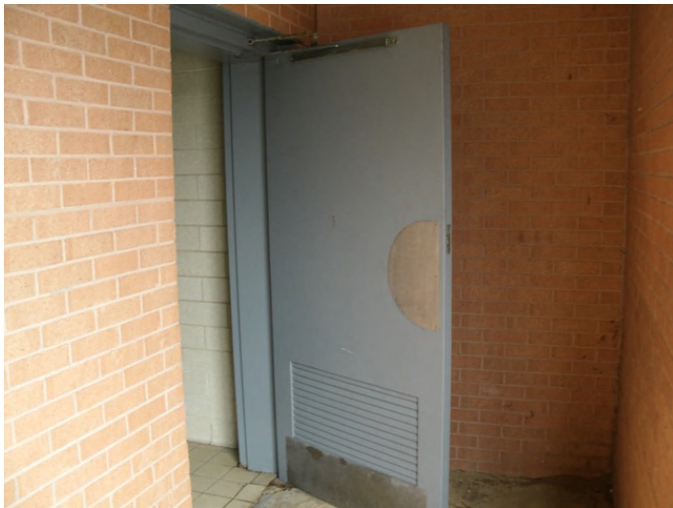
**System: C1020 - Interior Doors**

**Location:** Throughout Building

**Distress:** Beyond Service Life

**Notes:** The interior doors are beyond their useful life and should be replaced.

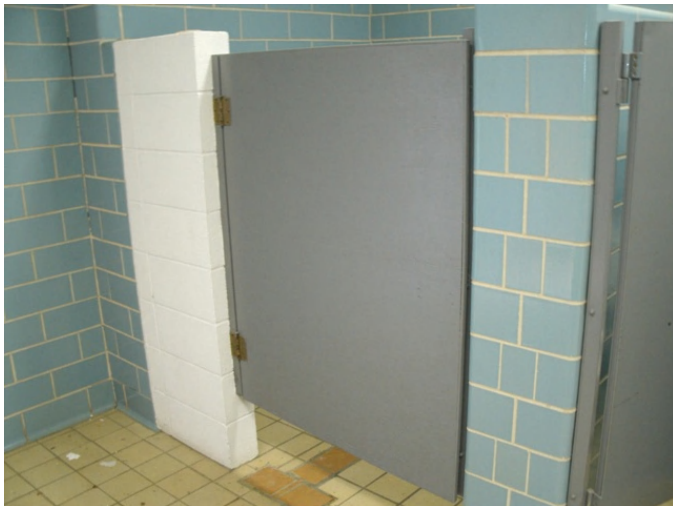
**System: C1030 - Fittings**

**Location:** East Stand

**Distress:** Beyond Service Life

**Notes:** The fittings are beyond their expected service life, not ADA compliant, and should be scheduled for replacement.

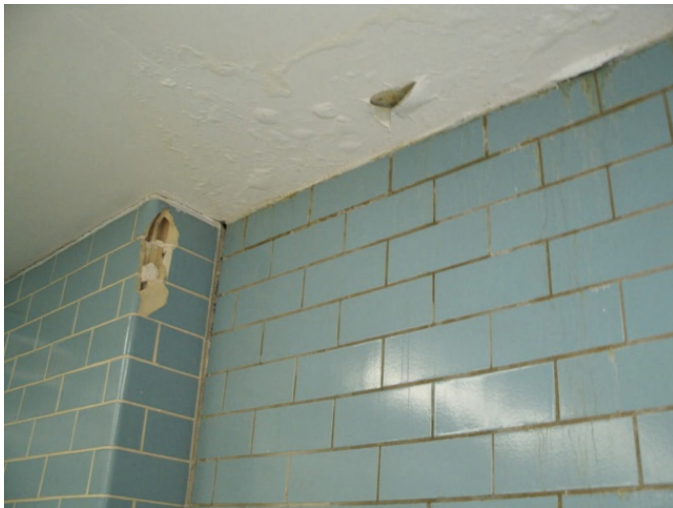
**System: C3030 - Ceiling Finishes**

**Location:** East Stand

**Distress:** Damaged

**Notes:** The ceiling finishes are damaged and should be replaced.

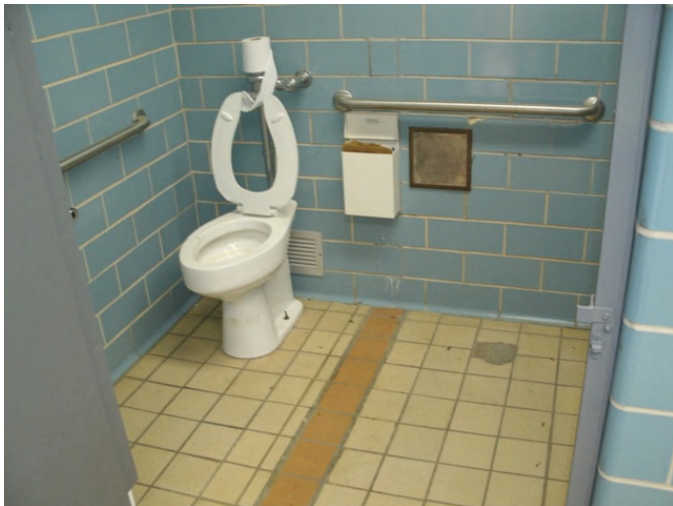
**System: D2010 - Plumbing Fixtures**

**Location:** East Stand

**Distress:** Beyond Service Life

**Notes:** The plumbing fixtures are beyond service life, inadequate, not ADA compliant, and should be scheduled for replacement.

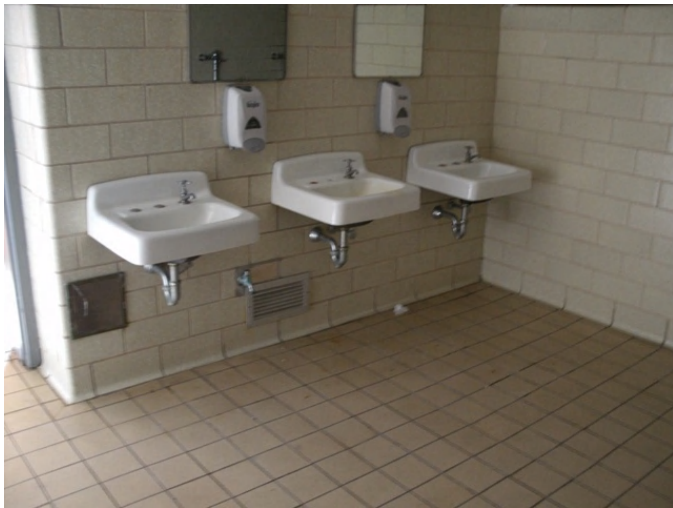
**System: D2020 - Domestic Water Distribution**

**Location:** East Stand

**Distress:** Beyond Service Life

**Notes:** The domestic water system is beyond its expected service life and should be scheduled for replacement.

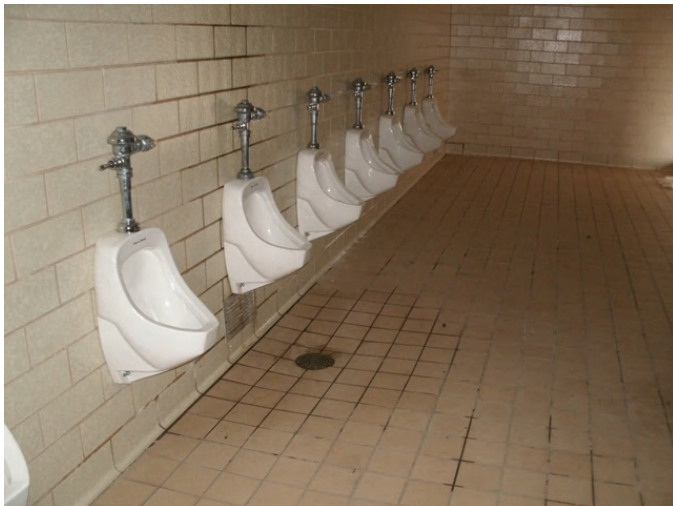
**System: D2030 - Sanitary Waste**

**Location:** East Stand

**Distress:** Beyond Service Life

**Notes:** The sanitary sewer system is beyond its expected service life and should be scheduled for replacement.

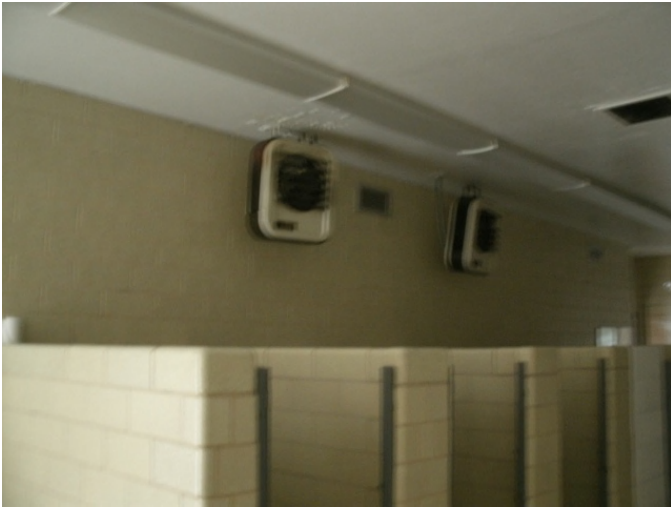
**System: D3040 - Distribution System**

**Location:** Restrooms

**Distress:** Beyond Service Life

**Notes:** The exhaust system is beyond its expected service life and should be scheduled for replacement.

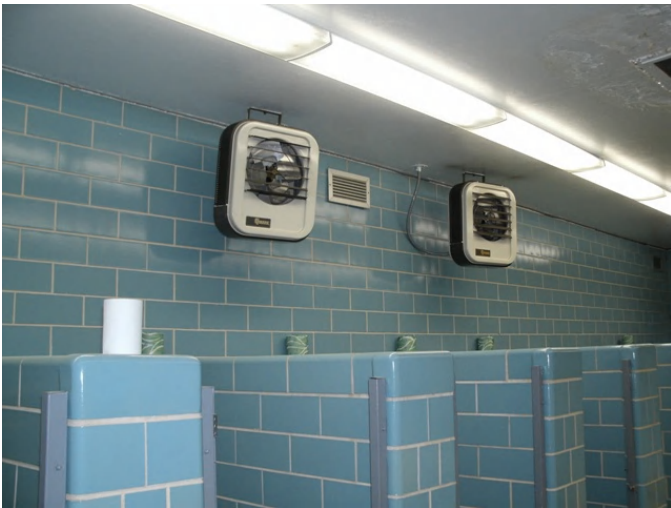
**System: D3050 - Terminal & Package Units**

**Location:** East Stand

**Distress:** Beyond Service Life

**Notes:** The unit heaters are beyond their expected service life and should be scheduled for replacement.

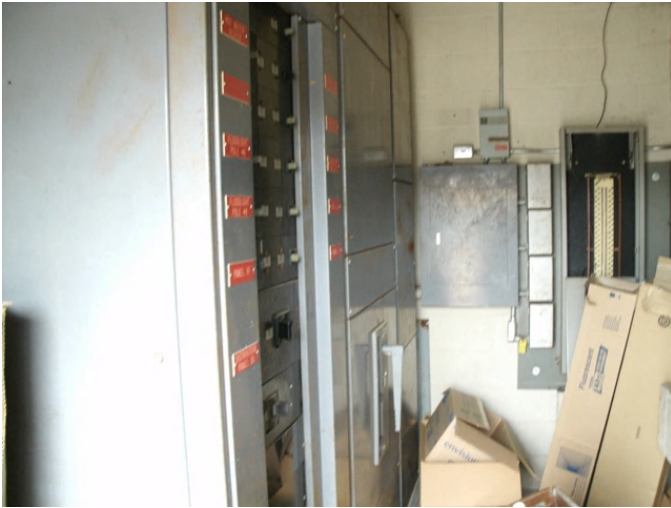
**System: D5010 - Electrical Service/Distribution**

**Location:** East Stand

**Distress:** Beyond Service Life

**Notes:** The original electrical service and distribution system is beyond its expected service life and should be scheduled for replacement.

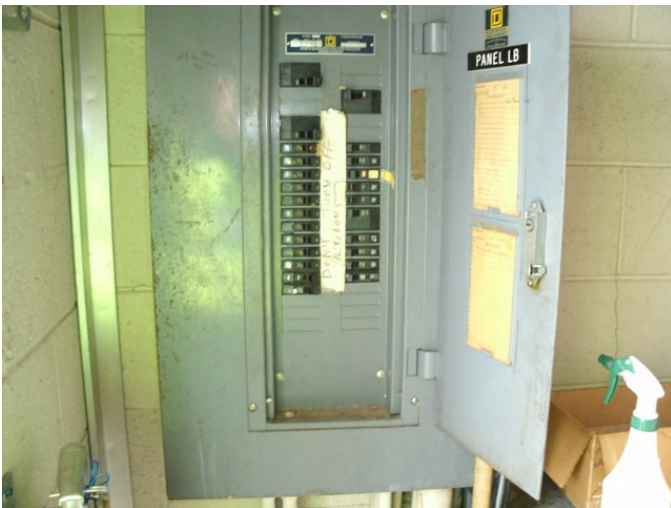
**System: D5020 - Lighting and Branch Wiring**

**Location:** East Stand

**Notes:** The branch wiring and lighting system is beyond its expected service life, inadequate, not code compliant, and should be scheduled for replacement.

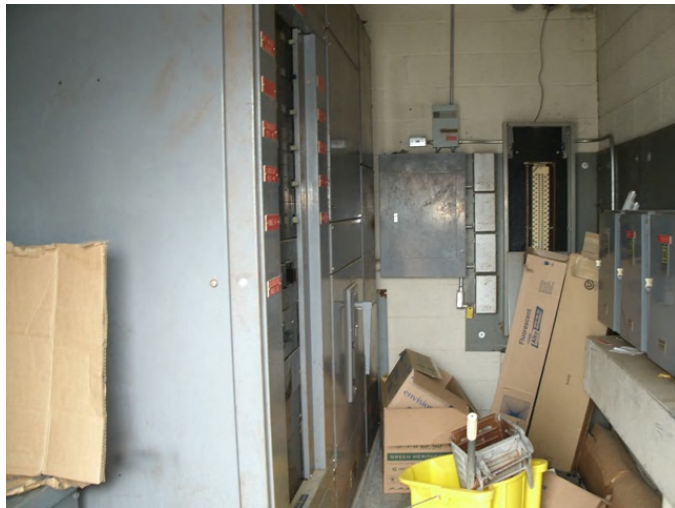
**System: D5030 - Communications and Security**

**Location:** East Stand

**Notes:** Telephone and data, PA and clock system, and security and CCTV systems are beyond service life and should be replaced. Audible and visible fire alarm is missing and should be added.

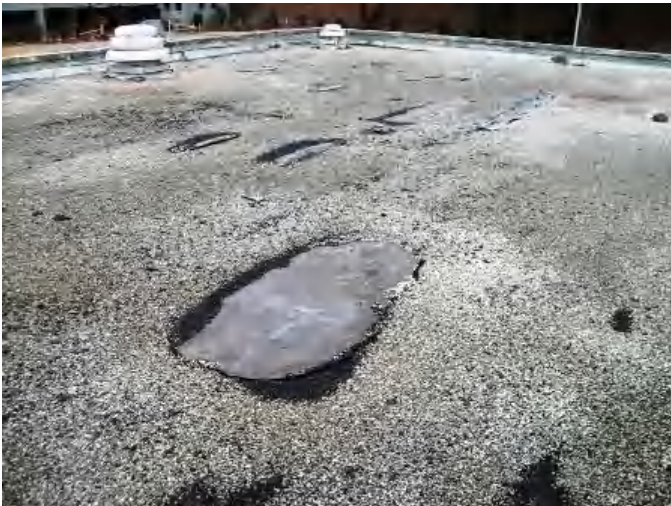
#### **System: B3010 - Roof Coverings - BUR**

**Location:** Field House

**Distress:** Damaged

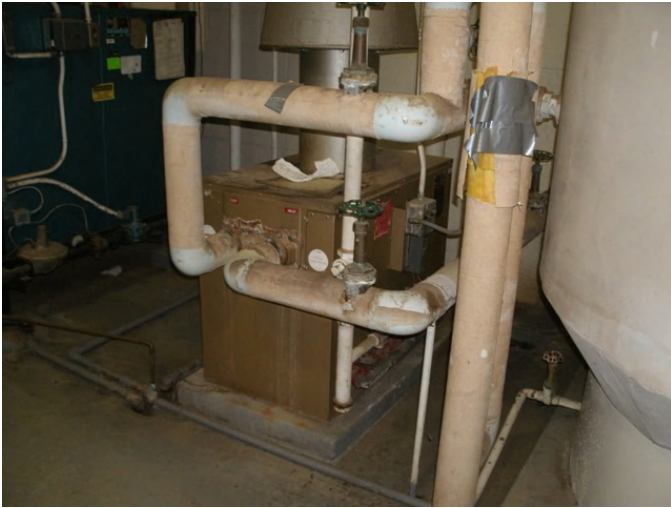
**System: D2090 - Other Plumbing Systems - Natural Gas**

**Location:** Field House  
**Distress:** Beyond Service Life  
**Category:** Deferred Maintenance  
**Priority:** 3 Priority  
**Correction:** Renew System  
**Qty:** 5,230.00  
**Unit of Measure:** S.F.  
**Estimate:** \$3,107.00  
**Assessor Name:** Ben Nixon  
**Date Created:** 05/11/2015

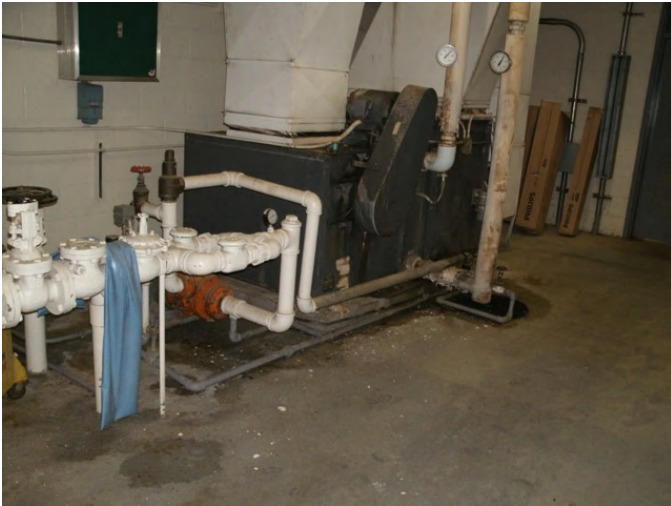
**System: D3040 - Distribution Systems & Exhaust Systems**

**Location:** Field House  
**Distress:** Beyond Service Life  
**Category:** Deferred Maintenance / Building Code Compliance  
**Priority:** 3 Priority  
**Correction:** Renew System  
**Qty:** 5,230.00  
**Unit of Measure:** S.F.  
**Estimate:** \$30,088.00  
**Assessor Name:** Ben Nixon  
**Date Created:** 04/11/2015

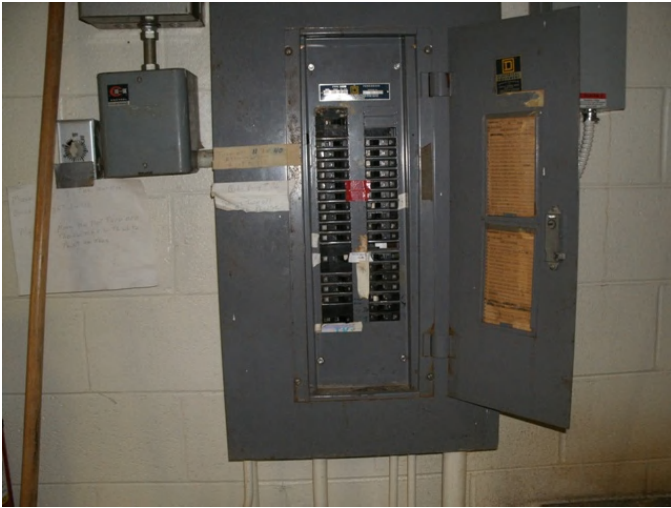
**System: D5010 - Electrical Service/Distribution**

**Location:** Field House  
**Distress:** Beyond Service Life  
**Category:** Deferred Maintenance  
**Priority:** 3 Priority  
**Correction:** Renew System  
**Qty:** 5,230.00  
**Unit of Measure:** S.F.  
**Estimate:** \$17,604.00  
**Assessor Name:** Ben Nixon  
**Date Created:** 04/11/2015

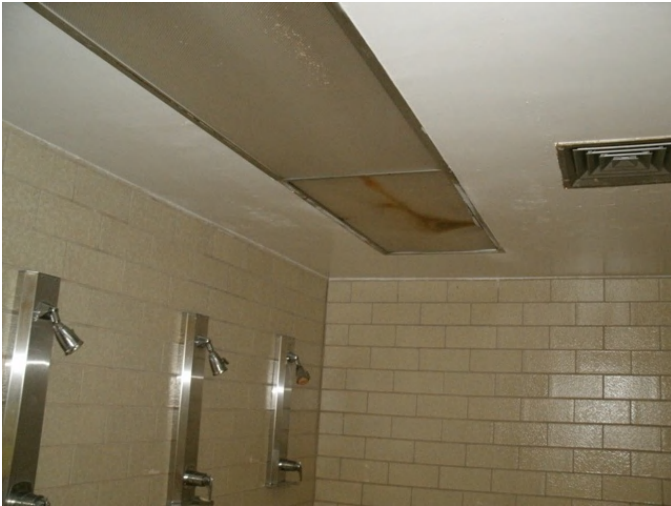
**System: D5020 - Lighting and Branch Wiring**

**Location:** Field House  
**Distress:** Beyond Service Life  
**Category:** Deferred Maintenance  
**Priority:** 3 Priority  
**Correction:** Renew System  
**Qty:** 5,230.00  
**Unit of Measure:** S.F.  
**Estimate:** \$72,315.00  
**Assessor Name:** Ben Nixon  
**Date Created:** 04/11/2015

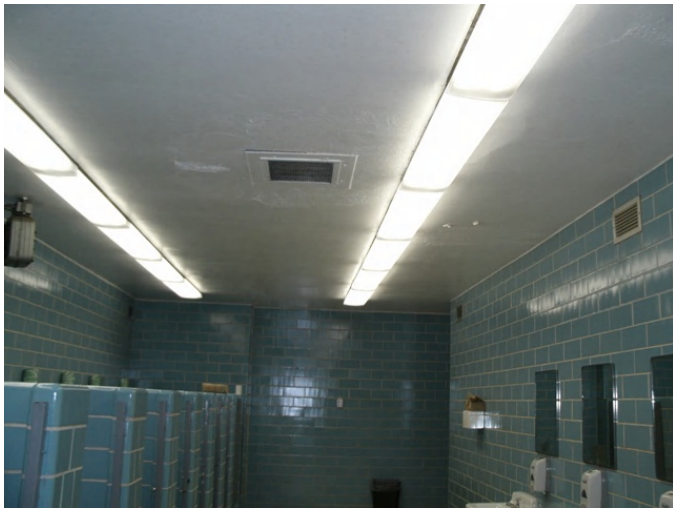
**System: D3040 - Distribution System**

**Location:** Restrooms  
**Distress:** Beyond Service Life  
**Category:** Deferred Maintenance  
**Priority:** 3 Priority  
**Correction:** Renew System  
**Qty:** 5,200.00  
**Unit of Measure:** S.F.  
**Estimate:** \$27,170.00  
**Assessor Name:** Sam Mandola  
**Date Created:** 08/19/2015

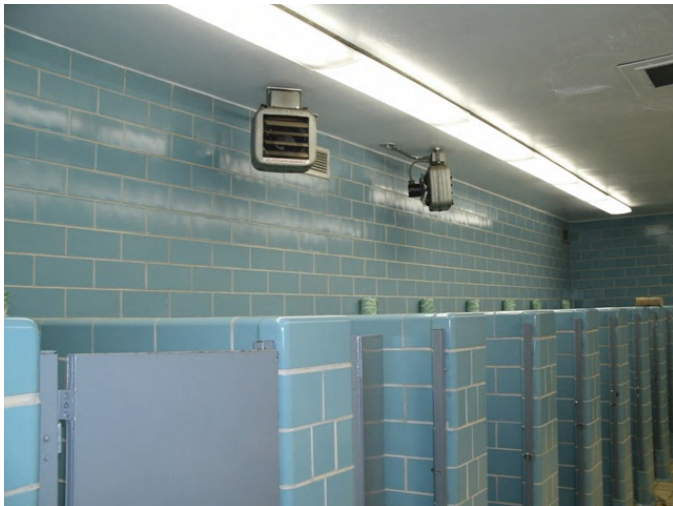
**System: D3050 - Terminal & Package Units**

**Location:** West Stand  
**Distress:** Beyond Service Life  
**Category:** Deferred Maintenance  
**Priority:** 3 Priority  
**Correction:** Renew System  
**Qty:** 5,200.00  
**Unit of Measure:** S.F.  
**Estimate:** \$31,574.00  
**Assessor Name:** Sam Mandola  
**Date Created:** 05/12/2015

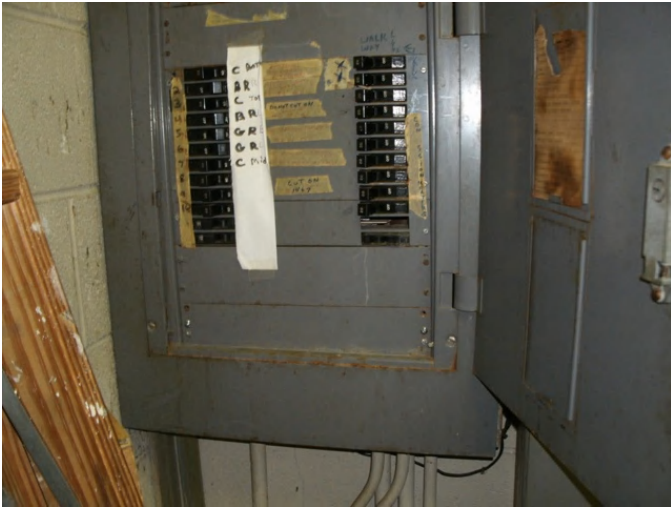
**System: D5020 - Lighting and Branch Wiring**

**Location:** West Stand  
**Distress:** Beyond Service Life  
**Category:** Deferred Maintenance  
**Priority:** 3 Priority  
**Correction:** Renew System  
**Qty:** 42,497.00  
**Unit of Measure:** S.F.  
**Estimate:** \$855,932.00  
**Assessor Name:** Sam Mandola  
**Date Created:** 04/11/2015

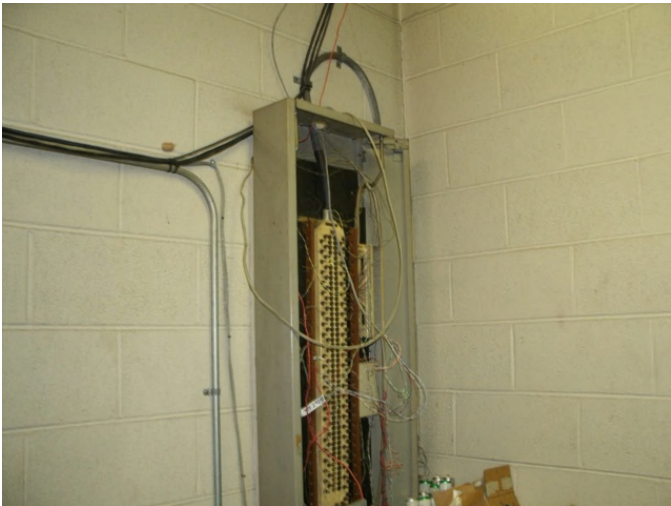
**System: D5030 - Communications and Security**

**Location:** West Stand  
**Distress:** Beyond Service Life  
**Category:** Deferred Maintenance / Building Code Compliance  
**Priority:** 3 Priority  
**Correction:** Renew System  
**Qty:** 42,497.00  
**Unit of Measure:** S.F.  
**Estimate:** \$254,302.00  
**Assessor Name:** Sam Mandola  
**Date Created:** 05/12/2015
