DeKalb County School District/Elementary Schools

Livsey Elementary

School Assessment Report

May 19, 2016

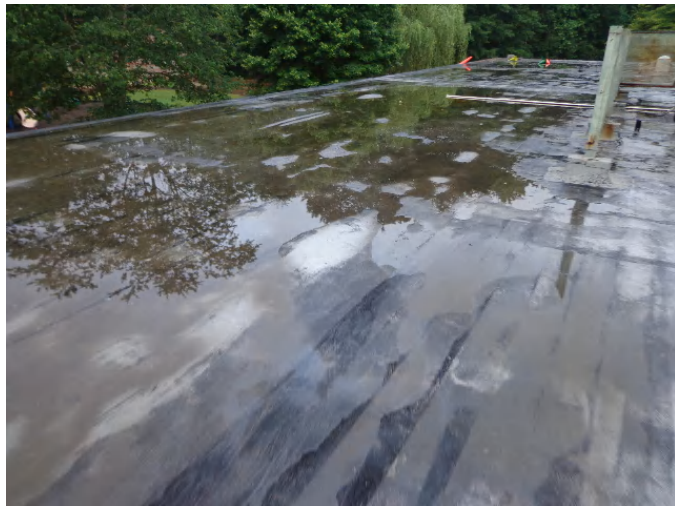
System: B3010 - Roof Coverings - BUR

Distress: Beyond Service Life

Notes: Built-up roof covering is in deteriorating condition, with many patches, water ponding, deteriorating flashing, improper repairs, and reported water leaks through parapets and other areas. SPLOST project 418-422 to replace the roof on the 71 building.

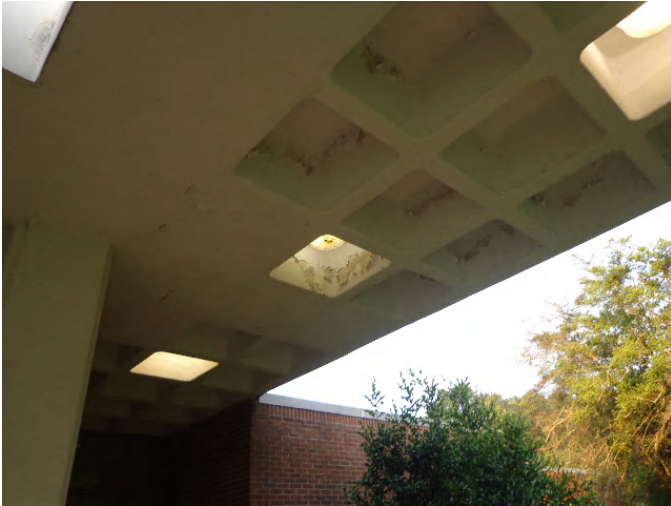
System: B2010 - Exterior Walls

Distress: Beyond Service Life

Notes: The painted finish on the exterior soffit is aged, flaking and stained, and should be replaced. Staff reports ceiling finish is falling on students.

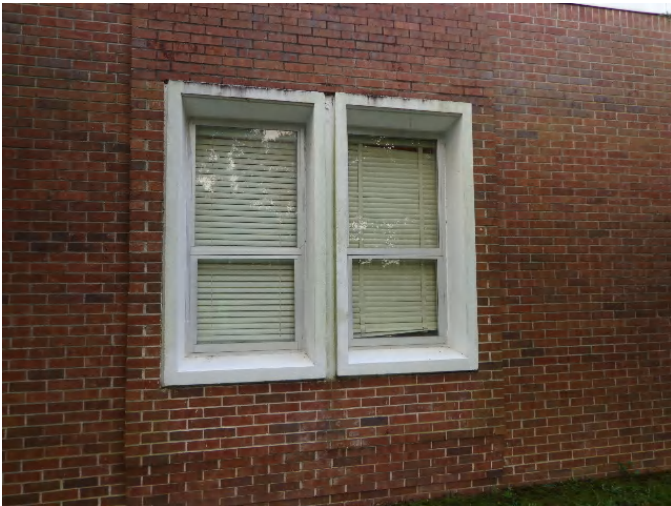
System: B2020 - Exterior Windows

Distress: Beyond Service Life

Notes: The aluminum frame, operable, single pane windows are aged, damaged, not energy efficient, and should be replaced.

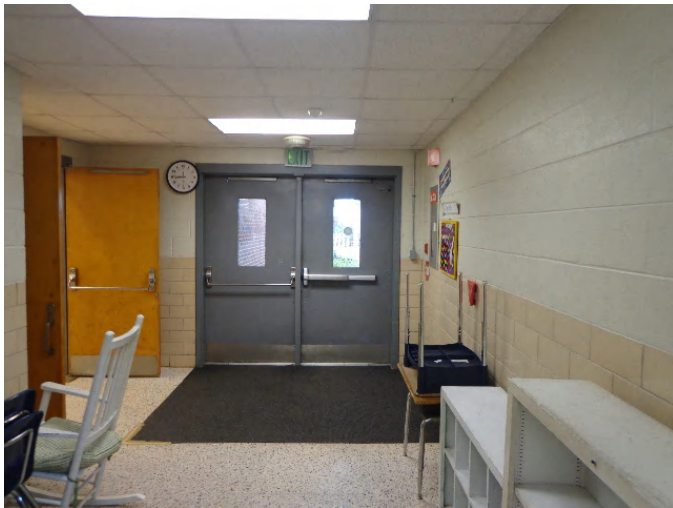
System: B2030 - Exterior Doors

Distress: Beyond Service Life

Notes: The original exterior doors are aged, rusted, and should be replaced.

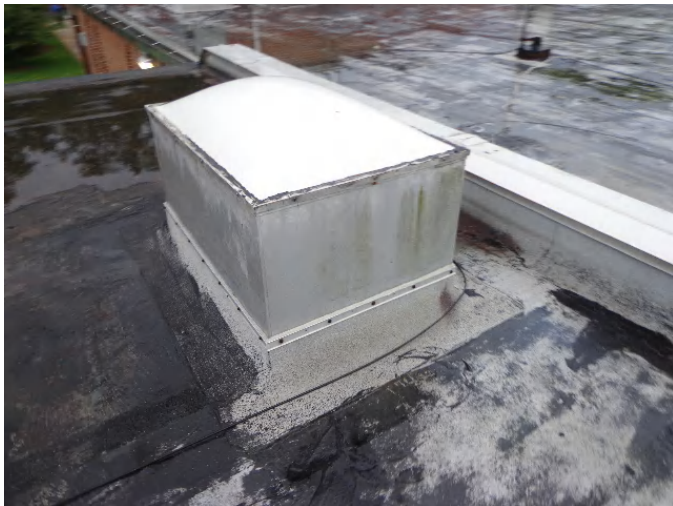
System: B3020 - Roof Openings

Distress: Beyond Service Life

Notes: The small acrylic domes are beyond their expected life and should be replaced with the roof.

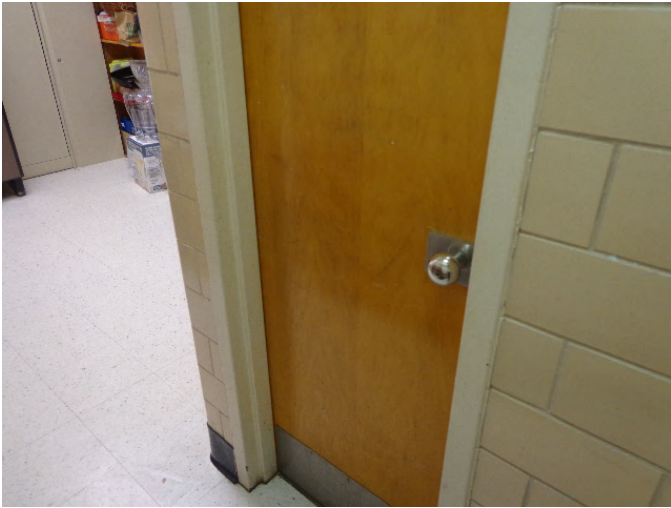
System: C1020 - Interior Doors

Distress: Beyond Service Life

Notes: The original interior doors are beyond their expected service life, hardware is not ADA compliant, and should be replaced.

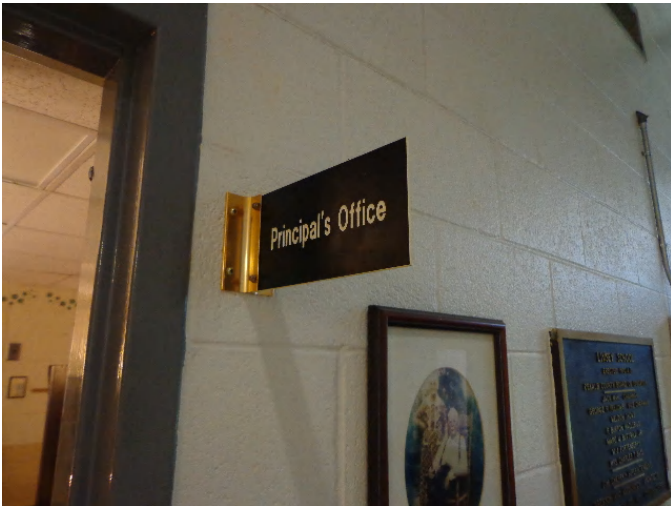
System: C1030 - Fittings

Distress: Inadequate

Correction: Remove and replace the signage w/ADA compliant signage.

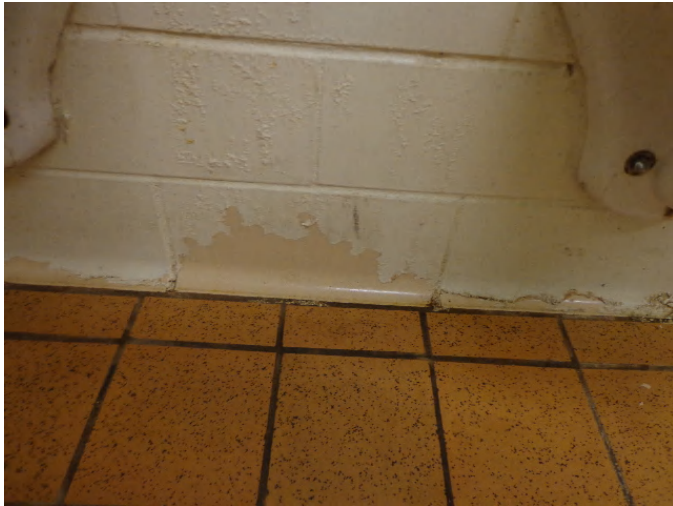
System: C3010 - Wall Finishes - Paint

Distress: Inadequate

Notes: The ceramic wall tiles were recently painted and the surface was not properly prepared and/or the paint is not the adequate. Paint is peeling and cracking and should be replaced.

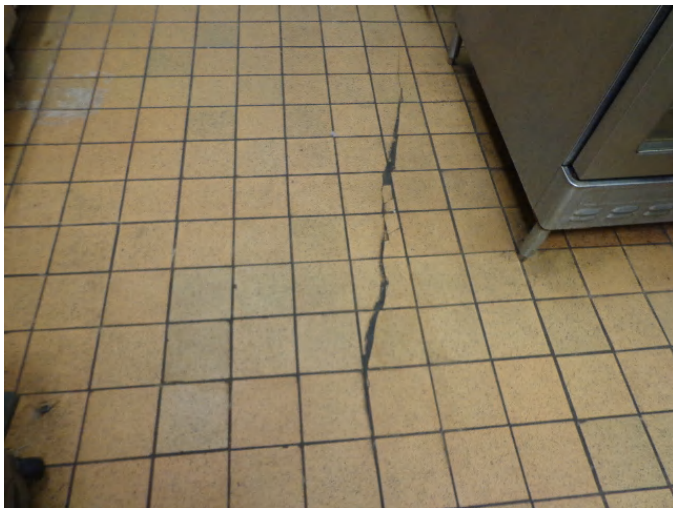
System: C3020 - Floor Finishes - Ceramic & Quarry Tile

Distress: Beyond Service Life

Notes: The tile floor covering is beyond its expected service life, cracked, patched and worn, and should be replaced.

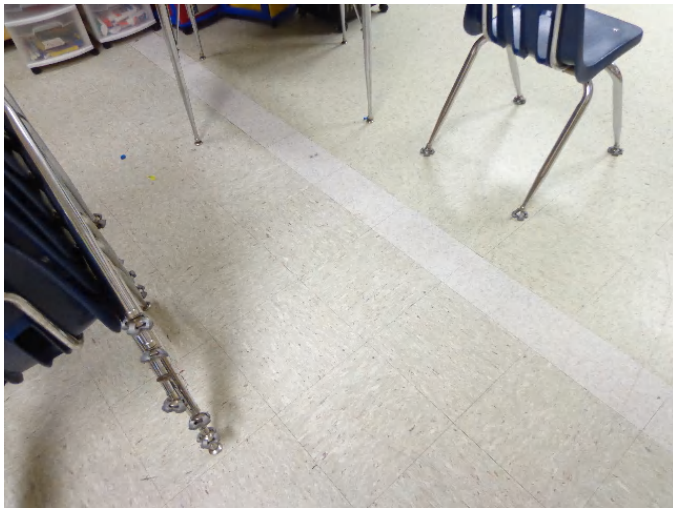
System: C3020 - Floor Finishes - VCT

Distress: Beyond Service Life

Notes: The VCT flooring is aged, patched and worn, and should be replaced.

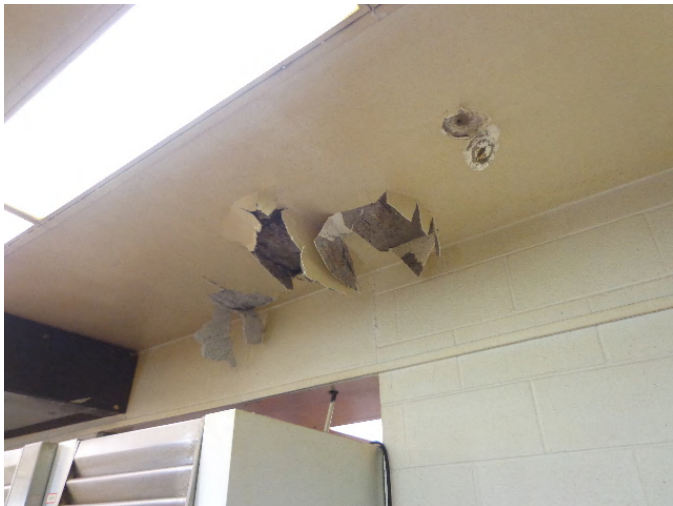
System: C3030 - Ceiling Finishes

Distress: Damaged

Notes: The original ceiling finish is aged, failing, and should be replaced.

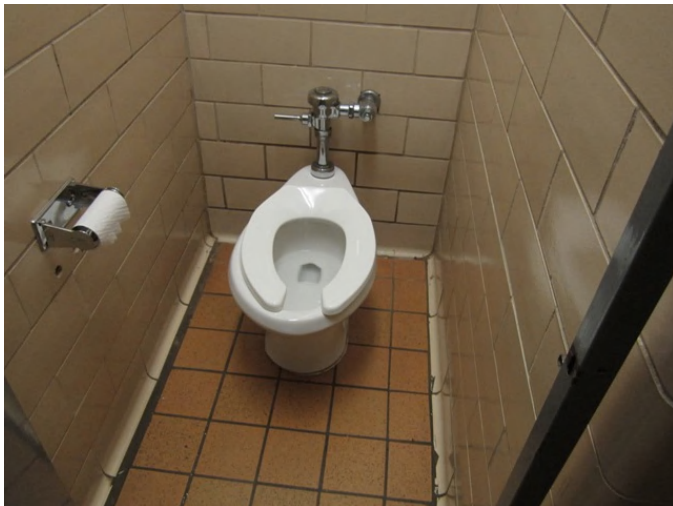
System: D2010 - Plumbing Fixtures

Distress: Beyond Service Life

Notes: The plumbing fixtures are beyond their expected service life and should be scheduled for replacement.

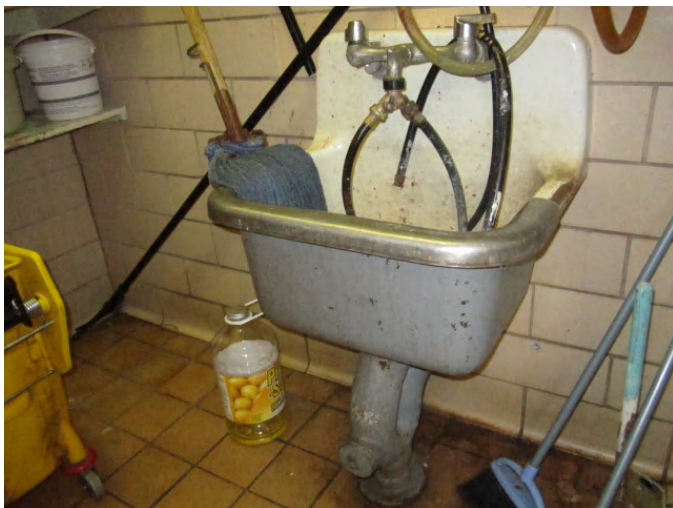
System: D2020 - Domestic Water Distribution

Distress: Beyond Service Life

Notes: The domestic water distribution system is beyond its expected service life and should be scheduled for replacement.

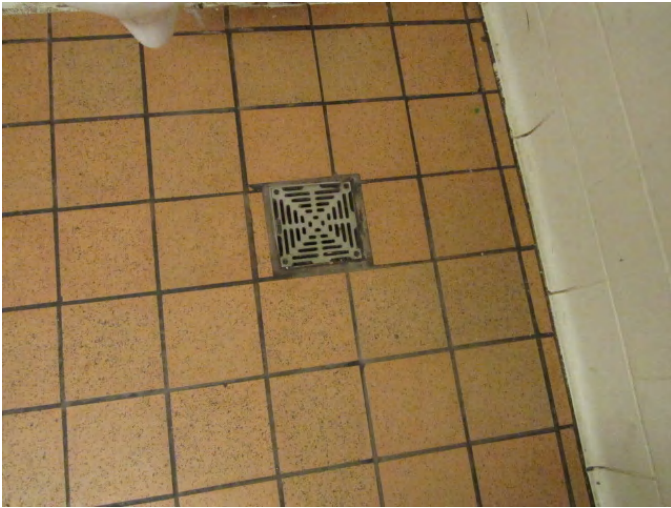
System: D2030 - Sanitary Waste

Location: Throughout Building
Distress: Beyond Service Life
Category: Deferred Maintenance
Priority: 3 Priority
Correction: Renew System
Qty: 34,936.00
Unit of Measure: S.F.
Estimate: \$131,045.00
Assessor Name: Ben Nixon
Date Created: 06/19/2015

Notes: The sanitary sewer system is beyond its expected service life and should be scheduled for replacement.

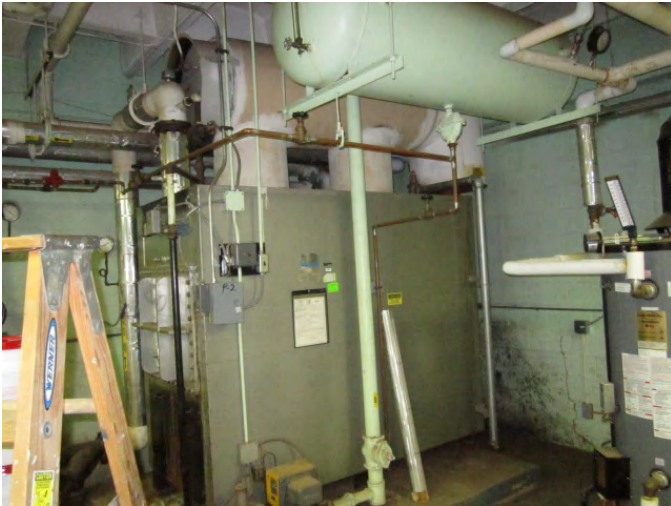
System: D2090 - Other Plumbing Systems - Natural Gas

Location: Throughout Building
Distress: Beyond Service Life
Category: Deferred Maintenance
Priority: 3 Priority
Correction: Renew System
Qty: 34,936.00
Unit of Measure: S.F.
Estimate: \$15,756.00
Assessor Name: Sam Mandola
Date Created: 06/19/2015

Notes: The natural gas system is beyond its expected service life and should be scheduled for replacement. SPLOST project 418-422 to replace grease trap.

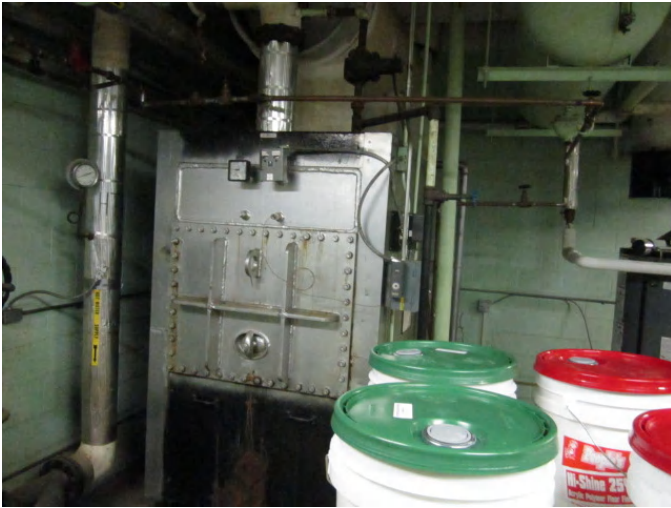
System: D3020 - Heat Generating Systems

Distress: Beyond Service Life

Notes: The heat generating system is beyond its expected service life, intermittent, not code compliant, and should be scheduled for replacement.

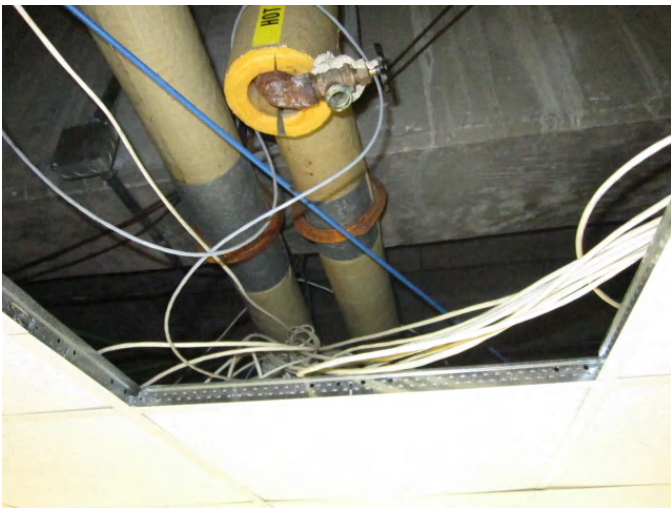
System: D3040 - Distribution & Exhaust Systems

Distress: Beyond Service Life

Notes: The distribution and exhaust systems are beyond their expected service life and should be scheduled for replacement.

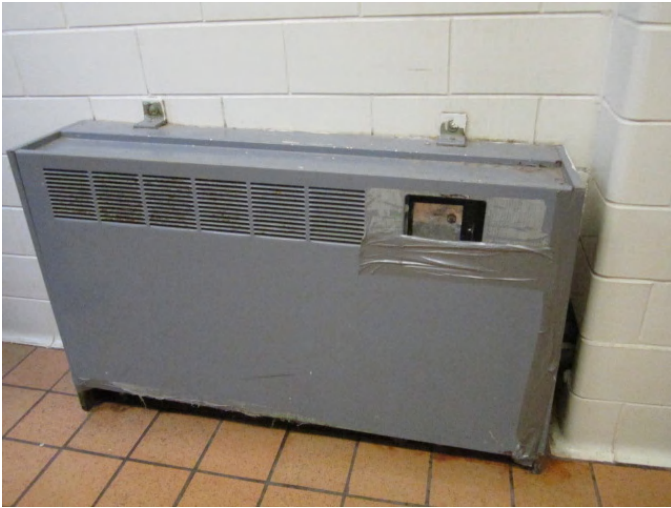
System: D3050 - Terminal & Package Units

Distress: Beyond Service Life

Notes: The terminal and package units are beyond their expected service life, intermittent, and should be scheduled for replacement.

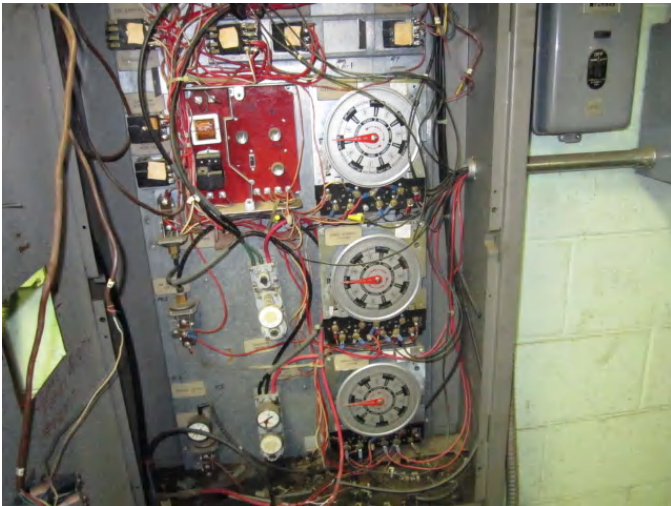
System: D3060 - Controls & Instrumentation

Distress: Beyond Service Life

Notes: The controls and instrumentation system is beyond its expected service life and should be scheduled for replacement.

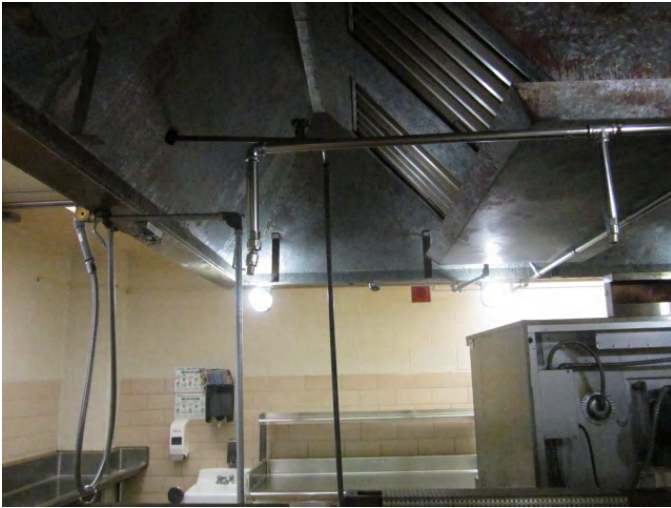
System: D3090 - Other HVAC Systems/Equip - Kitchen Hood

Distress: Beyond Service Life

Notes: The kitchen hood system is beyond its expected service life and should be scheduled for replacement. SPLOST IV is looking to replace the kitchen hood, depending on budget.

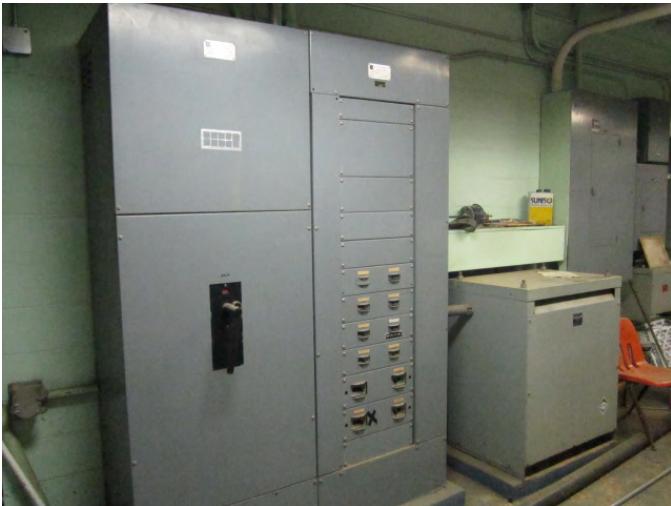
System: D5010 - Electrical Service/Distribution

Distress: Beyond Service Life

Notes: The electric service/distribution system is beyond its expected service life, not code compliant, and should be scheduled for replacement.

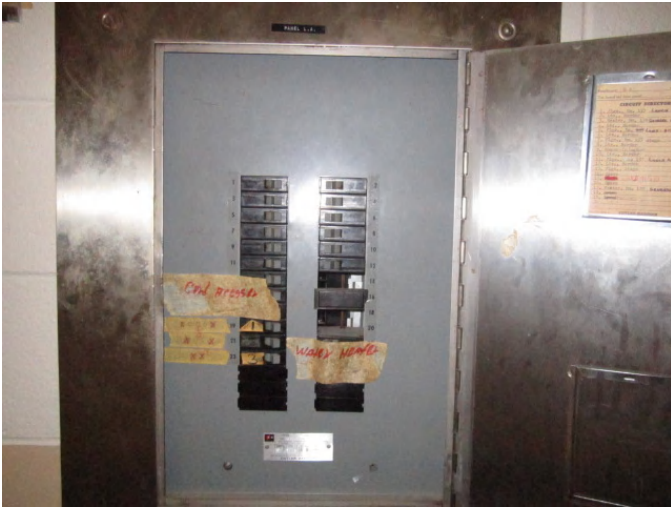
System: D5020 - Branch Wiring

Distress: Beyond Service Life

Notes: The branch wiring system is beyond its expected service life, not code compliant, and should be scheduled for replacement. Electrical outlets are not GFI in wet areas.

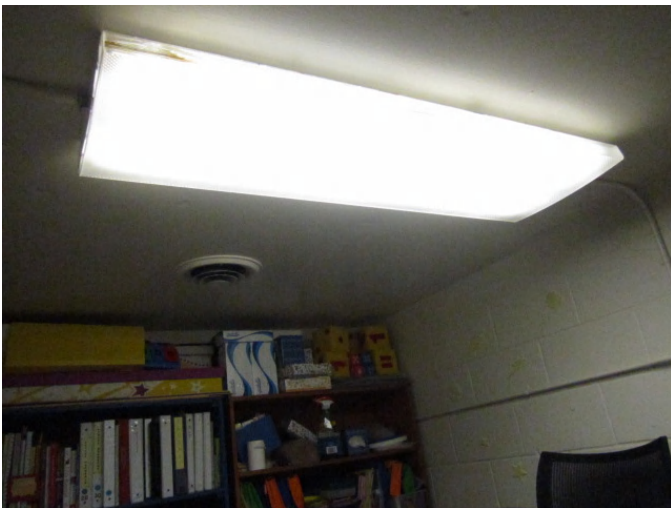
System: D5020 - Lighting

Distress: Beyond Service Life

Notes: The lighting system is beyond its expected service life and should be scheduled for replacement.

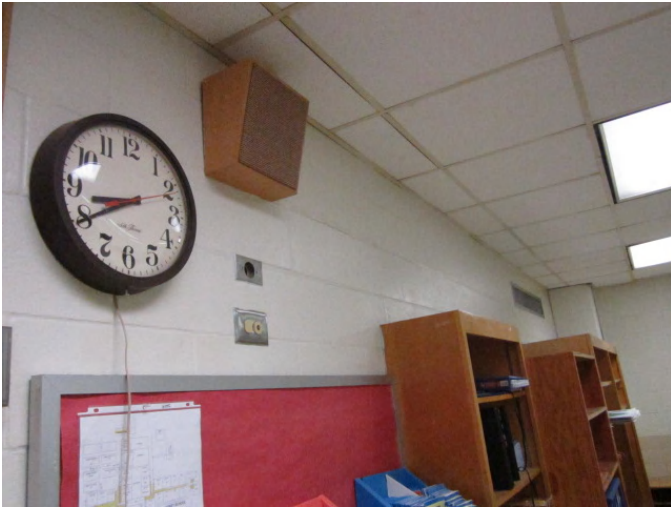
System: D5030 - Communications and Security - Clock & PA Systems

Distress: Beyond Service Life

Notes: Clock and PA systems are beyond their expected service life and should be scheduled for replacement.

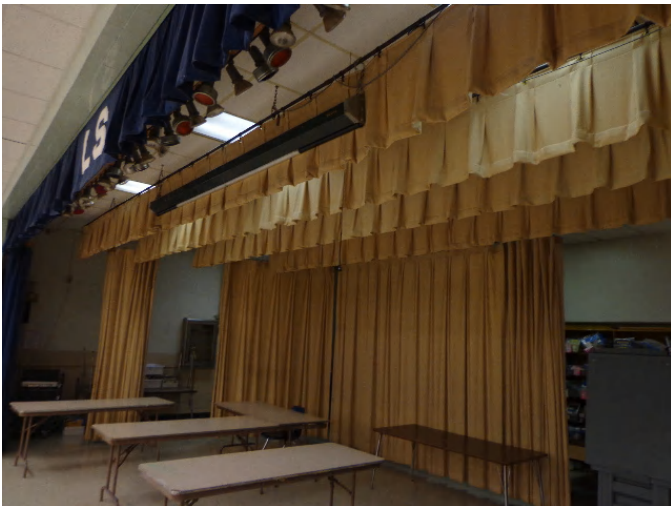
System: E1020 - Institutional Equipment

Distress: Beyond Service Life

Notes: Institutional equipment, such as theater and stage equipment and audio-visual equipment, is beyond its expected service life and should be scheduled for replacement.

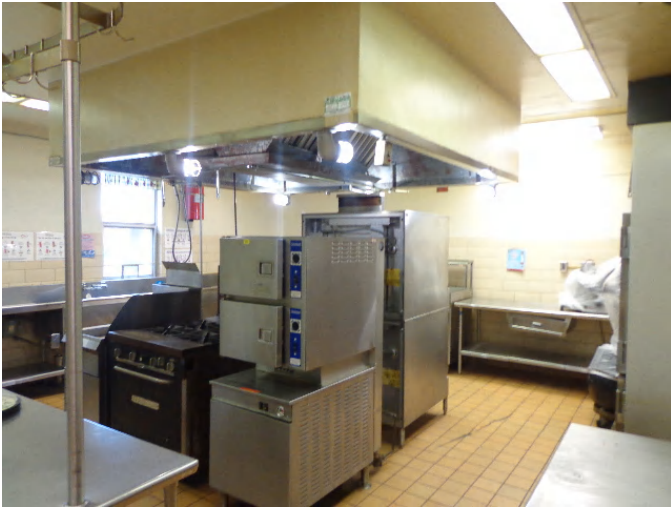
System: E1090 - Other Equipment

Distress: Beyond Service Life

Notes: Kitchen equipment is beyond its expected service life and should be scheduled for replacement.

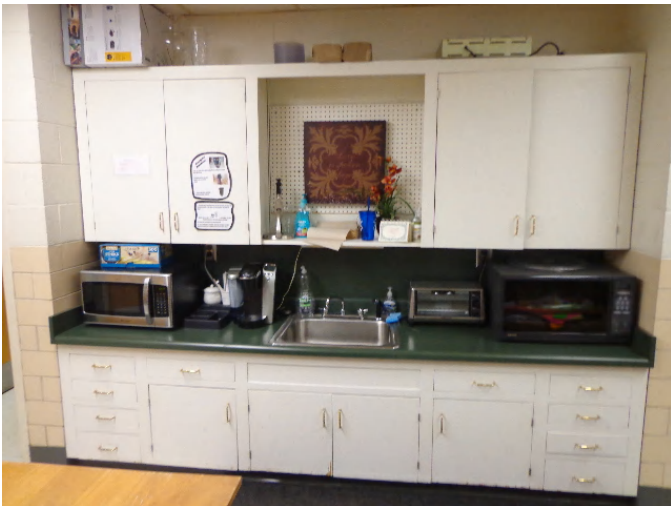
System: E2010 - Fixed Furnishings

Distress: Beyond Service Life

Notes: Fixed furnishings, such as built-in cabinets, are beyond their expected service life and worn, and should be replaced.

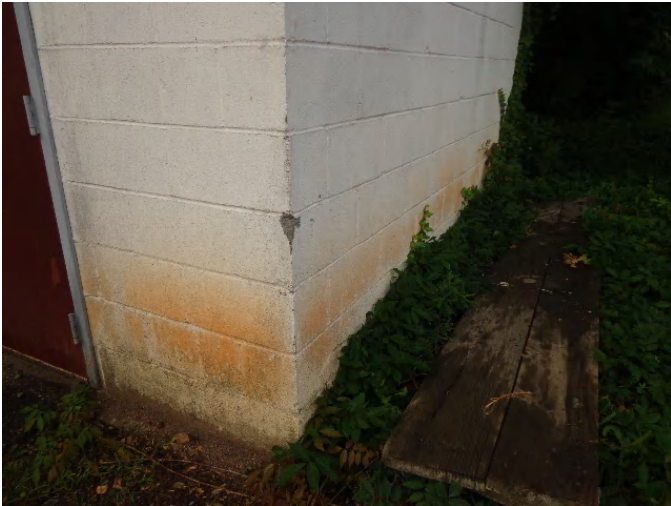
System: B2010 - Exterior Walls

Distress: Damaged

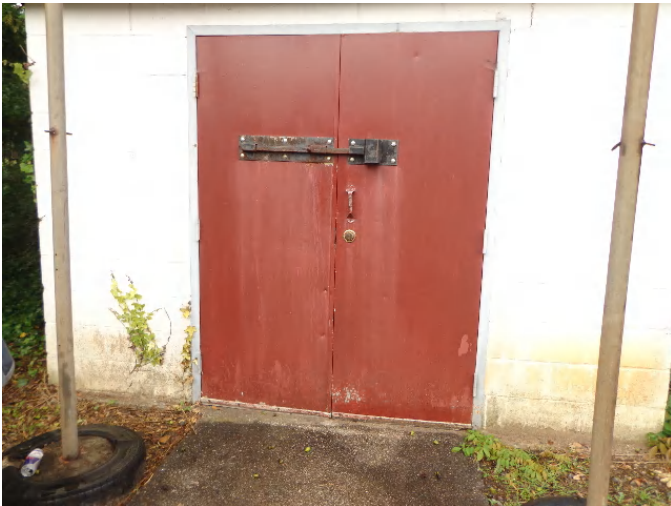
System: B2030 - Exterior Doors

Distress: Beyond Service Life

Notes: The original exterior doors are aged and should be replaced.

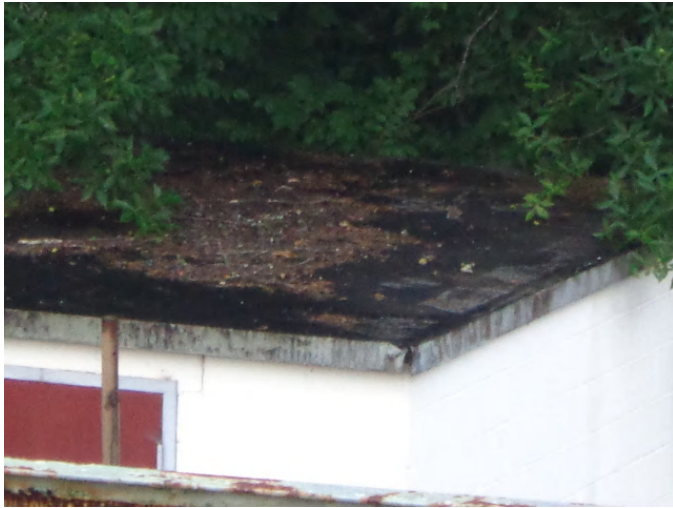
System: B3010 - Roof Coverings -BUR

Distress: Beyond Service Life
