DeKalb County School District/Elementary Schools

Marbut Elementary

School Assessment Report
May 19, 2016

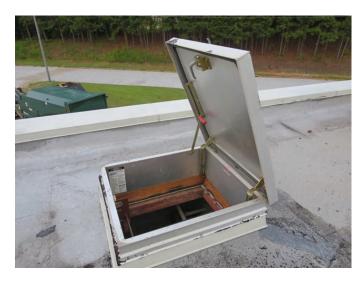
System: B3020 - Roof Openings

Location: Roof

Distress: Inadequate

Notes: The roof opening is aged, rusted, not OSHA compliant, and should be replaced. SPLOST project 317-422 to install a roof hatch and ladder.

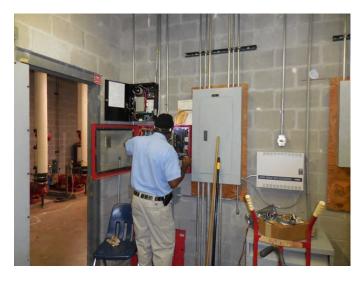
System: D5030 - Communications and Security - Fire Alarm

Location: Throughout Building

Distress: Needs Remediation

Notes: During the facility assessment, the school was on a fire watch. The alarm system was malfunctioning and had to be turned off. The entire system should be replaced/upgraded, as it is also beyond its expected service life.

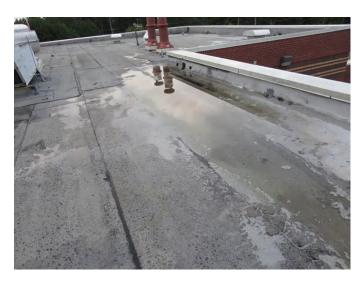
System: B3010 - Roof Coverings - BUR

Location: Roof

Distress: Needs Remediation

Notes: The built-up roof covering is aged, showing signs of failure, and should be replaced. SPLOST project 317-422 to replace the

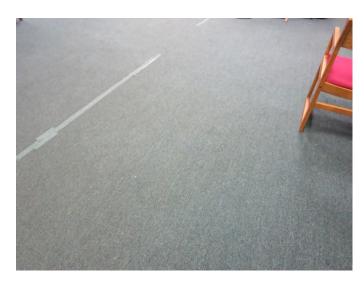
System: C3020 - Floor Finishes - Carpet

Location: Media Center, Music, and Offices

Distress: Beyond Service Life

Notes: The carpet in the music room is stained, damaged, and a trip hazard, and should be replaced.

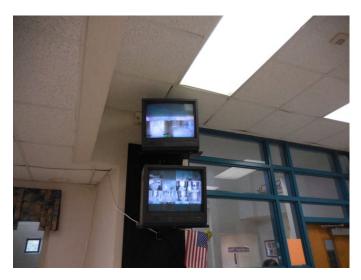
System: D5030 - Communications and Security - Security & CCTV

Location: Throughout Building

Distress: Inadequate

Notes: The security and CCTV systems are beyond their expected service life, inadequate, and should be scheduled for replacement/upgrade to provide full coverage.

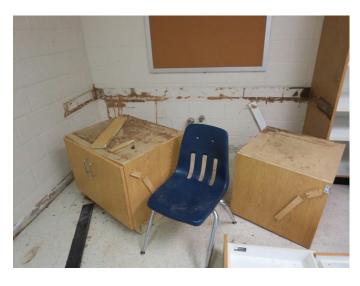
System: E2010 - Fixed Furnishings

Location: Throughout Building

Distress: Beyond Service Life

Notes: The fixed wood furnishing are aged, decaying due to termites, and should be replaced.

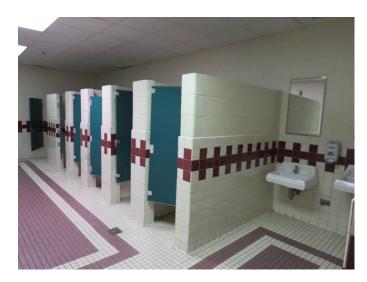
System: C1030 - Fittings

Location: Restrooms

Distress: Beyond Service Life

Notes: Some of the accessible toilet stalls throughout the building are not ADA compliant. Rooms signs do not have raised characters and Braille. The entire fittings system is beyond its expected service life and should be scheduled for replacement.

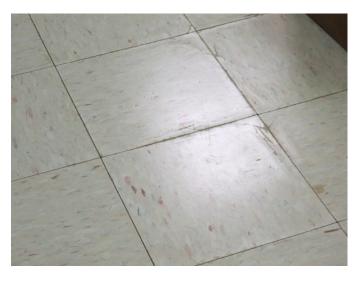
System: C3020 - Floor Finishes - VCT

Location: Classrooms

Distress: Beyond Service Life

Notes: The VCT flooring is aged, cracked and worn, and should be replaced.

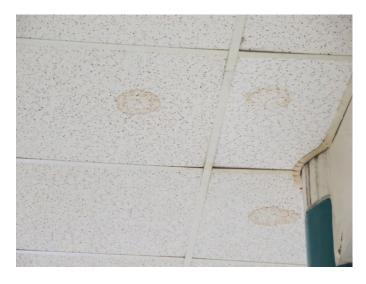
System: C3030 - Ceiling Finishes

Location: Throughout Building

Distress: Beyond Service Life

Notes: Some of the acoustical ceiling tiles and grid system is damaged due to roof leaks and should be replaced.

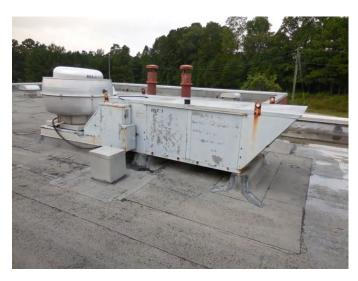
System: D3040 - Distribution & Exhaust Systems

Location: Throughout Building

Distress: Damaged

Notes: The distribution and exhaust systems are nearing the end of their expected service life, worn, and should be scheduled for replacement. Staff reports that the exhaust system constantly malfunctions.

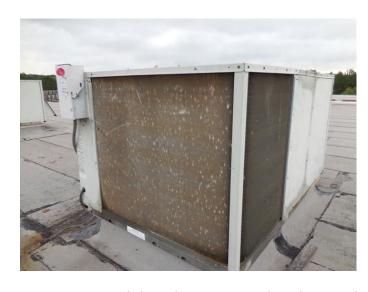
System: D3050 - Terminal & Package Units

Location: Roof

Distress: Beyond Service Life

Notes: System includes make-up-air, mini split packages, and exhaust air heat recovery units. Staff reports that the units are constantly down for maintenance. Units are corroded/rusted, beyond their expected service life, and should be replaced.

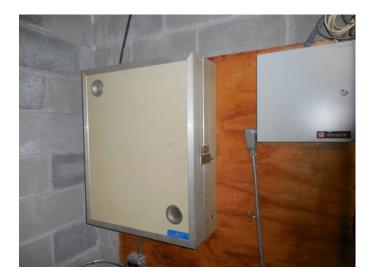
System: D3060 - Controls & Instrumentation

Location: Throughout Building

Distress: Beyond Service Life

Notes: The controls and instrumentation system is beyond its expected service life and should be scheduled for replacement.

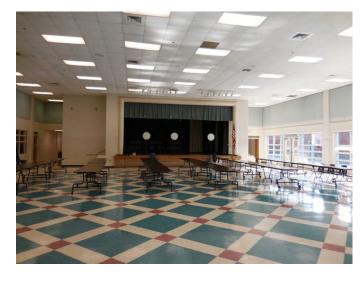
System: D5020 - Lighting

Location: Throughout Building

Distress: Inadequate

Notes: The lighting system is original with T-12 bulbs and should be scheduled for replacement with more energy efficient fixtures.

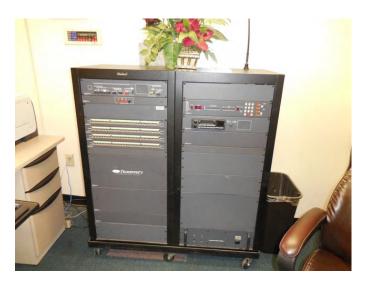
System: D5030 - Communications and Security - Clock & PA Systems

Location: Throughout Building

Distress: Beyond Service Life

Notes: Clock and PA systems are beyond their expected service life and should be scheduled for replacement. Staff reports that systems have stopped working on several occasions.

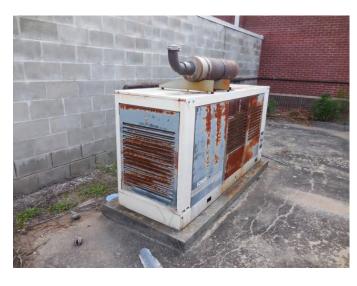
System: D5090 - Other Electrical Systems - Emergency Generator

Location: Outside Mechanical Room

Distress: Beyond Service Life

Notes: The emergency generator is beyond its expected service life, has had several reported maintenance breakdowns, is rusted, and should be scheduled for replacement. SPLOST project 317-422 to replace the emergency generator.

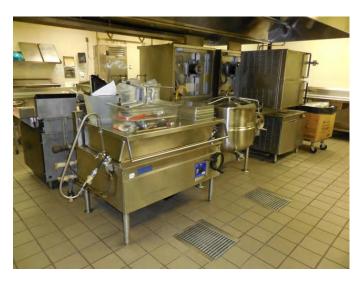
System: E1090 - Other Equipment - Kitchen Equipment

Location: Kitchen

Distress: Beyond Service Life

Notes: Kitchen equipment is beyond its expected service life and should be scheduled for replacement.

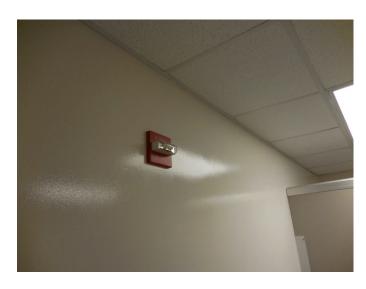
System: D5030 - Communications and Security - Fire Alarm

Location: Throughout Building

Distress: Needs Remediation

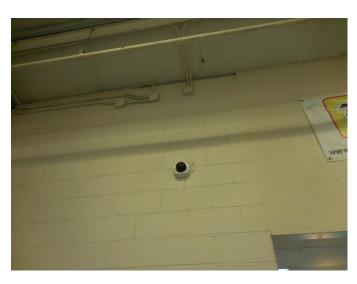
System: D5030 - Communications and Security - Security & CCTV

Location: Throughout Building

Distress: Inadequate

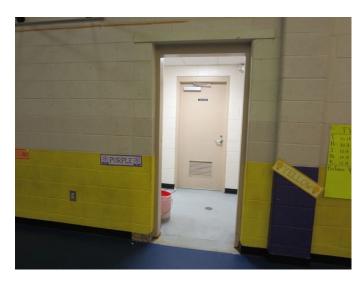
System: C3010 - Wall Finishes - Paint

Location: Throughout Building

Distress: Beyond Service Life

Notes: The painted wall finishes are beyond their expected service life, faded and stained, and should be replaced.

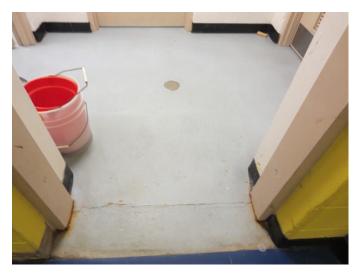
System: C3020 - Floor Finishes - Epoxy

Location: Restrooms

Distress: Beyond Service Life

Notes: The epoxy flooring is aged, cracked and worn, and should be replaced.

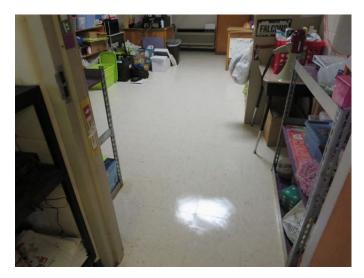
System: C3020 - Floor Finishes - VCT

Location: Entrance Area and Offices

Distress: Beyond Service Life

Notes: The VCT flooring has some deterioration due to age and use and should be replaced.

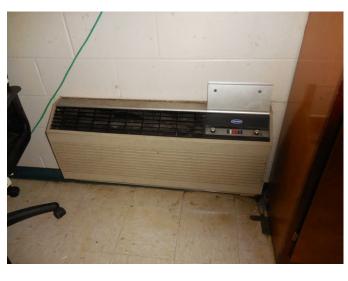
System: D3050 - Terminal & Package Units

Location: Throughout Building

Distress: Inadequate

Notes: One PTAC AC unit is located in the office area of the gym. It is beyond its expected service life and should be scheduled for replacement. The main gym area does not have air conditioning and it should be provided. SPLOST project 317-422 to install a 20-ton HVAC package in the gym.

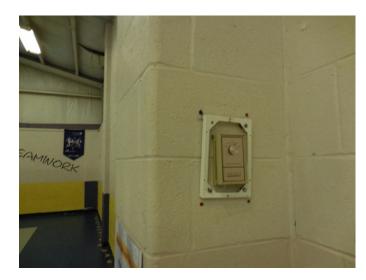
System: D3060 - Controls & Instrumentation

Location: Throughout Building

Distress: Beyond Service Life

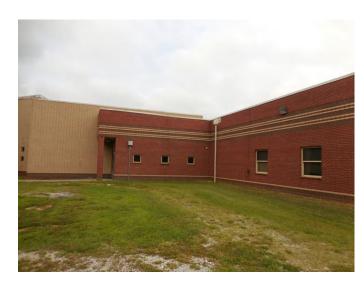
System: G4030 - Site Communications & Security

Location: Site

Distress: Inadequate

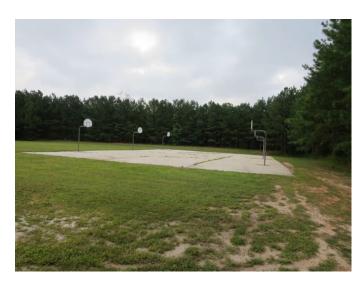
System: G2040 - Hard Surface Play Area

Location: Site

Distress: Beyond Service Life

Notes: The hard surface play area is beyond its expected service life, damaged with cracks, and should be replaced. Basketball goals are also damaged and should be replaced.

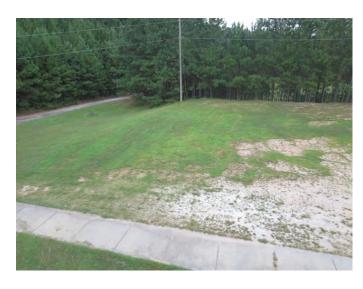
System: G2040 - Playing Field

Location: Site

Distress: Beyond Service Life
