DeKalb County School District/High Schools

Martin Luther King Jr. High

School Assessment Report

May 19, 2016

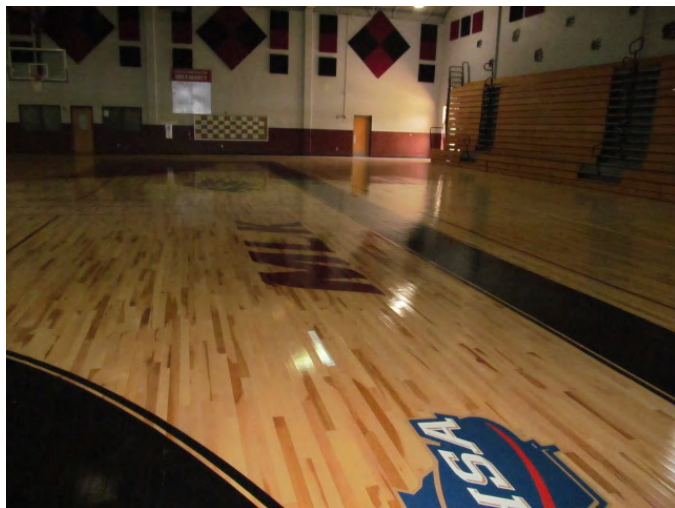
System: C3020 - Floor Finishes - Wood

Location: Gym

Distress: Damaged

Notes: The gym floor is uneven and should be repaired or replaced.

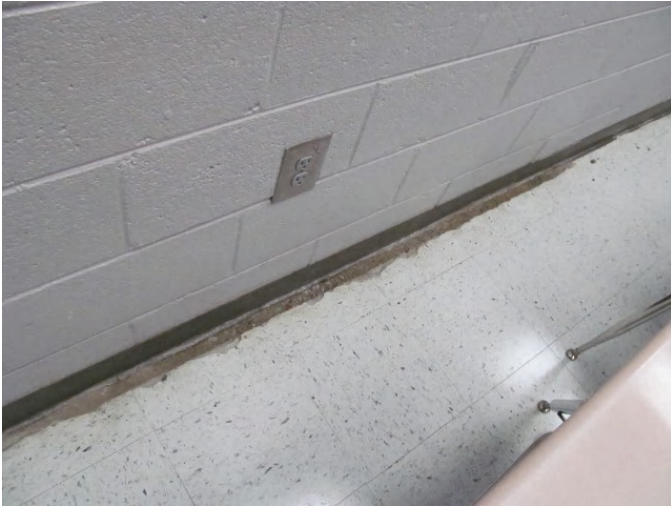
System: A1010 - Standard Foundations

Location: South Wall of Old Building

Distress: Damaged

Notes: The south wall of the building is pulling away from the upper floor and has many cracks along the floor and up the wall in multiple locations. An engineering study is recommended to determine the cause. Deficiency pricing does not include remediation measures. SPLOST project 316-422 to repair the horizontal roof expansion joints and exterior wall vertical expansion joints.

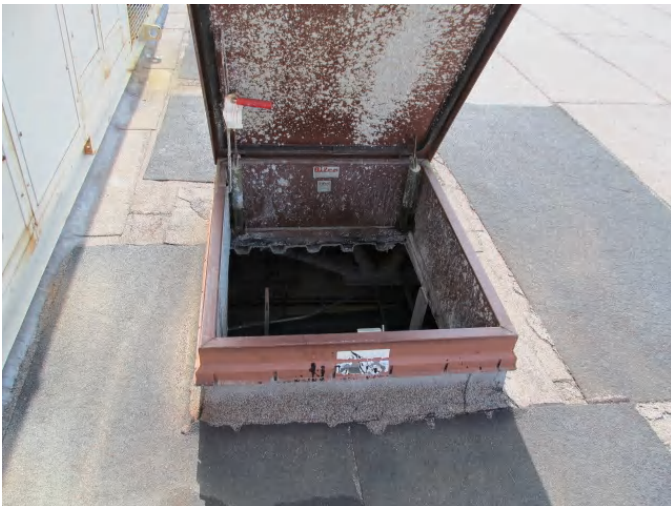
System: B3020 - Roof Openings

Location: Roof

Distress: Damaged

Notes: The roof access hatch is not safe and the ladder is loose and the skylights are reported to leak. Replace the roof hatch and skylights.

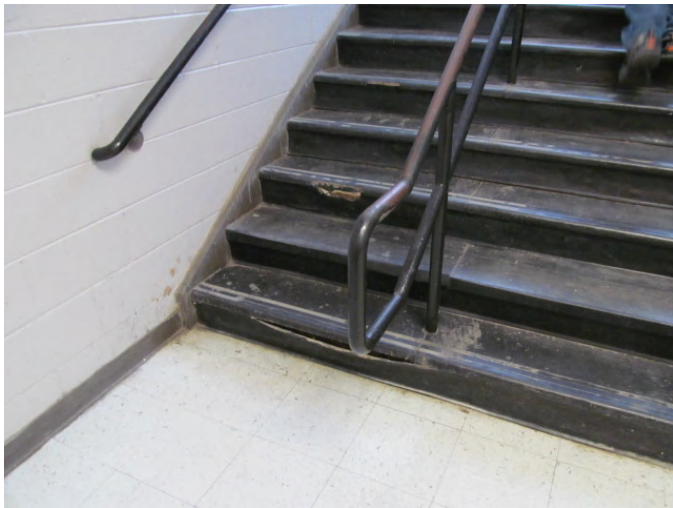
System: C2010 - Stair Construction

Location: Throughout Building

Distress: Damaged

Notes: The stairs are damaged, failing early, showing signs of crumbling concrete in places, and are tripping hazards that should be repaired.

Correction: Replace stairs (\$2.05/sf)

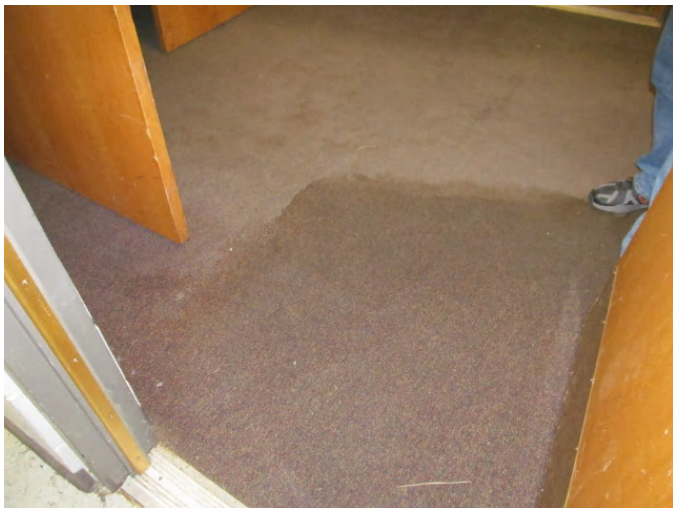
System: C3020 - Floor Finishes - Carpet

Location: Throughout Building

Distress: Beyond Service Life

Notes: The carpet is beyond its expected service life, damaged and has trip hazards, and should be replaced.

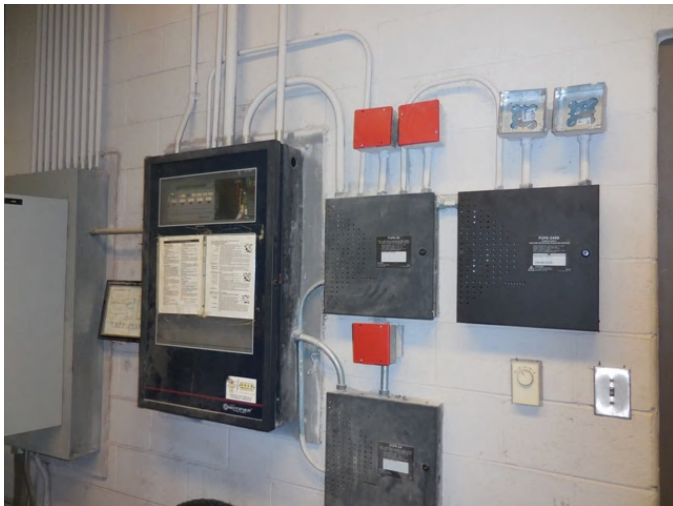
System: D5030 - Communications and Security - Fire Alarm

Location: Throughout Building

Distress: Inadequate

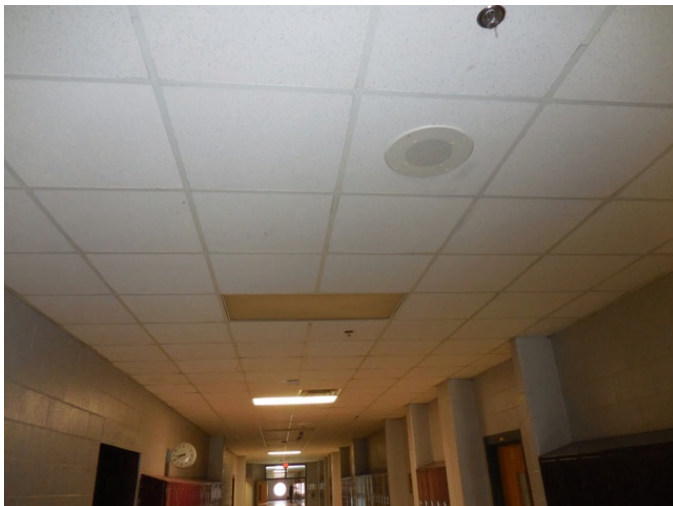
System: D5030 - Communications and Security - PA & Clock Systems

Location: Throughout Building

Distress: Needs Remediation

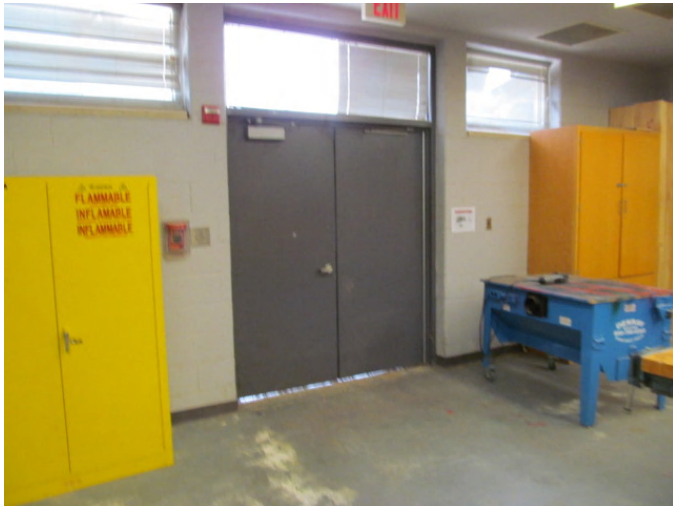
System: B2030 - Exterior Doors

Location: Throughout Building

Distress: Damaged

Notes: The exterior doors are reported to leak, open from the outside when pulled hard, and should be replaced.

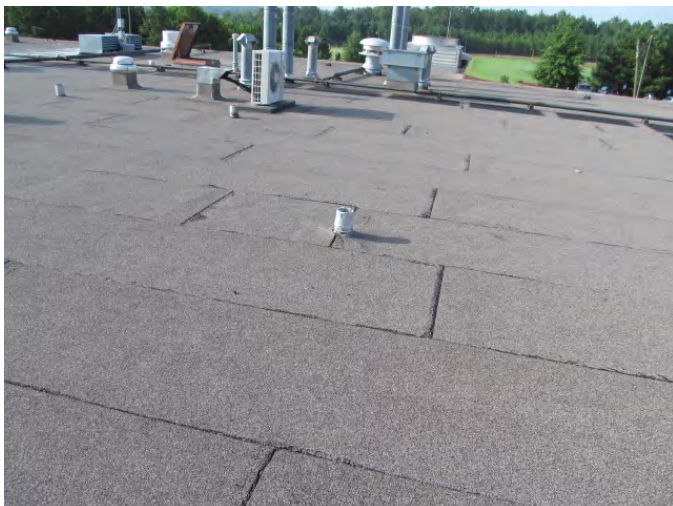
System: B3010 - Roof Coverings - BUR

Location: Roof

Distress: Damaged

Notes: The roof covering is failing early and should be replaced. It has reported leaks over gym and cafeteria, multiple soft and spongy spots, and multiple bubbles that appear cracked.

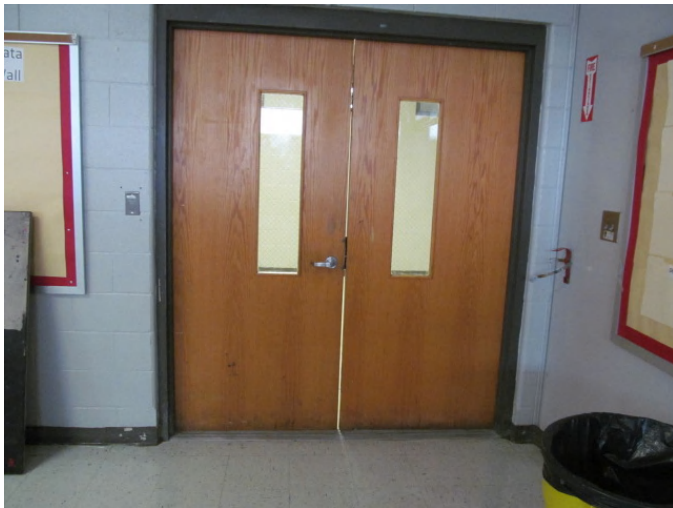
System: C1020 - Interior Doors

Location: Throughout Building

Distress: Damaged

Notes: The interior doors are damaged, are hard to open and close, are failing early, and should be replaced.

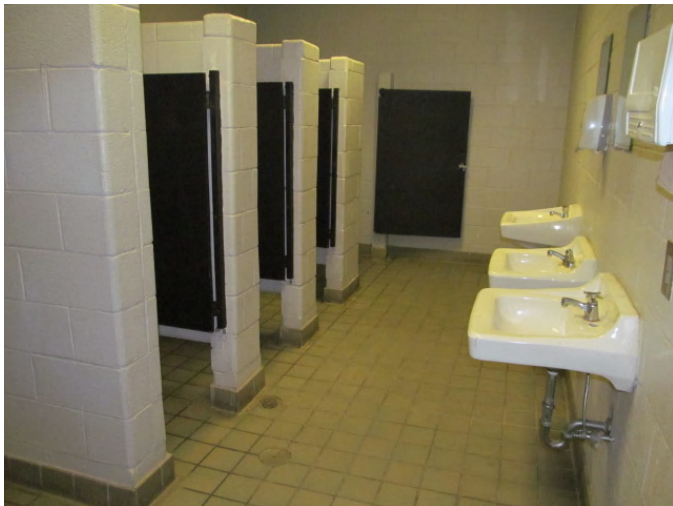
System: C1030 - Fittings

Location: Throughout Building

Distress: Beyond Service Life

Notes: Fittings, such as toilet partitions, handrails and signage, are beyond their expected service life, damaged and inadequate, and should be replaced. Rooms signs do not have raised characters and braille.

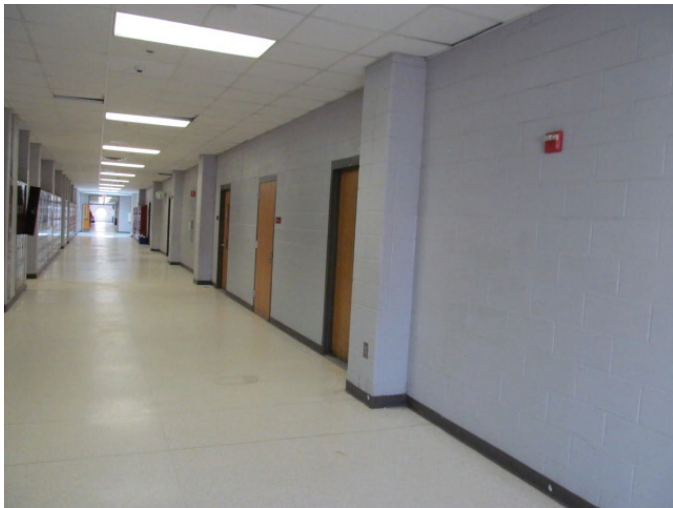
System: C3010 - Wall Finishes - Paint

Location: Throughout Building

Distress: Beyond Service Life

Notes: The painted wall finishes are beyond their expected service life and should be replaced.

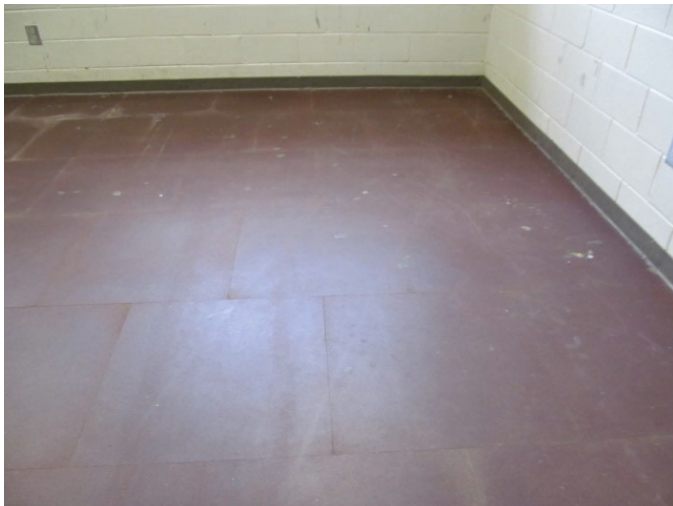
System: C3020 - Floor Finishes - Neoprene Flooring

Location: Wrestling Room

Distress: Damaged

Notes: The athletic floor covering is beyond its expected service life and should be replaced.

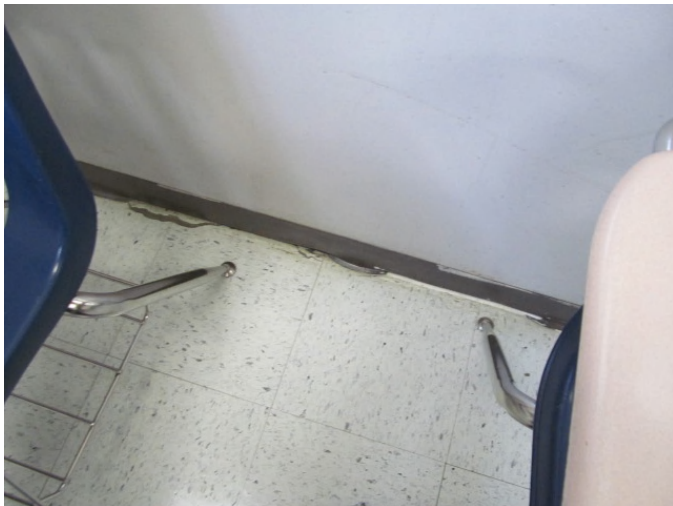
System: C3020 - Floor Finishes - VCT

Location: Throughout Building

Distress: Beyond Service Life

Notes: The VCT flooring is failing early and should be replaced.

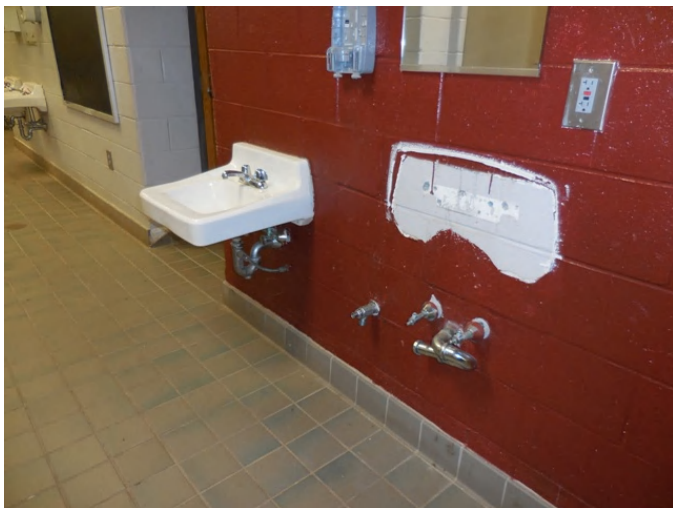
System: D2010 - Plumbing Fixtures

Location: Throughout Building

Distress: Damaged

Notes: Plumbing fixtures are broken, loose, missing or stained, not ADA compliant, and should be scheduled for replacement.

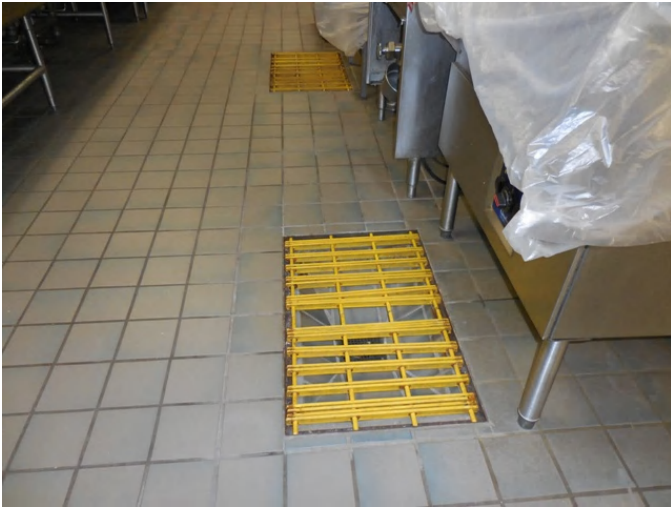
System: D2030 - Sanitary Waste

Location: Throughout Building

Distress: Needs Remediation

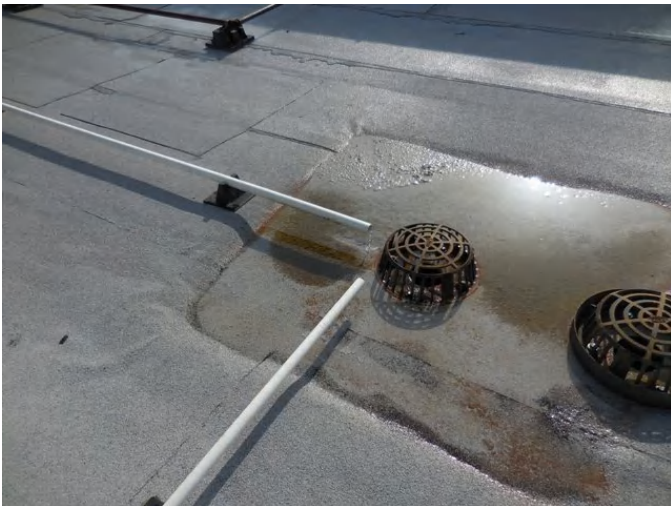
System: D2040 - Rain Water Drainage

Location: Throughout Building

Distress: Inadequate

Notes: Roof structure around the drains is inadequate. Ponding water sits around roof drain areas. The piping at ground level is disconnected and needs repair.

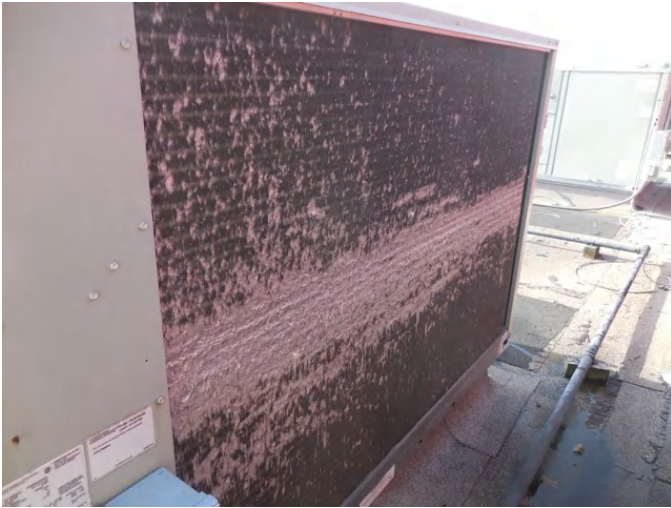
System: D3050 - Terminal & Package Units

Location: Roof

Distress: Damaged

Notes: Maintenance staff report that the roof top units constantly have mechanical issues. HRUs, RTUs, and heat pumps coils are corroded or damaged. Units are nearing the end of their expected service life and should be scheduled for replacement. SPLOST project 316-422 to replace roof top units over gym.

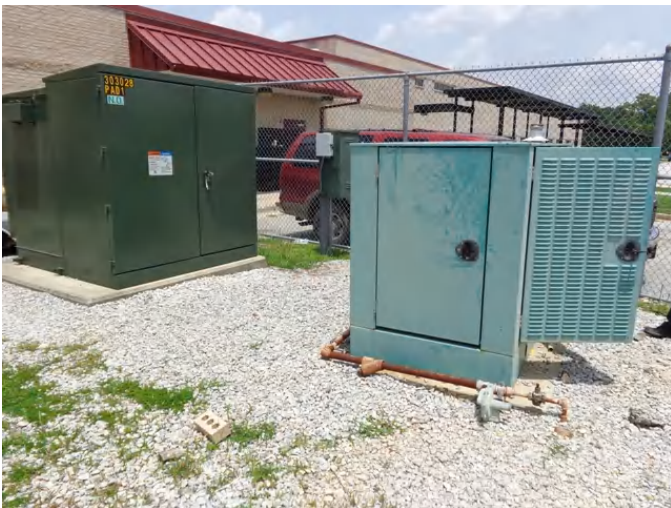
System: D5090 - Other Electrical Systems - Emergency Generator

Location: Outside Mechanical Room

Distress: Damaged

Notes: Staff reports that the generator is constantly down for repairs. The generator was out of service during the 2015 facility assessment.

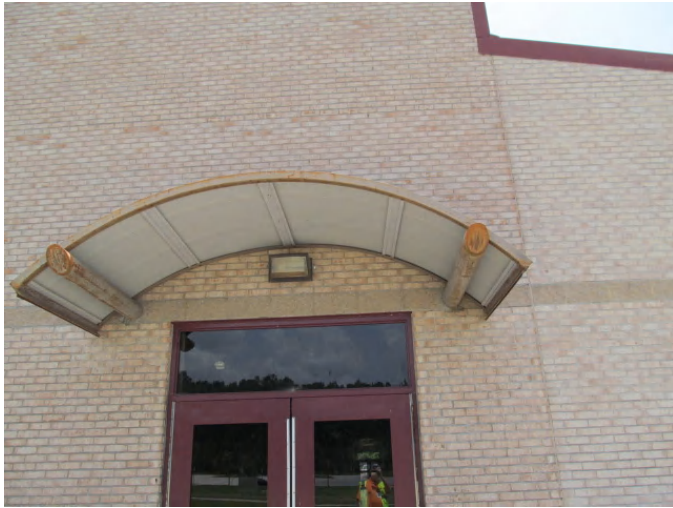
System: F1010 - Special Structures - Canopies

Location: Building Exterior

Distress: Damaged

Notes: The canopies are rusted, damaged, and should be renovated/replaced.

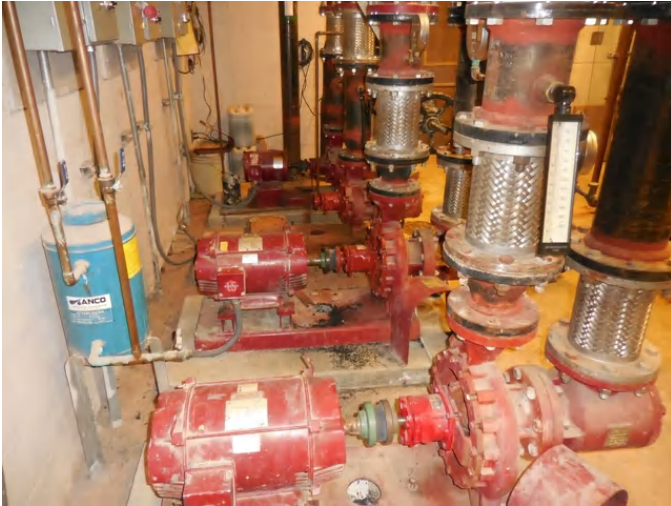
System: D3020 - Heat Generating Systems

Location: Mechanical Room

Distress: Damaged

Notes: The circulation pumps and boiler show signs of heavy wear. The boiler is rusted and dented. Pump motors are subject to heavy use.

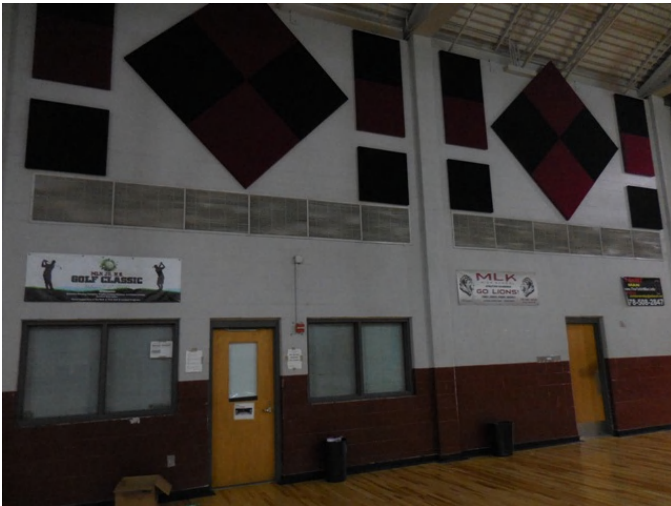
System: D3040 - Distribution Systems & Exhaust Systems

Location: Throughout Building

Distress: Damaged

Notes: The exhaust fans and duct system are damaged and dirty throughout the building. SPLOST project 316-422 to replace duct system exhaust fans.

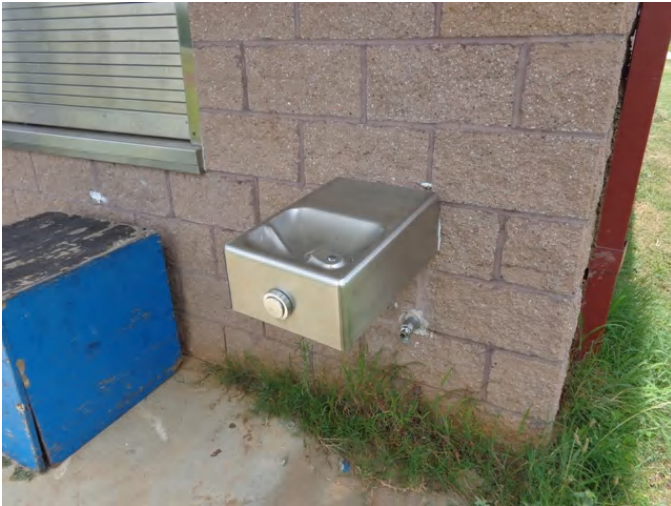
System: D2010 - Plumbing Fixtures

Location: Throughout Building

Distress: Damaged

Notes: The plumbing fixtures are damaged and should be replaced.

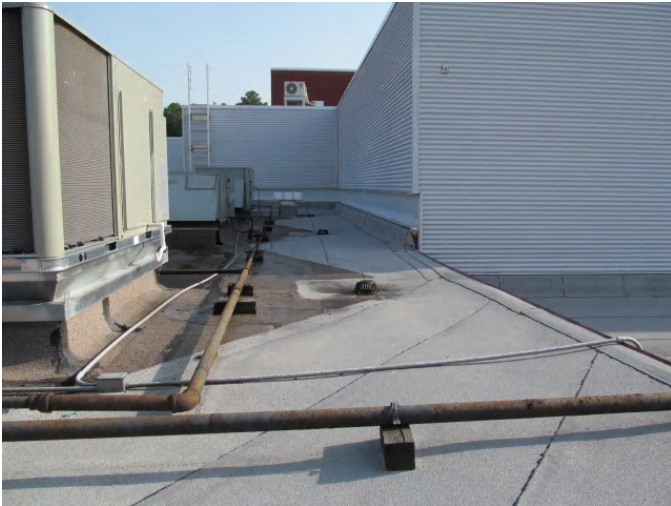
System: B2010 - Exterior Walls

Location: Roof

Distress: Inadequate

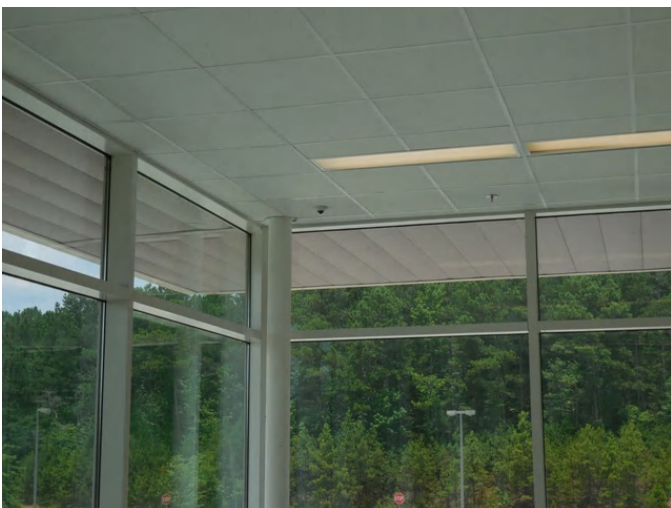
System: D5030 - Communications and Security - Security & CCTV

Location: Throughout Building

Distress: Inadequate
