DeKalb County School District/Elementary Schools

Midvale Elementary

School Assessment Report
May 19, 2016

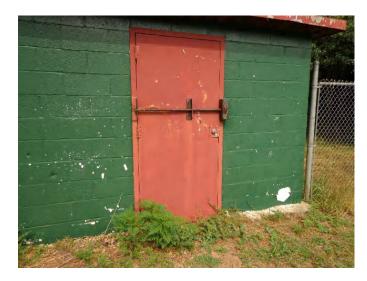
System: B2030 - Exterior Doors

Location: Exterior Wall

Distress: Beyond Service Life

Notes: The original exterior doors are aged, rusted, and should be replaced.

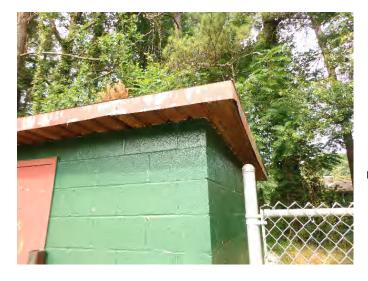
System: B3010 - Roof Coverings

Location: Roof

Distress: Beyond Service Life

Notes: The built-up roof covering is aged, showing signs of failure, and should be replaced.

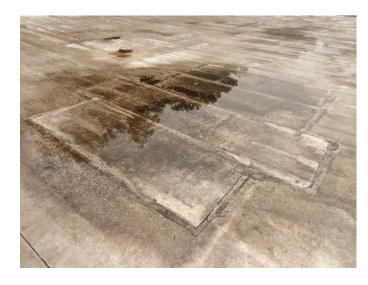
System: B3010 - Roof Coverings - EPDM

Location: Roof

Distress: Needs Remediation

Notes: The low-slope roof deck is not adequate for rain water to drain toward roof drains, creating ponding and eventually seeping into the building. Provide effective cricket design in areas between the drain and the wall where it is low and collects water.

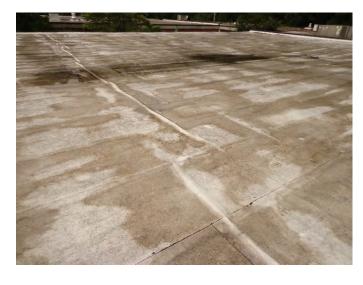
System: B3010 - Roof Coverings - EPDM

Location: Roof

Distress: Needs Remediation

Notes: Roof covering was replaced in 2010. However, there is a crease on the north side where there is a need of an expansion joint on the roof covering before further bubbling or tear of the roof membrane.

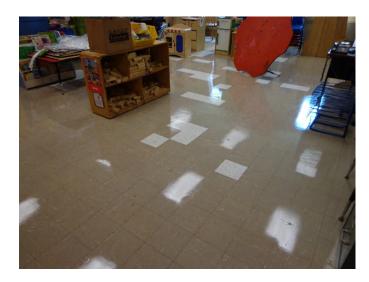
System: C3020 - Floor Finishes - VCT

Location: Throughout Building

Distress: Beyond Service Life

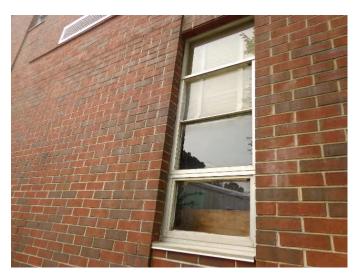
System: B2020 - Exterior Windows

Location: Throughout Building

Distress: Beyond Service Life

Notes: The aluminum frame, operable, single pane windows are aged, not energy efficient, and should be replaced.

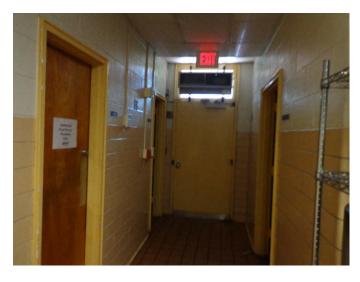
System: B2030 - Exterior Doors

Location: Throughout Building

Distress: Beyond Service Life

Notes: The original exterior doors are aged, rusted, and should be replaced. The exterior door in the kitchen opens in opposite direction of egress and should be replaced and include panic hardware.

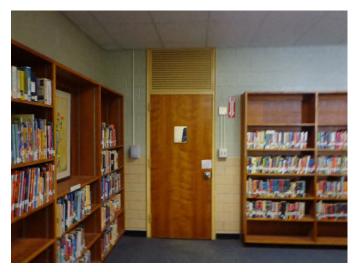
System: C1020 - Interior Doors

Location: Throughout Building

Distress: Beyond Service Life

Notes: The interior doors are aged, failing, not ADA or building code compliant, and should be replaced. Some interior doors open in the opposite direction of egress and they should be revised to comply with code. Some door openings are not 32 inches clear.

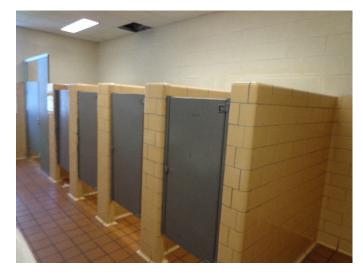
System: C1030 - Fittings

Location: Throughout Building

Distress: Beyond Service Life

Notes: Fittings, such as toilet partitions, handrails and signage, are beyond their expected service life, not ADA compliant, and should be replaced. Handrails at stairs are not building code compliant. Many, but not all of the toilet partitions were replaced in 2014.

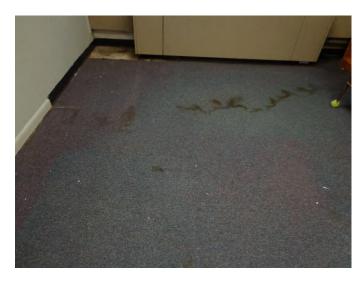
System: C3020 - Floor Finishes - Carpet

Location: Throughout Building

Distress: Beyond Service Life

Notes: The carpet in the principal's office was recently replaced. However, in most areas, the carpet is stained and torn, and should be replaced.

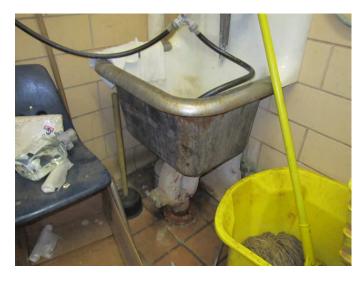
System: D2010 - Plumbing Fixtures

Location: Throughout Building

Distress: Beyond Service Life

Notes: ADA-compliant restrooms were installed in 2013; however, the remainder of the plumbing fixtures are beyond their expected service life and should be scheduled for replacement.

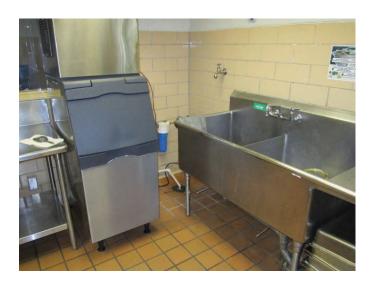
System: D2020 - Domestic Water Distribution

Location: Throughout Building

Distress: Beyond Service Life

Notes: The domestic water distribution system is beyond its expected service life, aged, and should be scheduled for replacement.

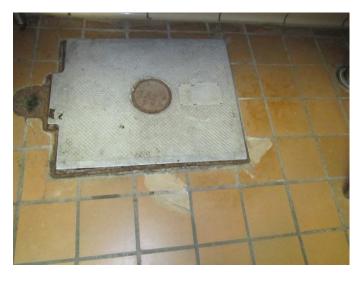
System: D2030 - Sanitary Waste

Location: Throughout Building

Distress: Beyond Service Life

Notes: The sanitary waste system is beyond its expected service life and should be scheduled for replacement.

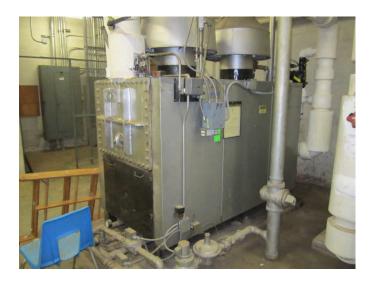
System: D2090 - Other Plumbing Systems - Natural Gas

Location: Throughout Building

Distress: Beyond Service Life

Notes: The natural gas system is beyond its expected service life and should be scheduled for replacement.

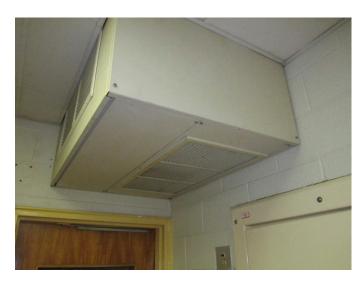
System: D3040 - Distribution & Exhaust Systems

Location: Throughout Building

Distress: Beyond Service Life

Notes: The distribution and exhaust systems are beyond their expected service life and should be scheduled for replacement.

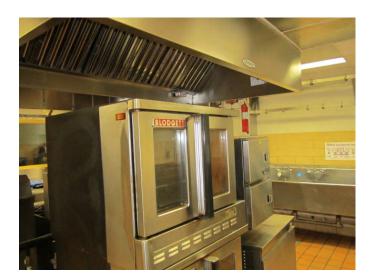
System: D3090 - Other HVAC Systems/Equip - Kitchen Hood

Location: Kitchen

Distress: Beyond Service Life

Notes: The kitchen hood system is beyond its expected service life, aged, and should be scheduled for replacement.

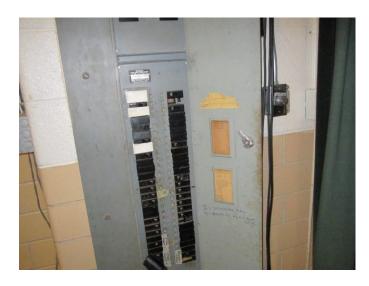
System: D5020 - Branch Wiring

Location: Throughout Building

Distress: Beyond Service Life

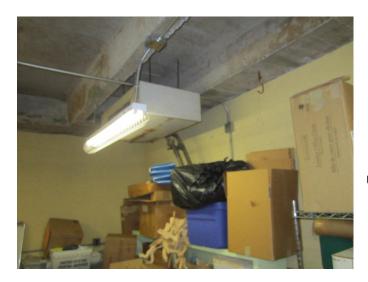
System: D5020 - Lighting

Location: Throughout Building

Distress: Beyond Service Life

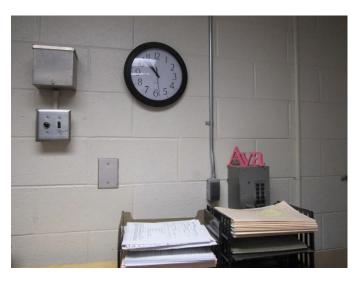
System: D5030 - Communications and Security - Clock & PA Systems

Location: Throughout Building

Distress: Beyond Service Life

Notes: Clock and PA systems are beyond their expected service life, aged, and should be scheduled for replacement.

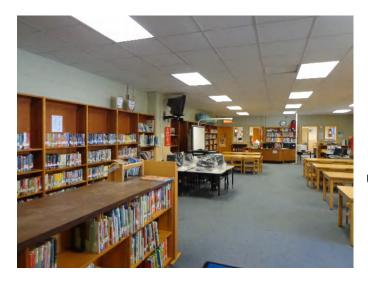
System: E1020 - Institutional Equipment

Location: Throughout Building

Distress: Beyond Service Life

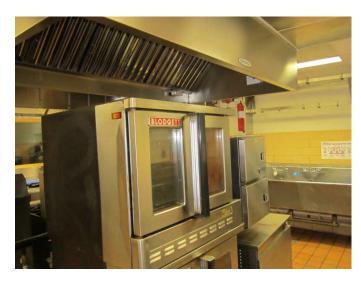
System: E1090 - Other Equipment - Kitchen Equipment

Location: Kitchen

Distress: Beyond Service Life

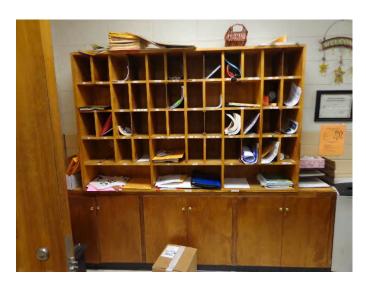
System: E2010 - Fixed Furnishings

Location: Throughout Building

Distress: Beyond Service Life

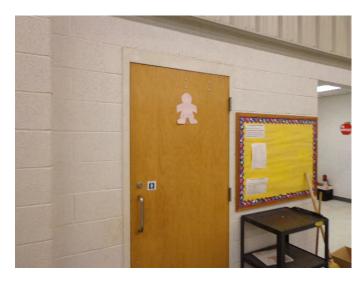
System: C1030 - Fittings

Location: Throughout Building

Distress: Missing

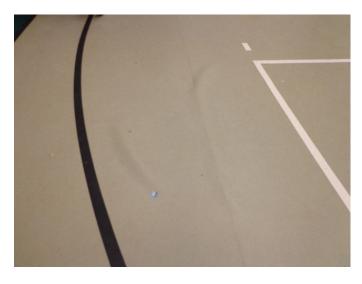
System: C3020 - Floor Finishes - Neoprene

Location: Basketball Court

Distress: Beyond Service Life

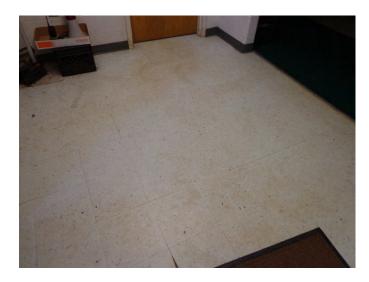
System: C3020 - Floor Finishes - VCT

Location: Entrance Area and Offices

Distress: Beyond Service Life

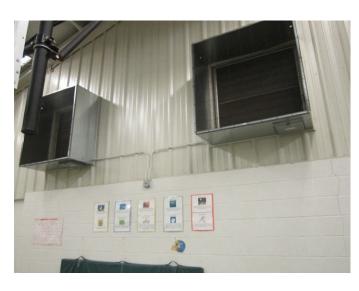
System: D3050 - Terminal & Package Units

Location: Gym

Distress: Missing

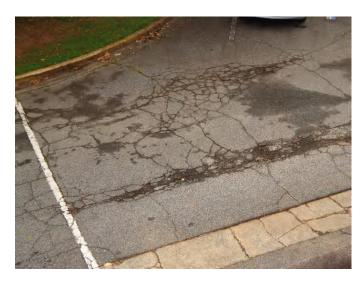
System: G2010 - Roadways

Location: Site

Distress: Beyond Service Life

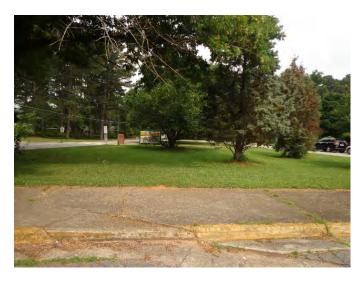
System: G2030 - Pedestrian Paving

Location: Site

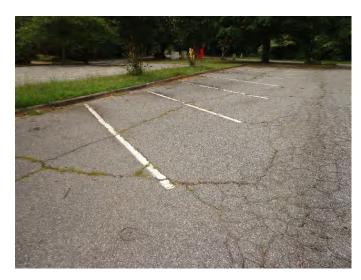
System: G2020 - Parking Lots

Location: Site

Distress: Beyond Service Life

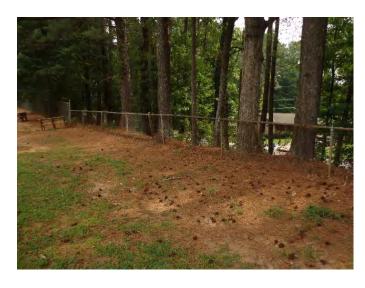
System: G2040 - Fencing & Guardrails

Location: Site

Distress: Beyond Service Life

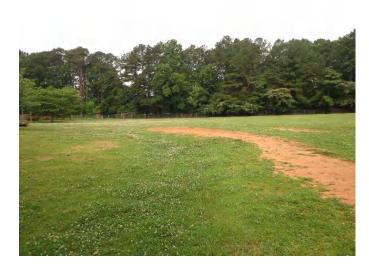
System: G2040 - Playing Field

Location: Site

Distress: Beyond Service Life

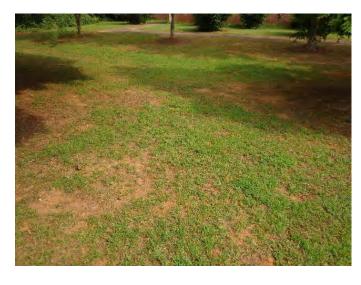
System: G2050 - Landscaping

Location: Site

Distress: Beyond Service Life

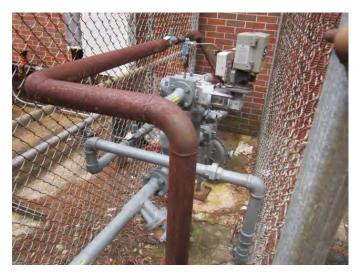
System: G3060 - Fuel Distribution

Location: Site

Distress: Beyond Service Life

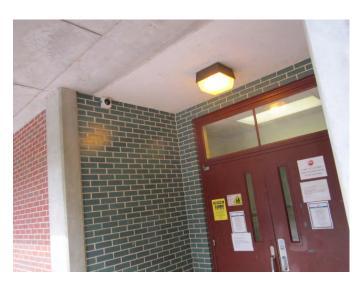
System: G4020 - Site Lighting

Location: Site

Distress: Beyond Service Life

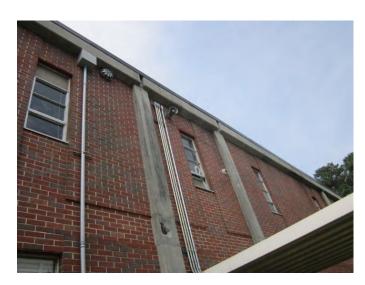
System: G4030 - Site Communications & Security

Location: Site

Distress: Beyond Service Life
