**DeKalb County School District/Middle Schools**

# **Miller Grove Middle**

## **School Assessment Report**

**May 20, 2016**

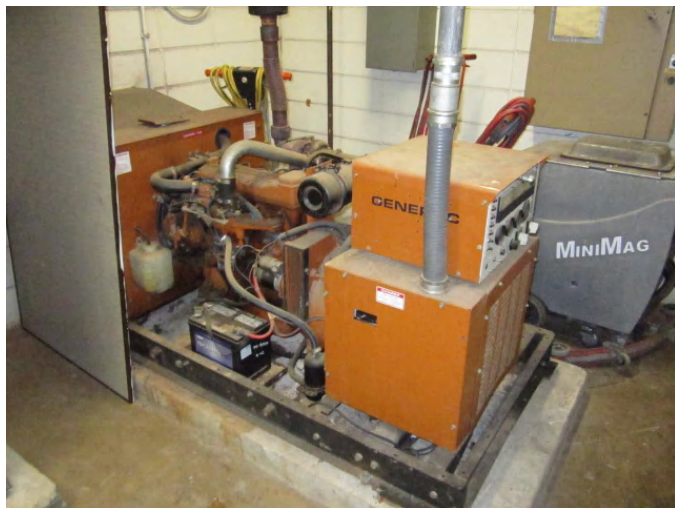
#### System: D5090 - Other Electrical Systems - Emergency Generator

**Location:** Throughout Building

**Distress:** Beyond Service Life

**Notes:** The emergency generator is beyond its expected service life and should be replaced. Current SPLOST project 122-422 to replace the emergency generator. There is also an inadequate number of emergency lights for safe egress from the building in case of loss of normal utility power.

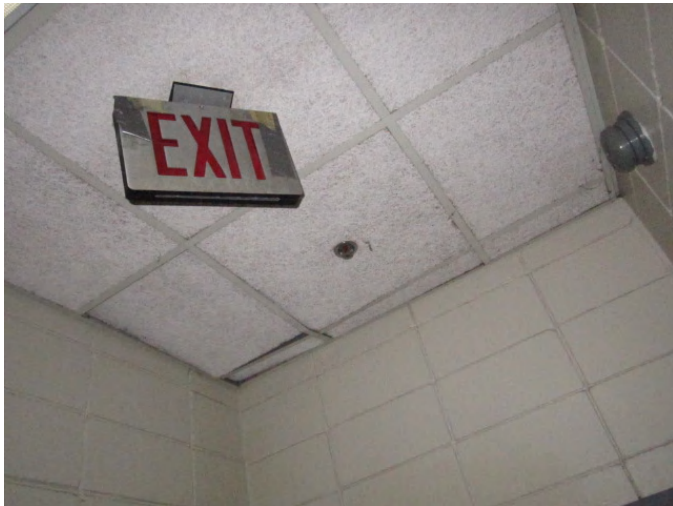
**System: D5020 - Lighting**

**Location:** Throughout Building

**Distress:** Beyond Service Life

**Notes:** The lighting system is beyond its expected service life, inadequate, and should be scheduled for replacement. A very large percentage of light fixtures do not function. A large number of exit signs do not function as well, which is a safety issue. SPLOST project 122-422 to replace ceilings and lighting.

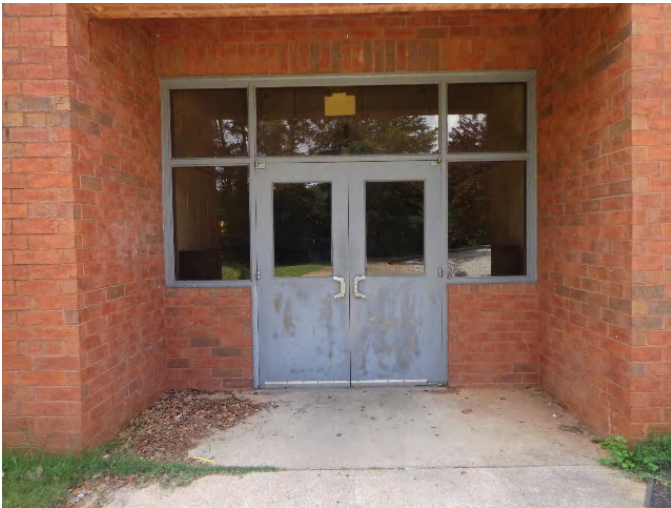
**System: B2030 - Exterior Doors**

**Location:** Throughout Building

**Distress:** Beyond Service Life

**Notes:** The original exterior doors are aged, damaged and not energy efficient, and should be replaced. Chains are currently used secure exterior doors after hours. SPLOST project 421-305 to provide ADA accessible entrance door and hardware.

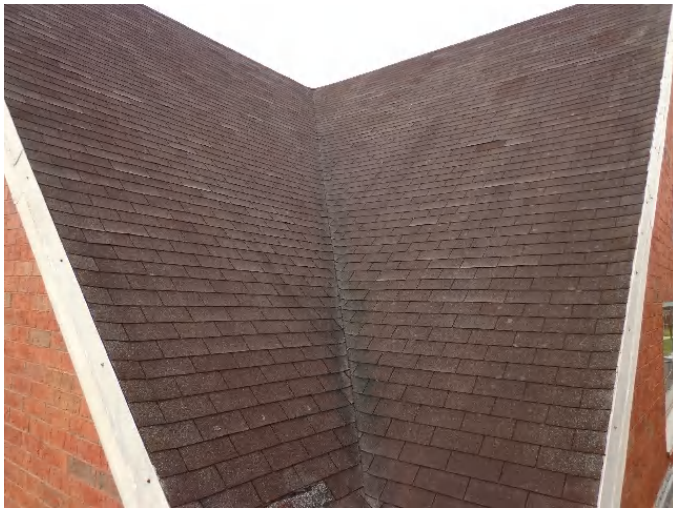
**System: B3010 - Roof Coverings - Asphalt Shingles**

**Location:** Roof  
**Distress:** Beyond Service Life  
**Category:** Deferred Maintenance  
**Priority:** 3 Priority  
**Correction:** Renew System  
**Qty:** 11,200.00  
**Unit of Measure:** S.F.  
**Estimate:** \$53,222.00  
**Assessor Name:** Ben Nixon  
**Date Created:** 06/05/2015

**Notes:** The asphalt shingle roofing is aged, damaged, and should be replaced.

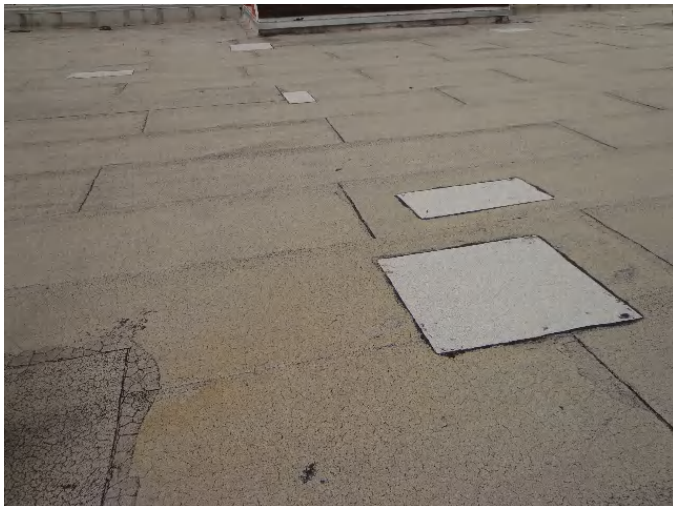
**System: B3010 - Roof Coverings - BUR**

**Location:** Roof  
**Distress:** Beyond Service Life  
**Category:** Deferred Maintenance / Energy  
**Priority:** 3 Priority  
**Correction:** Renew System  
**Qty:** 100,800.00  
**Unit of Measure:** S.F.  
**Estimate:** \$2,295,216.00  
**Assessor Name:** Ben Nixon  
**Date Created:** 06/05/2015

**Notes:** The built-up roof covering is in deteriorating condition, with cracks, bubbling, patches and reported water leaks throughout the building.

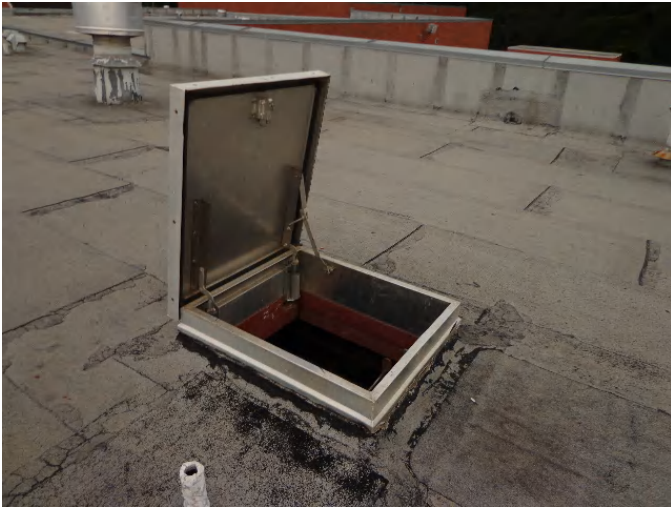
### **System: B3020 - Roof Openings**

**Location:** Roof

**Distress:** Beyond Service Life

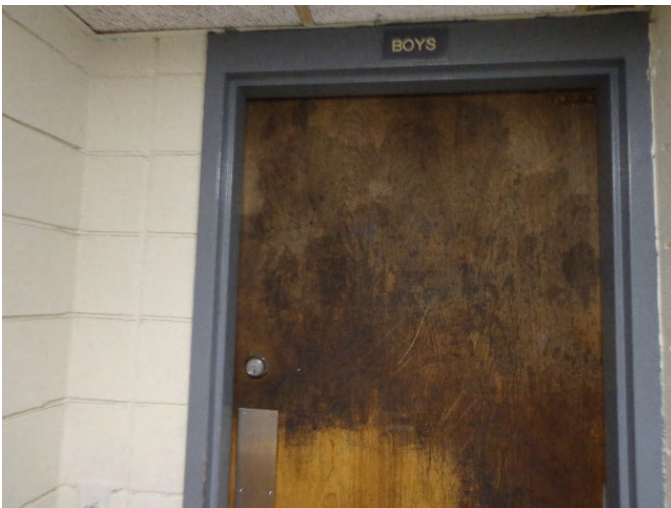
### **System: C1020 - Interior Doors**

**Location:** Throughout Building

**Distress:** Beyond Service Life

**Notes:** The interior doors are aged, failing, (hardware is) not ADA compliant, and should be replaced.

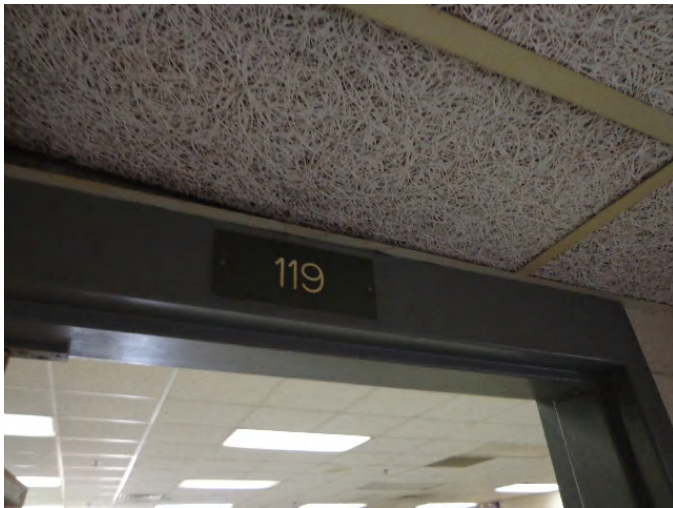
**System: C1030 - Fittings**

**Location:** Throughout Building

**Distress:** Inadequate

**Notes:** Room signage is not ADA compliant and should be replaced.

**Correction:** Remove and replace the signage w/ADA compliant signage.

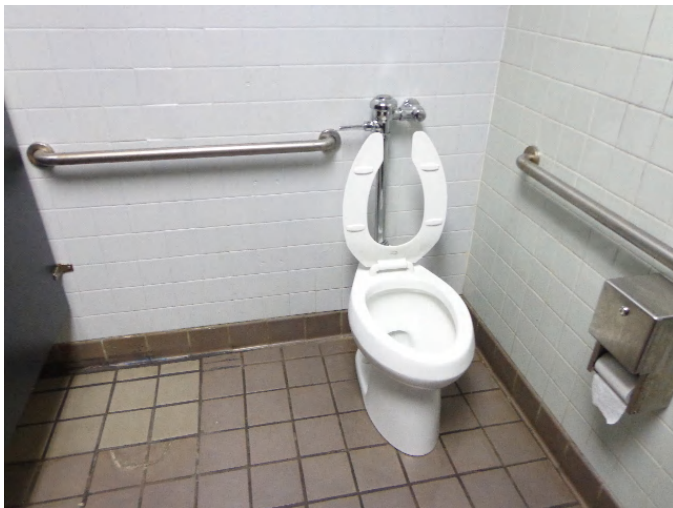
**System: C1030 - Fittings**

**Location:** Student Restrooms

**Correction:** Remove and replace grab bars w/ADA compliant grab bars.

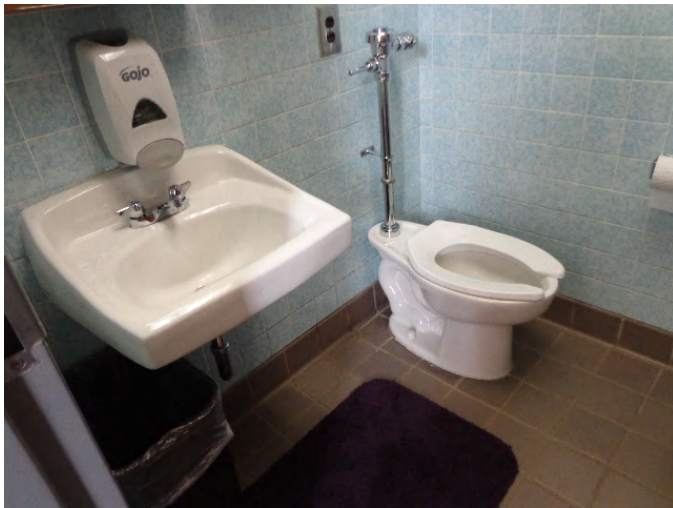
**System: C3010 - Wall Finishes - Ceramic & Glazed**

**Location:** Restrooms

**Notes:** The wall tiles are beyond their expected service life and should be scheduled for replacement.

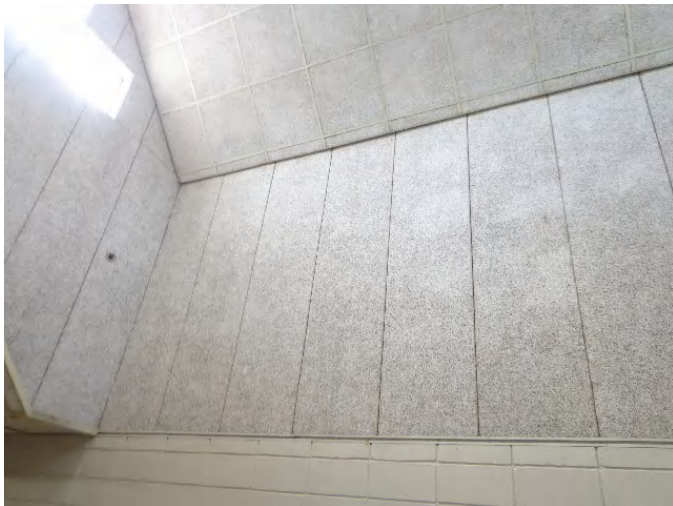
**System: C3010 - Wall Finishes - Tectum**

**Location:** Throughout Building

**Notes:** The Tectum panels are beyond expected service life and should be replaced/removed.

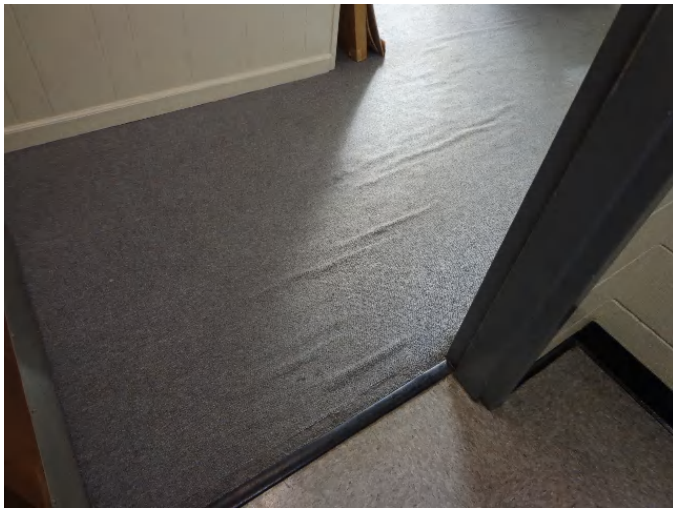
**System: C3020 - Floor Finishes - Carpet**

**Location:** Offices, Media Center, and Weight Room

**Notes:** The carpet is aged, stained, frayed and torn, and should be replaced.

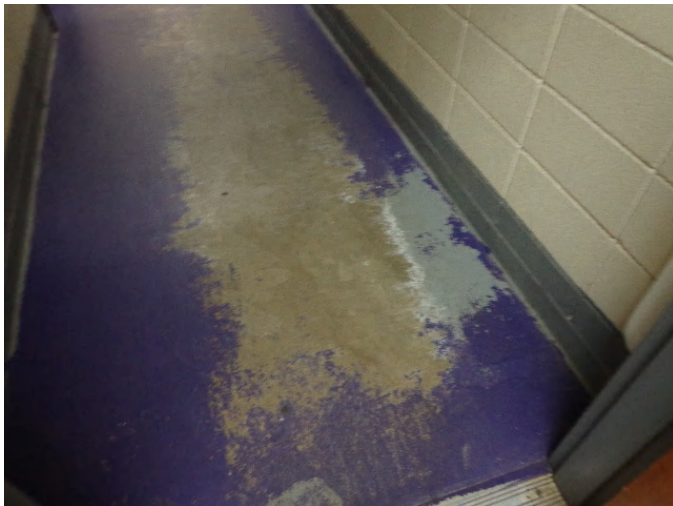
**System: C3020 - Floor Finishes - Epoxy**

**Location:** Locker Rooms

**Distress:** Damaged

**Notes:** The epoxy floor finish is showing signs of early failure and should be replaced.

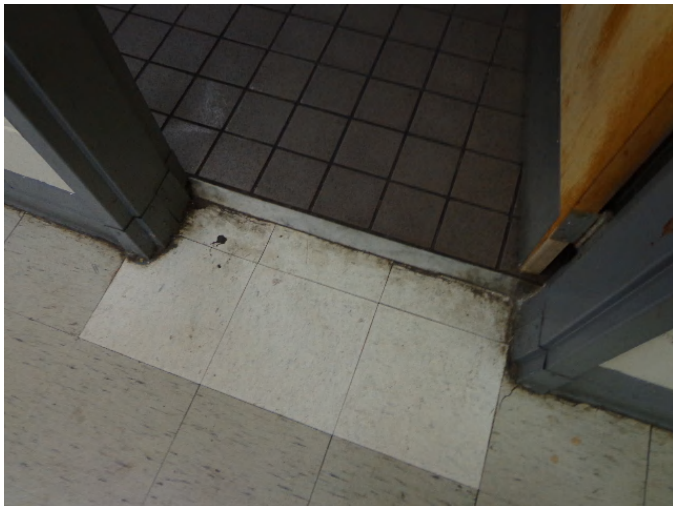
**System: C3020 - Floor Finishes - VCT**

**Location:** Throughout Building

**Notes:** The VCT is aged, patched and worn, and should be replaced.

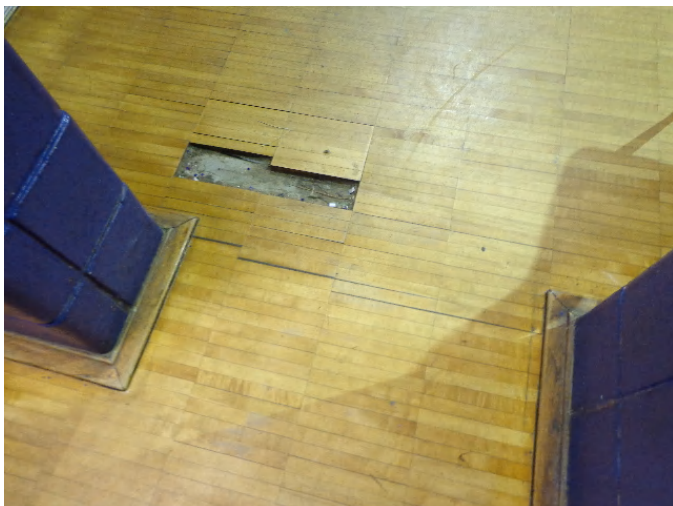
**System: C3020 - Floor Finishes - Wood**

**Location:** Gym

**Notes:** The wood floor is aged, cracked, chipped and worn, and should be replaced.

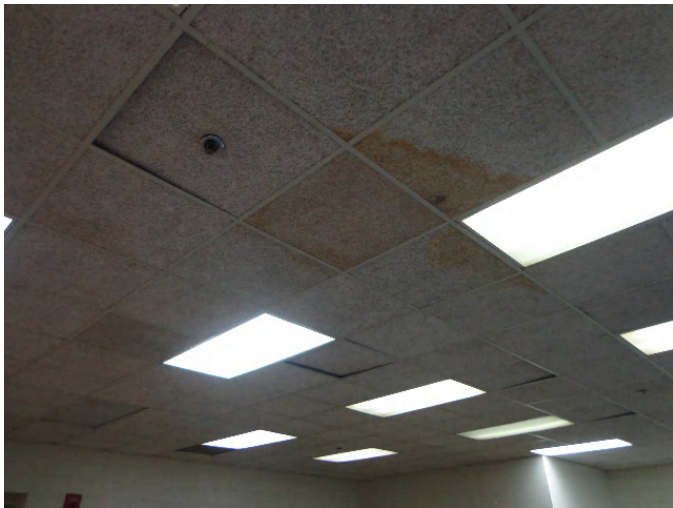
**System: C3030 - Ceiling Finishes**

**Location:** Throughout Building

**Notes:** The ceiling finishes are stained and damaged, failing in areas, and should be replaced. SPLOST project 122-422 to replace ceilings and lighting.

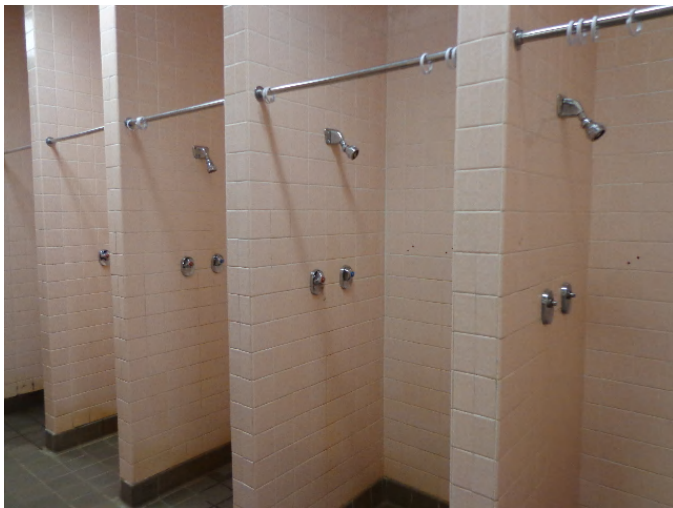
**System: D2010 - Plumbing Fixtures**

**Location:** Student Dressing Room

**Distress:** Missing

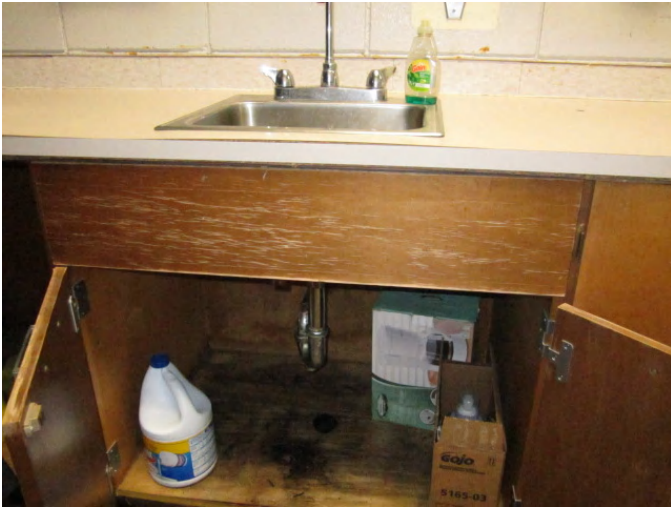
**System: D2020 - Domestic Water Distribution**

**Location:** Throughout Building  
**Distress:** Beyond Service Life  
**Category:** Deferred Maintenance  
**Priority:** 3 Priority  
**Correction:** Renew System  
**Qty:** 112,000.00  
**Unit of Measure:** S.F.  
**Estimate:** \$473,088.00  
**Assessor Name:** Ben Nixon  
**Date Created:** 04/11/2015

**Notes:** The domestic water distribution system is beyond its expected service life and should be scheduled for replacement.

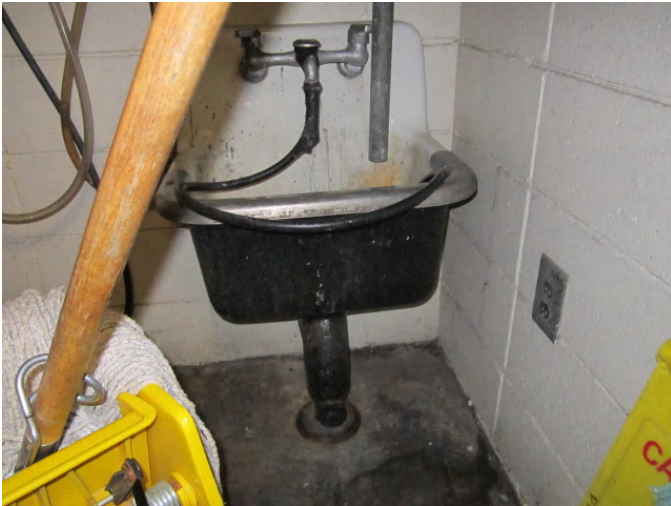
**System: D2030 - Sanitary Waste**

**Location:** Throughout Building  
**Distress:** Beyond Service Life  
**Category:** Deferred Maintenance  
**Priority:** 3 Priority  
**Correction:** Renew System  
**Qty:** 112,000.00  
**Unit of Measure:** S.F.  
**Estimate:** \$533,456.00  
**Assessor Name:** Ben Nixon  
**Date Created:** 04/11/2015

**Notes:** The sanitary waste system is beyond its expected service life and should be scheduled for replacement. School staff reports repeated instances of sewage backups into restrooms since the ADA upgrades to restrooms in 2014. SPLOST project 122-422 to upgrade the kitchen grease trap system.

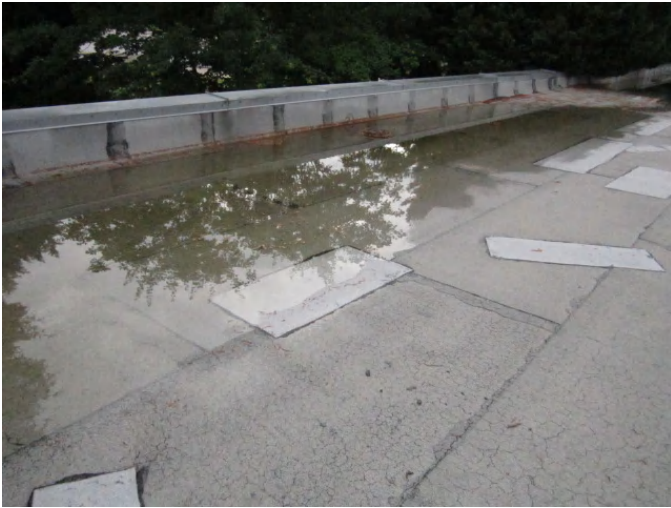
**System: D2040 - Rain Water Drainage**

**Location:** Roof

**Notes:** The rainwater drainage system is beyond its expected service life and should be scheduled for replacement. Many roof drains are clogged and there is standing water in large areas on the roof.

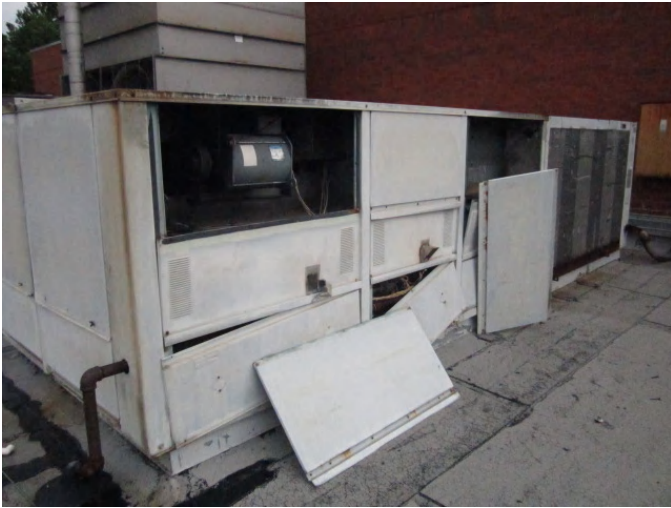
**System: D3050 - Terminal & Package Units**

**Location:** Roof

**Notes:** Terminal and package units are beyond their expected service life and should be scheduled for replacement. School staff report that the HVAC has not been reliable for a number of years. Rooftop units have been vandalized in 2014. White mastic on fiberglass pipe insulation is identified as ACM by others. SPLOST project 122-422 to replace the HVAC systems.

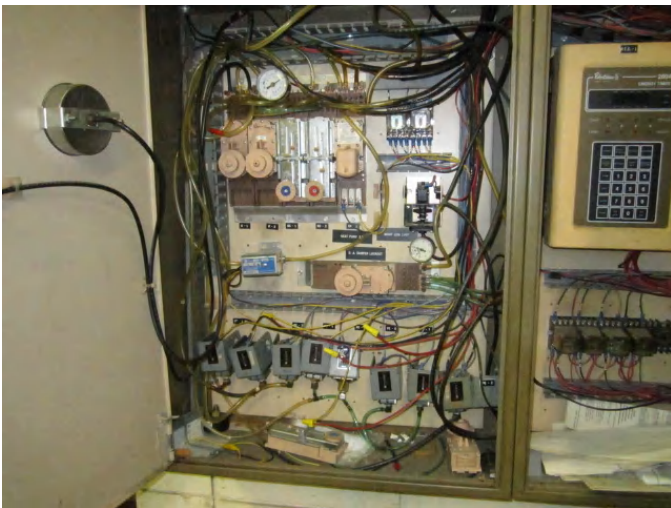
**System: D3060 - Controls & Instrumentation**

**Location:** Throughout Building

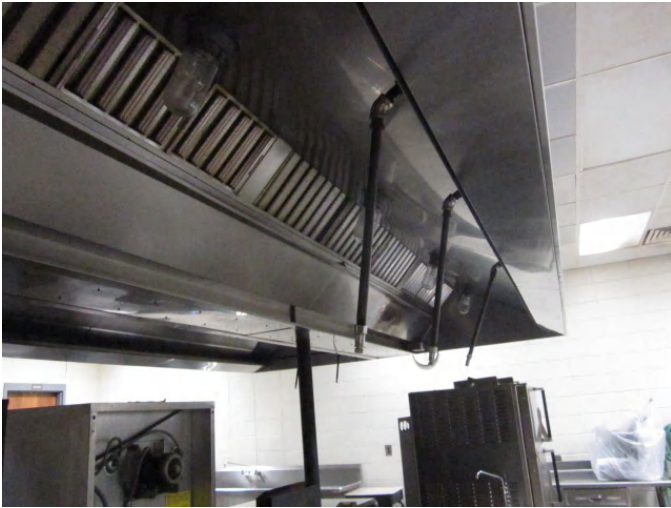
**System: D3090 - Other HVAC Systems/Equip - Kitchen Hood**

**Location:** Kitchen

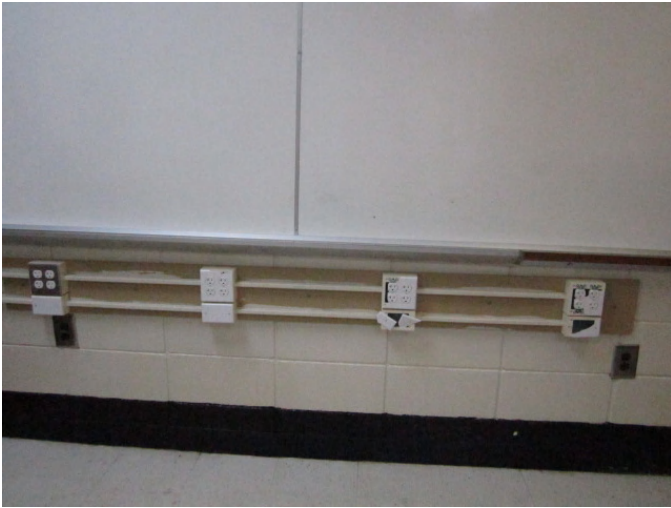
**System: D5020 - Branch Wiring**

**Location:** Throughout Building

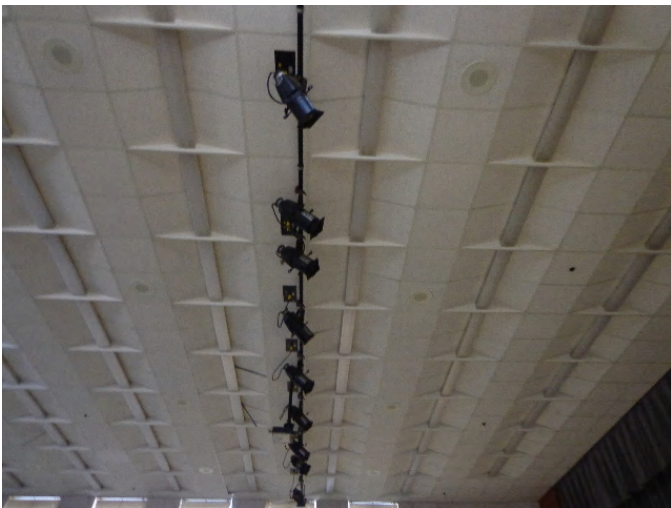
**System: E1020 - Institutional Equipment**

**Location:** Throughout Building

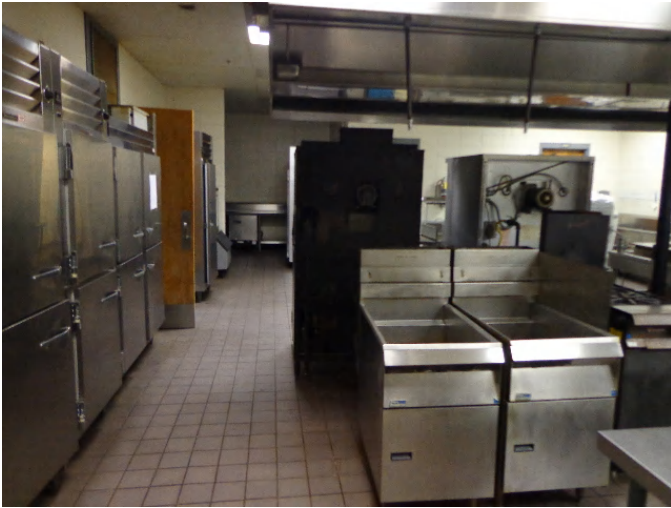
**System: E1090 - Other Equipment - Kitchen Equipment**

**Location:** Kitchen  
**Distress:** Beyond Service Life  
**Category:** Deferred Maintenance  
**Priority:** 3 Priority  
**Correction:** Renew System  
**Qty:** 112,000.00  
**Unit of Measure:** S.F.  
**Estimate:** \$564,256.00  
**Assessor Name:** Ben Nixon  
**Date Created:** 04/11/2015

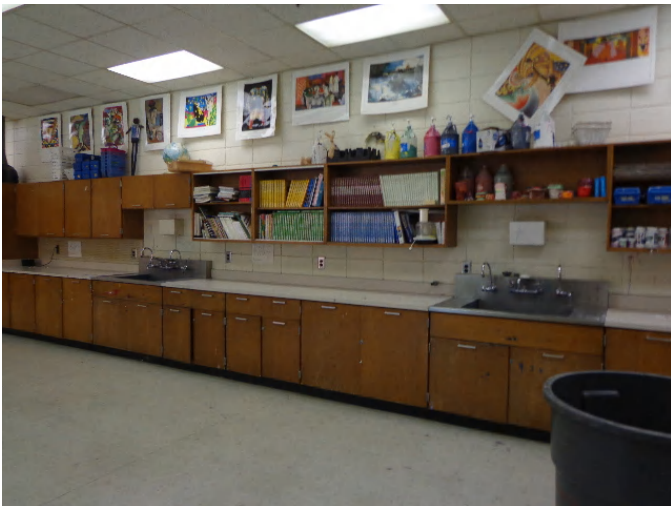
**System: E2010 - Fixed Furnishings**

**Location:** Throughout Building  
**Distress:** Beyond Service Life  
**Category:** Deferred Maintenance  
**Priority:** 3 Priority  
**Correction:** Renew System  
**Qty:** 112,000.00  
**Unit of Measure:** S.F.  
**Estimate:** \$809,424.00  
**Assessor Name:** Ben Nixon  
**Date Created:** 04/11/2015

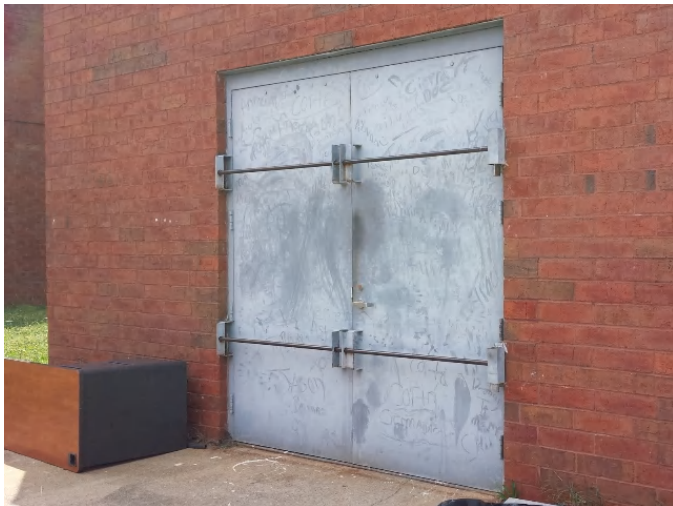
#### **System: B2030 - Exterior Doors**

**Location:** Exterior Wall

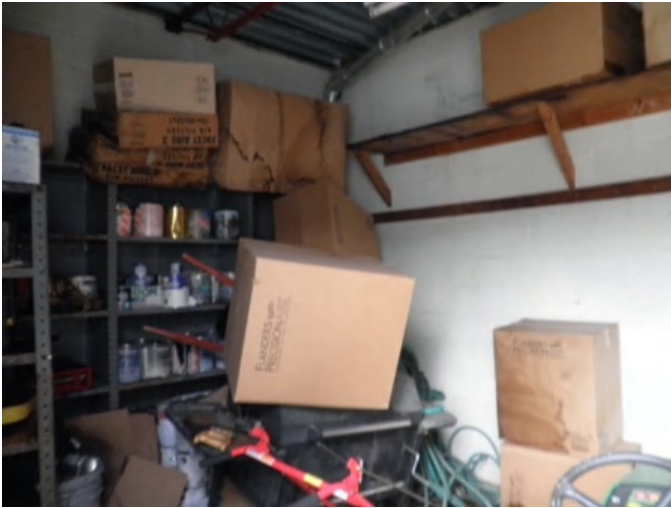
### **System: C3010 - Wall Finishes**

**Location:** Throughout Building

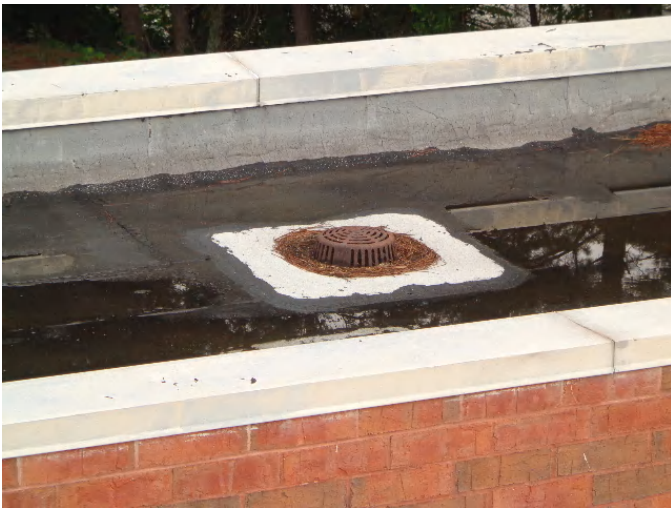
### **System: D2040 - Rain Water Drainage**

**Location:** Roof

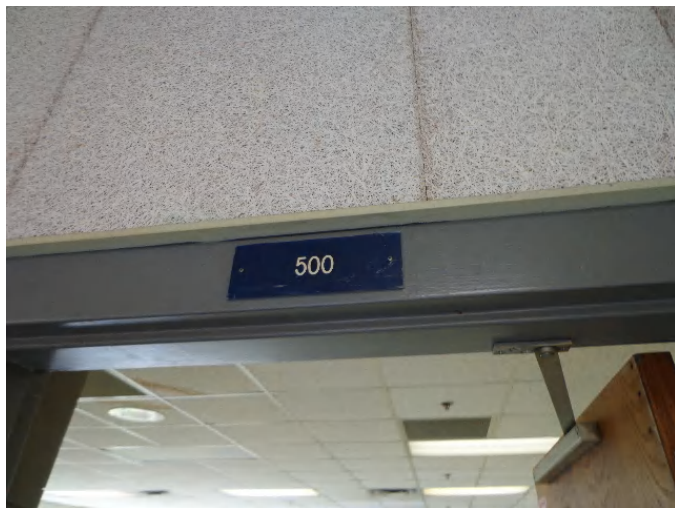
#### System: C1030 - Fittings

**Location:** Throughout Building

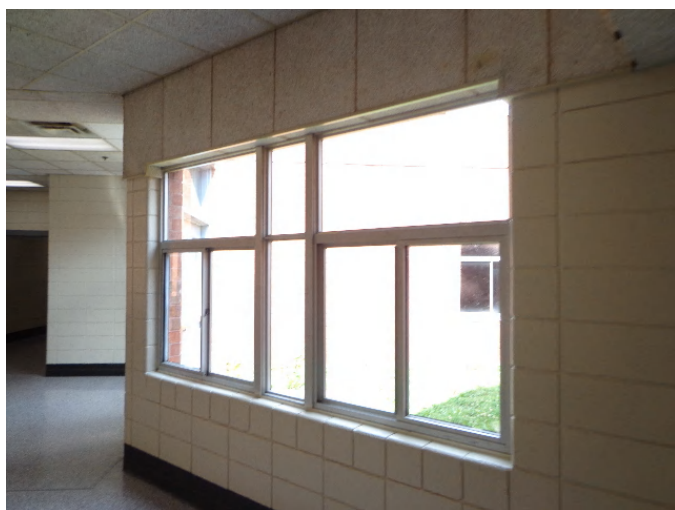
#### System: C3010 - Wall Finishes - Tectum

**Location:** Hallways

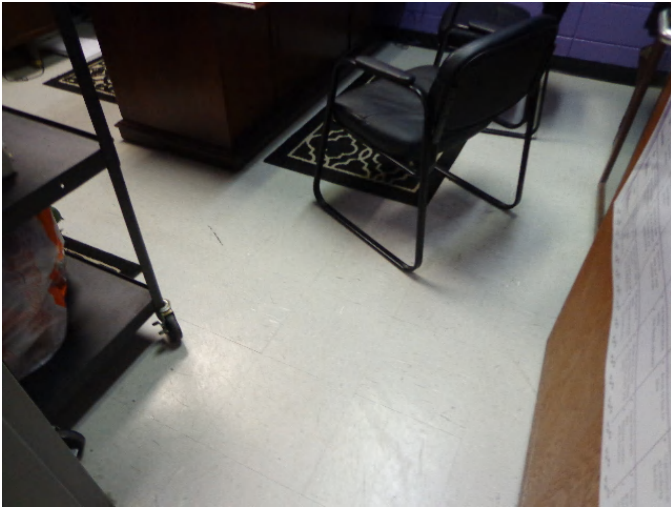
**System: C3020 - Floor Finishes - VCT**

**Location:** Throughout Building

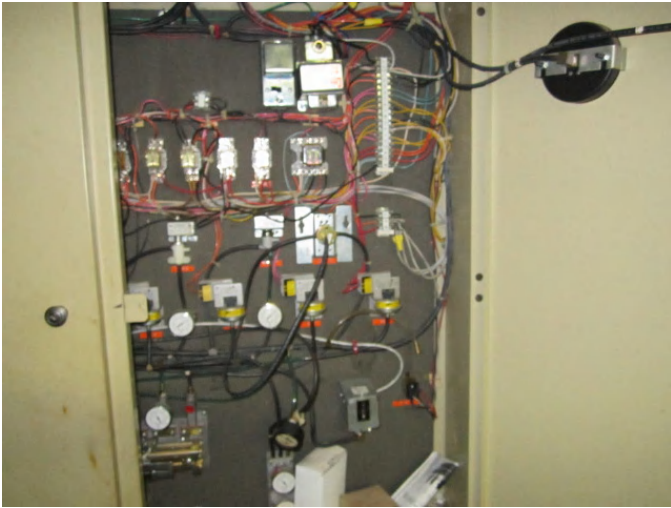
**System: D3060 - Controls & Instrumentation**

**Location:** Throughout Building

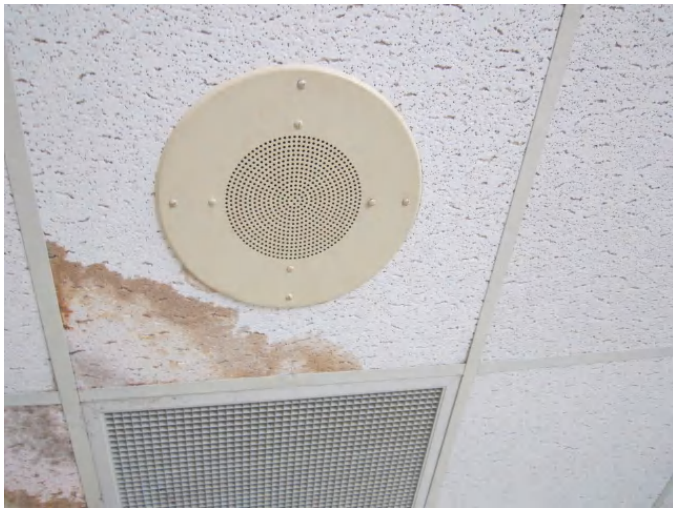
**System: D5030 - Communications and Security - PA & Clock Systems**

**Location:** Throughout Building

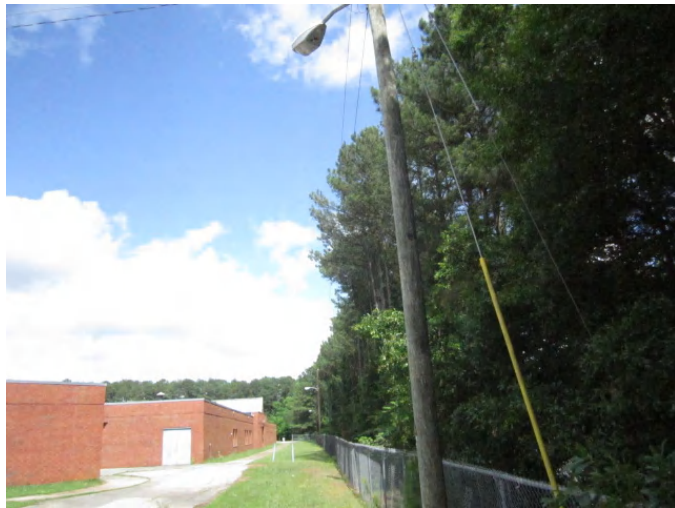
#### **System: G4020 - Site Lighting**

**Location:** Site

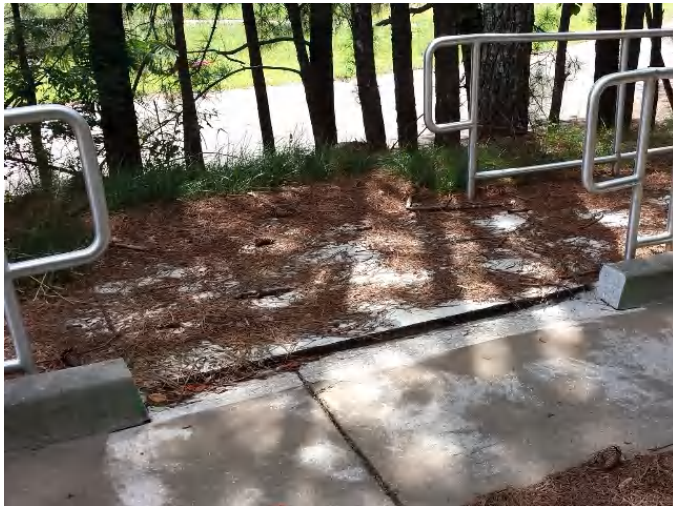
**System: G2030 - Pedestrian Paving**

**Location:** Site

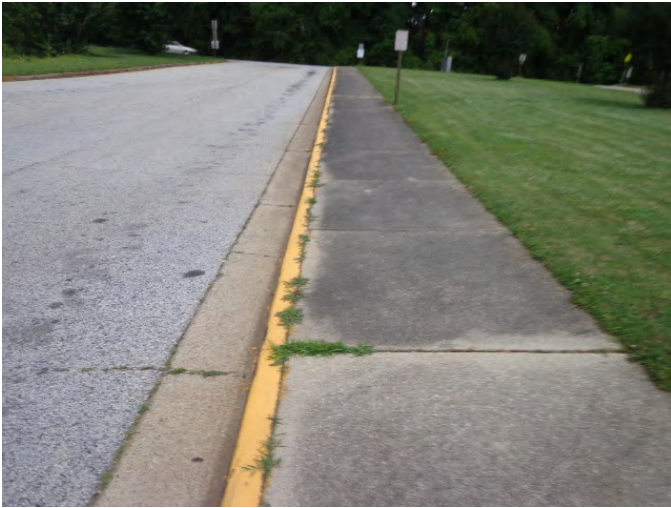
**System: G2030 - Pedestrian Paving**

**Location:** Site

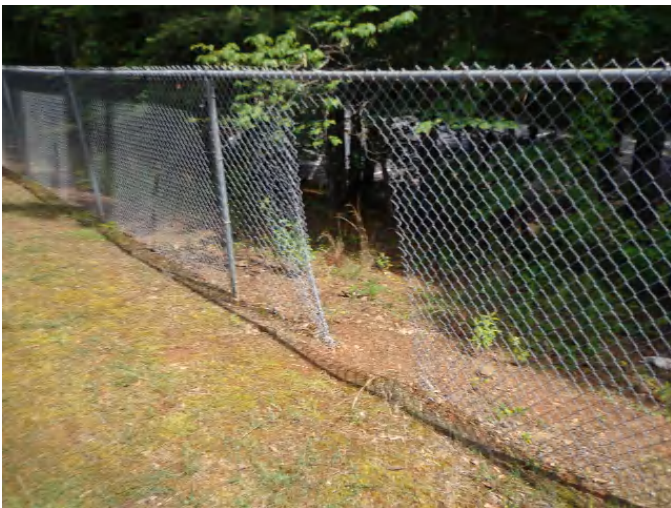
**System: G2040 - Fencing & Guardrails**

**Location:** Site

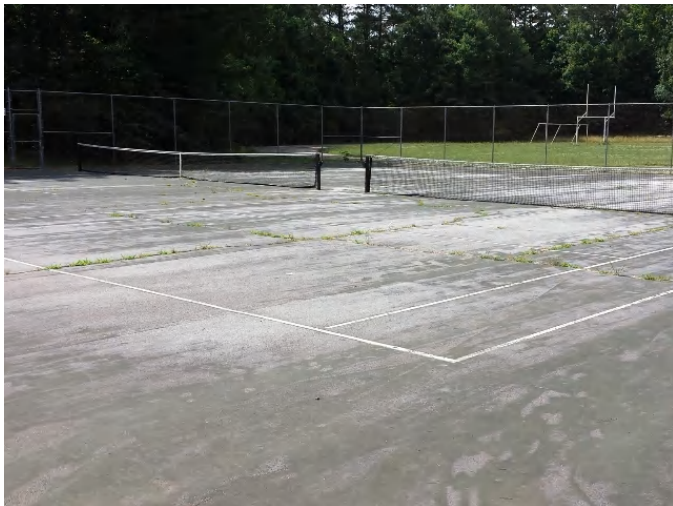
**System: G2040 - Tennis Courts**

**Location:** Site  
**Distress:** Beyond Service Life  
**Category:** Deferred Maintenance  
**Priority:** 3 Priority  
**Correction:** Renew System  
**Qty:** 13,029.00  
**Unit of Measure:** S.F.  
**Estimate:** \$264,710.19  
**Assessor Name:** Eduardo Lopez  
**Date Created:** 05/26/2015

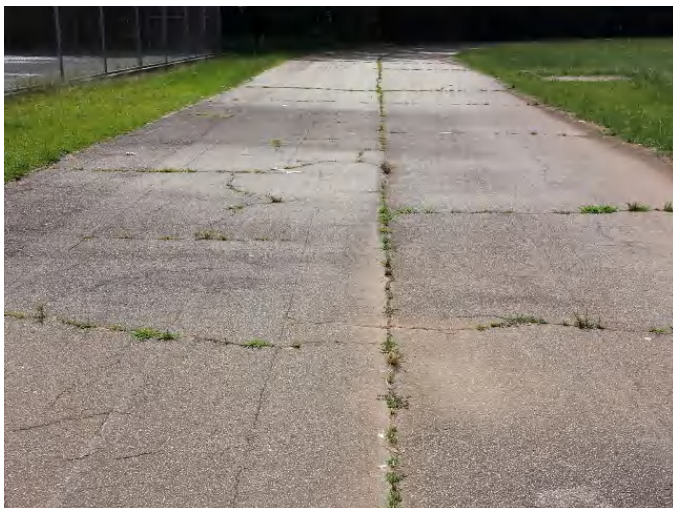
**System: G2040 - Track**

**Location:** Site  
**Distress:** Beyond Service Life  
**Category:** Deferred Maintenance  
**Priority:** 3 Priority  
**Correction:** Renew System  
**Qty:** 34,592.00  
**Unit of Measure:** S.F.  
**Estimate:** \$267,880.45  
**Assessor Name:** Eduardo Lopez  
**Date Created:** 05/26/2015

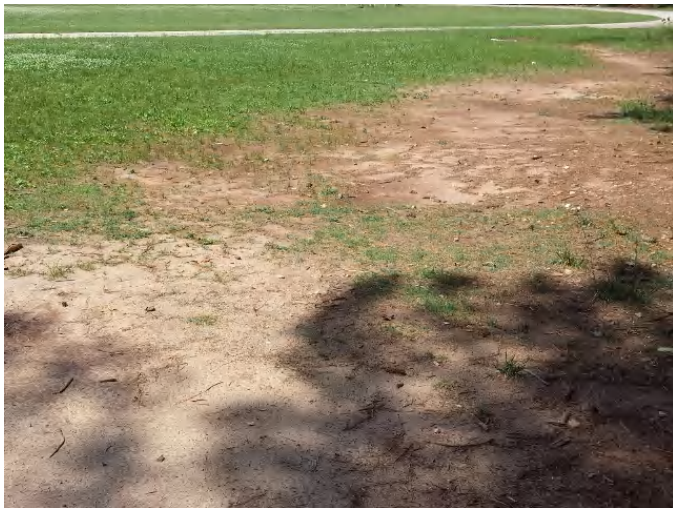
### **System: G2050 - Landscaping**

**Location:** Site
