DeKalb County School District/Elementary Schools

Montgomery Elementary

School Assessment Report
May 20, 2016

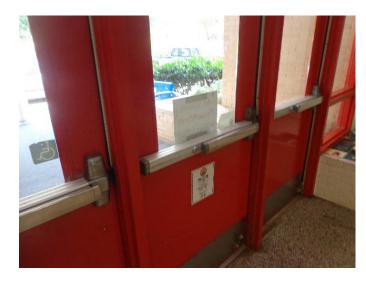
System: B2030 - Exterior Doors

Location: Throughout Building

Distress: Beyond Service Life

Notes: The original exterior doors are aged, rusted, do not operate properly, and should be replaced.

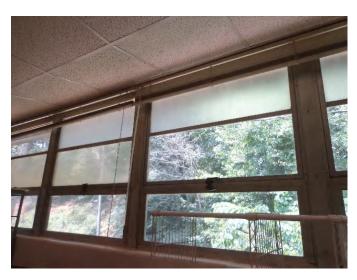
System: B2020 - Exterior Windows

Location: Throughout Building

Distress: Beyond Service Life

Notes: The aluminum frame, operable, single pane windows are aged, not energy efficient, and should be replaced.

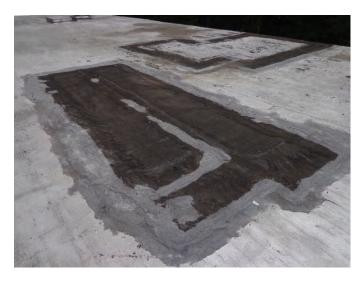
System: B3010 - Roof Coverings - BUR

Location: Roof

Distress: Beyond Service Life

Notes: Built-up roof covering is in deteriorating condition, with cracks, loss of surface, patches, ponding, and reported water leaks throughout building, and should be replaced. SPLOST project 123-422 to replace roof and ancillary roofing elements, including ladder and roof hatch (1963, 1965, 1966, and 1968 buildings).

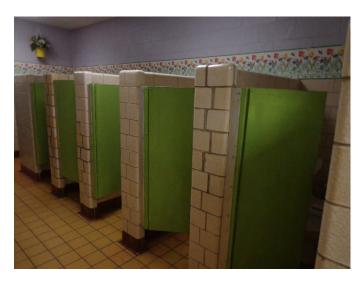
System: C1030 - Fittings

Location: Throughout Building

Distress: Beyond Service Life

Notes: Fittings, such as toilet partitions, handrails and signage, are beyond their expected service life, and should be replaced to improve ADA accessibility. SPLOST project 123-422 to renovate hall restrooms.

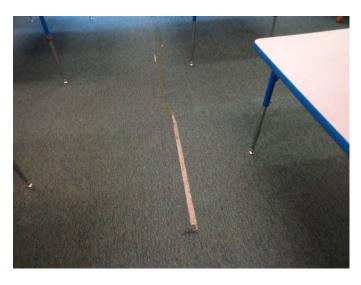
System: C3020 - Floor Finishes - Carpet

Location: Throughout Building

Distress: Beyond Service Life

Notes: The carpet is aged, stained and frayed, and should be replaced.

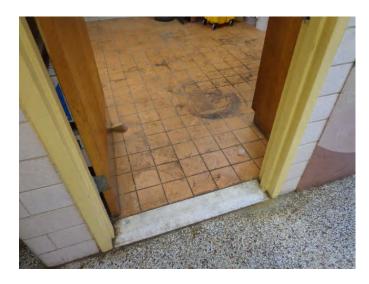
System: C3020 - Floor Finishes - Ceramic & Quarry Tile

Location: Kitchen and Restrooms

Distress: Beyond Service Life

Notes: The tile floor covering is beyond its expected service life, cracked, patched and worn, and should be replaced.

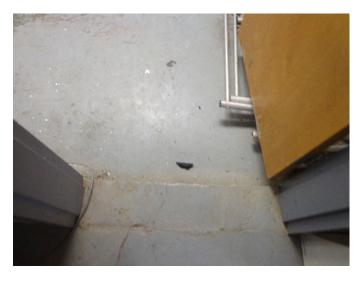
System: C3020 - Floor Finishes - Epoxy

Location: Basement

Distress: Beyond Service Life

Notes: The epoxy flooring is in poor condition and should be replaced.

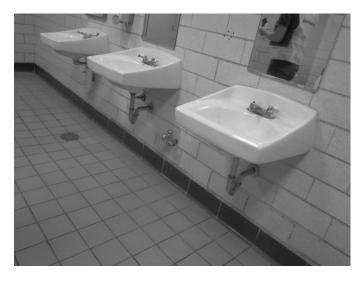
System: D2020 - Domestic Water Distribution

Location: Throughout Building

Distress: Beyond Service Life

Notes: The domestic water distribution system is beyond its expected service life, not building code compliant, and should be scheduled for replacement. Domestic water heaters or converters are not equipped with adequate expansion compensation.

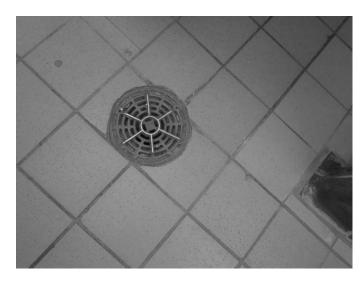
System: D2030 - Sanitary Waste

Location: Throughout Building

Distress: Beyond Service Life

Notes: The sanitary waste system is beyond its expected service life and should be scheduled for replacement. Floor drains in custodian room and basement reportedly clog often.

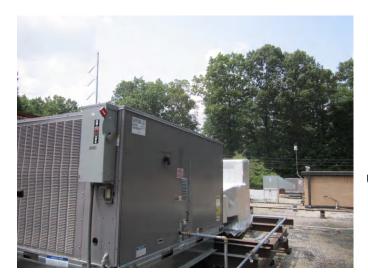
System: D2090 - Other Plumbing Systems - Natural Gas

Location: Throughout Building

Distress: Beyond Service Life

Notes: The natural gas system is beyond its expected service life and should be scheduled for replacement.

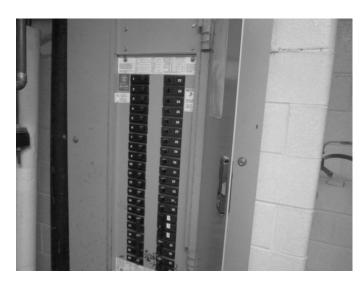
System: D5020 - Branch Wiring

Location: Throughout Building

Distress: Beyond Service Life

Notes: The branch wiring system is beyond its expected service life, aged, and should be scheduled for replacement.

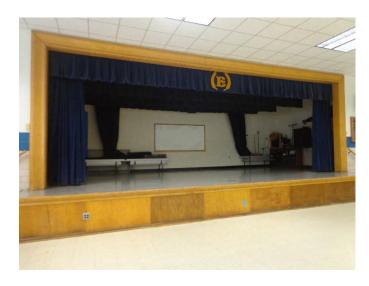
System: E1020 - Institutional Equipment

Location: Throughout Building

Distress: Beyond Service Life

Notes: Institutional equipment, such as theater and stage equipment, library equipment and audio-visual equipment, is beyond its expected service life and should be scheduled for replacement.

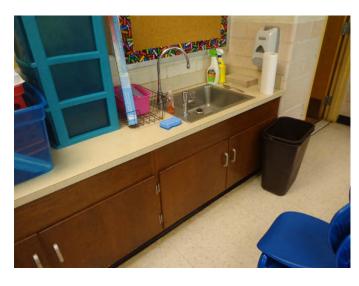
System: E2010 - Fixed Furnishings

Location: Throughout Building

Distress: Beyond Service Life

Notes: Fixed furnishings, such as built-in cabinets, are beyond their expected service life and worn, and should be replaced.

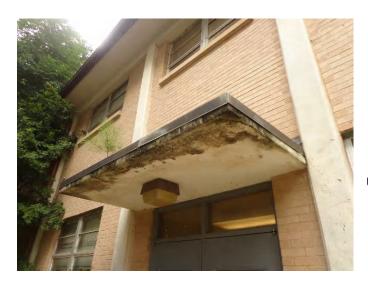
System: F1010 - Special Structures - Canopies

Location: Exterior of Building

Distress: Beyond Service Life

Notes: Canopies are beyond their expected service life, deteriorated, and should be renovated or replaced.

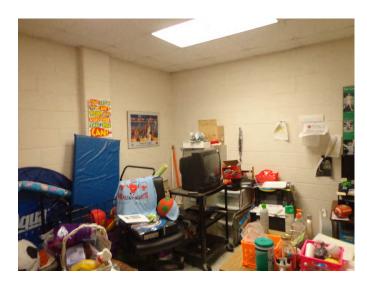
System: C3010 - Wall Finishes - Paint

Location: Throughout Building

Distress: Beyond Service Life

Notes: The painted wall finishes are beyond their expected service life, scuffed, faded and stained, and should be replaced.

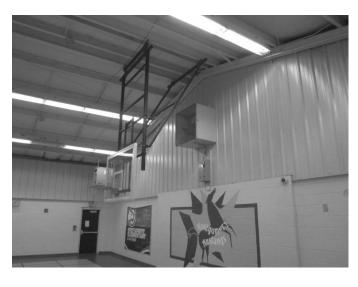
System: D3050 - Terminal & Package Units

Location: Gym

Distress: Inadequate

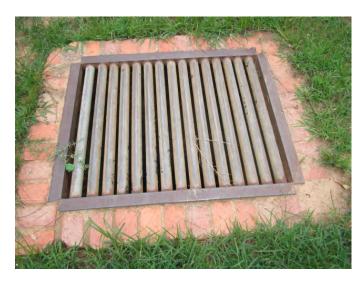
System: G3030 - Storm Sewer

Location: Site

Distress: Beyond Service Life

Notes: The storm sewer system is beyond its expected service life and should be scheduled for replacement. There are open drains at the rear of the building that are a potential safety hazard. The parking lot near the trailers reportedly floods when it rains.

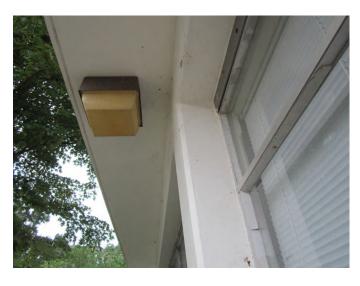
System: G4020 - Site Lighting

Location: Site

Distress: Beyond Service Life

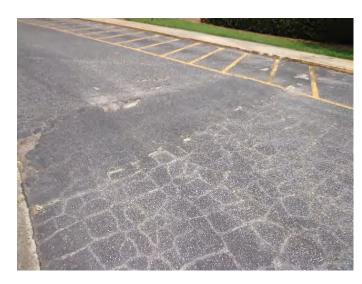
System: G2010 - Roadways

Location: Site

Distress: Beyond Service Life

Notes: Roadways are beyond their expected service life, damaged with many cracks, worn, and should be replaced.

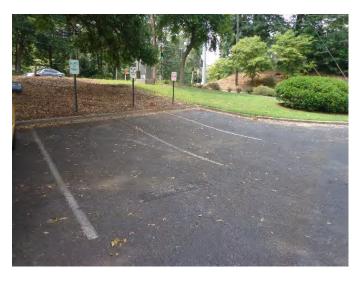
System: G2020 - Parking Lots

Location: Site

Distress: Beyond Service Life

Notes: The parking lot is beyond its expected service life and should be replaced and re-striped.

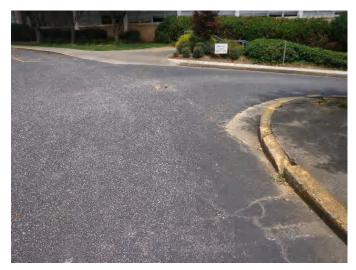
System: G2030 - Pedestrian Paving

Location: Site

Distress: Beyond Service Life

Notes: Some pedestrian pavement has been replaced and improvements have been made to include ramps from parking area. However, the system in general is beyond its expected service life, damaged, missing ramps from the site to the building per ADA standards, and should be replaced.

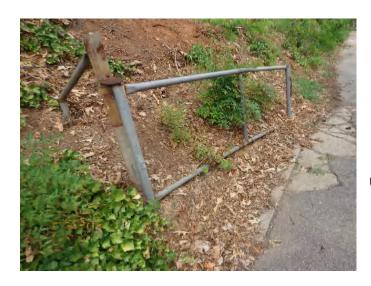
System: G2040 - Fencing & Guardrails

Location: Site

Distress: Beyond Service Life

Notes: Fencing is beyond its expected service life, rusted and failing, and should be scheduled for replacement.

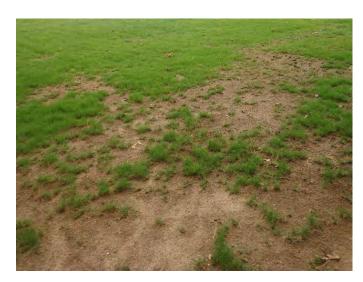
System: G2040 - Playing Field

Location: Site

Distress: Beyond Service Life

Notes: The playing fields are beyond their expected service life, have bare spots, and should be re-sodded to prevent erosion.

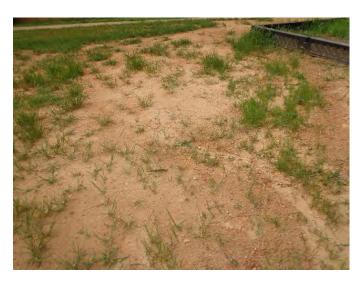
System: G2050 - Landscaping

Location: Site

Distress: Beyond Service Life

Notes: Landscaping is in poor condition, with overgrown weeds and eroded areas, and should be replaced.

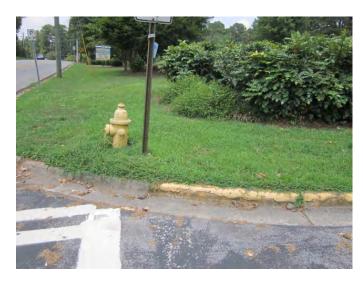
System: G3010 - Water Supply

Location: Site

Distress: Beyond Service Life

Notes: The site water supply system is beyond its expected service life and should be scheduled for replacement.

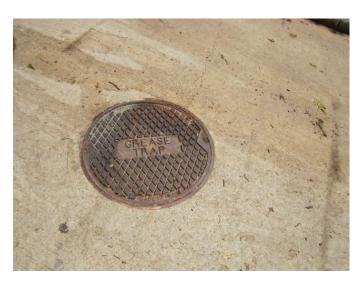
System: G3020 - Sanitary Sewer

Location: Site

Distress: Beyond Service Life

Notes: The site sanitary sewer system is beyond its expected service life and should be scheduled for replacement.

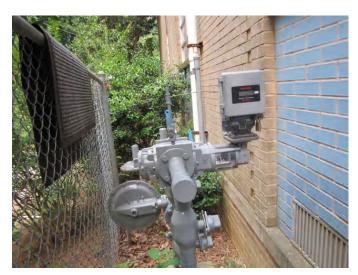
System: G3060 - Fuel Distribution

Location: Site

Distress: Beyond Service Life

Notes: The site fuel distribution system is beyond its expected service life and should be scheduled for replacement.

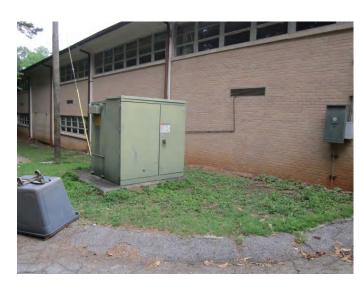
System: G4010 - Electrical Distribution

Location: Site

Distress: Beyond Service Life

Notes: The site electrical distribution system is beyond its expected service life and should be scheduled for replacement.

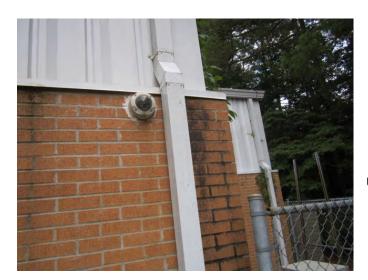
System: G4030 - Site Communications & Security

Location: Site

Distress: Beyond Service Life
