DeKalb County School District/Stadiums

North DeKalb Stadium

School Assessment Report

May 20, 2016

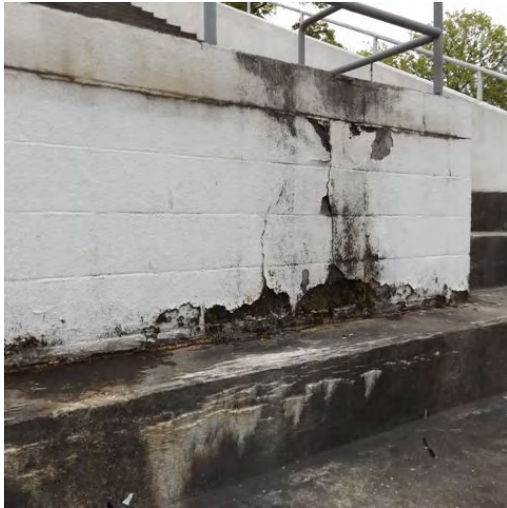
System: B2010 - Exterior Walls

Location: Exterior Wall

Distress: Damaged

Notes: The exterior walls have observable cracks that should be studied by a professional engineer. Pricing does not include remediation measures.

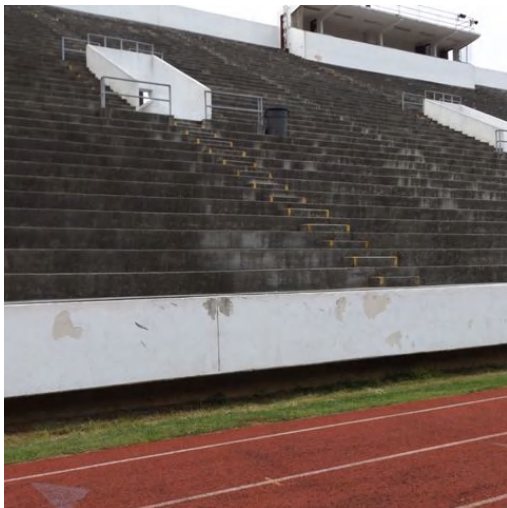
System: C2010 - Stair Construction

Location: Stadium

Distress: Inadequate

Notes: The stadium steps, access ramps, and stairs are damaged, do not have adequate railing, and do not provide ADA accessibility to all areas.

Correction: Replace stadium stairs (\$2.08/sf)

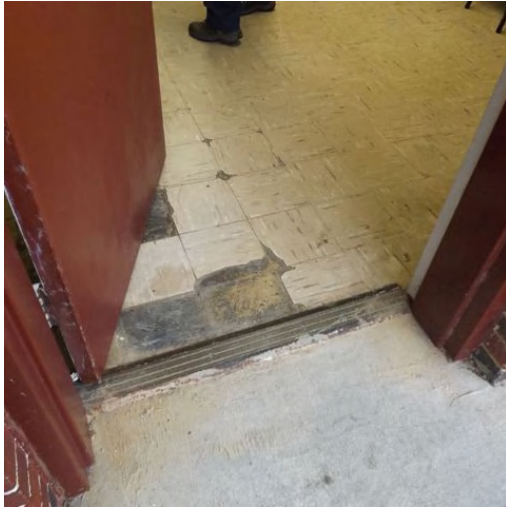
System: C3020 - Floor Finishes - Ceramic Tile

Location: Stadium
Distress: Damaged
Category: Deferred Maintenance / Environmental
Priority: 2 Priority
Correction: Renew System
Qty: 9,300.00
Unit of Measure: S.F.
Estimate: \$148,233.00
Assessor Name: Sam Mandola
Date Created: 04/11/2015

Notes: The floor finishes are damaged, appear to be hazardous material in some locations, are beyond their expected service life, and should be replaced.

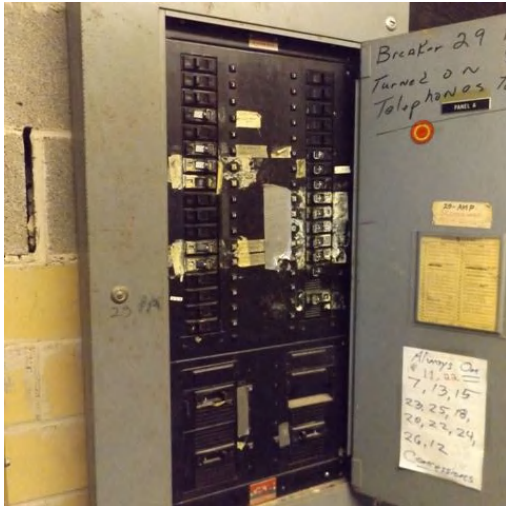
System: D5010 - Electrical Service/Distribution

Location: Stadium
Distress: Inadequate
Category: Deferred Maintenance / Safety
Priority: 2 Priority
Correction: Renew System
Qty: 36,000.00
Unit of Measure: S.F.
Estimate: \$137,808.00
Assessor Name: Sam Mandola
Date Created: 04/11/2015

Notes: The electrical service and distribution system is installed in a cramped space and does not have adequate space for safe maintenance, is beyond its expected service life, and should be replaced in a more adequate space.

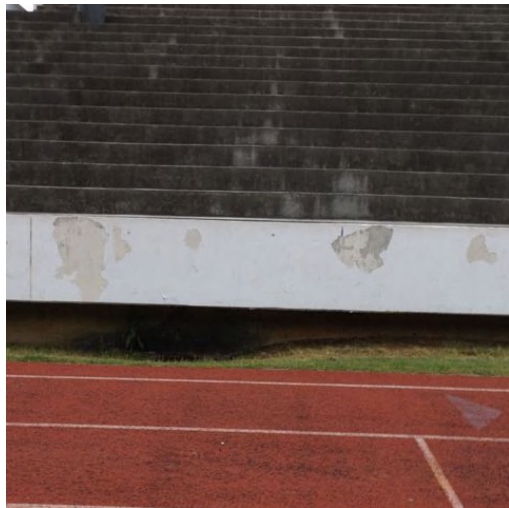
System: B2010 - Exterior Walls

Location: Exterior Surfaces

Distress: Damaged

Notes: The exterior surfaces are stained and damaged, and need to be pressure washed, repaired, and repainted.

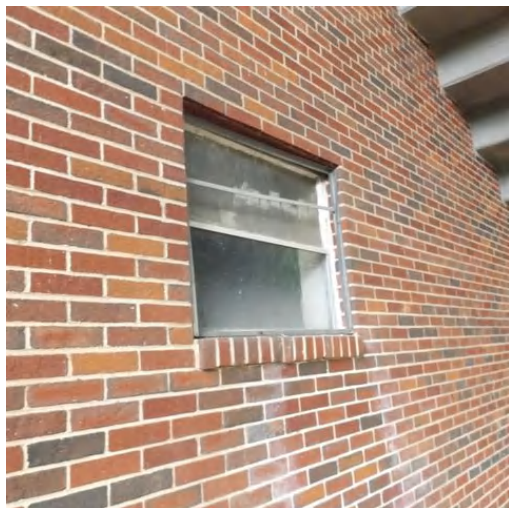
System: B2020 - Exterior Windows

Location: Stadium

Distress: Damaged

Notes: The original exterior windows are damaged, beyond their service life, and should be replaced.

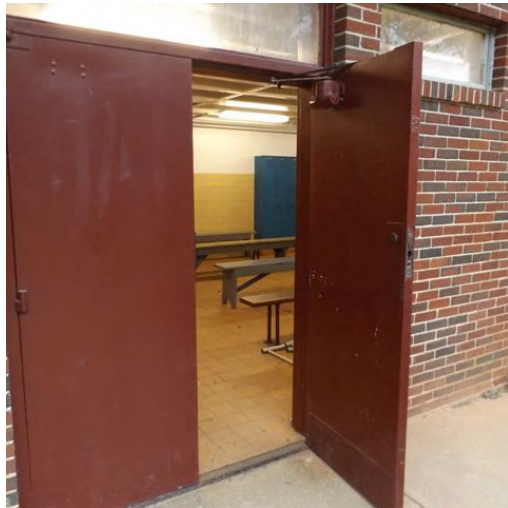
System: B2030 - Exterior Doors

Location: Stadium

Notes: The original exterior doors are beyond their service life and should be replaced to improve ADA accessibility.

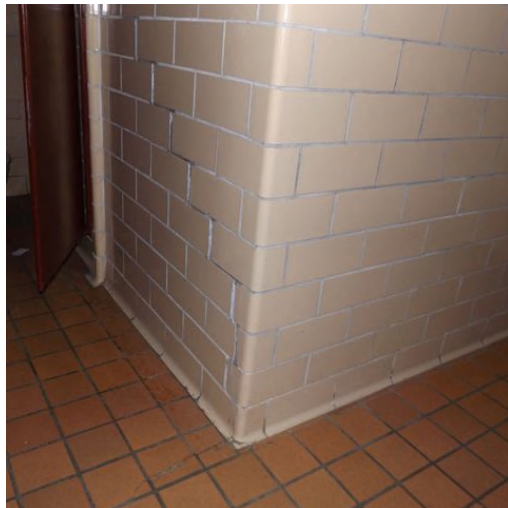
System: C1010 - Partitions

Location: Stadium

Notes: The original partitions are beyond their expected service life, damaged, and should be replaced.

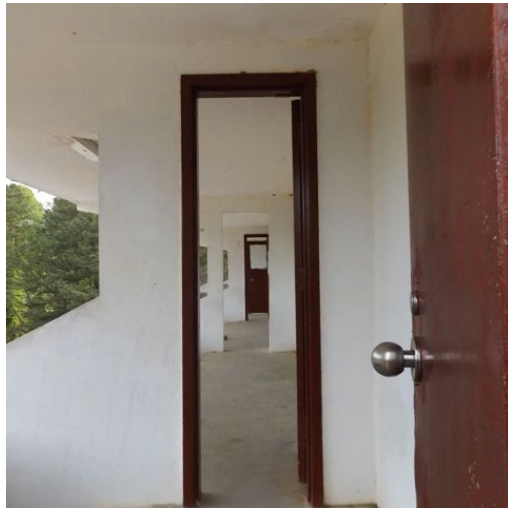
System: C1020 - Interior Doors

Location: Concourse Area, Locker Rooms, and Press Box
Distress: Beyond Service Life
Category: Deferred Maintenance
Priority: 3 Priority
Correction: Renew System
Qty: 10,500.00
Unit of Measure: S.F.
Estimate: \$23,940.00
Assessor Name: Sam Mandola
Date Created: 08/19/2015

Notes: The interior doors are beyond their expected service life and should be scheduled for replacement.

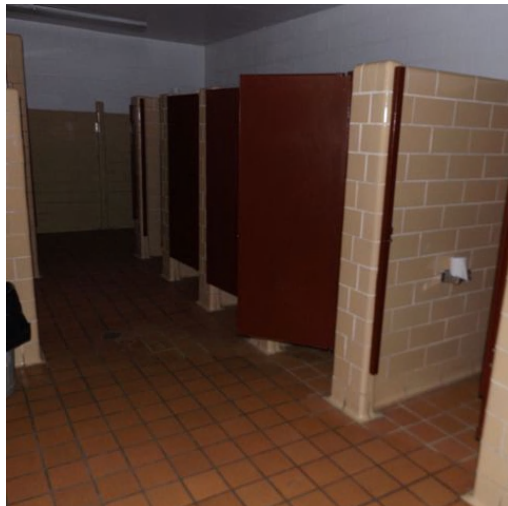
System: C1030 - Fittings

Location: Stadium
Distress: Inadequate
Category: Deferred Maintenance / Accessibility Code Compliance
Priority: 3 Priority
Correction: Renew System
Qty: 10,500.00
Unit of Measure: S.F.
Estimate: \$35,112.00
Assessor Name: Sam Mandola
Date Created: 04/11/2015

Notes: The fittings, such as toilet partitions, handrails and signage, are inadequate, beyond their service life, not ADA compliant, and should be replaced.

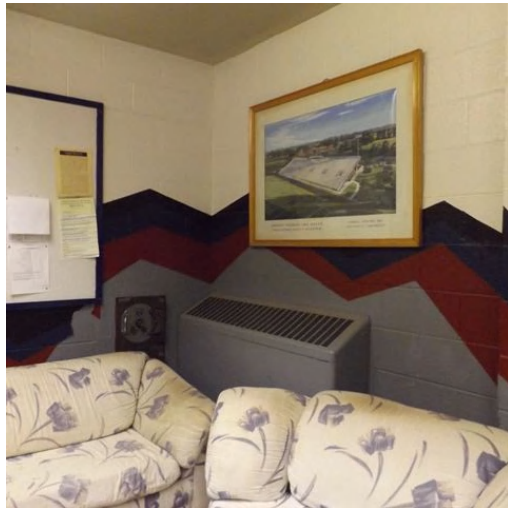
System: C3010 - Wall Finishes - Paint

Location: Stadium
Distress: Beyond Service Life
Category: Deferred Maintenance
Priority: 3 Priority
Correction: Renew System
Qty: 10,500.00
Unit of Measure: S.F.
Estimate: \$18,596.00
Assessor Name: Sam Mandola
Date Created: 04/11/2015

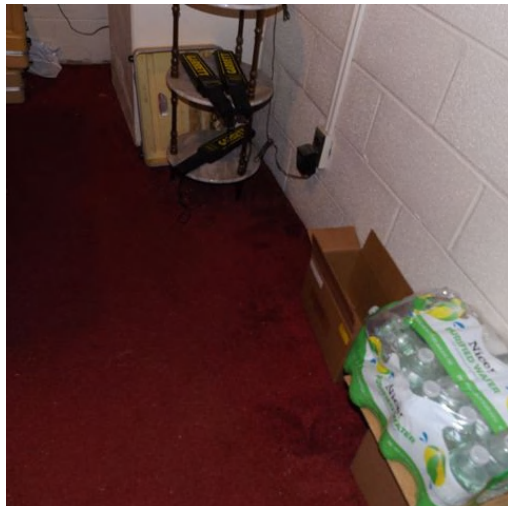
System: C3020 - Floor Finishes - Carpet

Location: Office
Distress: Damaged
Category: Deferred Maintenance
Priority: 3 Priority
Correction: Renew System
Qty: 200.00
Unit of Measure: S.F.
Estimate: \$1,870.00
Assessor Name: Sam Mandola
Date Created: 05/14/2015

Notes: The carpet is stained, worn, damaged, and should be scheduled for replacement.

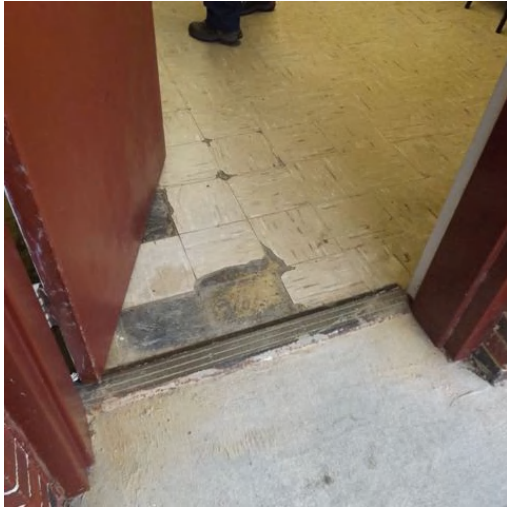
System: C3020 - Floor Finishes - VCT

Location: Office
Distress: Beyond Service Life
Category: Deferred Maintenance
Priority: 3 Priority
Correction: Renew System
Qty: 1,000.00
Unit of Measure: S.F.
Estimate: \$10,494.00
Assessor Name: Sam Mandola
Date Created: 05/14/2015

Notes: The original vinyl tile flooring is beyond its expected service life, damaged, and should be scheduled for replacement.

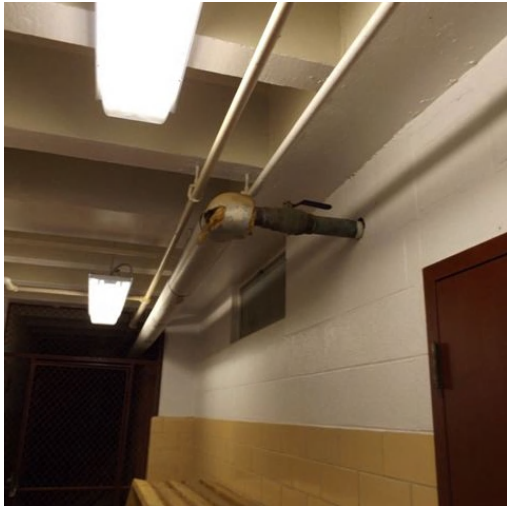
System: D2020 - Domestic Water Distribution

Location: Stadium
Distress: Beyond Service Life
Category: Deferred Maintenance / Building Code Compliance
Priority: 3 Priority
Correction: Renew System
Qty: 10,500.00
Unit of Measure: S.F.
Estimate: \$40,194.00
Assessor Name: Sam Mandola
Date Created: 04/11/2015

Notes: The original domestic water system is beyond its expected service life, not code compliant, and should be scheduled for replacement.

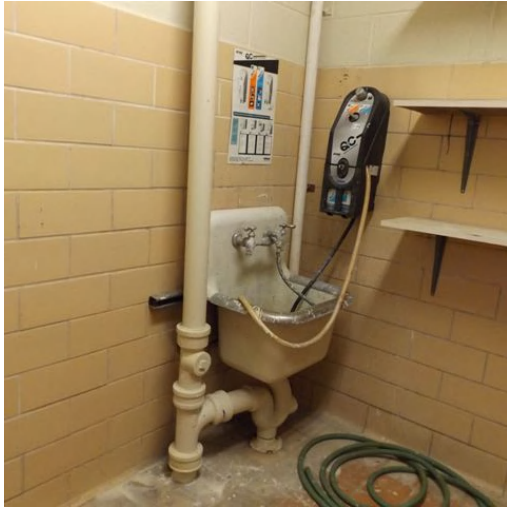
System: D2030 - Sanitary Waste

Location: Stadium

Notes: The original sanitary waste system is beyond its expected service life and should be scheduled for replacement.

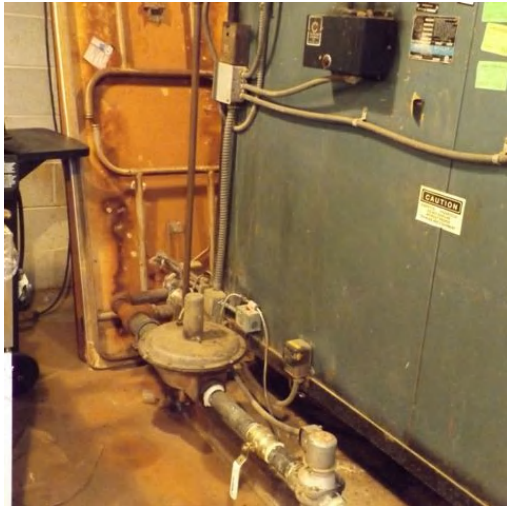
System: D2090 - Other Plumbing Systems - Nat Gas

Location: Stadium

Notes: The original natural gas piping is beyond its expected service life, not code compliant, and should be scheduled for replacement.

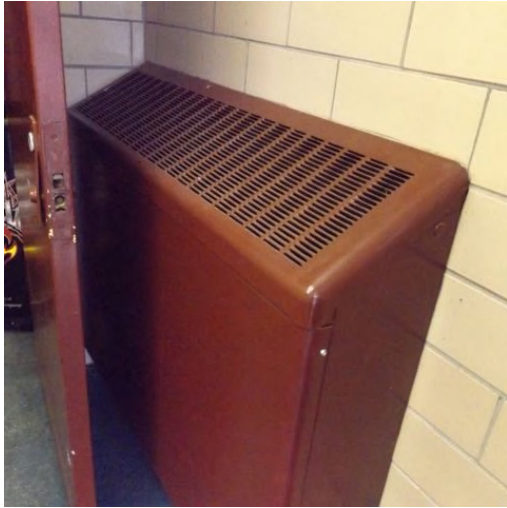
System: D3040 - Distribution Systems

Location: Stadium
Distress: Beyond Service Life
Category: Deferred Maintenance
Priority: 3 Priority
Correction: Renew System
Qty: 10,500.00
Unit of Measure: S.F.
Estimate: \$61,793.00
Assessor Name: Sam Mandola
Date Created: 04/11/2015

Notes: The original HVAC distribution system is beyond its expected service life and should be scheduled for replacement.

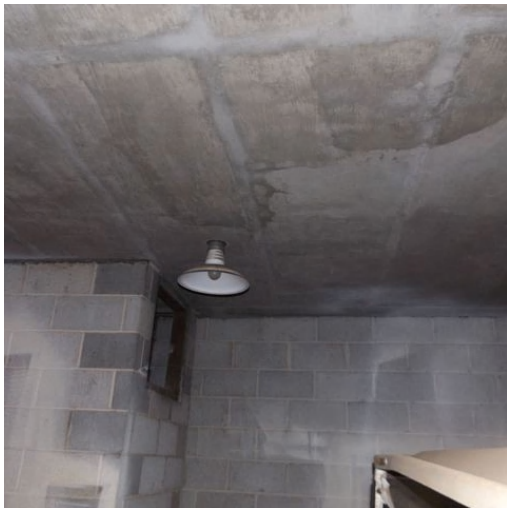
System: D5020 - Lighting and Branch Wiring

Location: Stadium
Distress: Beyond Service Life
Category: Deferred Maintenance / Building Code Compliance
Priority: 3 Priority
Correction: Renew System
Qty: 36,000.00
Unit of Measure: S.F.
Estimate: \$725,076.00
Assessor Name: Sam Mandola
Date Created: 04/11/2015

Notes: The lighting and branch wiring system is beyond its expected service life, not code compliant, and should be scheduled for replacement. SPLOST IV project 208-422 to replace stadium lighting is expected to be complete by August 2016.

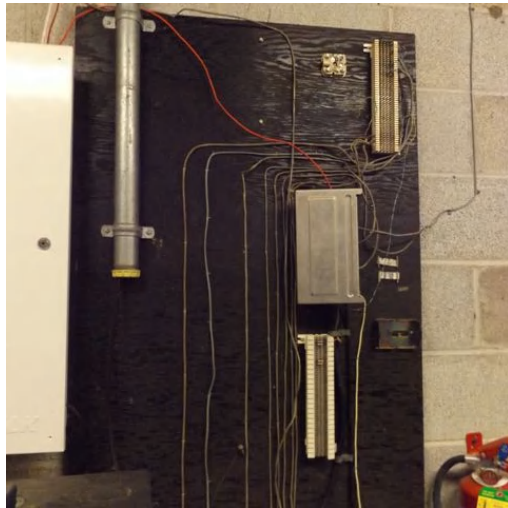
System: D5030 - Communications and Security

Location: Stadium

Notes: Telephone and data, PA and clock system, and security and CCTV systems are beyond service life and should be replaced. Audible and visible fire alarm is missing and should be added.

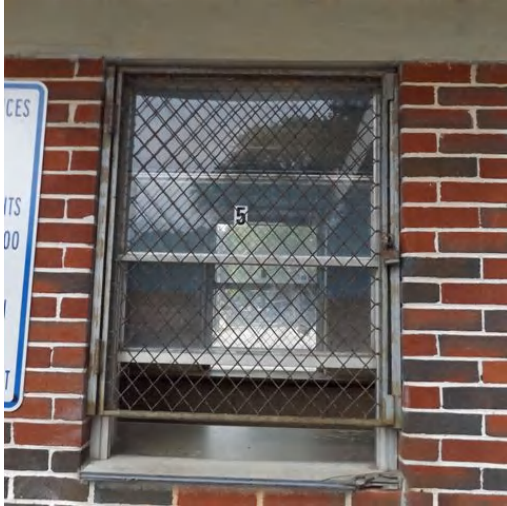
System: B2020 - Exterior Windows

Location: Ticket Booth

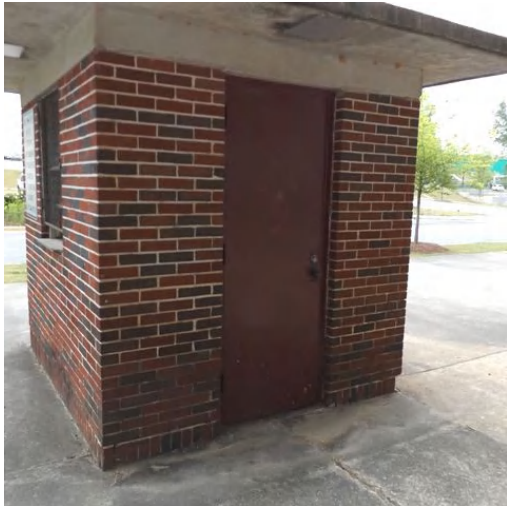
System: B2030 - Exterior Doors

Location: Ticket Booth

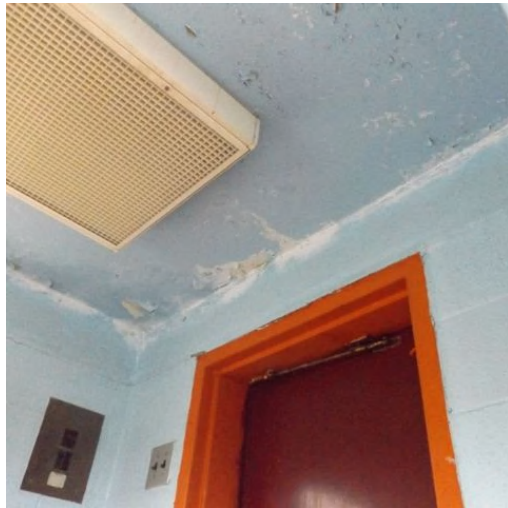
System: C3010 - Wall Finishes - paint

Location: Ticket Booth
Distress: Damaged
Category: Deferred Maintenance
Priority: 3 Priority
Correction: Renew System
Qty: 64.00
Unit of Measure: S.F.
Estimate: \$227.00
Assessor Name: Somnath Das
Date Created: 04/11/2015

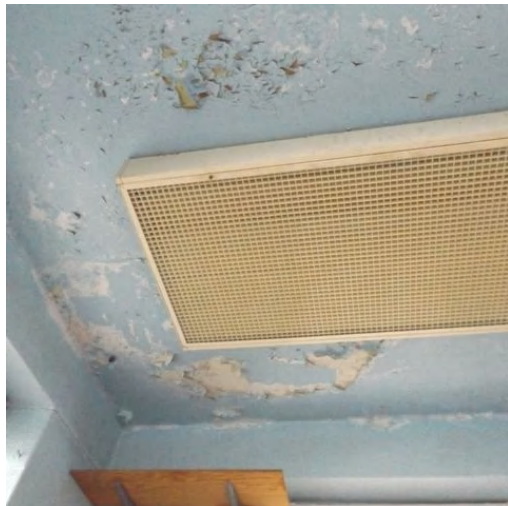
System: C3030 - Ceiling Finishes

Location: Ticket Booth
Distress: Damaged
Category: Deferred Maintenance
Priority: 3 Priority
Correction: Renew System
Qty: 64.00
Unit of Measure: S.F.
Estimate: \$427.00
Assessor Name: Somnath Das
Date Created: 04/11/2015

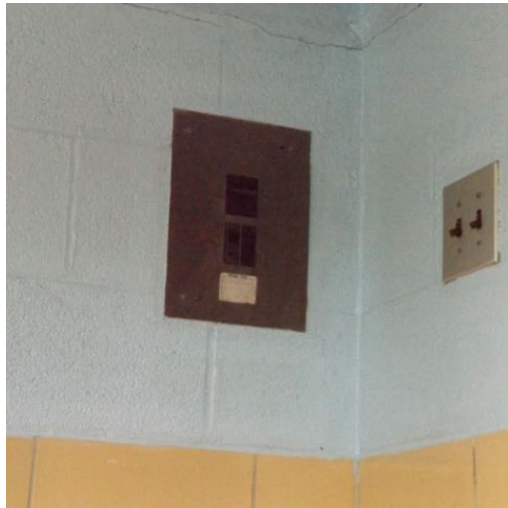
System: D5010 - Electrical Service/Distribution

Location: Ticket Booth
Distress: Beyond Service Life
Category: Deferred Maintenance
Priority: 3 Priority
Correction: Renew System
Qty: 64.00
Unit of Measure: S.F.
Estimate: \$215.00
Assessor Name: Somnath Das
Date Created: 04/11/2015

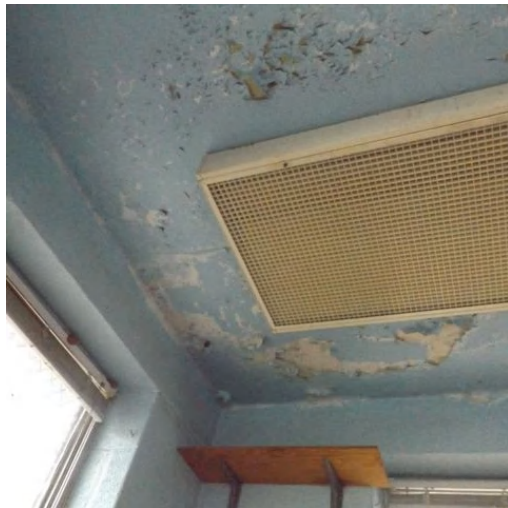
System: D5020 - Lighting and Branch Wiring

Location: Ticket Booth
Distress: Beyond Service Life
Category: Deferred Maintenance
Priority: 3 Priority
Correction: Renew System
Qty: 64.00
Unit of Measure: S.F.
Estimate: \$885.00
Assessor Name: Somnath Das
Date Created: 04/11/2015

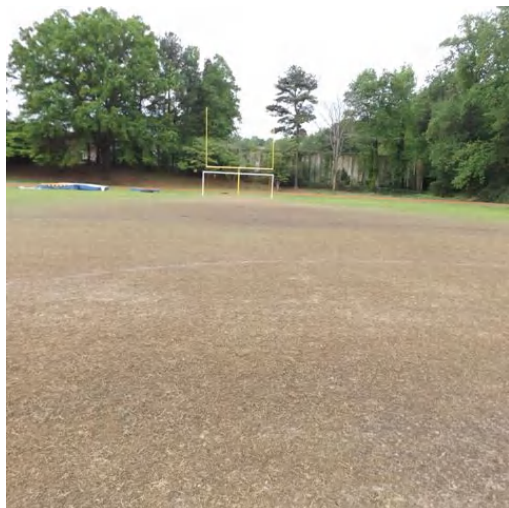
System: G2040 - Football Field

Location: Football Field

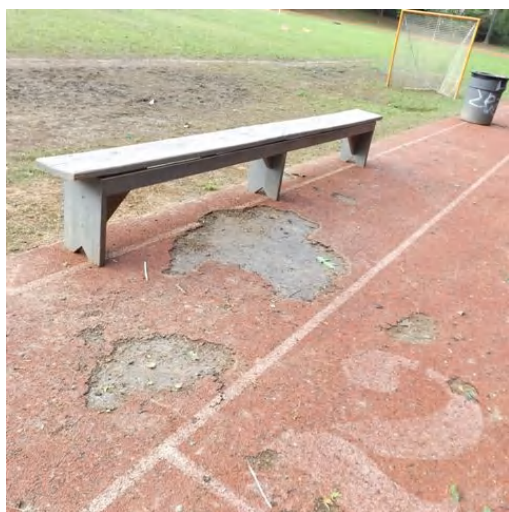
System: G2040 - Track

Location: Track

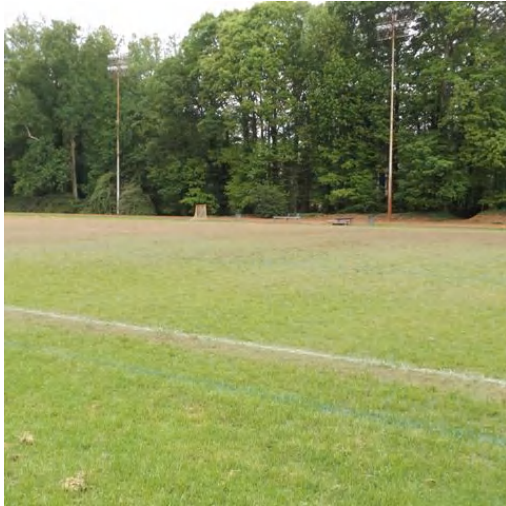
System: G4020 - Site Lighting

Location: Site

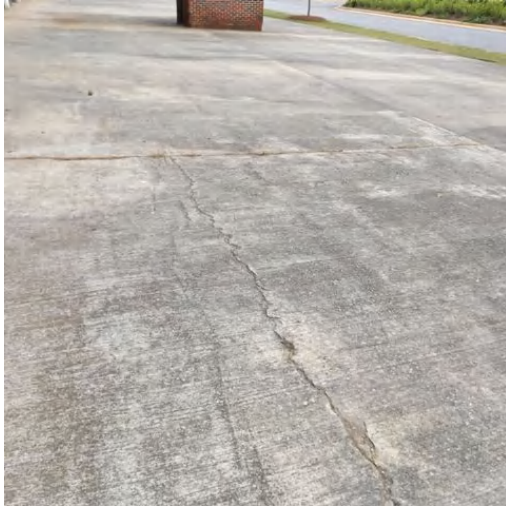
System: G2030 - Pedestrian Paving

Location: Site

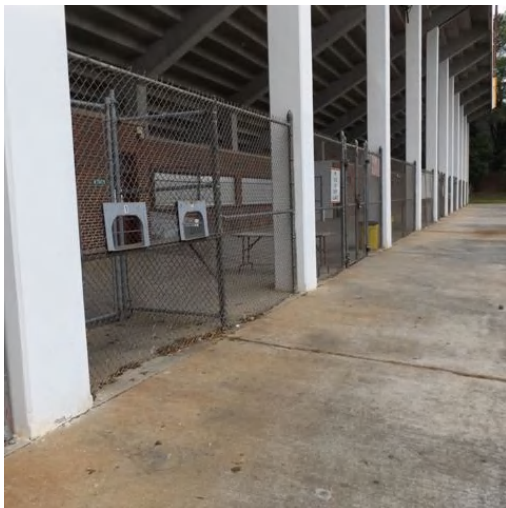
System: G2040 - Fencing & Guardrails

Location: Site

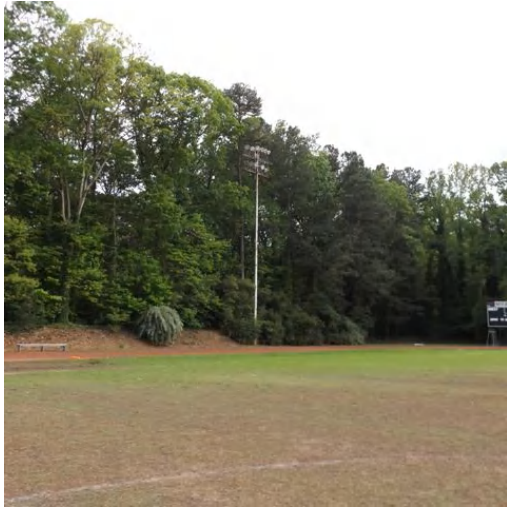
System: G2050 - Landscaping

Location: Site
Distress: Beyond Service Life
Category: Deferred Maintenance
Priority: 3 Priority
Correction: Renew System
Qty: 36,128.00
Unit of Measure: S.F.
Estimate: \$57,624.16
Assessor Name: Eduardo Lopez
Date Created: 04/27/2015

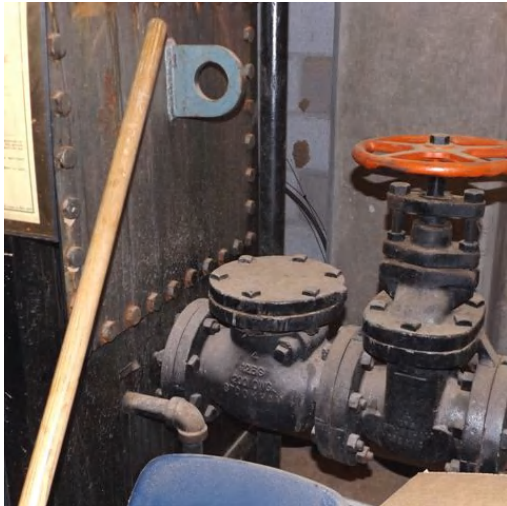
System: G3010 - Water Supply

Location: Site
Distress: Beyond Service Life
Category: Deferred Maintenance / Building Code Compliance
Priority: 3 Priority
Correction: Renew System
Qty: 36,128.00
Unit of Measure: S.F.
Estimate: \$72,725.66
Assessor Name: Eduardo Lopez
Date Created: 04/27/2015

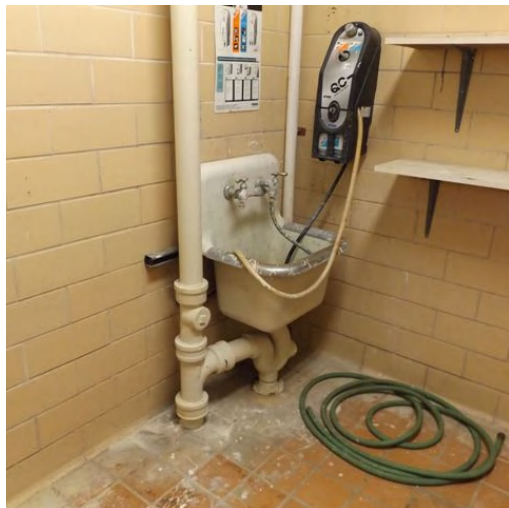
System: G3020 - Sanitary Sewer

Location: Site

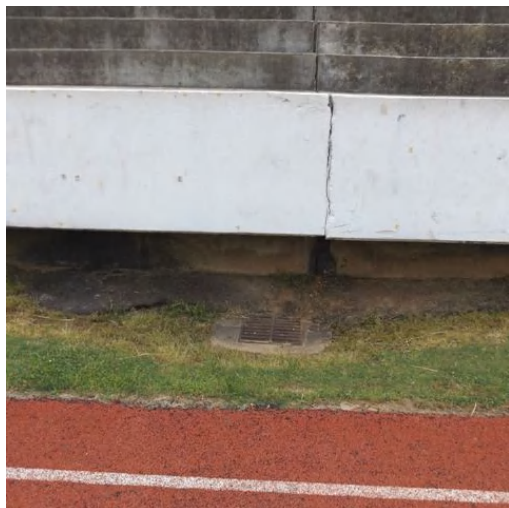
System: G3030 - Storm Sewer

Location: Site

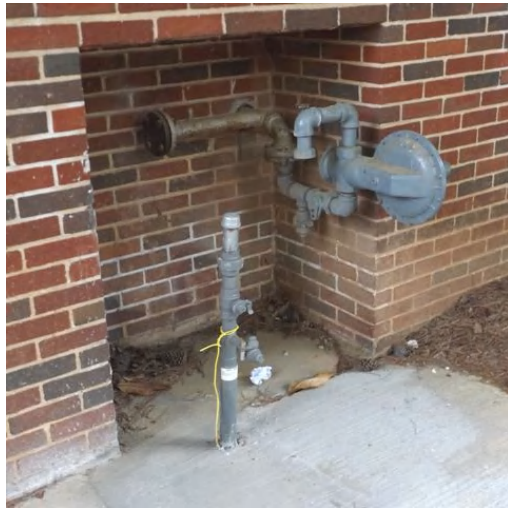
System: G3060 - Fuel Distribution

Location: Site
Distress: Beyond Service Life
Category: Deferred Maintenance
Priority: 3 Priority
Correction: Renew System
Qty: 36,128.00
Unit of Measure: S.F.
Estimate: \$30,997.82
Assessor Name: Eduardo Lopez
Date Created: 04/27/2015

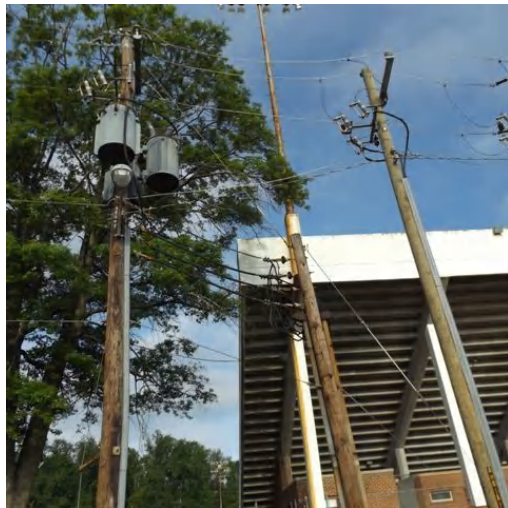
System: G4010 - Electrical Distribution

Location: Site
Distress: Beyond Service Life
Category: Deferred Maintenance
Priority: 3 Priority
Correction: Renew System
Qty: 36,128.00
Unit of Measure: S.F.
Estimate: \$73,917.89
Assessor Name: Eduardo Lopez
Date Created: 04/27/2015

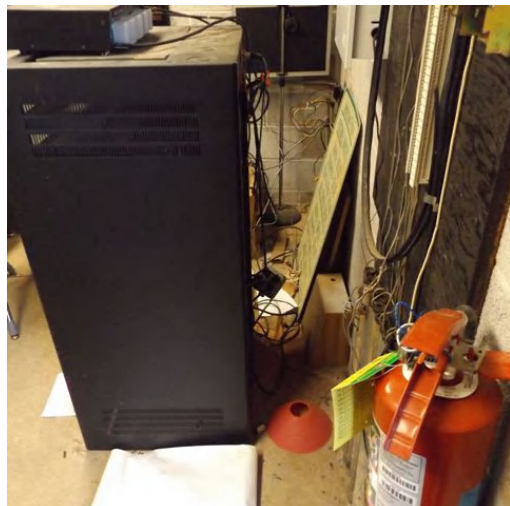
System: G4030 - Site Communications & Security

Location: Site
