**DeKalb County School District/Admin/Support**

# **Panthersville Administrative**

School Assessment Report
May 19, 2016

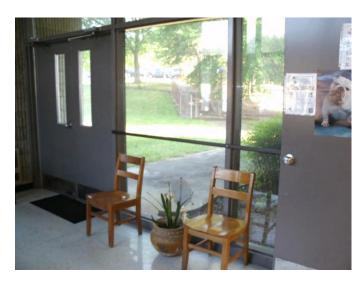
System: B2020 - Exterior Windows

**Location:** Throughout Building

**Distress:** Beyond Service Life

Notes: The exterior windows are beyond their expected service life and should be scheduled for replacement.

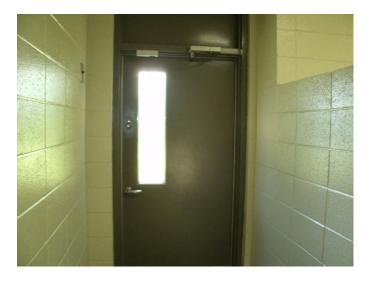
#### System: B2030 - Exterior Doors

**Location:** Throughout Building

**Distress:** Beyond Service Life

**Notes:** The exterior doors are beyond their expected service life, do not have emergency egress hardware, and should be scheduled for replacement.

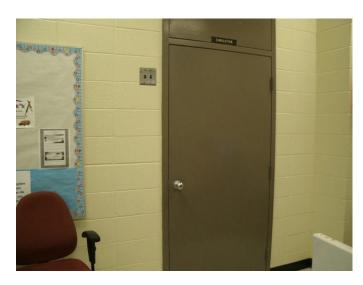
#### System: C1020 - Interior Doors

**Location:** Throughout Building

**Distress:** Beyond Service Life

Notes: The interior doors are beyond their expected service life and should be scheduled for replacement.

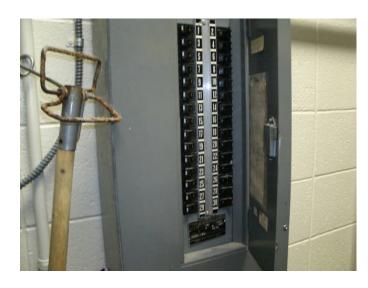
#### System: D5020 - Branch Wiring

**Location:** Throughout Building

**Distress:** Beyond Service Life

Notes: Branch wiring is beyond its expected service life and should be scheduled for replacement.

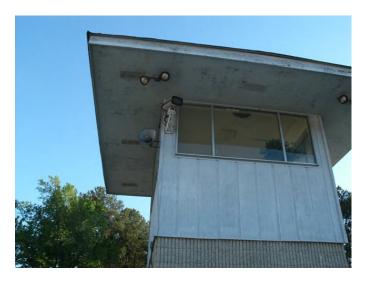
**System: B2020 - Exterior Windows**

**Location:** Exterior Walls

**Distress:** Beyond Service Life

Notes: The exterior windows are beyond their service life and should be scheduled for replacement.

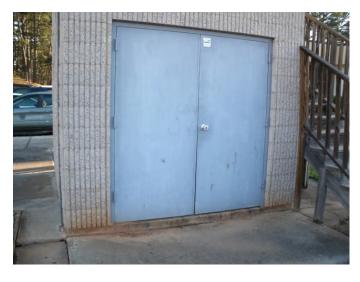
#### System: B2030 - Exterior Doors

**Location:** Exterior Wall

**Distress:** Beyond Service Life

**Notes:** The exterior doors are beyond their service life and should be scheduled for replacement.

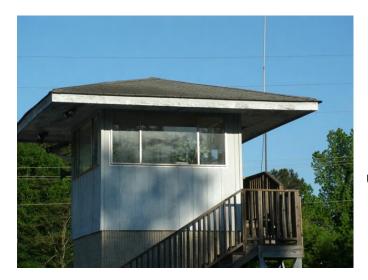
#### System: B3010 - Roof Coverings - Asphalt Shingles

**Location:** Roof

**Distress:** Beyond Service Life

**Notes:** The asphalt shingles are showing signs of wear and should be scheduled for replacement.

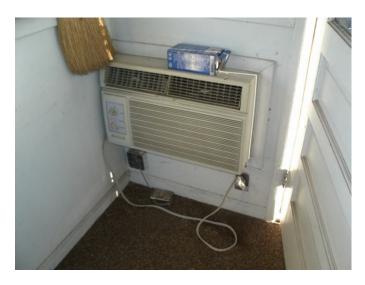
#### System: C3010 - Wall Finishes - Paint

**Notes:** The walls should be repainted.

**Location:** Throughout Building

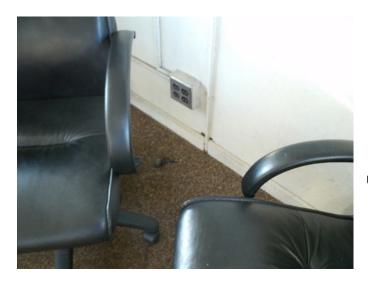
#### System: C3020 - Floor Finishes - Carpet

**Location:** Throughout Building

**Distress:** Beyond Service Life

**Notes:** The carpet is beyond its service life and should be scheduled for replacement.

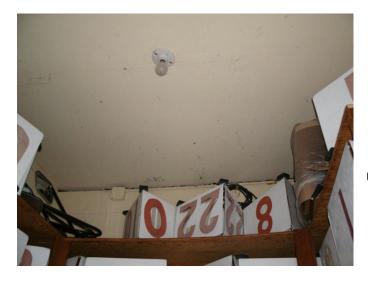
#### System: C3030 - Ceiling Finishes

**Notes:** The ceiling should be repainted.

**Location:** Throughout Building

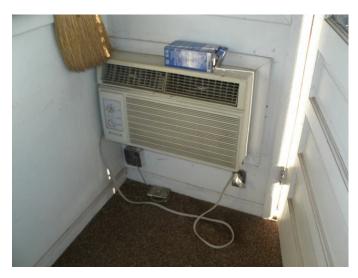
#### System: D3050 - Terminal & Package Units

**Location:** Second Floor, Exterior Wall

**Distress:** Beyond Service Life

Notes: The window unit is beyond its expected service life and should be scheduled for replacement.

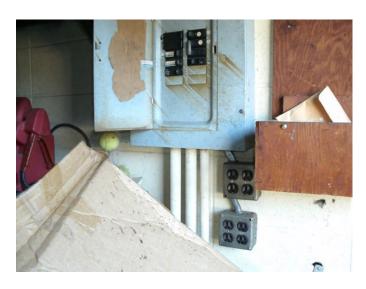
#### System: D5020 - Branch Wiring

**Location:** Throughout Building

**Distress:** Beyond Service Life

Notes: The lighting and branch wiring system is beyond its expected service life and should be scheduled for replacement.

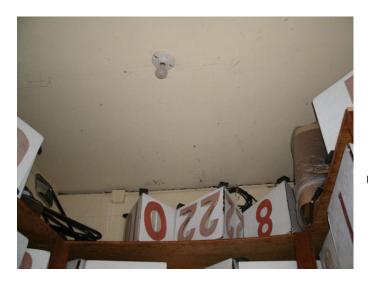
#### System: D5020 - Lighting

**Location:** Throughout Building

**Distress:** Beyond Service Life

**Notes:** Lighting is beyond its service life and should be scheduled for replacement.

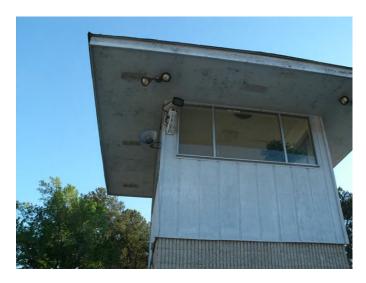
#### System: D5030 - Communications and Security - PA System

**Location:** Throughout Building

**Distress:** Beyond Service Life

Notes: The PA system is beyond its expected service life and should be scheduled for replacement.

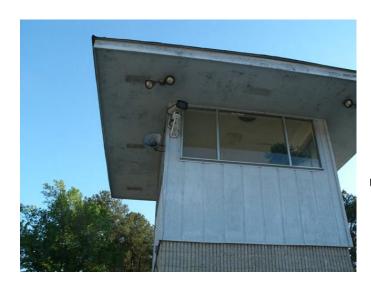
#### System: D5030 - Communications and Security - Security & CCTV

**Location:** Exterior Wall

**Distress:** Beyond Service Life

**Notes:** The CCTV system is beyond its expected service life and should be scheduled for replacement.

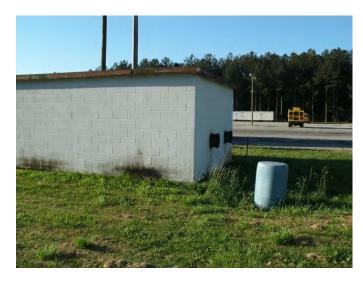
**System: B2010 - Exterior Walls**

**Location:** Exterior Walls

**Distress:** Damaged

**Notes:** The exterior walls are stained and should be repainted.

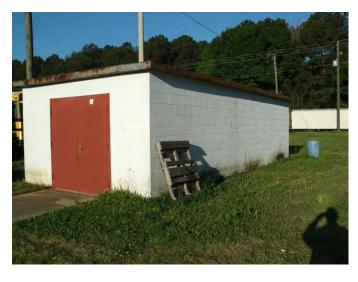
#### System: B2030 - Exterior Doors

**Location:** Exterior Wall

**Distress:** Beyond Service Life

Notes: The exterior doors are beyond their service life and should be scheduled for replacement.

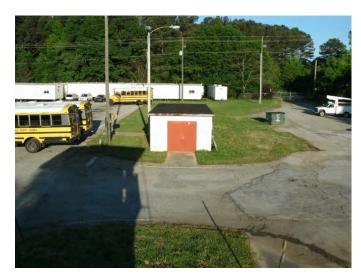
#### System: B3010 - Roof Coverings

**Location:** Roof

**Distress:** Beyond Service Life

**Notes:** The asphalt roof covering is beyond its service life and should be scheduled for replacement.

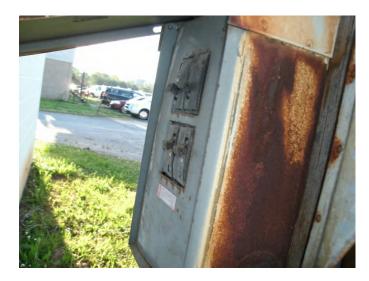
#### System: D5020 - Lighting and Branch Wiring

**Location:** Throughout Building

**Distress:** Beyond Service Life

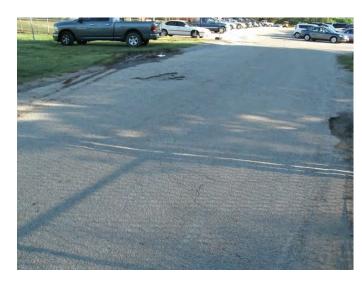
System: G2010 - Roadways

Location: Site

**Distress:** Damaged

**Notes:** The roadways are damaged and failing, and should be scheduled for replacement.

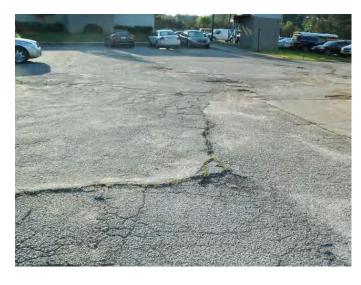
#### System: G2020 - Parking Lots

Location: Site

**Distress:** Damaged

Notes: The parking lots are buckled, damaged, and failing, and should be scheduled for replacement.

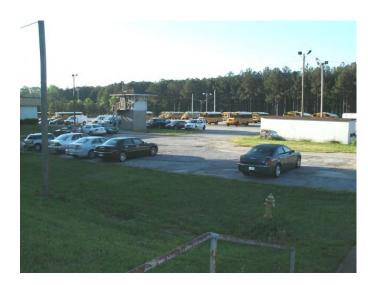
#### System: G3010 - Water Supply

Location: Site

**Distress:** Missing

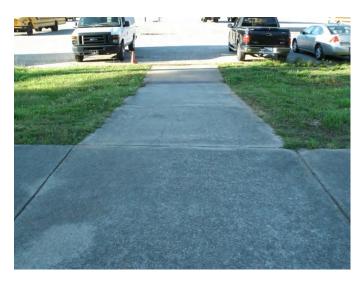
#### System: G2030 - Pedestrian Paving

**Location:** Site

**Distress:** Beyond Service Life

Notes: The pedestrian paving is beyond its service life and should be scheduled for replacement.

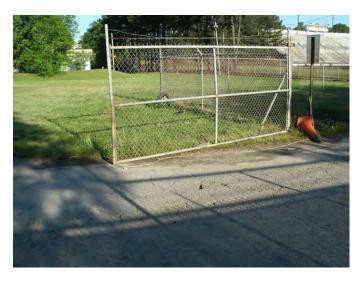
#### System: G2040 - Fencing & Guardrails

Location: Site

**Distress:** Damaged

**Notes:** The site fencing is rusted, damaged in places, failing, and should be replaced.

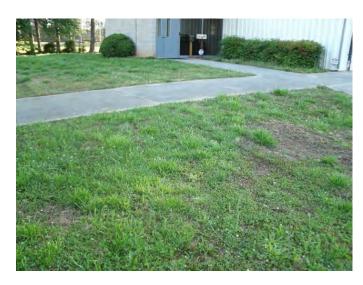
#### System: G2050 - Landscaping

Location: Site

**Distress:** Beyond Service Life

**Notes:** The landscaping is showing wear, is beyond its expected service life, and should be scheduled for replacement.

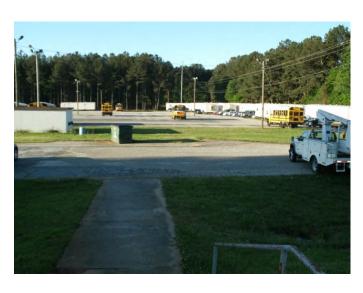
#### System: G4020 - Site Lighting

**Location:** Site

**Distress:** Beyond Service Life

**Notes:** The site lighting is beyond its expected service life and should be scheduled for replacement.

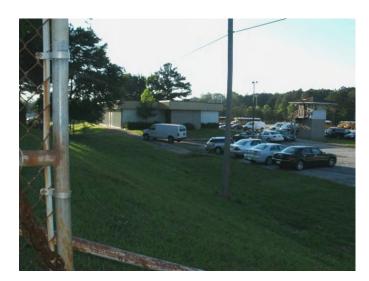
#### **System: G4030 - Site Communications & Security**

Location: Site

**Distress:** Beyond Service Life
