DeKalb County School District/Elementary Schools

Redan Elementary

School Assessment Report

May 20, 2016

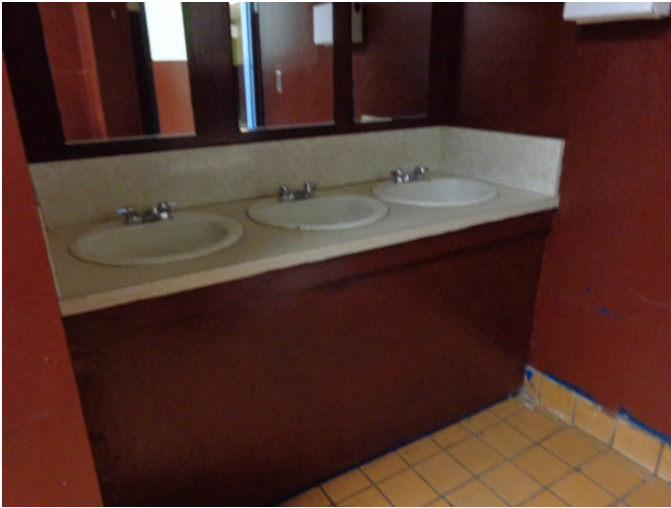
System: D2010 - Plumbing Fixtures

Location: Throughout Building

Distress: Beyond Service Life

Notes: Plumbing fixtures are aged, worn, stained and not to ADA compliant, and should be replaced. SPLOST project 126-422 to renovate unisex adult restrooms in halls.

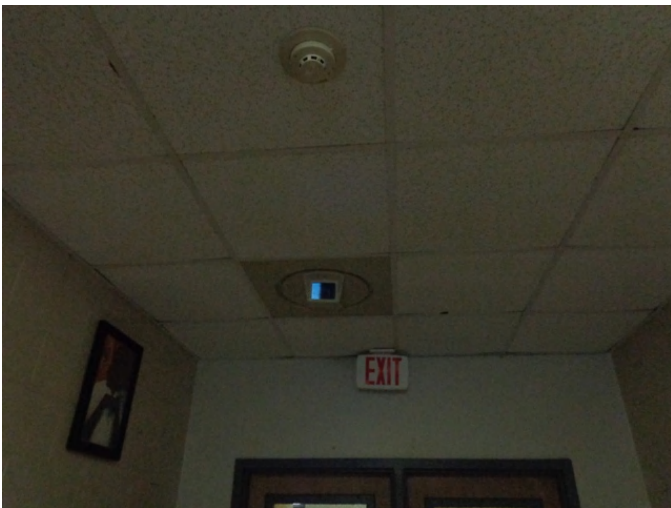
System: D5030 - Communications and Security - Security & CCTV

Location: Throughout Building

Distress: Inadequate

Notes: The security system is beyond its expected service life and has inadequate intrusion detection and camera surveillance. The entire system should be replaced/upgraded to provide full coverage.

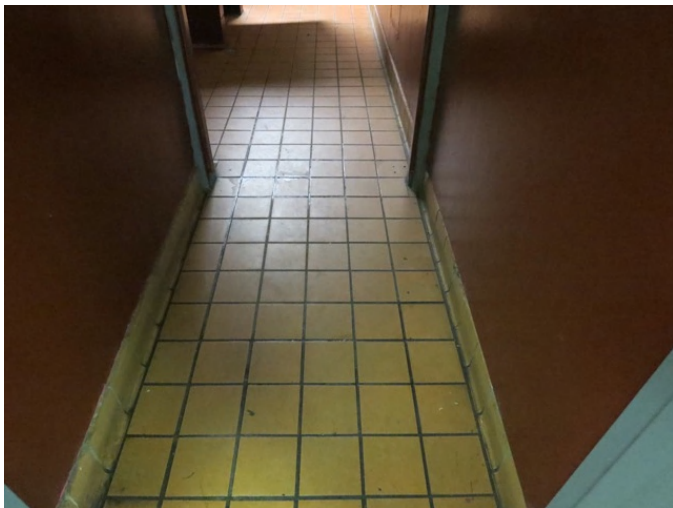
System: C3020 - Floor Finishes - Ceramic & Quarry Tile

Location: Restrooms

Distress: Beyond Service Life

Notes: The tile floor covering is beyond its expected service life, cracked, patched and worn, and should be replaced.

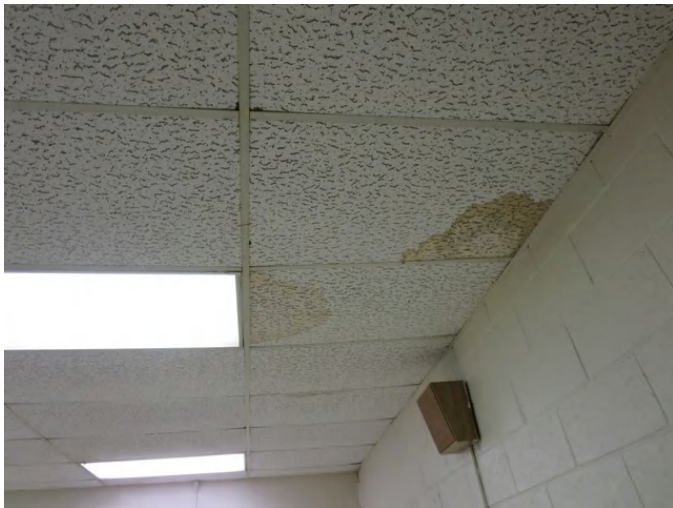
System: C3030 - Ceiling Finishes

Location: Throughout Building

Distress: Beyond Service Life

Notes: The acoustical ceiling system is beyond its expected service life and should be replaced.

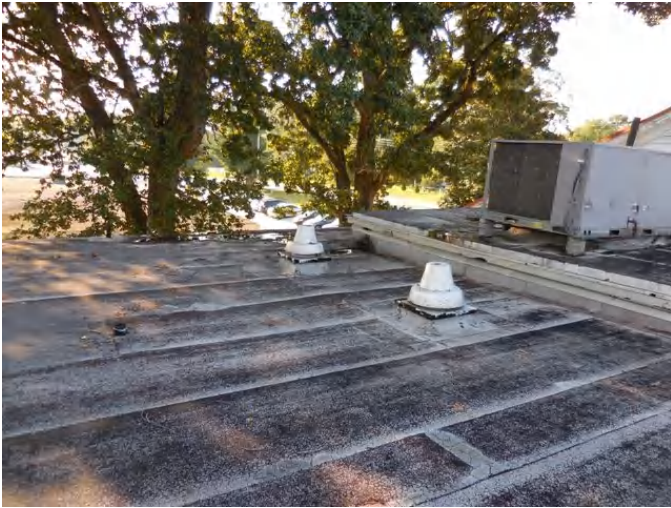
System: D3040 - Distribution & Exhaust Systems

Location: Throughout Building

Distress: Beyond Service Life

Notes: Roof top exhaust fans are not functional and the ventilation system is dirty. The system is beyond its expected service life and should be scheduled for replacement.

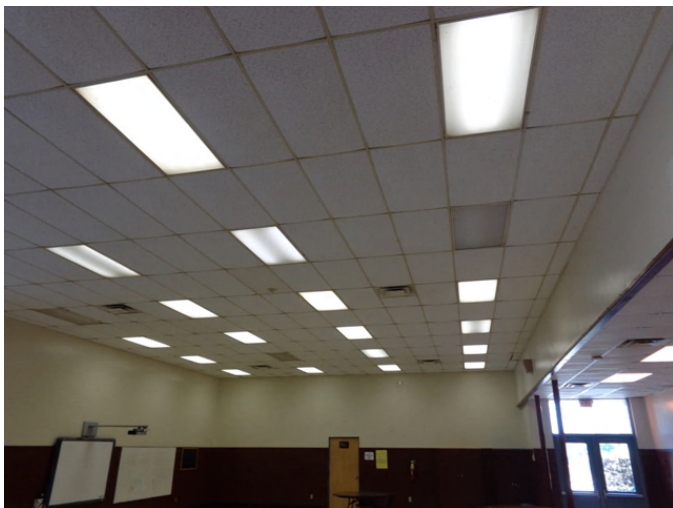
System: D5020 - Lighting

Location: Throughout Building

Distress: Beyond Service Life

Notes: The lighting system is beyond its expected service life and should be scheduled for replacement with energy efficient light fixtures. SPLOST project 126-422 to replace the lighting system throughout the building.

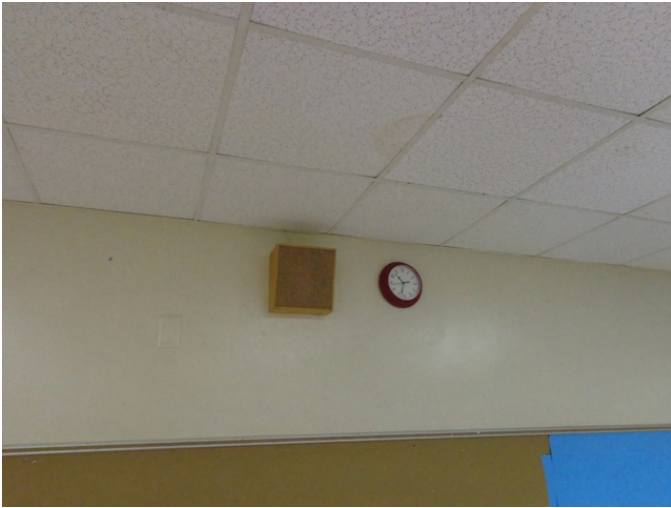
System: D5030 - Communications and Security - Clock & PA Systems

Location: Throughout Building

Distress: Beyond Service Life

Notes: Clock and PA systems are beyond their expected service life, outdated, inadequate, and should be scheduled for replacement.

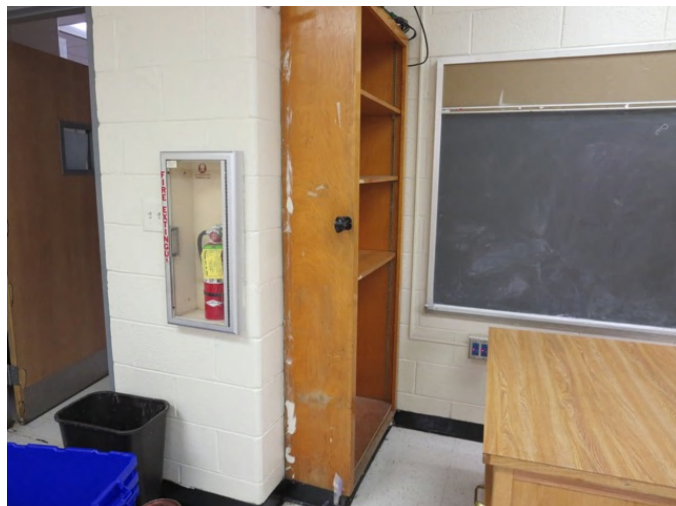
System: E2010 - Fixed Furnishings

Location: Throughout Building

Distress: Beyond Service Life

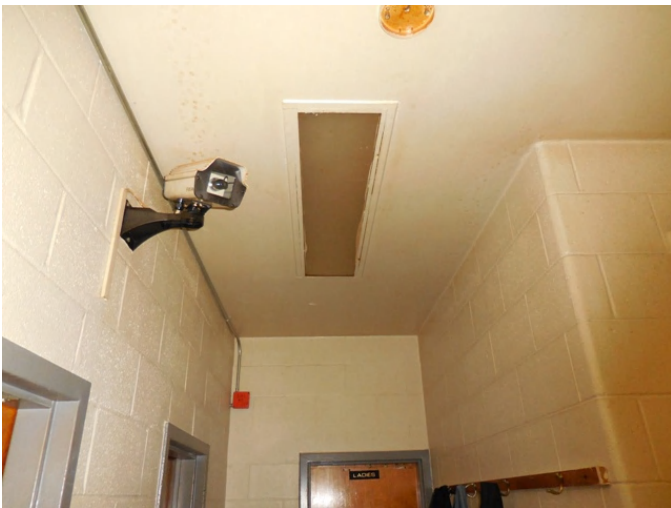
System: D5030 - Communications and Security - Security & CCTV

Location: Throughout Building

Distress: Inadequate

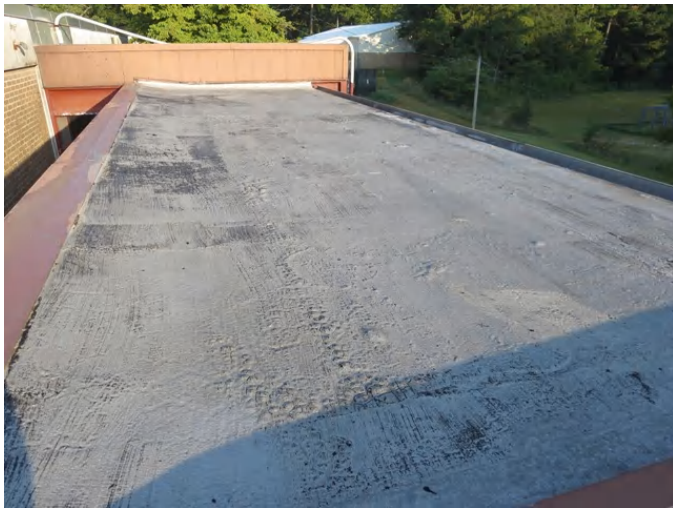
System: B3010 - Roof Coverings - BUR

Location: Roof

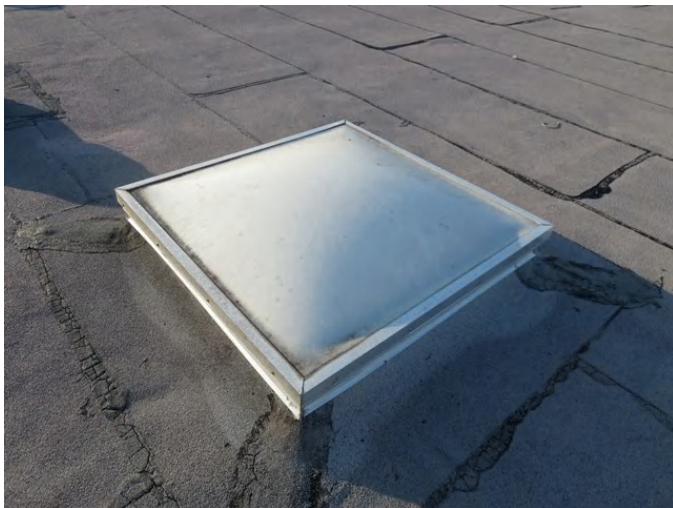
System: B3020 - Roof Openings

Location: Roof

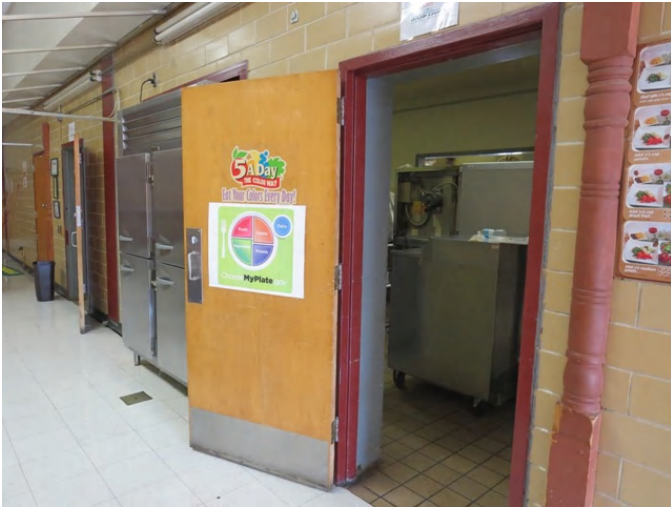
System: C1020 - Interior Doors

Location: Throughout Building

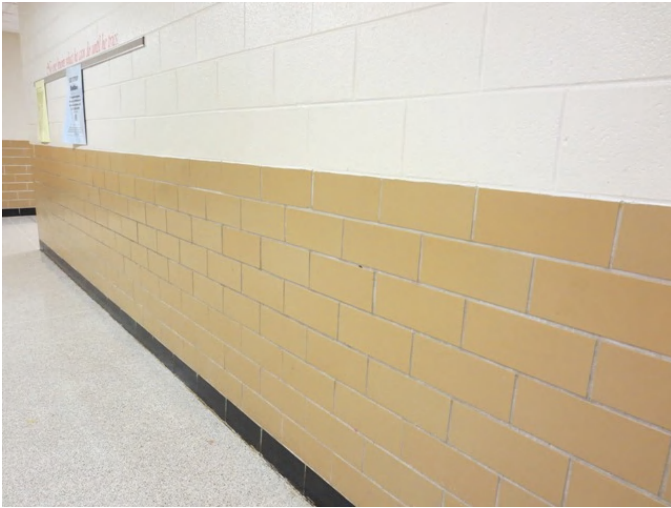
System: C3010 - Wall Finishes - Ceramic & Glazed

Location: Throughout Building

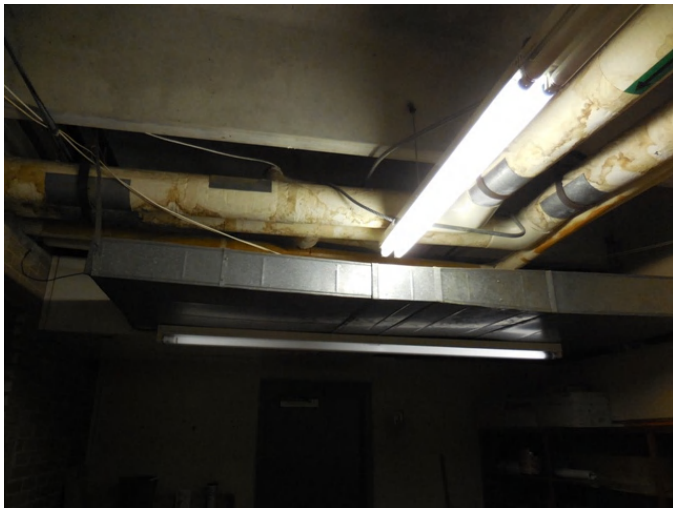
System: D2020 - Domestic Water Distribution

Location: Throughout Building

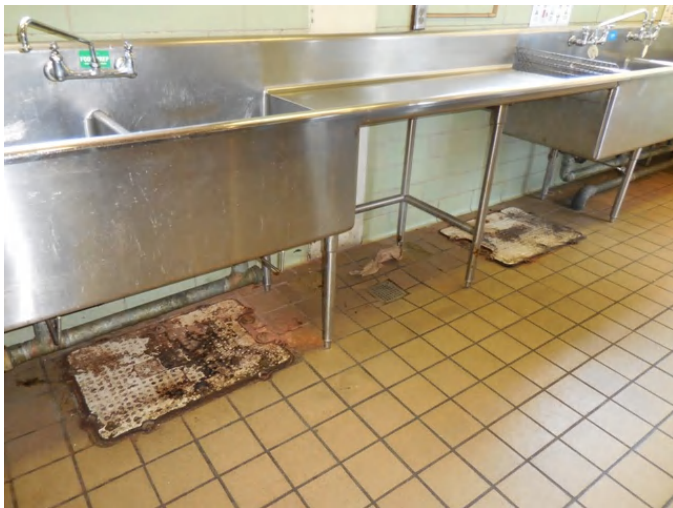
System: D2030 - Sanitary Waste

Location: Throughout Building

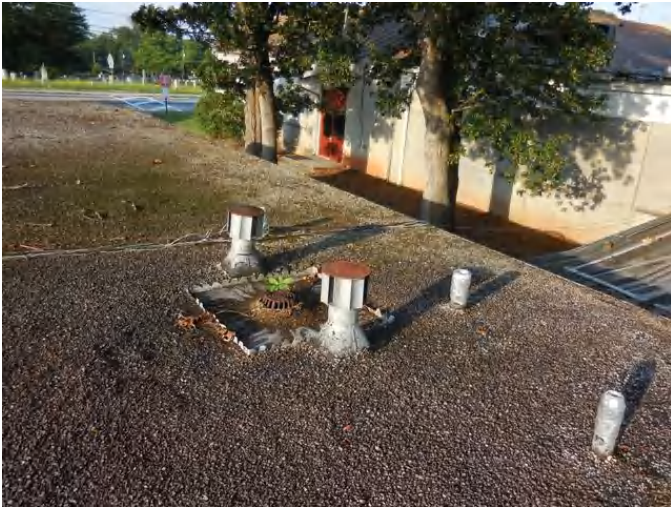
System: D2040 - Rain Water Drainage

Location: Throughout Building

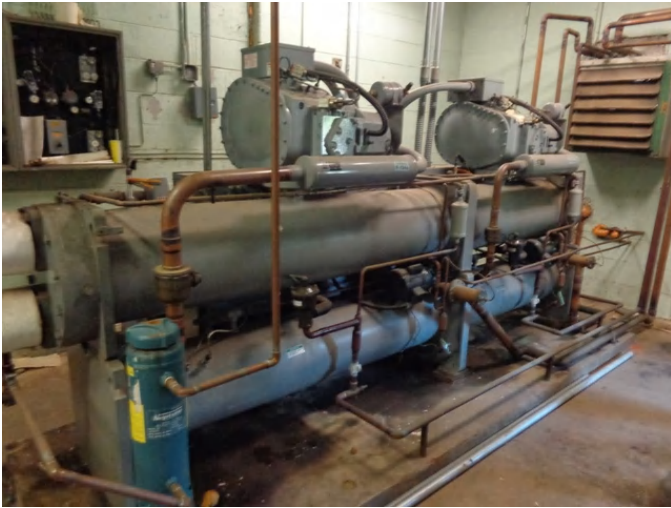
System: D3030 - Cooling Generating Systems

Location: Mechanical Room/Throughout Building

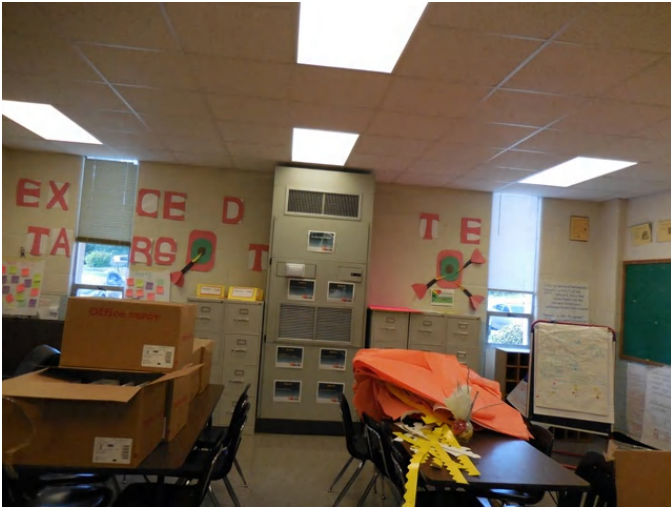
System: D3050 - Terminal & Package Units

Location: Throughout Building

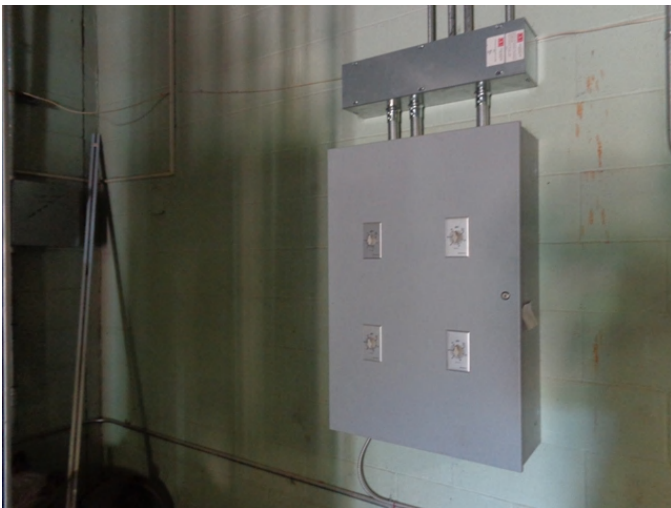
System: D3060 - Controls & Instrumentation

Location: Throughout Building

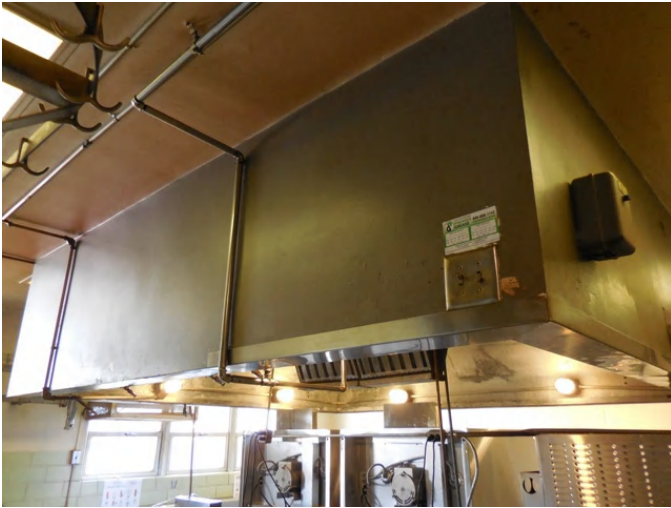
System: D3090 - Other HVAC Systems/Equip - Kitchen Hood

Location: Kitchen

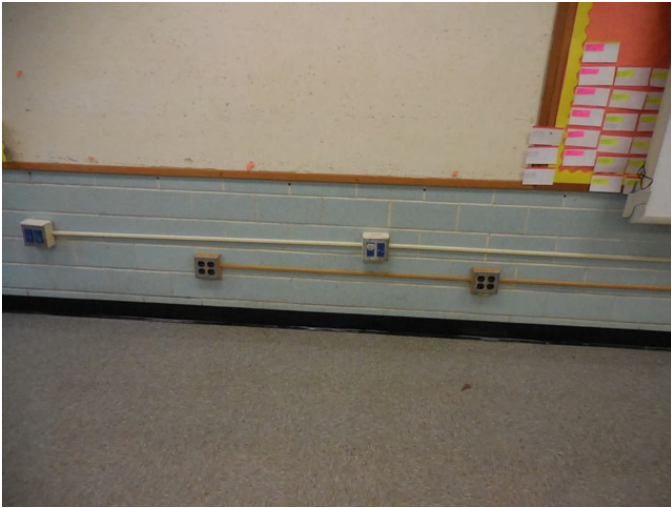
System: D5020 - Branch Wiring

Location: Throughout Building

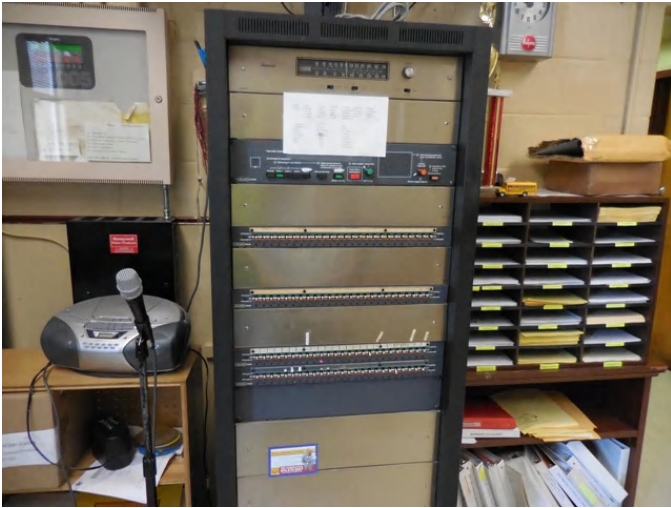
System: D5030 - Communications and Security - Clock & PA Systems

Location: Throughout Building

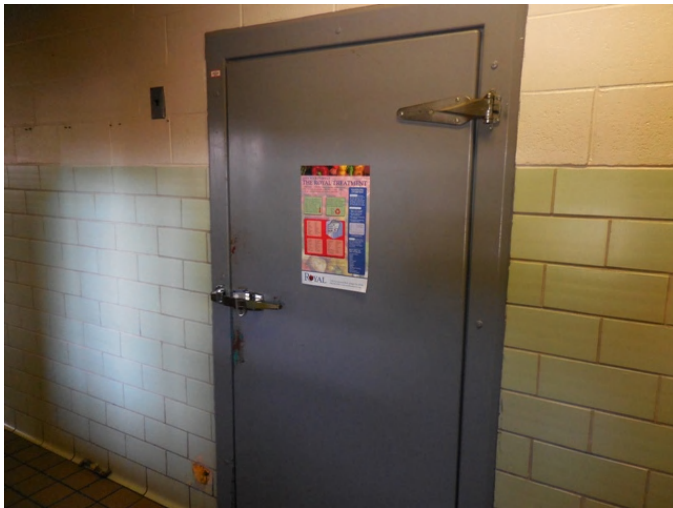
System: E1090 - Other Equipment - Kitchen Equipment

Location: Kitchen

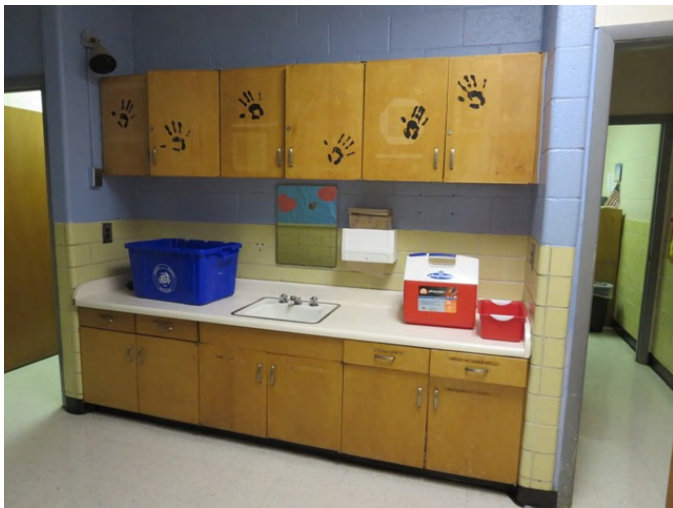
System: E2010 - Fixed Furnishings

Location: Throughout Building

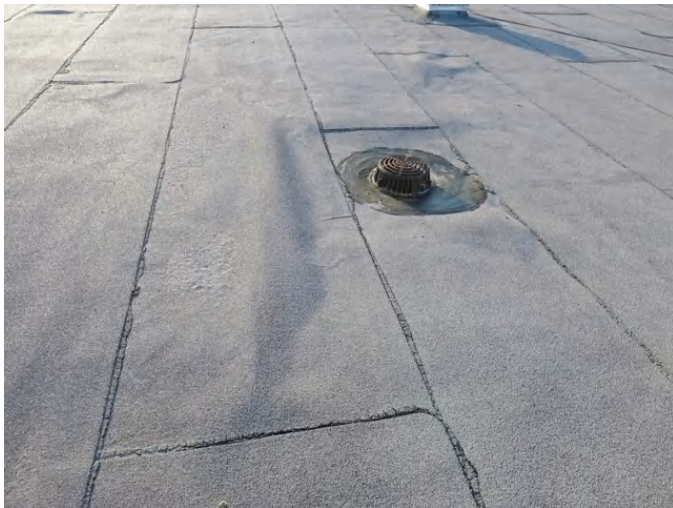
System: B3010 - Roof Coverings - BUR

Location: Roof

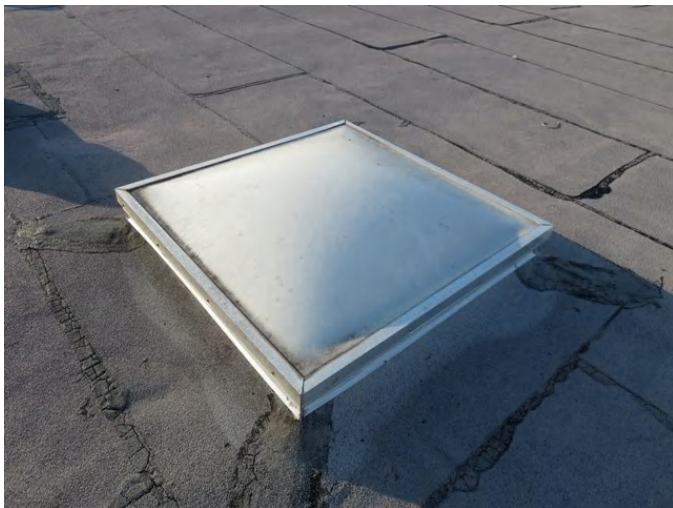
System: B3020 - Roof Openings

Location: Roof

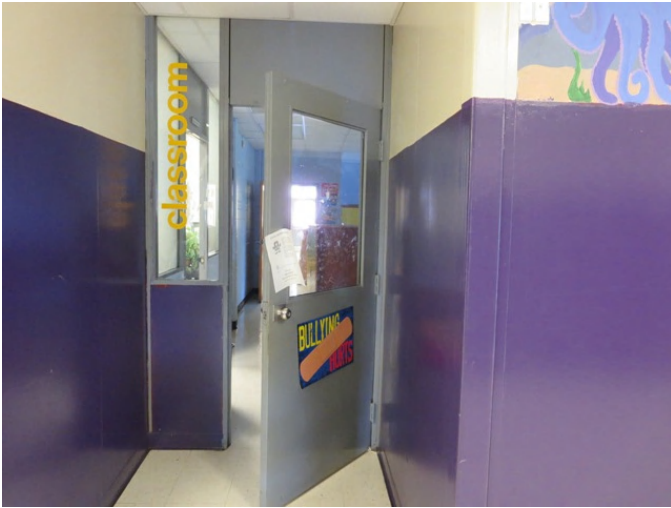
System: C1020 - Interior Doors

Location: Throughout Building

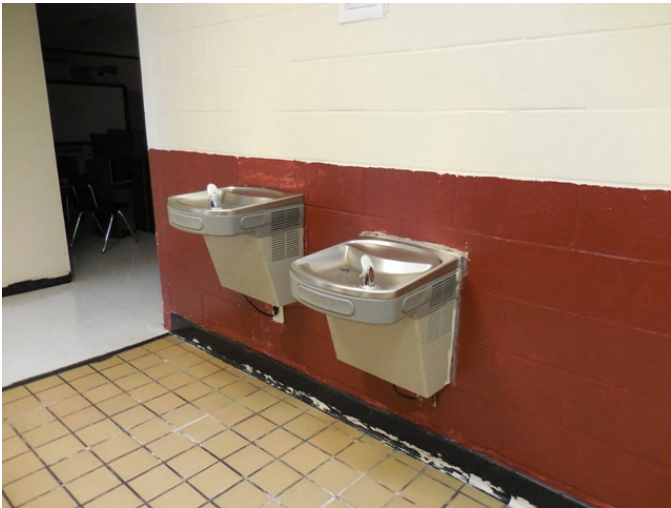
System: D2010 - Plumbing Fixtures

Location: Hallway

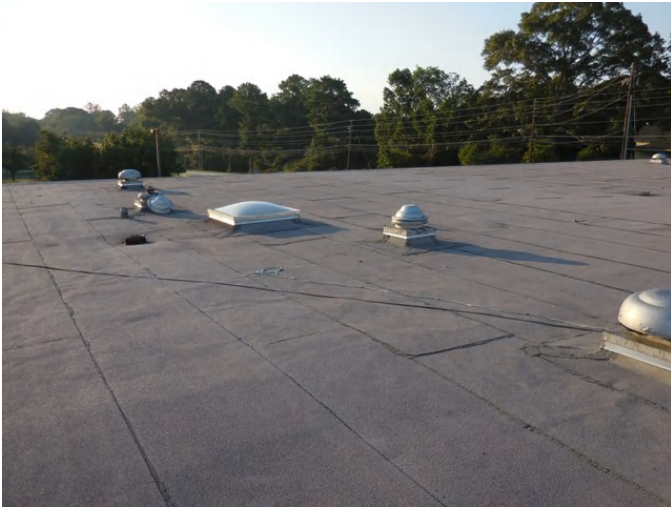
System: D3040 - Distribution & Exhaust Systems

Location: Throughout Building

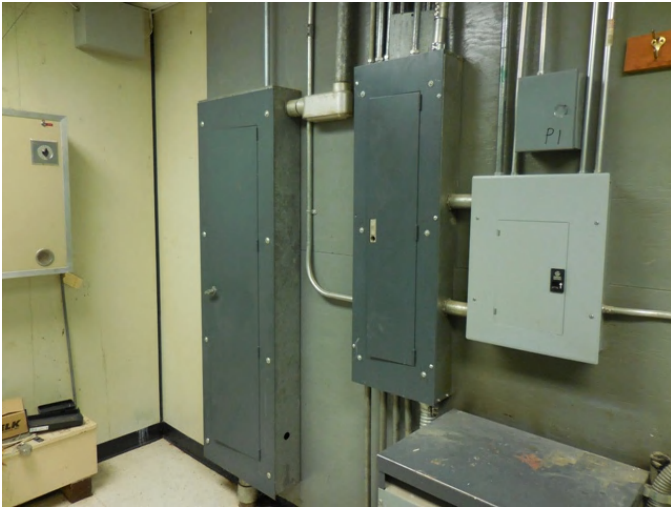
System: D5010 - Electrical Service/Distribution

Location: Main Switch Room/Throughout Building

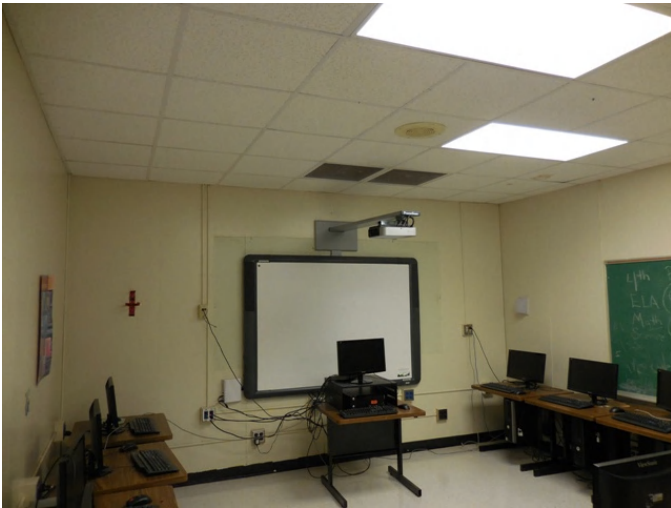
System: D5020 - Branch Wiring

Location: Throughout Building

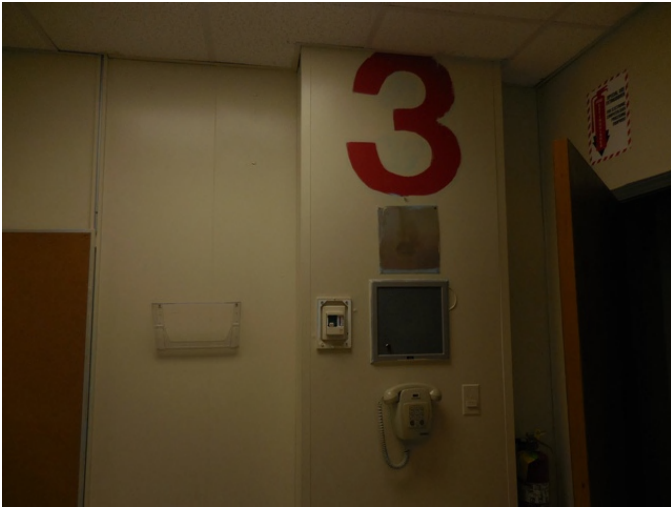
System: D5030 - Communications and Security - Clock & PA Systems

Location: Throughout Building
Distress: Beyond Service Life
Category: Deferred Maintenance
Priority: 3 Priority
Correction: Renew System
Qty: 21,000.00
Unit of Measure: S.F.
Estimate: \$129,360.00
Assessor Name: Sam Mandola
Date Created: 04/11/2015

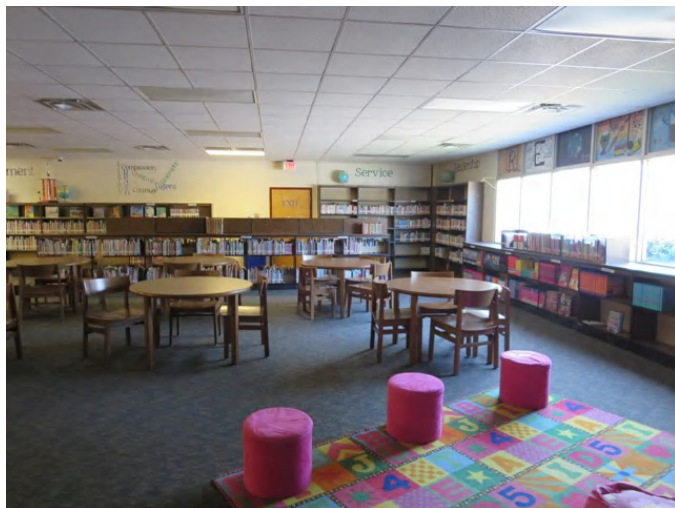
System: E2010 - Fixed Furnishings

Location: Media Center

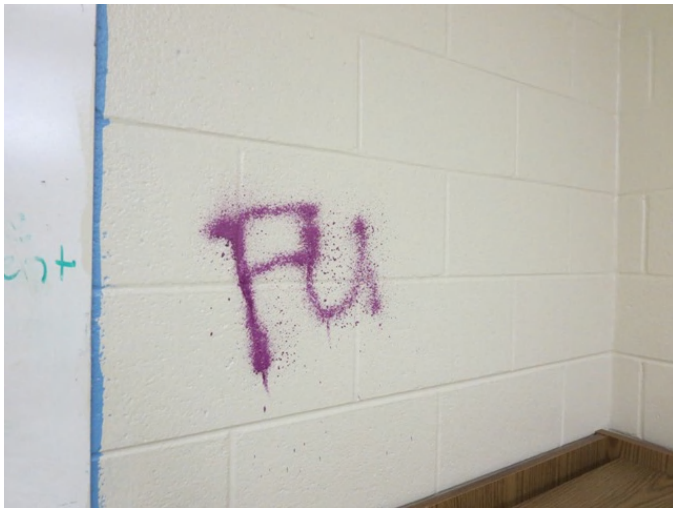
System: C3010 - Wall Finishes - Paint

Location: Throughout Building

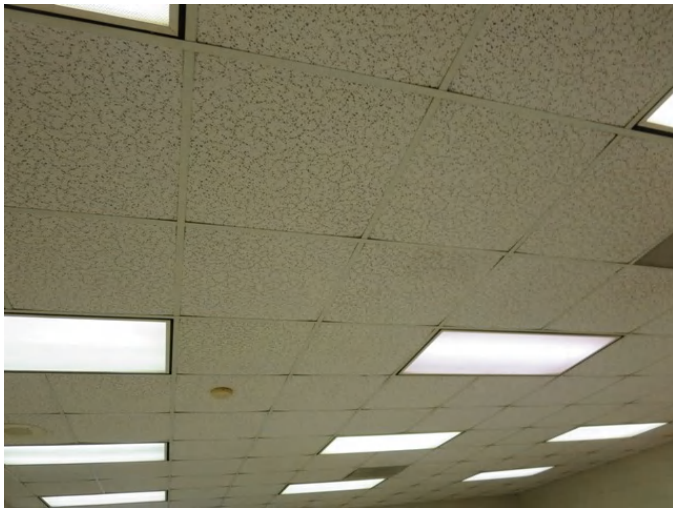
System: C3030 - Ceiling Finishes

Location: Throughout Building

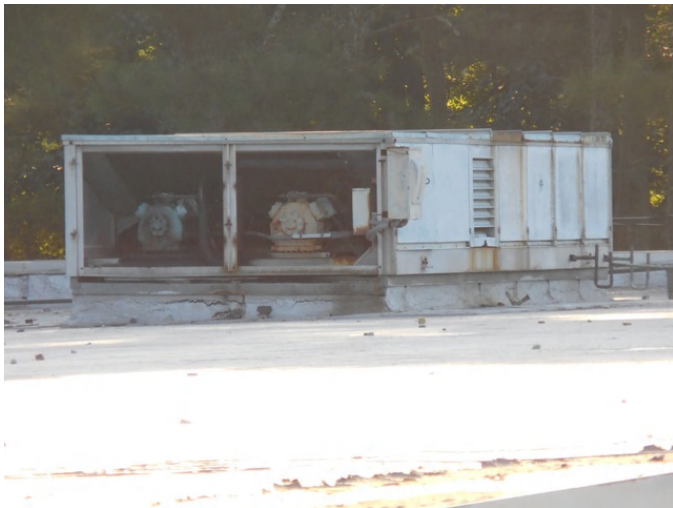
System: D3050 - Terminal & Package Units

Location: Roof

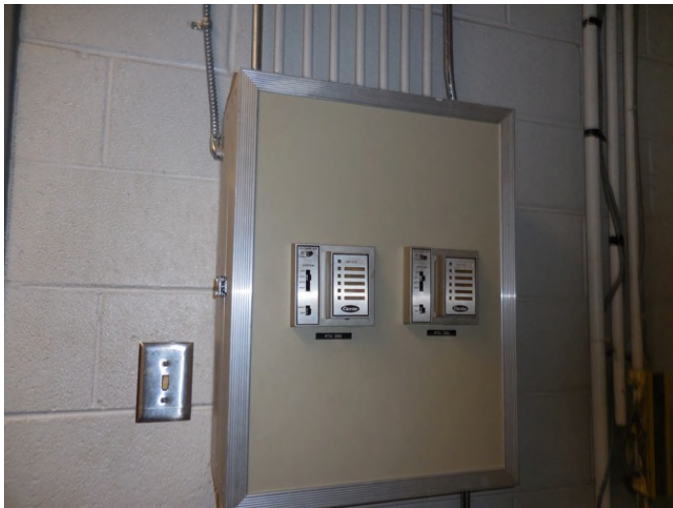
System: D3060 - Controls & Instrumentation

Location: Throughout Building

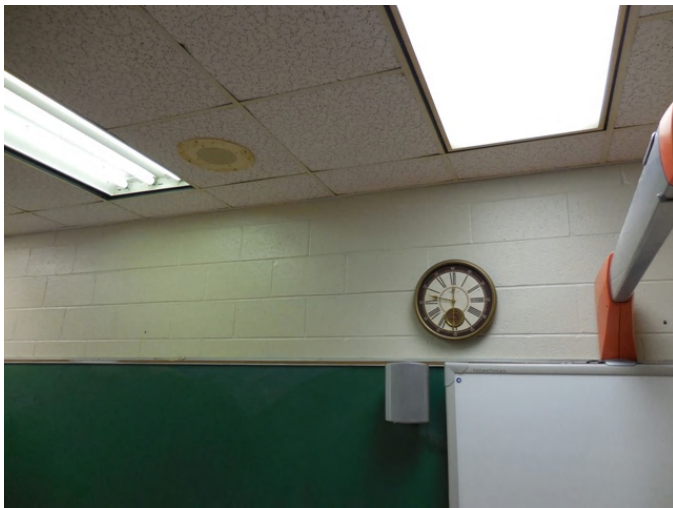
System: D5030 - Communications and Security - Clock & PA Systems

Location: Throughout Building

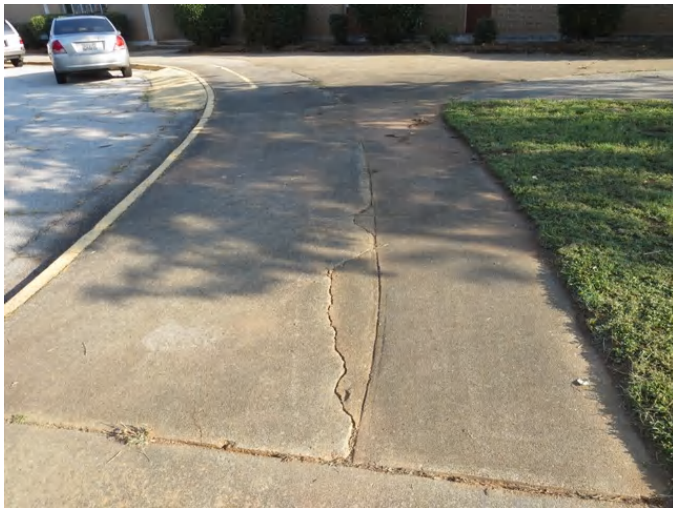
System: G2030 - Pedestrian Paving

Location: Site
Distress: Beyond Service Life
Category: Deferred Maintenance
Priority: 3 Priority
Correction: Renew System
Qty: 85,676.00
Unit of Measure: S.F.
Estimate: \$141,365.00
Assessor Name: Sam Mandola
Date Created: 08/11/2015

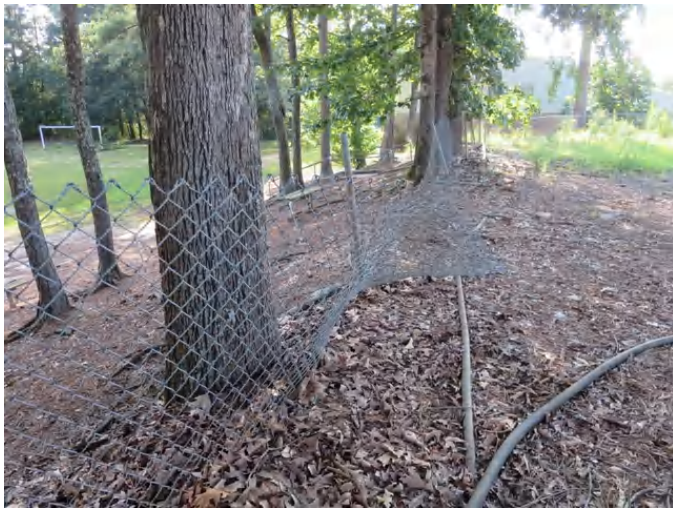
System: G2040 - Fencing & Guardrails

Location: Site
Distress: Beyond Service Life
Category: Deferred Maintenance
Priority: 3 Priority
Correction: Renew System
Qty: 85,676.00
Unit of Measure: S.F.
Estimate: \$85,762.00
Assessor Name: Sam Mandola
Date Created: 08/11/2015
