DeKalb County School District/Elementary Schools

# Rock Chapel Elementary

## School Assessment Report

May 20, 2016

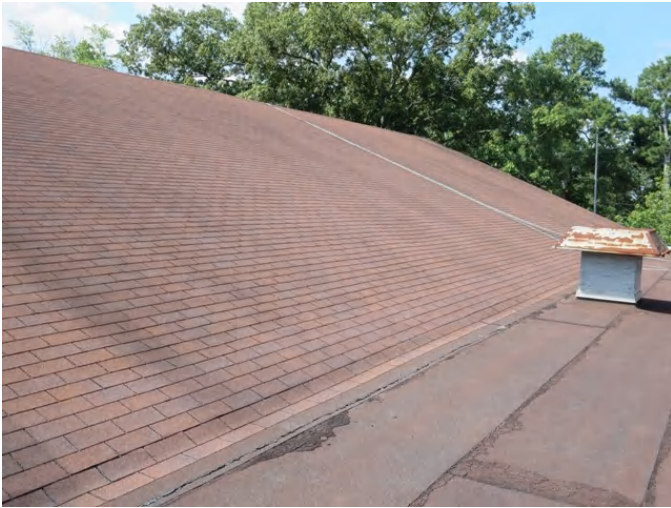
**System: B3010 - Roof Coverings - Asphalt Shingles**

**Location:** Pitch Roof

**Distress:** Beyond Service Life

**Notes:** The asphalt shingle roofing is aged, has some damage, and should be replaced. SPLOST project 323-422 to replace (or recommend other alternative) the asphalt roof shingles on the 1969 and 1975 buildings.

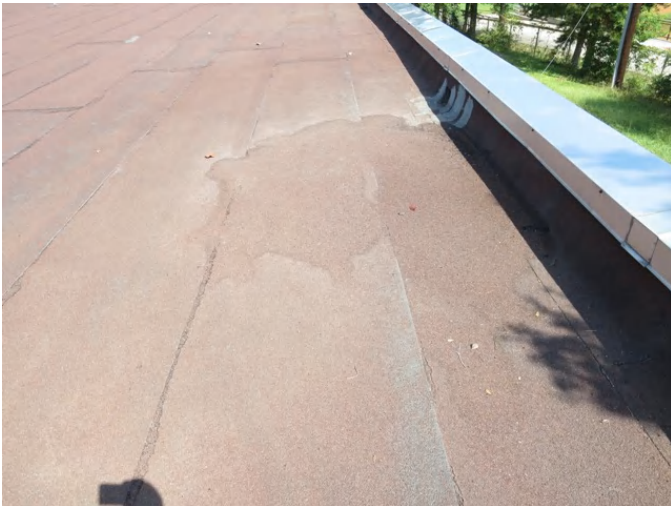
**System: B3010 - Roof Coverings - BUR**

**Location:** Roof

**Distress:** Inadequate

**Notes:** The built-up roof covering is aged, showing signs of failure, and should be replaced. SPLOST project 323-422 to replace the BUR roof on the 1969 and 1975 buildings.

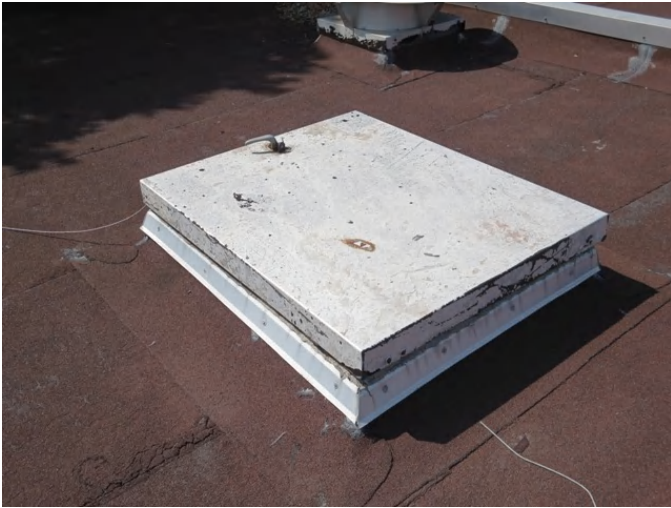
### **System: B3020 - Roof Openings**

**Location:** Roof

**Notes:** The original metal roof openings are rusted, damaged, and should be replaced. SPLOST project 323-422 to replace the roof openings and add ladders and roof hatches on all buildings.

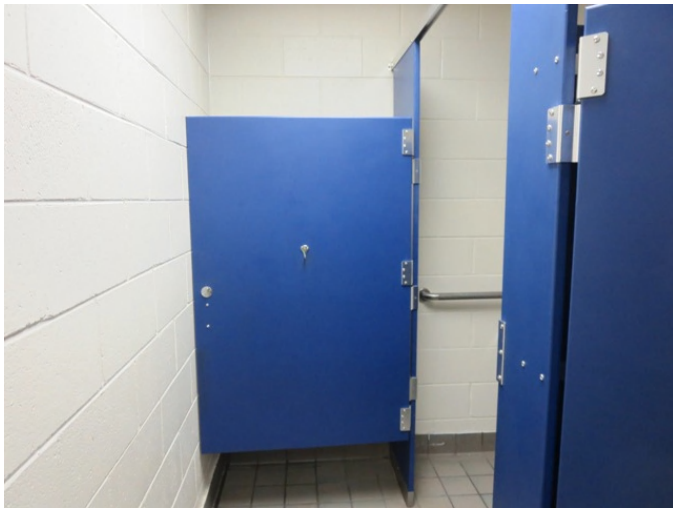
**System: C1030 - Fittings**

**Location:** Throughout Building

**Notes:** Fittings, such as toilet partitions, handrails and signage, are beyond their expected service life, not ADA complaint, and should be replaced.

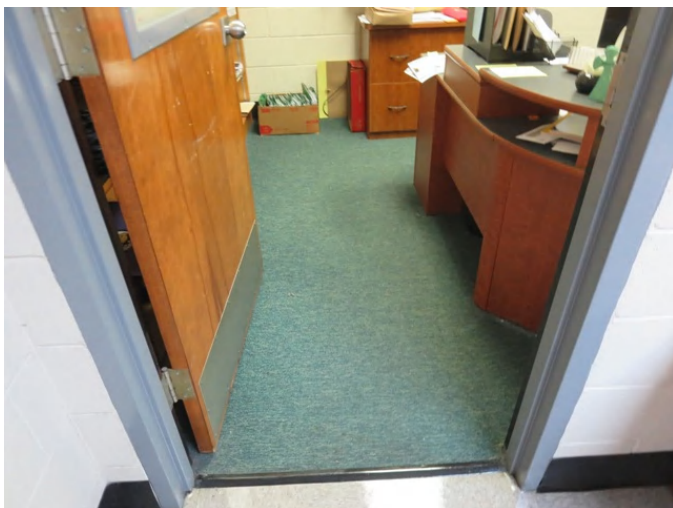
**System: C3020 - Floor Finishes - Carpet**

**Location:** Offices

**Notes:** The carpet in the meeting room is stained, showing signs of failure, and should be replaced. SPLOST project 323-422 to replace carpet throughout all buildings, as needed.

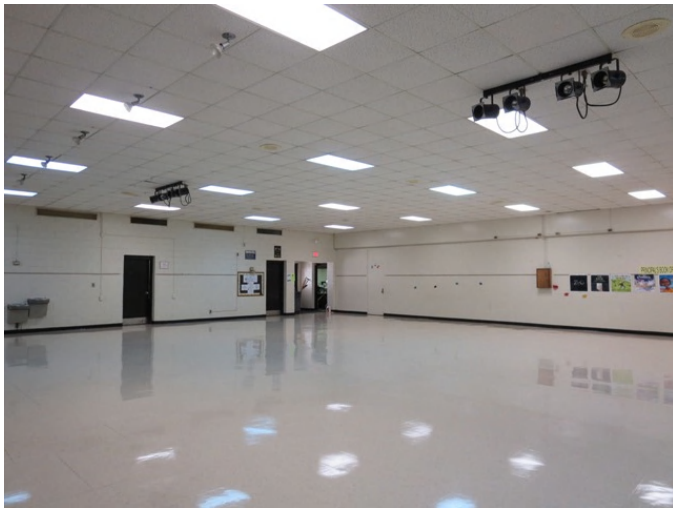
**System: C3020 - Floor Finishes - VCT**

**Location:** Cafeteria and Classrooms

**Notes:** The VCT flooring is aged, cracked and worn, and should be replaced.

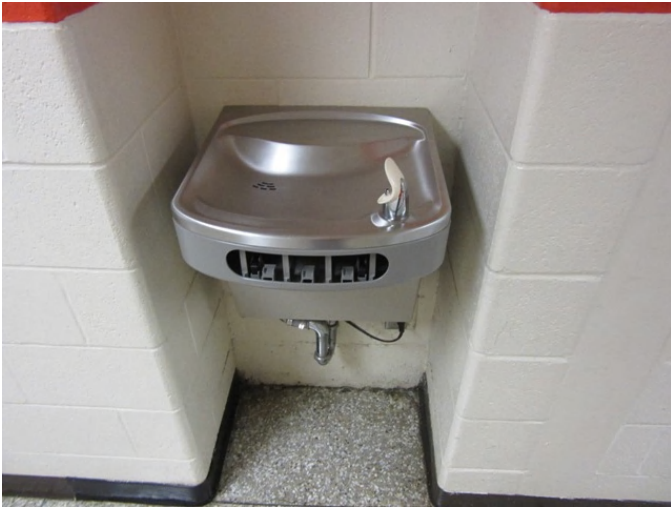
**System: D2010 - Plumbing Fixtures**

**Location:** Throughout Building

**Notes:** The plumbing fixtures are beyond their expected service life, damaged, not ADA compliant, and should be replaced. Some water fountains protrude more than 4" into hallway which is not ADA compliant.

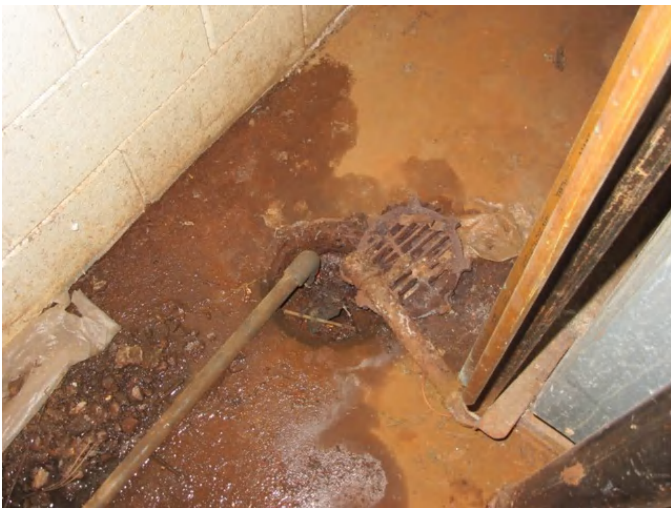
**System: D2030 - Sanitary Waste**

**Location:** Throughout Building

**Notes:** The sanitary waste system is beyond its expected service life and should be scheduled for replacement. School staff reports sewer smells in building.

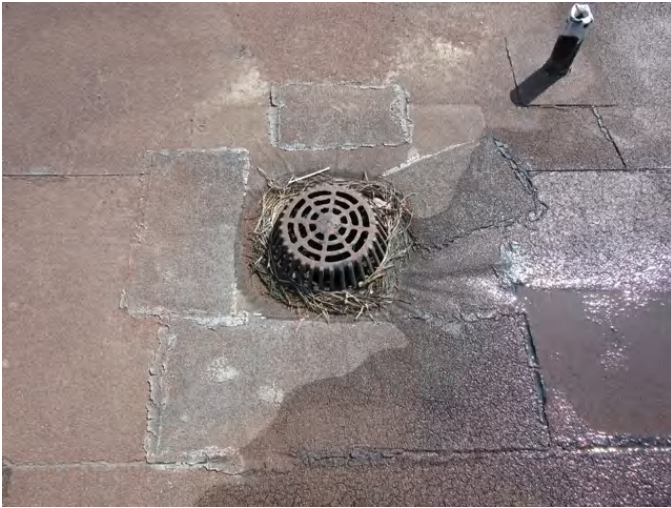
**System: D2040 - Rain Water Drainage**

**Location:** Throughout Building

**Notes:** The rainwater drainage system is beyond its expected service life and should be scheduled for replacement. School staff reports that the rain water collection system runs over and floods the building.

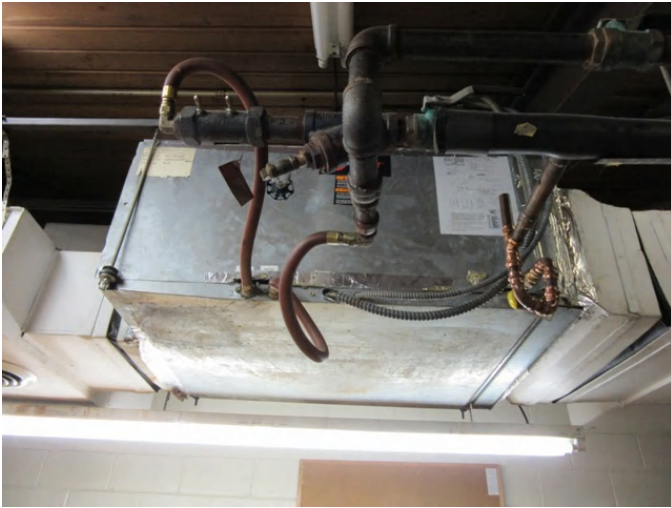
**System: D3050 - Terminal & Package Units**

**Location:** Throughout Building  
**Distress:** Beyond Service Life  
**Category:** Deferred Maintenance / Energy  
**Priority:** 3 Priority  
**Correction:** Renew System  
**Qty:** 22,251.00  
**Unit of Measure:** S.F.  
**Estimate:** \$453,297.00  
**Assessor Name:** Ben Nixon  
**Date Created:** 04/11/2015

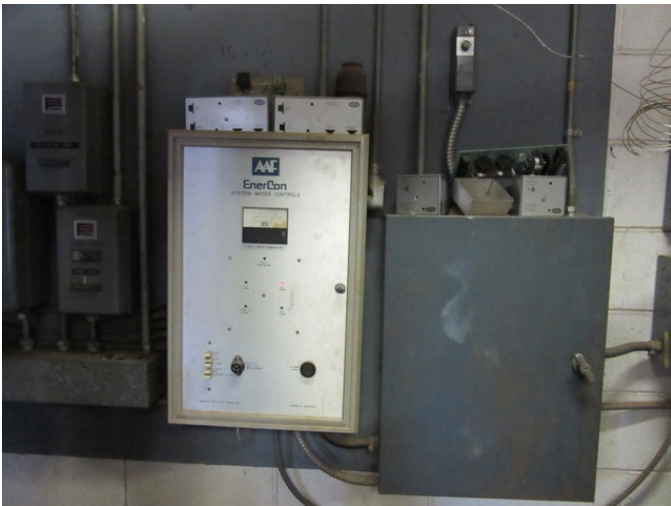
**System: D3060 - Controls & Instrumentation**

**Location:** Throughout Building  
**Distress:** Beyond Service Life  
**Category:** Deferred Maintenance / Energy  
**Priority:** 3 Priority  
**Correction:** Renew System  
**Qty:** 22,251.00  
**Unit of Measure:** S.F.  
**Estimate:** \$88,114.00  
**Assessor Name:** Ben Nixon  
**Date Created:** 04/11/2015

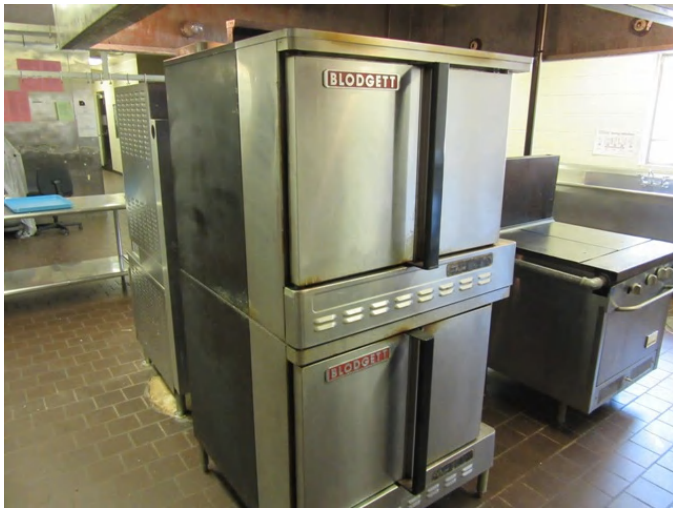
**System: E1090 - Other Equipment - Kitchen Equipment**

**Location:** Kitchen  
**Distress:** Beyond Service Life  
**Category:** Deferred Maintenance  
**Priority:** 3 Priority  
**Correction:** Renew System  
**Qty:** 22,251.00  
**Unit of Measure:** S.F.  
**Estimate:** \$497,599.00  
**Assessor Name:** Ben Nixon  
**Date Created:** 04/11/2015

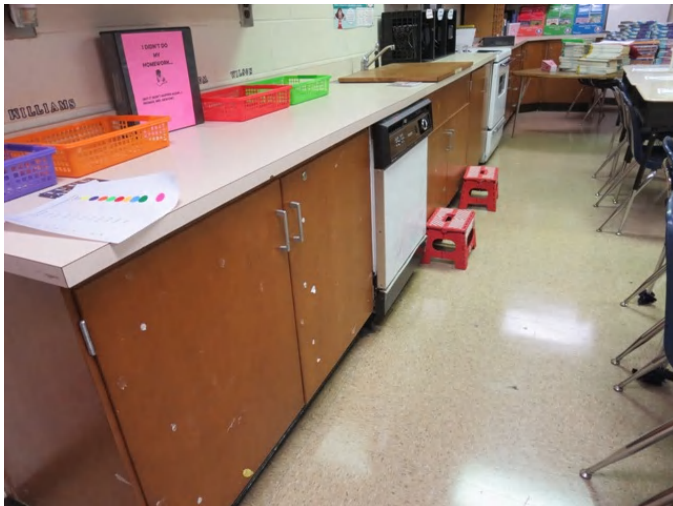
**System: E2010 - Fixed Furnishings**

**Location:** Throughout Building  
**Distress:** Beyond Service Life  
**Category:** Deferred Maintenance  
**Priority:** 3 Priority  
**Correction:** Renew System  
**Qty:** 22,251.00  
**Unit of Measure:** S.F.  
**Estimate:** \$131,437.00  
**Assessor Name:** Ben Nixon  
**Date Created:** 04/11/2015

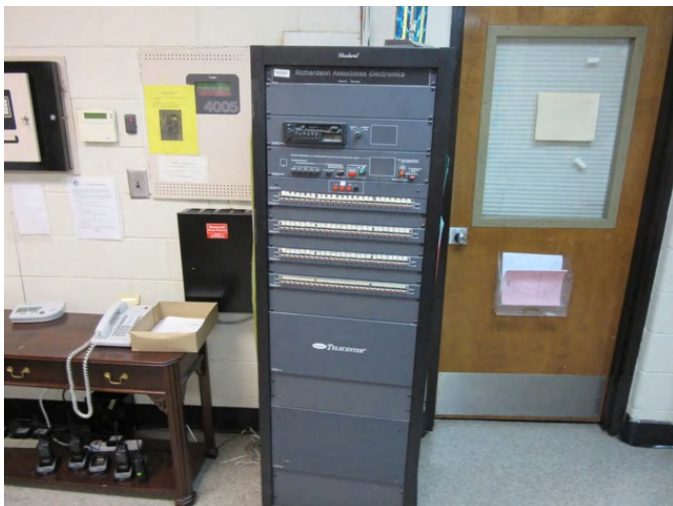
**System: D5030 - Communications and Security - Clock & PA Systems**

**Location:** Throughout Building  
**Distress:** Beyond Service Life  
**Category:** Deferred Maintenance  
**Priority:** 3 Priority  
**Correction:** Renew System  
**Qty:** 22,000.00  
**Unit of Measure:** S.F.  
**Estimate:** \$135,520.00  
**Assessor Name:** Ben Nixon  
**Date Created:** 07/27/2015

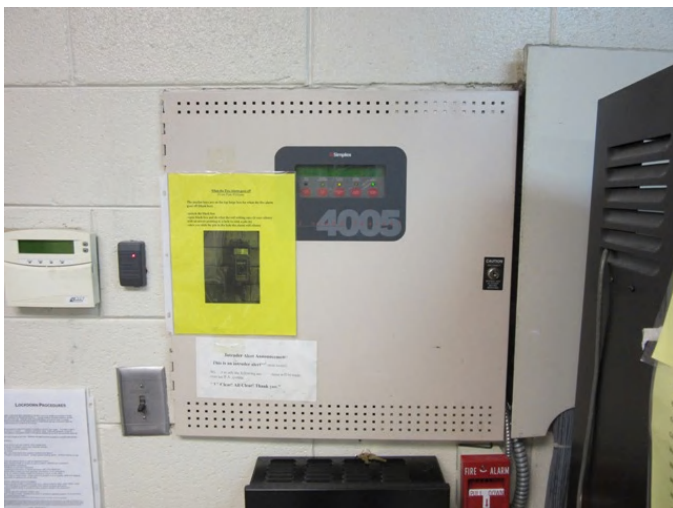
**System: D5030 - Communications and Security - Fire Alarm**

**Location:** Throughout Building  
**Distress:** Beyond Service Life  
**Category:** Deferred Maintenance / Building Code Compliance  
**Priority:** 3 Priority  
**Correction:** Renew System  
**Qty:** 22,000.00  
**Unit of Measure:** S.F.  
**Estimate:** \$29,766.00  
**Assessor Name:** Ben Nixon  
**Date Created:** 07/27/2015
