DeKalb County School District/Middle Schools

# Ronald McNair Sr. Middle

## School Assessment Report

May 20, 2016

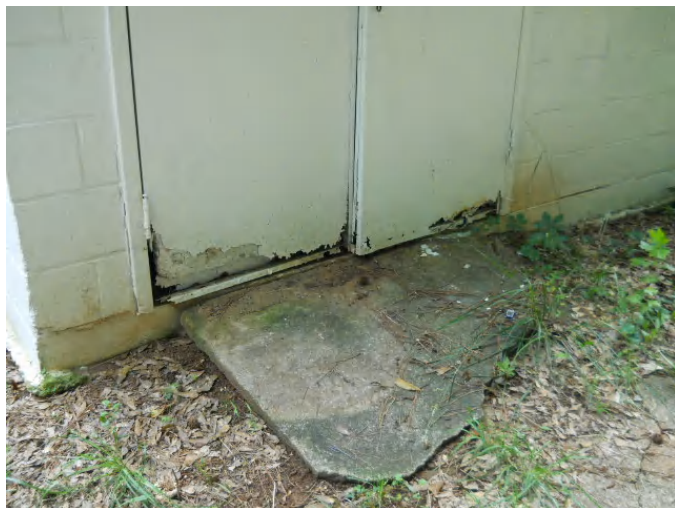
#### System: B2030 - Exterior Doors

**Location:** Exterior Walls

**Notes:** The exterior doors are beyond their expected service life, damaged and rusted, and should be replaced.

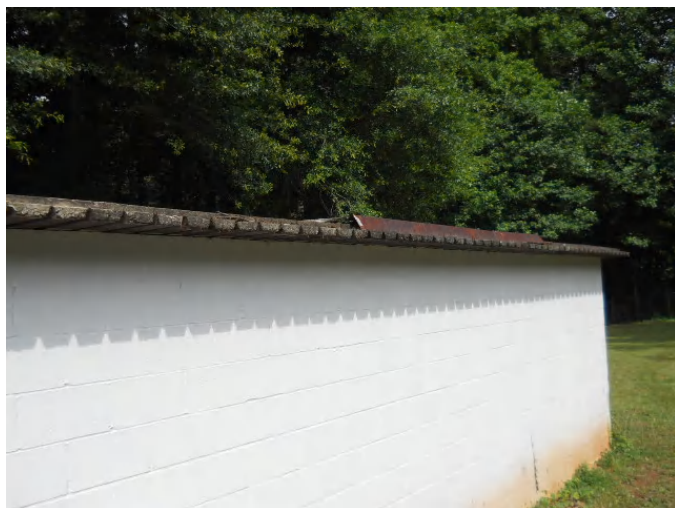
#### System: B3010 - Roof Coverings

**Location:** Roof

**Notes:** The roof covering is beyond its expected service life, damaged, and should be replaced.

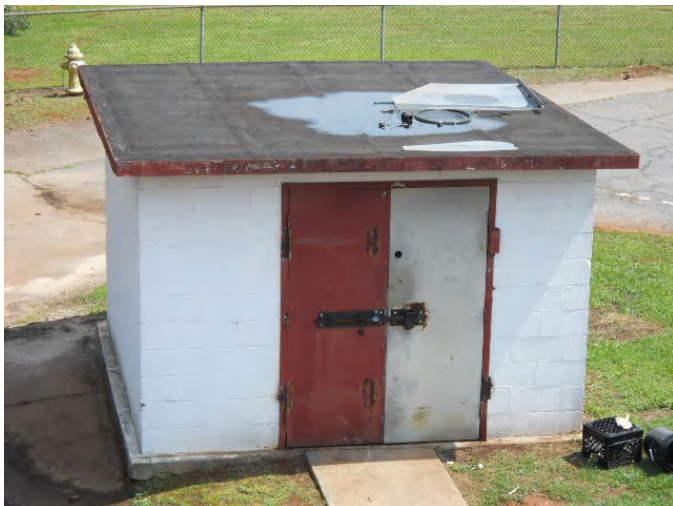
#### **System: B3010 - Roof Coverings**

**Location:** Roof

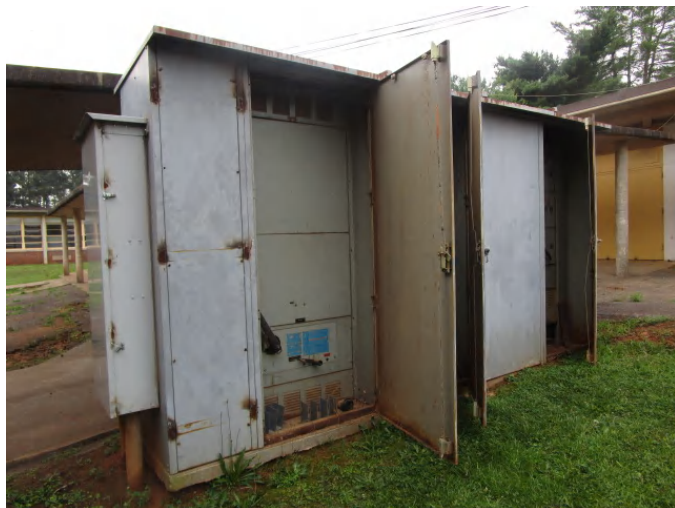
#### **System: D5010 - Electrical Service/Distribution**

**Location:** Outside Mechanical Room

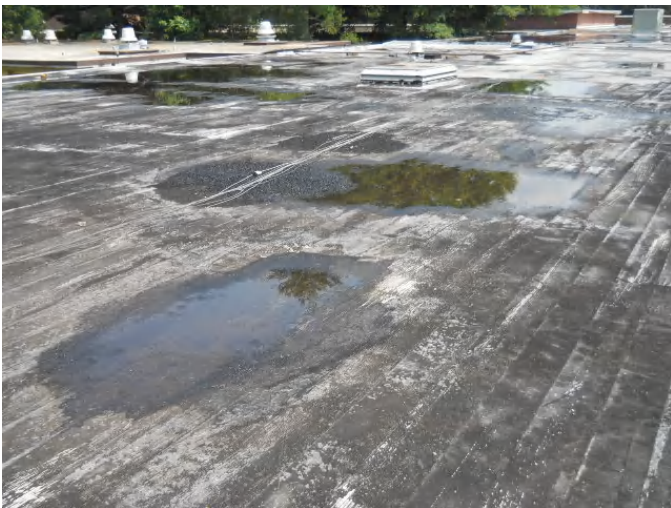
**System: B3020 - Roof Openings**

**Location:** Roof

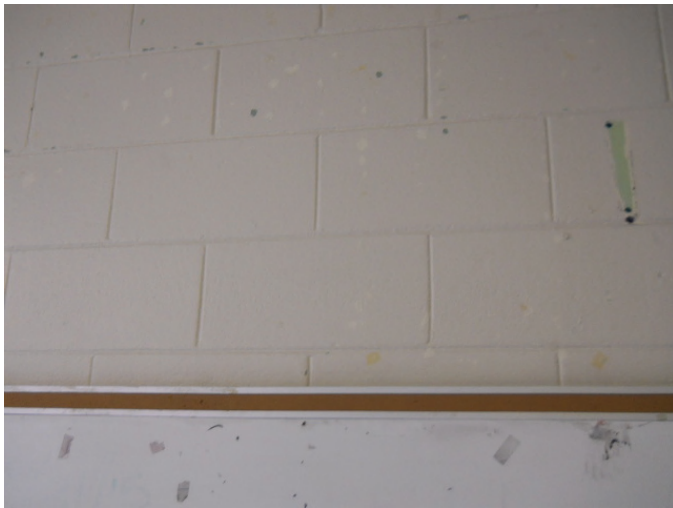
**System: C3010 - Wall Finishes - Paint**

**Location:** Throughout Building

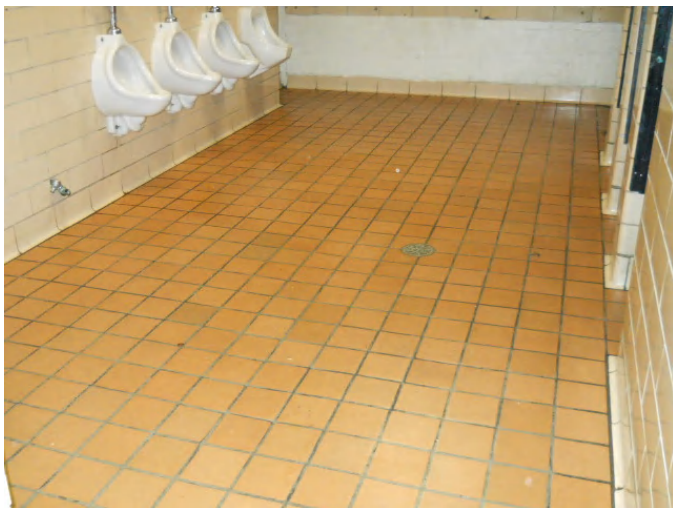
**System: C3020 - Floor Finishes - Ceramic & Quarry Tile**

**Location:** Kitchen, Restrooms

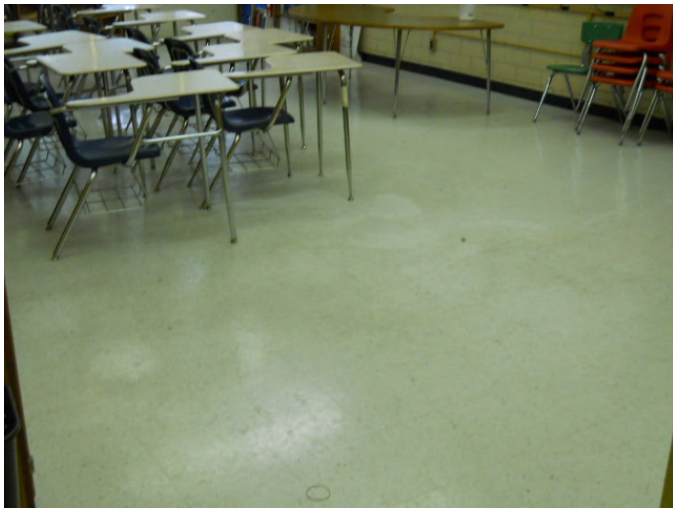
**System: C3020 - Floor Finishes - VCT**

**Location:** Throughout Building

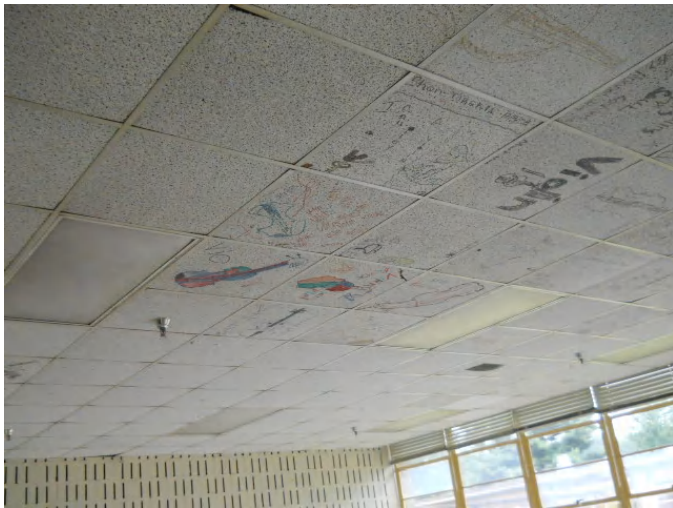
**System: C3030 - Ceiling Finishes**

**Location:** Throughout Building

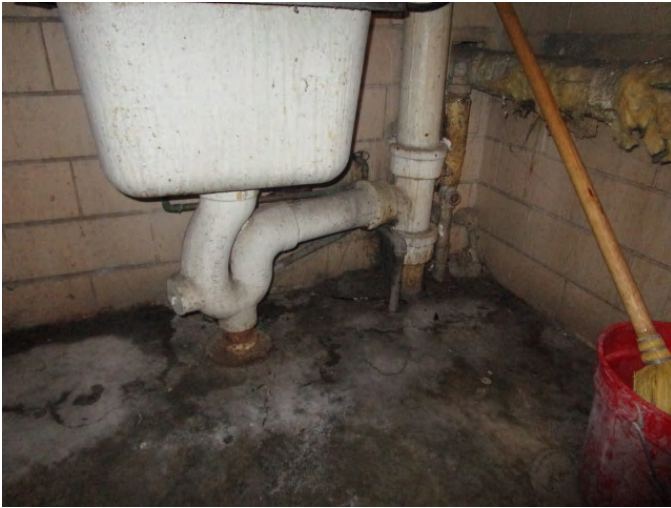
**System: D2030 - Sanitary Waste**

**Location:** Throughout Building  
**Distress:** Beyond Service Life  
**Category:** Deferred Maintenance  
**Priority:** 3 Priority  
**Correction:** Renew System  
**Qty:** 114,440.00  
**Unit of Measure:** S.F.  
**Estimate:** \$545,078.00  
**Assessor Name:** Ben Nixon  
**Date Created:** 04/11/2015

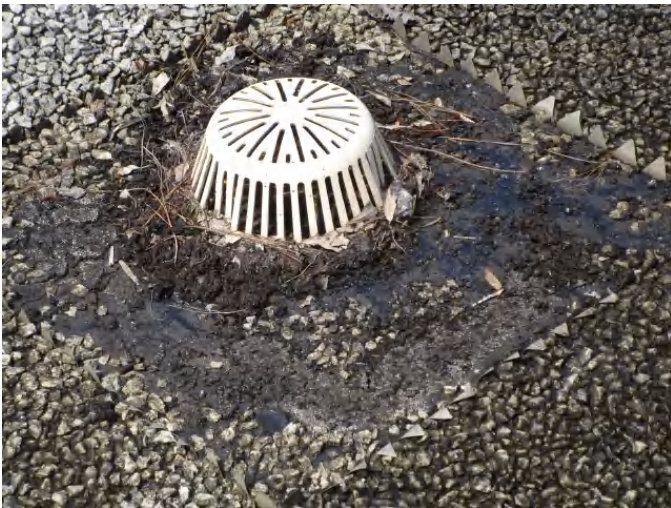
**System: D2040 - Rain Water Drainage**

**Location:** Throughout Building  
**Distress:** Beyond Service Life  
**Category:** Deferred Maintenance  
**Priority:** 3 Priority  
**Correction:** Renew System  
**Qty:** 114,440.00  
**Unit of Measure:** S.F.  
**Estimate:** \$115,813.00  
**Assessor Name:** Ben Nixon  
**Date Created:** 04/11/2015

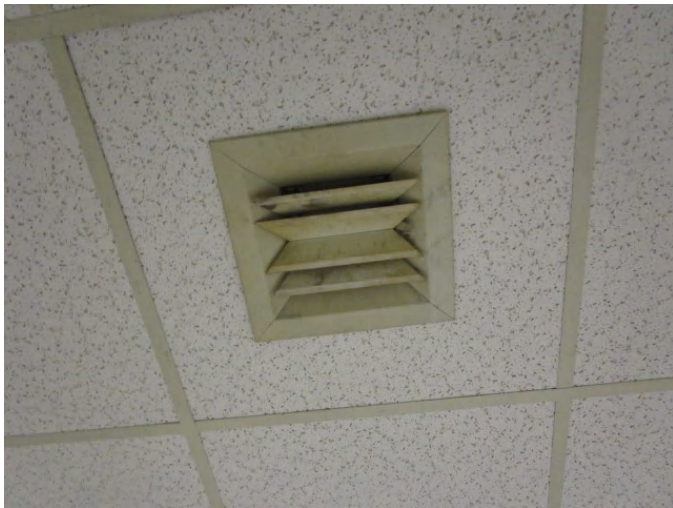
**System: D3040 - Distribution Systems & Exhaust Systems**

**Location:** Throughout Building

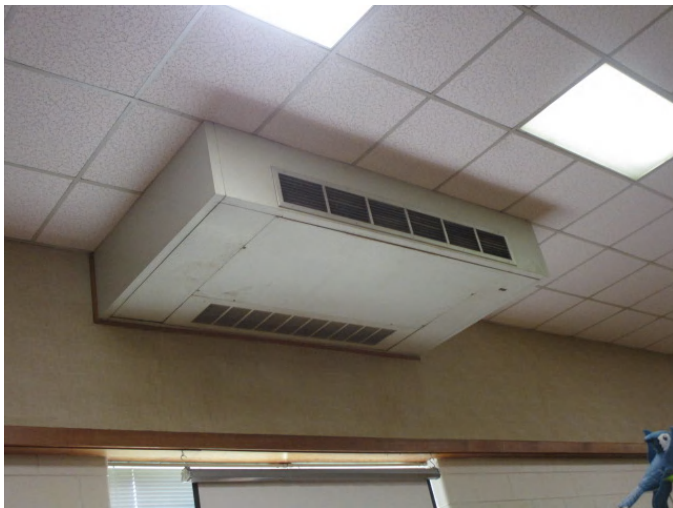
**System: D3050 - Terminal & Package Units**

**Location:** Throughout Building

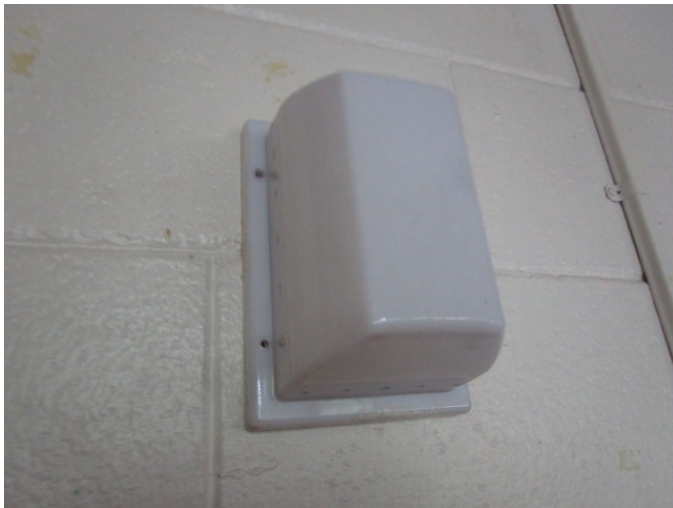
**System: D3060 - Controls & Instrumentation**

**Location:** Throughout Building

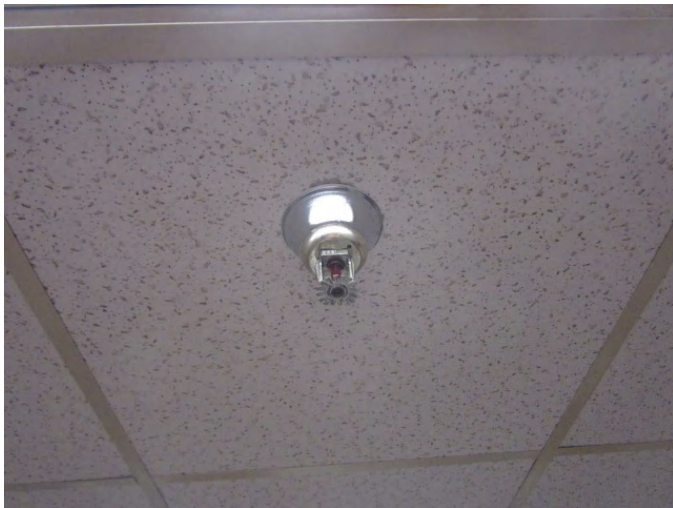
**System: D4010 - Sprinklers**

**Location:** Band and Chorus Classroom

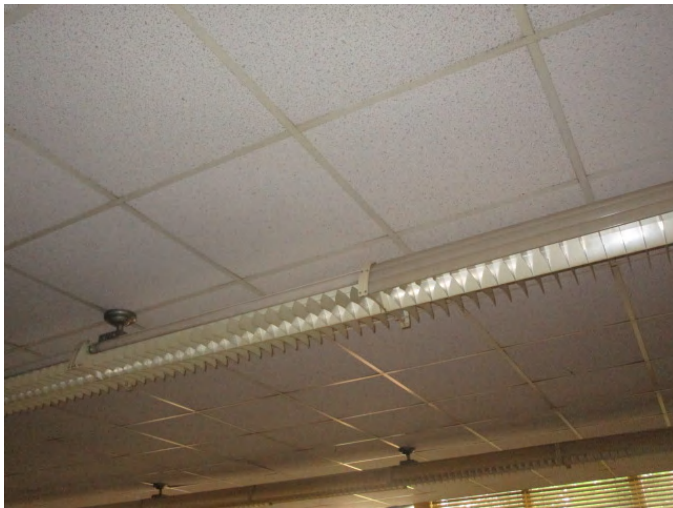
**System: D5020 - Lighting**

**Location:** Throughout Building

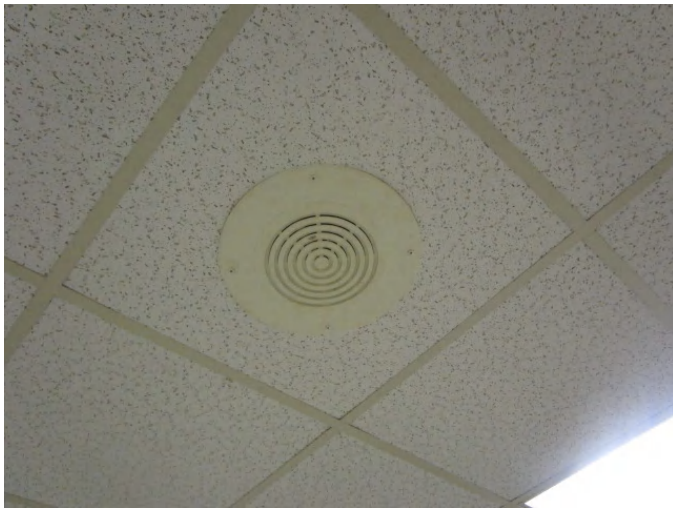
**System: D5030 - Communications and Security - PA & Clock Systems**

**Location:** Throughout Building

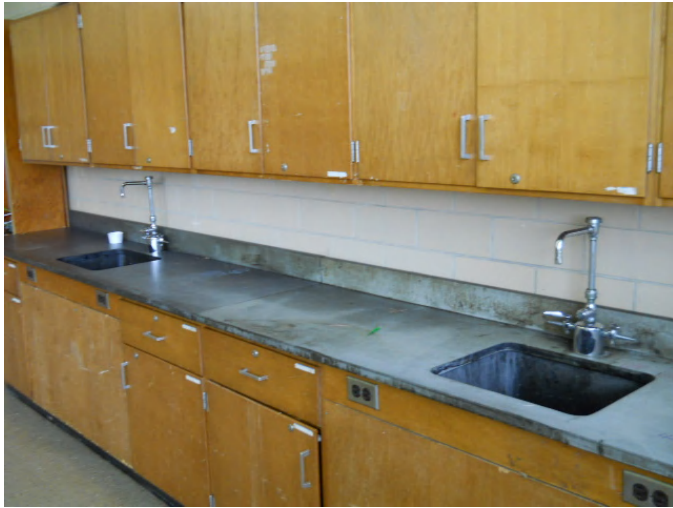
**System: E2010 - Fixed Furnishings**

**Location:** Throughout Building

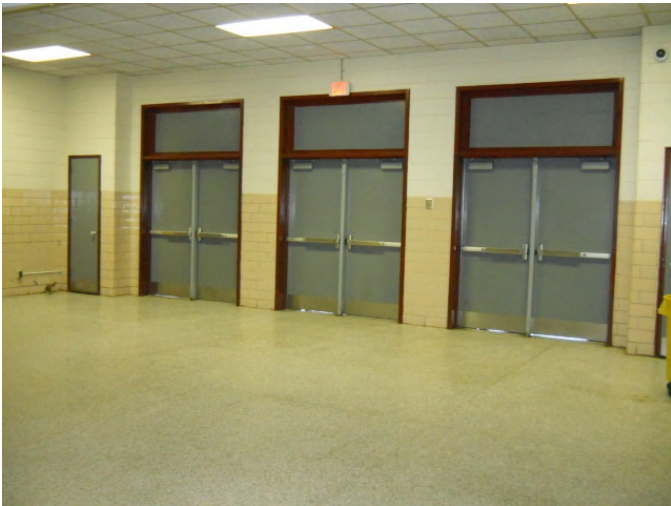
#### **System: B2030 - Exterior Doors**

**Location:** Throughout Building

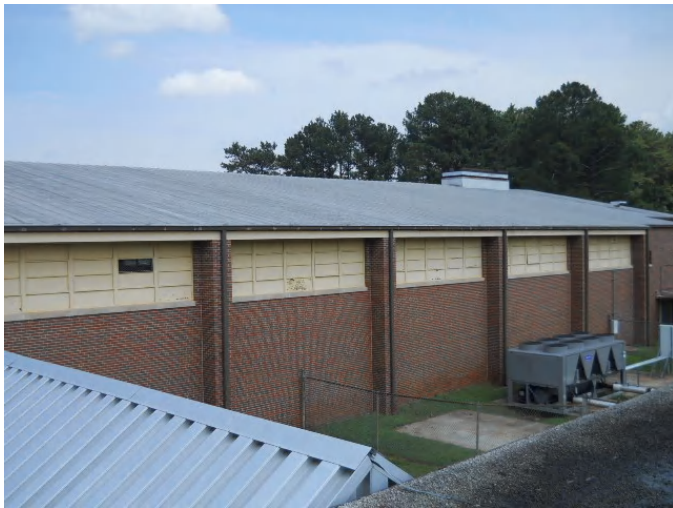
**System: B3010 - Roof Coverings - BUR**

**Location:** Roof

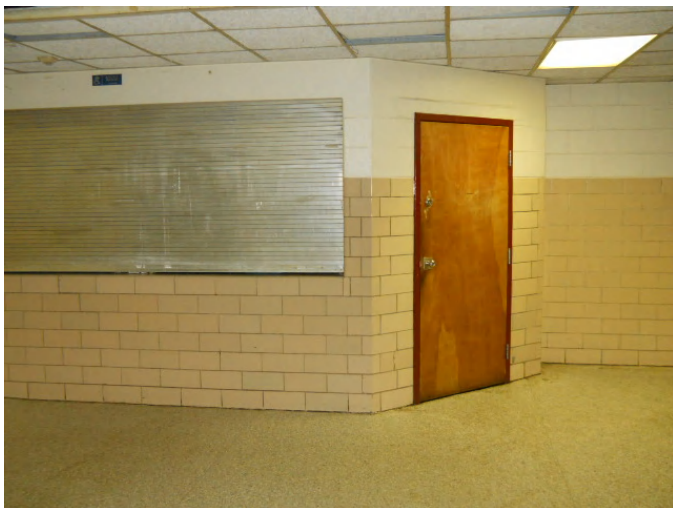
**System: C1020 - Interior Doors**

**Location:** Throughout Building

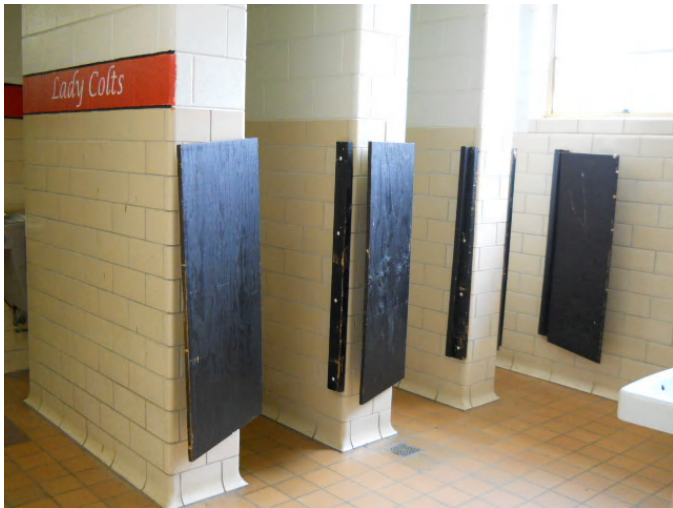
**System: C1030 - Fittings**

**Location:** Throughout Building

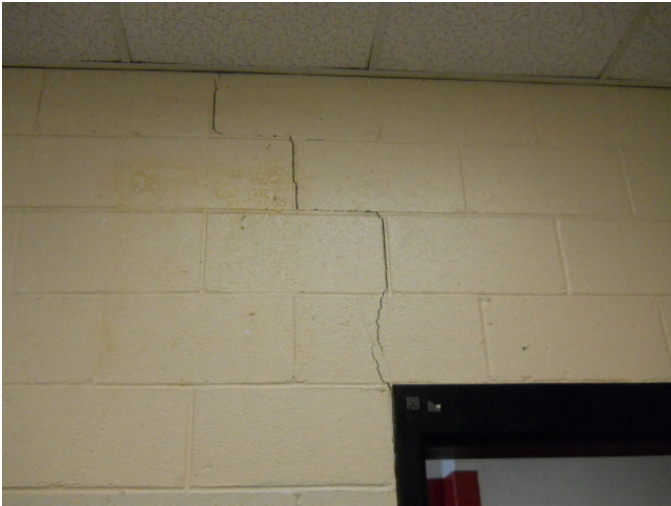
#### **System: A1010 - Standard Foundations**

**Location:** East Corner of Building

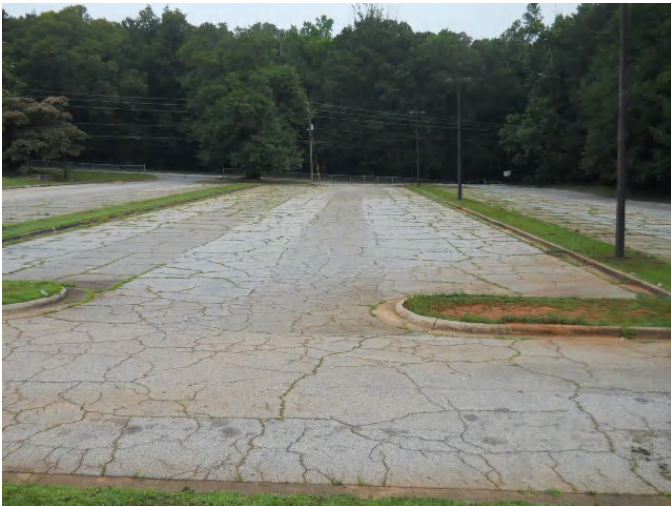
#### System: G2020 - Parking Lots

**Location:** Site

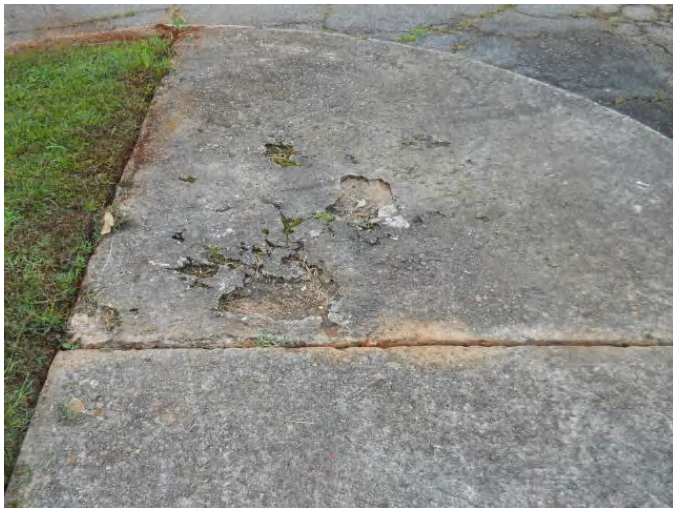
**System: G2030 - Pedestrian Paving**

**Location:** Site

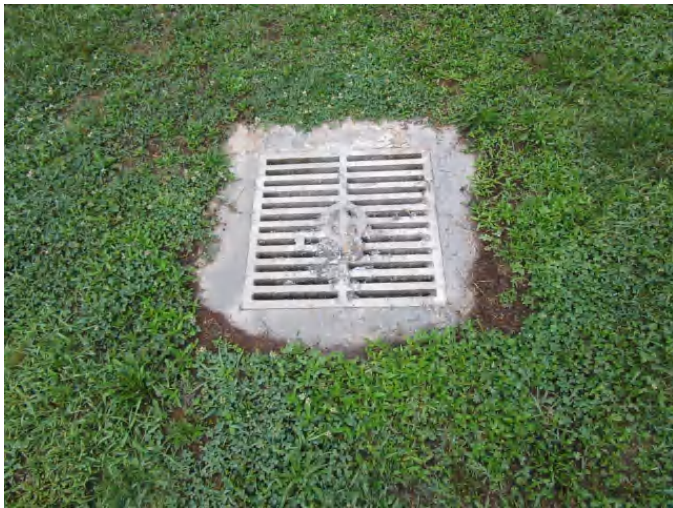
**System: G3030 - Storm Sewer**

**Location:** Site  
**Distress:** Beyond Service Life  
**Category:** Deferred Maintenance  
**Priority:** 3 Priority  
**Correction:** Renew System  
**Qty:** 177,110.00  
**Unit of Measure:** S.F.  
**Estimate:** \$691,614.55  
**Assessor Name:** Eduardo Lopez  
**Date Created:** 06/10/2015

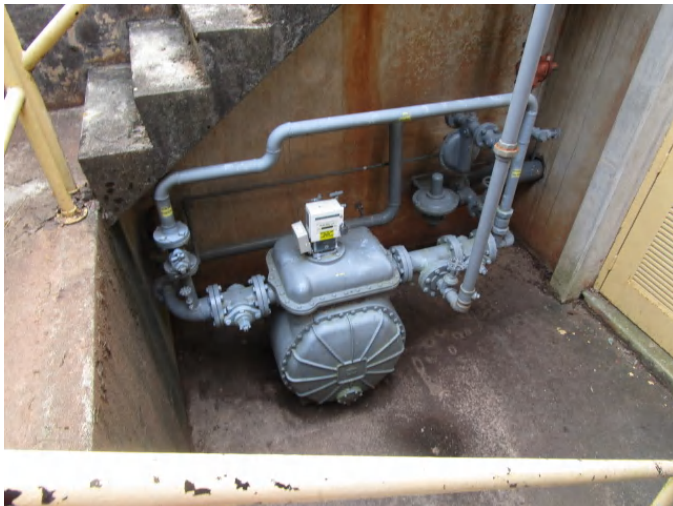
**System: G3060 - Fuel Distribution**

**Location:** Site  
**Distress:** Beyond Service Life  
**Category:** Deferred Maintenance  
**Priority:** 3 Priority  
**Correction:** Renew System  
**Qty:** 177,110.00  
**Unit of Measure:** S.F.  
**Estimate:** \$151,960.38  
**Assessor Name:** Eduardo Lopez  
**Date Created:** 06/10/2015

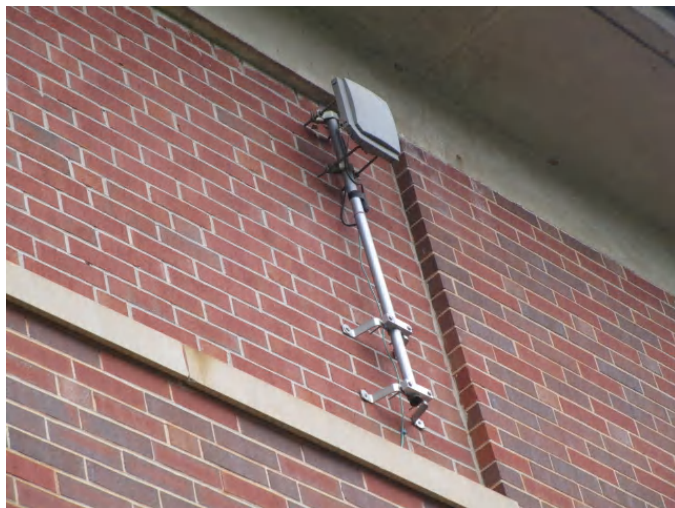
**System: G4030 - Site Communications & Security**

**Location:** Site
