DeKalb County School District/Admin/Support

Sam A. Moss Service Center

School Assessment Report

May 19, 2016

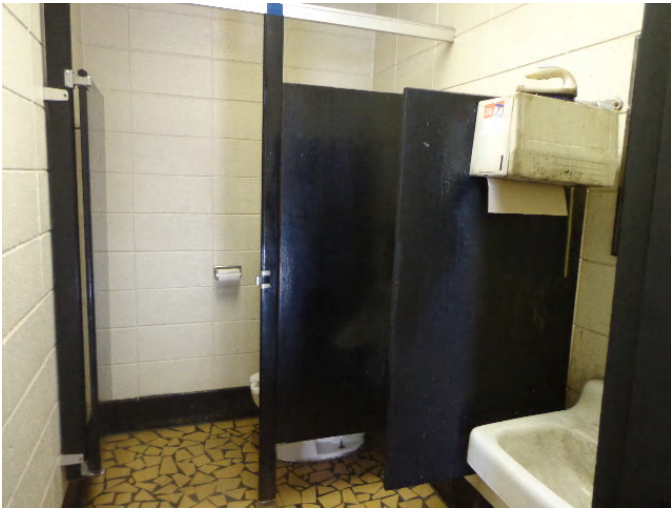
System: C1030 - Fittings

Notes: Fittings, such as toilet partitions, handrails and signage, are in marginal condition, not ADA compliant, and should be replaced.

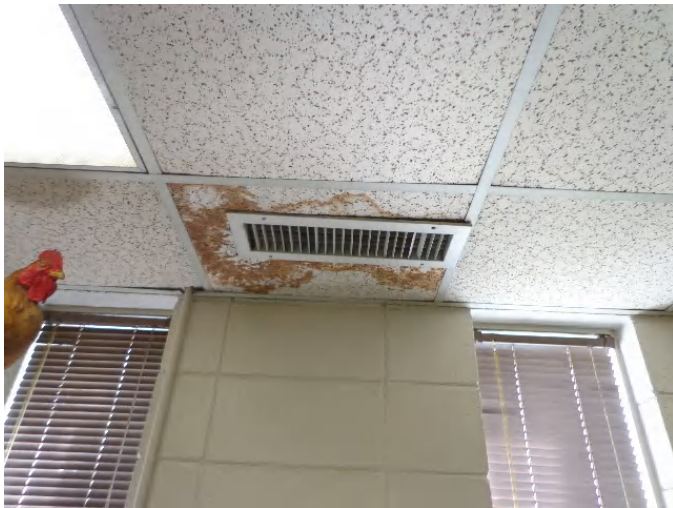
System: C3030 - Ceiling Finishes

Notes: The acoustical ceiling tiles have been replaced as needed. However, the grid shows signs of aging and most tiles are sagging or damaged, and the entire system should be replaced.

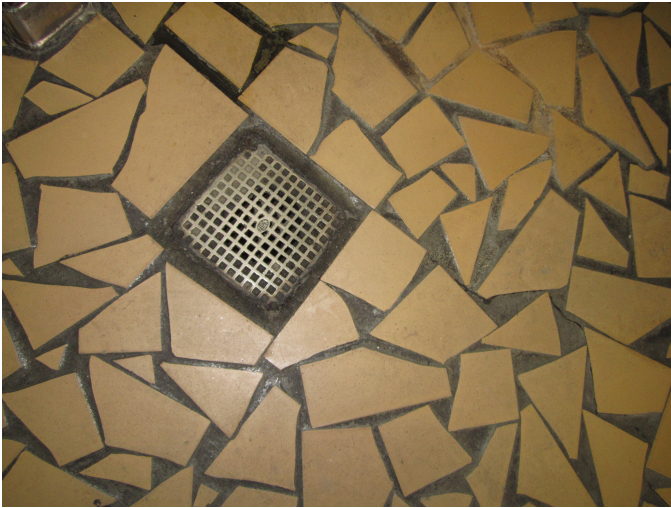
System: D2030 - Sanitary Waste

Notes: The sanitary waste system is beyond its expected service life and should be scheduled for replacement.

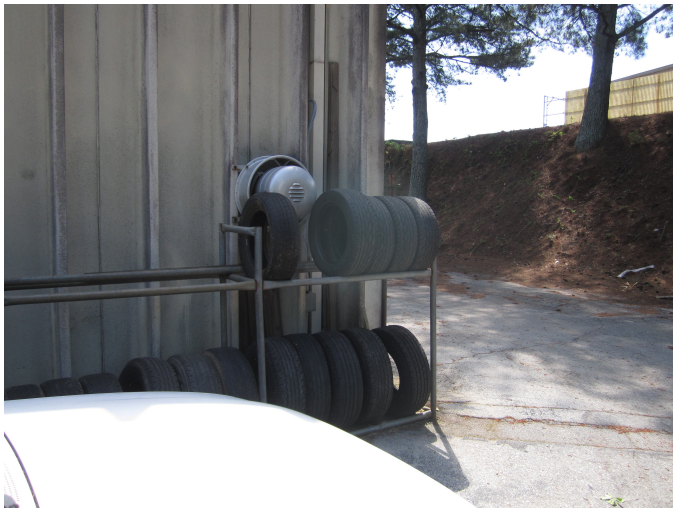
System: D3040 - Distribution Systems

Notes: Distribution systems are beyond their expected service life and should be scheduled for replacement.

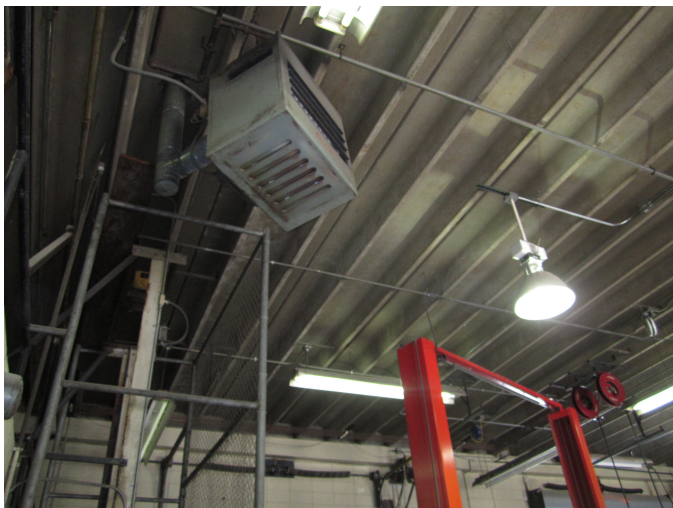
System: D3050 - Terminal & Package Units

Notes: Terminal and package units are beyond their expected service life and should be scheduled for replacement.

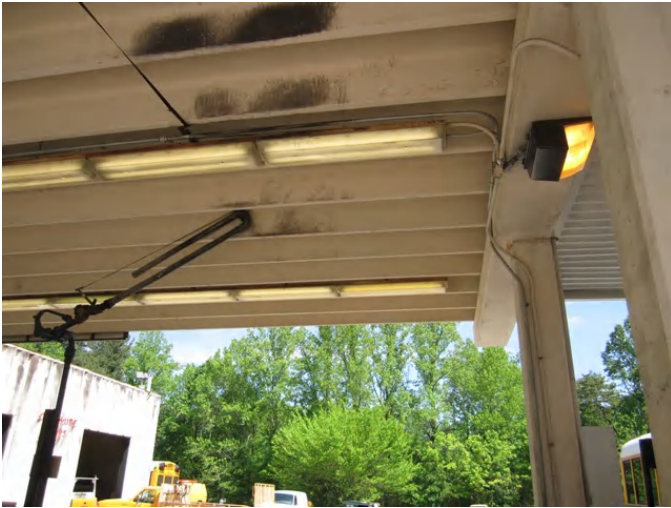
System: D5020 - Lighting and Branch Wiring

Notes: Lighting and branch wiring are beyond their expected service life and should be scheduled for replacement. Some of the lighting in the vehicle maintenance bays is newer and in good condition.

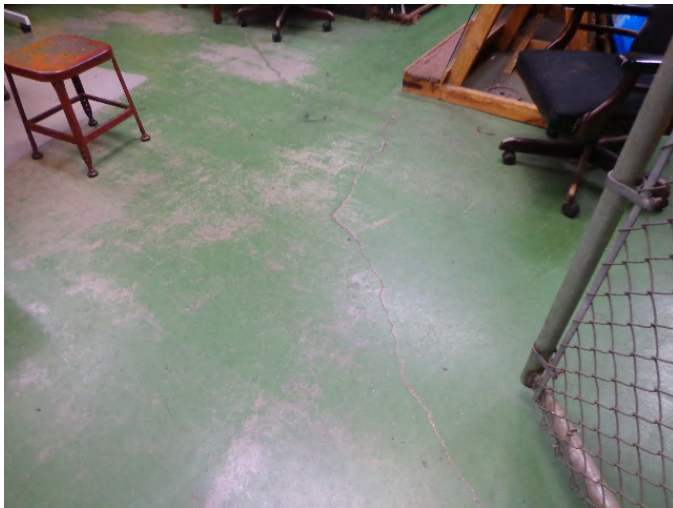
System: C3020 - Floor Finishes - Finished Concrete

Location: Throughout Building
Distress: Beyond Service Life
Category: Deferred Maintenance
Priority: 3 Priority
Correction: Renew System
Qty: 6,000.00
Unit of Measure: S.F.
Estimate: \$27,786.00
Assessor Name: Eduardo Lopez
Date Created: 08/26/2015

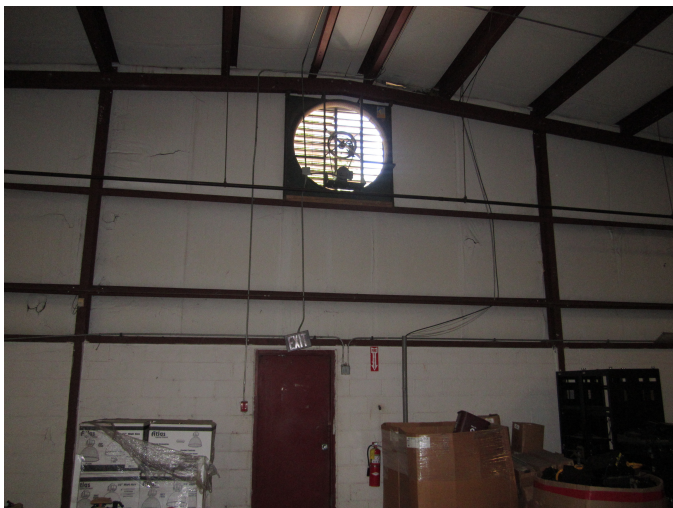
System: D3040 - Distribution System

Location: Throughout Building
Distress: Beyond Service Life
Category: Deferred Maintenance
Priority: 3 Priority
Correction: Renew System
Qty: 30,000.00
Unit of Measure: S.F.
Estimate: \$25,410.00
Assessor Name: Sam Mandola
Date Created: 05/06/2015

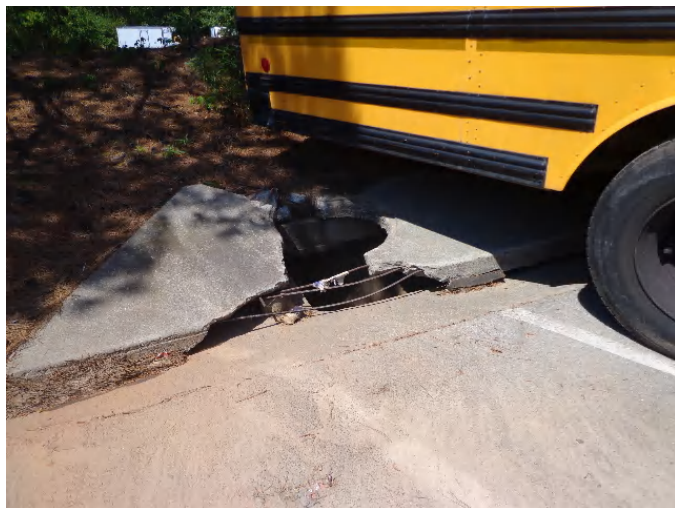
System: G3030 - Storm Sewer

Distress: Inadequate
