DeKalb County School District/Elementary Schools

Shadow Rock Elementary/Shadow Rock Center

School Assessment Report

May 20, 2016

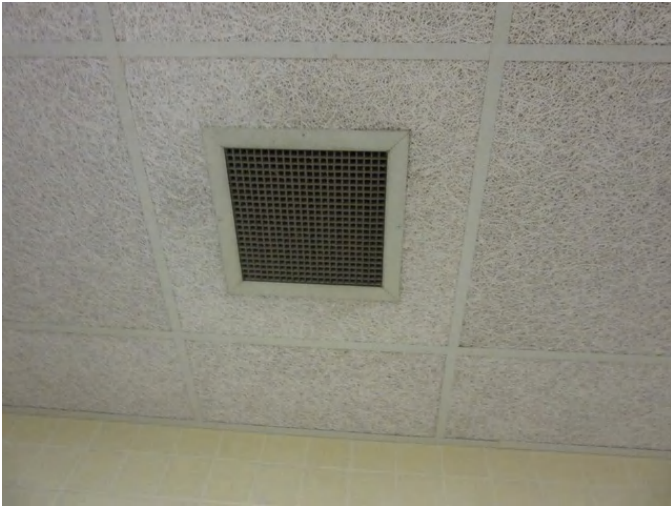
System: D3040 - Distribution & Exhaust Systems

Location: Throughout Lower Level

Distress: Inadequate

Notes: The exhaust systems on the lower level are non-functional or missing, and should be repaired or installed.

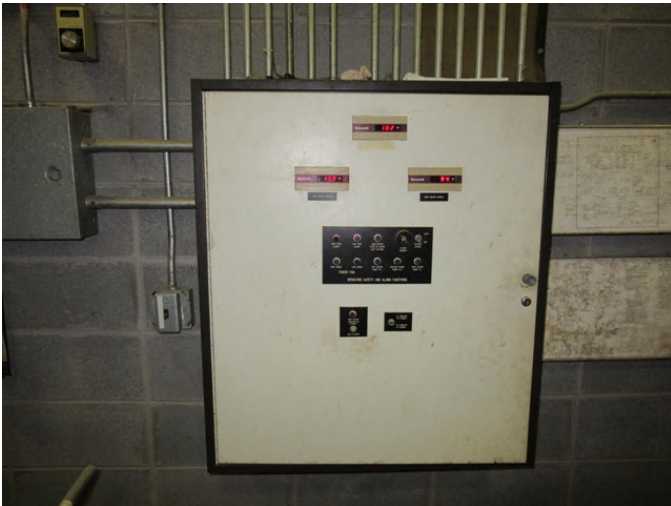
System: D3060 - Controls & Instrumentation

Location: Throughout Building

Distress: Beyond Service Life

Notes: The controls and instrumentation system is beyond its expected service life and should be scheduled for replacement.

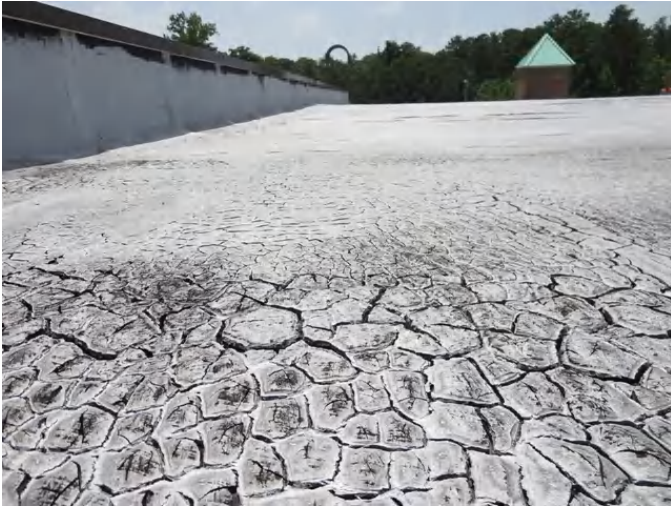
System: B3010 - Roof Coverings - BUR

Location: Roof

Distress: Needs Remediation

Notes: The built up roof covering is nearing the end of its expected service life, damaged, and should be replaced. SPLOST project 426-422 to replace the built up roofing.

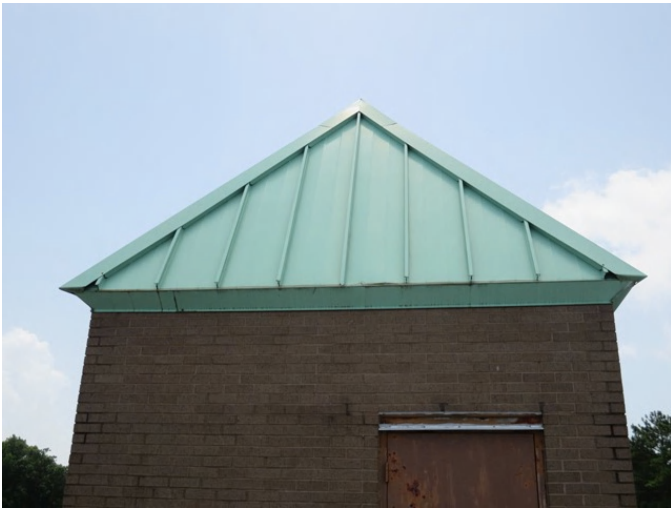
System: B3010 - Roof Coverings - Standing Seam Metal

Location: Roof

Distress: Needs Remediation

Notes: SPLOST project 426-422 to replace the standing seam metal roof on the ornamental tower of the 1991 building in conjunction with the built up roof.

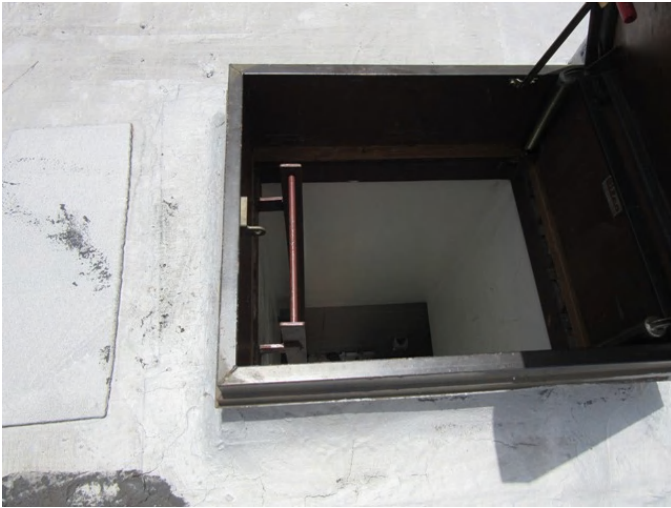
System: B3020 - Roof Openings

Location: Roof

Distress: Inadequate

Correction: Replace roof hatch and structure single unit

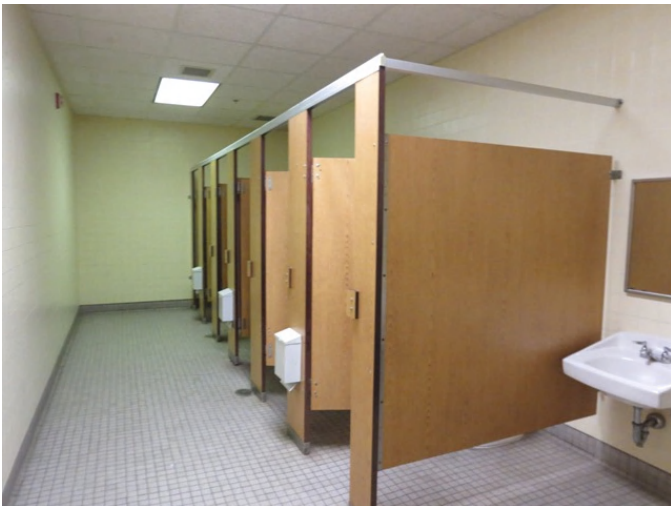
System: C1030 - Fittings

Location: Throughout Building

Distress: Beyond Service Life

Notes: Fittings, such as toilet partitions and signage, are beyond their expected service life, not ADA compliant, and should be replaced.

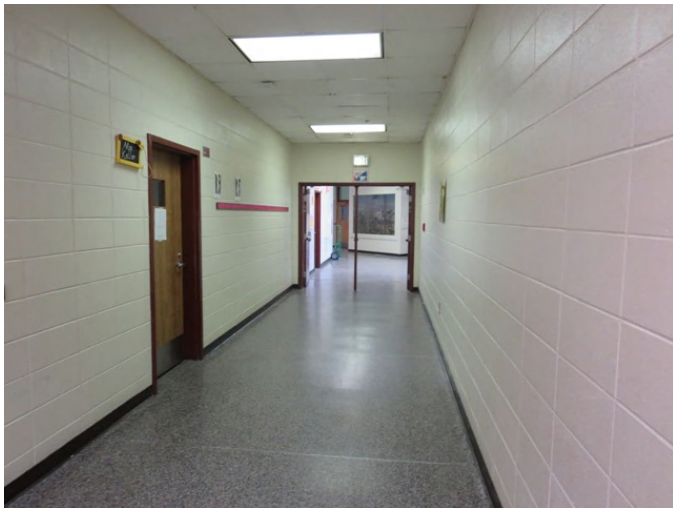
System: C3010 - Wall Finishes - Paint

Location: Throughout Building

Distress: Beyond Service Life

Notes: The painted wall finishes are beyond their expected service life, damaged and stained, and should be replaced.

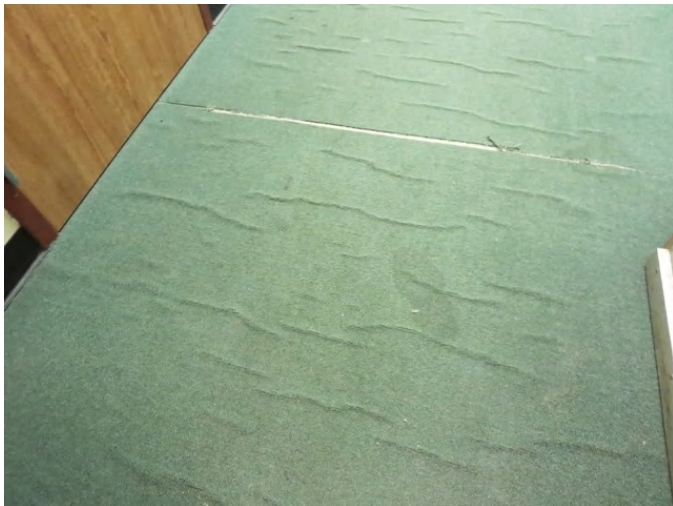
System: C3020 - Floor Finishes - Carpet

Location: Media Center, Conference Room, and Offices

Distress: Beyond Service Life

Notes: The carpet is aged, stained and frayed, and should be replaced.

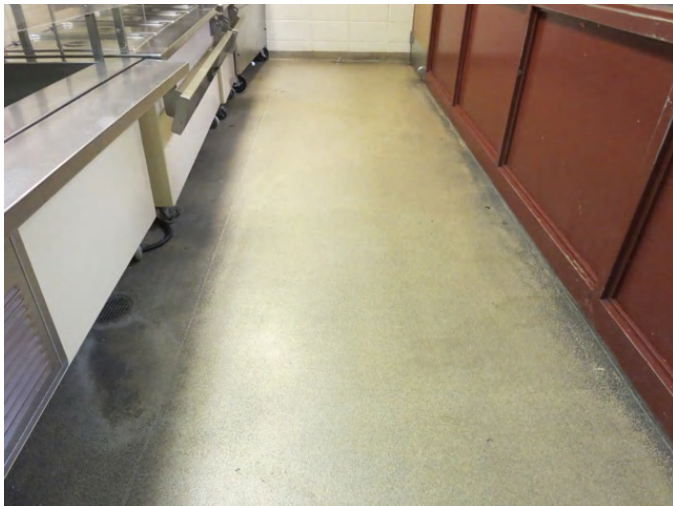
System: C3020 - Floor Finishes - Epoxy

Location: Kitchen

Distress: Beyond Service Life

Notes: The epoxy finish is aged, worn, and should be replaced.

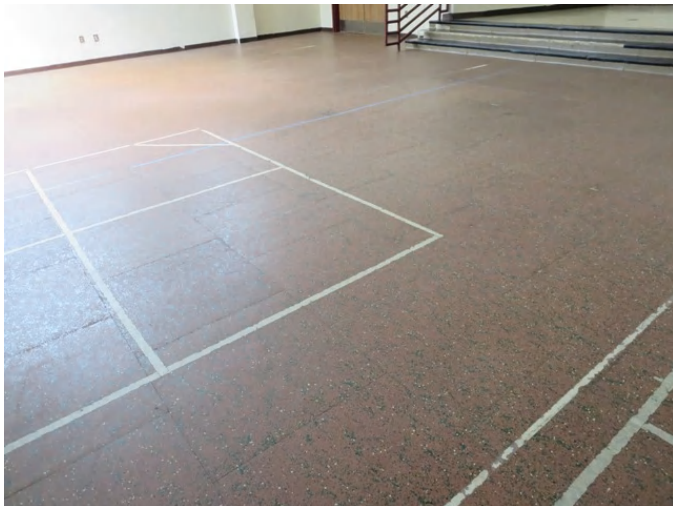
System: C3020 - Floor Finishes - Neoprene

Location: Small Gym

Distress: Beyond Service Life

Notes: The original rubber tile is in poor conditions, worn and with different areas separating from the substrate, and should be replaced.

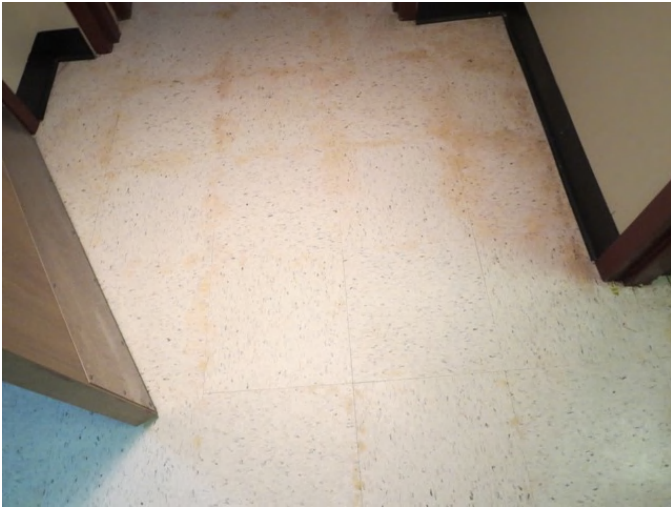
System: C3020 - Floor Finishes - VCT

Location: Classrooms

Distress: Beyond Service Life

Notes: The VCT flooring is aged, cracked, worn and stained, and should be replaced.

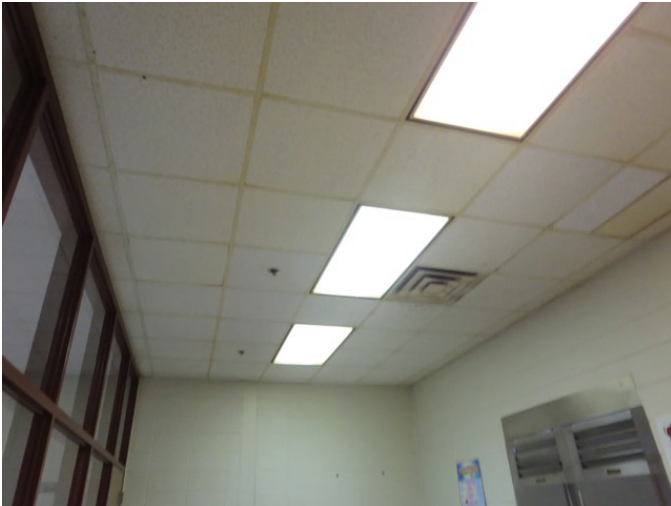
System: C3030 - Ceiling Finishes

Location: Throughout Building

Distress: Beyond Service Life

Notes: The acoustical ceiling system is damaged due to roof leaks and the environment, and should be replaced after the roof covering is replaced.

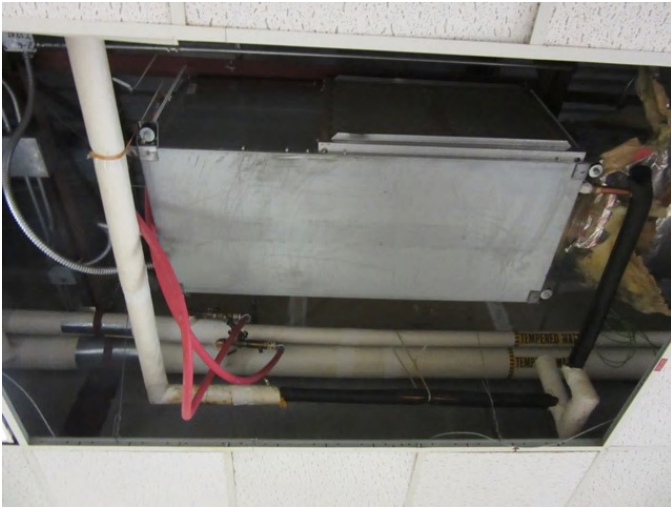
System: D3050 - Terminal & Package Units

Location: Throughout Building

Distress: Beyond Service Life

Notes: The primary water source heat pumps, rooftop air conditioners, and factory-integrated controls are beyond their expected service life, inadequate, and should be scheduled for replacement. An engineering study is recommended in order to determine the required cooling capacity of repurposed classrooms prior to system replacement.

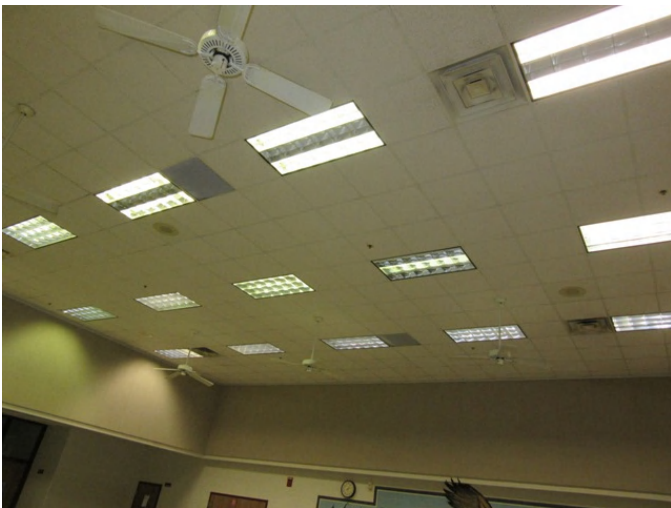
System: D5020 - Lighting

Location: Throughout Building

Distress: Beyond Service Life

Notes: The lighting system is beyond its expected service life, inadequate, and should be scheduled for replacement in conjunction with the deficient ceiling system.

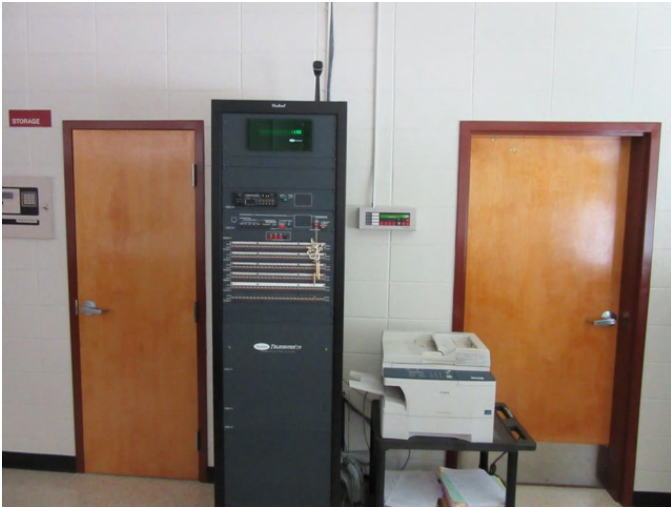
System: D5030 - Communications and Security - Clock & PA Systems

Location: Throughout Building

Distress: Beyond Service Life

Notes: Clock and PA systems are beyond their expected service life, have reported outages, and should be scheduled for replacement.

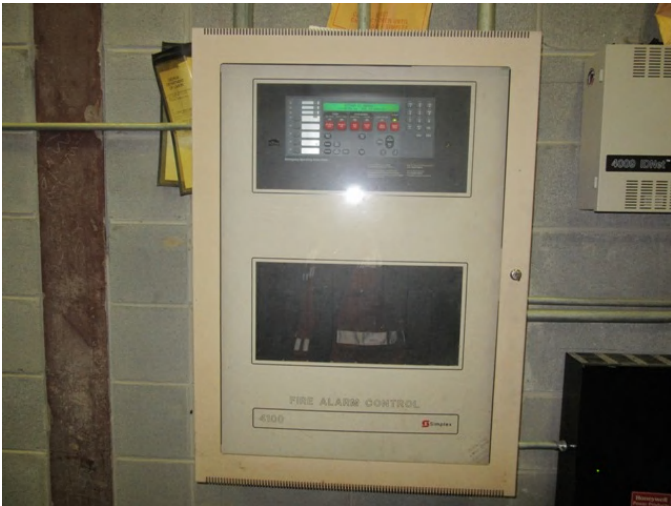
System: D5030 - Communications and Security - Fire Alarm

Location: Throughout Building

Distress: Beyond Service Life

Notes: The fire alarm system is beyond its expected service life and should be scheduled for replacement. Visible alarms (strobes) are missing in multiple occupancy, common use areas, such as restrooms.

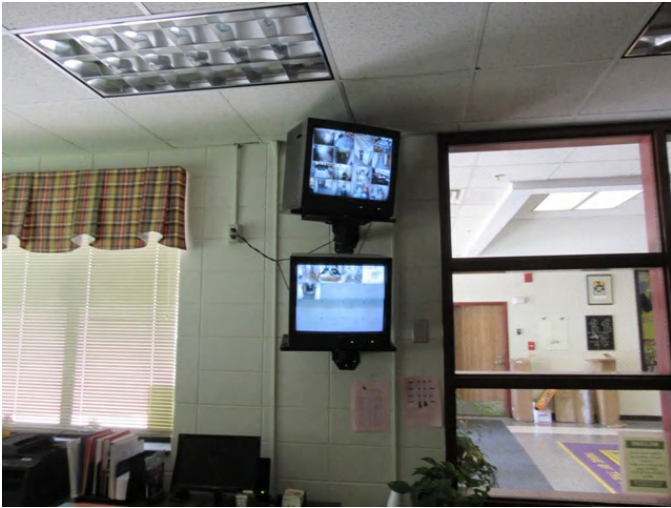
System: D5030 - Communications and Security - Security & CCTV

Location: Throughout Building

Distress: Beyond Service Life

Notes: The security and CCTV systems are beyond their expected service life and should be scheduled for replacement.

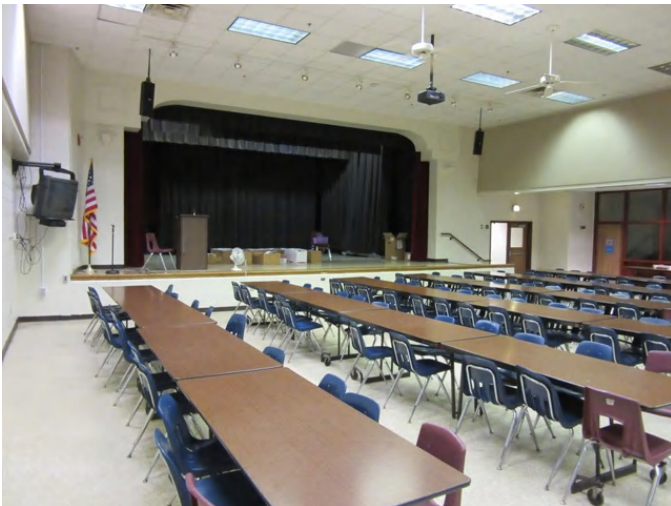
System: E1020 - Institutional Equipment

Location: Throughout Building

Distress: Beyond Service Life

Notes: Institutional equipment, such as theater and stage equipment, audio-visual equipment and library equipment, is beyond its expected service life and should be scheduled for replacement.

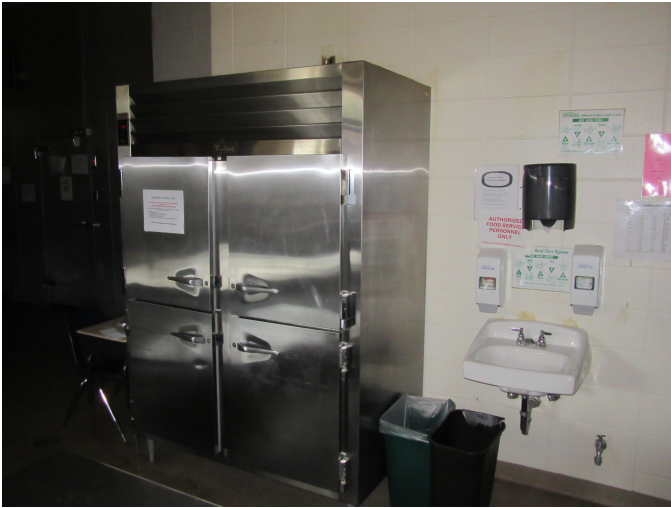
System: E1090 - Other Equipment - Kitchen Equipment

Location: Kitchen

Distress: Beyond Service Life

Notes: Kitchen equipment is beyond its expected service life and should be scheduled for replacement.

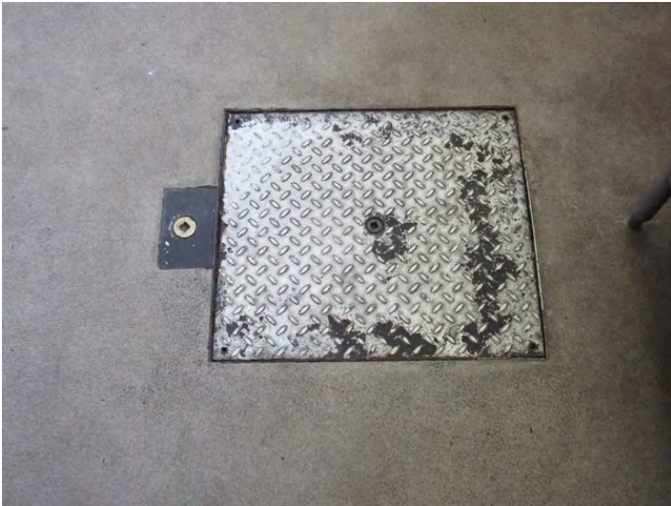
System: E1090 - Other Equipment - Kitchen Equipment

Location: Kitchen

Distress: Needs Remediation

Notes: The grease trap is beyond its expected service life and will be replaced under the SPLOST project 426-422.

Correction: Remove/replace grease trap

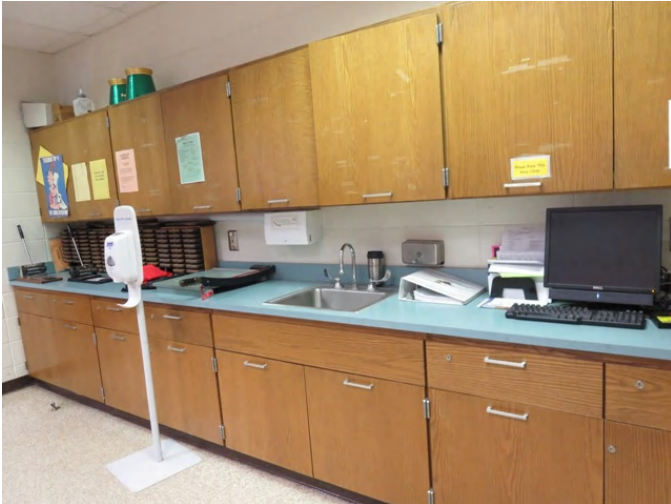
System: E2010 - Fixed Furnishings

Location: Throughout Building

Distress: Beyond Service Life

Notes: Fixed furnishings, such as built-in cabinets, are beyond their expected service life and worn, and should be replaced.

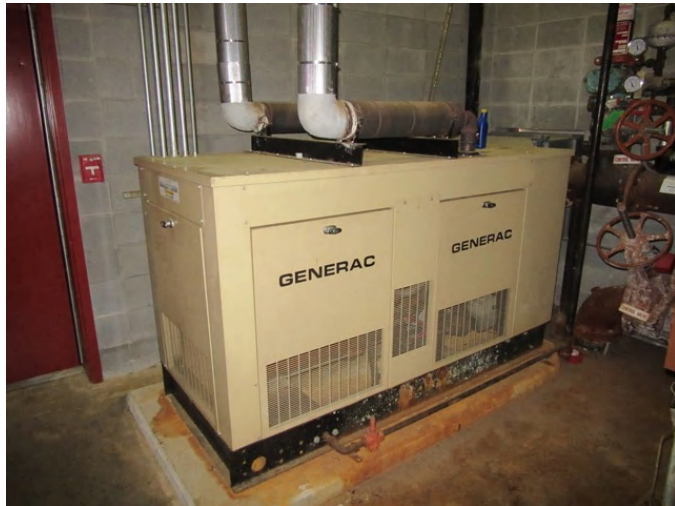
System: D5090 - Other Electrical Systems - Emergency Generator

Location: Mechanical Room

Distress: Beyond Service Life

Notes: The emergency generator is beyond its expected service life, but is sheltered and well maintained. Emergency generator to be replaced under SPLOST project 421-321-015G, Bulk Purchase Program Emergency Generator Installation.

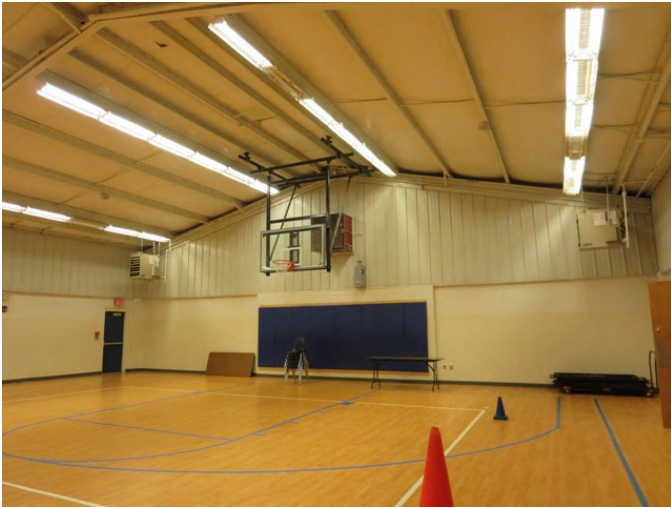
System: C3010 - Wall Finishes - Paint

Location: Throughout Building

Distress: Beyond Service Life

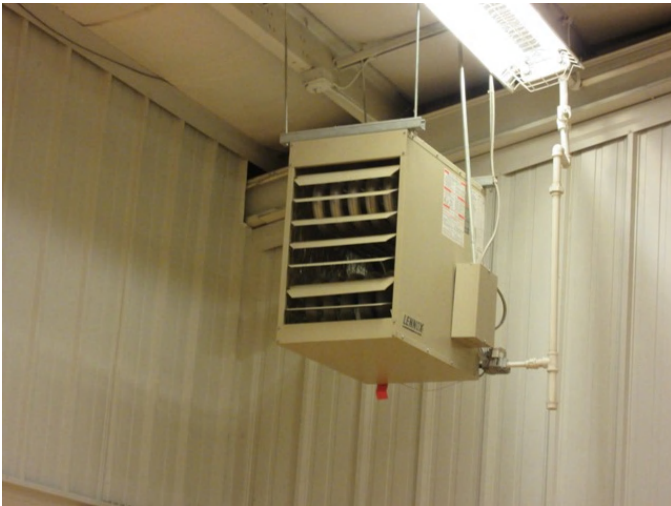
System: D3050 - Terminal & Package Units

Location: Throughout Building

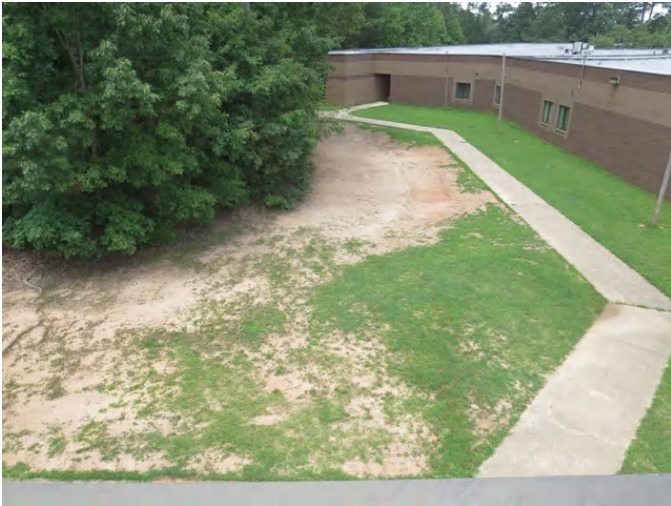
System: G2050 - Landscaping

Location: Northeast Side of Site

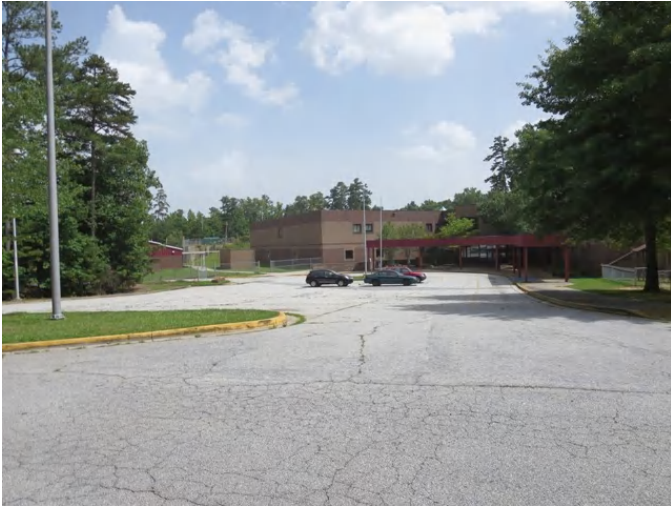
System: G2010 - Roadways

Location: East Side of Site

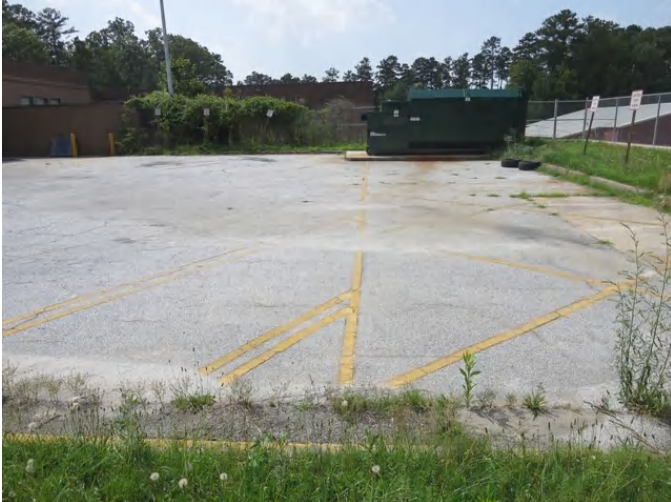
System: G2020 - Parking Lots

Location: South Side of Site

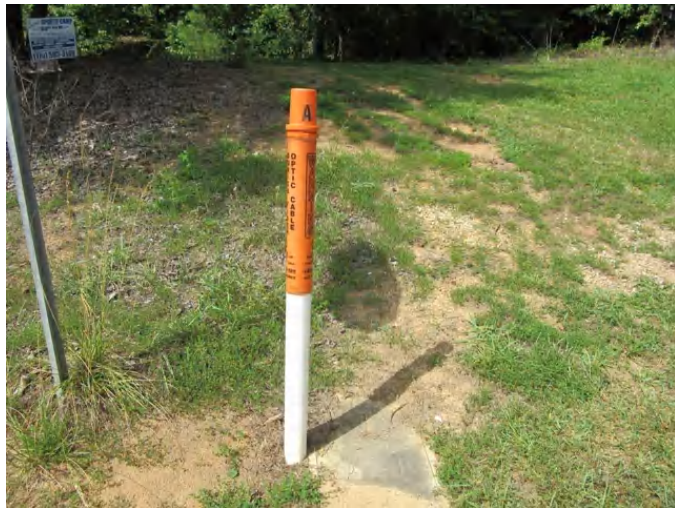
System: G4030 - Site Communications & Security

Location: Site

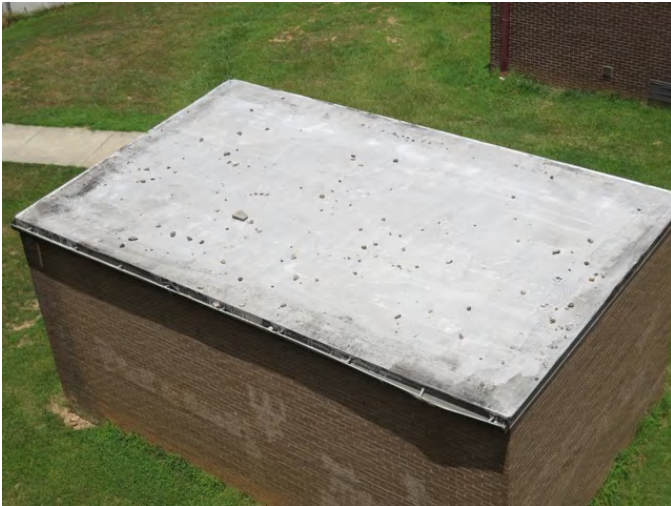
System: B3010 - Roof Coverings

Location: Roof
