DeKalb County School District/High Schools

Southwest DeKalb High

School Assessment Report
May 20, 2016

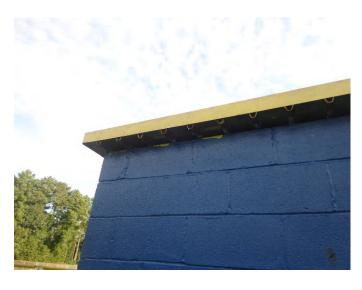
System: B3010 - Roof Coverings - BUR

Location: Roof

Distress: Beyond Service Life

Notes: The metal roofing is aged, rusted, and should be replaced.

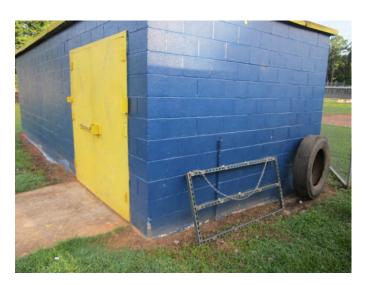
System: D5010 - Electrical Service/Distribution

Location: Throughout Building

Distress: Beyond Service Life

Notes: The electrical service/distribution system is beyond its expected service life, aged, and should be scheduled for replacement.

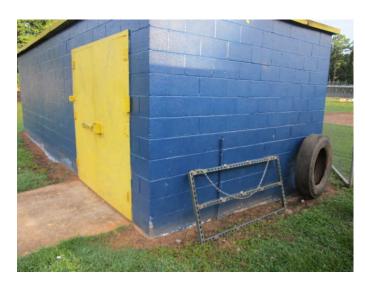
System: D5020 - Lighting and Branch Wiring

Location: Throughout Building

Distress: Beyond Service Life

Notes: Lighting and branch wiring are beyond their expected service life, aged, and should be replaced.

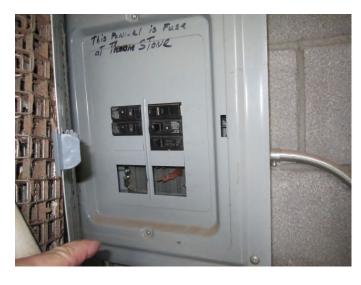
System: D5020 - Lighting and Branch Wiring

Location: Throughout Building

Distress: Beyond Service Life

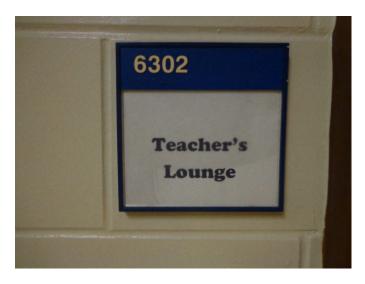
System: C1030 - Fittings

Location: Teacher's Lounge Restroom 6302.1

Distress: Missing

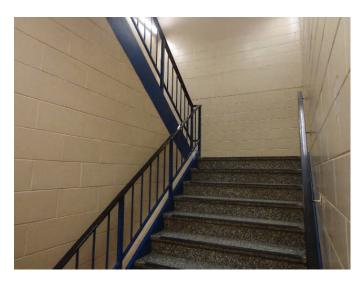
System: C2010 - Stair Construction

Location: Stairs

Distress: Inadequate

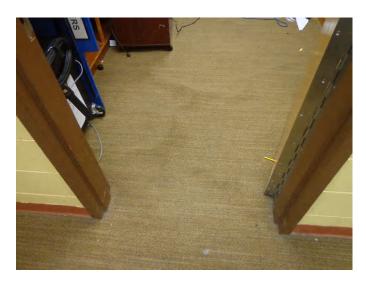
System: C3020 - Floor Finishes - Carpet

Location: Throughout Building

Distress: Beyond Service Life

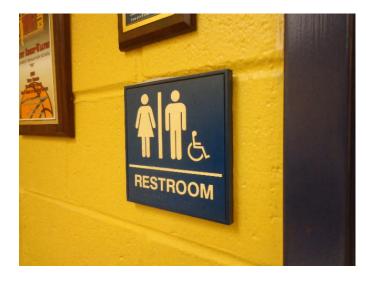
System: D2010 - Plumbing Fixtures

Location: Girls Locker Room and Restroom 3221.1

Distress: Needs Remediation

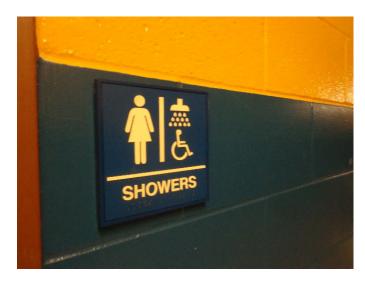
System: D2010 - Plumbing Fixtures

Location: Girls Locker Room and Boys Restroom 4200.8

Distress: Missing

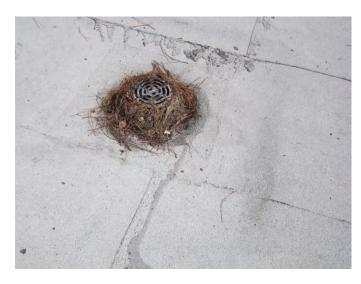
System: D2040 - Rain Water Drainage

Location: Throughout Building

Distress: Beyond Service Life

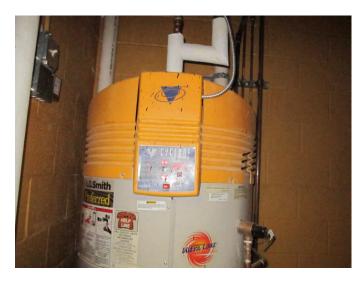
System: D2090 - Other Plumbing Systems - Natural Gas

Location: Throughout Building

Distress: Beyond Service Life

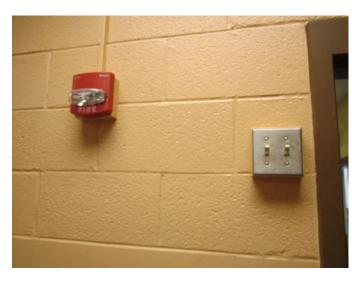
System: D5030 - Communications and Security - Fire Alarm

Location: Throughout Building

Distress: Beyond Service Life

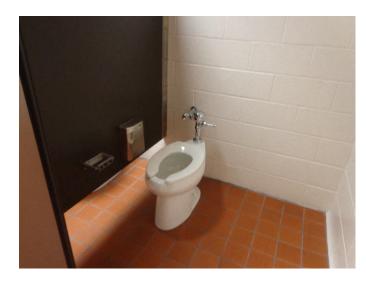
System: C1030 - Fittings

Location: Ground Floor Restrooms

Distress: Missing

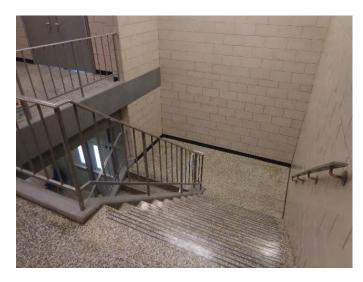
System: C2010 - Stair Construction

Location: Stairs

Distress: Inadequate

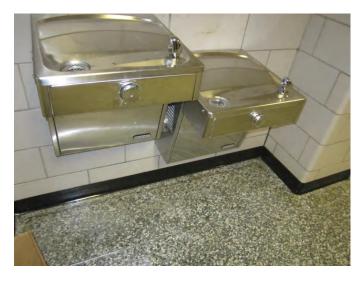
System: D2020 - Domestic Water Distribution

Location: Throughout Building

Distress: Beyond Service Life

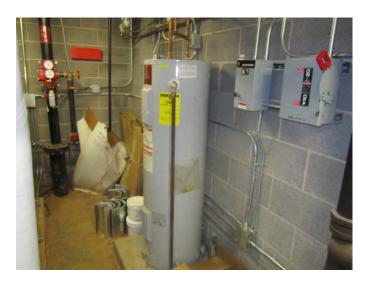
System: D2090 - Other Plumbing Systems - Natural Gas

Location: Throughout Building

Distress: Beyond Service Life

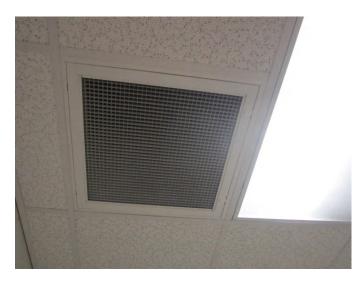
System: D3040 - Distribution Systems & Exhaust Systems

Location: Throughout Building

Distress: Beyond Service Life

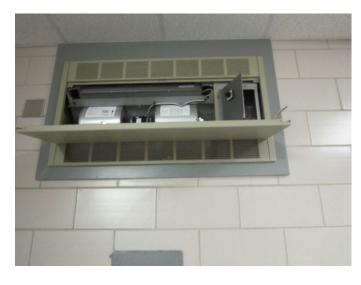
System: D3050 - Terminal & Package Units

Location: Throughout Building

Distress: Beyond Service Life

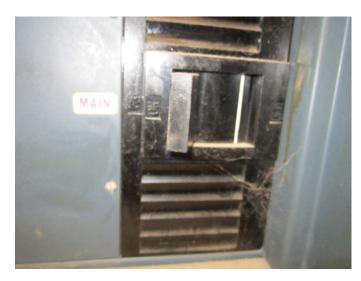
System: D5010 - Electrical Service/Distribution

Location: Main Switch Room/Throughout Building

Distress: Beyond Service Life

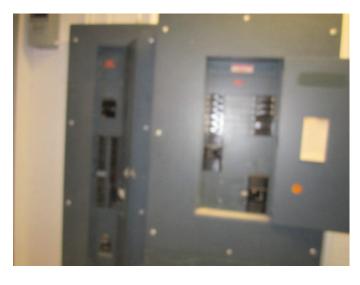
System: D5020 - Branch Wiring

Location: Throughout Building

Distress: Beyond Service Life

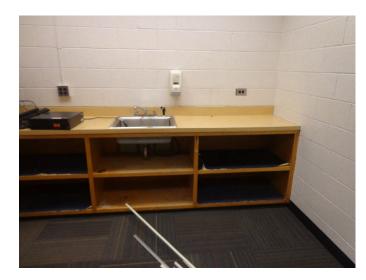
System: E2010 - Fixed Furnishings

Location: Throughout Building

Distress: Beyond Service Life

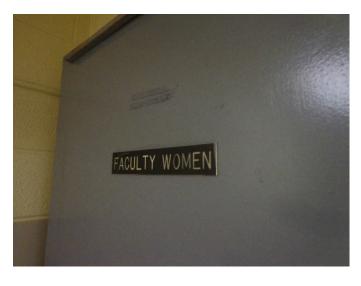
System: C1030 - Fittings

Location: Throughout Building

Distress: Beyond Service Life

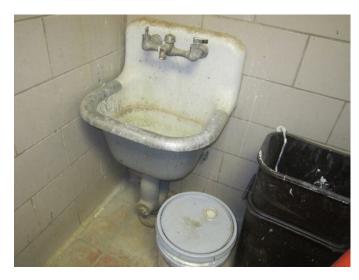
System: D2010 - Plumbing Fixtures

Location: Throughout Building

Distress: Beyond Service Life

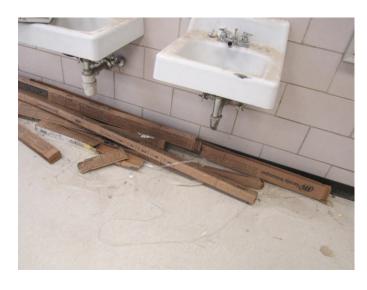
System: D2020 - Domestic Water Distribution

Location: Throughout Building

Distress: Beyond Service Life

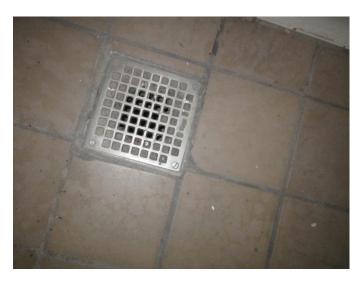
System: D2030 - Sanitary Waste

Location: Throughout Building

Distress: Beyond Service Life

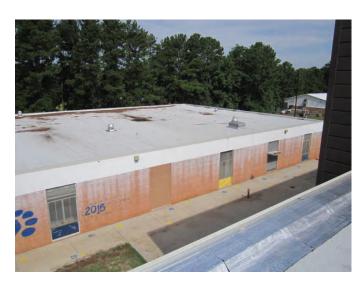
System: D2040 - Rain Water Drainage

Location: Throughout Building

Distress: Beyond Service Life

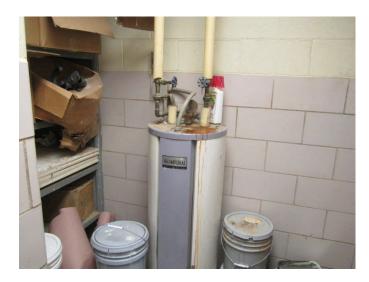
System: D2090 - Other Plumbing Systems - Natural Gas

Location: Throughout Building

Distress: Beyond Service Life

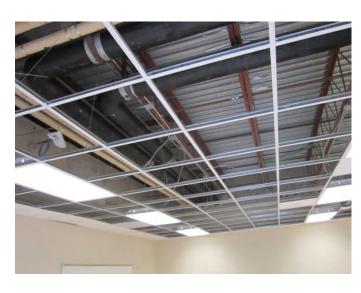
System: D3040 - Distribution Systems & Exhaust Systems

Location: Throughout Building

Distress: Beyond Service Life

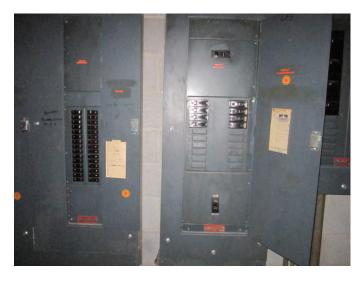
System: D5020 - Branch Wiring

Location: Throughout Building

Distress: Beyond Service Life

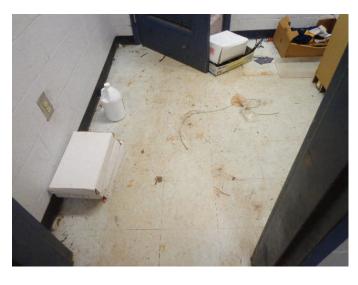
System: C3020 - Floor Finishes - VCT

Location: Throughout Building

Distress: Beyond Service Life

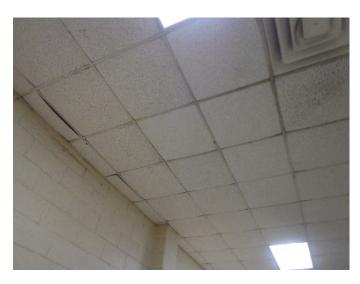
System: C3030 - Ceiling Finishes

Location: Throughout Building

Distress: Beyond Service Life

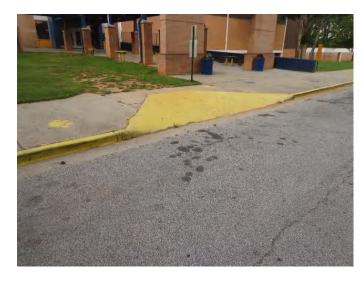
System: G2010 - Roadways

Location: Site

Distress: Missing

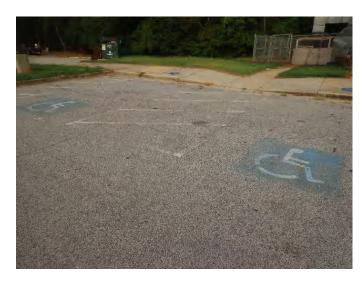
System: G2020 - Parking Lots

Location: Site

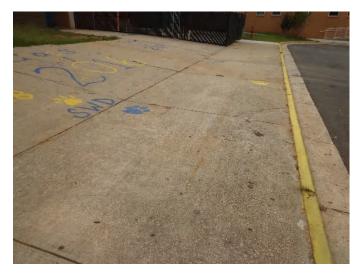
System: G2030 - Pedestrian Paving

Location: Site

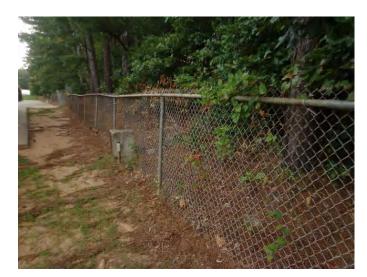
System: G2040 - Fencing & Guardrails

Location: Site

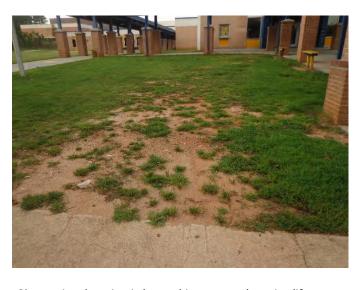
System: G2050 - Landscaping

Location: Site

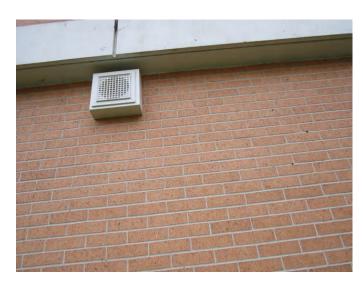
System: G4030 - Site Communications & Security

Location: Site
