DeKalb County School District/Elementary Schools

Stoneview Elementary

School Assessment Report

May 20, 2016

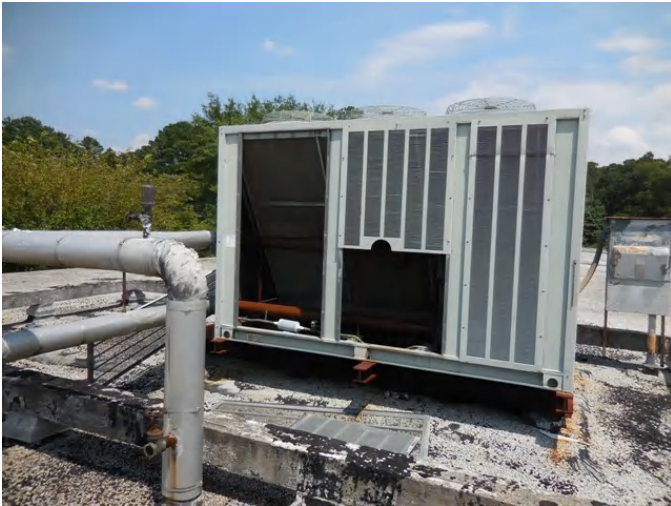
System: D3050 - Terminal & Package Units

Location: Roof/Throughout Building

Distress: Inadequate

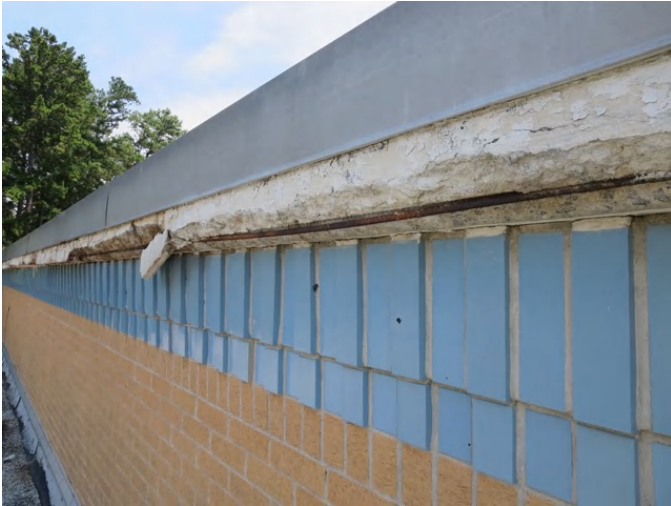
System: B2010 - Exterior Walls

Location: Cafeteria at Roof

Distress: Damaged

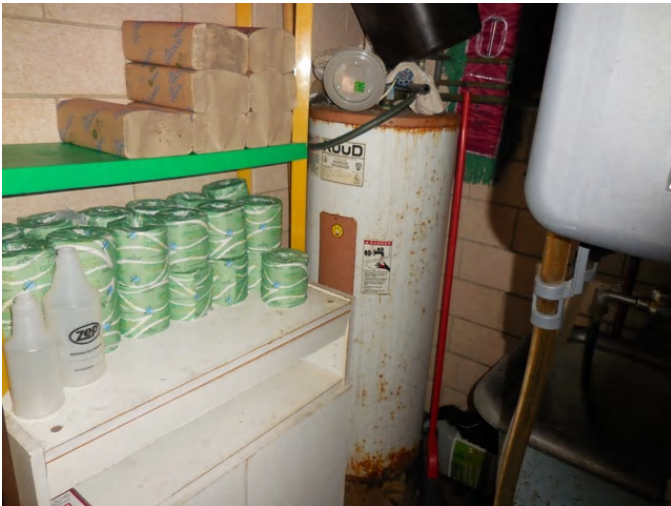
System: D2020 - Domestic Water Distribution

Location: Throughout Building

Distress: Damaged

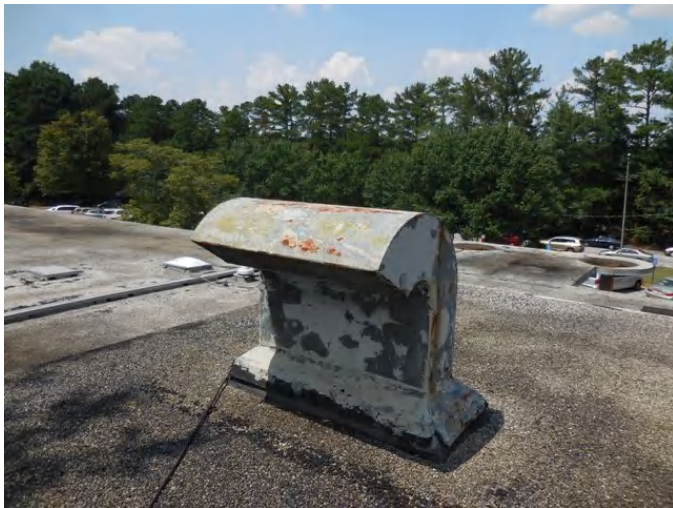
System: D3040 - Distribution & Exhaust Systems

Location: Throughout Building

Distress: Beyond Service Life

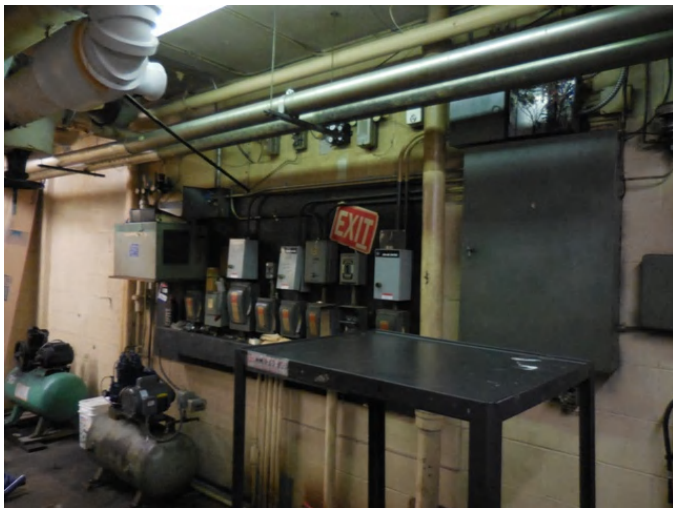
System: D3060 - Controls & Instrumentation

Location: Throughout Building

Distress: Inadequate

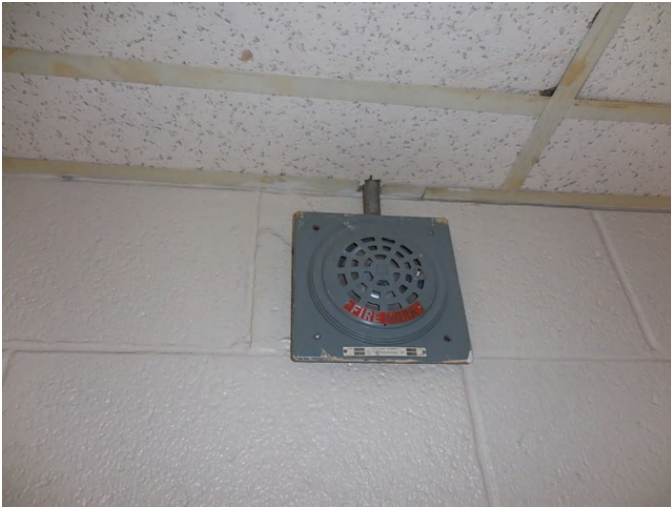
System: D5030 - Communications and Security - Fire Alarm

Location: Throughout Building

Distress: Beyond Service Life

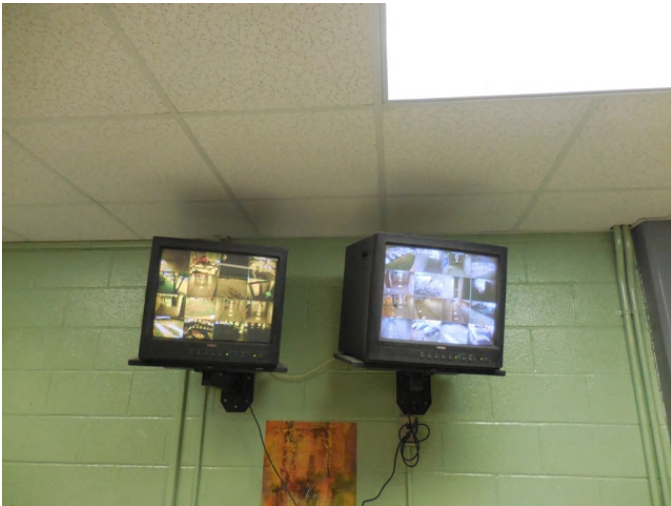
System: D5030 - Communications and Security - Security & CCTV

Location: Throughout Building

Distress: Inadequate

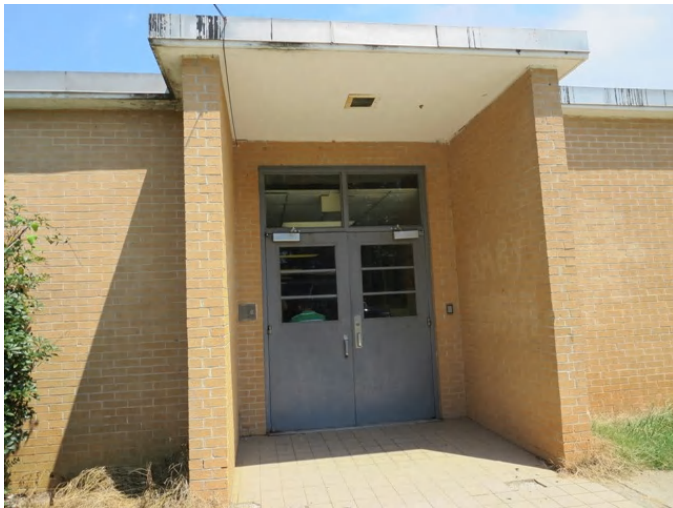
System: B2030 - Exterior Doors

Location: Throughout Building

Distress: Beyond Service Life

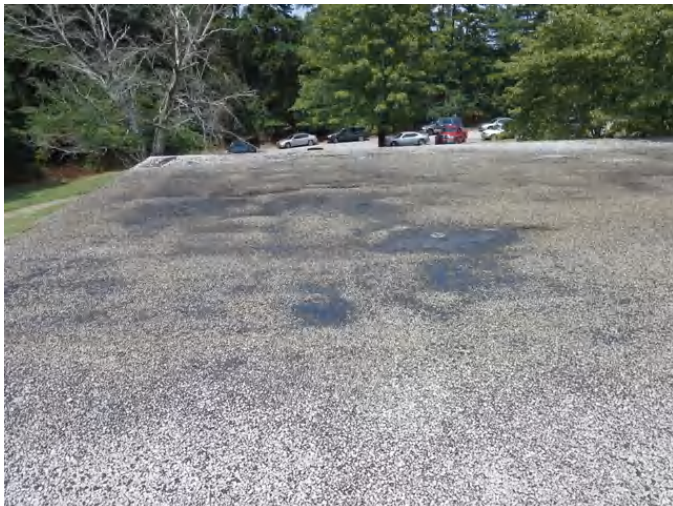
System: B3010 - Roof Coverings - BUR

Location: Roof

Distress: Beyond Service Life

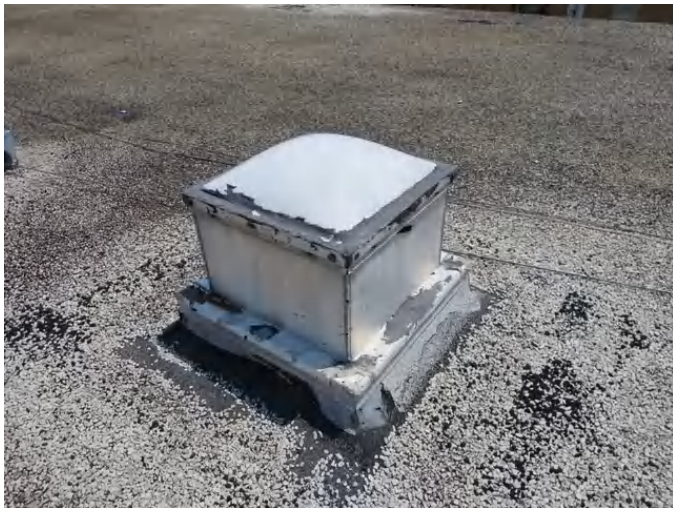
System: B3020 - Roof Openings

Location: Roof
Distress: Beyond Service Life
Category: Deferred Maintenance
Priority: 3 Priority
Correction: Renew System
Qty: 56,247.00
Unit of Measure: S.F.
Estimate: \$34,029.00
Assessor Name: Ben Nixon
Date Created: 04/11/2015

Notes: The roof openings are aged, rusted and damaged, and should be replaced in conjunction with the roof covering.

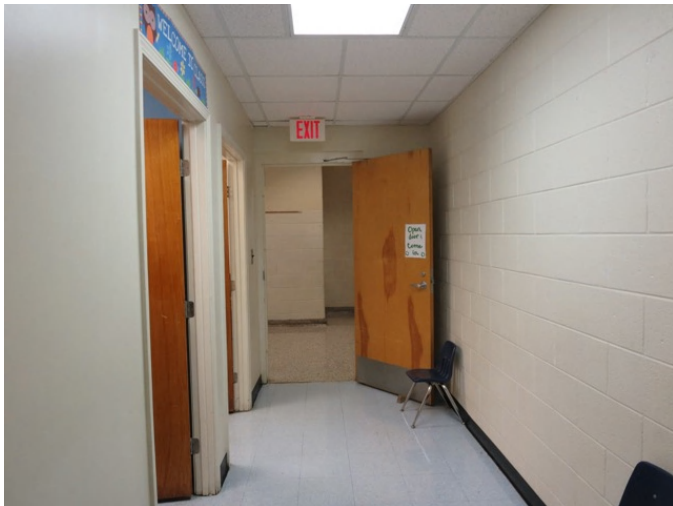
System: C1020 - Interior Doors

Location: Throughout Building
Distress: Beyond Service Life
Category: Deferred Maintenance / Accessibility Code Compliance
Priority: 3 Priority
Correction: Renew System
Qty: 56,247.00
Unit of Measure: S.F.
Estimate: \$94,495.00
Assessor Name: Ben Nixon
Date Created: 04/11/2015

Notes: The interior doors are aged, failing, not ADA compliant, and should be repaired or replaced.

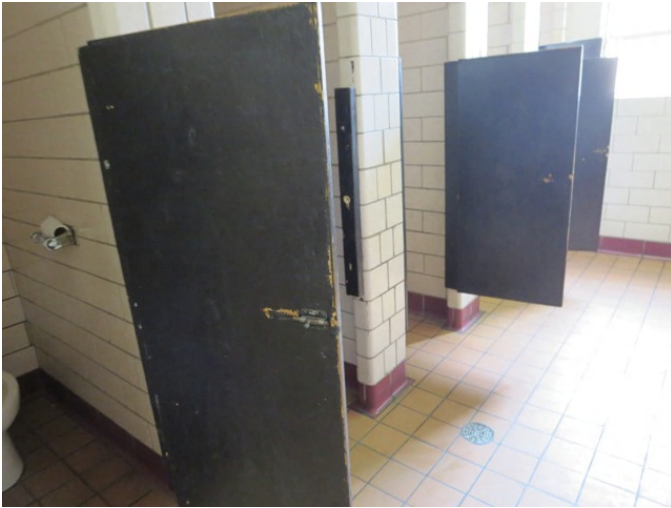
System: C1030 - Fittings

Location: Throughout Building

Distress: Beyond Service Life

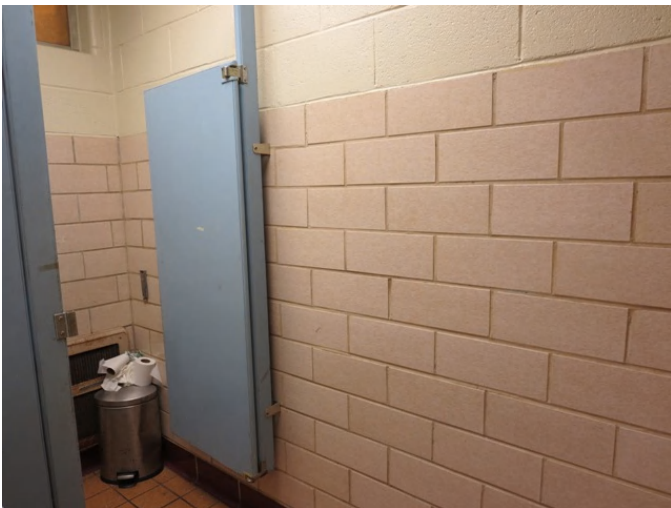
System: C3010 - Wall Finishes - Ceramic & Glazed

Location: Throughout Building

Distress: Beyond Service Life

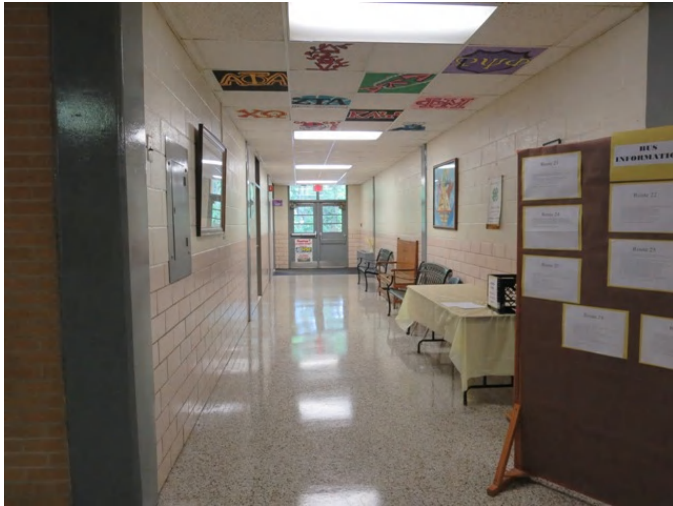
System: C3010 - Wall Finishes - Paint

Location: Throughout Building

Distress: Beyond Service Life

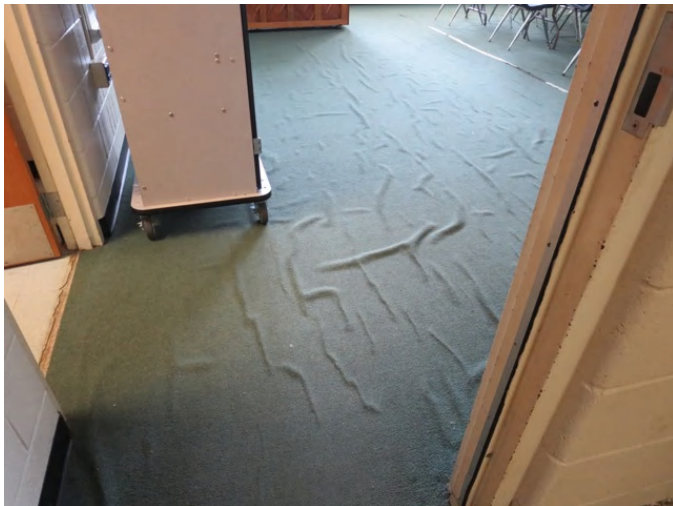
System: C3020 - Floor Finishes - Carpet

Location: Media Center and Offices

Distress: Beyond Service Life

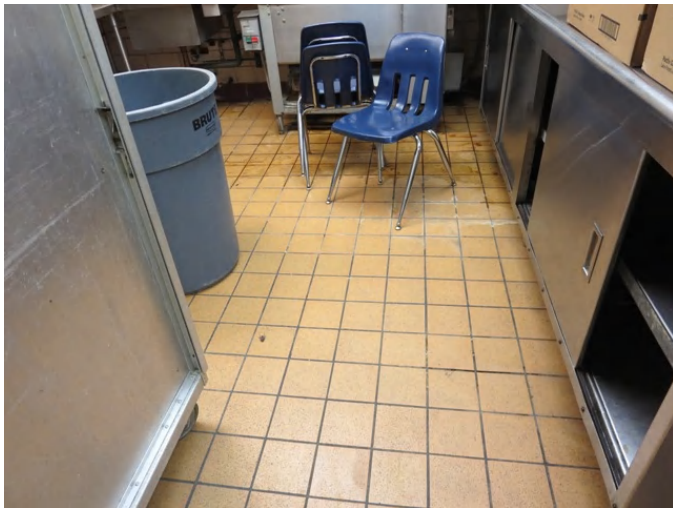
System: C3020 - Floor Finishes - Ceramic & Quarry Tile

Location: Kitchen and Restrooms

Distress: Beyond Service Life

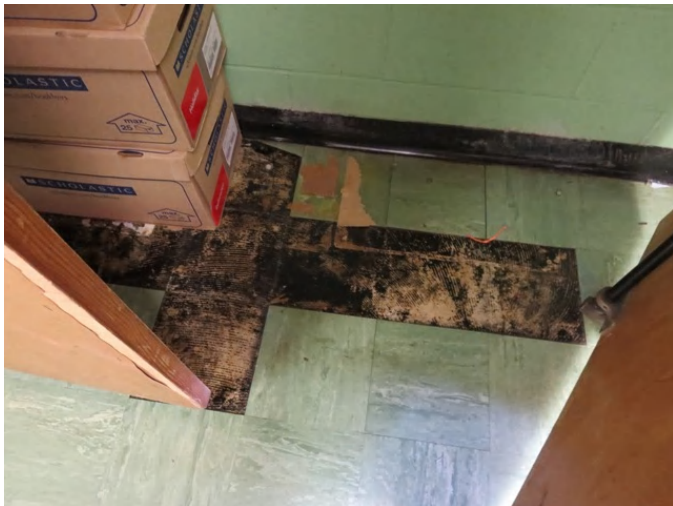
System: C3020 - Floor Finishes - VCT

Location: Throughout Building

Distress: Beyond Service Life

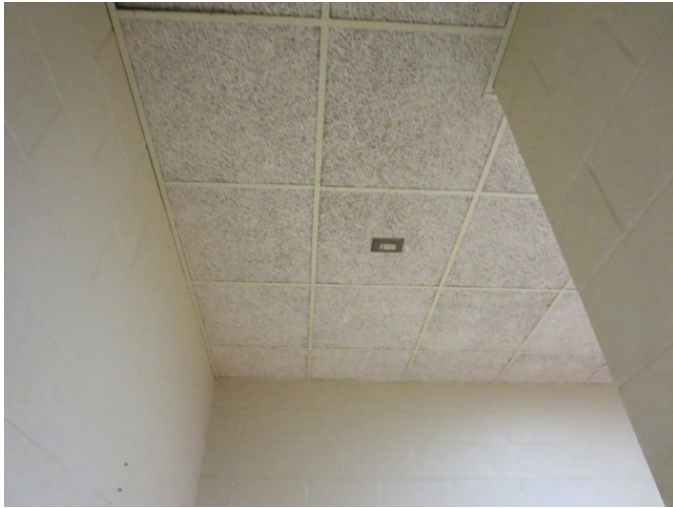
System: C3030 - Ceiling Finishes

Location: Throughout Building

Distress: Beyond Service Life

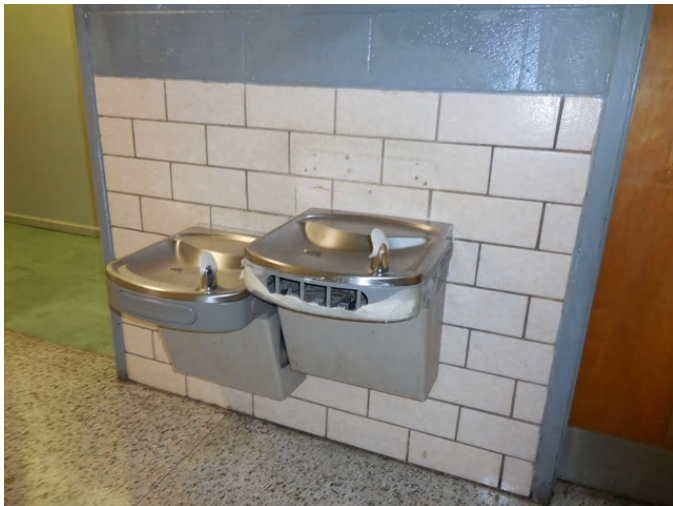
System: D2010 - Plumbing Fixtures

Location: Throughout Building

Distress: Damaged

Correction: Replace fountain drinking fountain

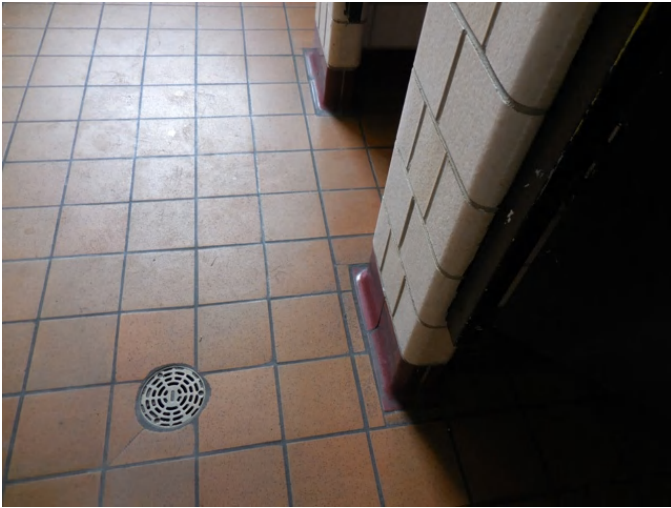
System: D2030 - Sanitary Waste

Location: Throughout Building

Distress: Beyond Service Life

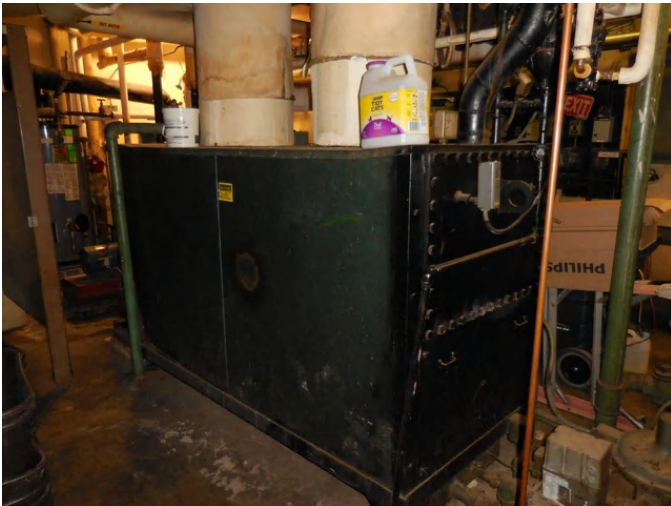
System: D3020 - Heat Generating Systems

Location: Mechanical Room

Distress: Beyond Service Life

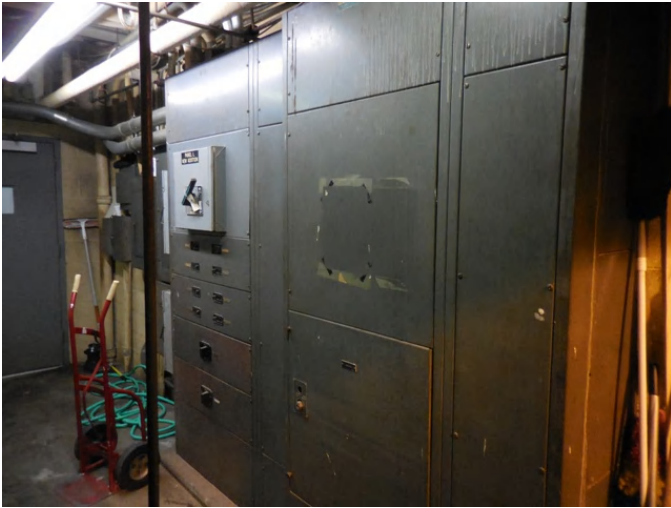
System: D5010 - Electrical Service/Distribution

Location: Main Switch Room/Throughout Building

Distress: Beyond Service Life

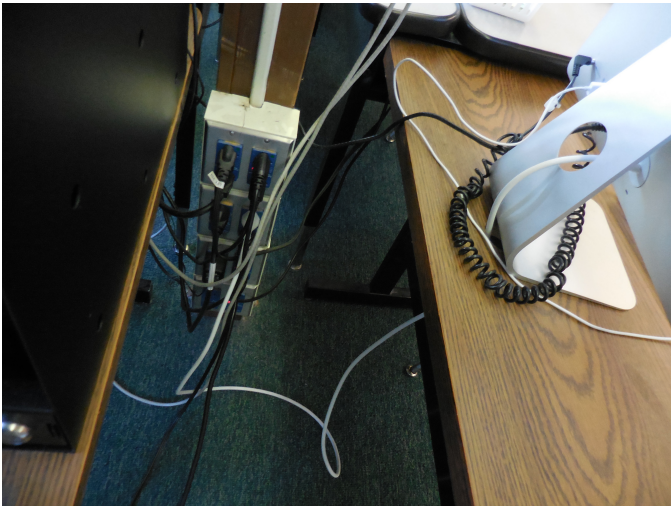
System: D5020 - Branch Wiring

Location: Throughout Building

Distress: Beyond Service Life

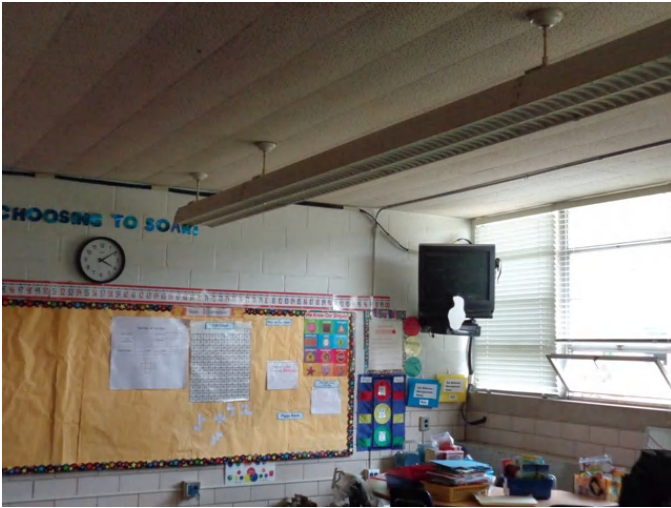
System: D5020 - Lighting

Location: Throughout Building

Distress: Beyond Service Life

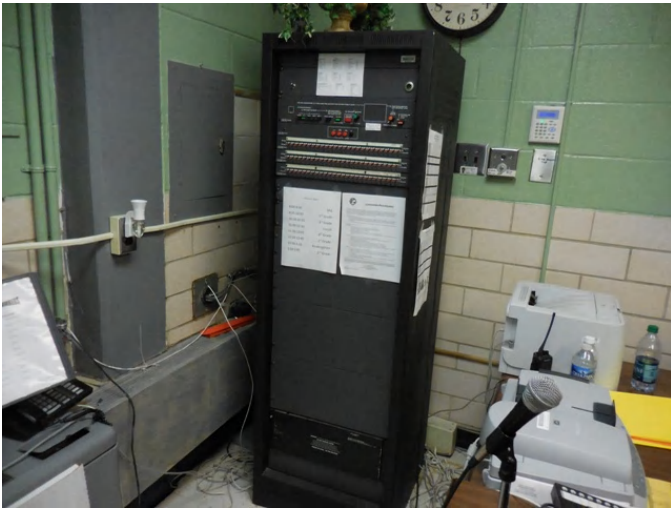
System: D5030 - Communications and Security - Clock & PA Systems

Location: Throughout Building

Distress: Beyond Service Life

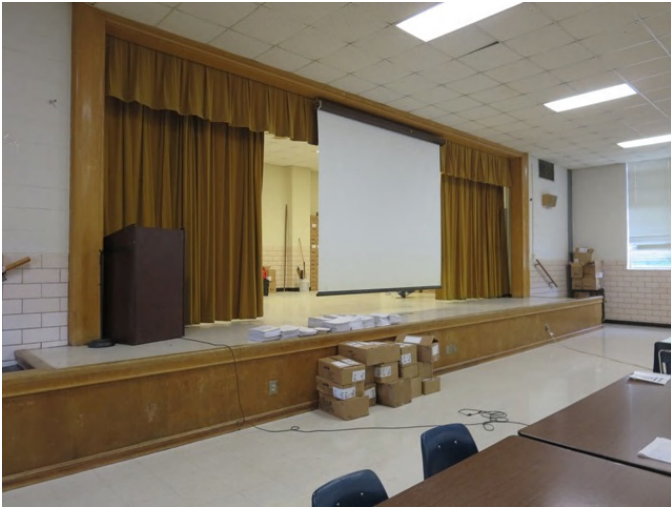
System: E1020 - Institutional Equipment

Location: Throughout Building

Distress: Beyond Service Life

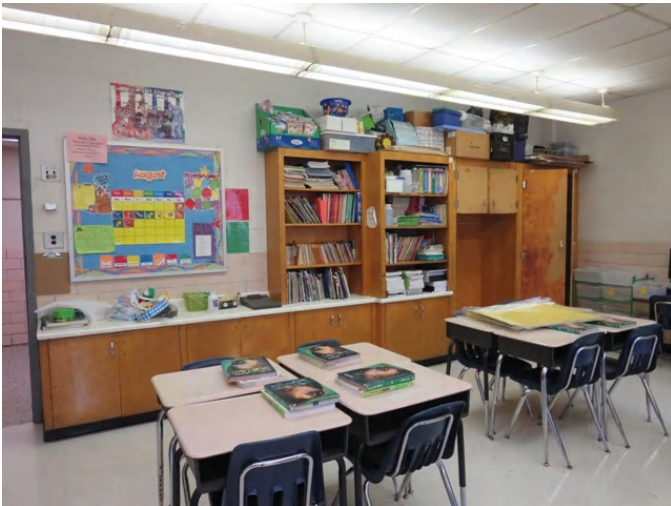
System: E2010 - Fixed Furnishings

Location: Throughout Building

Distress: Beyond Service Life

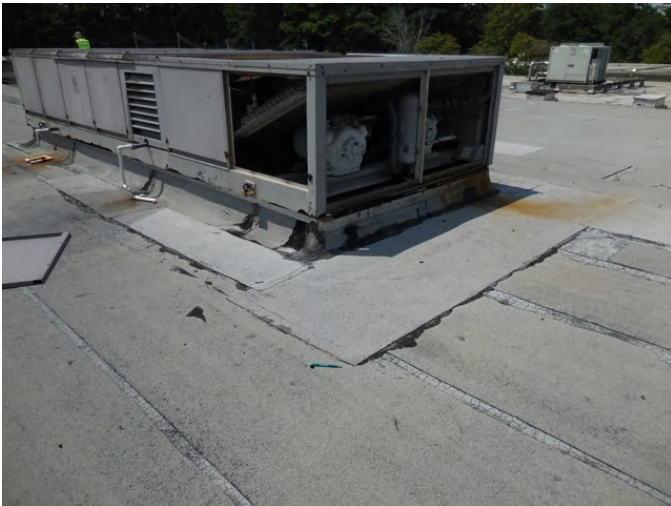
System: D3050 - Terminal & Package Units

Location: Roof

Distress: Beyond Service Life

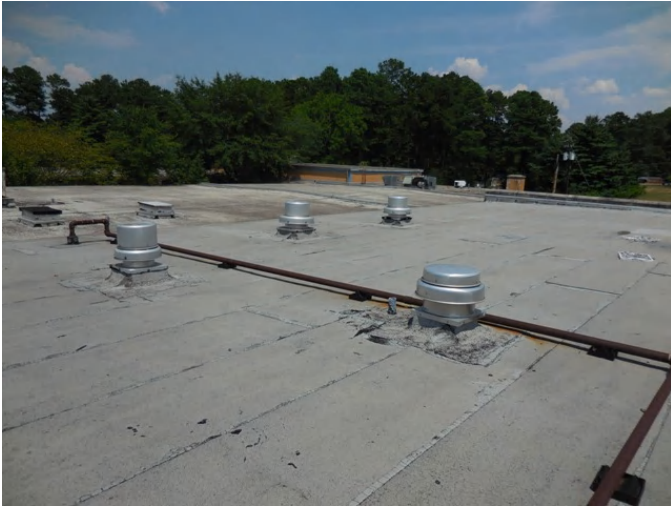
System: D3040 - Distribution & Exhaust Systems

Location: Throughout Building

Distress: Inadequate

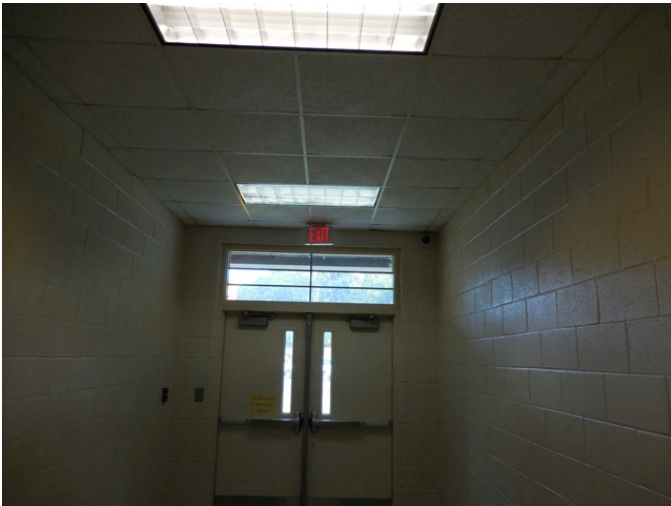
System: D5030 - Communications and Security - Security & CCTV

Location: Throughout Building

Distress: Inadequate

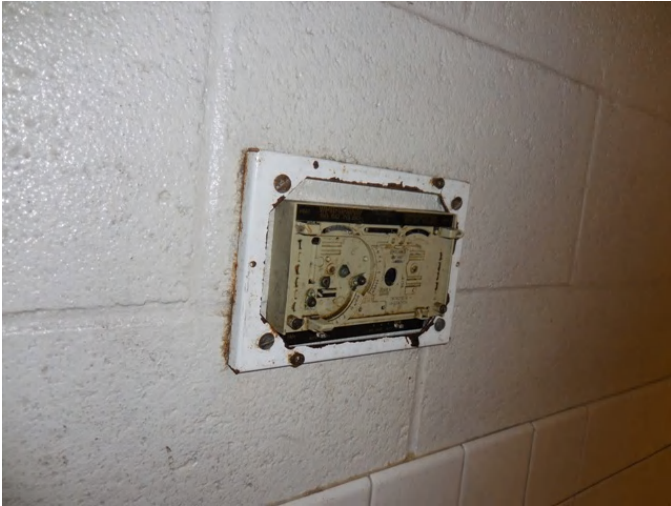
System: D3060 - Controls & Instrumentation

Location: Throughout Building

Distress: Damaged

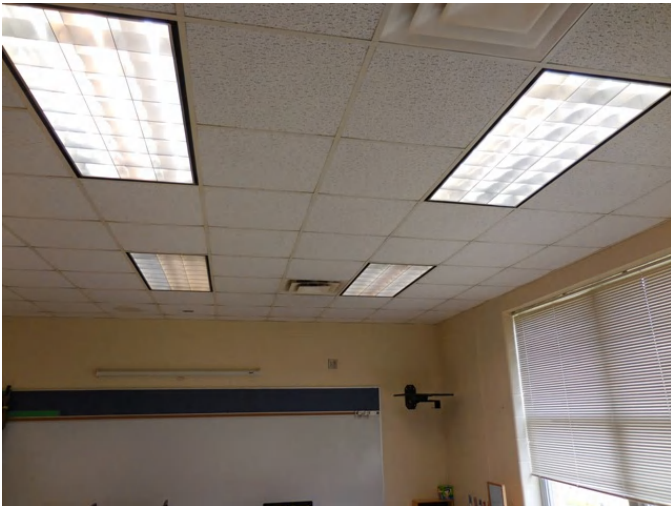
System: D5020 - Lighting

Location: Throughout Building

Distress: Beyond Service Life

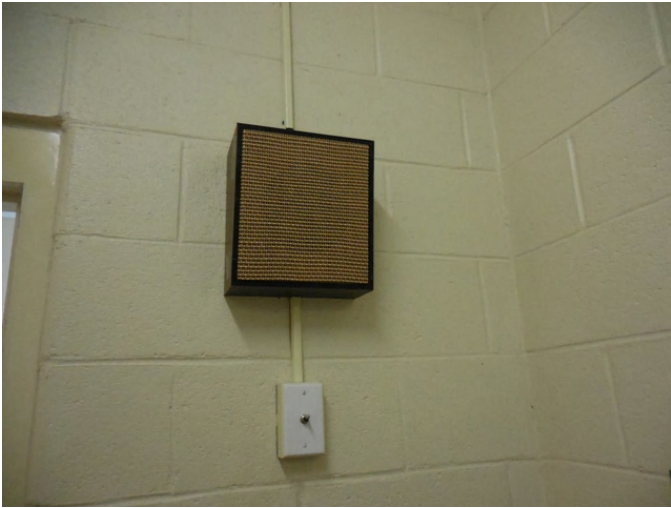
System: D5030 - Communications and Security - Clock & PA Systems

Location: Throughout Building

Distress: Beyond Service Life

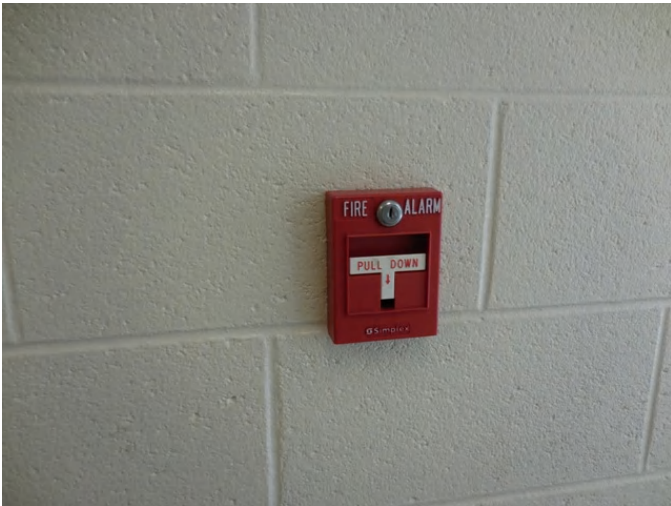
System: D5030 - Communications and Security - Fire Alarm

Location: Throughout Building

Distress: Beyond Service Life

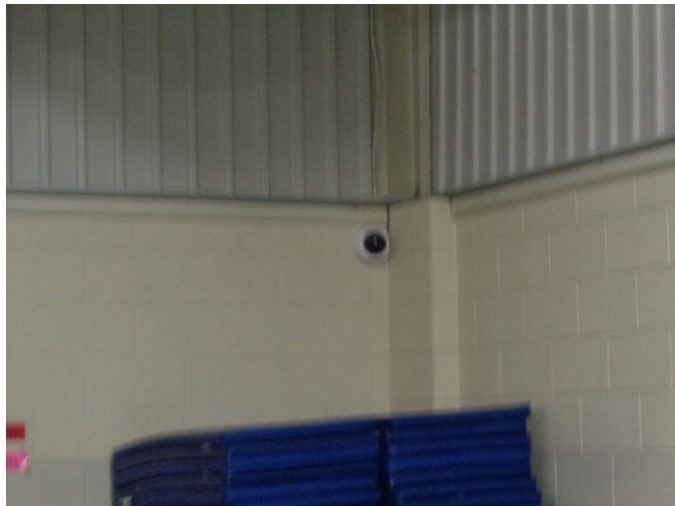
System: D5030 - Communications and Security - Security & CCTV

Location: Throughout Building

Distress: Inadequate

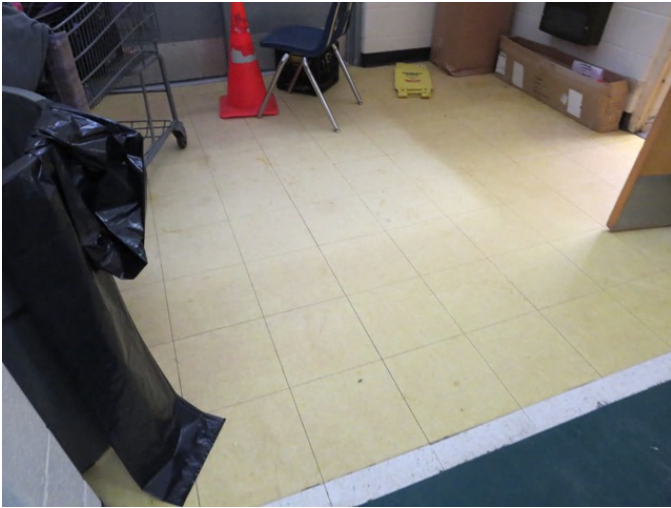
System: C3020 - Floor Finishes - VCT

Location: Entrance Area and Offices

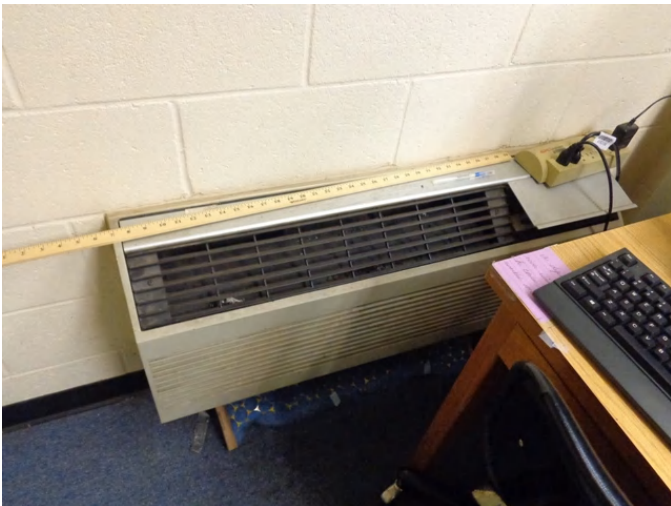
System: D3050 - Terminal & Package Units

Location: Throughout Building

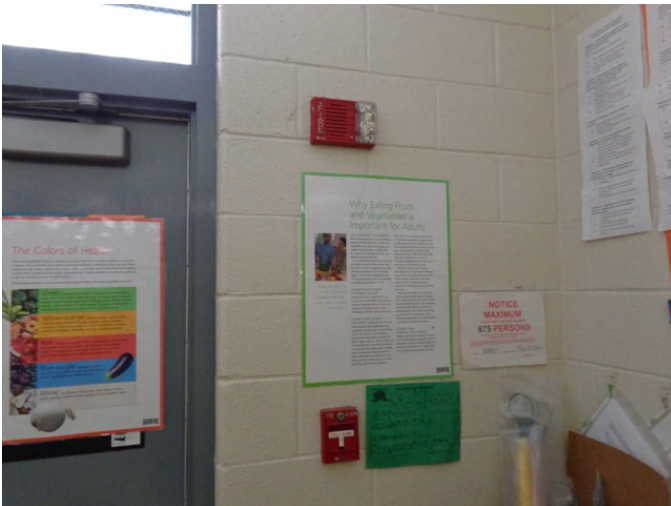
System: D5030 - Communications and Security - Fire Alarm

Location: Throughout Building

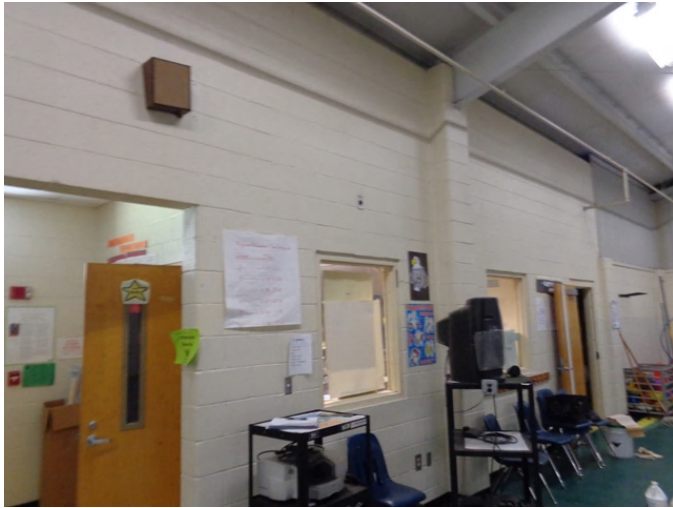
System: D5030 - Communications and Security - Public Address & Clock System

Location: Throughout Building

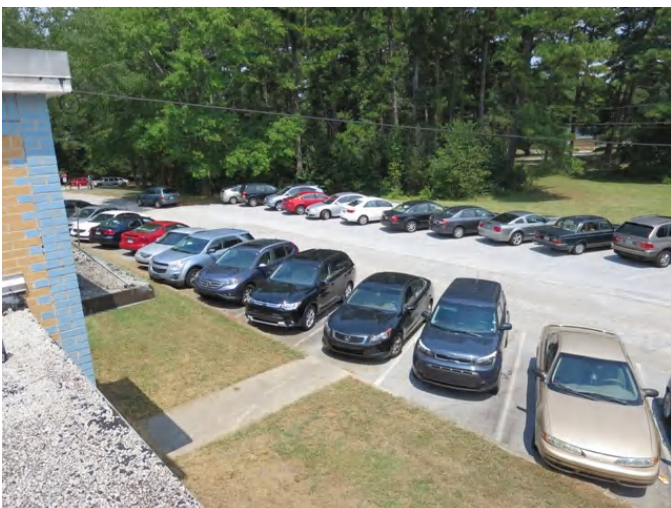
System: G2020 - Parking Lots

Location: Site

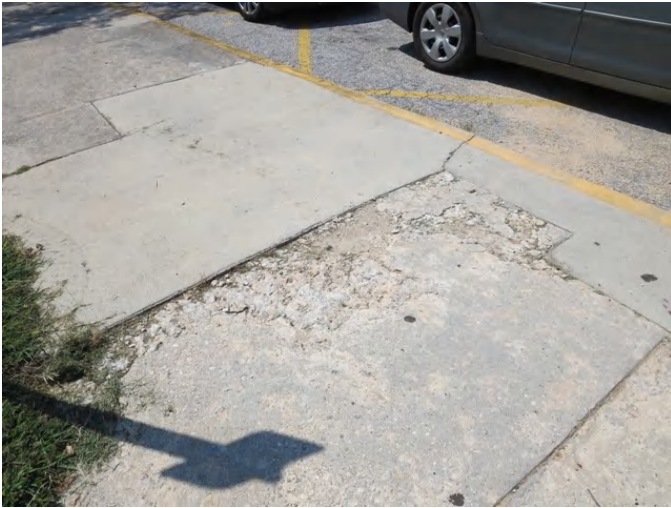
System: G2030 - Pedestrian Paving

Location: Site

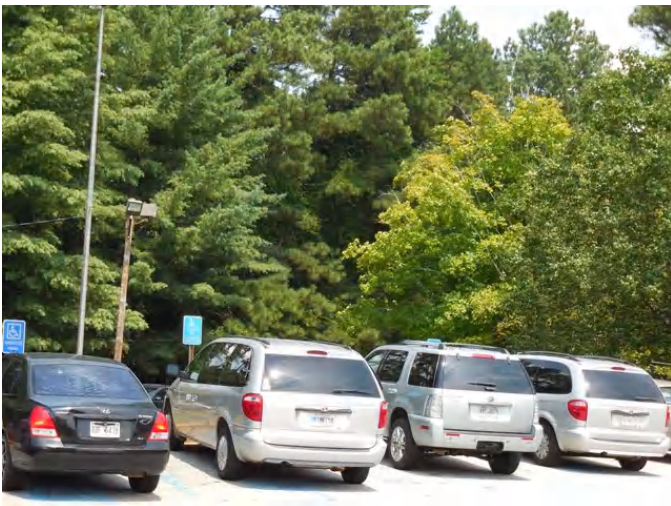
System: G4020 - Site Lighting

Location: Site

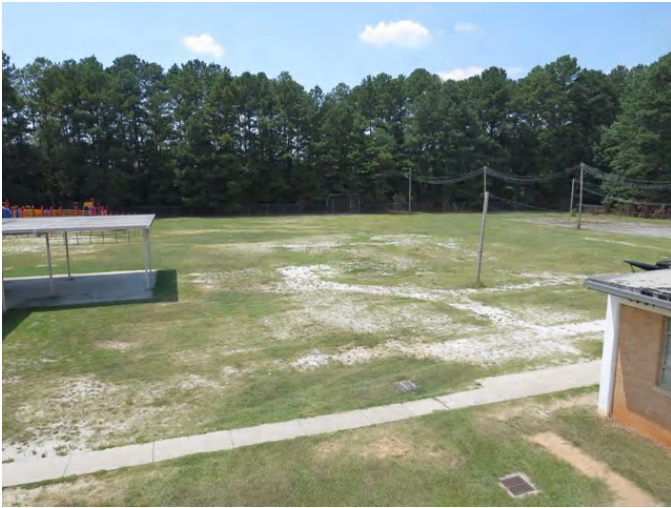
System: G2040 - Playing Field

Location: Site

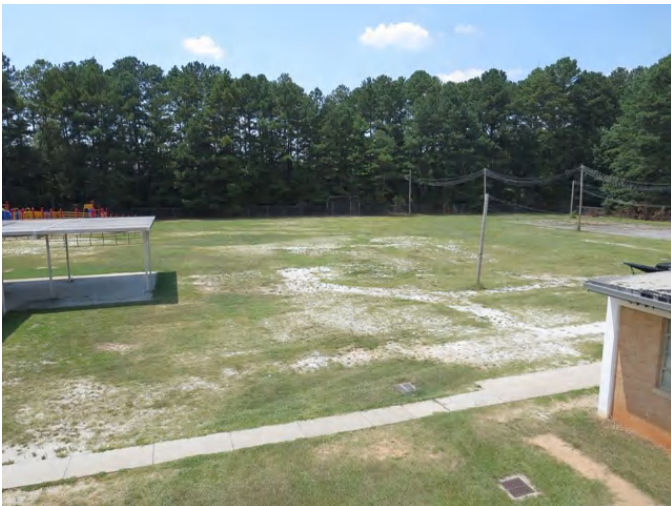
System: G2050 - Landscaping

Location: Site

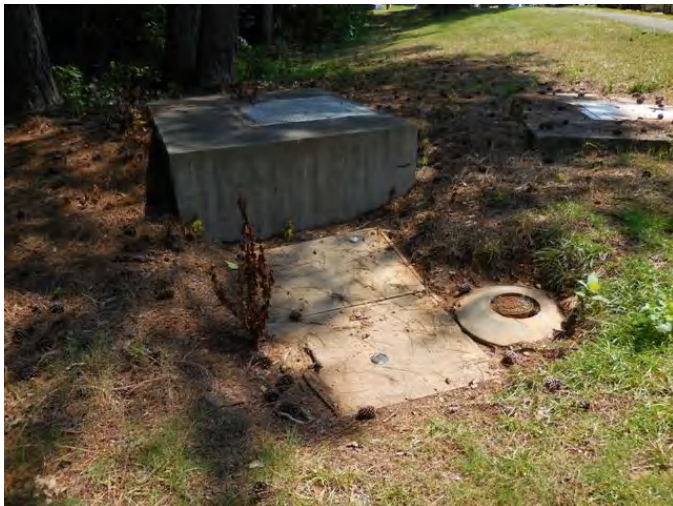
System: G3010 - Water Supply

Location: Exterior Water Service Line

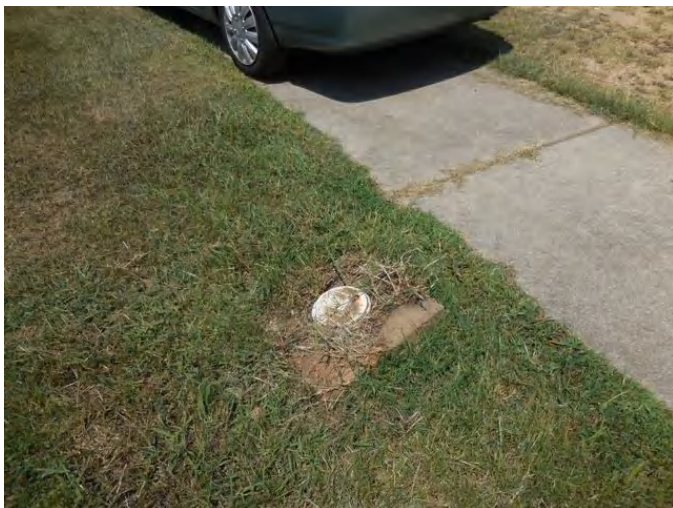
System: G3020 - Sanitary Sewer

Location: Site

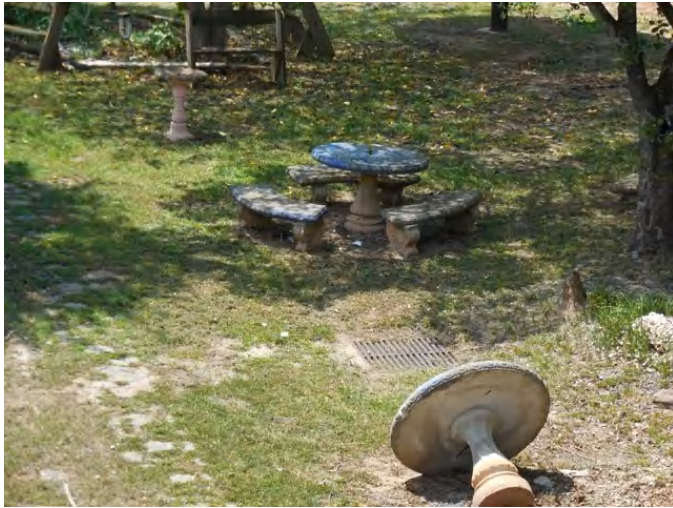
System: G3030 - Storm Sewer

Location: Site
