DeKalb County School District/Elementary Schools

Toney Elementary

School Assessment Report

May 20, 2016

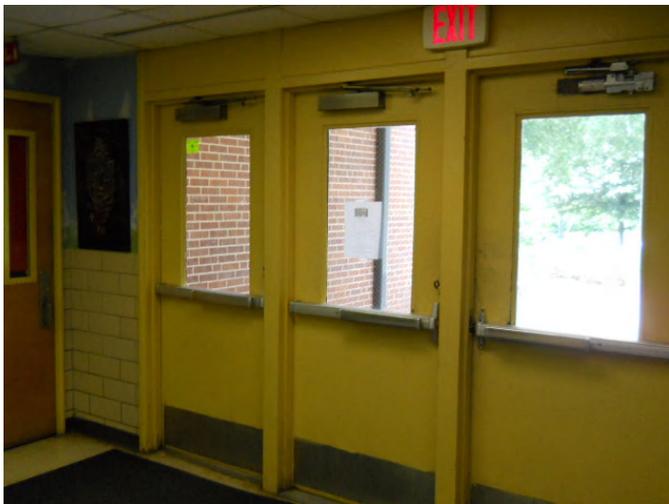
Location: Throughout Building

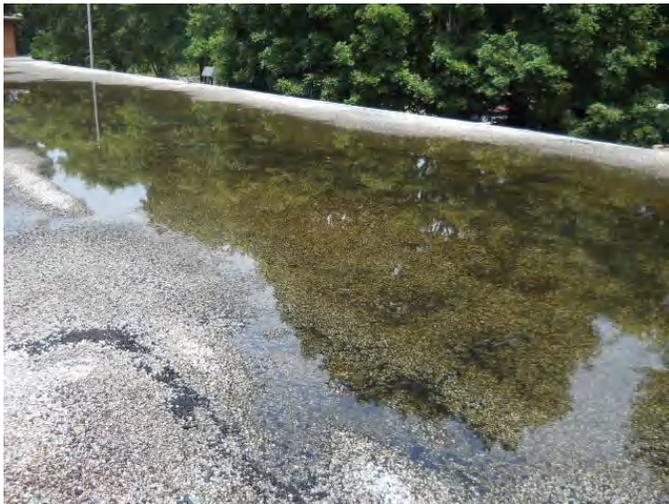
Location: Roof
Distress: Beyond Service Life
Category: Deferred Maintenance / Energy
Priority: 3 Priority
Correction: Renew System
Qty: 60,750.00
Unit of Measure: S.F.
Estimate: \$1,383,278.00
Assessor Name: Ben Nixon
Date Created: 04/11/2015

Notes: The roof covering has numerous reported leaks, ponding and delamination, and should be replaced. SPLOST project 132-422 to replace the roofs and roof openings.

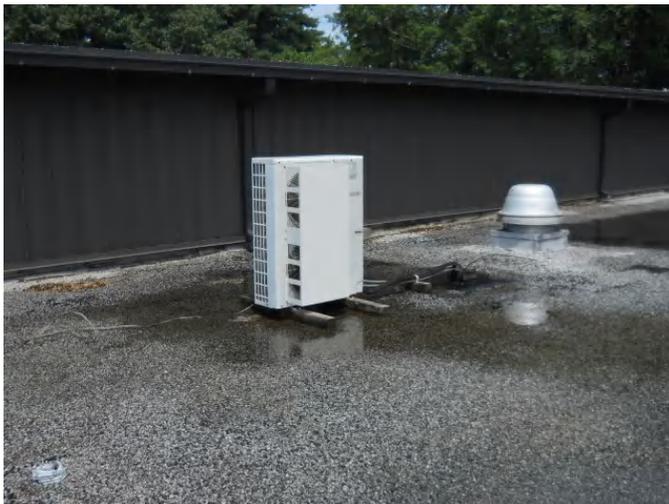
Location: Roof
Distress: Missing
Category: Safety
Priority: 3 Priority
Correction: Renew System
Qty: 60,750.00
Unit of Measure: S.F.
Estimate: \$36,754.00
Assessor Name: Ben Nixon
Date Created: 04/11/2015

Notes: The roof does not have an access hatch or ladder. Recommend installation of roof hatch/ladder system for safe access for maintenance personnel. SPLOST project 132-422 to replace the roofs and roof openings.

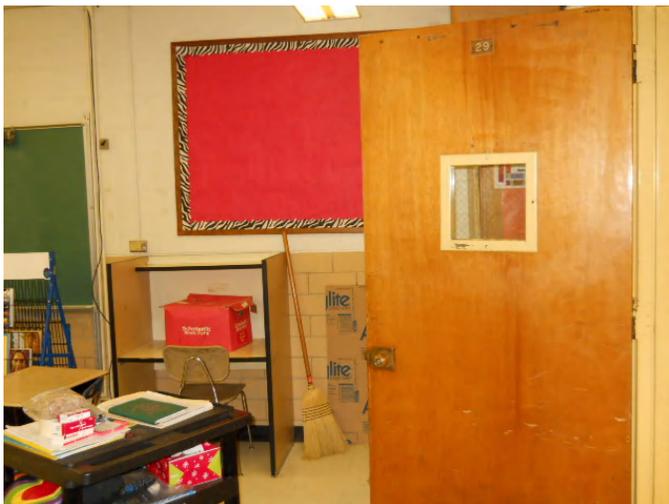
Location: Throughout Building
Distress: Beyond Service Life
Category: Deferred Maintenance / Building Code Compliance
Priority: 3 Priority
Correction: Renew System
Qty: 60,750.00
Unit of Measure: S.F.
Estimate: \$116,154.00
Assessor Name: Sam Mandola
Date Created: 04/11/2015

Notes: Interior doors are beyond their expected service life and should be replaced to improve ADA accessibility and comply with building code.

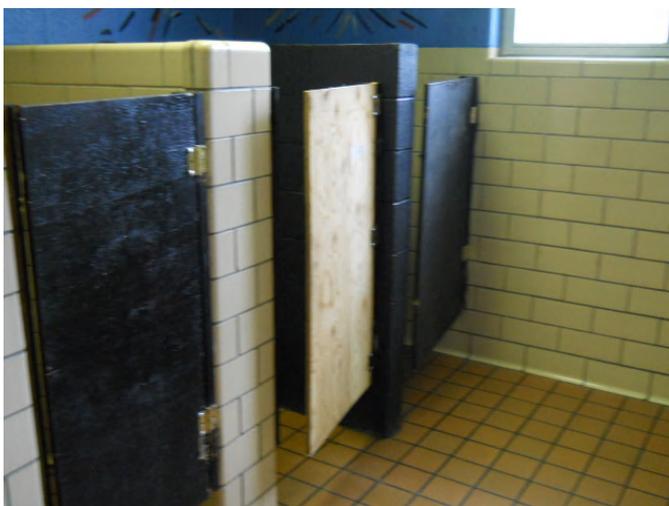
Location: Throughout Building
Distress: Beyond Service Life
Category: Deferred Maintenance / Accessibility Code Compliance
Priority: 3 Priority
Correction: Renew System
Qty: 60,750.00
Unit of Measure: S.F.
Estimate: \$186,442.00
Assessor Name: Ben Nixon
Date Created: 04/11/2015

Notes: Fittings, such as toilet partitions, handrails, signage and lockers, are beyond their expected service life, not ADA compliant, and should be replaced. SPLOST project 132-422 to provide ADA upgrades to hall restrooms.

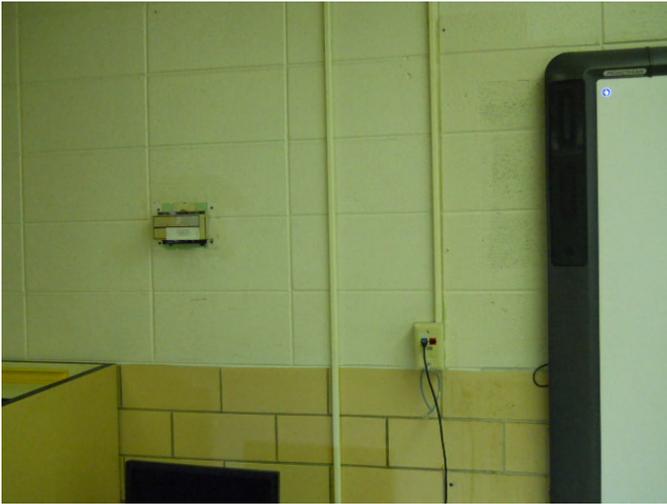
Location: Throughout Building
Distress: Beyond Service Life
Category: Deferred Maintenance
Priority: 3 Priority
Correction: Renew System
Qty: 36,450.00
Unit of Measure: S.F.
Estimate: \$77,383.00
Assessor Name: Ben Nixon
Date Created: 06/17/2015

Notes: The painted wall finishes are beyond their expected service life and should be replaced.

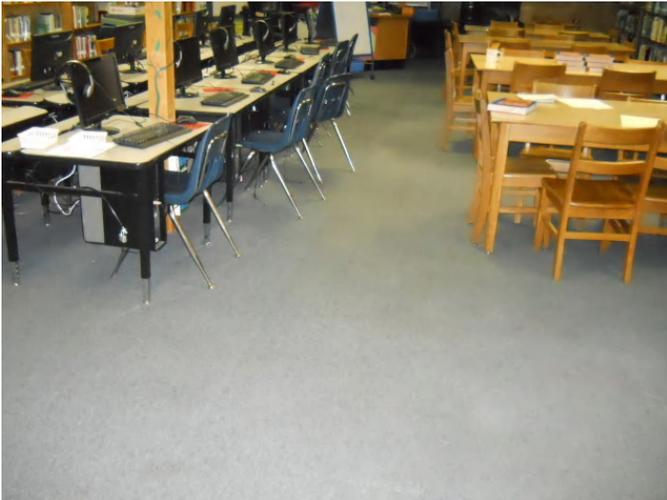
Location: Offices, Media Center
Distress: Beyond Service Life
Category: Deferred Maintenance
Priority: 3 Priority
Correction: Renew System
Qty: 4,860.00
Unit of Measure: S.F.
Estimate: \$45,441.00
Assessor Name: Ben Nixon
Date Created: 04/11/2015

Notes: The carpet is beyond its expected service life, worn, and should be replaced.

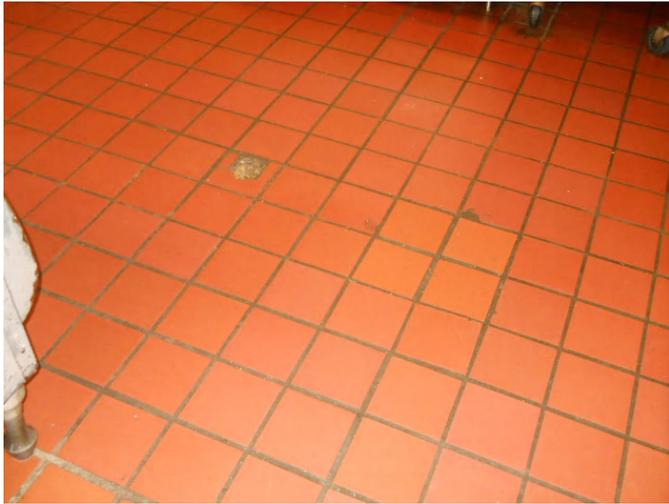
Location: Kitchen and Restrooms
Distress: Beyond Service Life
Category: Deferred Maintenance
Priority: 3 Priority
Correction: Renew System
Qty: 3,645.00
Unit of Measure: S.F.
Estimate: \$58,098.00
Assessor Name: Ben Nixon
Date Created: 06/17/2015

Notes: The tile floor covering is beyond its expected service life and should be replaced.

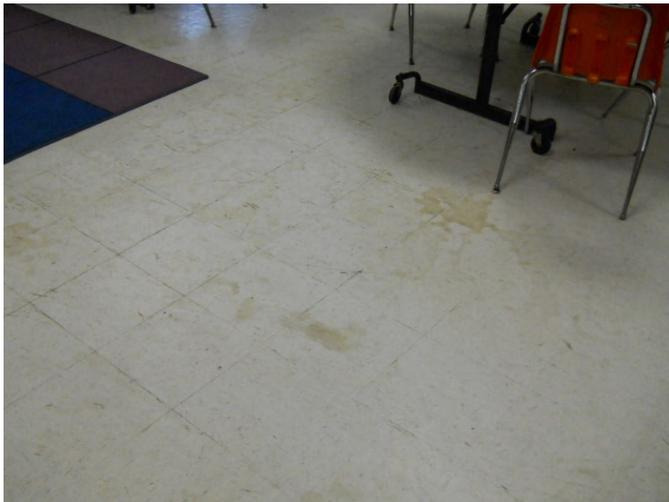
Location: Throughout Building
Distress: Beyond Service Life
Category: Deferred Maintenance / Environmental
Priority: 3 Priority
Correction: Renew System
Qty: 42,525.00
Unit of Measure: S.F.
Estimate: \$446,257.00
Assessor Name: Ben Nixon
Date Created: 04/11/2015

Notes: The VCT floor covering is beyond its expected service life and should be replaced.

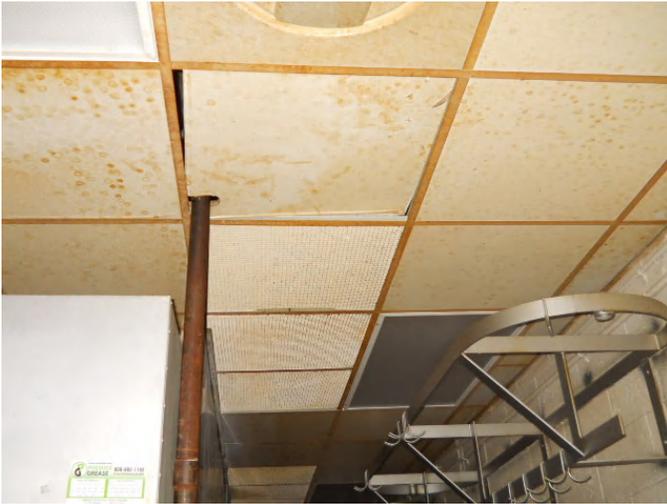
Location: Throughout Building
Distress: Beyond Service Life
Category: Deferred Maintenance
Priority: 3 Priority
Correction: Renew System
Qty: 60,750.00
Unit of Measure: S.F.
Estimate: \$666,914.00
Assessor Name: Ben Nixon
Date Created: 04/11/2015

Notes: The acoustical ceiling system is beyond its expected service life and should be replaced.

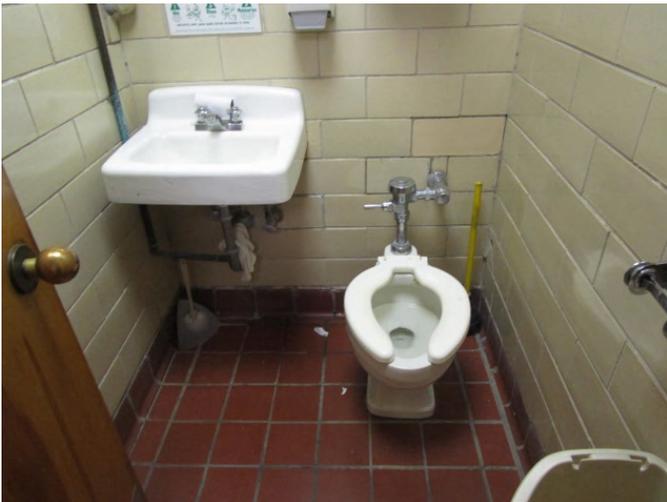
Location: Throughout Building
Distress: Beyond Service Life
Category: Deferred Maintenance / Accessibility Code Compliance
Priority: 3 Priority
Correction: Renew System
Qty: 60,750.00
Unit of Measure: S.F.
Estimate: \$1,180,130.00
Assessor Name: Sam Mandola
Date Created: 04/11/2015

Notes: The plumbing fixtures are beyond their expected service life, inadequate, and should be replaced to improve ADA accessibility. SPLOST project 132-422 to provide ADA upgrades to hall restrooms.

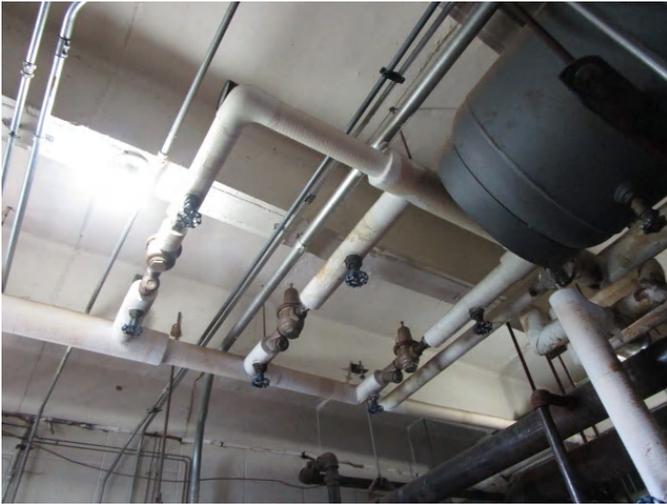
Location: Throughout Building
Distress: Beyond Service Life
Category: Deferred Maintenance
Priority: 3 Priority
Correction: Renew System
Qty: 60,750.00
Unit of Measure: S.F.
Estimate: \$266,632.00
Assessor Name: Ben Nixon
Date Created: 06/17/2015

Notes: The domestic water distribution system is beyond its expected service life and should be scheduled for replacement.

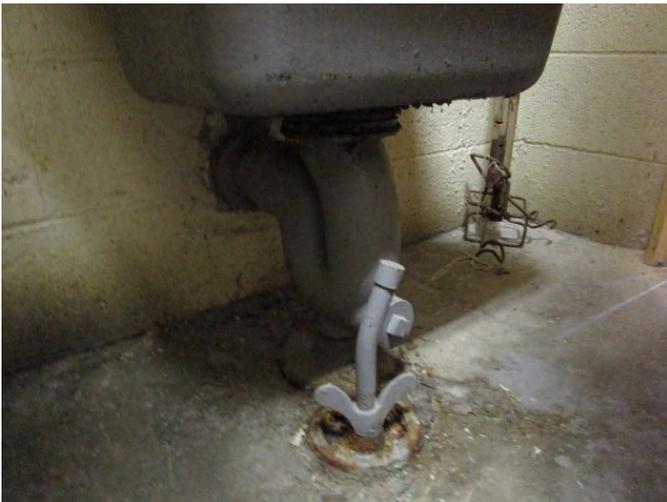
Location: Throughout Building
Distress: Beyond Service Life
Category: Deferred Maintenance
Priority: 3 Priority
Correction: Renew System
Qty: 60,750.00
Unit of Measure: S.F.
Estimate: \$227,873.00
Assessor Name: Ben Nixon
Date Created: 06/17/2015

Notes: The sanitary waste system is beyond its expected service life and should be scheduled for replacement. Floor drains reportedly clog often.

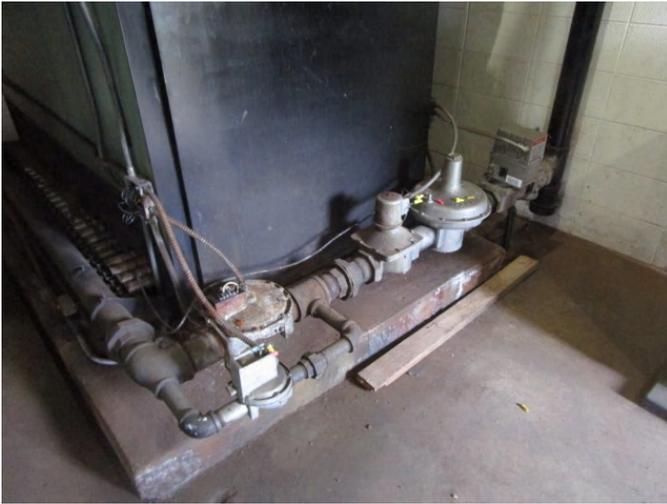
Location: Throughout Building
Distress: Beyond Service Life
Category: Deferred Maintenance
Priority: 3 Priority
Correction: Renew System
Qty: 60,750.00
Unit of Measure: S.F.
Estimate: \$27,398.00
Assessor Name: Ben Nixon
Date Created: 06/17/2015

Notes: The natural gas system is beyond its expected service life and should be scheduled for replacement.

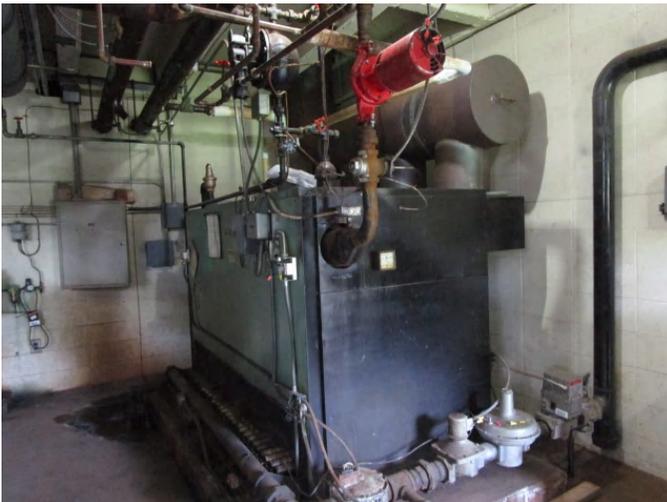
Location: Mechanical Room
Distress: Beyond Service Life
Category: Deferred Maintenance / Energy
Priority: 3 Priority
Correction: Renew System
Qty: 60,750.00
Unit of Measure: S.F.
Estimate: \$304,054.00
Assessor Name: Ben Nixon
Date Created: 04/11/2015

Notes: The heat generating system is beyond its expected service life, inadequate, and should be scheduled for replacement.

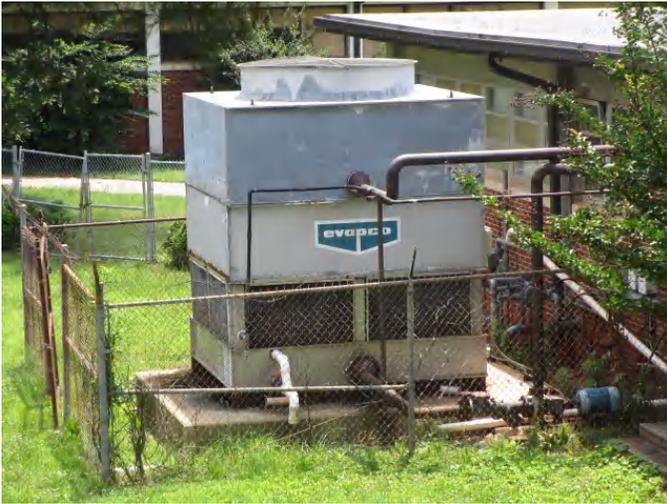
Location: Exterior of Building
Distress: Beyond Service Life
Category: Deferred Maintenance / Energy
Priority: 3 Priority
Correction: Renew System
Qty: 60,750.00
Unit of Measure: S.F.
Estimate: \$316,082.00
Assessor Name: Ben Nixon
Date Created: 04/11/2015

Notes: The cooling generating system is beyond its expected service life, inadequate, and should be scheduled for replacement.

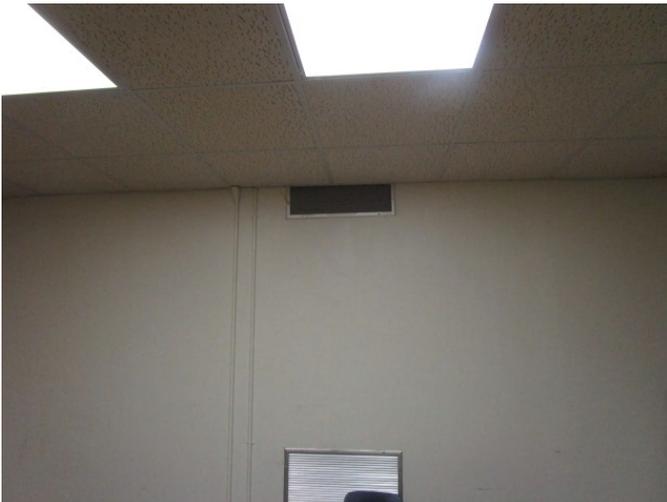
Location: Throughout Building
Distress: Beyond Service Life
Category: Deferred Maintenance / Environmental
Priority: 3 Priority
Correction: Renew System
Qty: 60,750.00
Unit of Measure: S.F.
Estimate: \$368,206.00
Assessor Name: Ben Nixon
Date Created: 04/11/2015

Notes: The distribution and exhaust systems are beyond their expected service life, inadequate, and should be scheduled for replacement. School staff identified ventilation as a safety issue.

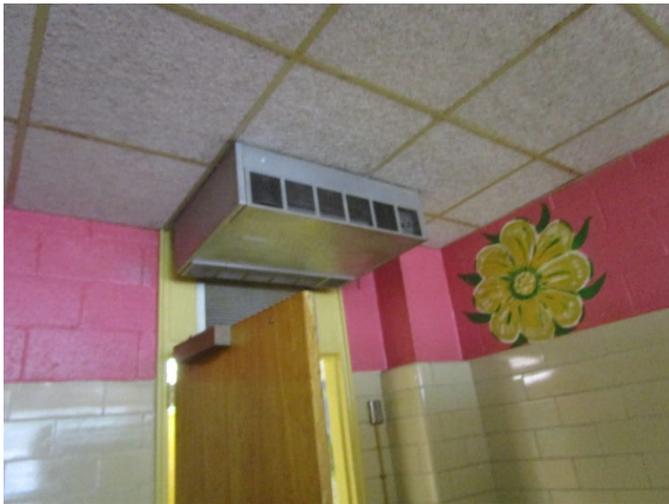
Location: Throughout Building
Distress: Beyond Service Life
Category: Deferred Maintenance / Energy
Priority: 3 Priority
Correction: Renew System
Qty: 60,750.00
Unit of Measure: S.F.
Estimate: \$1,237,599.00
Assessor Name: Ben Nixon
Date Created: 04/11/2015

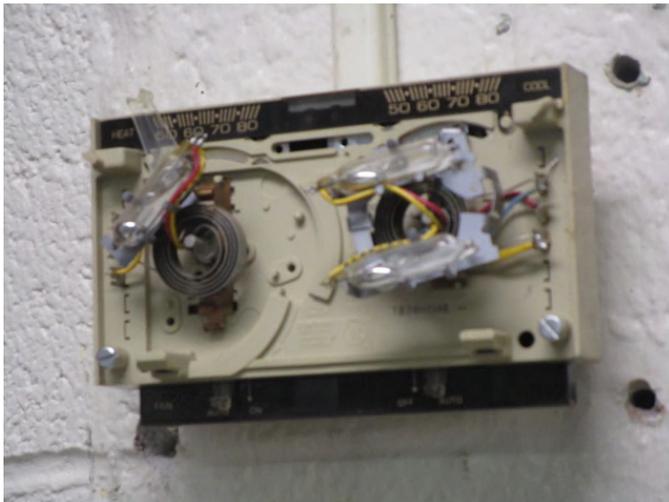
Location: Throughout Building
Distress: Beyond Service Life
Category: Deferred Maintenance / Energy
Priority: 3 Priority
Correction: Renew System
Qty: 60,750.00
Unit of Measure: S.F.
Estimate: \$240,570.00
Assessor Name: Ben Nixon
Date Created: 06/23/2015

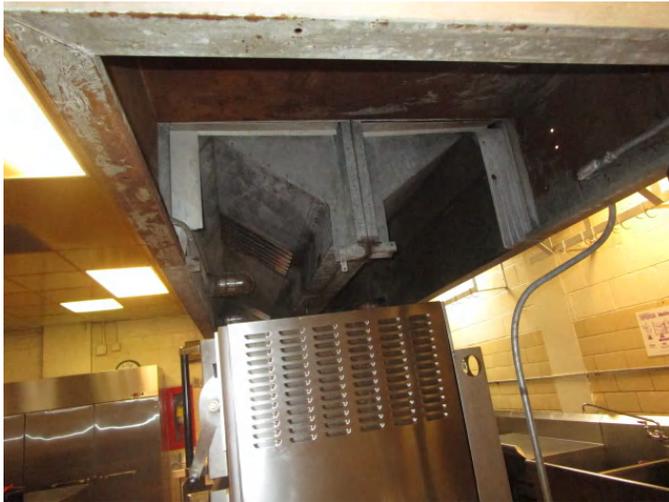
Location: Kitchen
Distress: Beyond Service Life
Category: Deferred Maintenance
Priority: 3 Priority
Correction: Renew System
Qty: 60,750.00
Unit of Measure: S.F.
Estimate: \$82,195.00
Assessor Name: Ben Nixon
Date Created: 04/11/2015

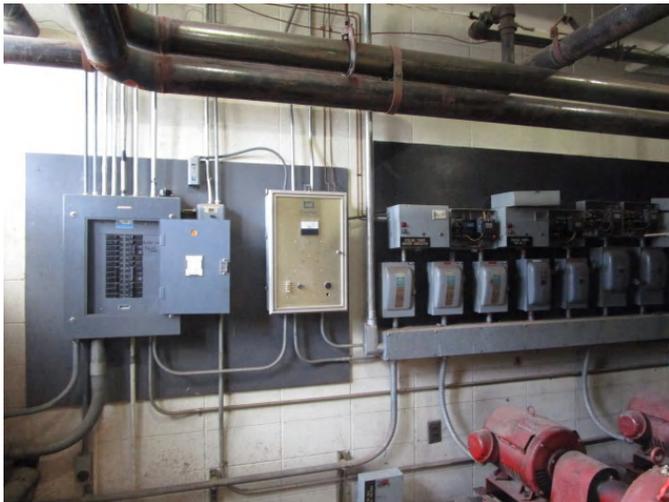
Location: Throughout Building
Distress: Beyond Service Life
Category: Deferred Maintenance / Building Code Compliance
Priority: 3 Priority
Correction: Renew System
Qty: 60,750.00
Unit of Measure: S.F.
Estimate: \$453,074.00
Assessor Name: Ben Nixon
Date Created: 04/11/2015

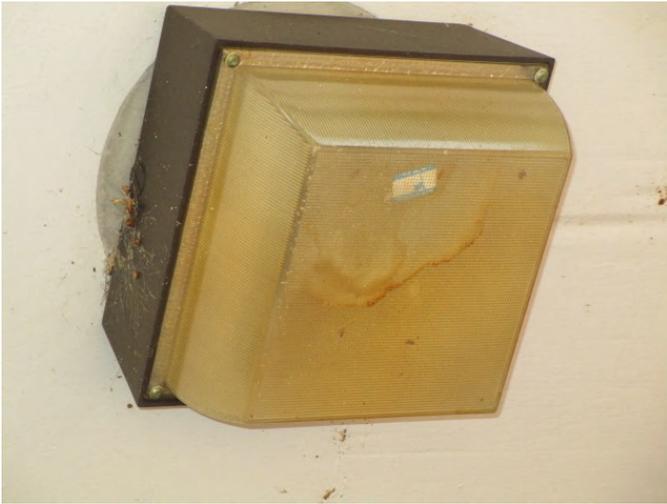
Location: Throughout Building
Distress: Beyond Service Life
Category: Deferred Maintenance / Energy
Priority: 3 Priority
Correction: Renew System
Qty: 60,750.00
Unit of Measure: S.F.
Estimate: \$594,743.00
Assessor Name: Ben Nixon
Date Created: 04/11/2015

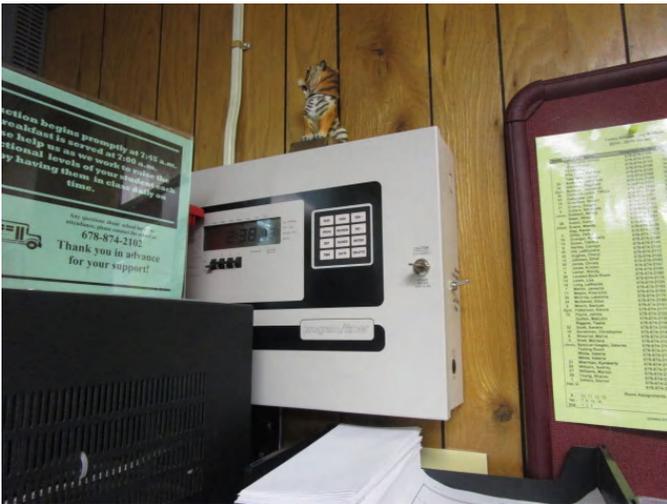
Location: Throughout Building
Distress: Beyond Service Life
Category: Deferred Maintenance
Priority: 3 Priority
Correction: Renew System
Qty: 60,750.00
Unit of Measure: S.F.
Estimate: \$374,220.00
Assessor Name: Ben Nixon
Date Created: 04/11/2015

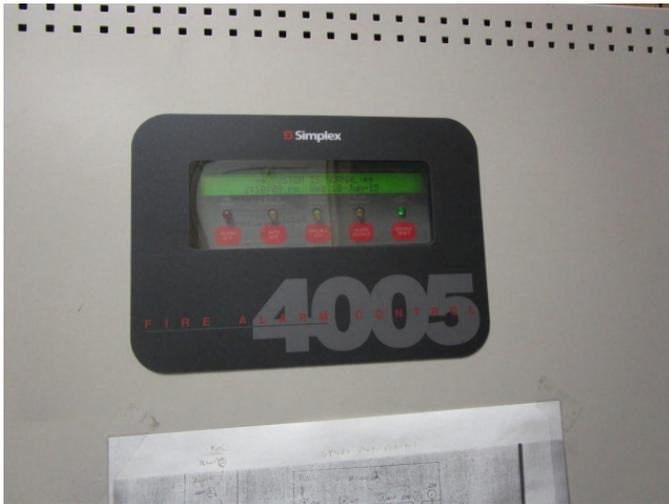
Location: Throughout Building
Distress: Beyond Service Life
Category: Deferred Maintenance
Priority: 3 Priority
Correction: Renew System
Qty: 60,750.00
Unit of Measure: S.F.
Estimate: \$82,195.00
Assessor Name: Ben Nixon
Date Created: 04/11/2015

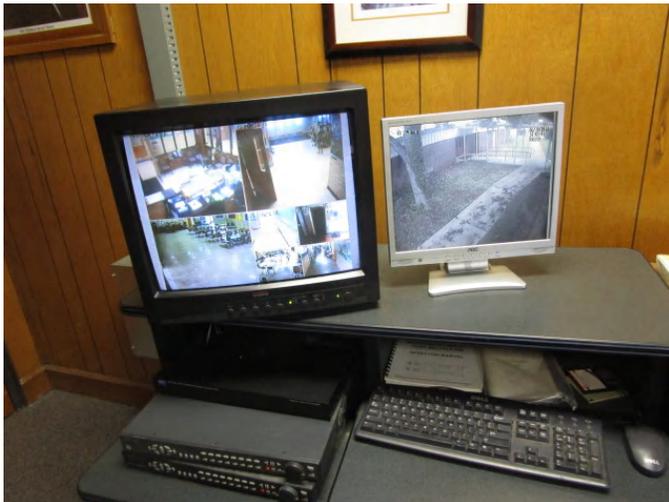
Location: Throughout Building
Distress: Beyond Service Life
Category: Deferred Maintenance
Priority: 3 Priority
Correction: Renew System
Qty: 60,750.00
Unit of Measure: S.F.
Estimate: \$40,763.00
Assessor Name: Ben Nixon
Date Created: 04/11/2015

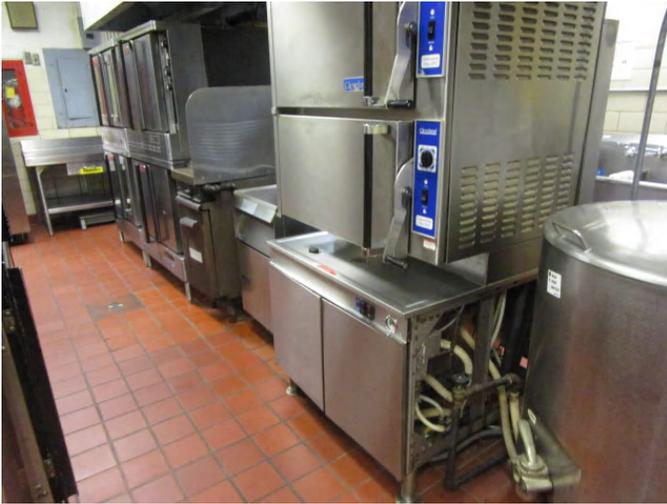
Location: Kitchen
Distress: Beyond Service Life
Category: Deferred Maintenance
Priority: 3 Priority
Correction: Renew System
Qty: 60,750.00
Unit of Measure: S.F.
Estimate: \$616,795.00
Assessor Name: Ben Nixon
Date Created: 04/11/2015

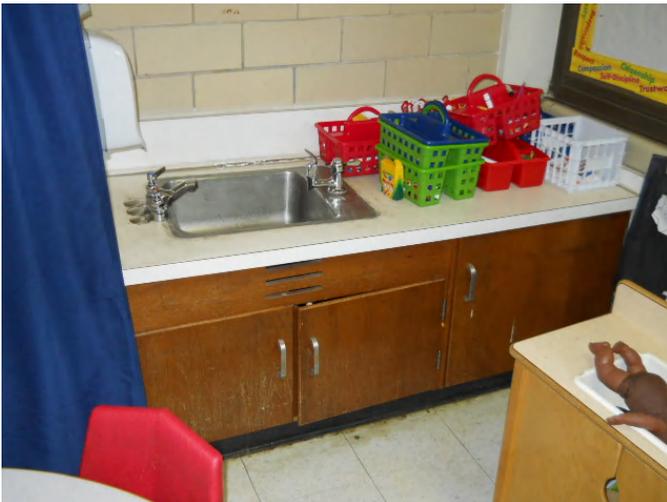
Location: Throughout Building
Distress: Beyond Service Life
Category: Deferred Maintenance
Priority: 3 Priority
Correction: Renew System
Qty: 60,750.00
Unit of Measure: S.F.
Estimate: \$358,850.00
Assessor Name: Ben Nixon
Date Created: 04/11/2015

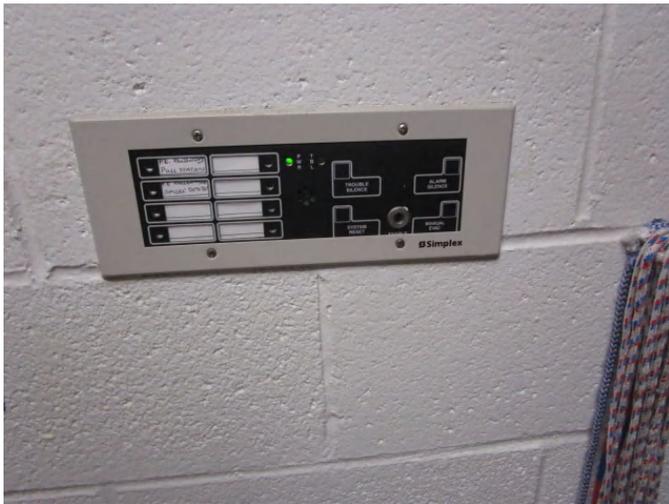
Location: Throughout Building
Distress: Beyond Service Life
Category: Deferred Maintenance
Priority: 3 Priority
Correction: Renew System
Qty: 5,478.00
Unit of Measure: S.F.
Estimate: \$12,835.00
Assessor Name: Ben Nixon
Date Created: 04/11/2015

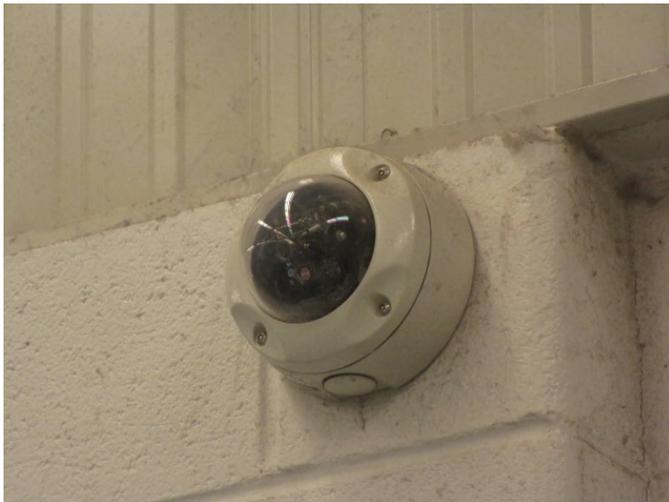
Location: Throughout Building
Distress: Beyond Service Life
Category: Deferred Maintenance
Priority: 3 Priority
Correction: Renew System
Qty: 5,478.00
Unit of Measure: S.F.
Estimate: \$5,303.00
Assessor Name: Ben Nixon
Date Created: 04/11/2015

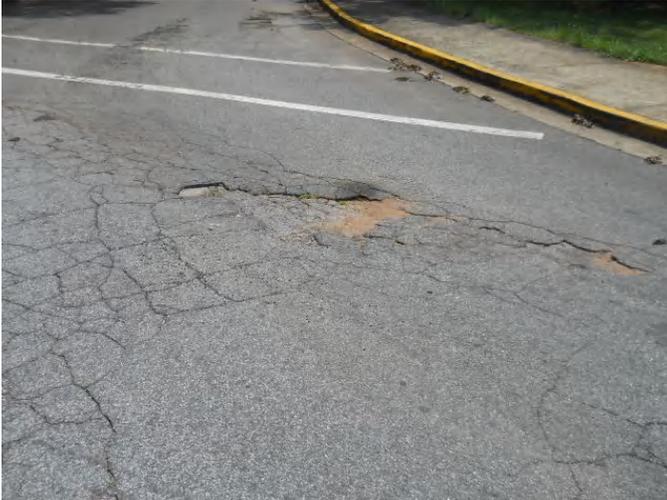
Location: Site
Distress: Beyond Service Life
Category: Deferred Maintenance
Priority: 3 Priority
Correction: Renew System
Qty: 25,967.00
Unit of Measure: S.F.
Estimate: \$147,674.33
Assessor Name: Eduardo Lopez
Date Created: 06/10/2015

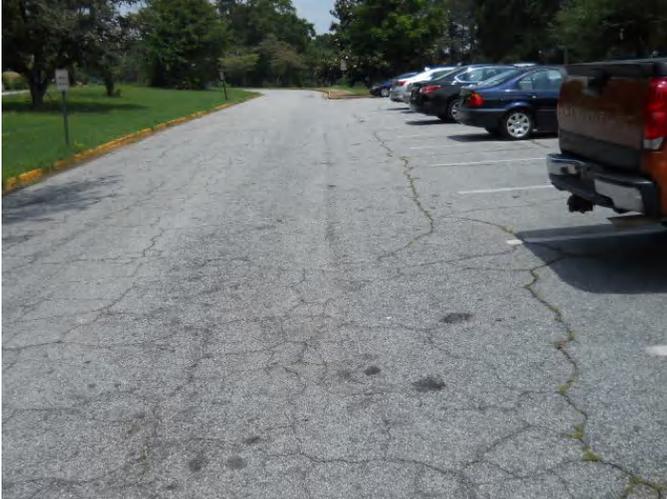
Location: Site
Distress: Beyond Service Life
Category: Deferred Maintenance / Accessibility Code Compliance
Priority: 3 Priority
Correction: Renew System
Qty: 11,434.00
Unit of Measure: S.F.
Estimate: \$57,352.94
Assessor Name: Sam Mandola
Date Created: 06/10/2015

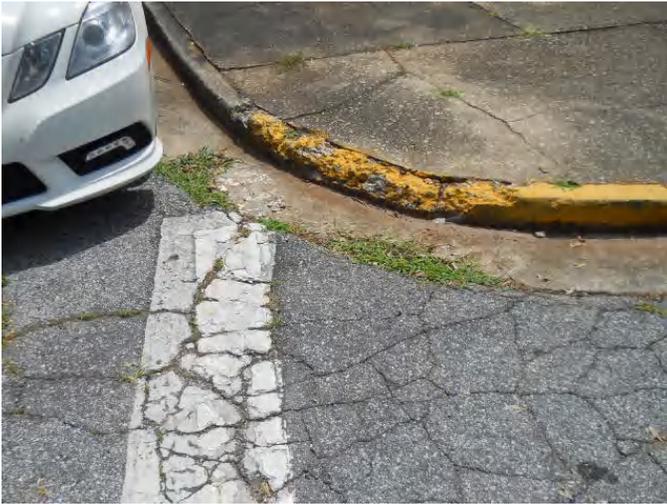
Location: Site
Distress: Beyond Service Life
Category: Deferred Maintenance
Priority: 3 Priority
Correction: Renew System
Qty: 66,348.00
Unit of Measure: S.F.
Estimate: \$109,474.20
Assessor Name: Eduardo Lopez
Date Created: 06/10/2015

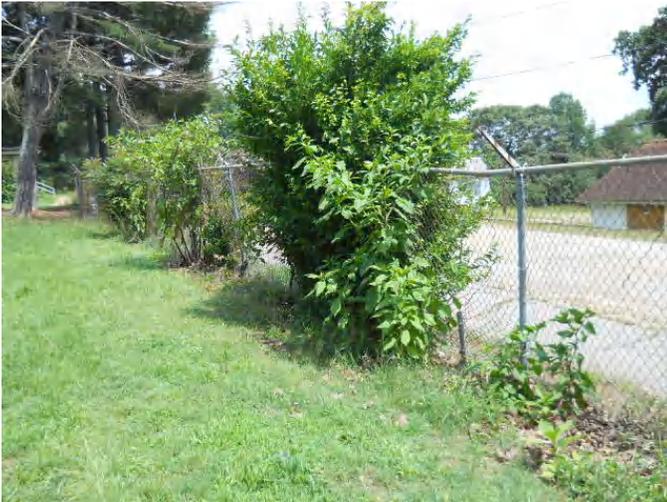
Location: Site
Distress: Beyond Service Life
Category: Deferred Maintenance
Priority: 3 Priority
Correction: Renew System
Qty: 66,348.00
Unit of Measure: S.F.
Estimate: \$66,414.35
Assessor Name: Eduardo Lopez
Date Created: 06/10/2015

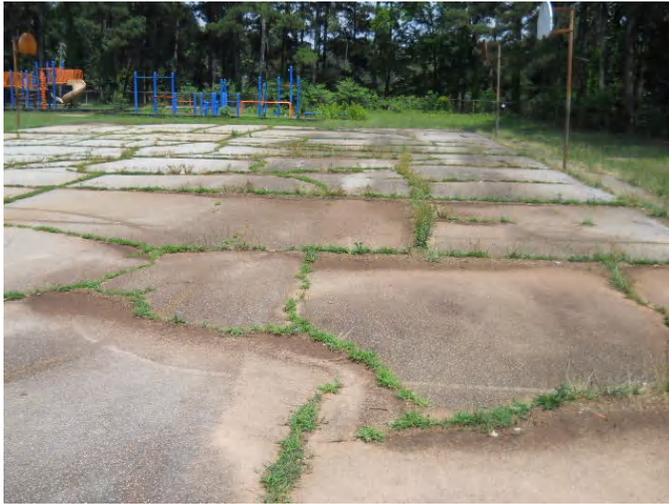
Location: Site
Distress: Beyond Service Life
Category: Deferred Maintenance
Priority: 3 Priority
Correction: Renew System
Qty: 7,939.00
Unit of Measure: S.F.
Estimate: \$54,667.95
Assessor Name: Eduardo Lopez
Date Created: 06/10/2015

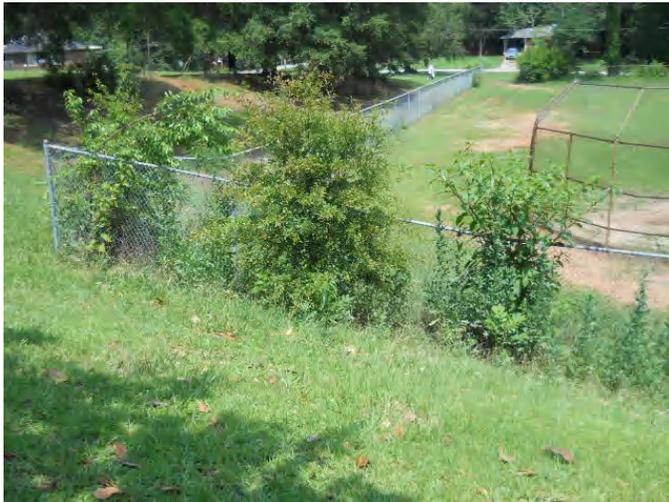
Location: Site
Distress: Beyond Service Life
Category: Deferred Maintenance
Priority: 3 Priority
Correction: Renew System
Qty: 66,348.00
Unit of Measure: S.F.
Estimate: \$105,825.06
Assessor Name: Eduardo Lopez
Date Created: 06/10/2015

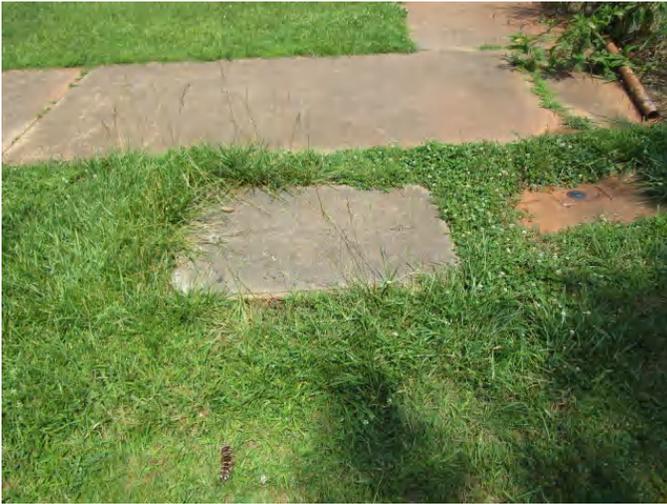
Location: Site
Distress: Beyond Service Life
Category: Deferred Maintenance
Priority: 3 Priority
Correction: Renew System
Qty: 66,348.00
Unit of Measure: S.F.
Estimate: \$133,558.52
Assessor Name: Eduardo Lopez
Date Created: 06/10/2015

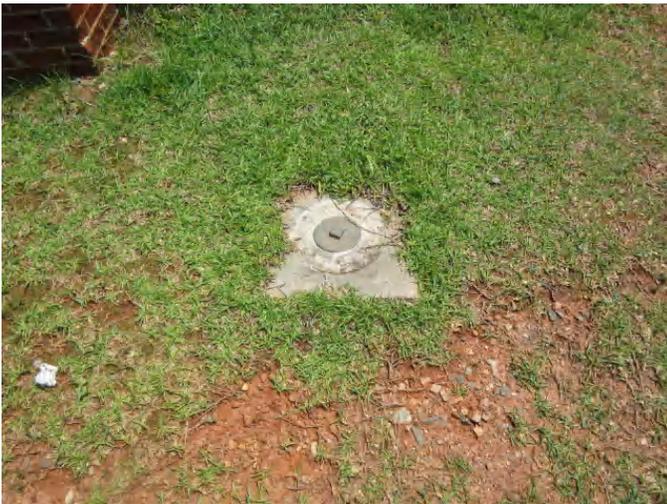
Location: Site
Distress: Beyond Service Life
Category: Deferred Maintenance
Priority: 3 Priority
Correction: Renew System
Qty: 66,348.00
Unit of Measure: S.F.
Estimate: \$83,930.22
Assessor Name: Eduardo Lopez
Date Created: 06/10/2015

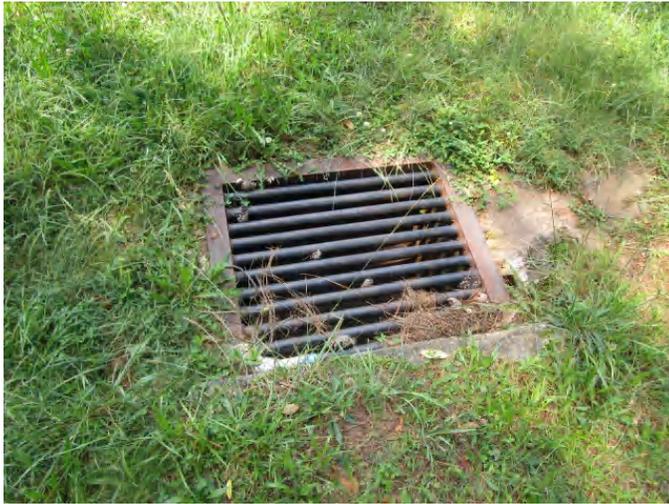
Location: Site
Distress: Beyond Service Life
Category: Deferred Maintenance
Priority: 3 Priority
Correction: Renew System
Qty: 66,348.00
Unit of Measure: S.F.
Estimate: \$259,088.94
Assessor Name: Eduardo Lopez
Date Created: 06/10/2015

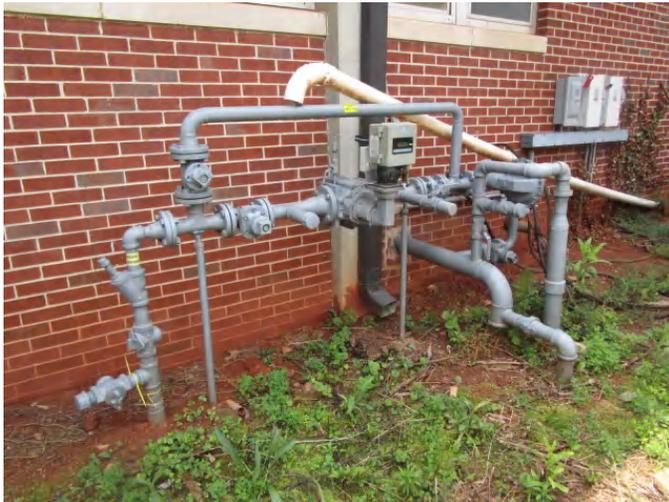
Location: Site
Distress: Beyond Service Life
Category: Deferred Maintenance
Priority: 3 Priority
Correction: Renew System
Qty: 66,348.00
Unit of Measure: S.F.
Estimate: \$56,926.58
Assessor Name: Eduardo Lopez
Date Created: 06/10/2015

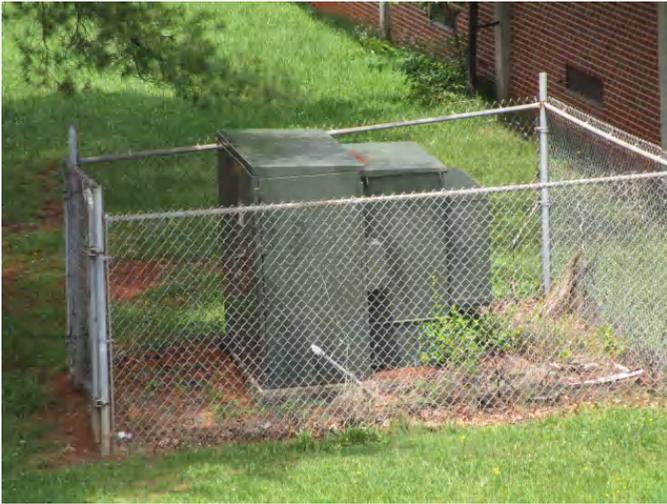
Location: Site
Distress: Beyond Service Life
Category: Deferred Maintenance
Priority: 3 Priority
Correction: Renew System
Qty: 66,348.00
Unit of Measure: S.F.
Estimate: \$135,748.01
Assessor Name: Eduardo Lopez
Date Created: 06/10/2015

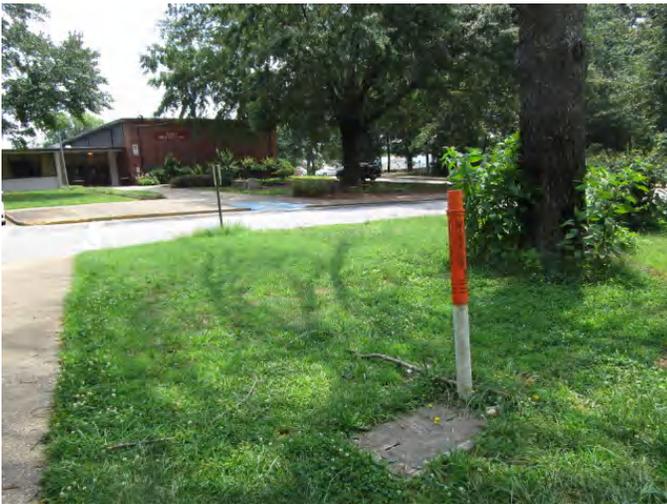
Location: Site
Distress: Beyond Service Life
Category: Deferred Maintenance
Priority: 3 Priority
Correction: Renew System
Qty: 66,348.00
Unit of Measure: S.F.
Estimate: \$48,898.48
Assessor Name: Eduardo Lopez
Date Created: 06/10/2015
