DeKalb County School District/Middle Schools

# Tucker Middle

## School Assessment Report

May 20, 2016

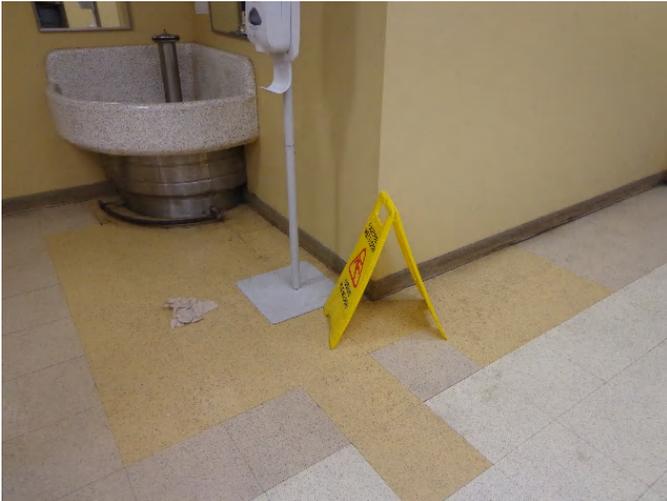
**Location:** In Corridor Outside First Floor North Boys Restroom 1125

**Distress:** Damaged

**Notes:** There is a recurrent leak in the area of the group wash fountain outside of the boys restroom. VCT is damaged in this area and requiring replacement. Source of water is unknown. Recommend to replace the fixture and verify correct connections to potable water and sanitary sewer.

**Correction:** Investigate and repair water leak

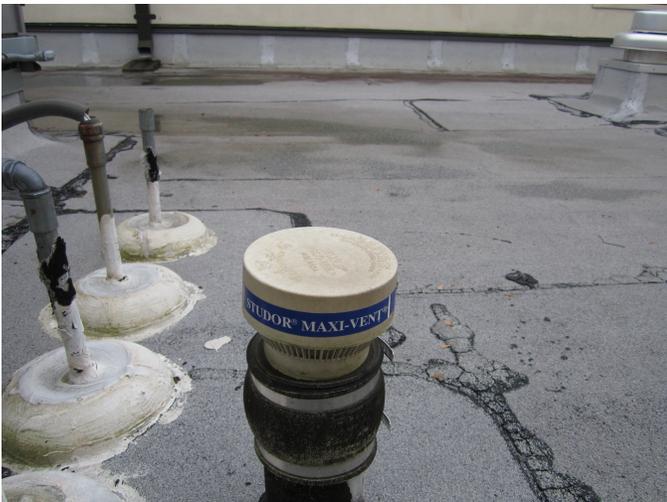
**Location:** Roof

**Distress:** Inadequate

**Notes:** Perform full maintenance or replace all studor vents throughout the facility to address problems with sewer gas odors on all three floors of the building.

**Correction:** Replace pipe, 4" pipe and fittings, PVC

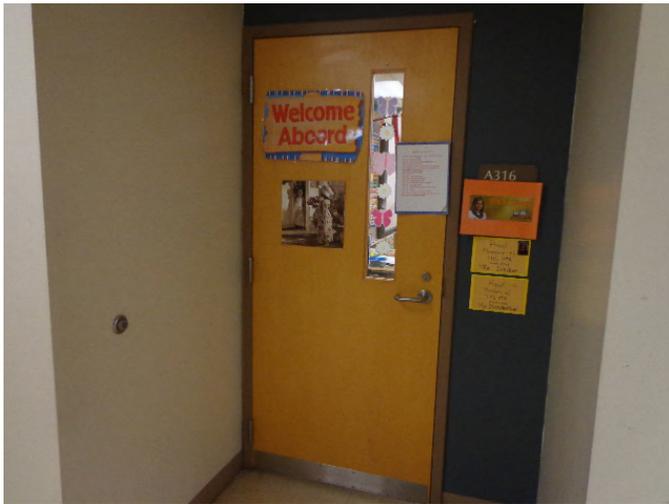
**Location:** Vicinity A316 Thru Stairwell; Vicinity B103 Thru B120; Vicinity A216

**Distress:** Inadequate

**Notes:** Strong sewer gas odors during cold weather, especially in vicinity of third floor classroom A316. Same problem to lesser degree in vicinity of first floor rooms B103 thru B120. Minor problems of same nature on second floor in vicinity of room A216. A number of efforts have been made since building opened in 2004 with no success. Recommend an engineering study to investigate, determine source and define corrective actions.

**Correction:** Engineering study for inadequate gas venting

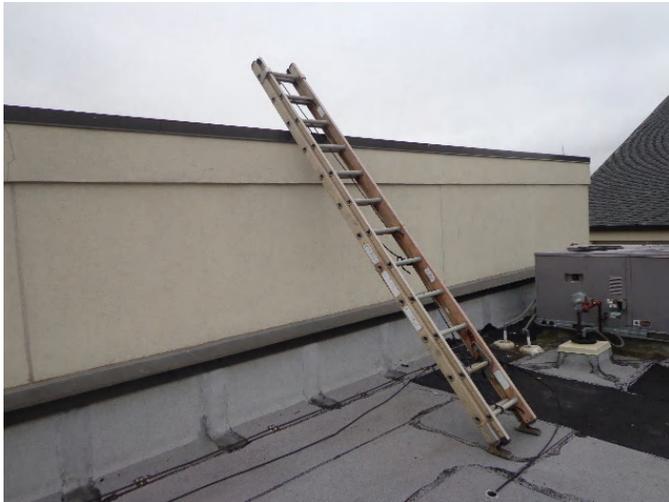
**Location:** Roof

**Distress:** Missing

**Notes:** Fixed parapet ladders with top access are missing in different locations throughout the roof and should be provided to comply with OSHA standards.

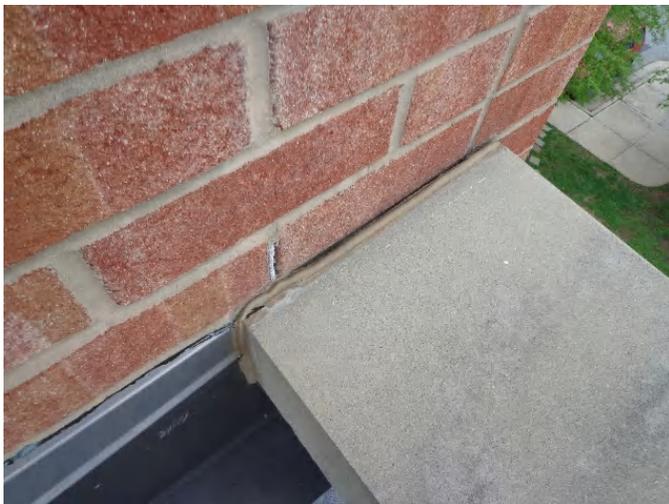
**Location:** Exterior of Building

**Distress:** Damaged

**Notes:** Repair/replace expansion joints as needed.

**Correction:** Repair / Replace expansion joint caulk material

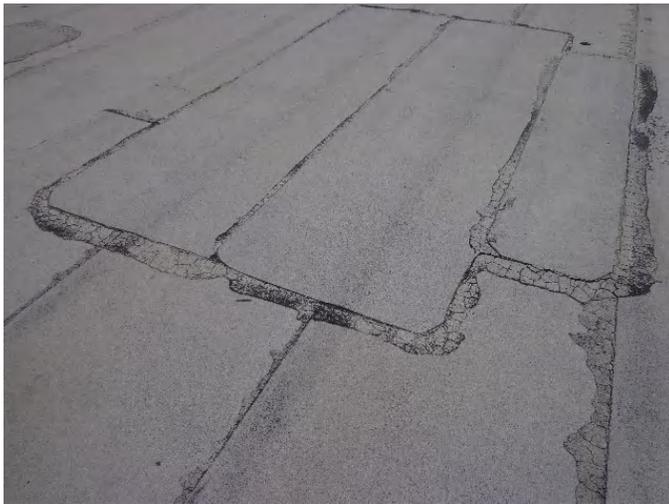
**Location:** Roof  
**Distress:** Damaged  
**Category:** Deferred Maintenance / Energy  
**Priority:** 2 Priority  
**Correction:** Renew System  
**Qty:** 42,402.00  
**Unit of Measure:** S.F.  
**Estimate:** \$965,494.00  
**Assessor Name:** Sam Mandola  
**Date Created:** 04/16/2015

**Notes:** The built-up roof covering is in deteriorating condition with signs of cracks, bubbling, and patches, and reported water leaks through parapets and other areas.

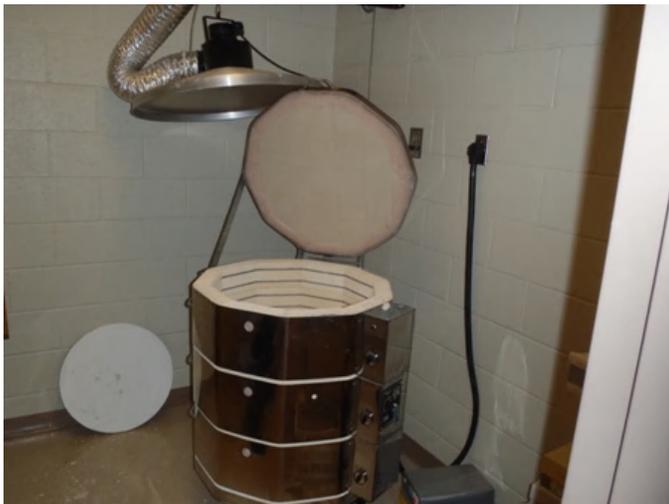
**Location:** Room B129  
**Distress:** Inadequate  
**Category:** Building Code Compliance  
**Priority:** 2 Priority  
**Correction:** Add restroom exhaust fan  
**Qty:** 1.00  
**Unit of Measure:** Ea.  
**Estimate:** \$18,601.46  
**Assessor Name:** Sam Mandola  
**Date Created:** 04/17/2015

**Notes:** Kiln exhaust system is inadequate and has no outside air available. Replace with code compliant system with run time delay.

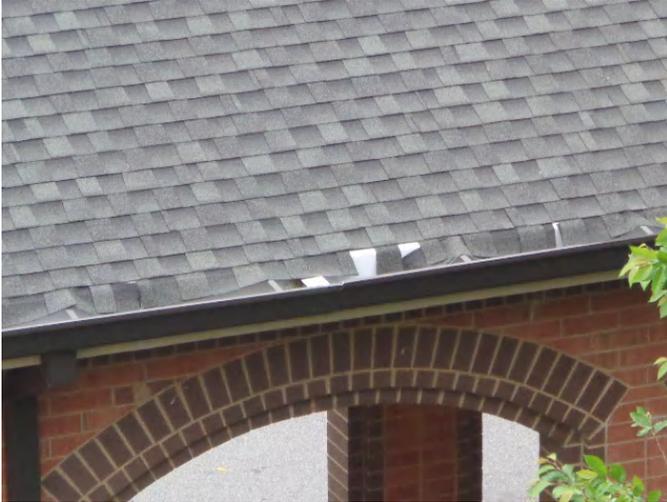
**Location:** Covered Walkways

**Distress:** Inadequate

**Notes:** Repair/replace asphalt shingles and flashing as needed.

**Correction:** Asphalt shingle flashing repairs, 2 S.F. per sq. repaired

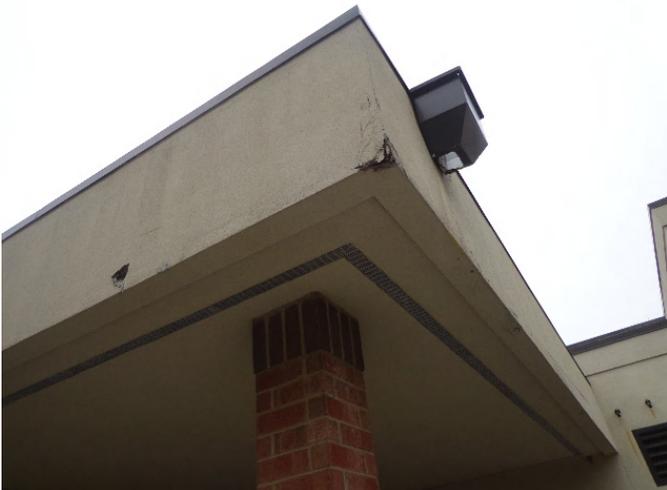
**Location:** Kitchen Service Entrance

**Distress:** Missing

**Notes:** Downspout at kitchen service entrance is missing and should be replaced.

**Correction:** Replace aluminum downspout, 3" x 4", .024" thick

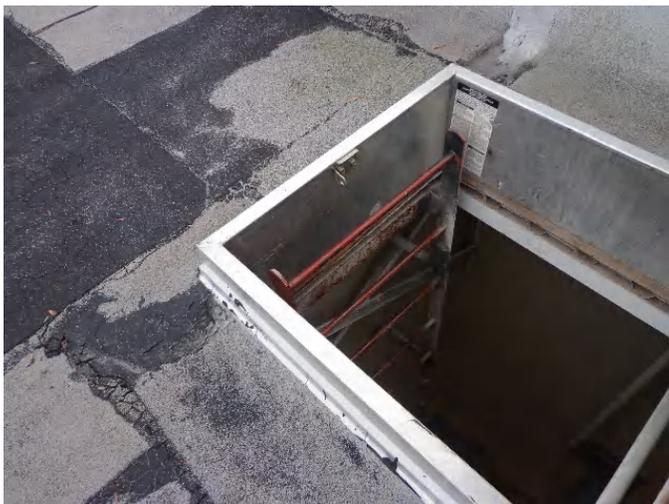
**Location:** Roof  
**Distress:** Inadequate  
**Category:** Building Code Compliance  
**Priority:** 3 Priority  
**Correction:** Renew System  
**Qty:** 152,350.00  
**Unit of Measure:** S.F.  
**Estimate:** \$5,028.00  
**Assessor Name:** Eduardo Lopez  
**Date Created:** 04/16/2015

**Notes:** Roof hatch does not comply with OSHA standards; roof opening protection and proper extension of fixed ladder to platform is not provided.

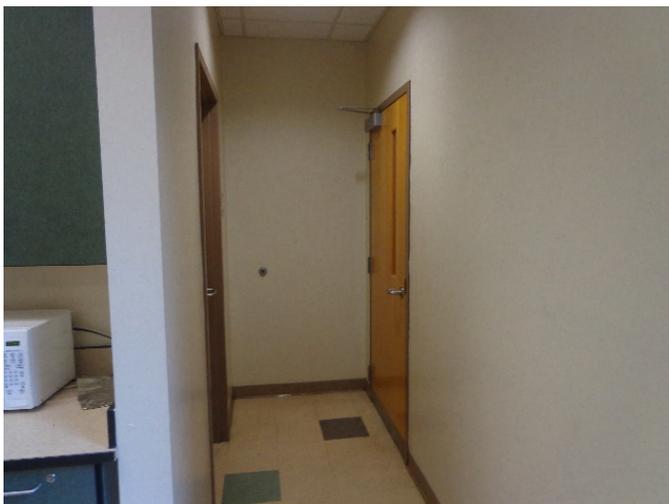
**Location:** B134 Faculty Lounge  
**Distress:** Inadequate  
**Category:** Accessibility Code Compliance  
**Priority:** 3 Priority  
**Correction:** Add/replace partitions to meet 1-hr rating  
**Qty:** 900.00  
**Unit of Measure:** S.F.  
**Estimate:** \$6,197.58  
**Assessor Name:** Eduardo Lopez  
**Date Created:** 04/16/2015

**Notes:** Swing door maneuvering clearance does not comply with ADA standards in women's restroom. Adjust partitions to comply with a minimum width of 42" for a side approach.

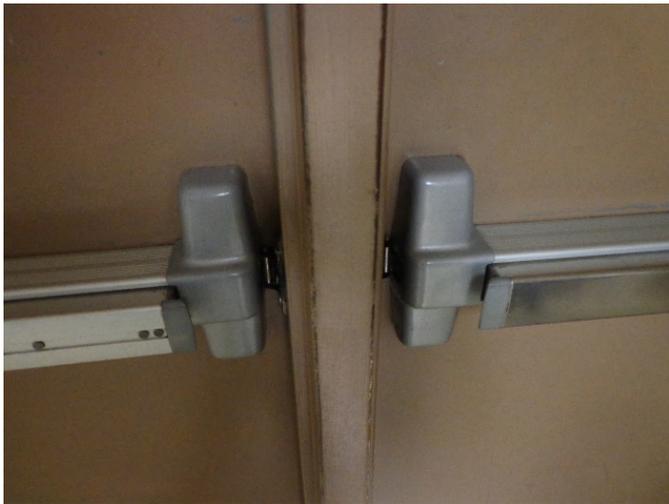
**Location:** Throughout Building  
**Distress:** Damaged  
**Category:** Deferred Maintenance  
**Priority:** 3 Priority  
**Correction:** Replace panic bar  
**Qty:** 20.00  
**Unit of Measure:** Ea.  
**Estimate:** \$33,964.28  
**Assessor Name:** Eduardo Lopez  
**Date Created:** 04/16/2015

**Notes:** Interior fire exit doors needs new panic bars due to age, wear and tear.

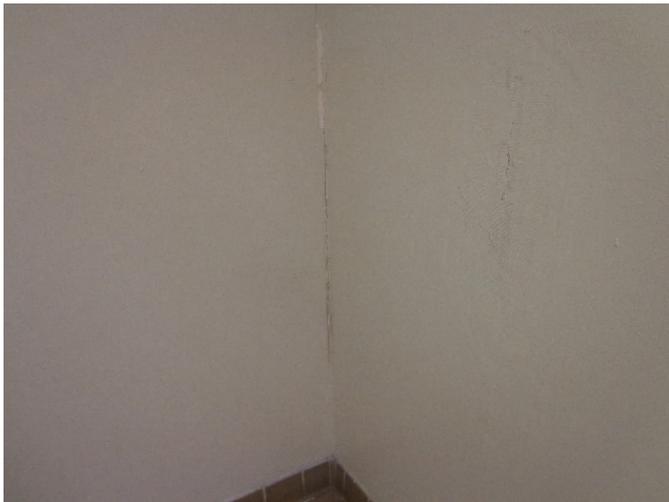
**Location:** Throughout Building  
**Distress:** Beyond Service Life  
**Category:** Deferred Maintenance  
**Priority:** 3 Priority  
**Correction:** Renew System  
**Qty:** 152,350.00  
**Unit of Measure:** S.F.  
**Estimate:** \$323,439.00  
**Assessor Name:** Eduardo Lopez  
**Date Created:** 04/11/2015

**Notes:** The painted wall finishes are beyond their expected life and should be replaced. A moisture protection surface is highly recommended in wet areas; ceramic tiles or fiber glass wainscot panels is also recommended.

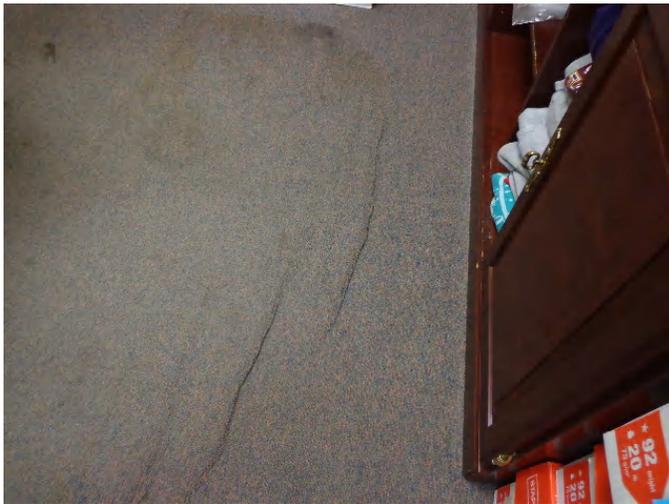
**Location:** Offices  
**Distress:** Beyond Service Life  
**Category:** Deferred Maintenance  
**Priority:** 3 Priority  
**Correction:** Renew System  
**Qty:** 3,539.00  
**Unit of Measure:** S.F.  
**Estimate:** \$33,090.00  
**Assessor Name:** Eduardo Lopez  
**Date Created:** 04/11/2015

**Notes:** The carpet is aged and stained, and should be replaced.

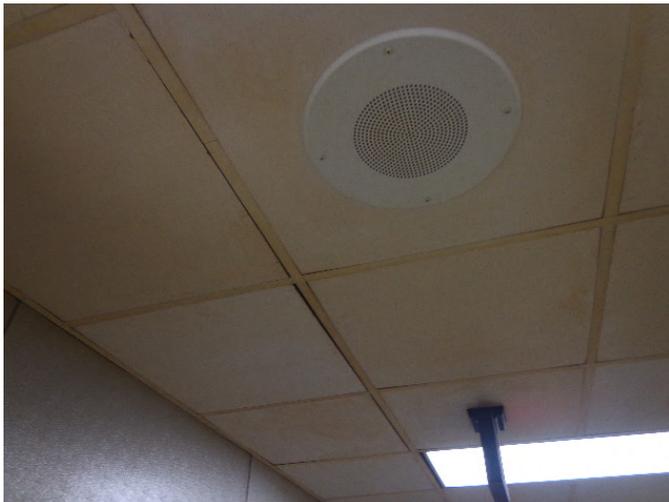
**Location:** Kitchen Area  
**Distress:** Inadequate  
**Category:** Deferred Maintenance  
**Priority:** 3 Priority  
**Correction:** Replace acoustic tile ceiling, fire-rated  
**Qty:** 30.00  
**Unit of Measure:** C.S.F.  
**Estimate:** \$20,278.76  
**Assessor Name:** Eduardo Lopez  
**Date Created:** 04/16/2015

**Notes:** Ceiling tiles and grid are inadequate condition with signs of rust and stains, and should be replaced.

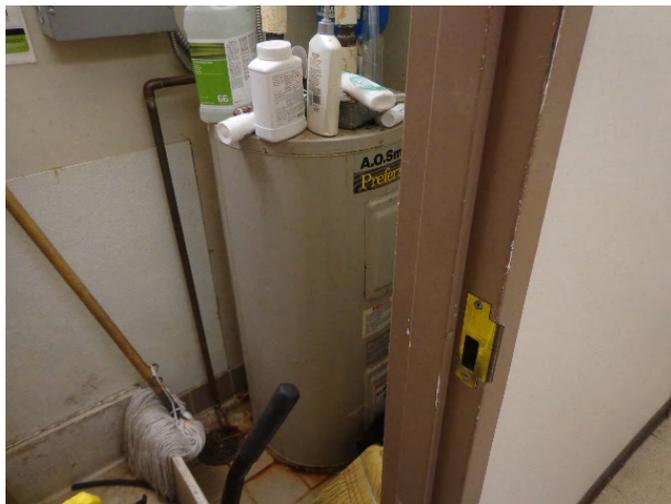
**Location:** B139 Janitor Room

**Distress:** Damaged

**Notes:** The water heater is leaking and rusting and should be replaced.

**Correction:** Replace water heater, electric, 120 gallon

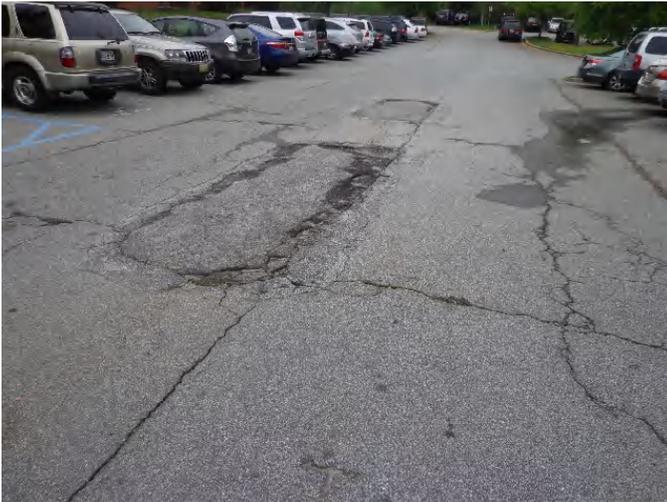
**Location:** East Entrance

**Distress:** Damaged

**Notes:** Two lanes at east paved roadway are damaged should be repaired.

**Correction:** Replace/resurface asphalt roadway

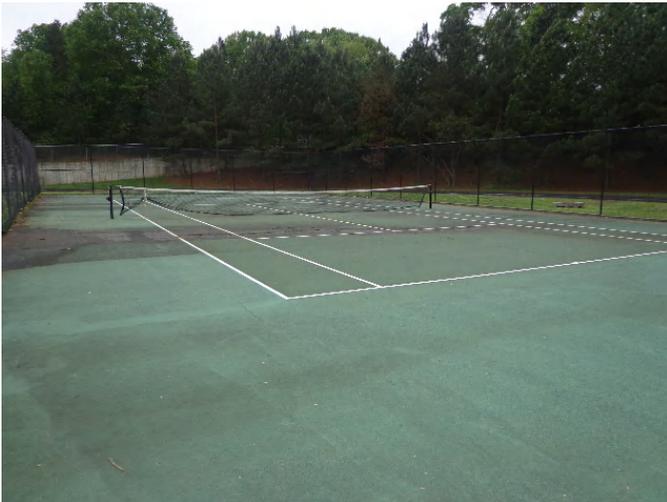
**Location:** Site

**Distress:** Damaged

**Notes:** Tennis court surface is deteriorating, with weeds growing within multiple cracks in the surface. Water infiltration from one side of the court is appears to be accelerating the deterioration.

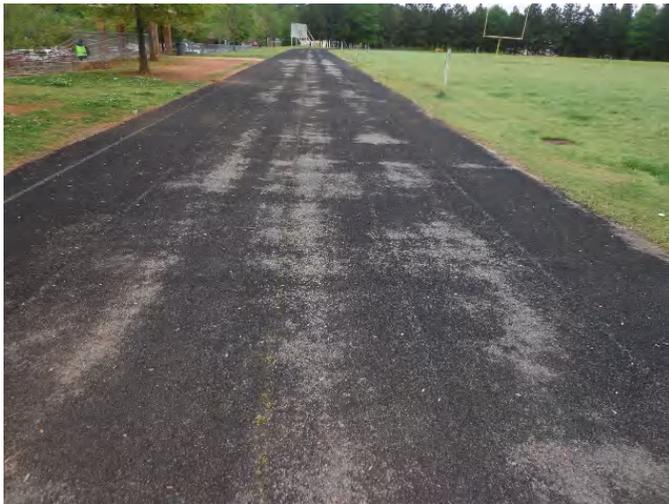
**Location:** Site  
**Distress:** Beyond Service Life  
**Category:** Deferred Maintenance  
**Priority:** 3 Priority  
**Correction:** Renew System  
**Qty:** 25,055.00  
**Unit of Measure:** S.F.  
**Estimate:** \$194,025.92  
**Assessor Name:** Eduardo Lopez  
**Date Created:** 04/16/2015

**Notes:** The track is severely deteriorated and uneven, and requires replacement.

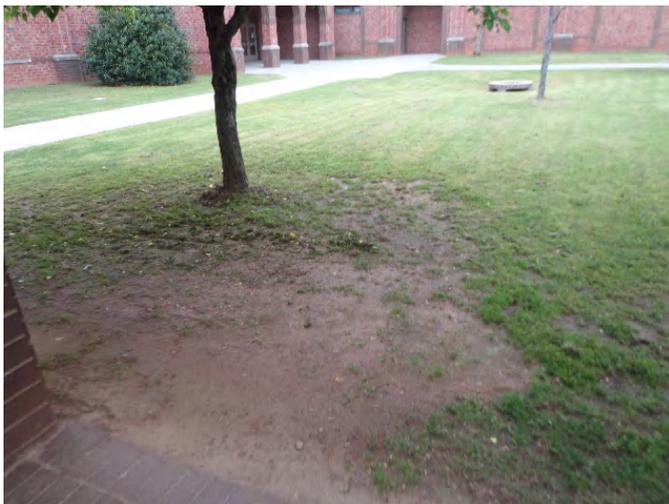
**Location:** Site  
**Distress:** Damaged  
**Category:** Deferred Maintenance  
**Priority:** 3 Priority  
**Correction:** Renew System  
**Qty:** 152,350.00  
**Unit of Measure:** S.F.  
**Estimate:** \$242,998.25  
**Assessor Name:** Eduardo Lopez  
**Date Created:** 04/16/2015

**Notes:** Landscaping is in deteriorating condition. This includes the irrigation system that is reported as partially operational. Work on the site damaged the irrigation system controls, which have been partially repaired, but should be fully repaired or be replaced. Also, the exterior door at the 6th grade west hall side is reported to have water seeping into the building when it rains, and it is recommended to improve grading during landscape improvements.
