Revision Date - 09/24/2021

FACILITY CONDITION ASSESSMENT

Administrative and Instructional Complex (AIC) (EAHS and DECA) | 2021

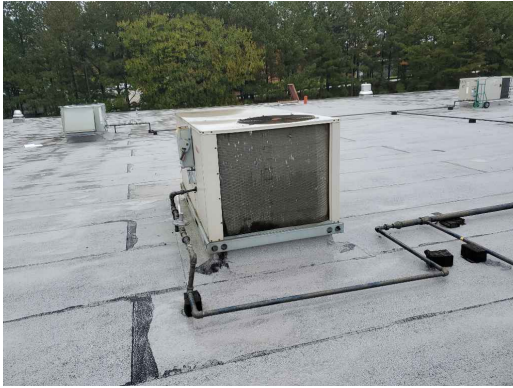
ERTU 20 Unit Coil Shows Corrosion And It Looks Like The Original Unit 5 Ton Unit With Gas Heat

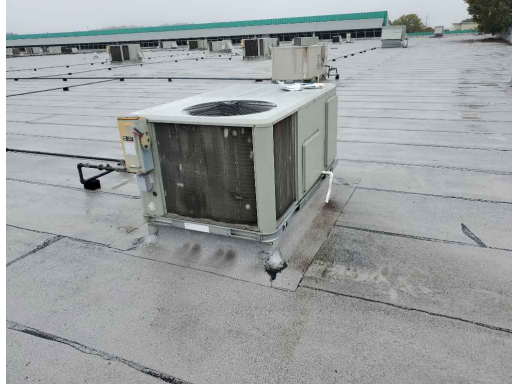
ERTU 22, 5 Ton Unit Shows Corrosion On Coil And Base. Replace These Units Have R-22 Refrigerant

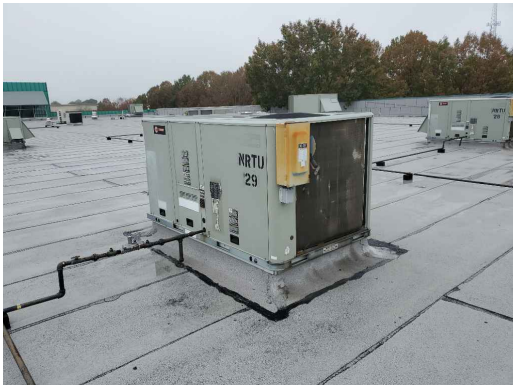
NRTU 29 , 10 Ton Unit Coil, Curb And Disconnect Showing Advance Corrosion. Replace

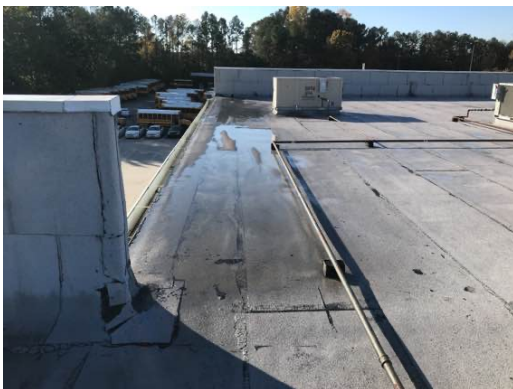
Ponding

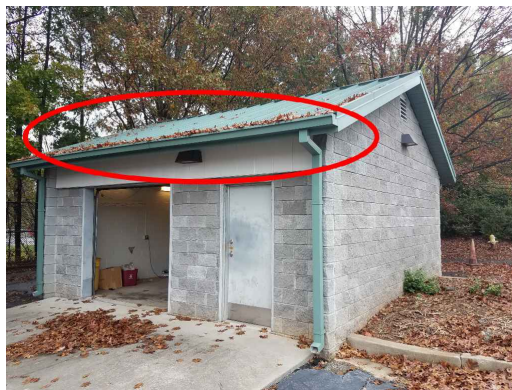
Gutter Needs Cleaning Of Tree Debris

Deficiency	Category	Qty	UoM	Priority	Repair Cost	ID
Debris In Gutter Removal	Deferred Maintenance	100	LF	3	\$485	1909
Note: Located Beneath Trees						
Splash Block Installation	Deferred Maintenance	4	Ea.	5	\$242	1910
Sub Total for System		2	items		\$727

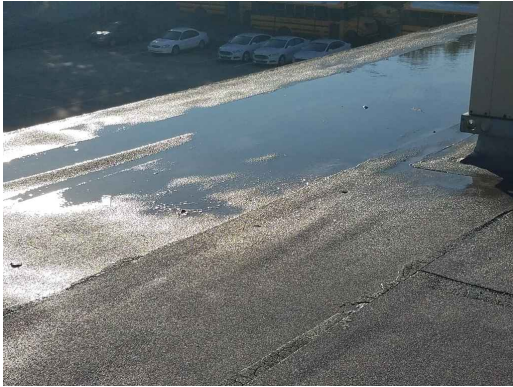
Puddling On The Roof

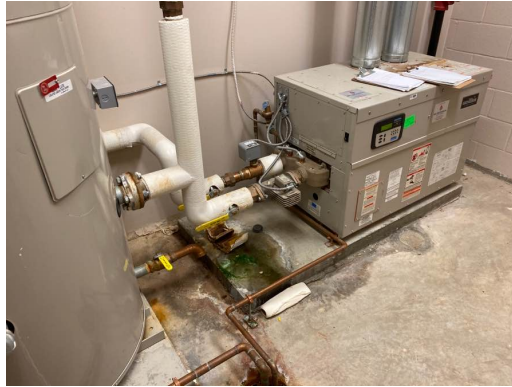
Gas Water Heater Is In Need Of Repair. Water Is Leaking Around Gaskets And Relief Valve
