Revision Date - 09/24/2021

FACILITY CONDITION ASSESSMENT

Shadow Rock Elementary School | 2021

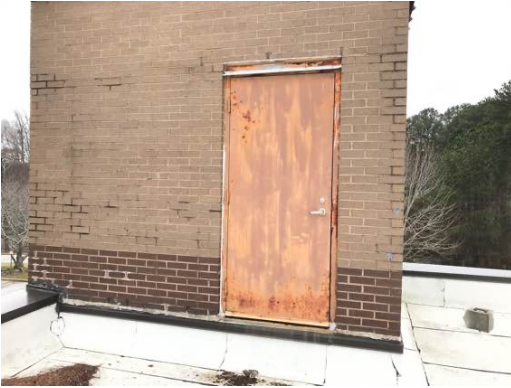
Replace Door On Roof To Bell Tower

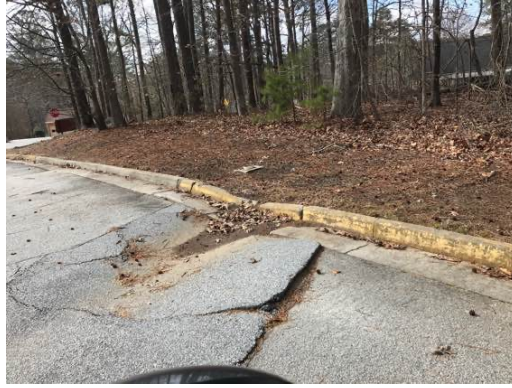
Fix Asphalt Damage

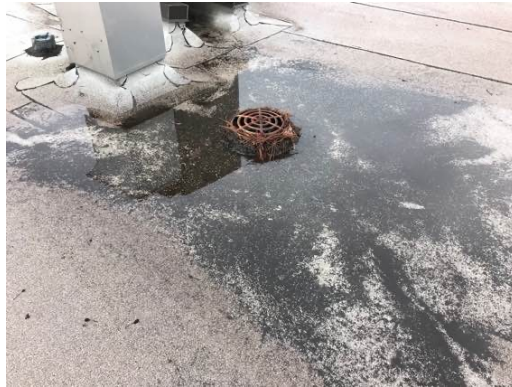
Clean Roof Drains

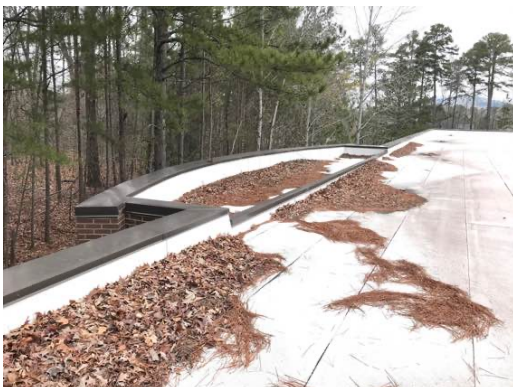
Clean Roof

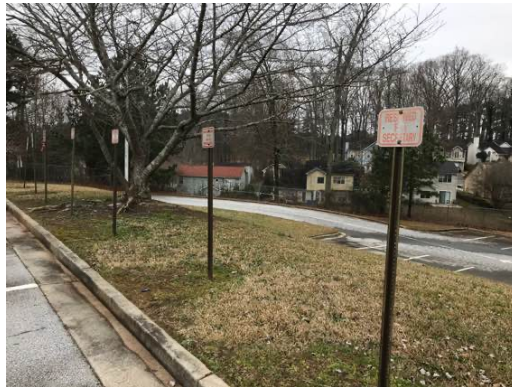
Replace Signs

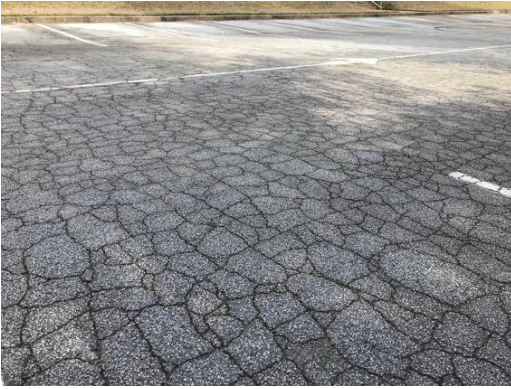
Resurface Asphalt
