# **Facility Condition Assessment Report**

**Marbut Elementary Facility Executive Summary Report**Report Date: 01 Jul 2011

Marbut Elementary School campus consists of one main school building located at 5776 Marbut Road in Lithonia, Georgia. The original campus was constructed in 1994 and a gymnasium building was constructed in 1996. In addition to the buildings, the campus contains a covered walkway, playgrounds, playfield, and hard surface play area. This report contains condition and adequacy data collected during the 2010/2011 Facility Condition Assessment (FCA). The detailed condition and deficiency statements are contained in this report for each building and other facilities on the campus.

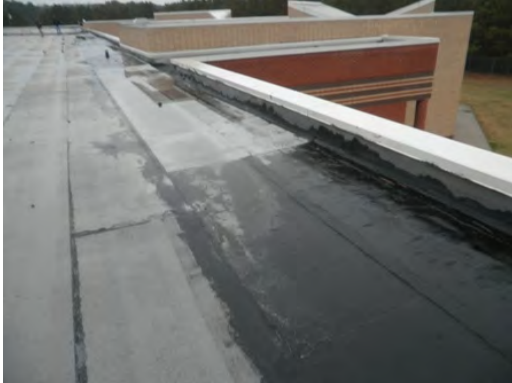
Assembly: **B3010**  
System: **Roof Coverings - BUR**  
Material: **System**  
Distress: **Beyond Service Life**  
Category: **Deferred Maintenance**  
Correction: **Renew System**

Note: **The built-up roofing is aged, has reported leaks, and should be replaced.**

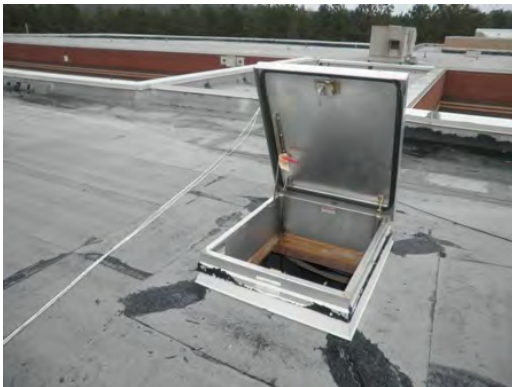
Assembly: **B3020**  
System: **Roof Openings**  
Material: **Roof Hatches, Skylights**  
Distress: **Inadequate**  
Category: **Safety**  
Correction: **Replace Roof Hatches, Skylights**

Note: **The roof hatch and ladder do not comply with OSHA safety requirements and should be replaced with new hatch and ladder.**

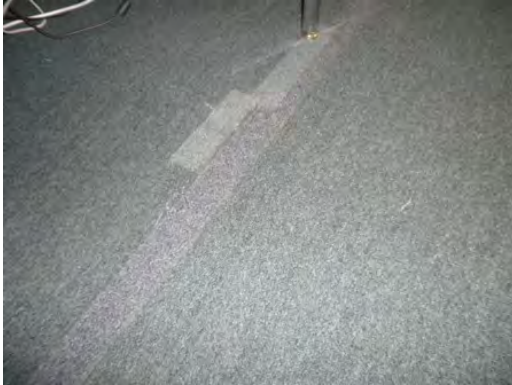
Assembly: **C3020**  
 System: **Floor Finishes - Carpet**  
 Material: **System**  
 Distress: **Beyond Service Life**  
 Category: **Deferred Maintenance**  
 Correction: **Renew System**  
 Note: **The carpet is aged, worn, stained, and frayed, and should be replaced.**

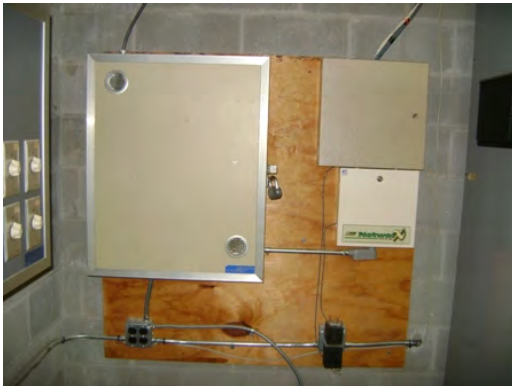
Assembly: **D3060**  
 System: **Controls & Instrumentation**  
 Material: **System**  
 Distress: **Beyond Service Life**  
 Category: **Deferred Maintenance**  
 Correction: **Renew System**  
 Note: **The HVAC controls are inadequate with obsolete parts and equipment and should be replaced.**

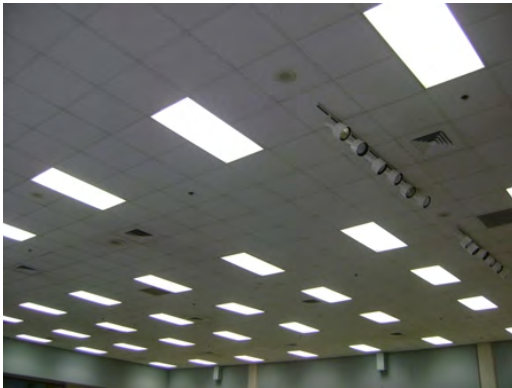
Assembly: **D5020**  
 System: **Lighting**  
 Material: **System**  
 Distress: **Beyond Service Life**  
 Category: **Deferred Maintenance**  
 Correction: **Renew System**

Note: **The original lighting system is operating properly, but is aged and inefficient and should be replaced with an energy efficient system.**

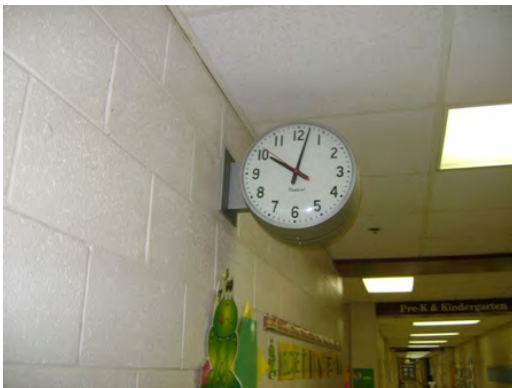
Assembly: **D5030**  
 System: **Communications and Security - Clock & PA**  
 Material: **System**

Distress: **Beyond Service Life**  
 Category: **Deferred Maintenance**  
 Correction: **Renew System**

Note: **Clock and PA systems are aged and outdated and should be replaced.**

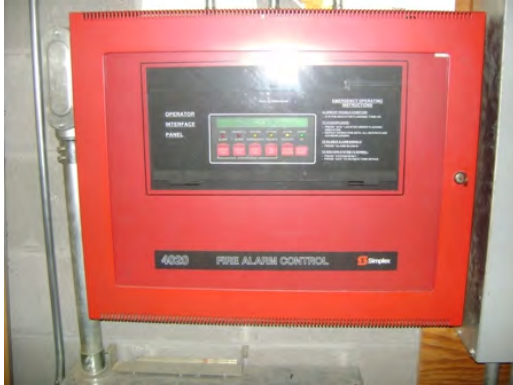
Note: **The original fire alarm system is aged, has reported outages, and should be replaced.**

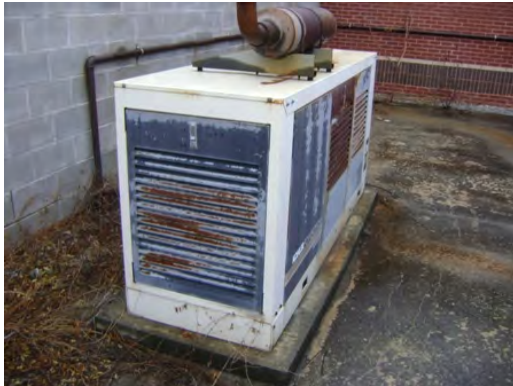
Note: **The emergency generator is aged, worn, and becoming logistically unsupportable, and should be replaced.**

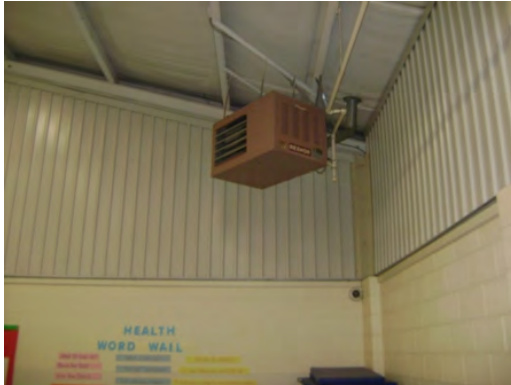
Assembly: **D3050**  
 System: **Terminal & Package Units**  
 Material: **Packaged A/C, Elec. Ht., Const. Volume**  
 Distress: **Missing**  
 Category: **Capital Improvement**  
 Correction: **Install Package A/C - 20 ton**  
 Note: **An air conditioning system is missing in the gymnasium and should be installed.**

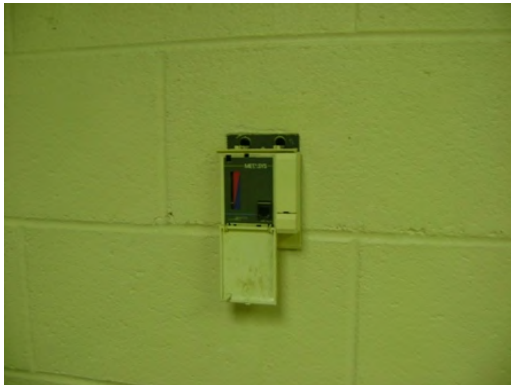
Assembly: **D3060**  
 System: **Controls & Instrumentation**  
 Material: **System**  
 Distress: **Beyond Service Life**  
 Category: **Deferred Maintenance**  
 Correction: **Renew System**  
 Note: **The HVAC controls are aged and outdated and in need of replacement.**

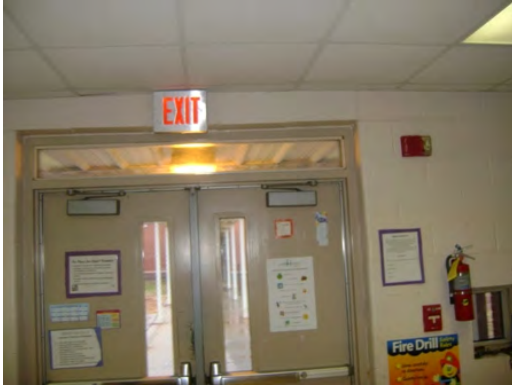
Material: **System**  
Distress: **Inadequate**  
Category: **Code Compliance**  
Correction: **Renew System**

Note: **The security system is inadequate in the gym and should be replaced.**

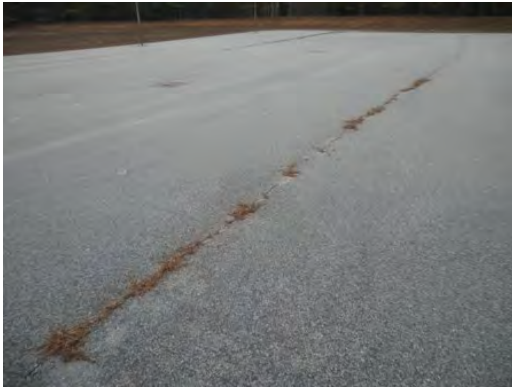
Correction: **The hard surface is cracked and worn and should be replaced.**

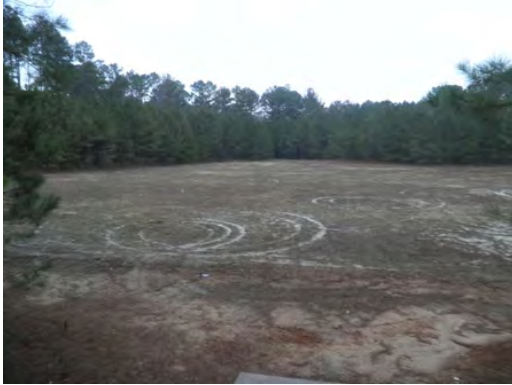
Assembly: **F1040**  
System: **Special Facilities - Sports Field - Natural Turf System**  
Material: **System**  
Distress: **Beyond Service Life**  
Category: **Deferred Maintenance**  
Correction: **Renew System**  
Note: **The grass is worn and should be reseeded.**

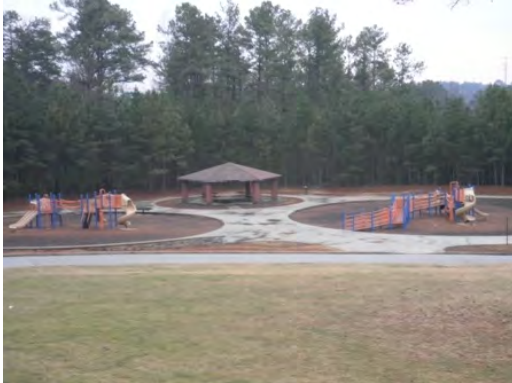
Assembly: **G2040**  
 System: **Site Development**  
 Material: **System**  
 Distress: **Beyond Service Life**  
 Category: **Safety**  
 Correction: **Renew System**  
 Note: **The playground surface is worn, beyond its service life, and needs to be replaced to provide fall protection.**

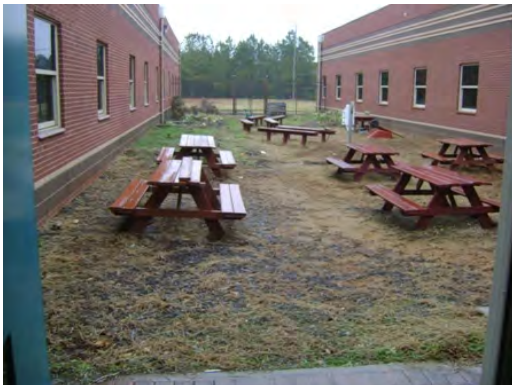
G3030	Storm Sewer	Engineering Study for Storm Drainage		Inadequate	Study analyze and develop solution	1	Ea.	\$25,000	\$6,500	\$31,500	Necessary	Deferred Maintenance	A engineering study is necessary to determine the cause of and solution to the storm and rain water back-up and intrusion into the courtyards.

Assembly: **G3030**  
 System: **Storm Sewer**  
 Material: **Engineering Study for Storm Drainage**  
 Distress: **Inadequate**  
 Category: **Deferred Maintenance**  
 Correction: **Study analyze and develop solution**  
 Note: **A engineering study is necessary to determine the cause of and solution to the storm and rain water back-up and intrusion into the courtyards.**
