DeKalb County School District/Education Other

# Avondale High/DeKalb School of the Arts

## School Assessment Report

May 19, 2016

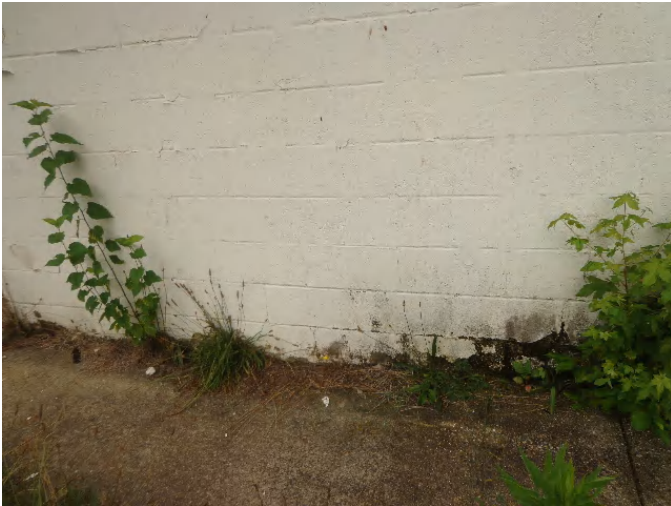
#### System: B2010 - Exterior Walls

**Location:** Exterior Walls

**Distress:** Inadequate

**Notes:** The painted exterior wall finish is aged and stained, and should be replaced.

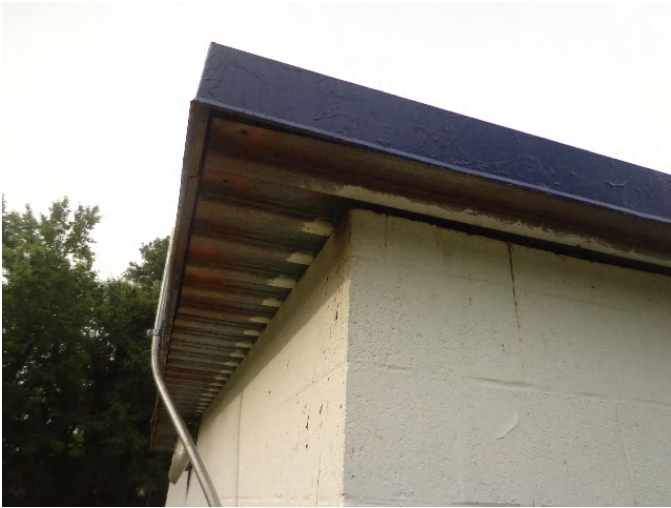
**System: B3010 - Roof Coverings**

**Location:** Roof  
**Distress:** Beyond Service Life  
**Category:** Deferred Maintenance  
**Priority:** 3 Priority  
**Correction:** Renew System  
**Qty:** 380.00  
**Unit of Measure:** S.F.  
**Estimate:** \$6,103.00  
**Assessor Name:** Eduardo Lopez  
**Date Created:** 09/02/2015

**Notes:** The roof covering is aged, showing signs of failure, and should be replaced.

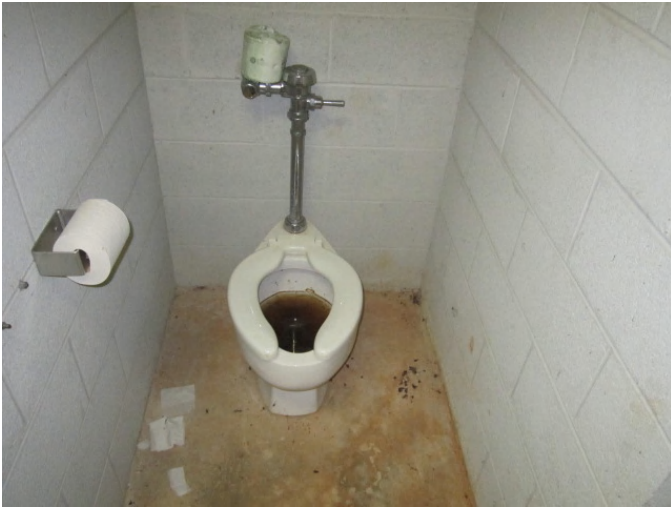
**System: D2010 - Plumbing Fixtures**

**Location:** Restrooms  
**Distress:** Beyond Service Life  
**Category:** Deferred Maintenance  
**Priority:** 3 Priority  
**Correction:** Renew System  
**Qty:** 380.00  
**Unit of Measure:** S.F.  
**Estimate:** \$3,223.00  
**Assessor Name:** Eduardo Lopez  
**Date Created:** 09/02/2015

**Notes:** The plumbing fixtures are beyond their expected service life and should be scheduled for replacement.

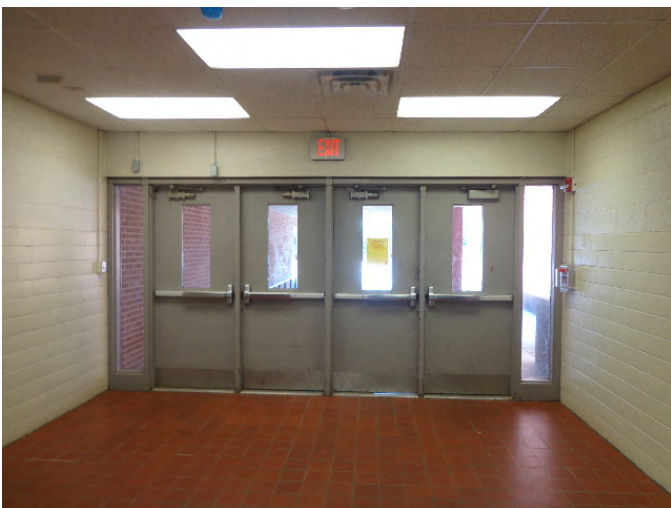
#### **System: B2030 - Exterior Doors**

**Location:** Throughout Building

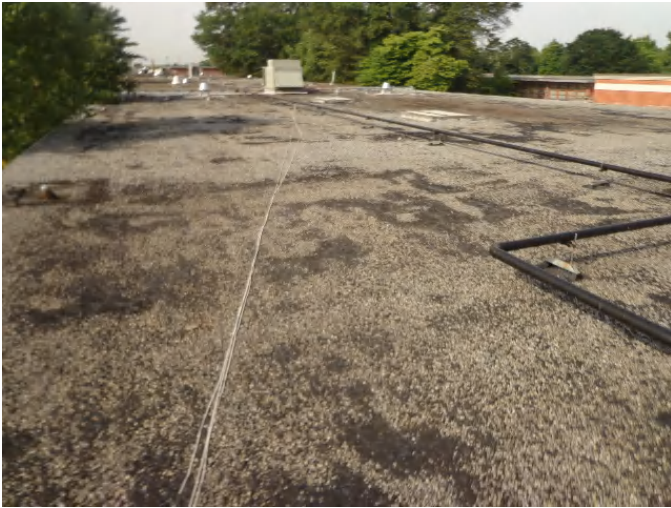
**System: B3010 - Roof Coverings - BUR**

**Location:** Roof

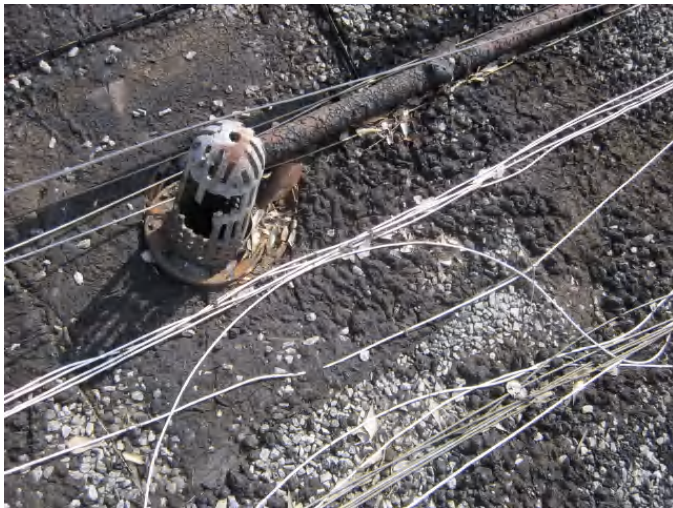
**System: D2040 - Rain Water Drainage**

**Location:** Roof  
**Distress:** Beyond Service Life  
**Category:** Deferred Maintenance  
**Priority:** 3 Priority  
**Correction:** Renew System  
**Qty:** 106,700.00  
**Unit of Measure:** S.F.  
**Estimate:** \$98,591.00  
**Assessor Name:** Ben Nixon  
**Date Created:** 04/11/2015

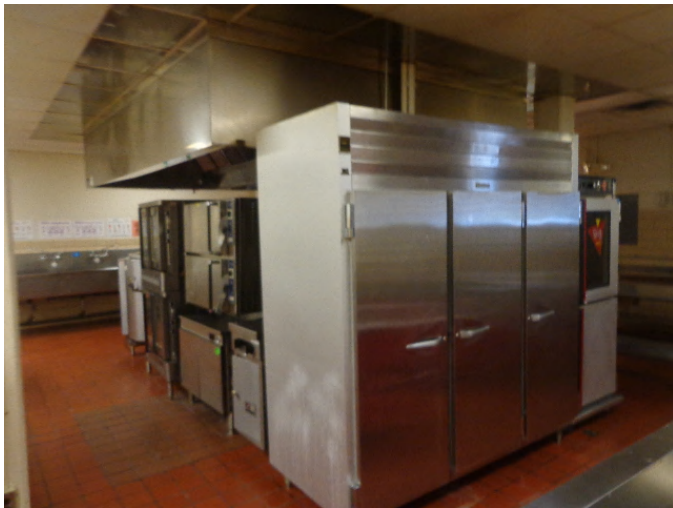
**System: E1090 - Other Equipment - Kitchen Equipment**

**Location:** Kitchen  
**Distress:** Beyond Service Life  
**Category:** Deferred Maintenance  
**Priority:** 3 Priority  
**Correction:** Renew System  
**Qty:** 106,700.00  
**Unit of Measure:** S.F.  
**Estimate:** \$413,996.00  
**Assessor Name:** Ben Nixon  
**Date Created:** 04/11/2015

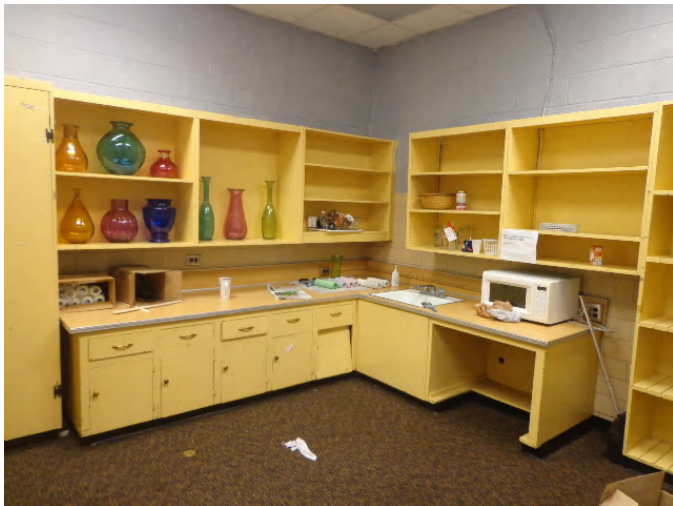
**System: E2010 - Fixed Furnishings**

**Location:** Throughout Building  
**Distress:** Beyond Service Life  
**Category:** Deferred Maintenance  
**Priority:** 3 Priority  
**Correction:** Renew System  
**Qty:** 106,700.00  
**Unit of Measure:** S.F.  
**Estimate:** \$1,064,546.00  
**Assessor Name:** Ben Nixon  
**Date Created:** 09/03/2015

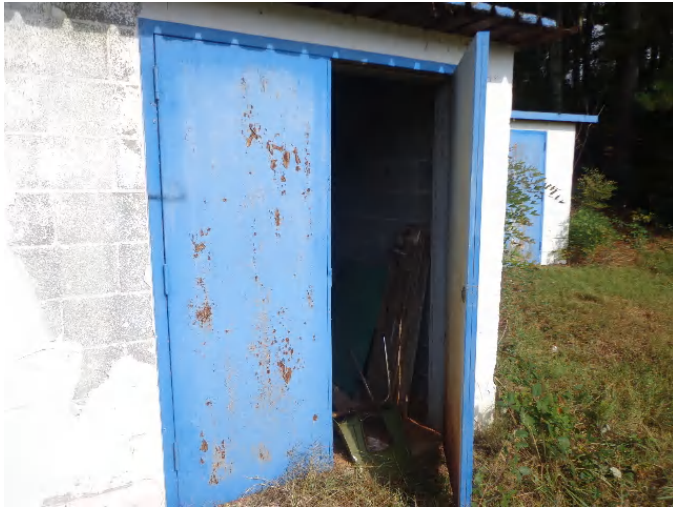
**Location:** Exterior Wall  
**Distress:** Beyond Service Life  
**Category:** Deferred Maintenance  
**Priority:** 3 Priority  
**Correction:** Renew System  
**Qty:** 700.00  
**Unit of Measure:** S.F.  
**Estimate:** \$3,973.00  
**Assessor Name:** Eduardo Lopez  
**Date Created:** 04/11/2015

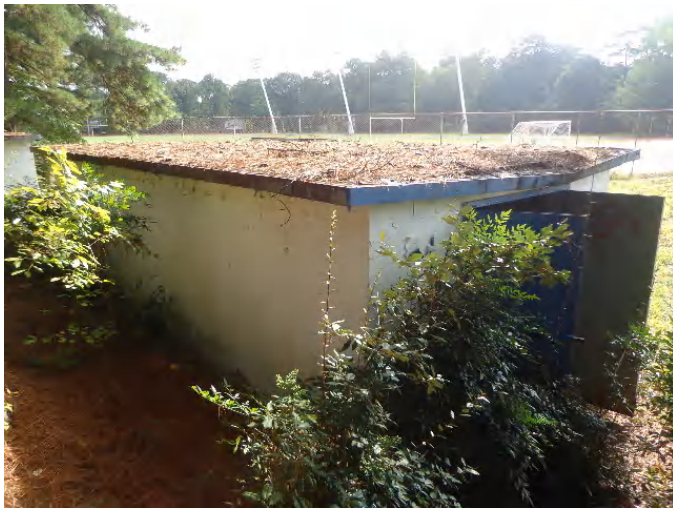
**Location:** Roof  
**Distress:** Beyond Service Life  
**Category:** Deferred Maintenance  
**Priority:** 3 Priority  
**Correction:** Renew System  
**Qty:** 700.00  
**Unit of Measure:** S.F.  
**Estimate:** \$12,928.00  
**Assessor Name:** Eduardo Lopez  
**Date Created:** 04/11/2015

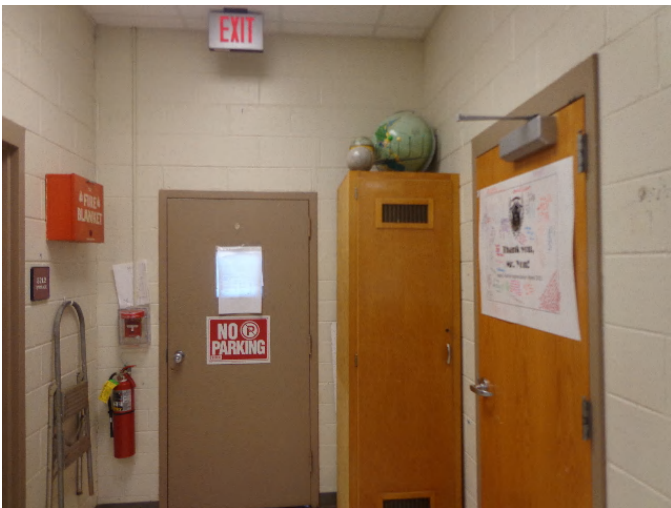
**Location:** Throughout Building

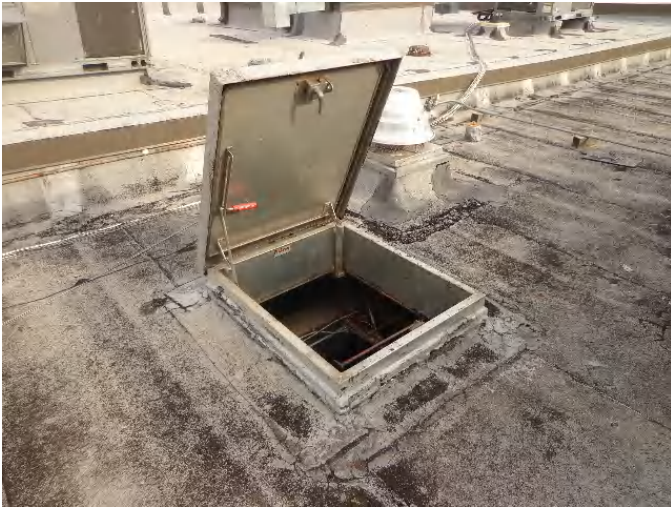
**Location:** Roof  
**Distress:** Beyond Service Life  
**Category:** Deferred Maintenance / Building Code Compliance  
**Priority:** 3 Priority  
**Correction:** Renew System  
**Qty:** 45,260.00  
**Unit of Measure:** S.F.  
**Estimate:** \$2,987.00  
**Assessor Name:** Eduardo Lopez  
**Date Created:** 04/11/2015

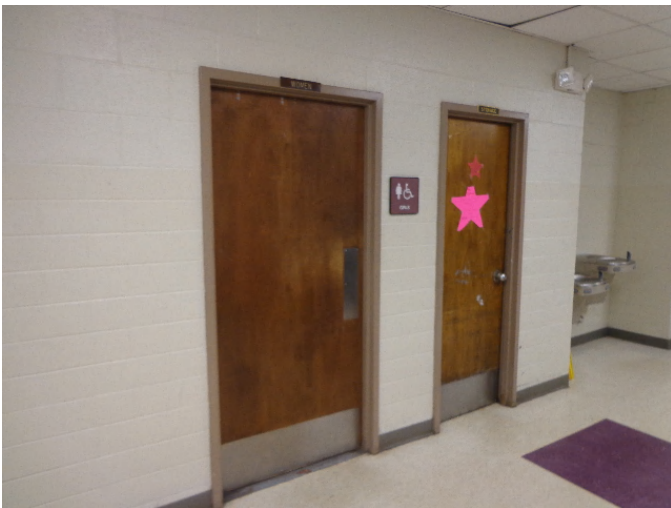
**Location:** First Floor Corridor  
**Distress:** Beyond Service Life  
**Category:** Deferred Maintenance / Accessibility Code Compliance  
**Priority:** 3 Priority  
**Correction:** Remove/replace wood door/frame w/fire rated ADA compliant wood door w/metal frame  
**Qty:** 25.00  
**Unit of Measure:** Ea.  
**Estimate:** \$33,269.04  
**Assessor Name:** Eduardo Lopez  
**Date Created:** 09/03/2015

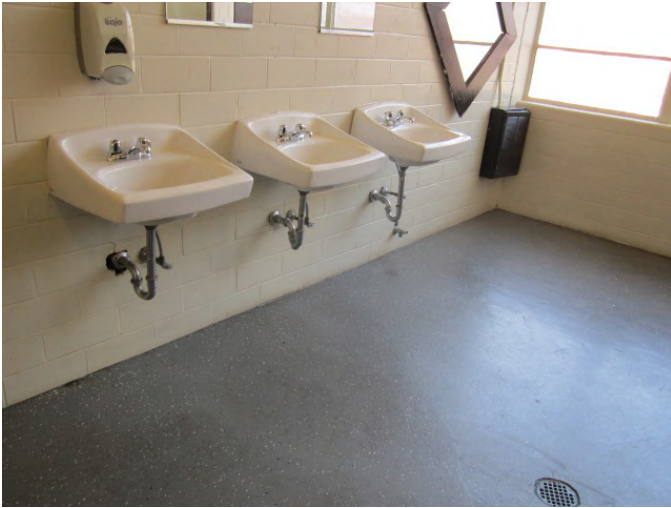
**Location:** Throughout Building  
**Distress:** Beyond Service Life  
**Category:** Deferred Maintenance  
**Priority:** 3 Priority  
**Correction:** Renew System  
**Qty:** 45,260.00  
**Unit of Measure:** S.F.  
**Estimate:** \$213,084.00  
**Assessor Name:** Eduardo Lopez  
**Date Created:** 04/11/2015

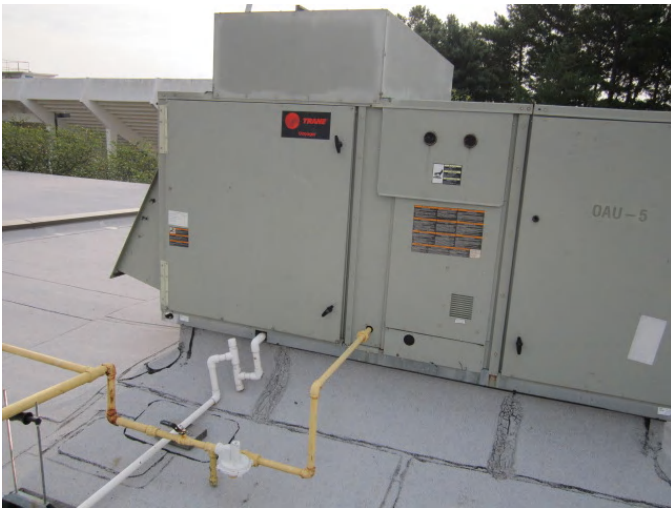
**Location:** Throughout Building  
**Distress:** Beyond Service Life  
**Category:** Deferred Maintenance  
**Priority:** 3 Priority  
**Correction:** Renew System  
**Qty:** 45,260.00  
**Unit of Measure:** S.F.  
**Estimate:** \$34,352.00  
**Assessor Name:** Eduardo Lopez  
**Date Created:** 04/11/2015

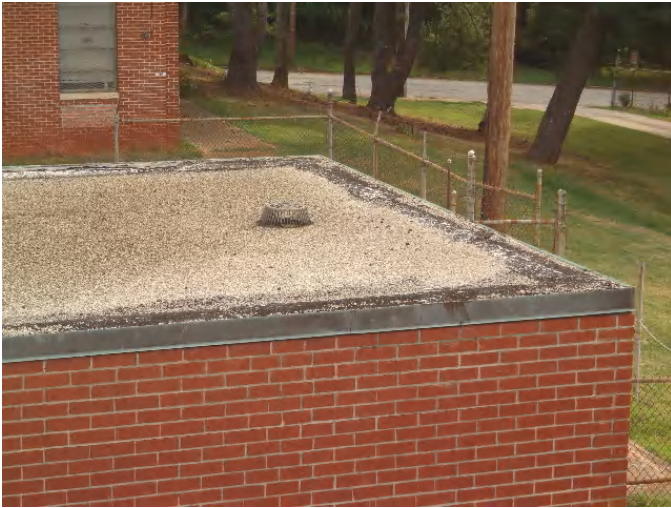
**Location:** Roof  
**Distress:** Beyond Service Life  
**Category:** Deferred Maintenance  
**Priority:** 3 Priority  
**Correction:** Renew System  
**Qty:** 225.00  
**Unit of Measure:** S.F.  
**Estimate:** \$1,403.00  
**Assessor Name:** Eduardo Lopez  
**Date Created:** 09/03/2015

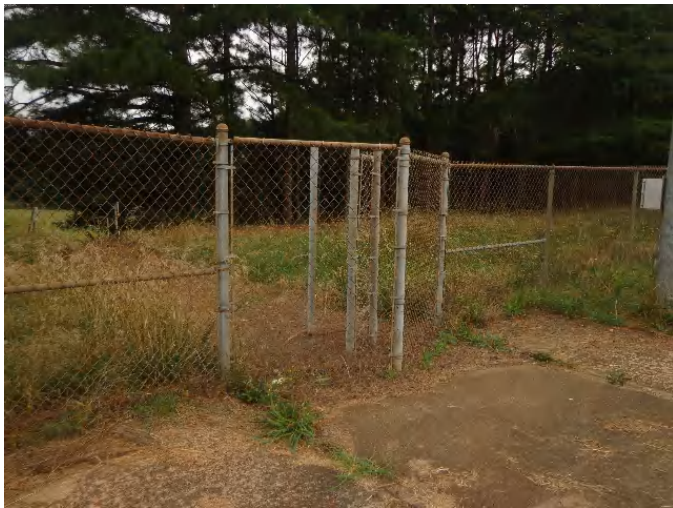
**Location:** Site  
**Distress:** Beyond Service Life  
**Category:** Deferred Maintenance  
**Priority:** 3 Priority  
**Correction:** Renew System  
**Qty:** 164,365.00  
**Unit of Measure:** S.F.  
**Estimate:** \$164,529.37  
**Assessor Name:** Eduardo Lopez  
**Date Created:** 06/25/2015

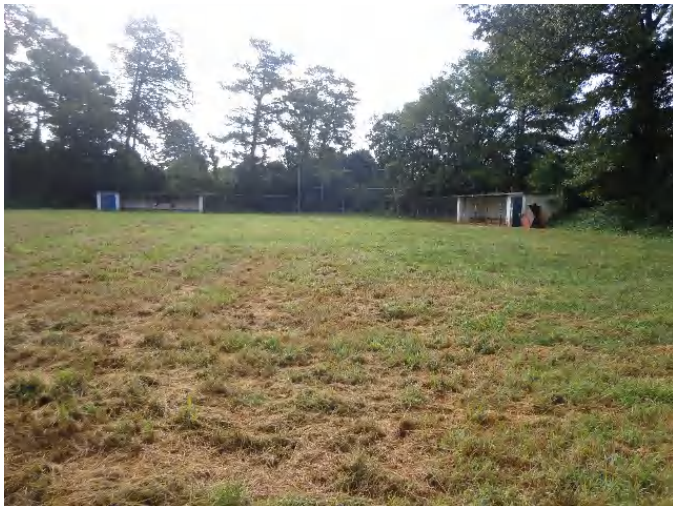
**Location:** Site  
**Distress:** Beyond Service Life  
**Category:** Deferred Maintenance  
**Priority:** 3 Priority  
**Correction:** Renew System  
**Qty:** 36,830.00  
**Unit of Measure:** S.F.  
**Estimate:** \$358,945.18  
**Assessor Name:** Eduardo Lopez  
**Date Created:** 09/03/2015

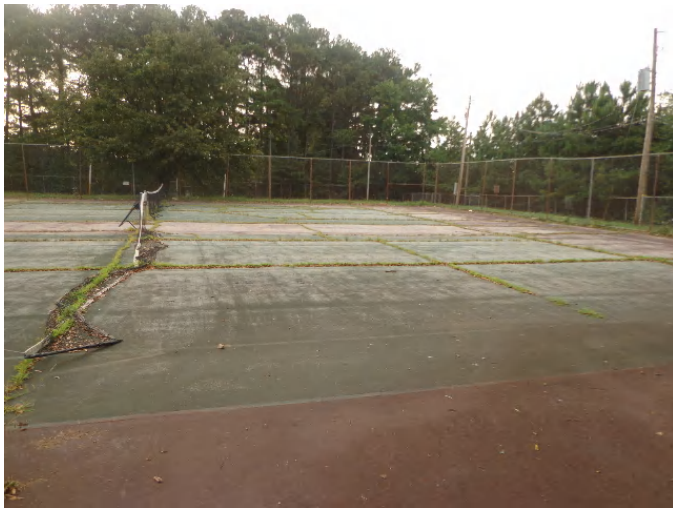
**Location:** Site  
**Distress:** Beyond Service Life  
**Category:** Deferred Maintenance  
**Priority:** 3 Priority  
**Correction:** Renew System  
**Qty:** 13,132.00  
**Unit of Measure:** S.F.  
**Estimate:** \$266,802.84  
**Assessor Name:** Eduardo Lopez  
**Date Created:** 09/03/2015

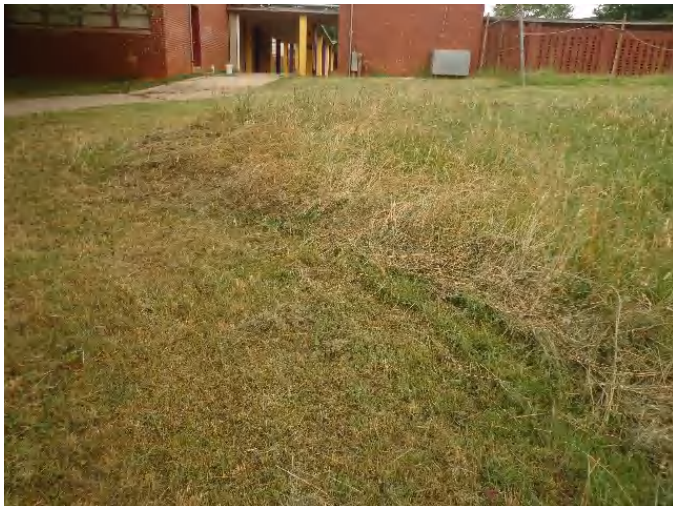
**Location:** Site  
**Distress:** Beyond Service Life  
**Category:** Deferred Maintenance  
**Priority:** 3 Priority  
**Correction:** Renew System  
**Qty:** 164,365.00  
**Unit of Measure:** S.F.  
**Estimate:** \$262,162.18  
**Assessor Name:** Eduardo Lopez  
**Date Created:** 06/25/2015

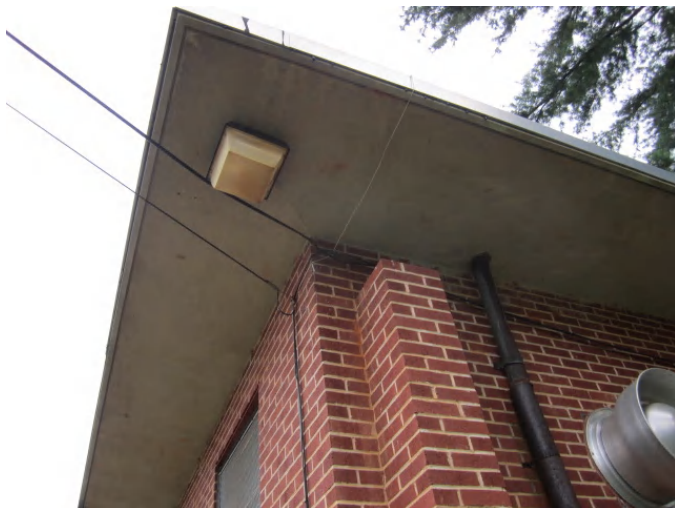
**Location:** Site  
**Distress:** Beyond Service Life  
**Category:** Deferred Maintenance / Safety  
**Priority:** 3 Priority  
**Correction:** Renew System  
**Qty:** 164,365.00  
**Unit of Measure:** S.F.  
**Estimate:** \$207,921.73  
**Assessor Name:** Eduardo Lopez  
**Date Created:** 06/25/2015

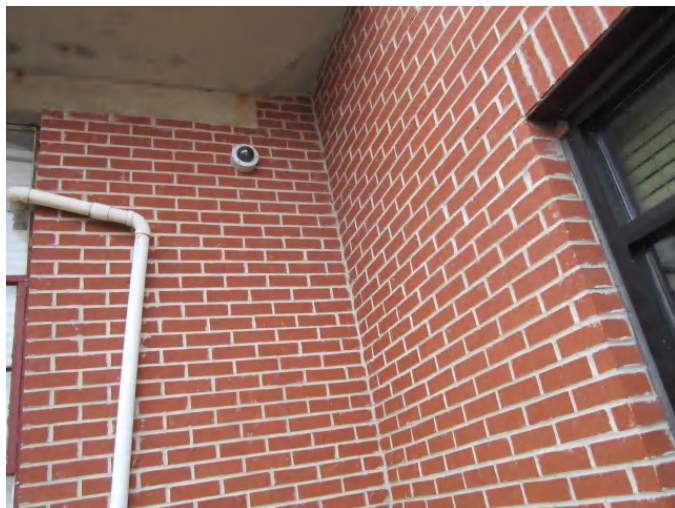
**Location:** Site  
**Distress:** Beyond Service Life  
**Category:** Deferred Maintenance / Safety  
**Priority:** 3 Priority  
**Correction:** Renew System  
**Qty:** 164,365.00  
**Unit of Measure:** S.F.  
**Estimate:** \$121,137.01  
**Assessor Name:** Sam Mandola  
**Date Created:** 06/25/2015
